Inspection Photos

API: 071-06094

Operator: AMOCO PRODUCTION COMPANY

Inspection Date: 7/22/2021

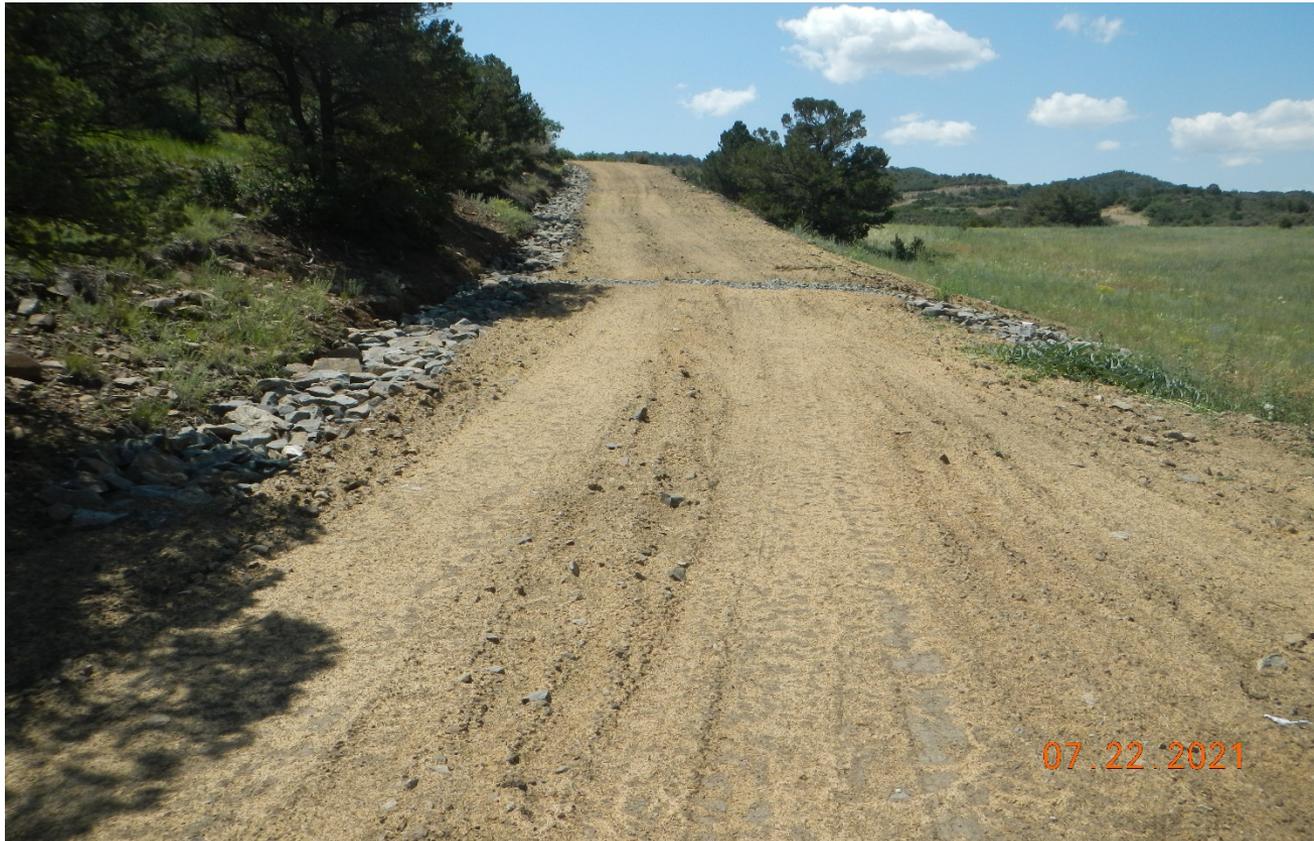
Photo 1. Facing south toward the access road. The road was not recontoured and reclaimed per the rules. Stormwater BMP's have been installed along the road.

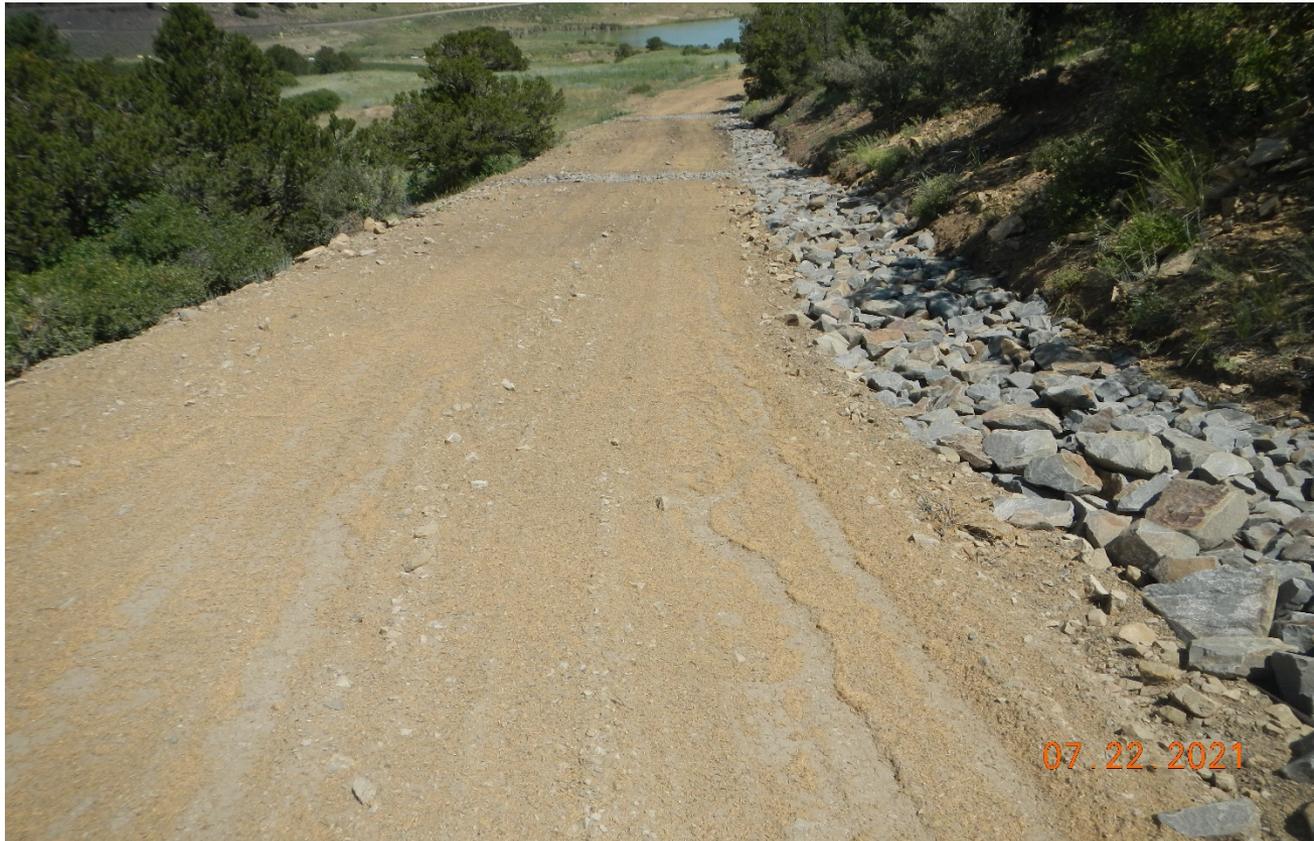
Photo 2. Facing back down the road. Rock rip/rap has been installed along the side of the road but is higher than the road which may cause stormwater to flow down the road.

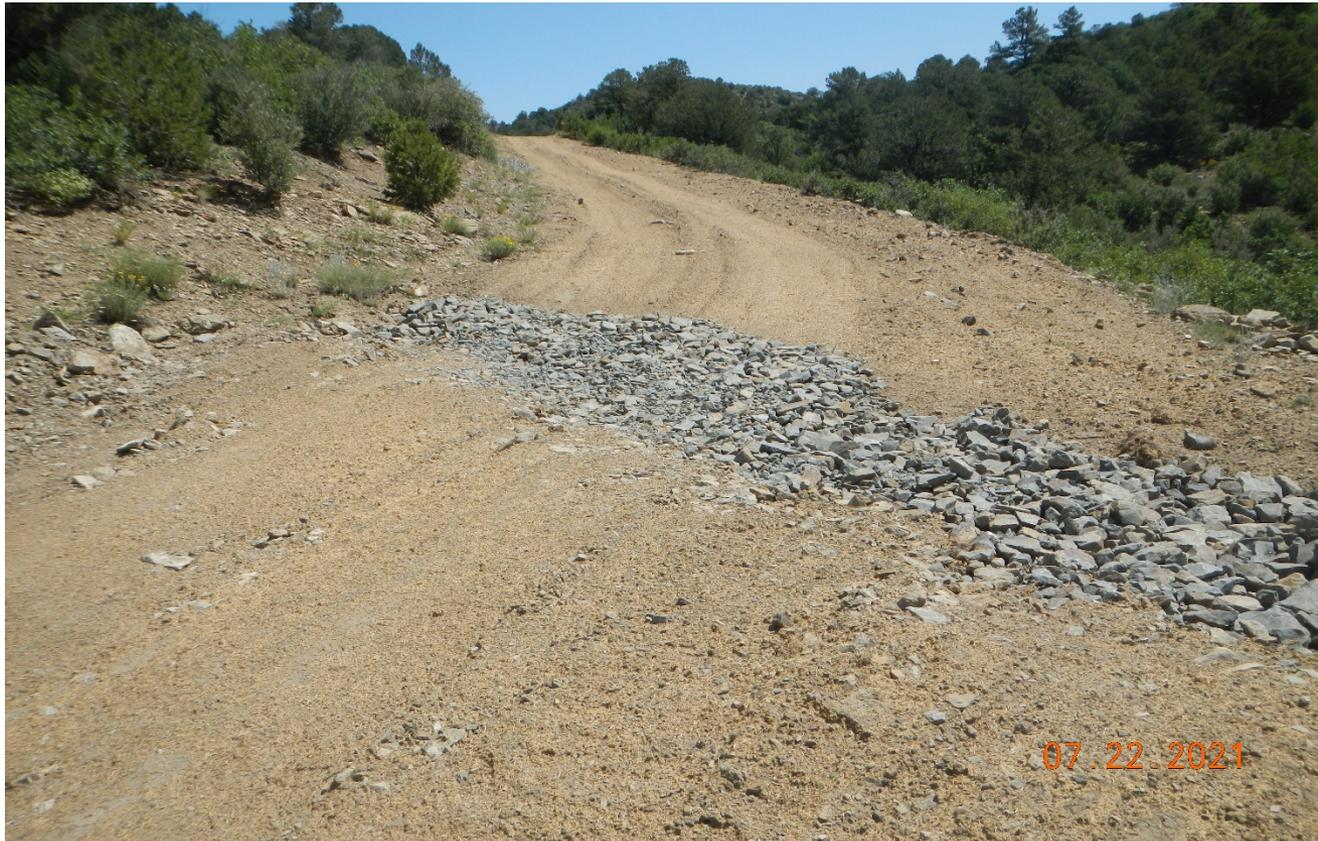
Photo 3. Facing northeast along the access road.

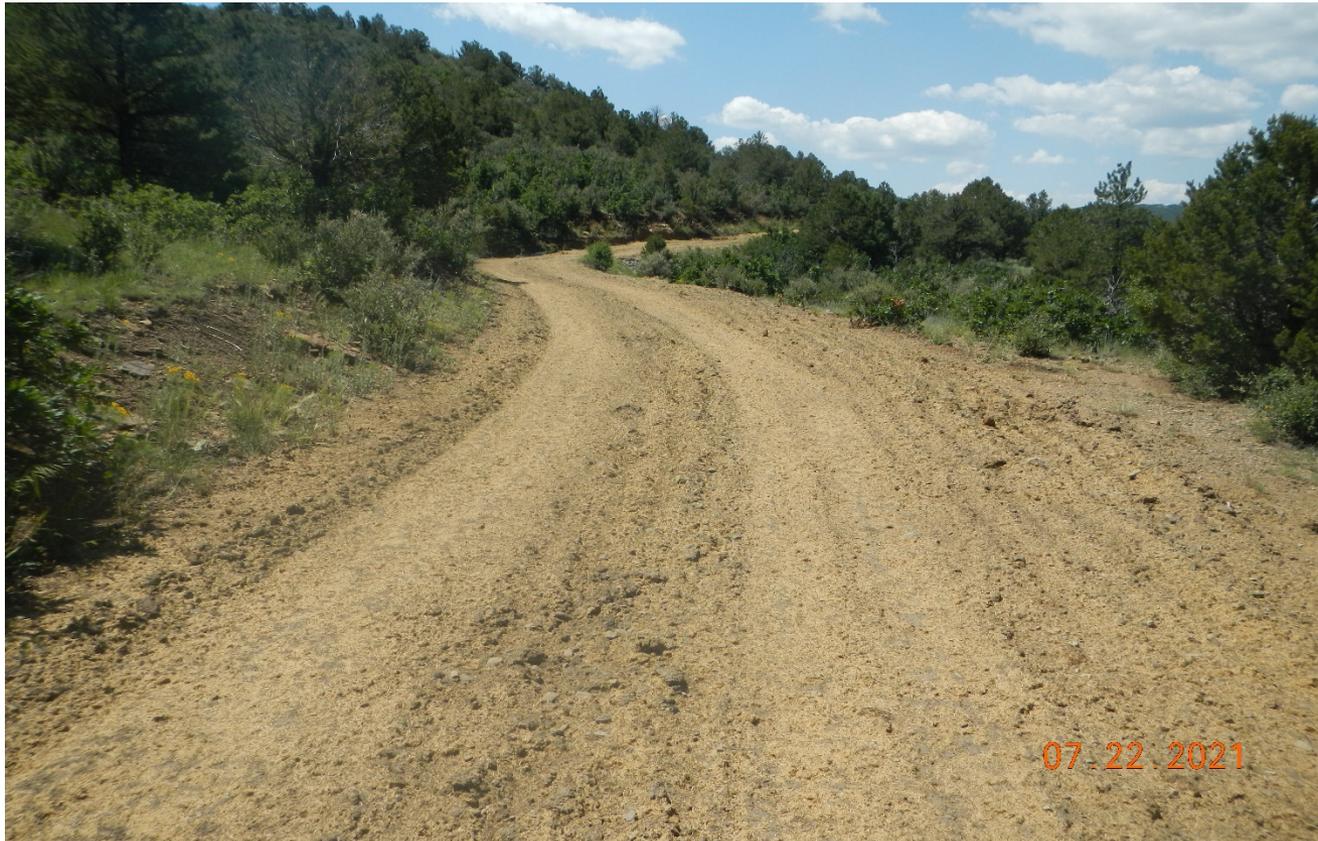
Photo 4. Facing south along the access road.

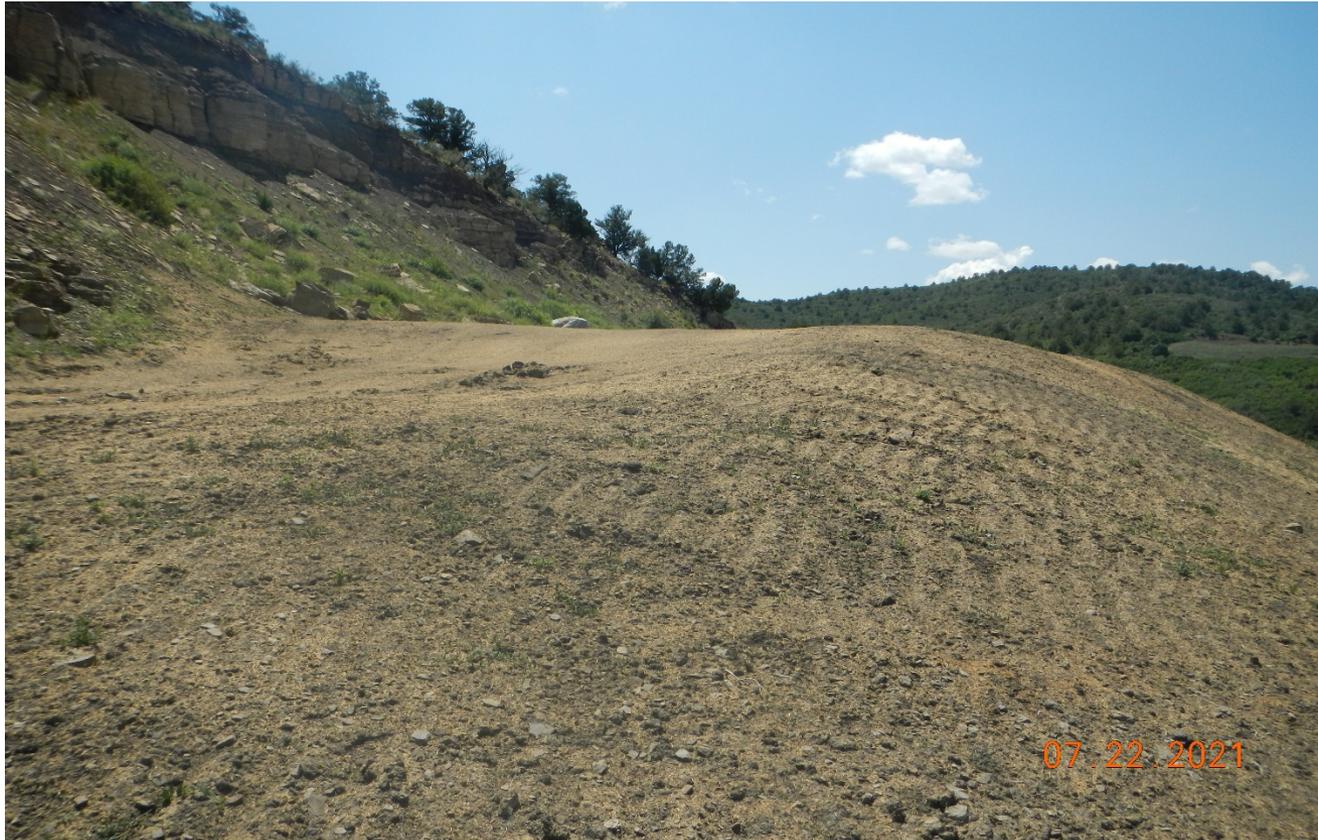
Photo 5. Facing south toward the location. The location has not been recontoured and reclaimed per the rules.

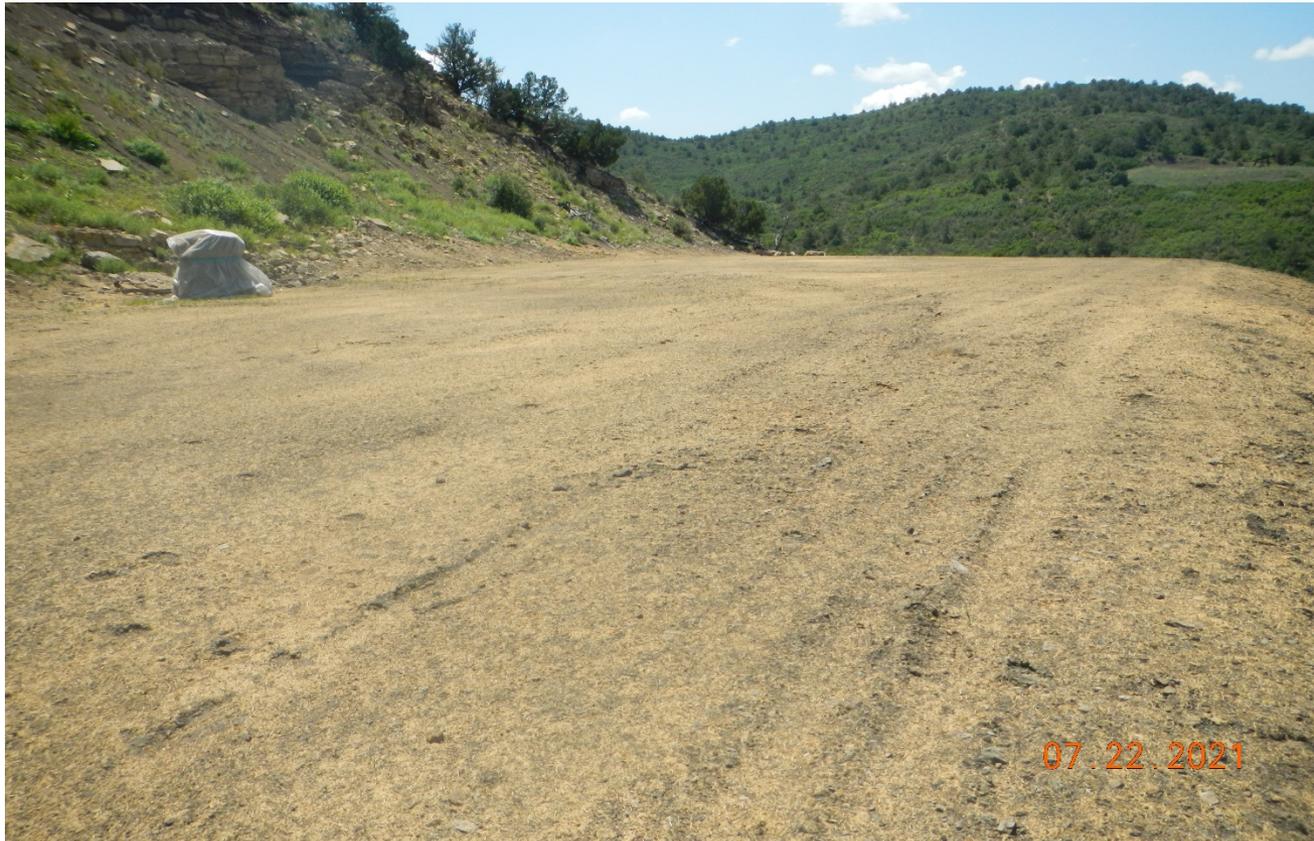
Photo 6. The flat surface of the well pad still remains.

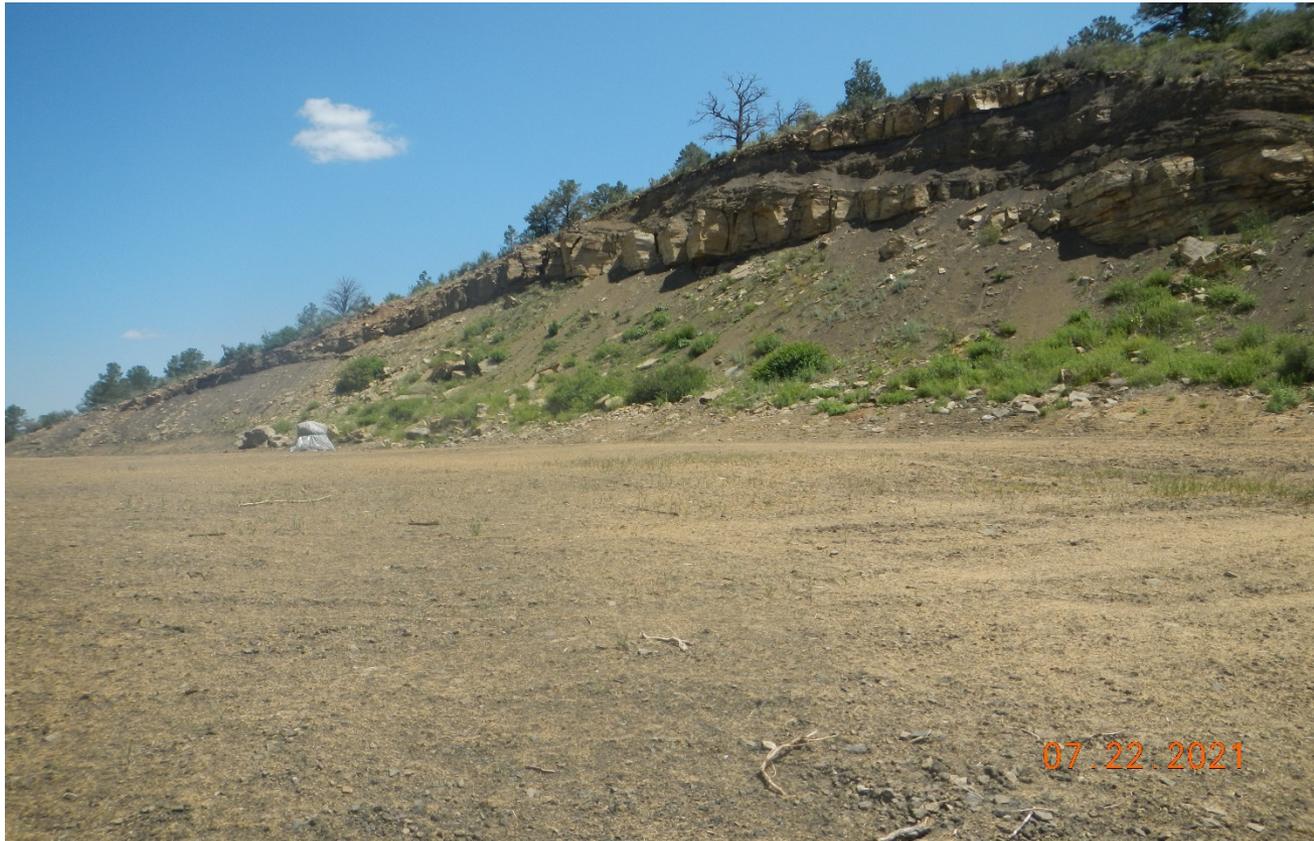
Photo 7. Facing northeast toward the location. A vertical unstable cut slope still remains. The fill slope material was not resloped back to the cut slope.

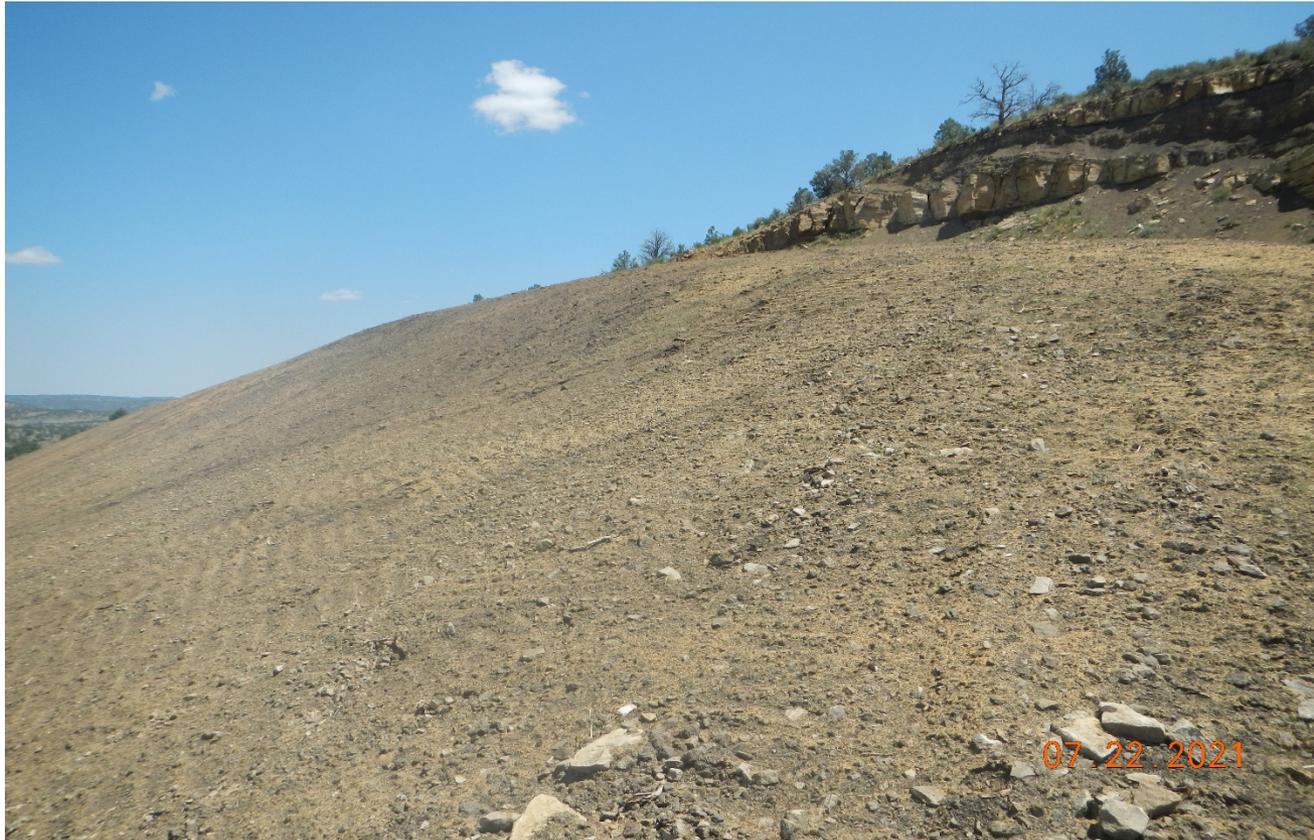
Photo 8. Facing northeast toward the fill slope of the location. This fill material was not recontoured back into the cut slope.

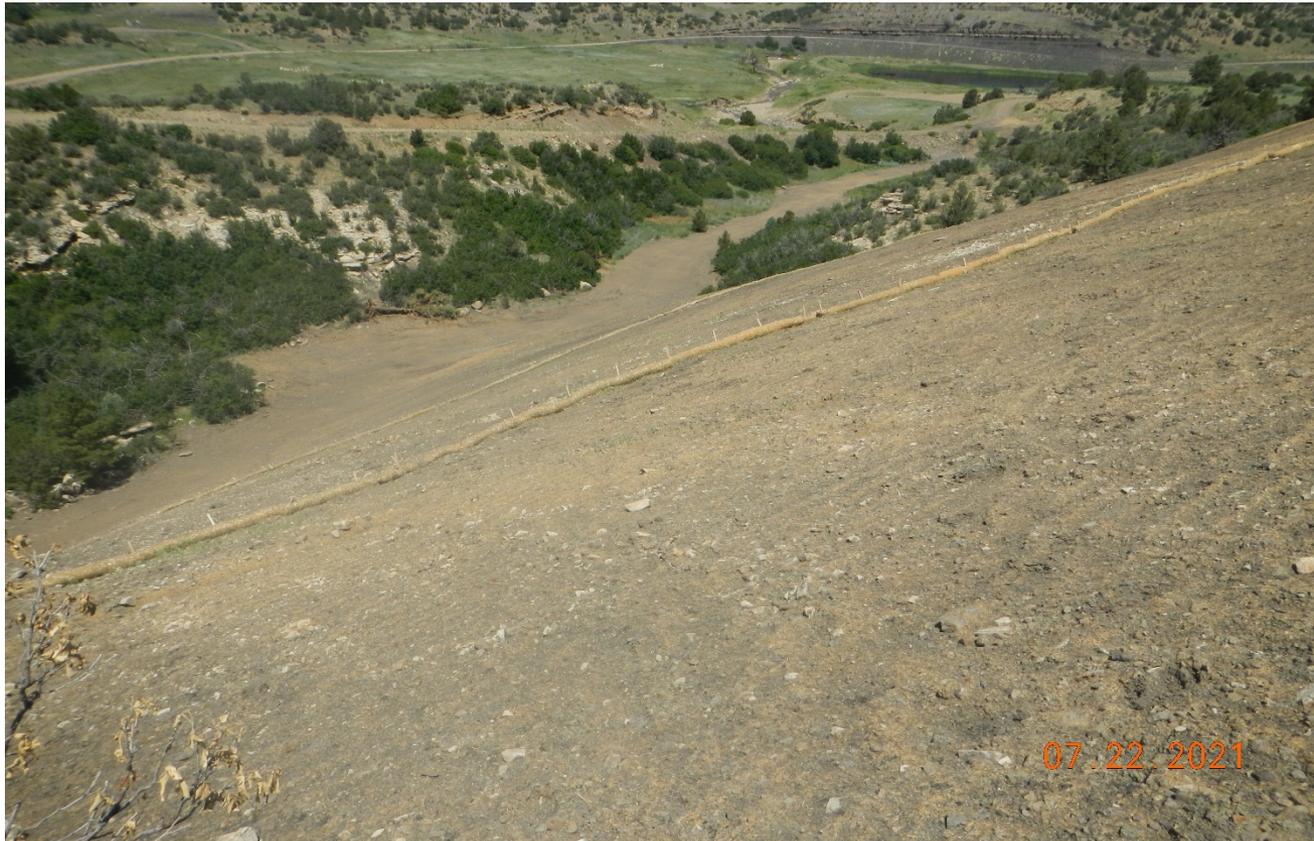
Photo 9. Facing down the fill slope of the location which was graded and seeded. It was observed that a light amount of hydromulch was applied to soils. There are only two rows of wattles installed on the steep slope which may not be sufficient.

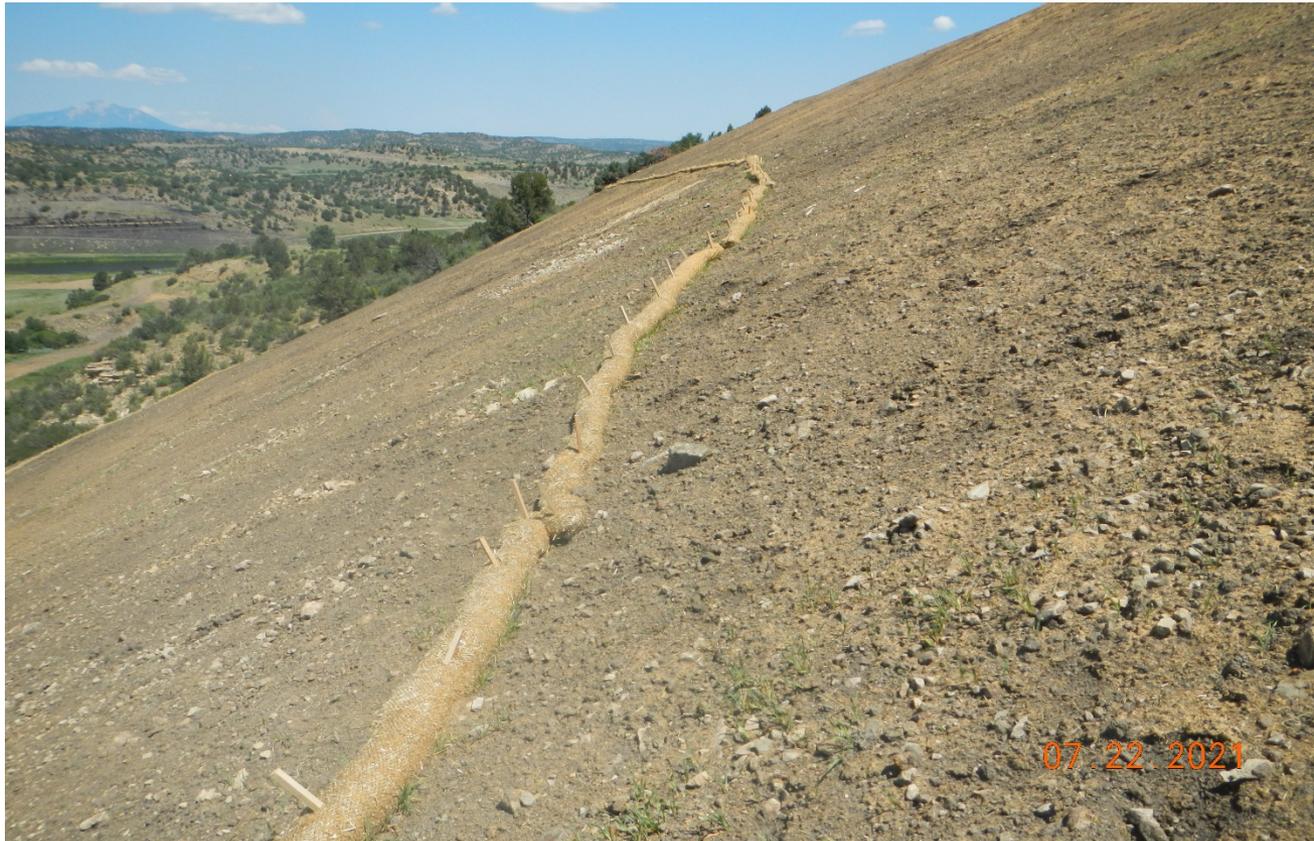
Photo 10. Facing north along the fill slope. The wattles along the slope did not appear to be properly trenched into the soil which can cause the wattles to be displaced.

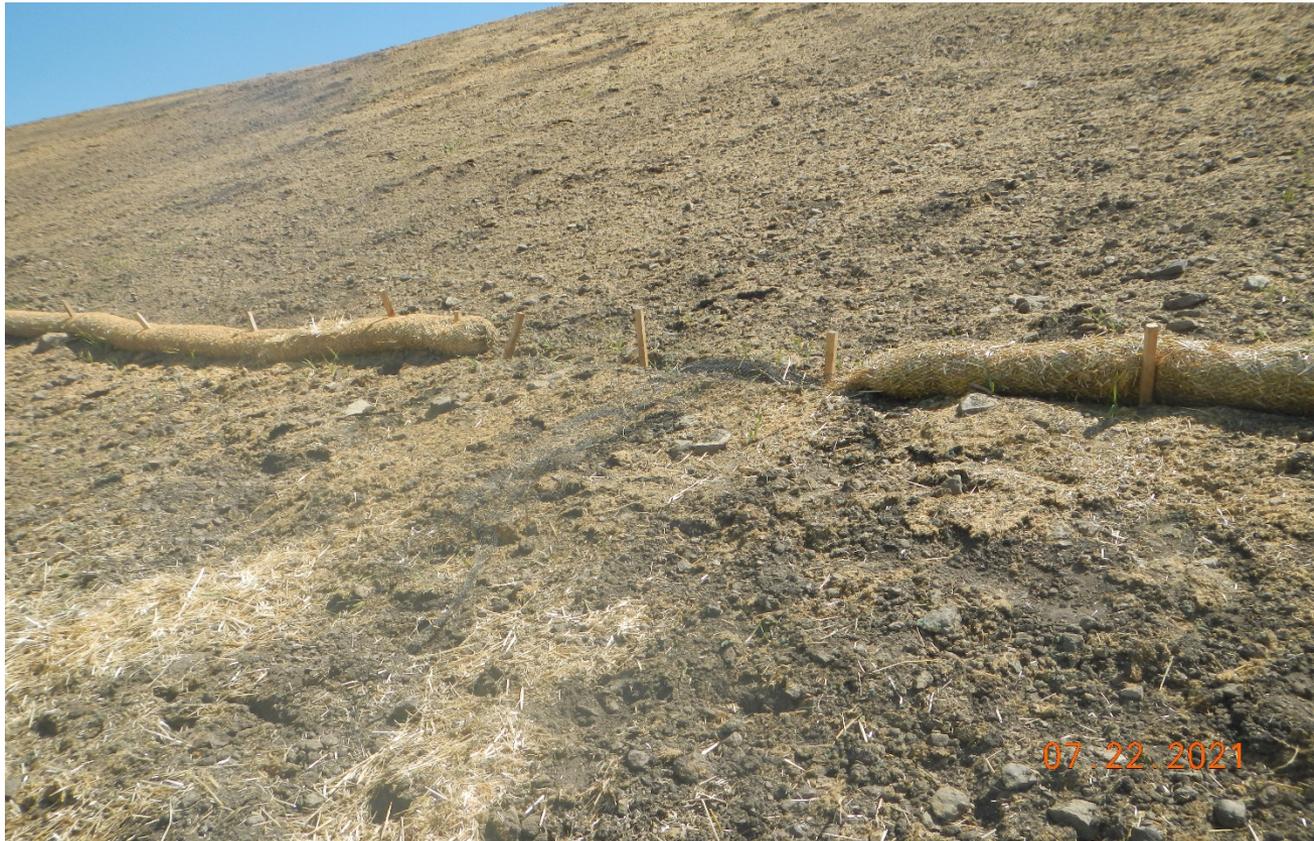
Photo 11. This wattle is displaced from wildlife in the area. BMP's will need to be monitored and maintained.

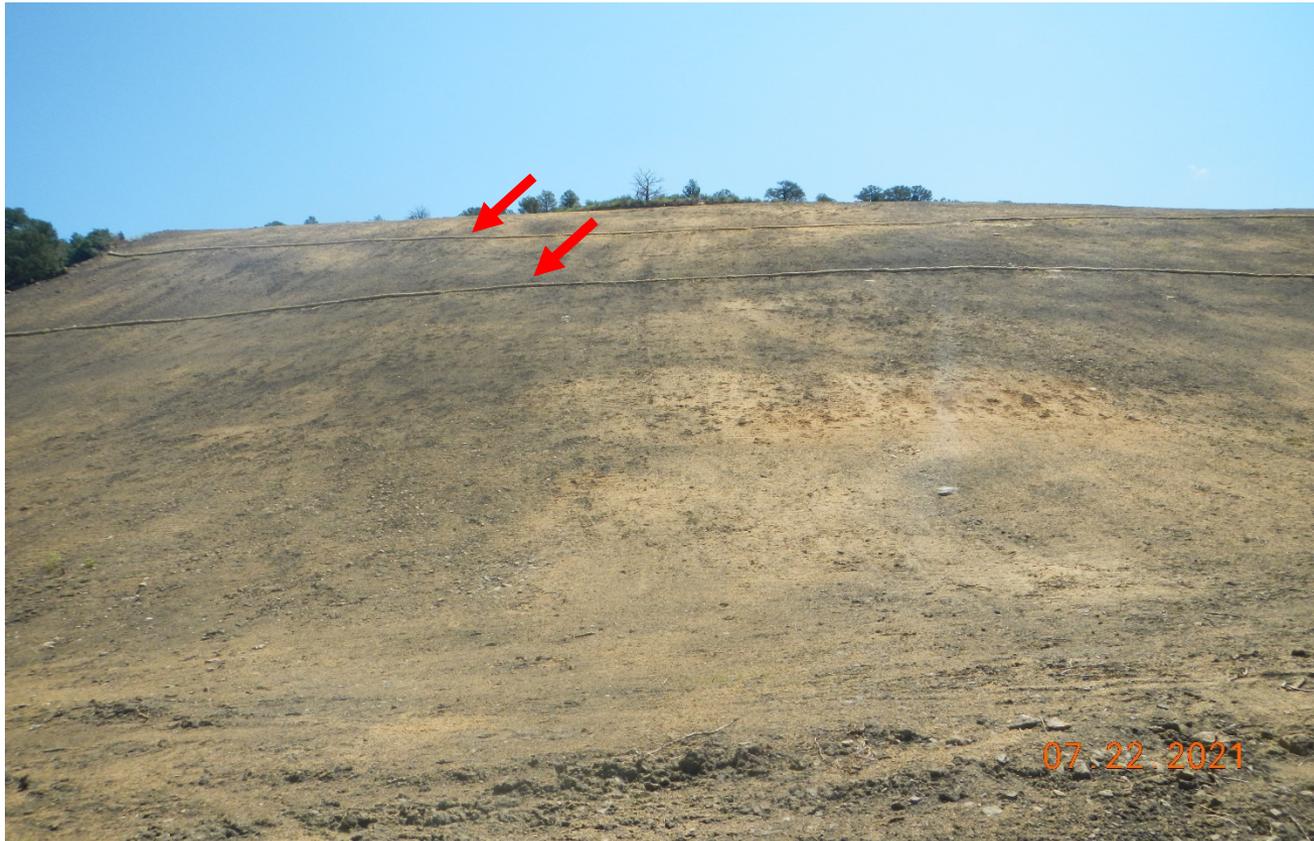
Photo 12. Standing at the bottom of the canyon facing east toward location. The fill slope was graded, seeded, and hydromulched. There does not appear to be sufficient stormwater controls along the fill slope. The red arrows point to two rows of wattles along the approximate 250 ft. slope.

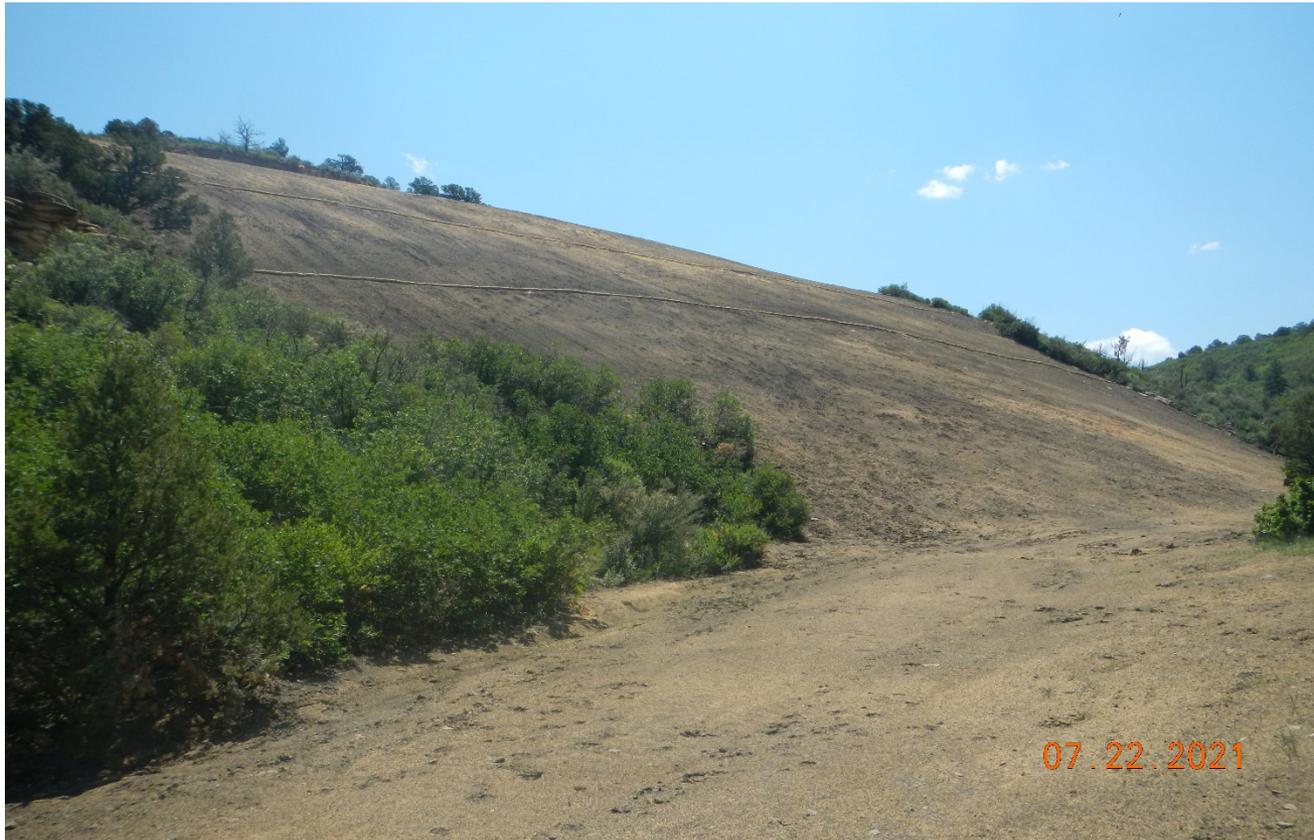
Photo 13. Facing southeast toward the location standing at bottom of the canyon. Additional BMP's should be installed along the canyon bottom where concentrated stormwater flows.

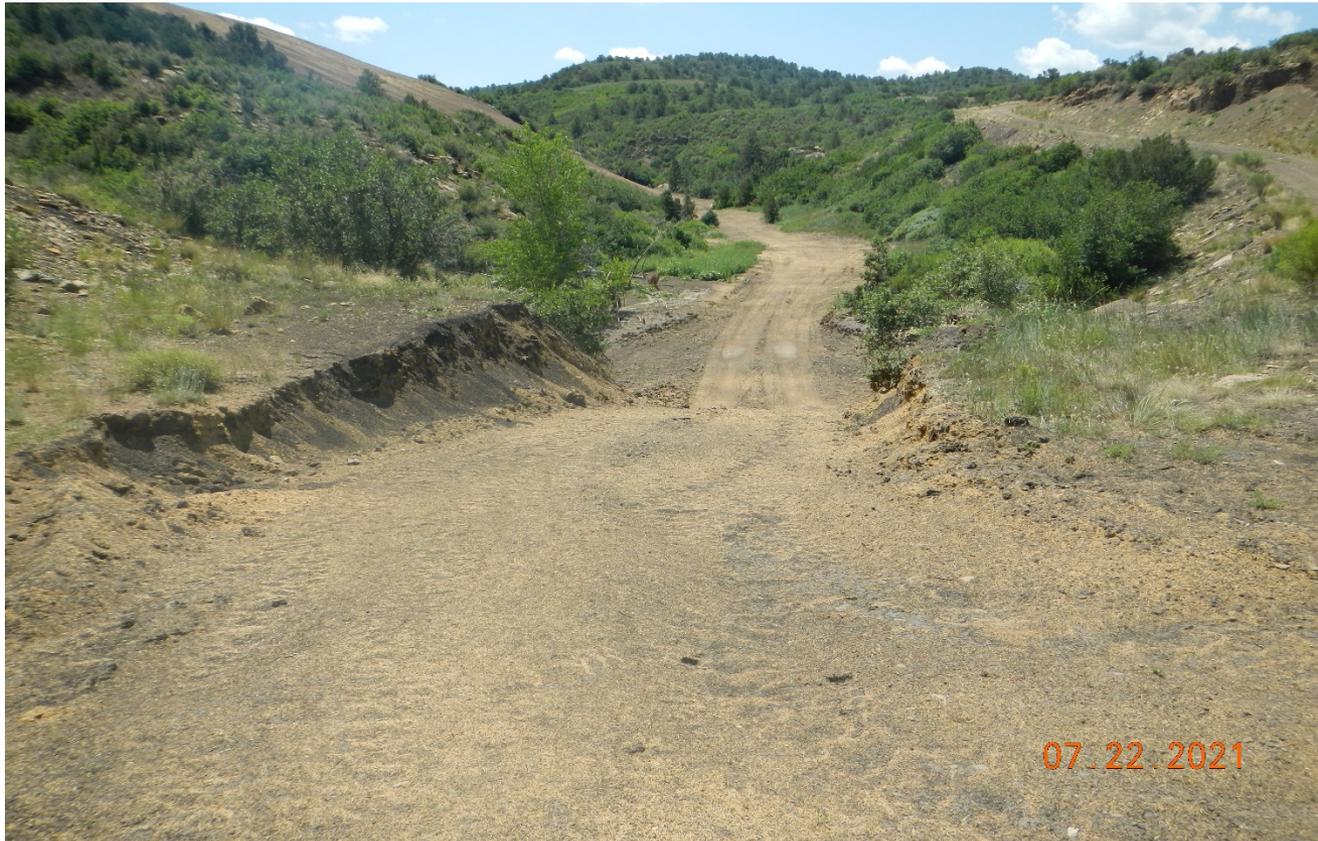
Photo 14. The road that was cut to access the canyon bottom was not recontoured.

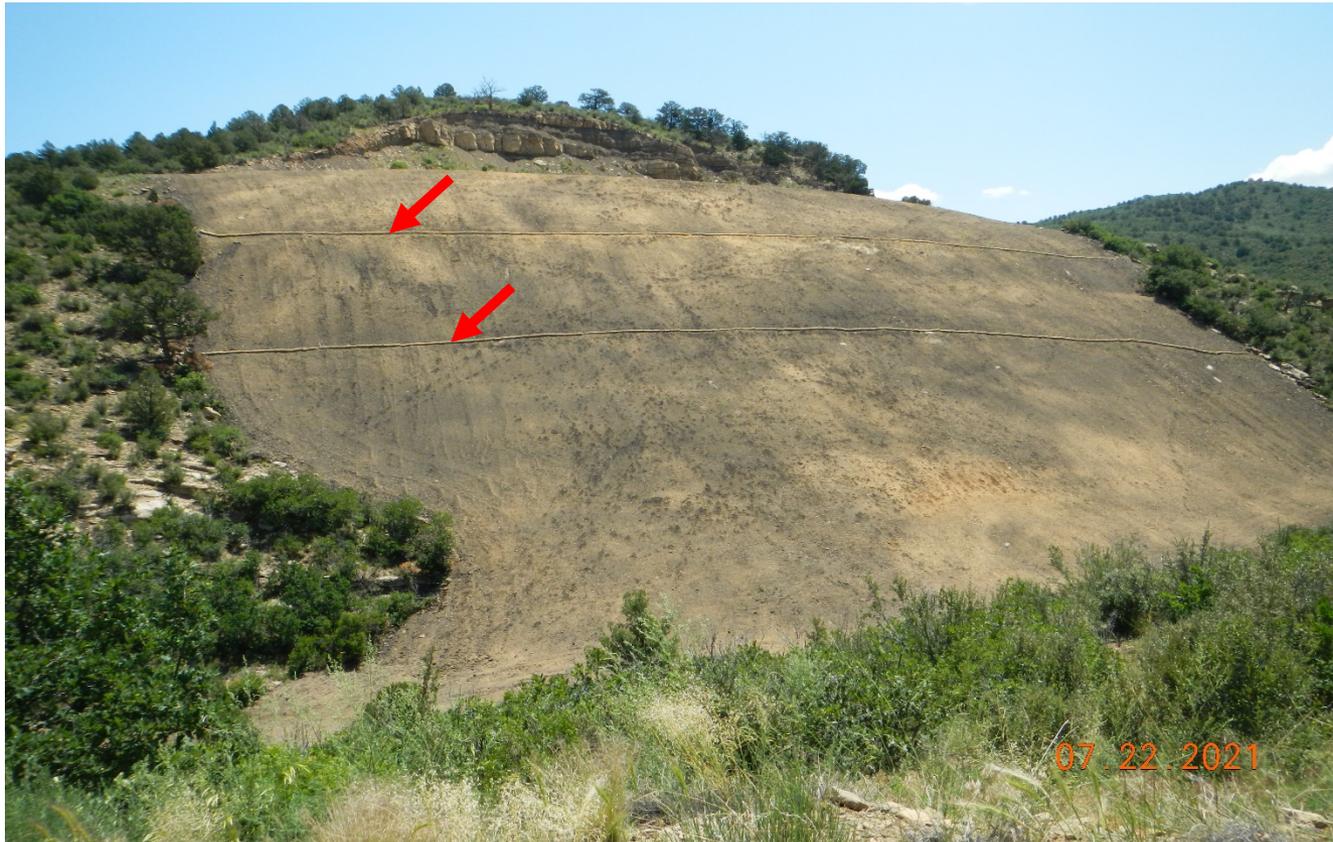
Photo 15. Standing at the road across the canyon facing east toward the location. There does not appear to be sufficient stormwater controls along the fill slope. The red arrows point to two rows of wattles along the approximate 250 ft. slope.

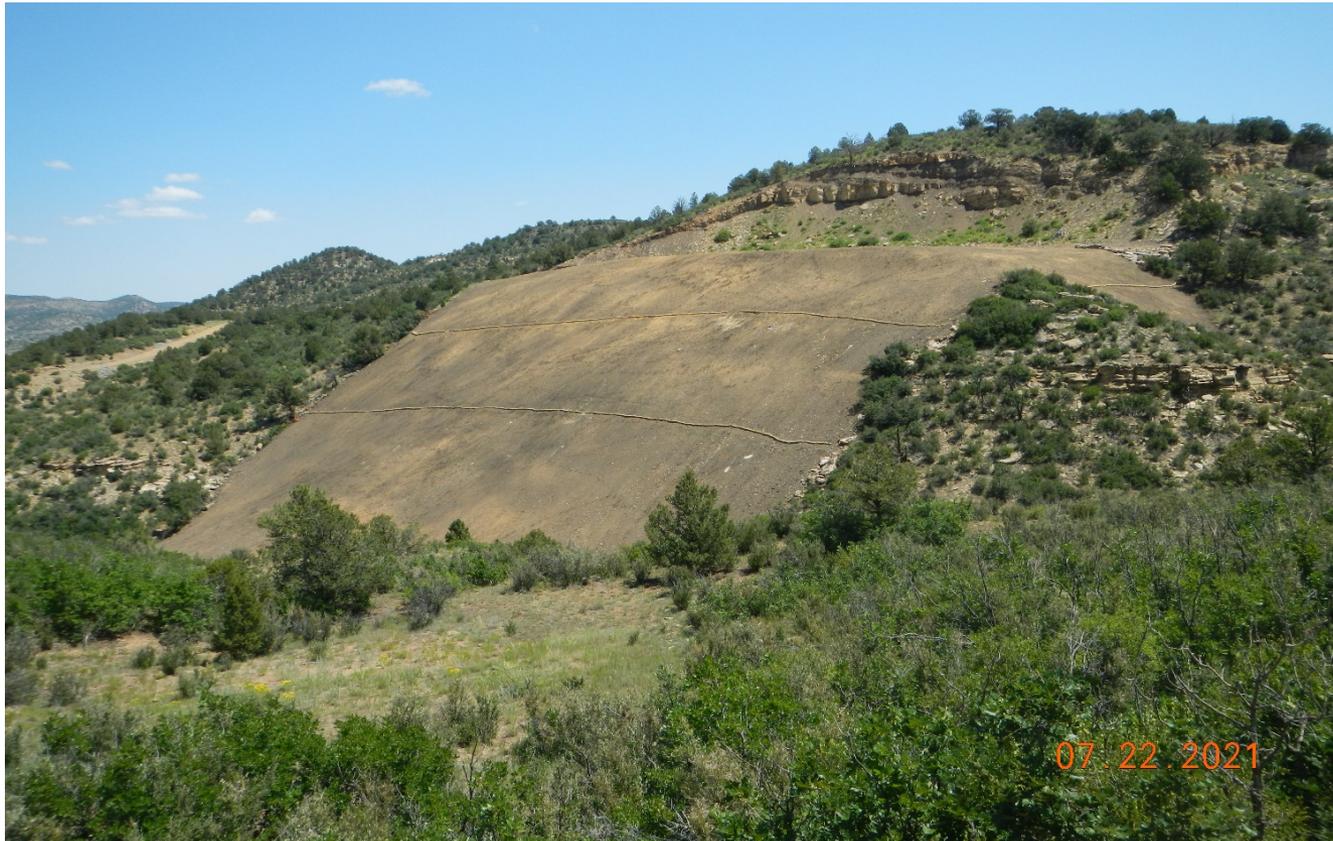
Photo 16. Facing northeast toward the location. The photo shows that the fill slope was graded but not recontoured and the cut slope remains.

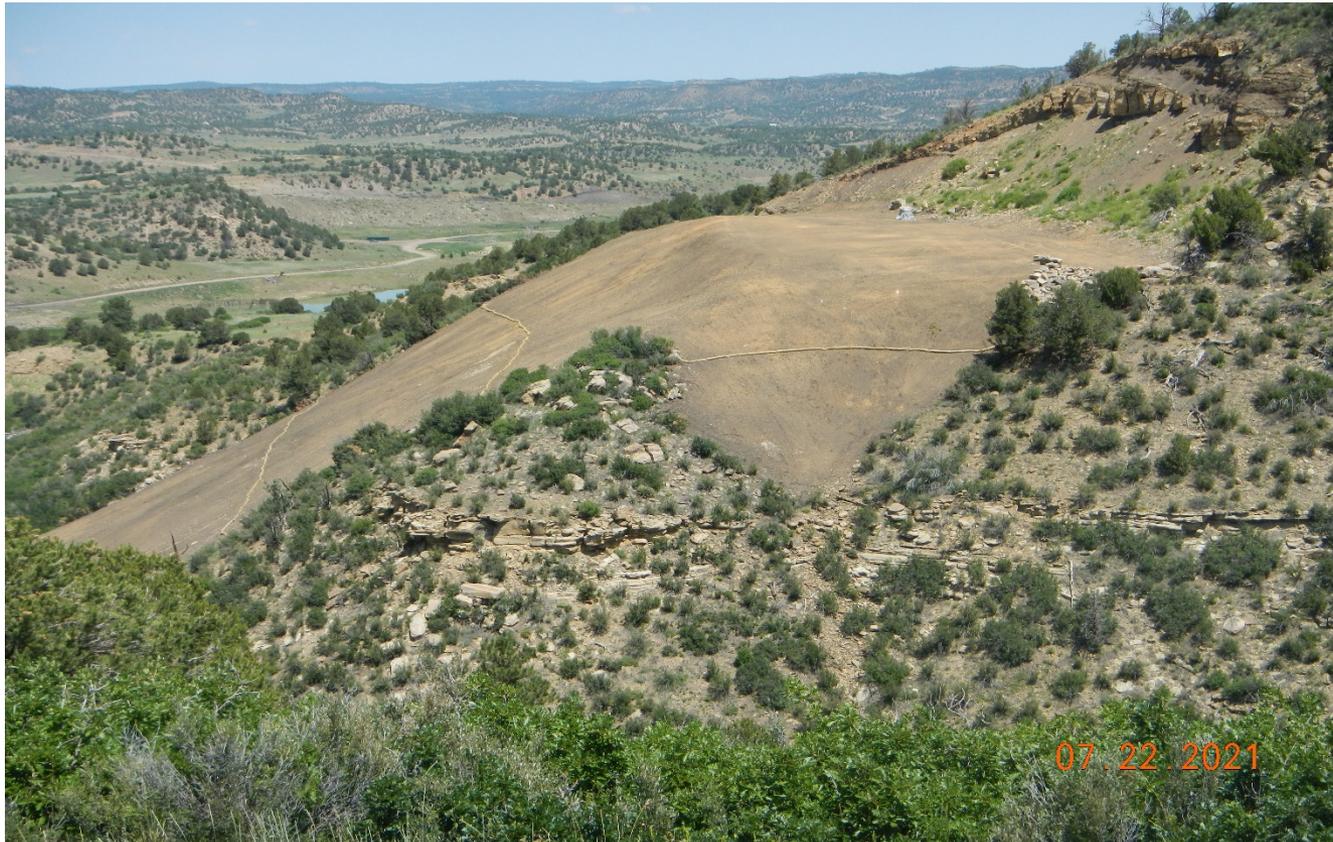
Photo 17. Facing north toward the location. The photo shows the fill slope and cut slope remains. The location does not comply with the reclamation requirements.
