Inspection Photos
Location Name: Champlin 75 Amoco K 2
Location ID: 320149

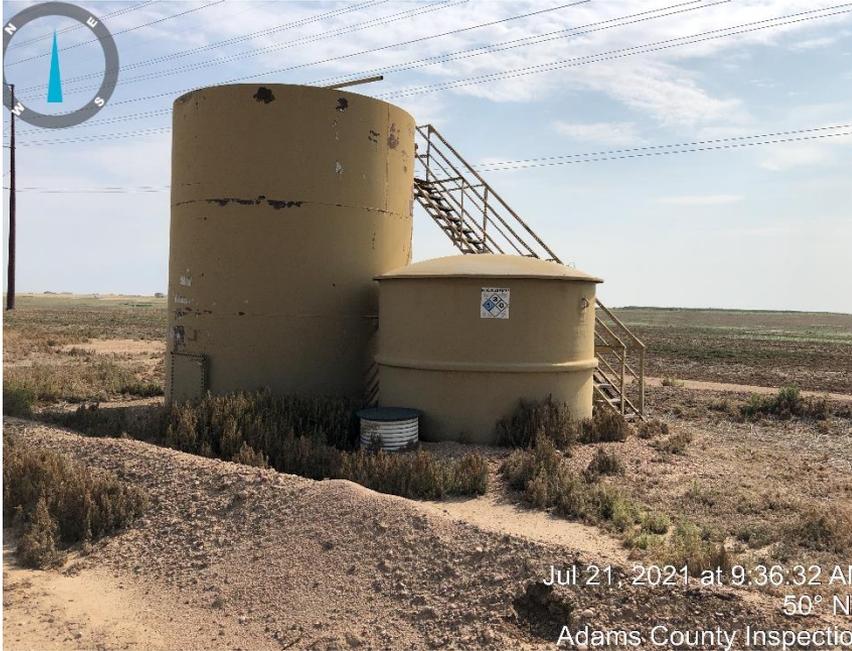
Photo #1 Tanks

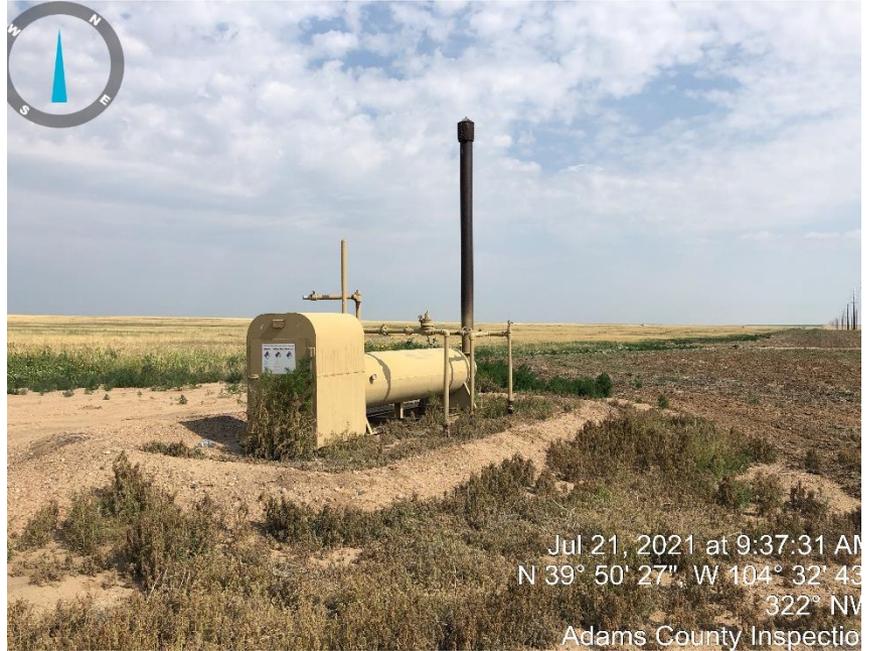
Photo #2 Separator.

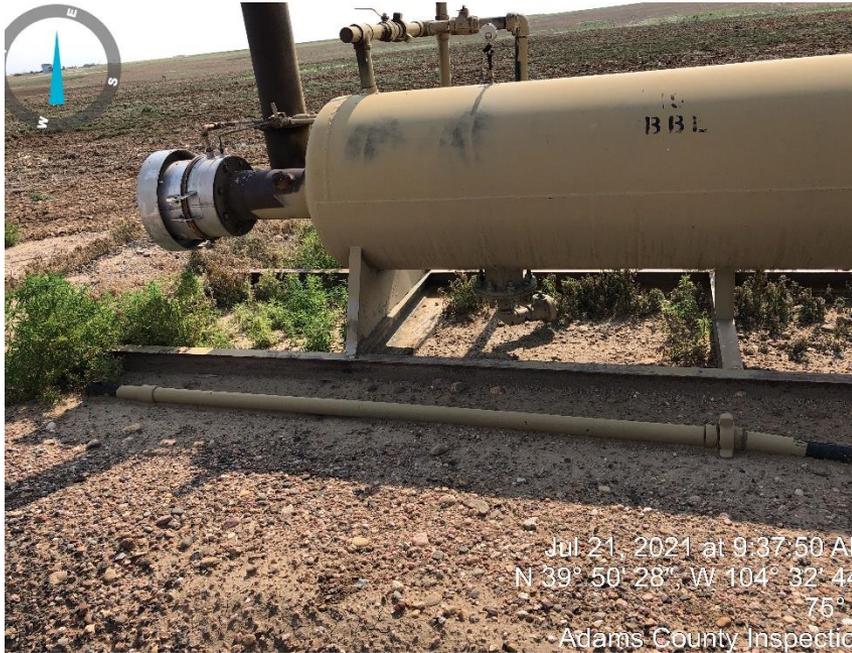
Photo #3 unused equipment

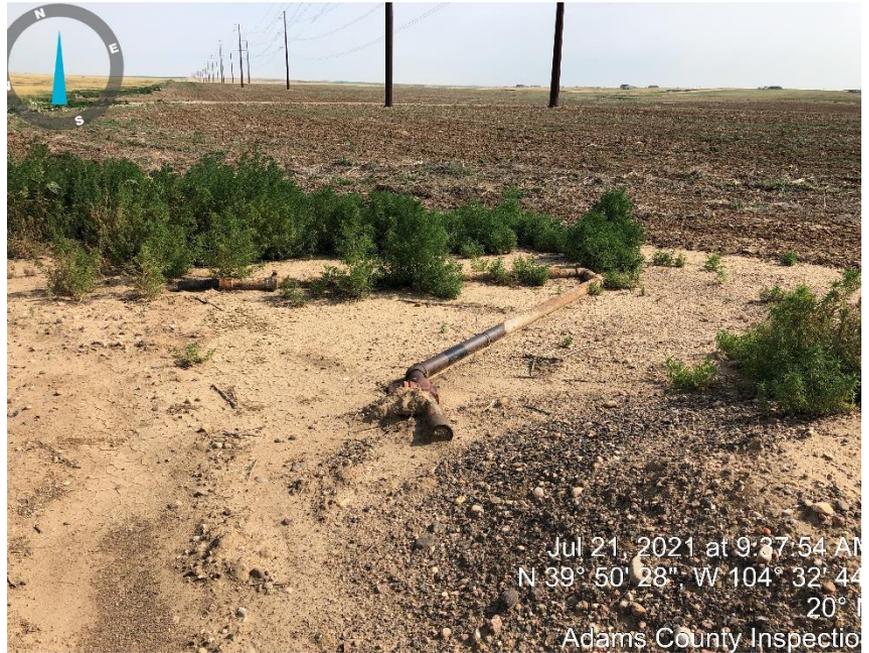
Photo #4 unused equipment

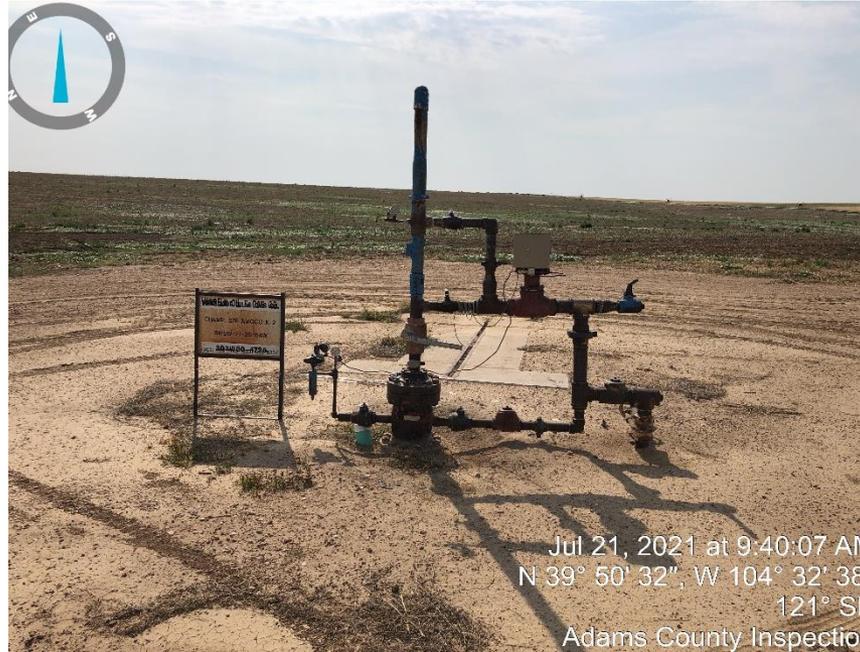
Photo #5 Well Head.
