# Inspection Photos

7/21/2021

Operator: GUNNISON ENERGY LLC # 10515

Location ID: 453805

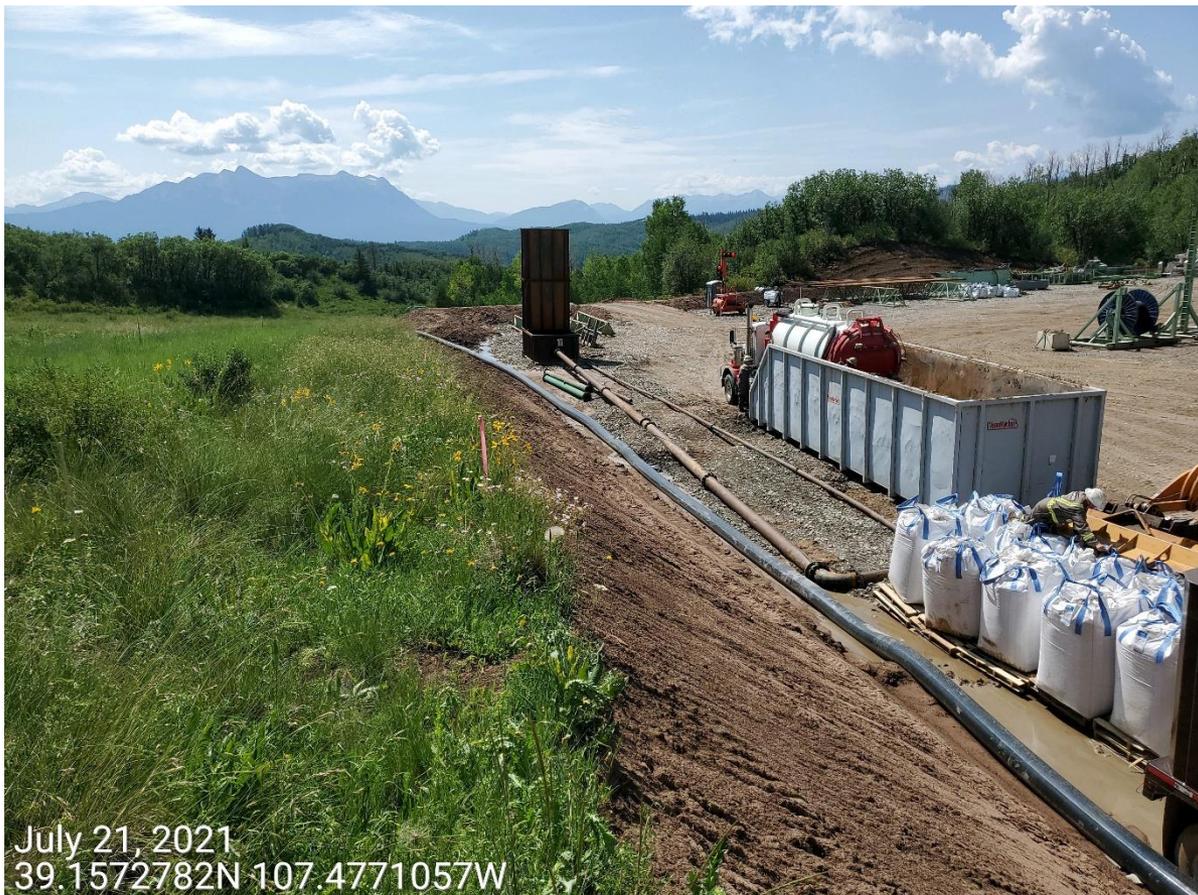
**Photo 1:** Photo taken from the east end of the Location, facing south. Photos 1-4 provide an overview of the Location from south, southwest, northwest to north.

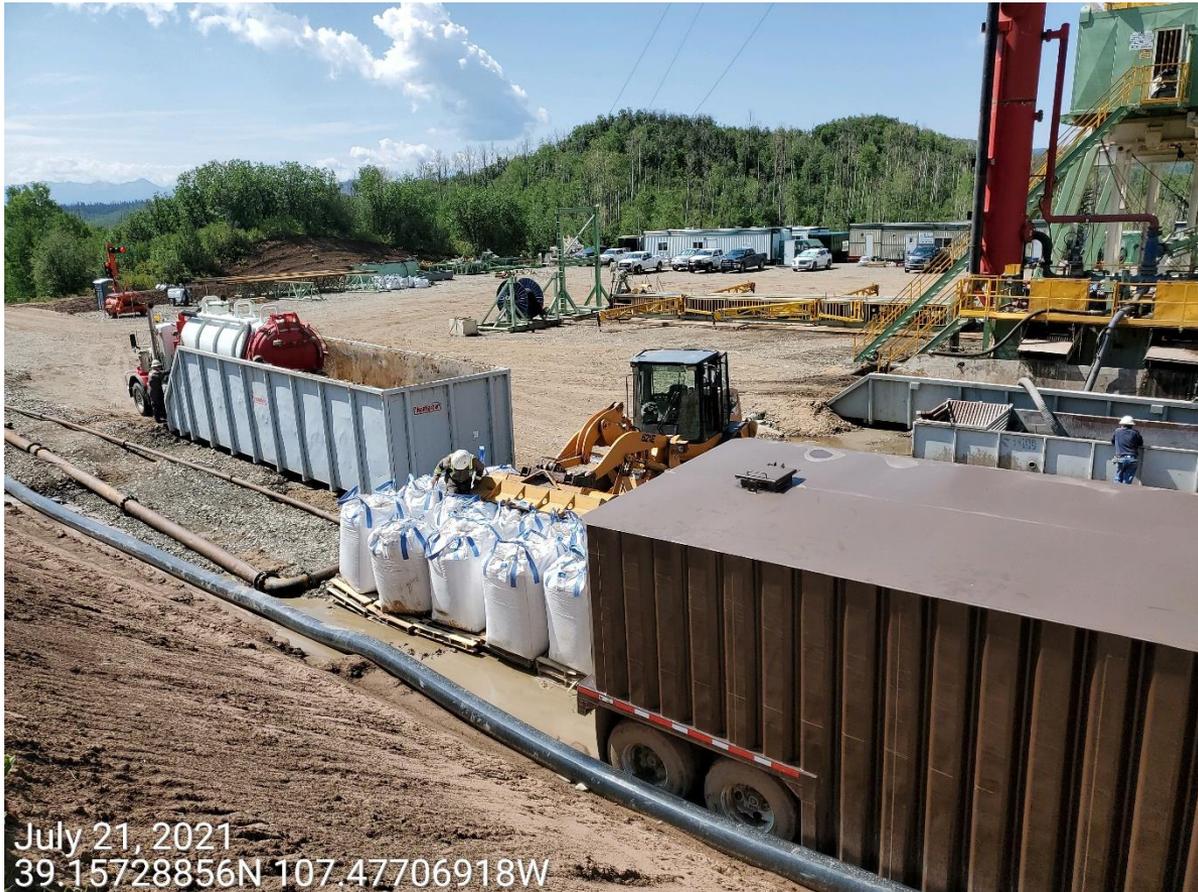
**Photo 2:** See comments under photo 1.

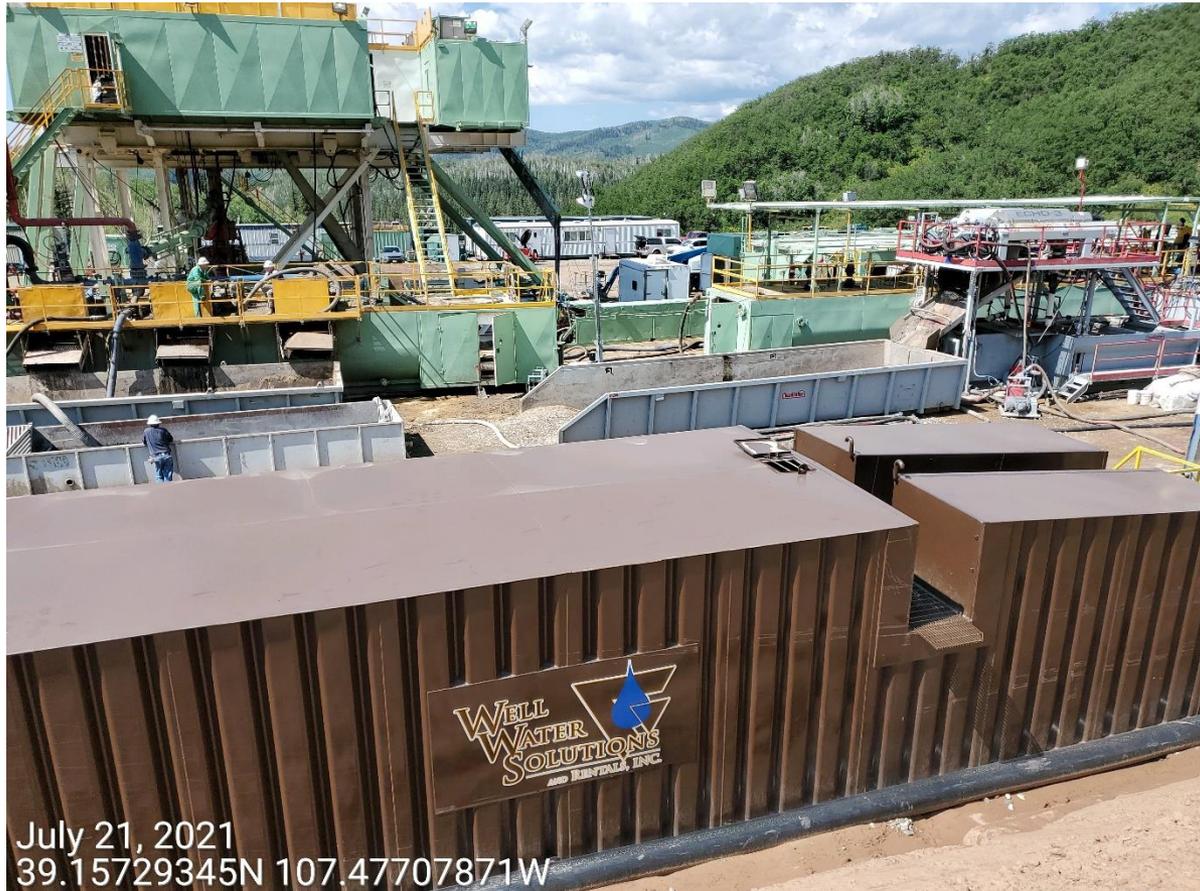
**Photo 3:** See comments under photo 1.

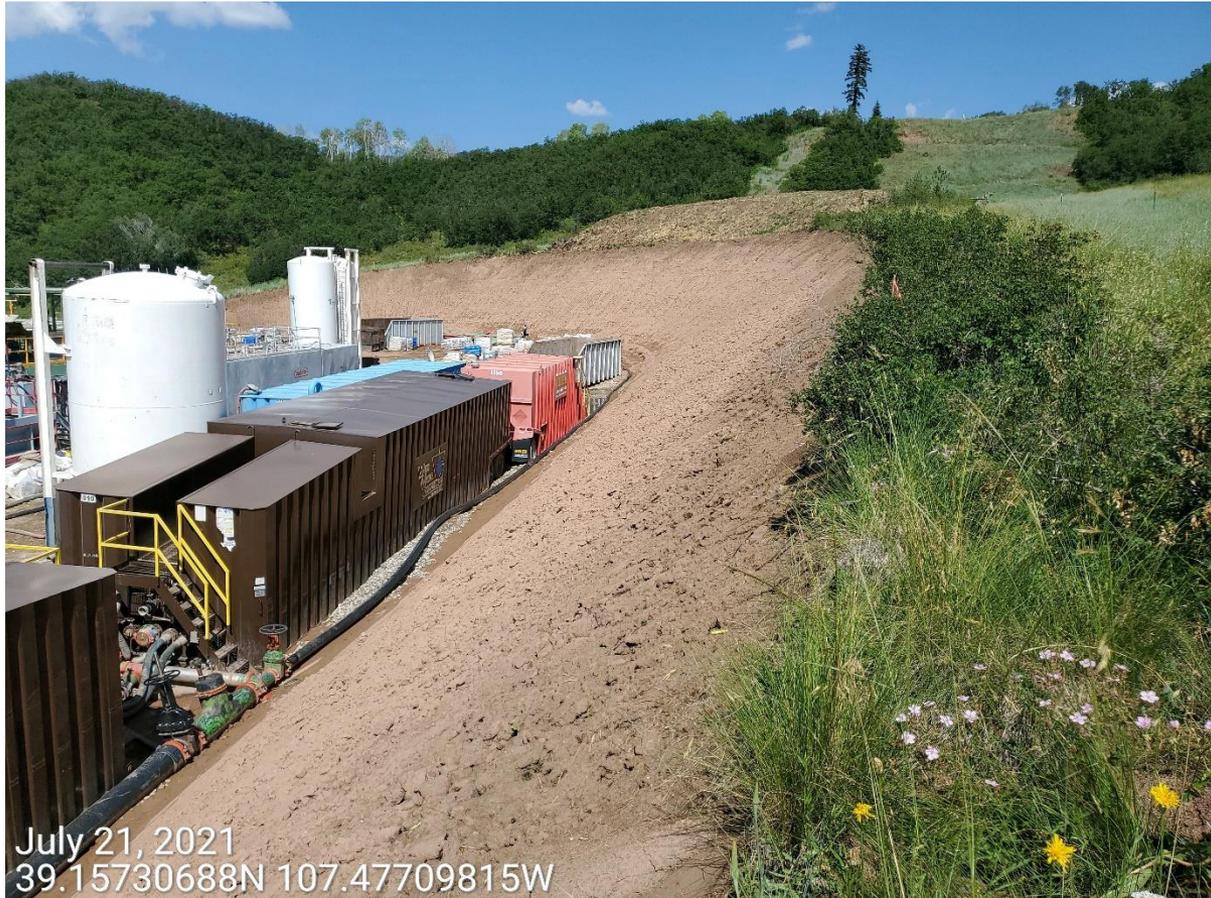
**Photo 4:** See comments under photo 1.

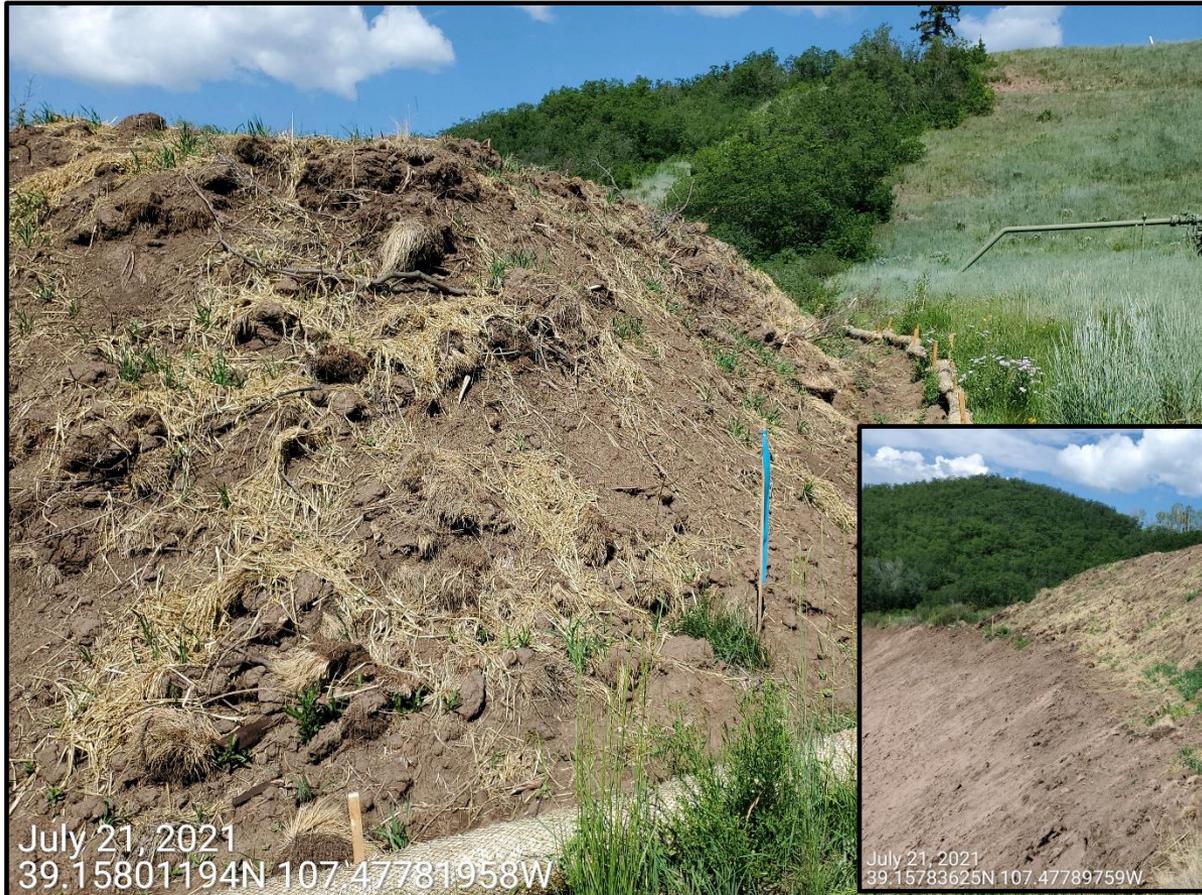
**Photo 5:** Photo taken from the topsoil stockpile on the north end of the Location. Photo shows BMPs remain missing or insufficient at the topsoil stockpile; straw mulch application not uniform, has not been crimped or used in conjunction with any other stabilization BMP, and is insufficient alone to stabilize and protect the topsoil stockpile; BMPs remain missing or insufficient along the entire perimeter of the topsoil stockpile to prevent sediment transport.

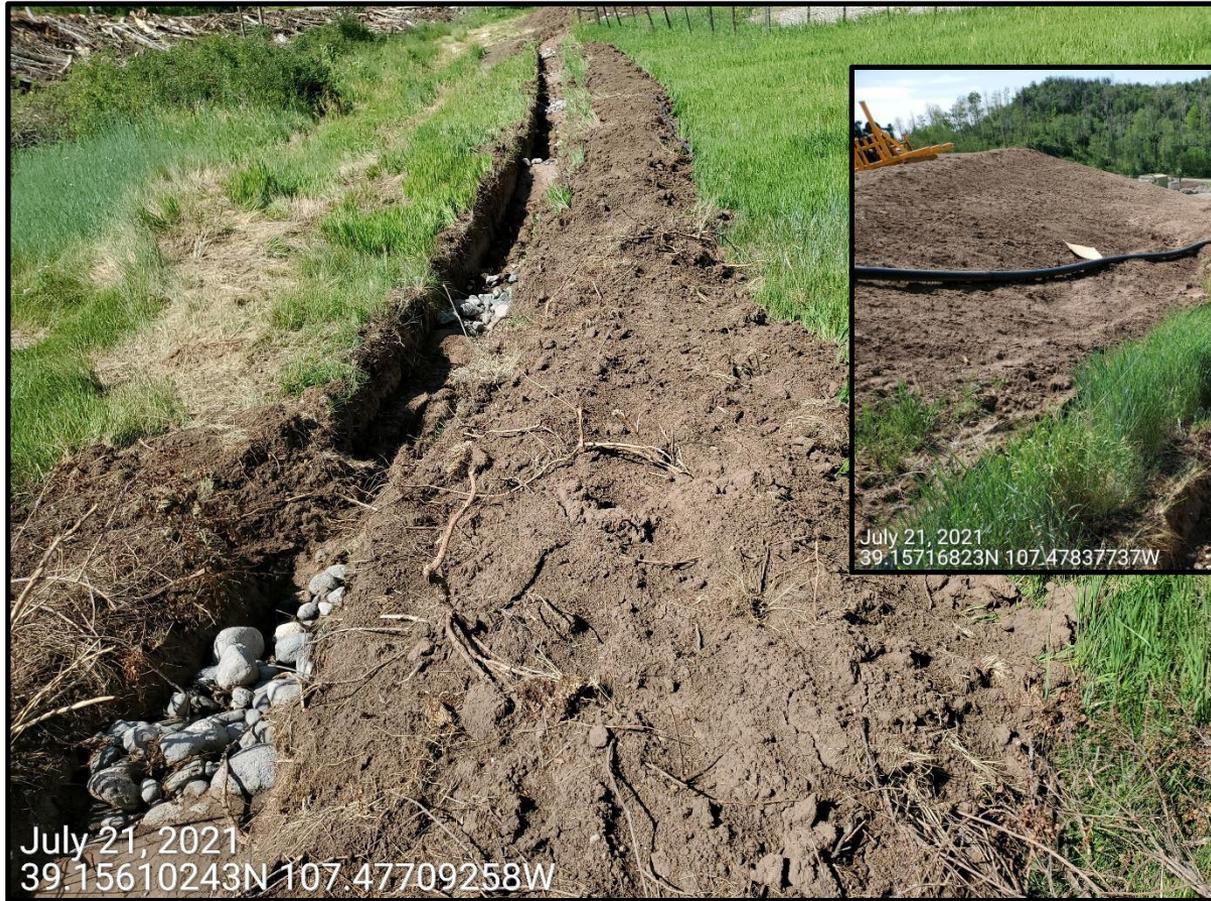
**Photo 6:** Photos show “ditches” constructed on the southwest/northwest ends of the Location. BMPs have been constructed with vertical slopes; BMP has not been constructed in accordance with good engineering practices. Extracted soils have been left along channel unconsolidated, and is considered a pollutant source.

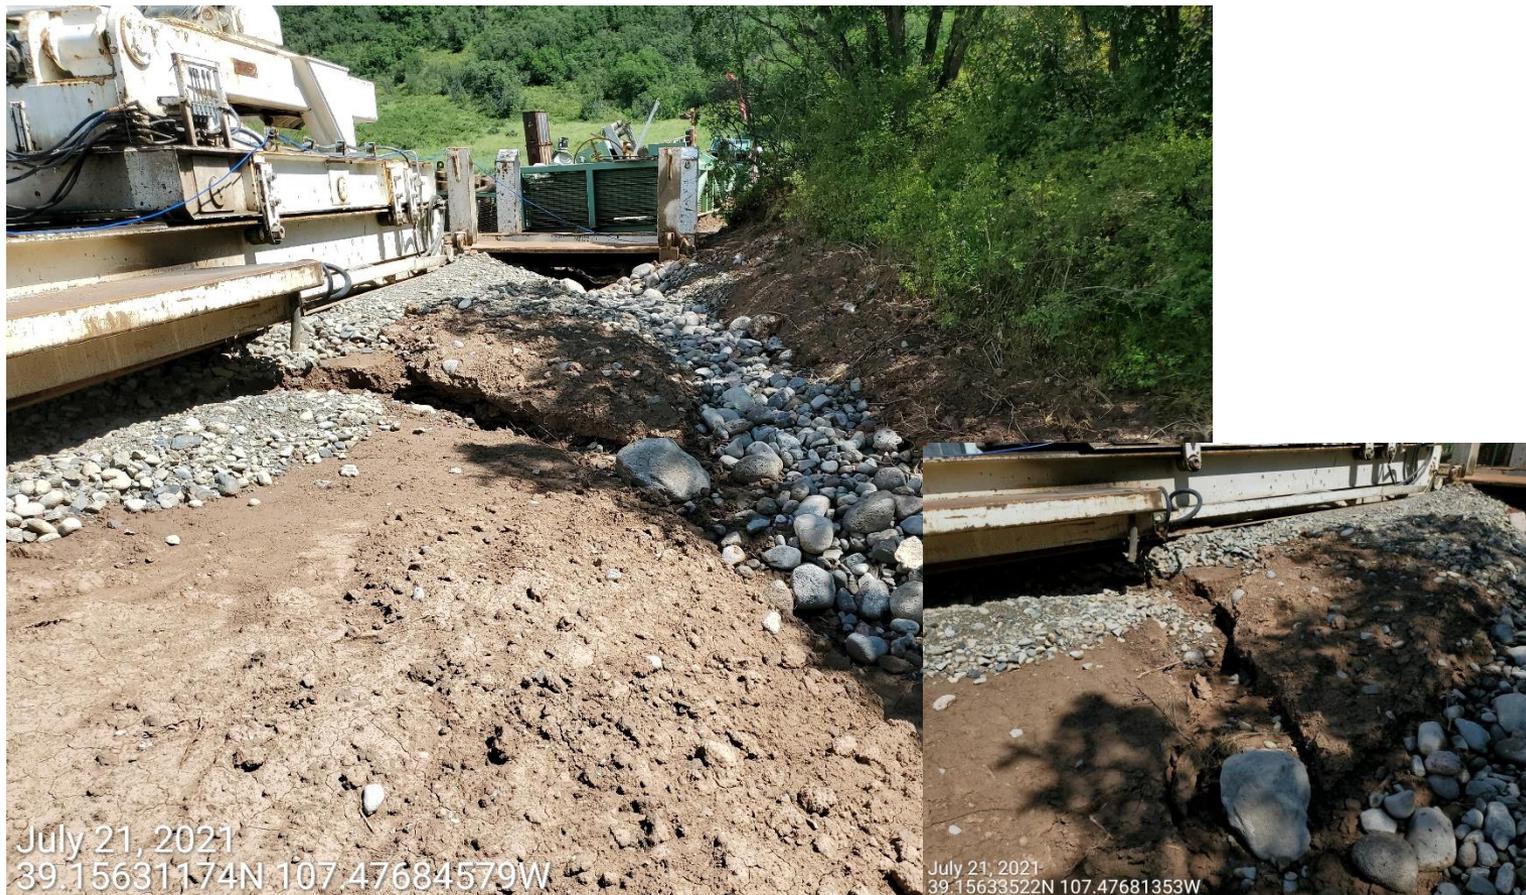
**Photo 7:** Photo taken from the southwest end of the Location, facing east. Photo shows inlet armoring is inadequate; erosion degradation observed at inlet of ditch.

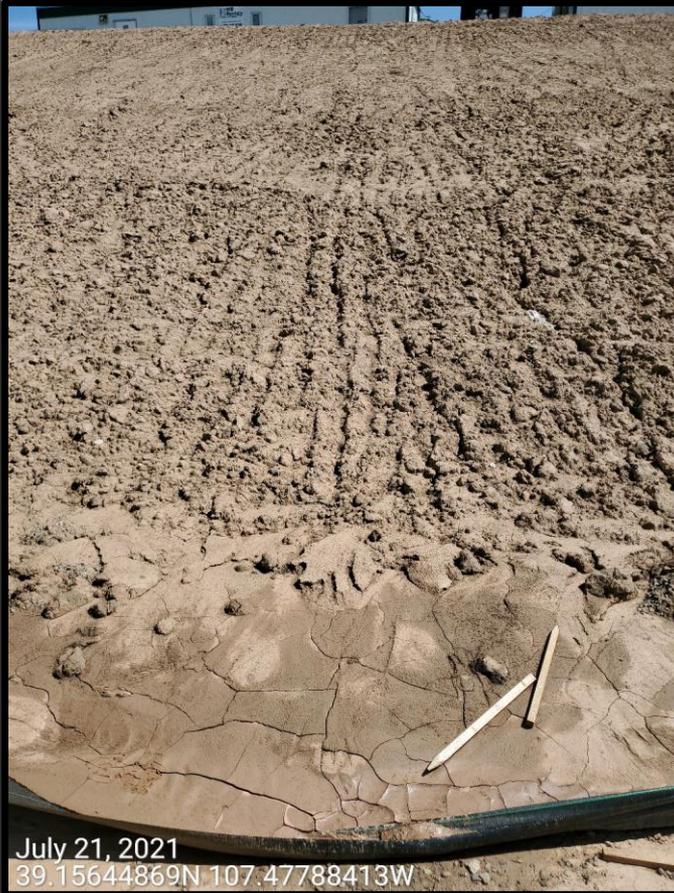
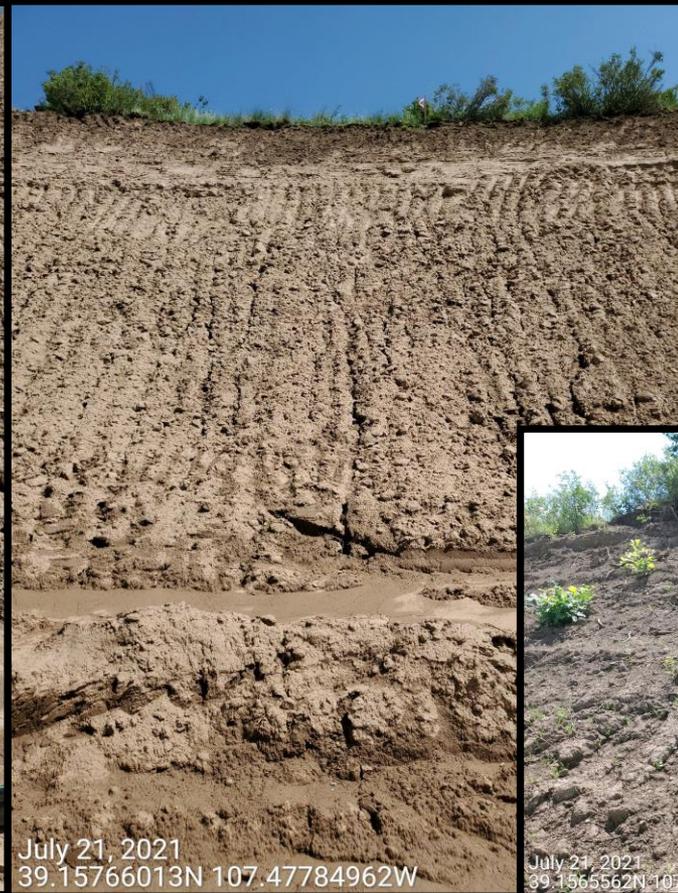
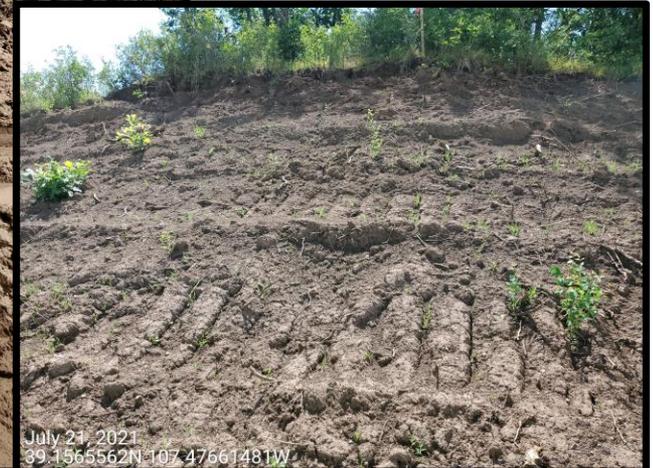
**Photo 8:** Photos show the western fill slopes (left photo), the cut slopes on the north/east end of the Location (middle photo), and the cut slopes on the south end of the Location. Previous inspection noted that Operator implemented tracking along the contour of the cut/fill slopes, and that the BMP was not implemented per good engineering practices. Photo shows improper tracking and has facilitated erosion degradation on the slopes; Stormwater and erosion control measures remain missing/insufficient to protect and stabilize the cut and fill slopes of the Location.

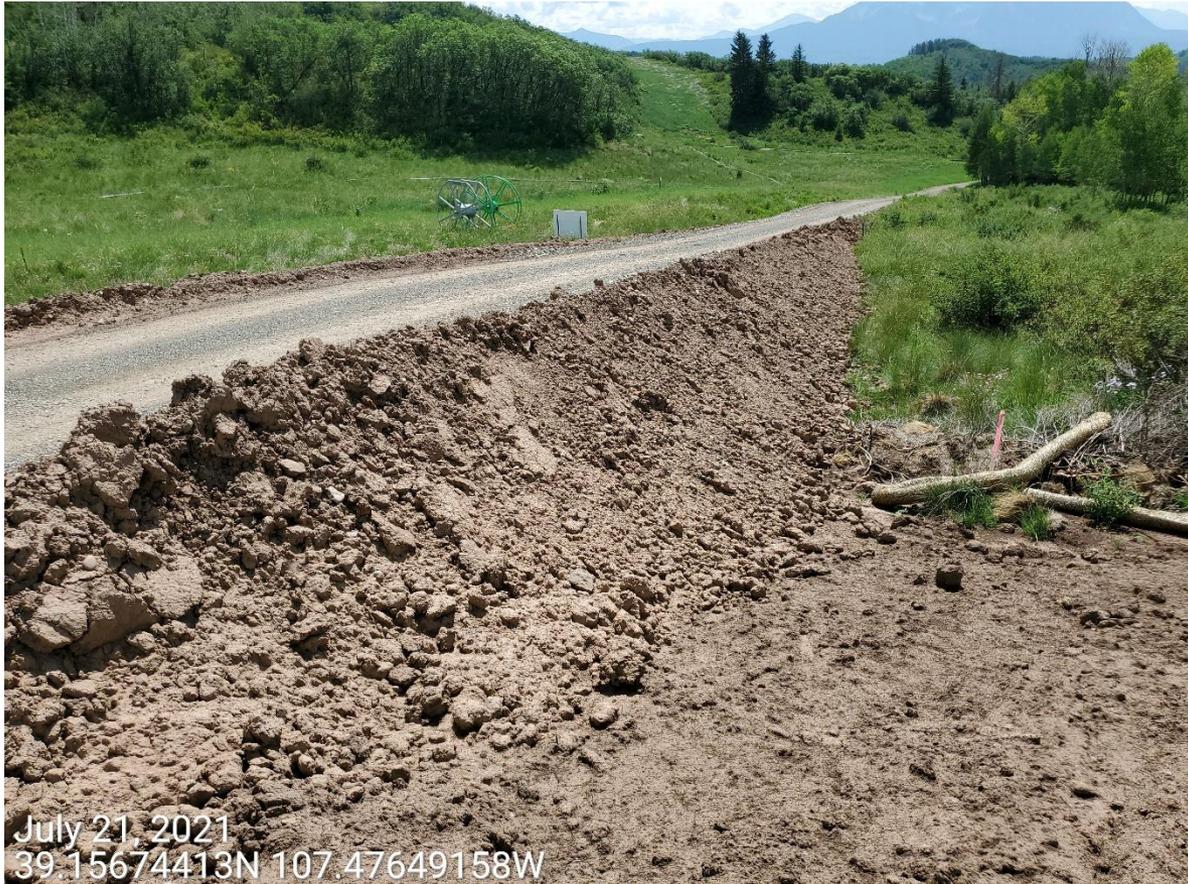
**Photo 9:** Photo taken from the fill slopes on the southeast end of the Location. Photo shows that BMPs remain missing or insufficient to protect/stabilize southeastern fill slopes and allow for sediment laden-free discharge per good engineering practices.

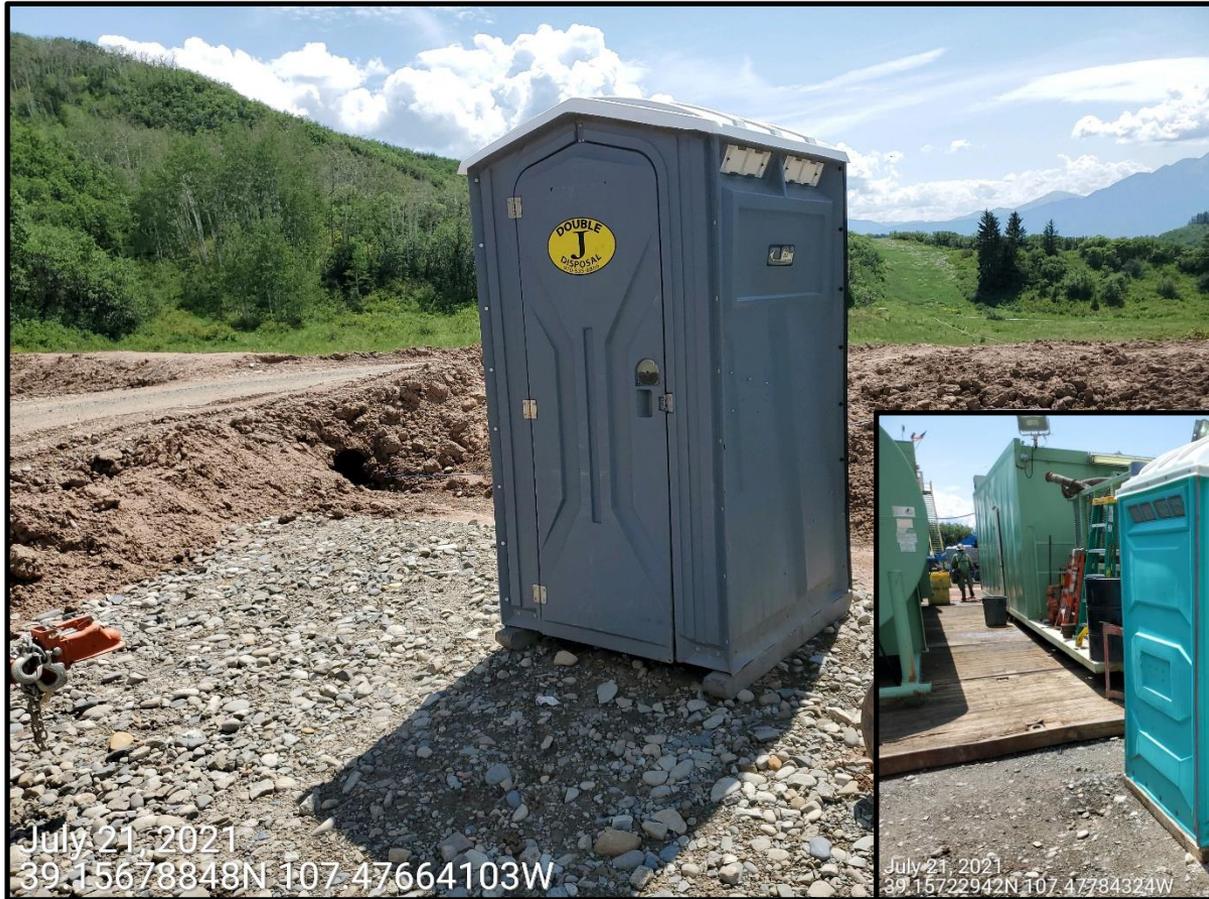
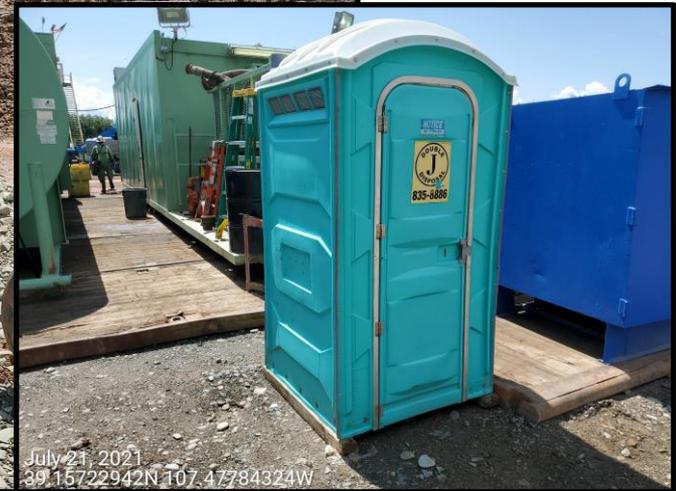
**Photo 10:** Photo shows the two porta-johns on the Location; porta-johns observed to not be properly secured in place; this is considered improper spill prevention practices.

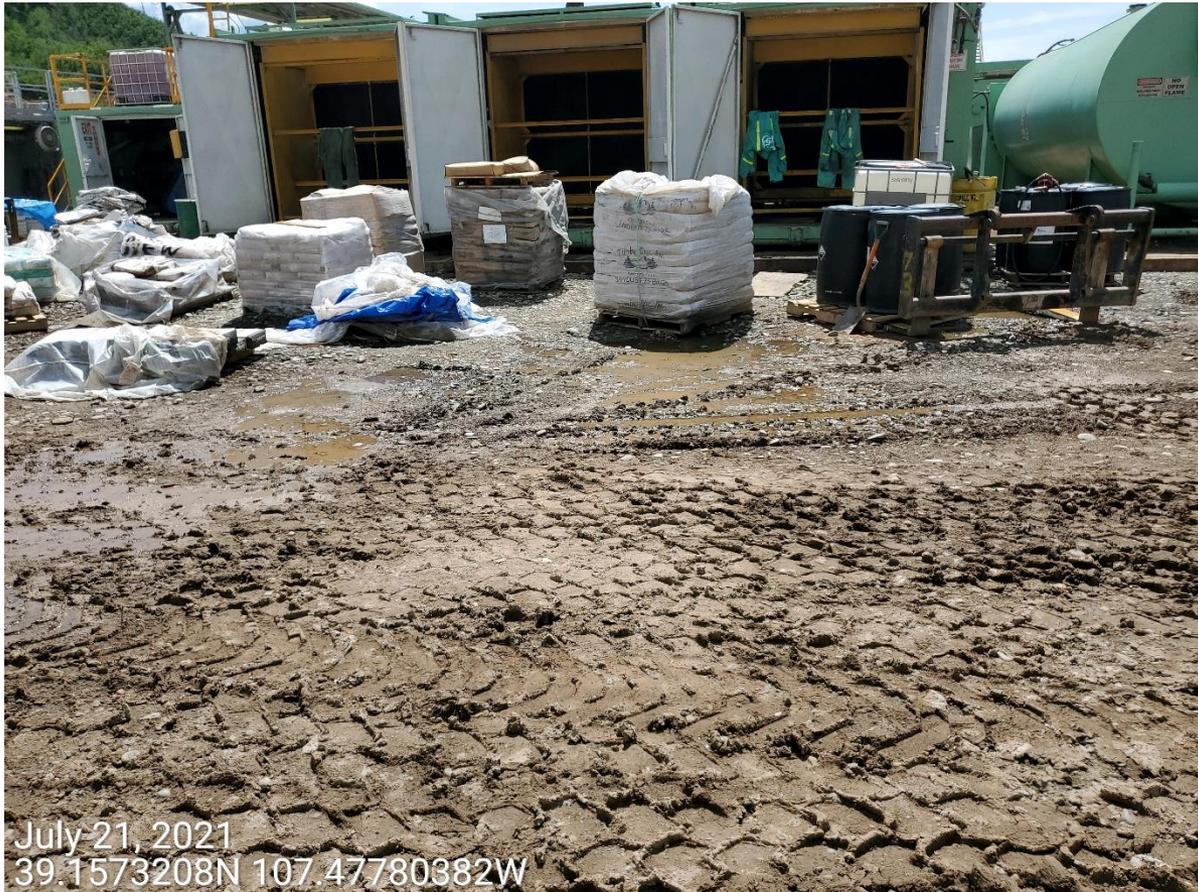
**Photo 11:** Photo taken from the north end of the Location. Photo provides example of stored materials onsite without proper covering to minimize contact of precipitation and stormwater runoff with materials, wastes, equipment, and activities with potential to result in discharges causing pollution of surface waters.

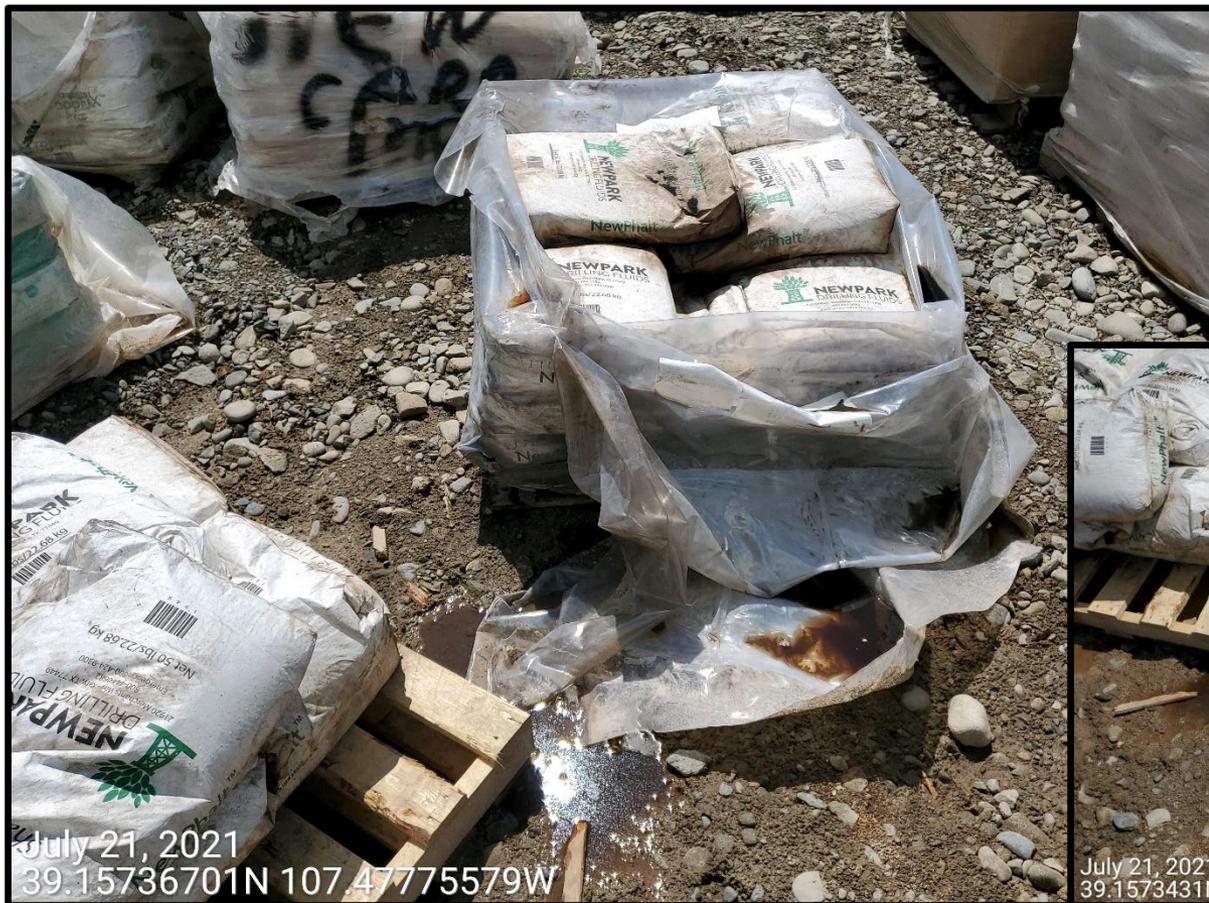
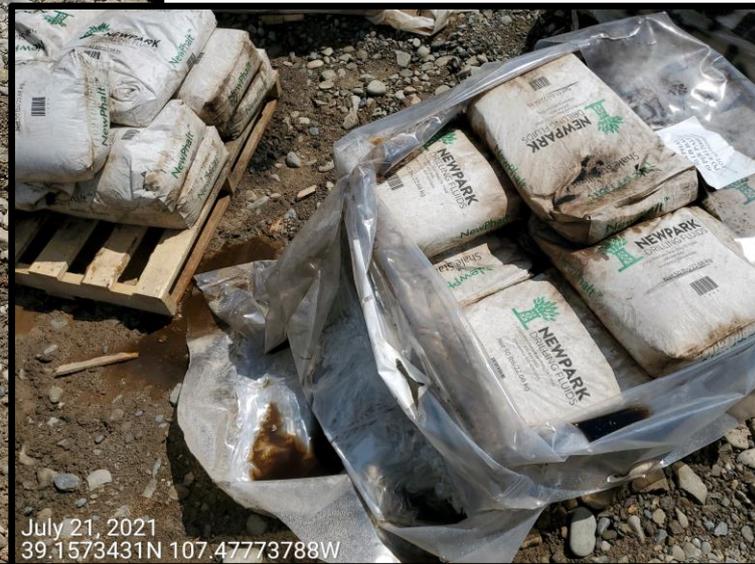
**Photo 12:** Photo provides example of stored materials onsite without proper covering to minimize contact of precipitation and stormwater runoff with materials, wastes, equipment, and activities with potential to result in discharges causing pollution of surface waters.

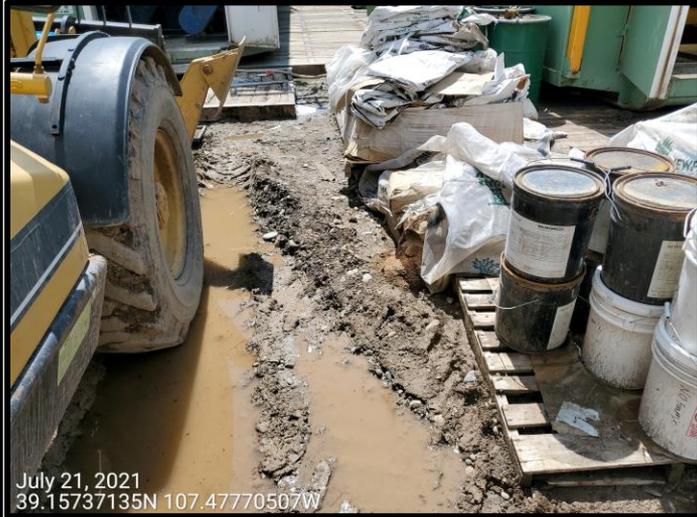
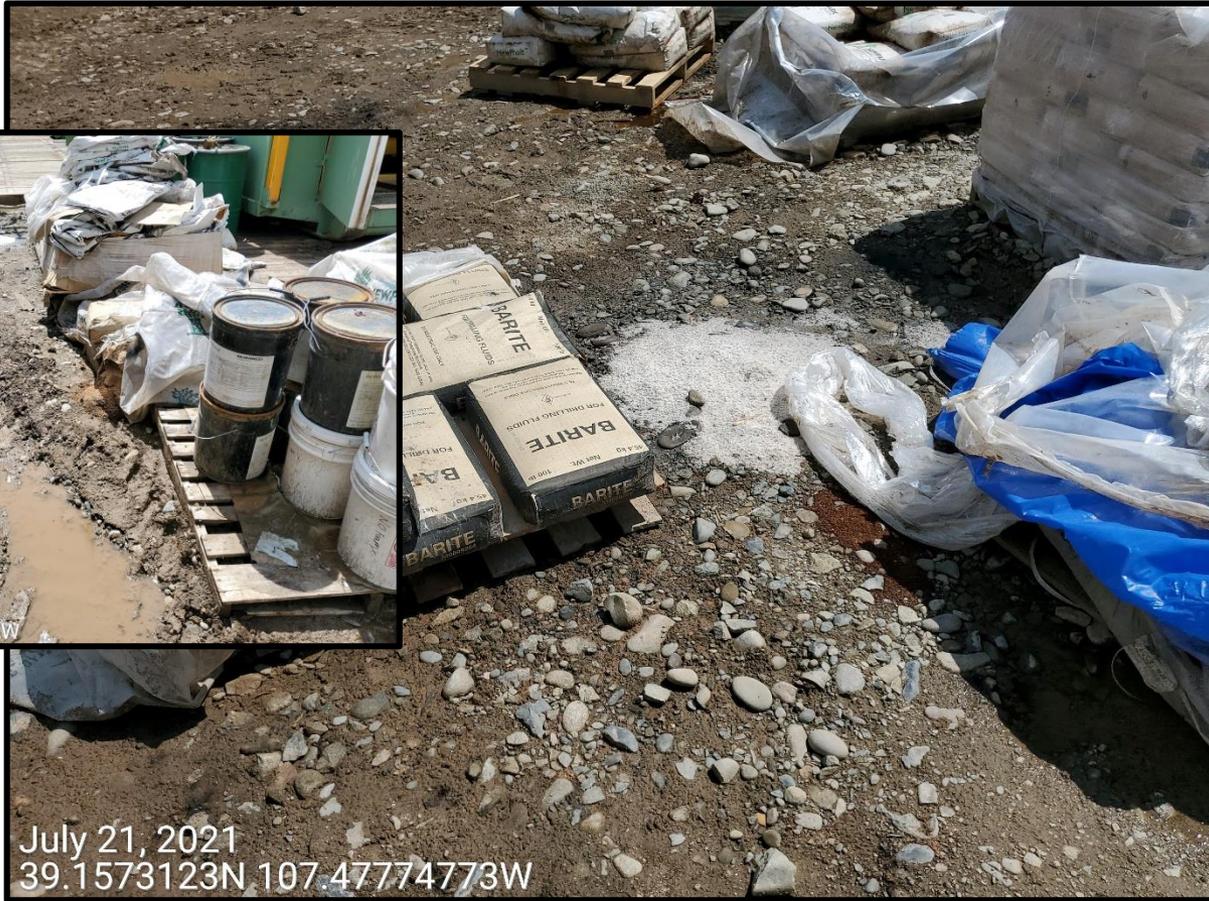
**Photo 13:** Photo taken from the north end of the Location. Photo shows example of improper materials management that has resulted in several spills throughout the Location.

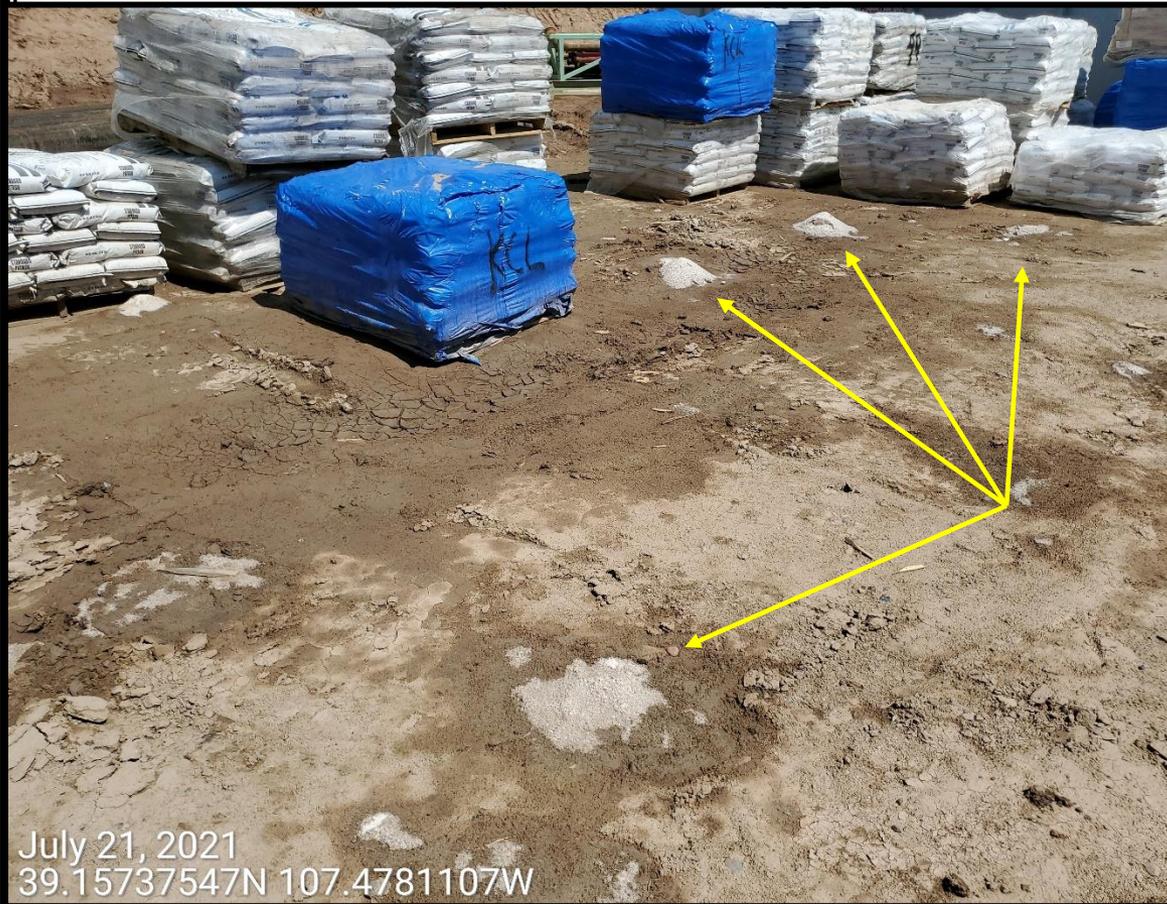
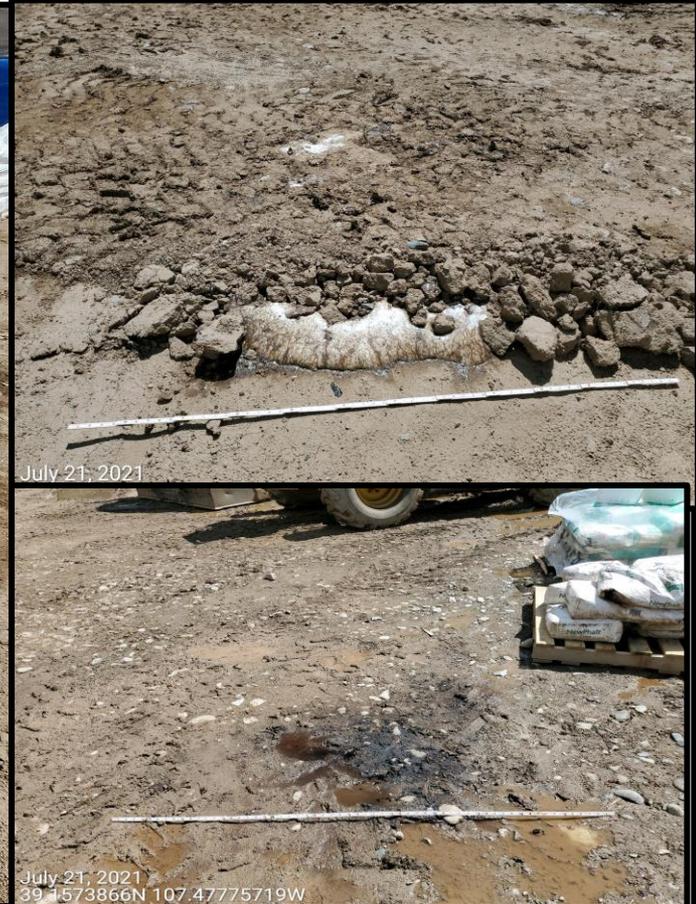
**Photo 14:** Photo taken from the north end of the Location. Photo shows example of improper materials management that has resulted in several spills throughout the Location.

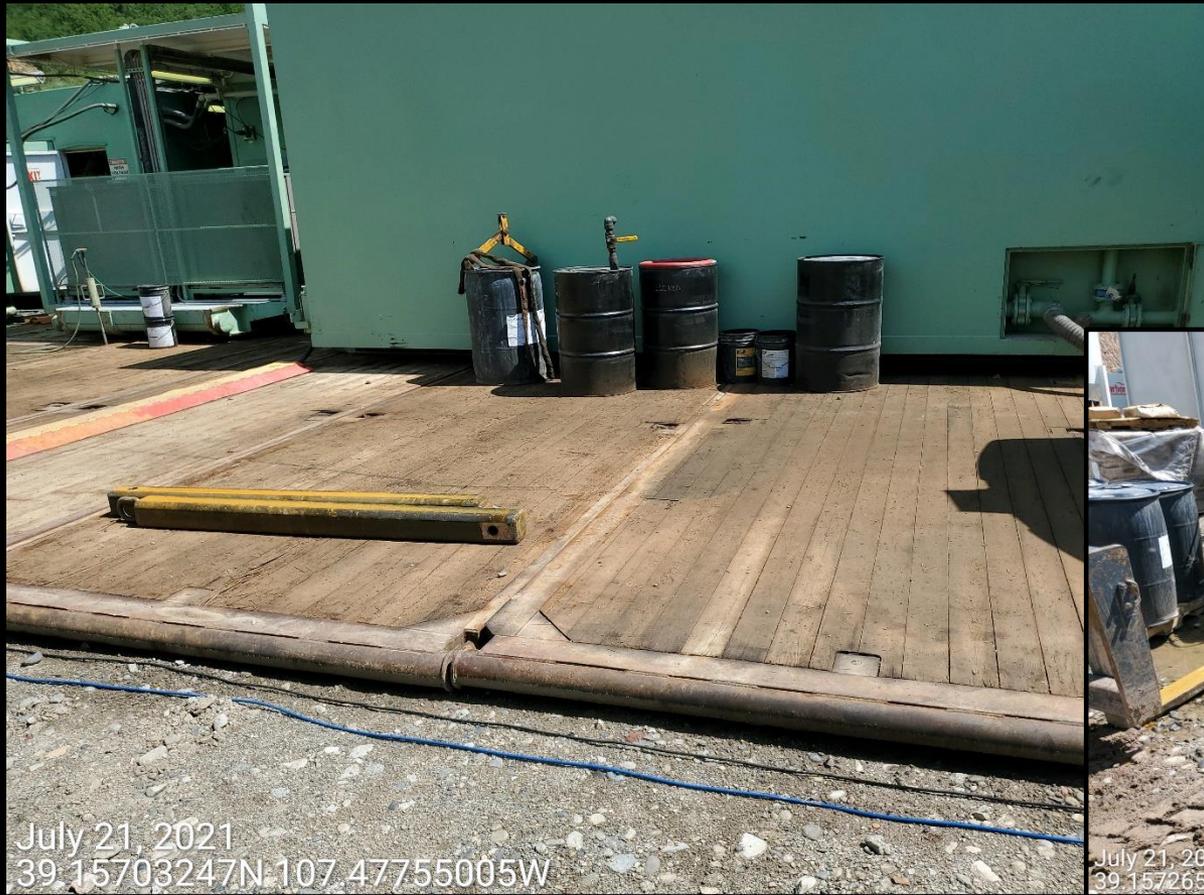
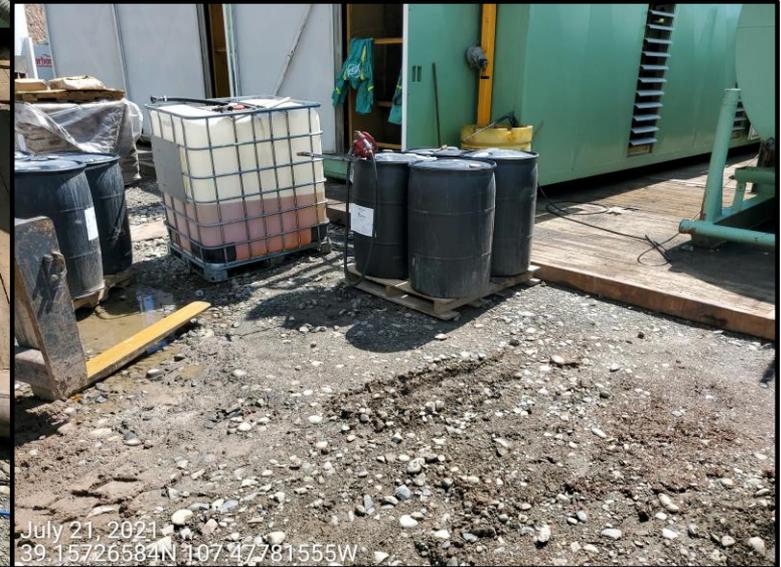
**Photo 15:** Photo shows example of barrels/tanks/containers observed stored on the location without proper secondary containment; BMPs missing or insufficient to contain spill.

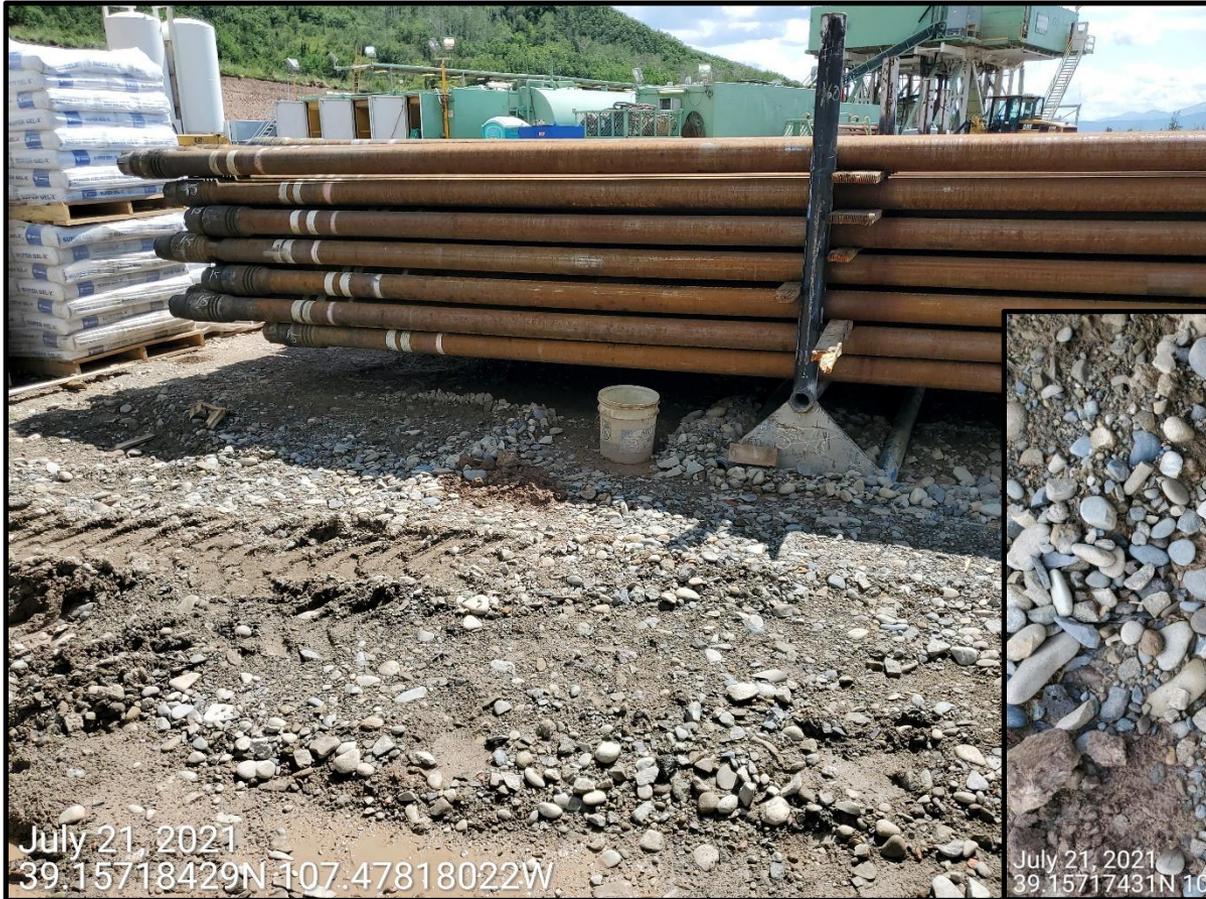
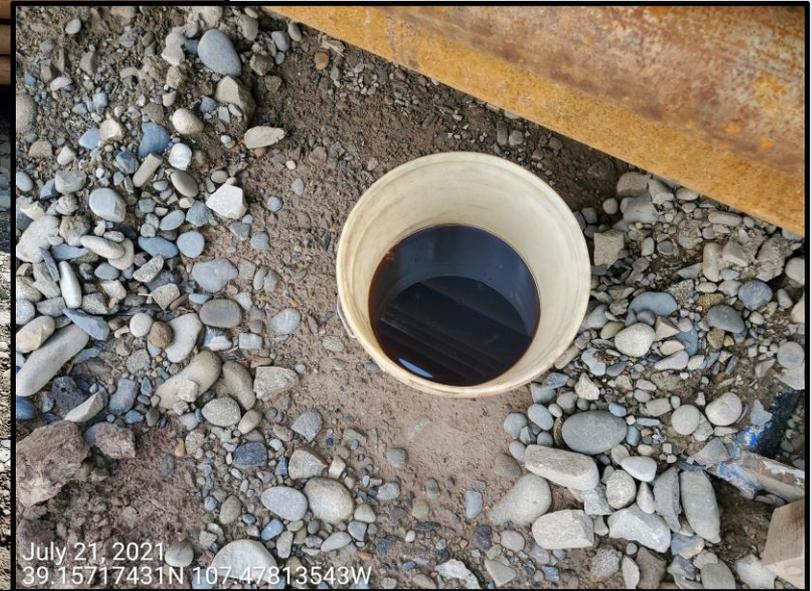
**Photo 16:** Photo taken from the north end of the Location. Photo shows bucket containing unknown fluids.

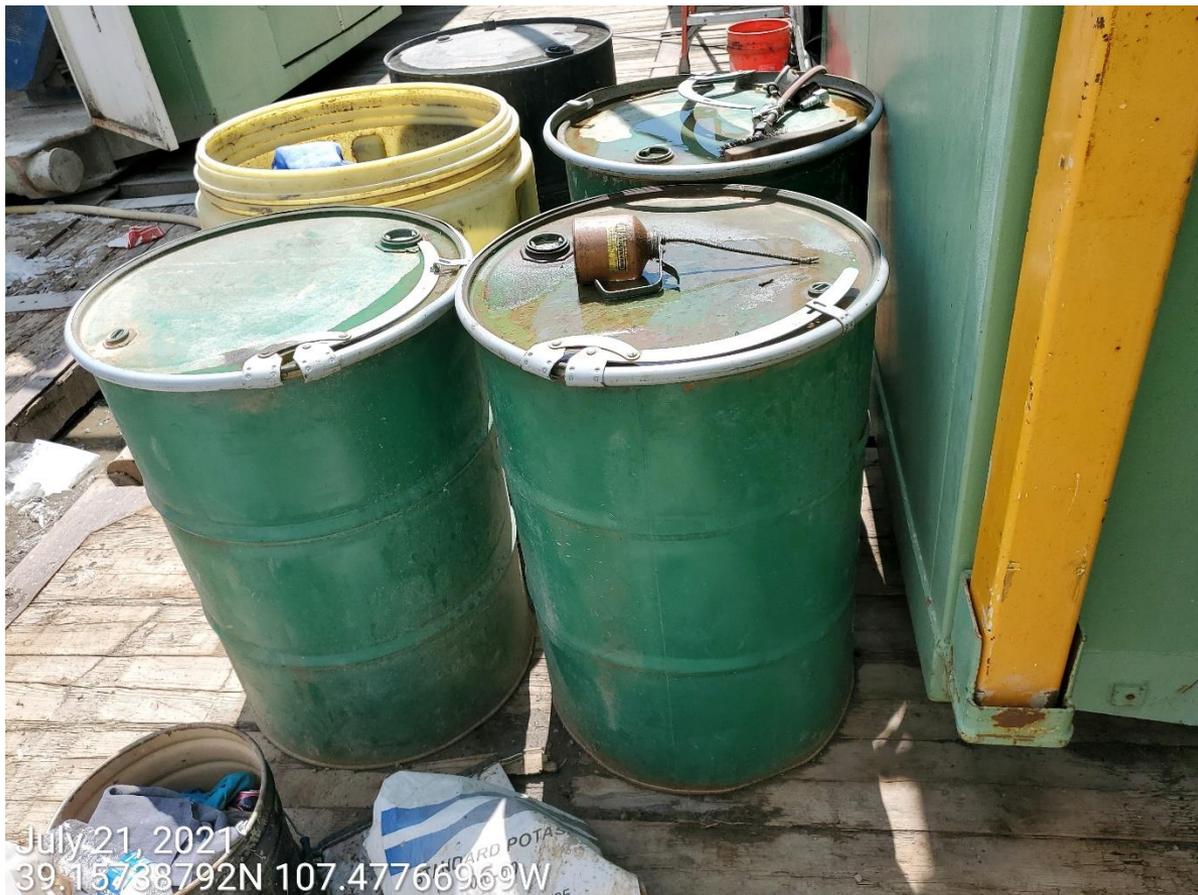
**Photo 17:** Photo shows green barrels with unknown contents; photo shows example of barrels, and containers missing labeling information (Labeling was observed on the black barrel).
