# Inspection Photos

7/21/2021

Operator: GUNNISON ENERGY LLC # 10515

Location ID: 453805

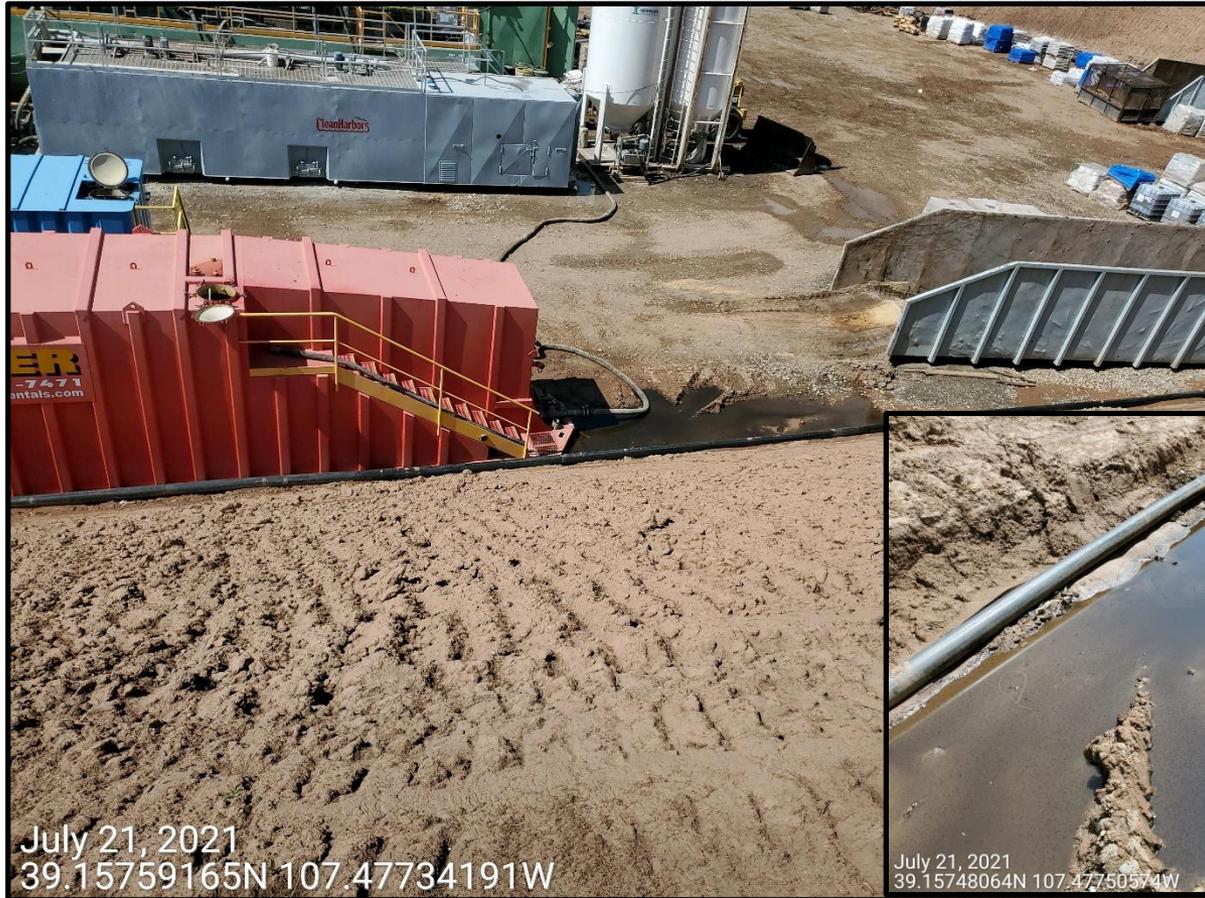
**Photo 18:** Photo taken from the east end of the Location, facing west. Photos 18-21 provide example of various spills and impacted stormwater observed on the Location, including within the perimeter stormwater ditch.

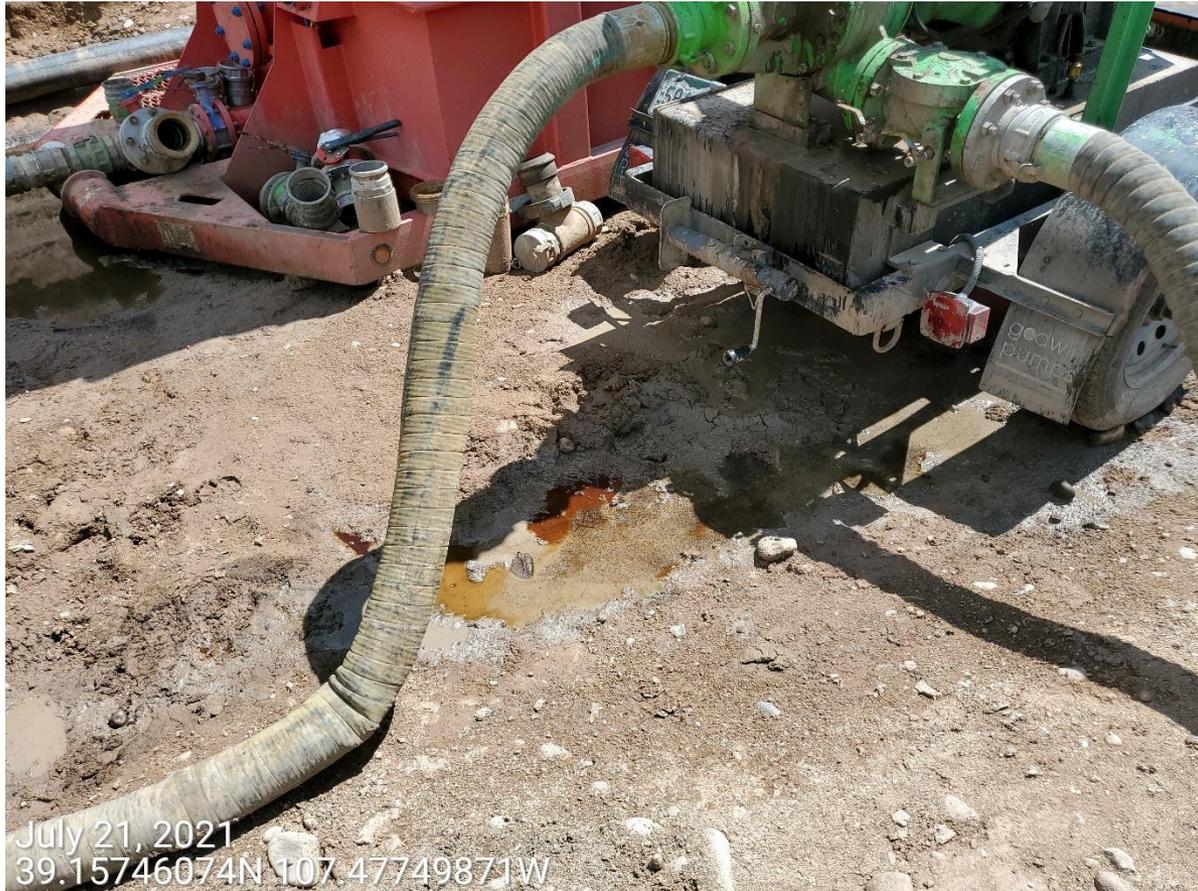
**Photo 19:** See comments under photo 18.

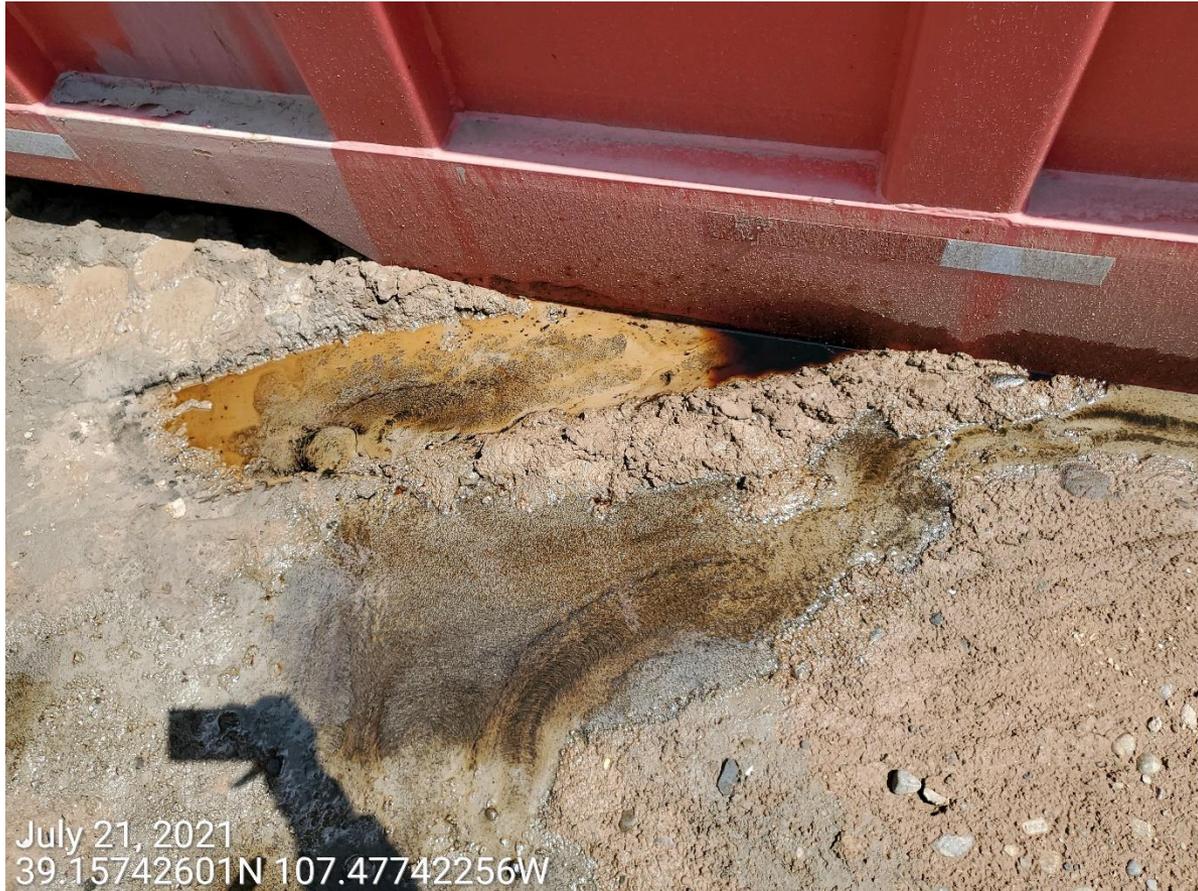
**Photo 20:** See comments under photo 18.

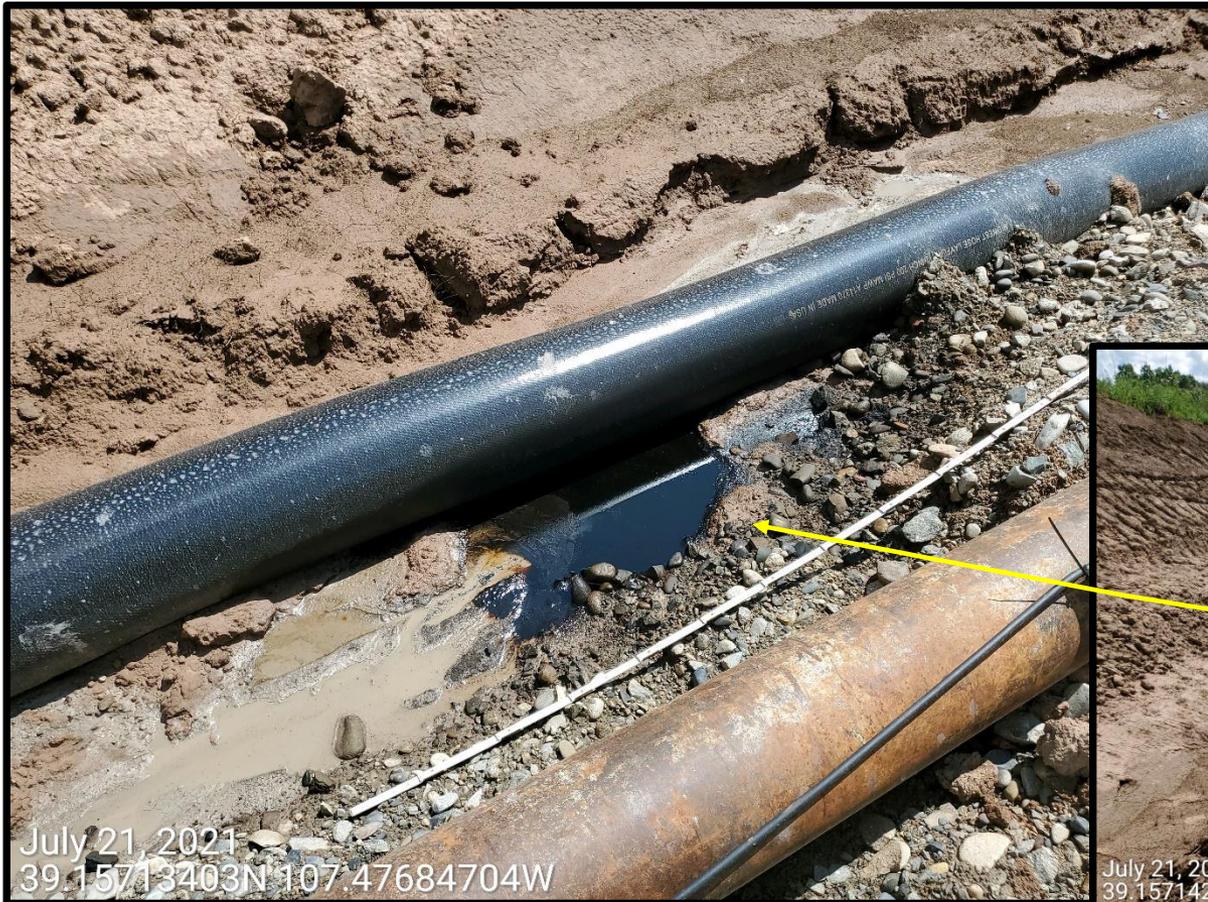
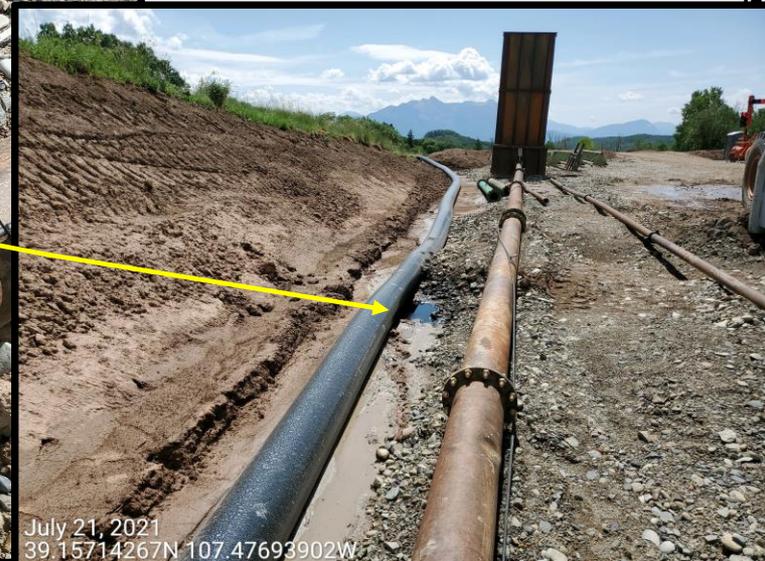
**Photo 21:** See comments under photo 18.

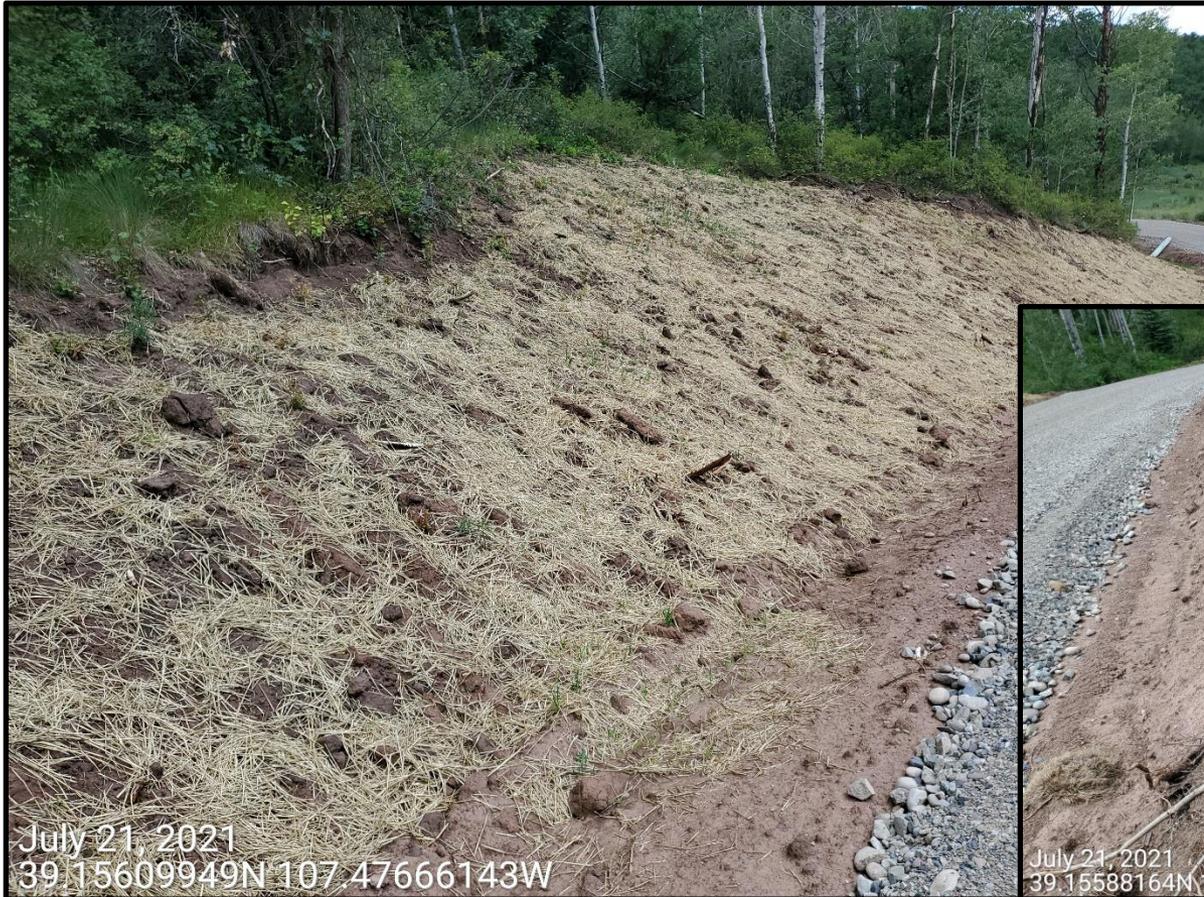
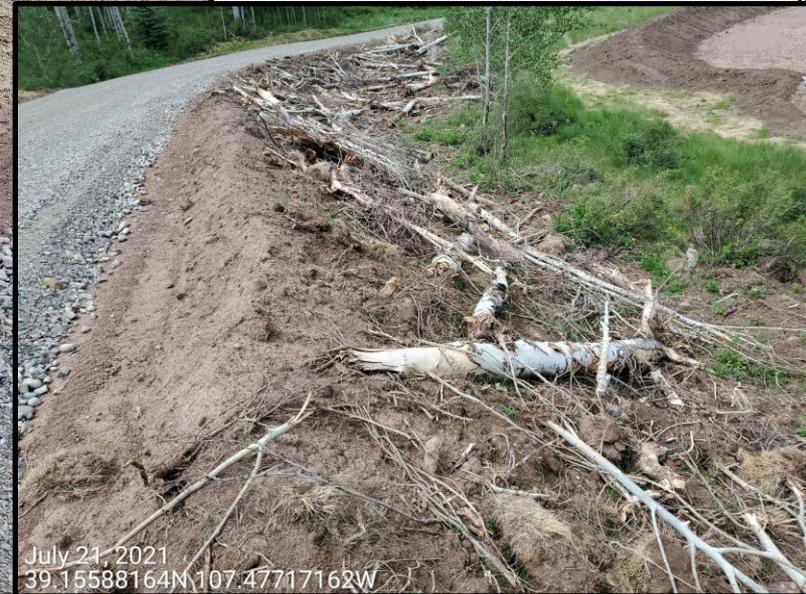
**Photo 22:** Photo taken from the cut and fill slopes of the access road. Photos show that mulch has been applied to the cut slopes, and slash material has been applied to the fill. Application observed to be uniform, though loose. It is unclear at time of inspection if BMPs are adequate to protect and stabilize slopes of the access road; additional BMPs in conjunction with mulch maybe necessary. Continue to monitor/manage slopes. A followup inspection will be conducted to determine compliance with 1002.f

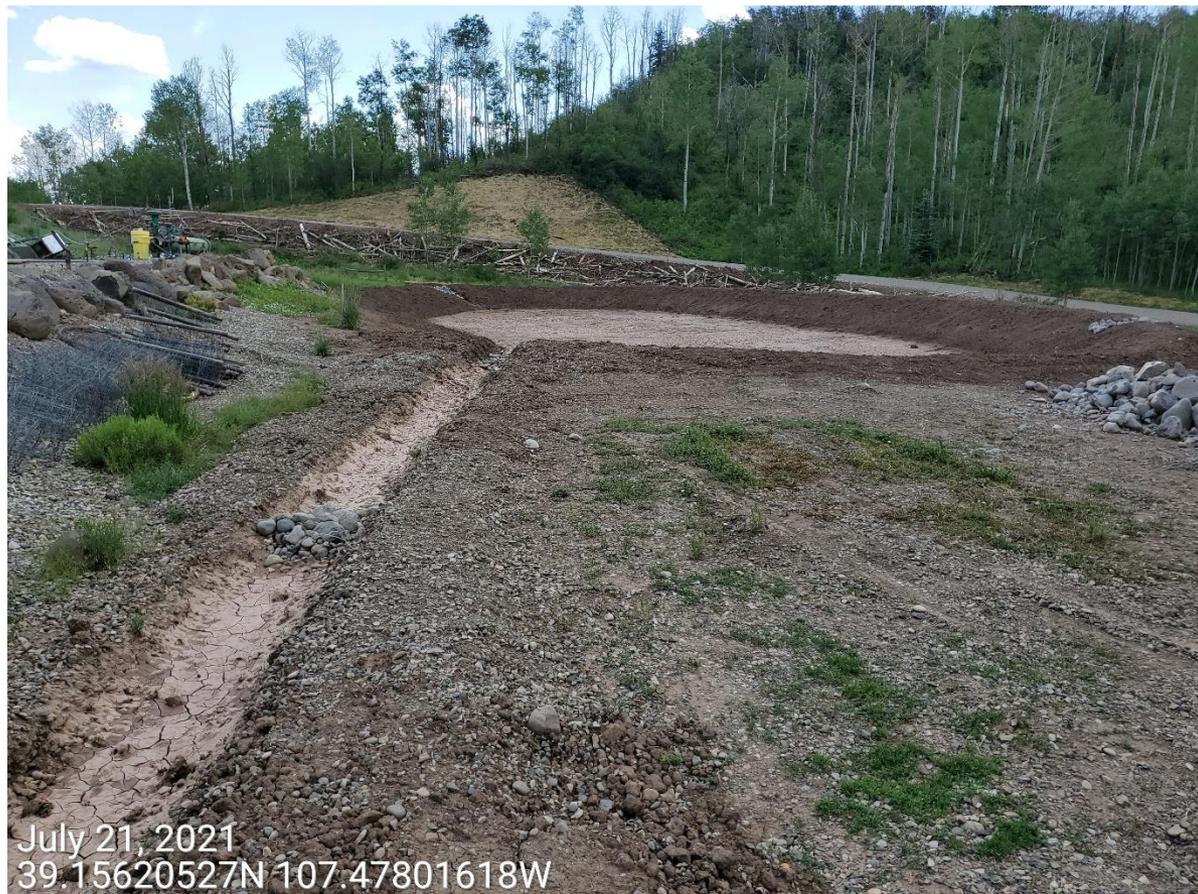
**Photo 23:** Photo taken from the sediment trap on the west end of the Location.

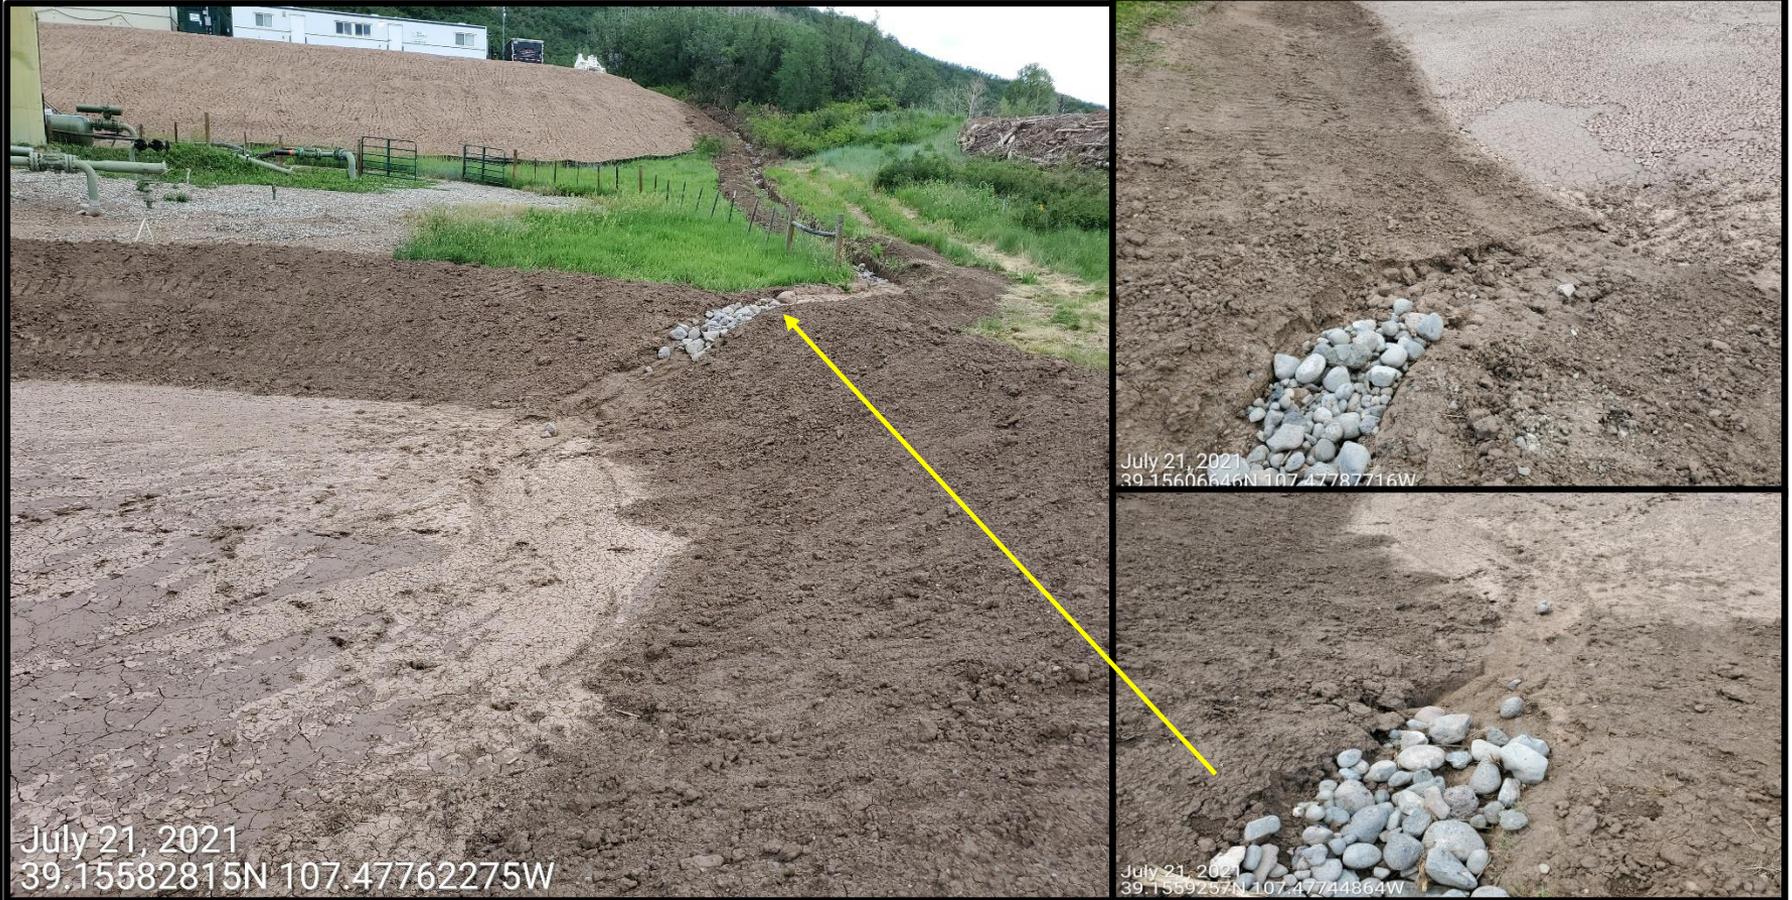
**Photo 24:** Continued from photo 23. Photo show inlets at the sediment trap are inadequate; erosion degradation observed at inlets. Geotextile lining does not appear to have been implemented at trap's inlets/outlets per good engineering practices.

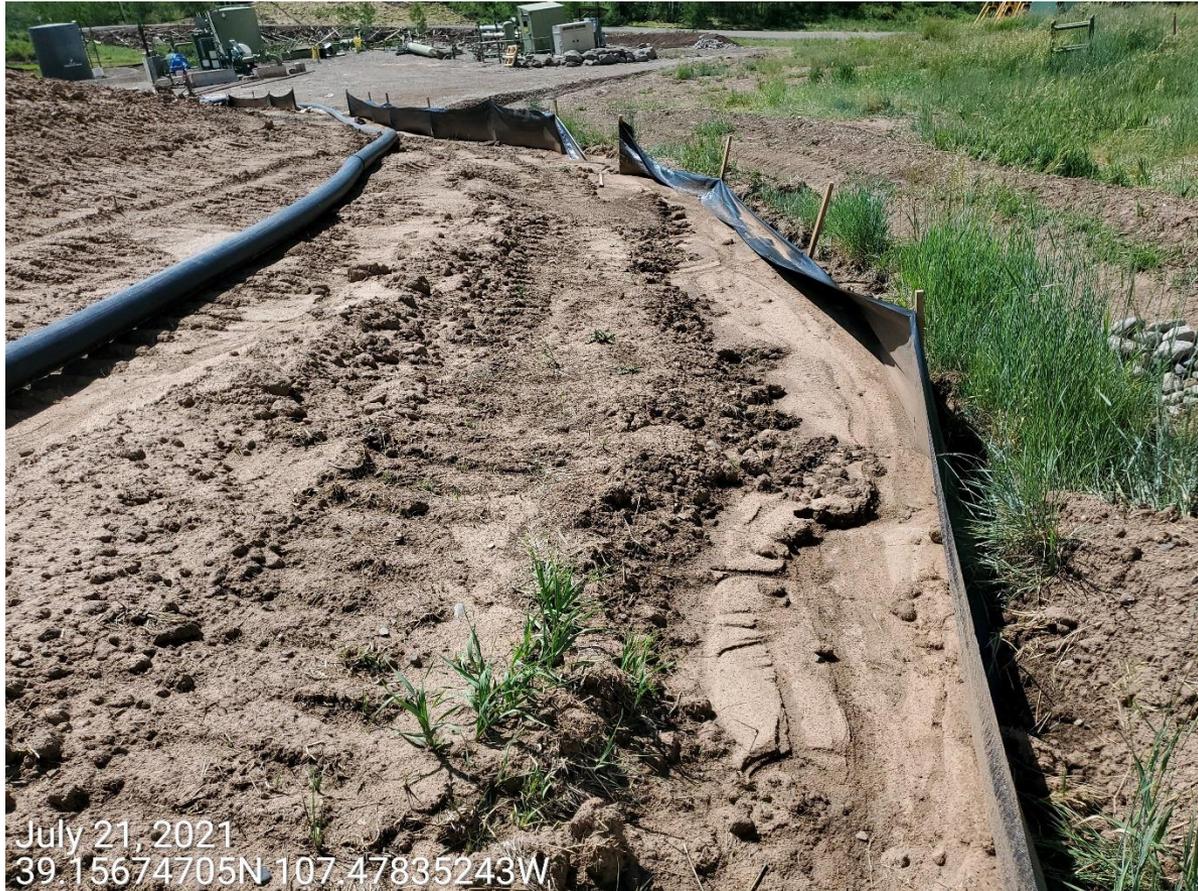
**Photo 25:** Photos 26-27 taken from the western perimeter of the Location. Photo shows perimeter stormwater and erosion control measures remain inadequate to properly manage runoff, and to allow for sediment laden-free stormwater discharge; offsite sediment transport evident. Sediment due to improper stabilization of the fill slopes has filled the silt traps.

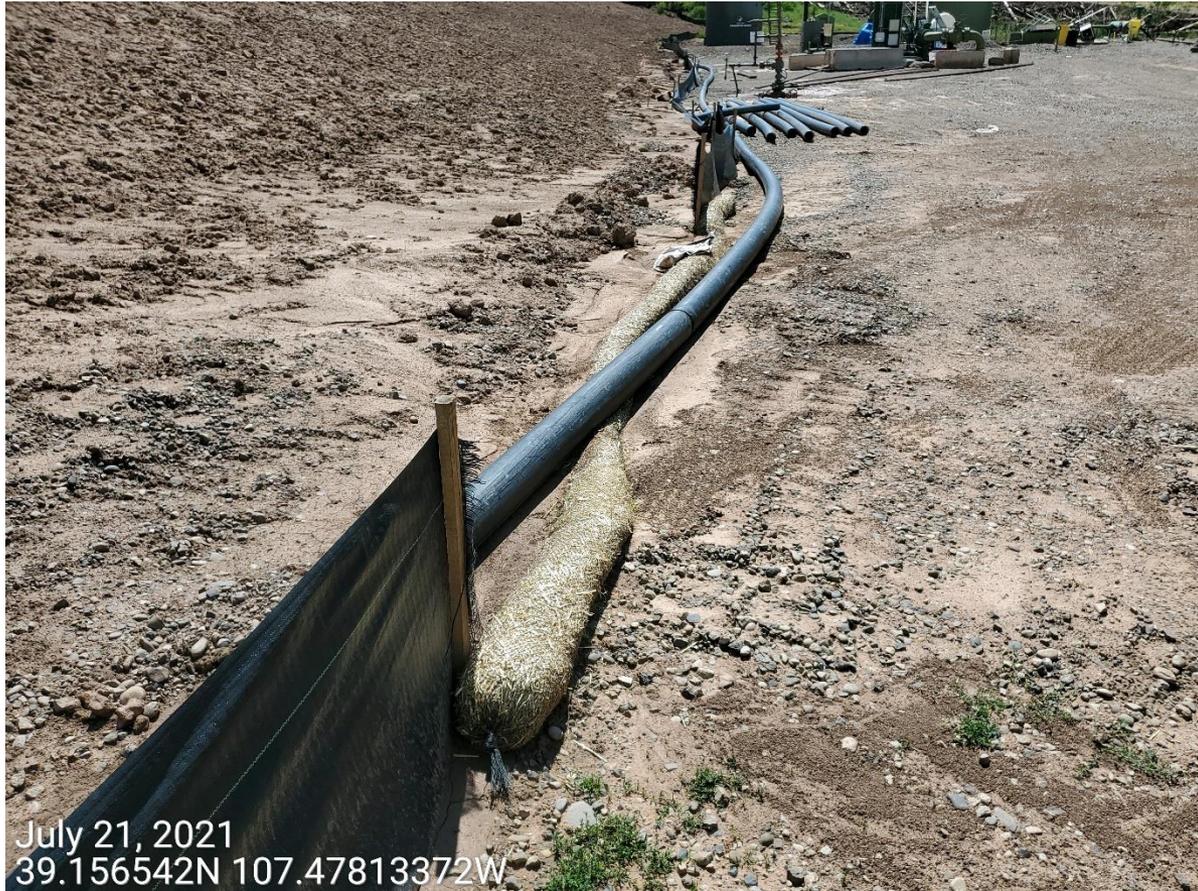
**Photo 26:** See comments from photo 25. Photo shows a straw wattle was placed along a gap of the silt fence; wattle not installed in accordance with good engineering practices, or maintained in proper functioning condition; Operator placed a pipeline on top of the wattle, rendering it inadequate.

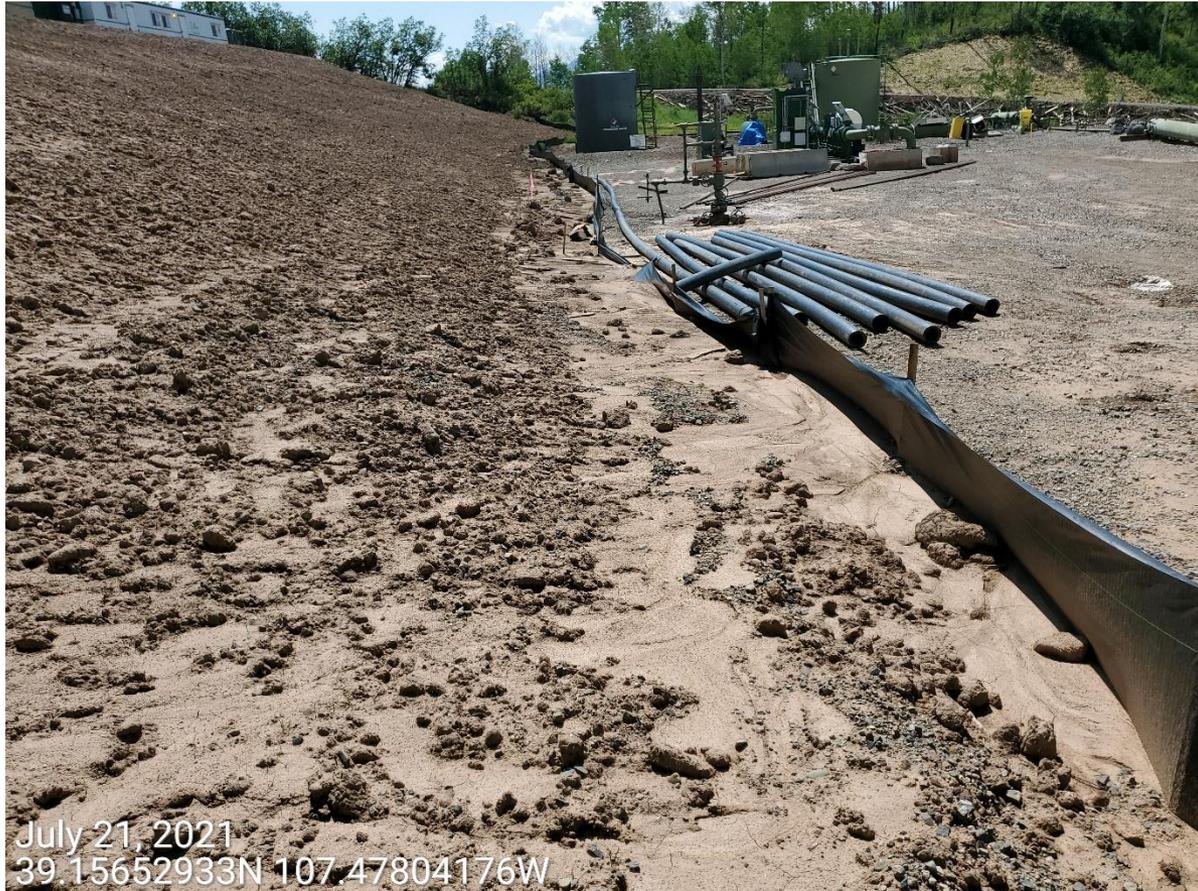
**Photo 27:** See comments from photo 25.
