Inspection Photos
Operator: Simcoe
API: 067-09077
Date: 7/23/2021

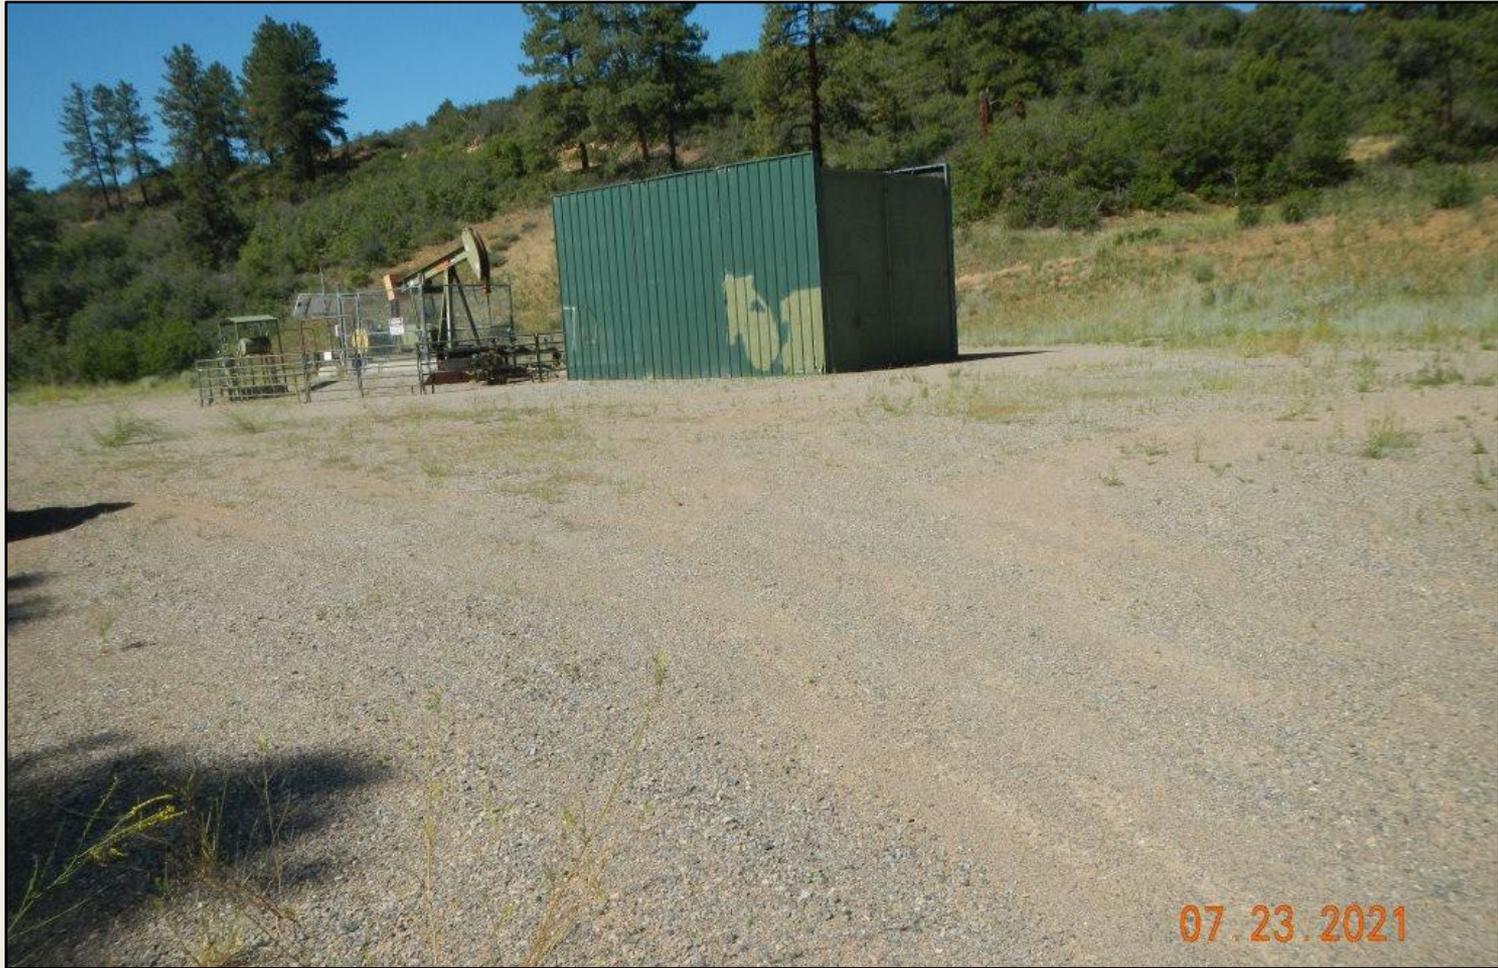
Photo 1. View of the project area from the well pad entrance facing center.

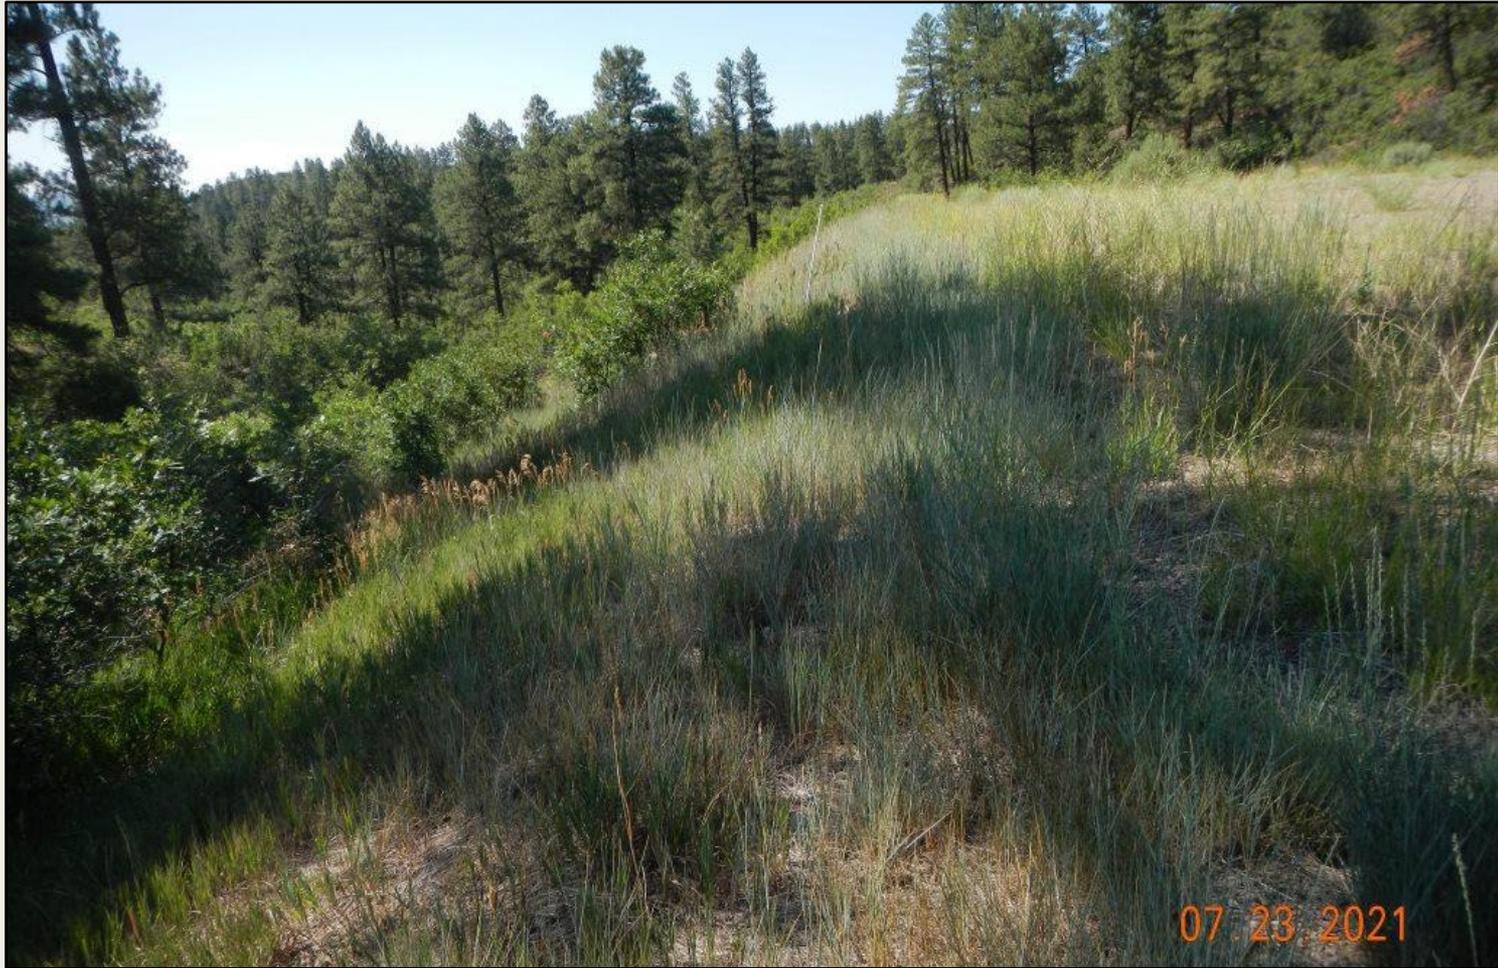
Photo 2. View of the eastern fill slope from the northeastern corner facing southward. Revegetation is progressing with western wheatgrass, sand dropseed, and smooth brome.

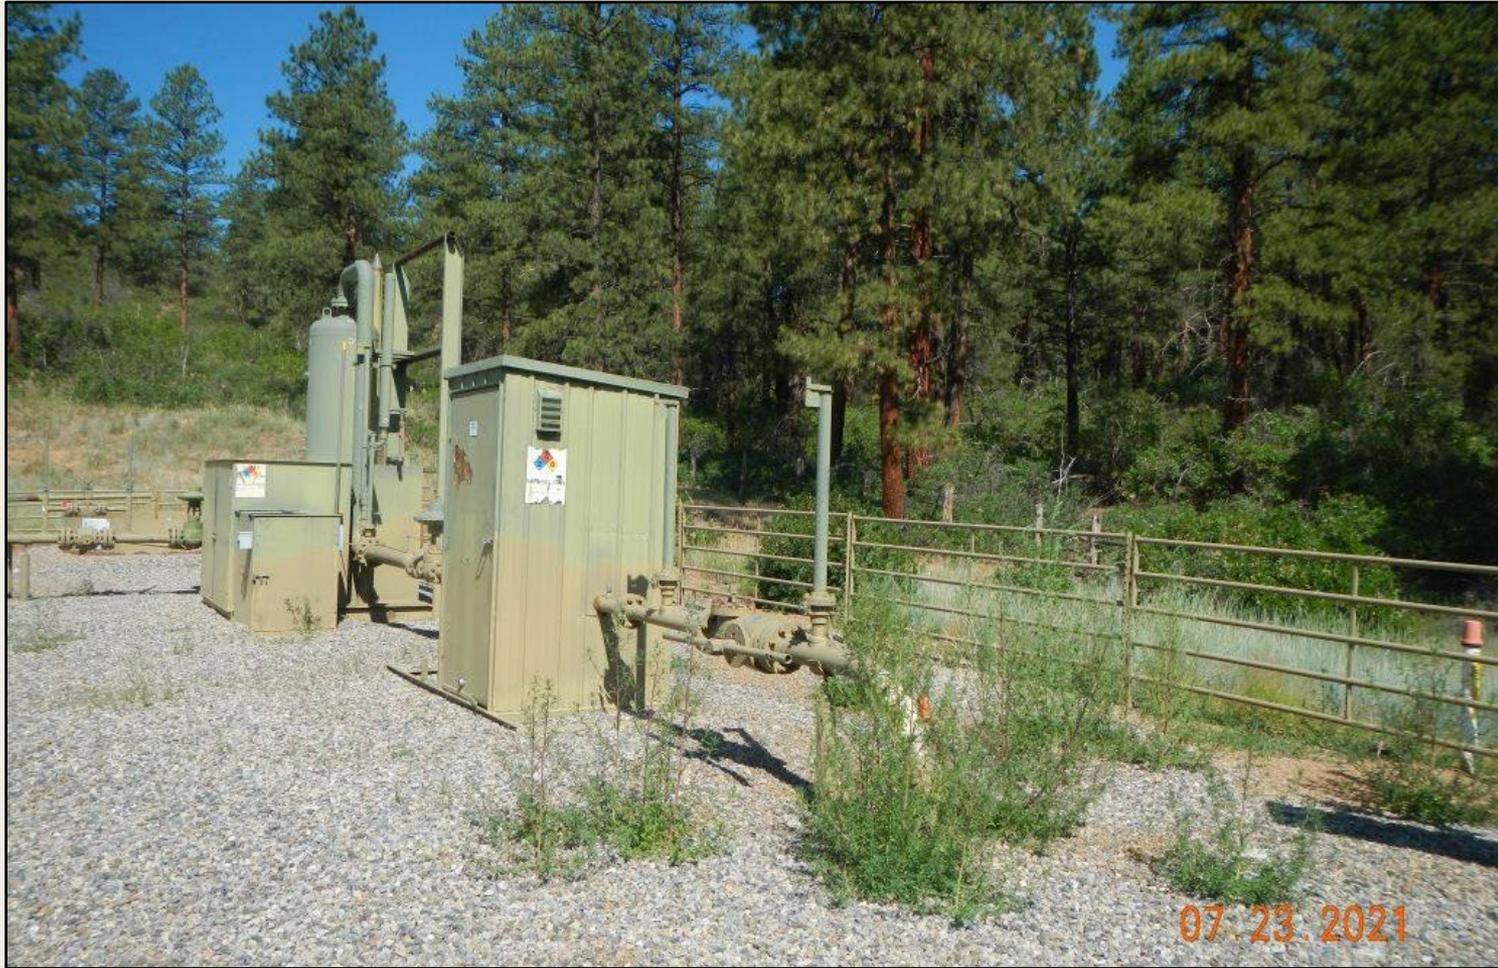
Photo 3. View of weeds growing around equipment needing management.

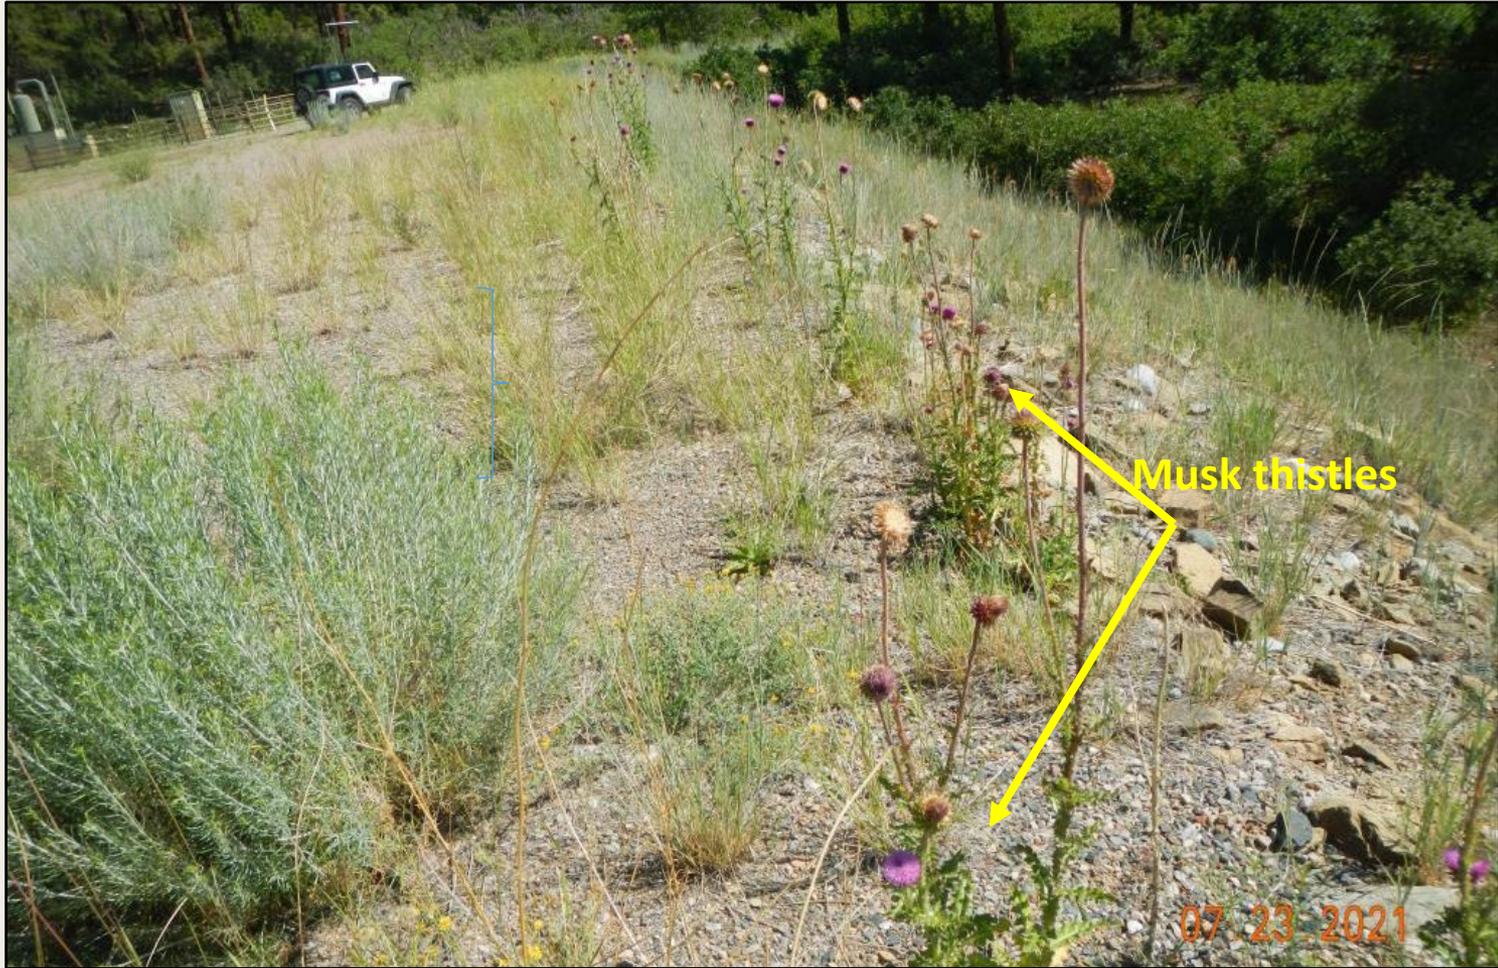
Photo 4. View of musk thistles within the project area. Approximately 75 blooming individuals observed.
