Inspection Photos  
Operator: Simcoe  
API: 067-07400  
Date: 7/23/2021

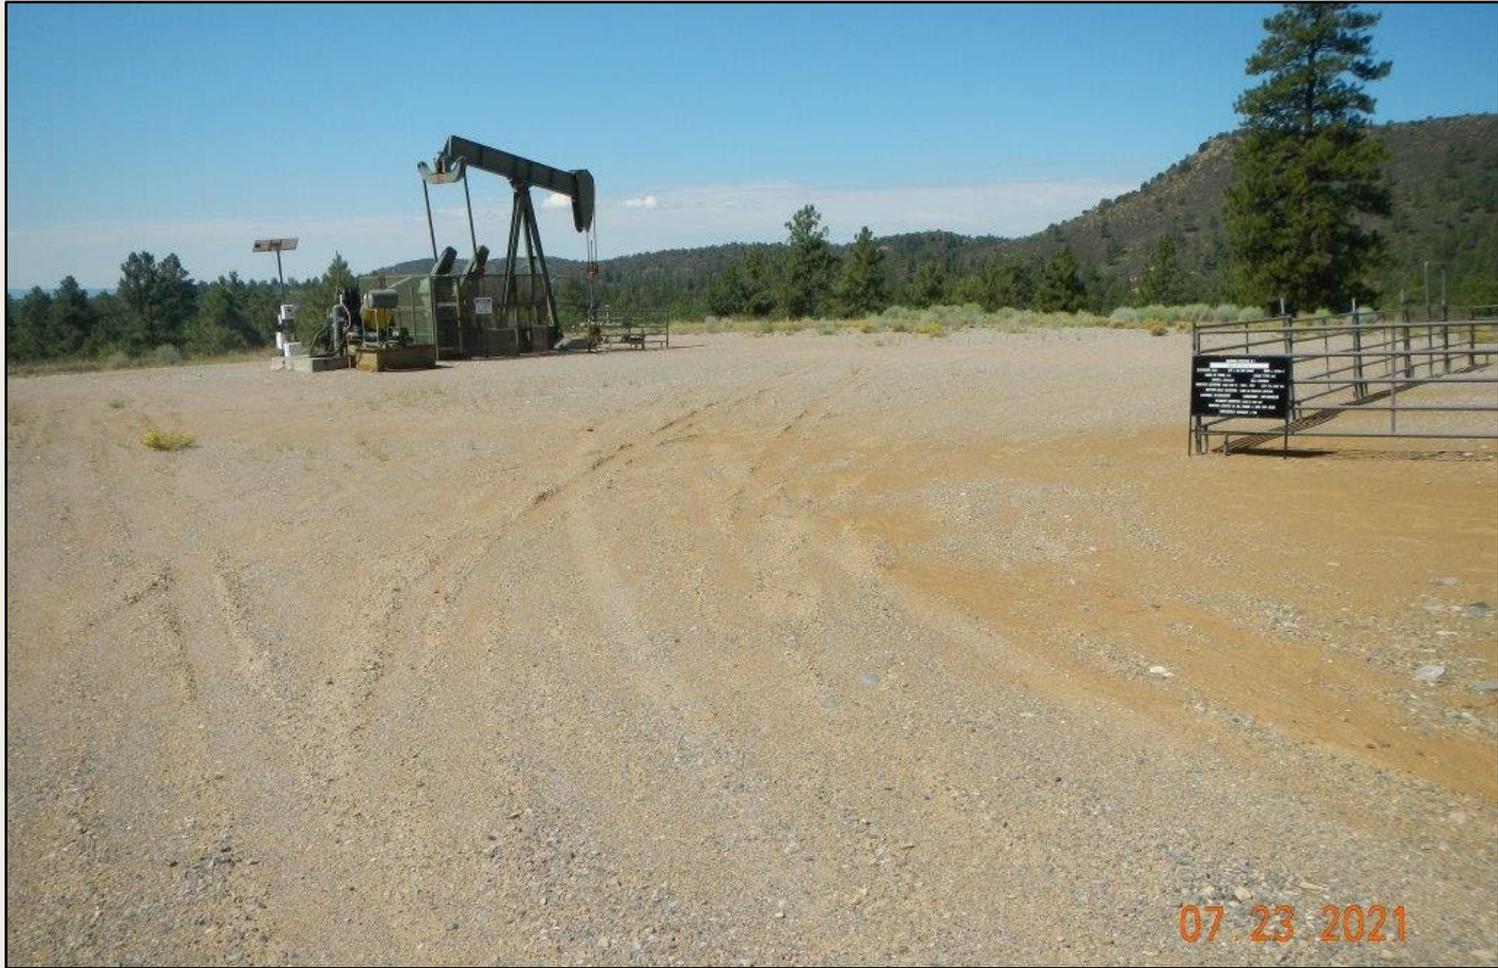
Photo 1. View of the project area from the well pad entrance facing center.

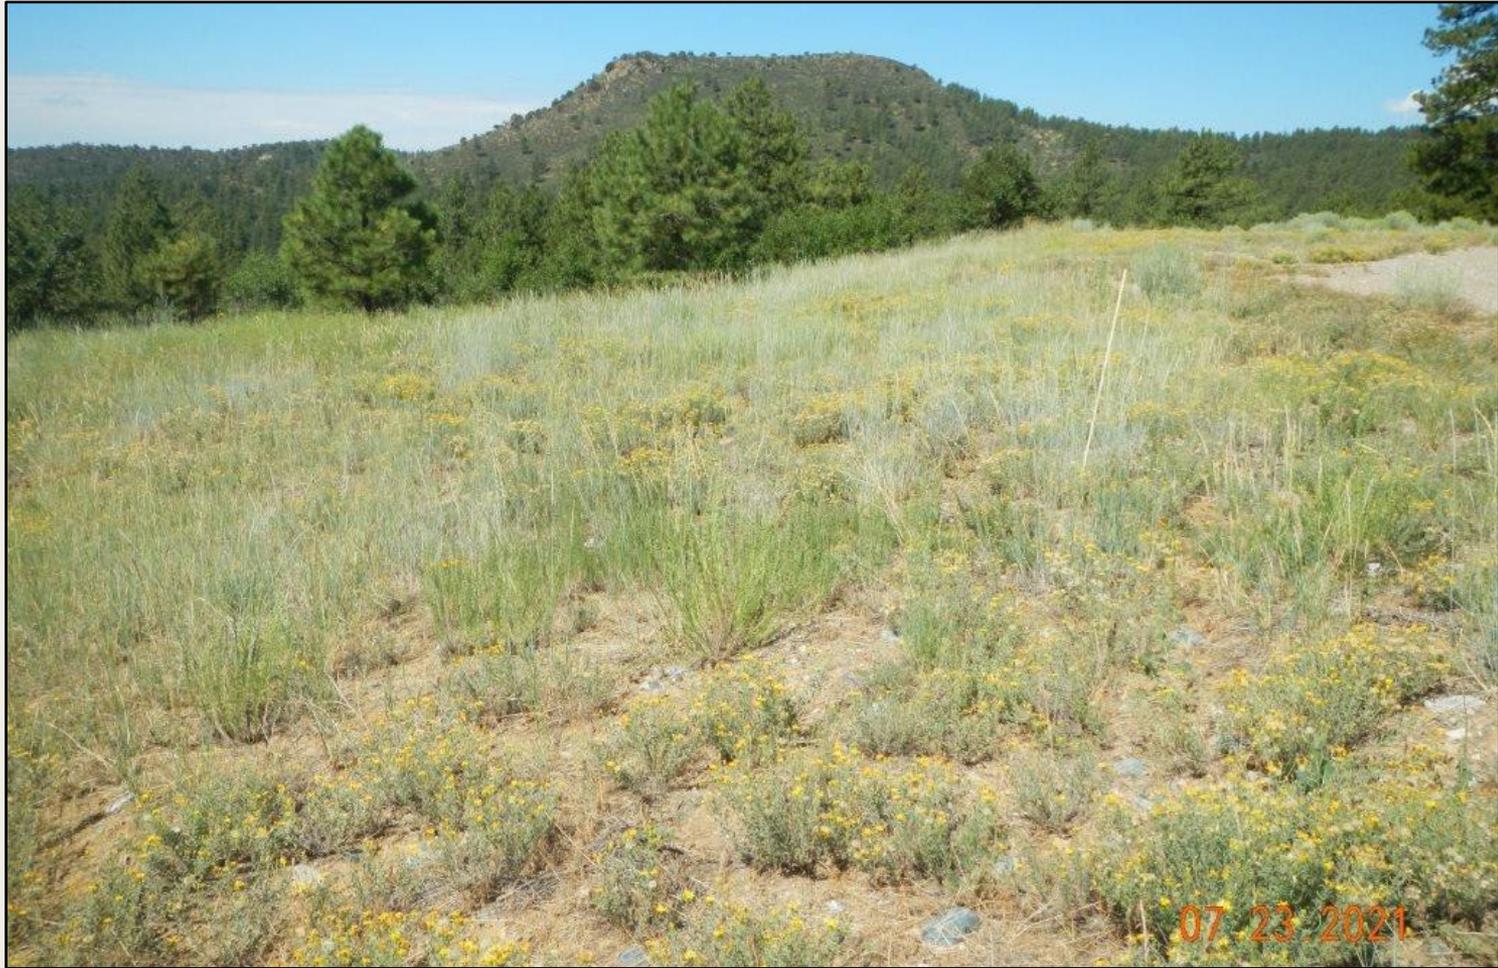
Photo 2. View of the southern project area from the southeastern corner facing westward. Revegetation is progressing with western wheatgrass, crested wheatgrass, and yellow goldenaster.

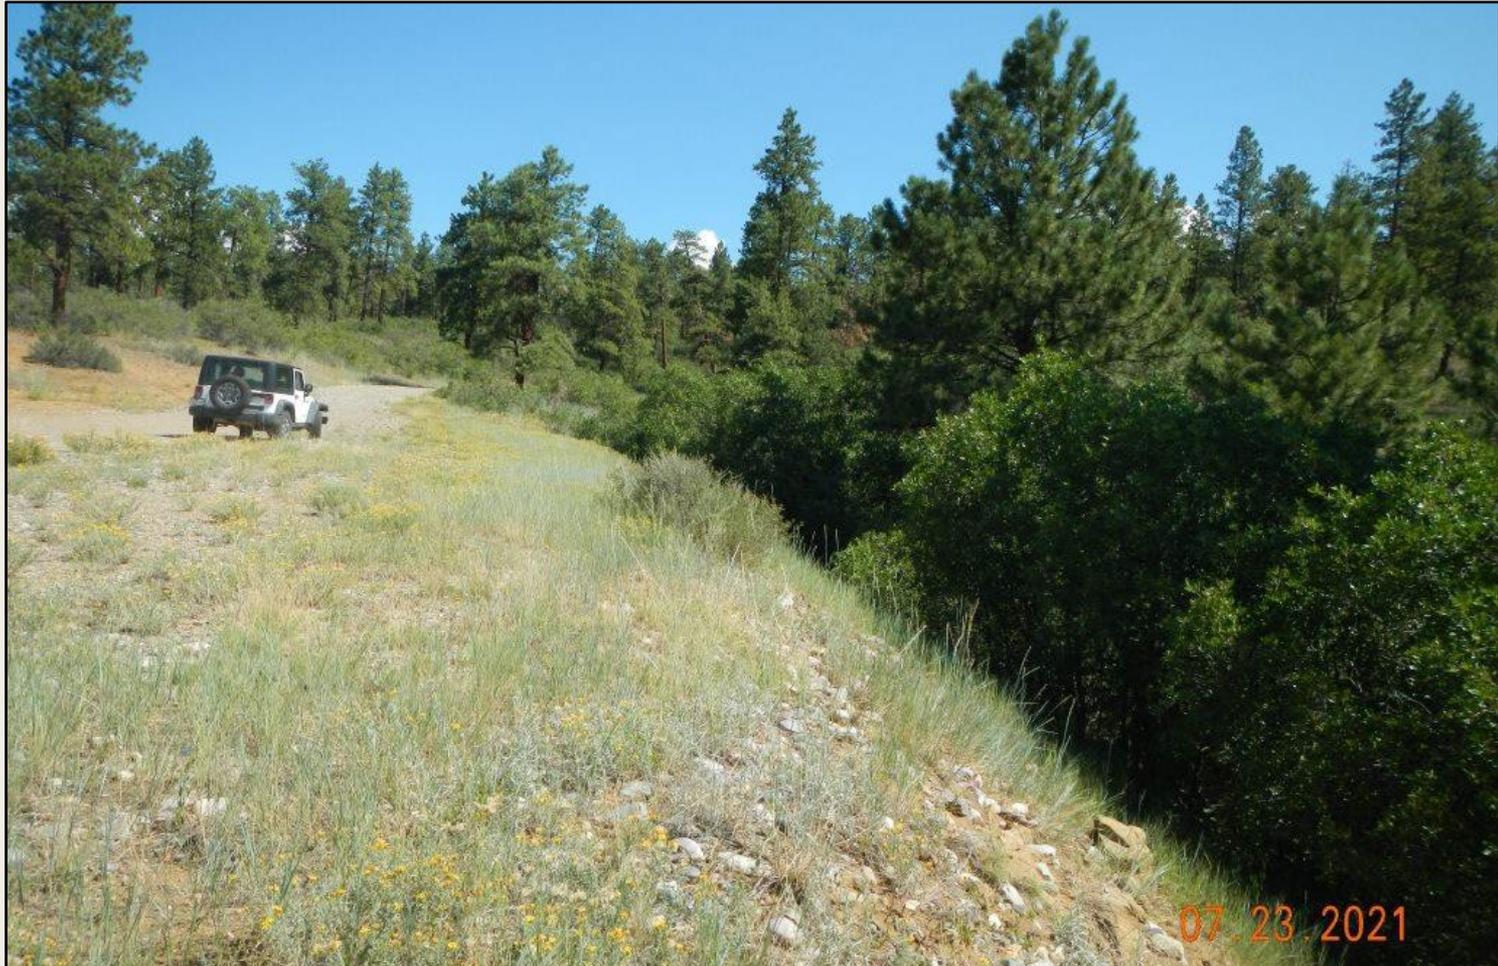
Photo 3. View of the eastern project area from the southeastern corner facing northward.

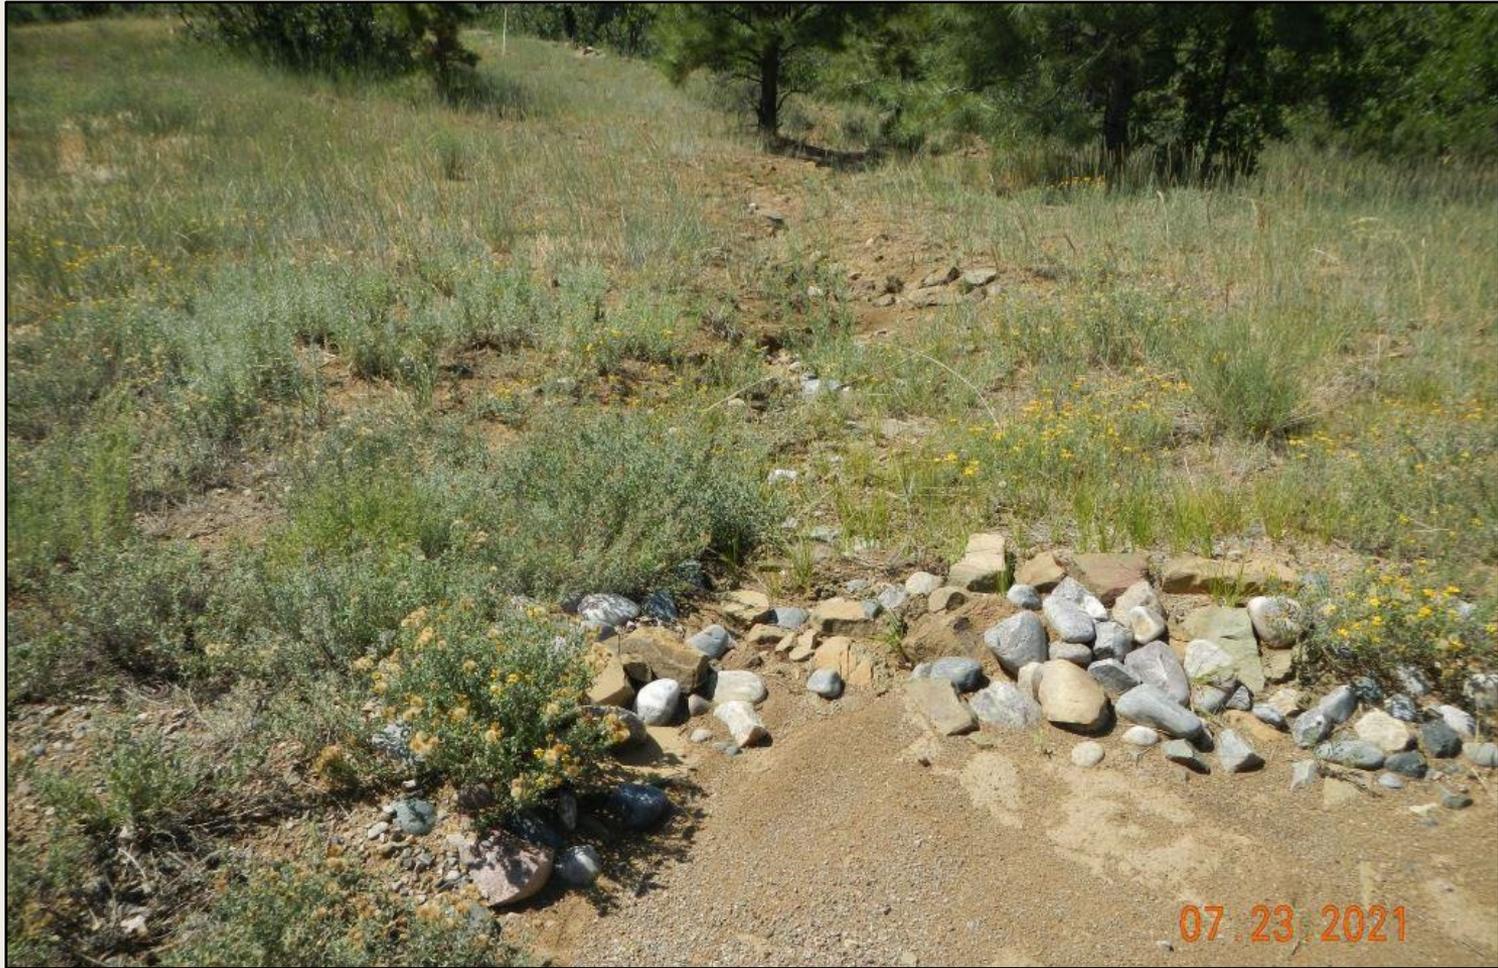
Photo 4. View of rock BMP within the southern project area, full of sediment and needing maintenance.

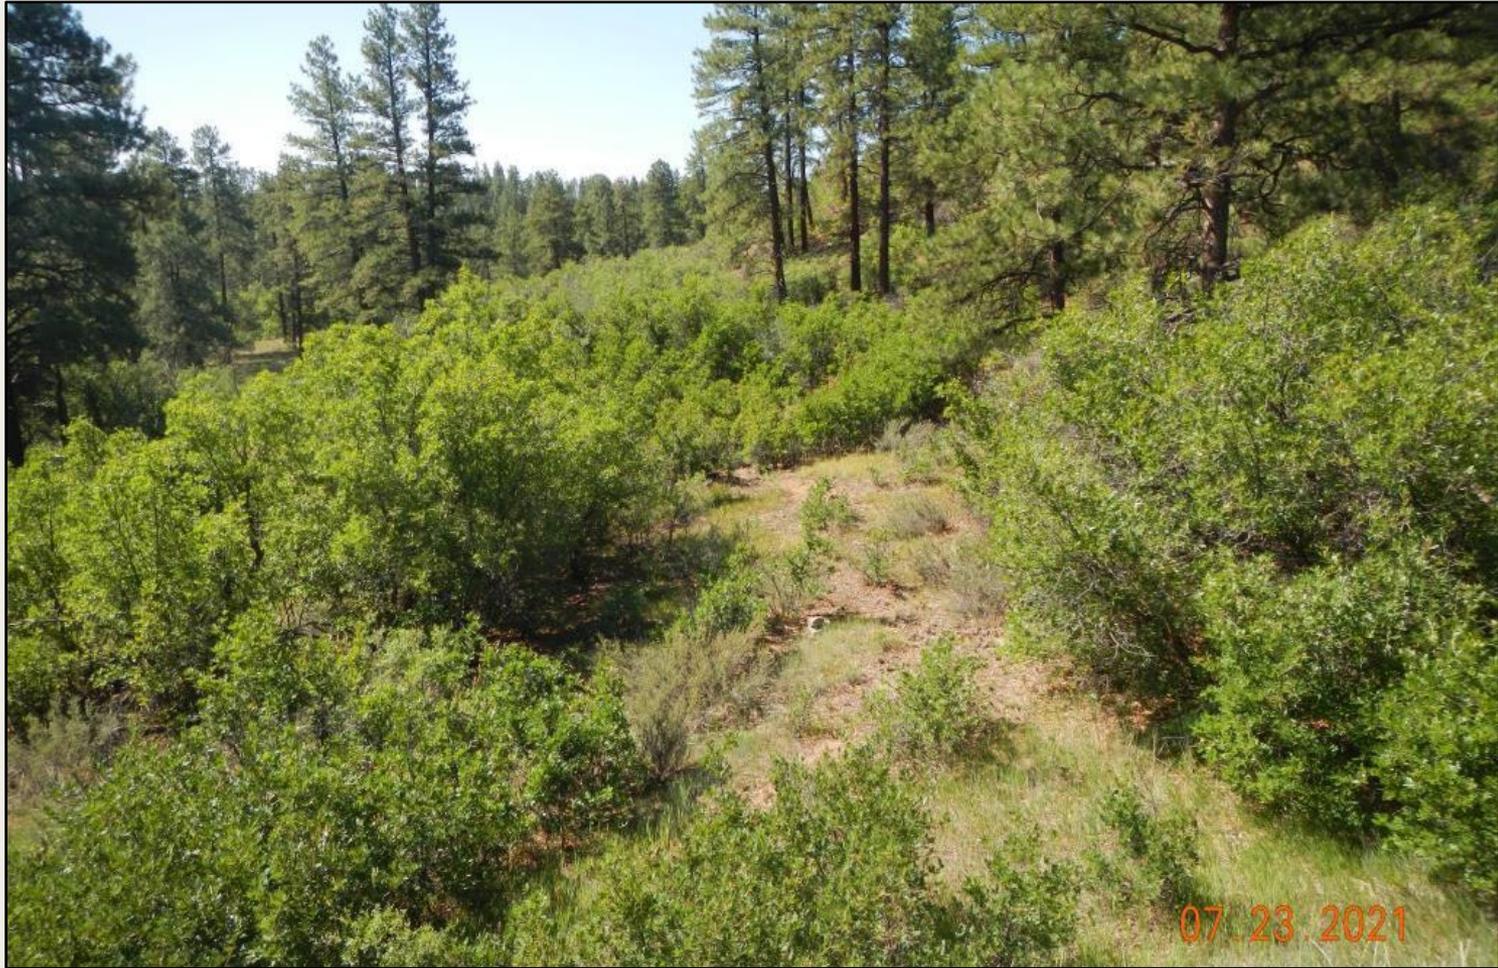
Photo 5. View the reference area comprised of ponderosa pine woodland with understory of gambel oak, serviceberry, western wheatgrass, and Oregon grape.
