Inspection Photos

API: 071-06124

Operator: OGRIS OPERATING LLC

Inspection Date: 7/29/2021

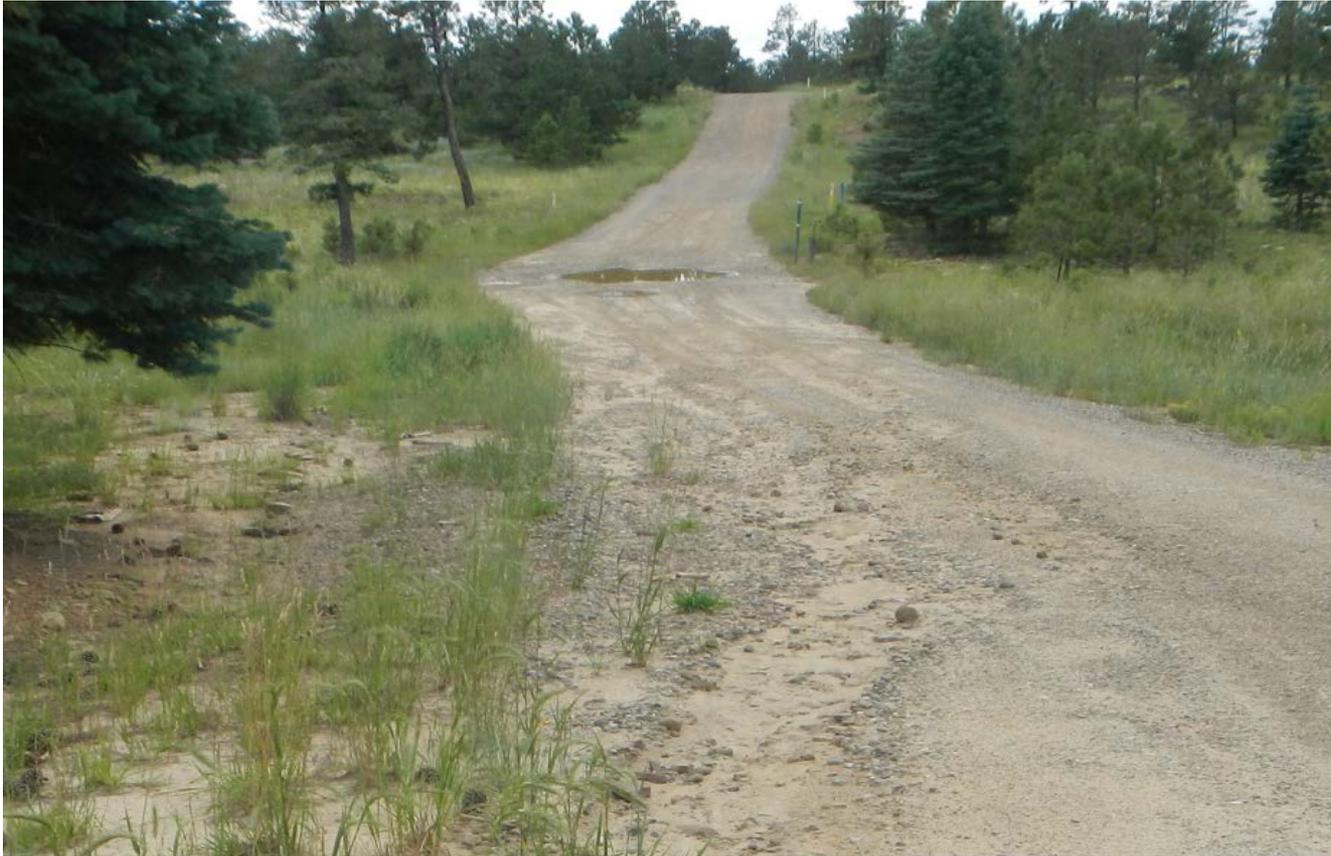
Photo 1. Facing south along the main road. Stormwater is accumulating on the road causing widening of the road. Stormwater needs to be diverted off the road. This area shown in previous inspection was not repaired.

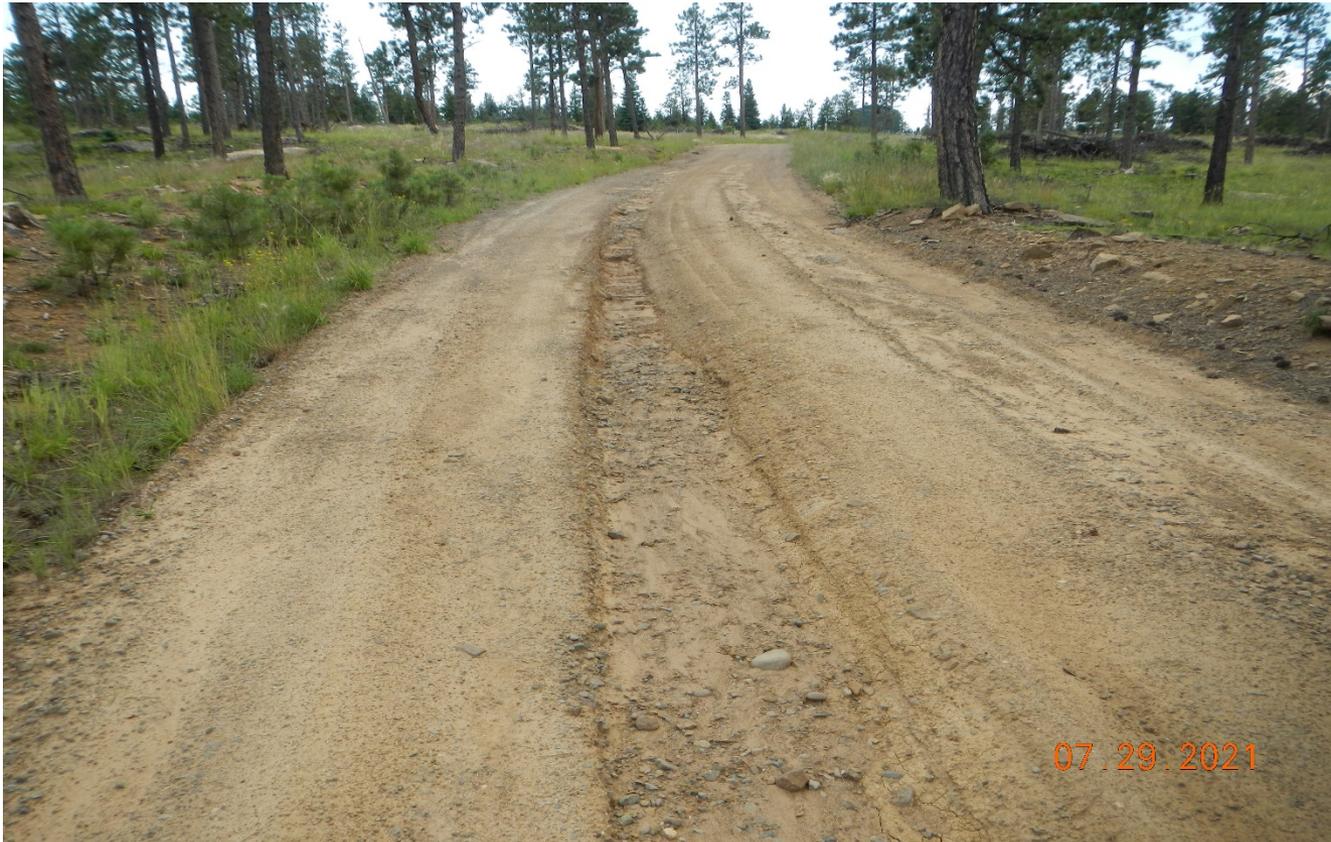
Photo 2. Vehicle rutting along the road has not been repaired and stormwater is causing erosion of the road.

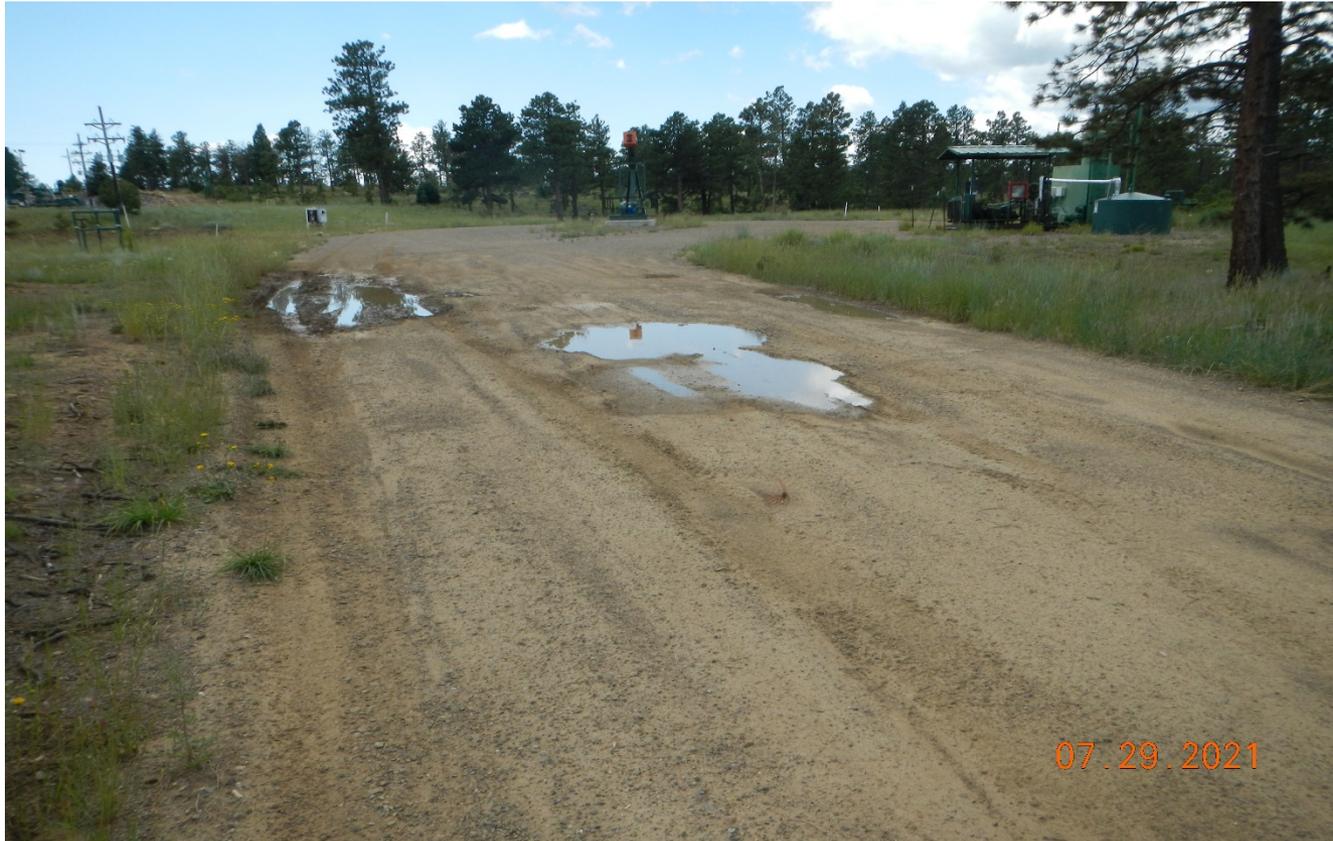
Photo 3. Facing southwest along the main road near the location. Vehicles have caused widening of the road. This area has not been repaired since previous inspection.

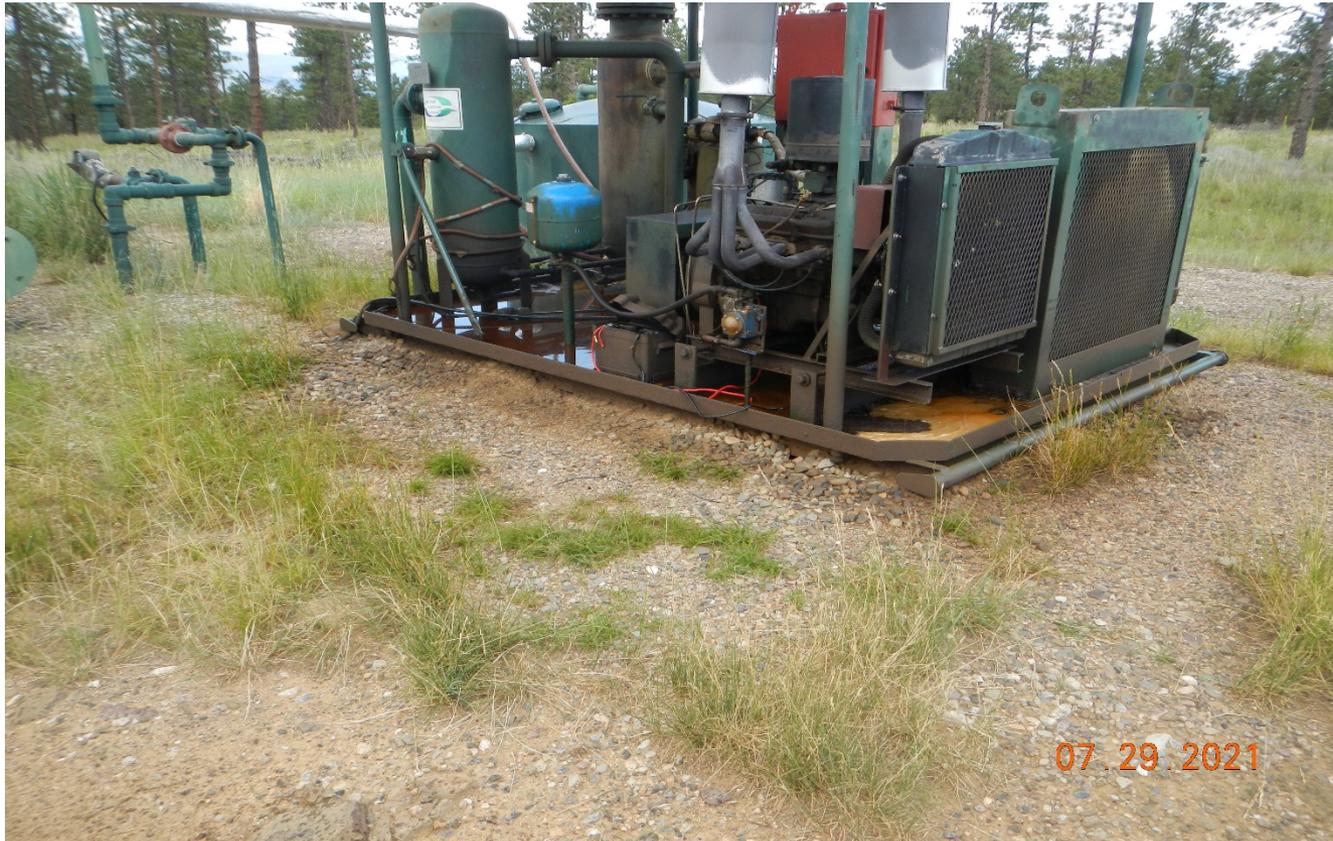
Photo 4. There is still oil inside the engine skid that needs to be cleaned up.
