Inspection Photos

7/29/2021

Operator: CAERUS PICEANCE LLC - 10456

Location ID: 335904

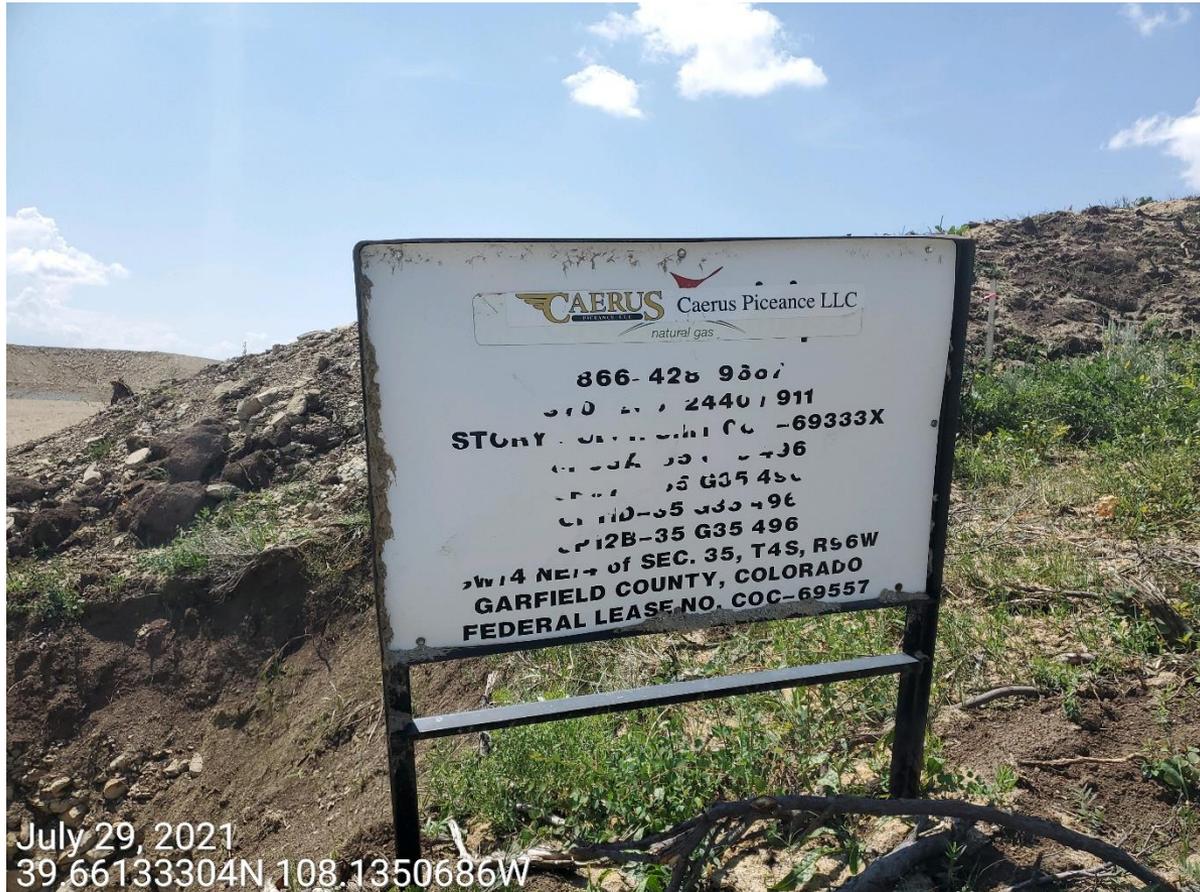
Photo 1: Photo shows sign at the Location's entrance remains illegible, including the emergency number.

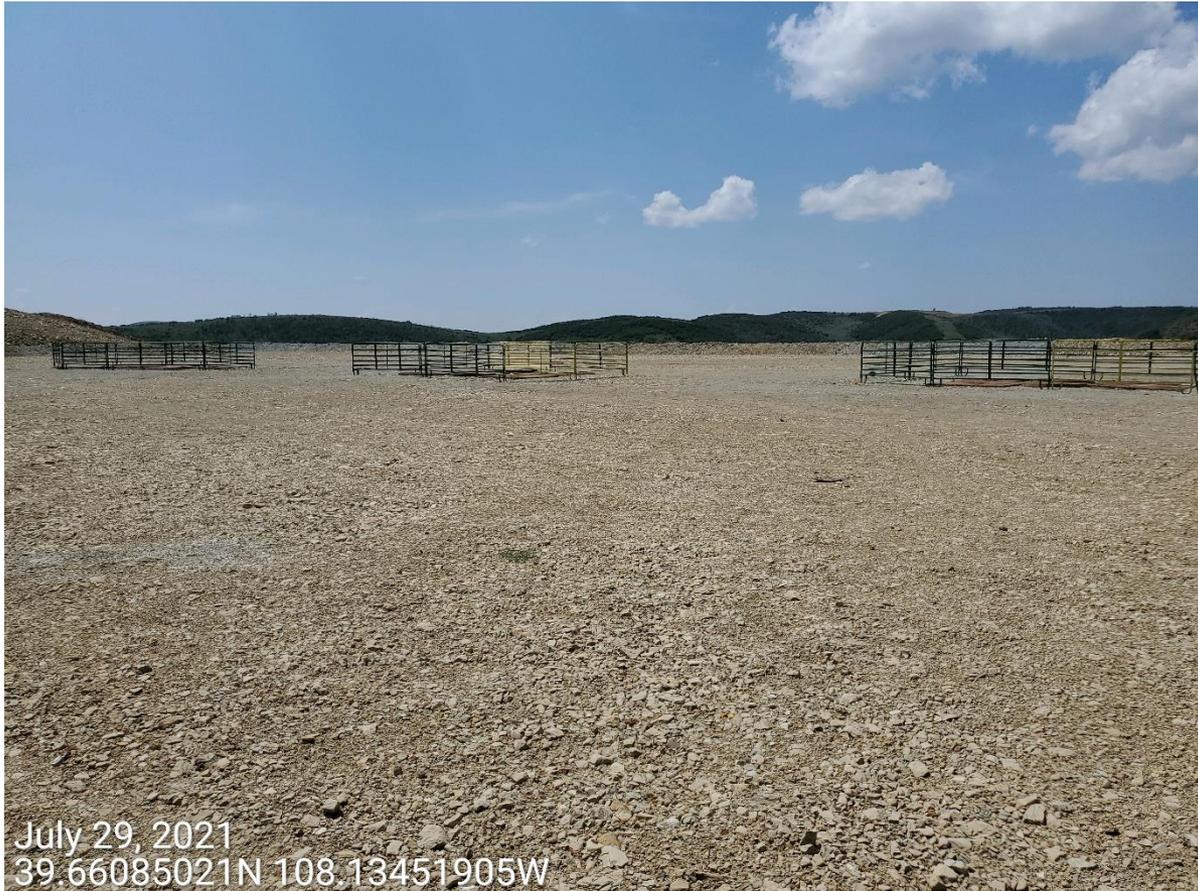
Photo 2: Photo of the wells on site; conductors have been set. Photo shows that ongoing/continuous drilling or subsequent operations has not been performed.

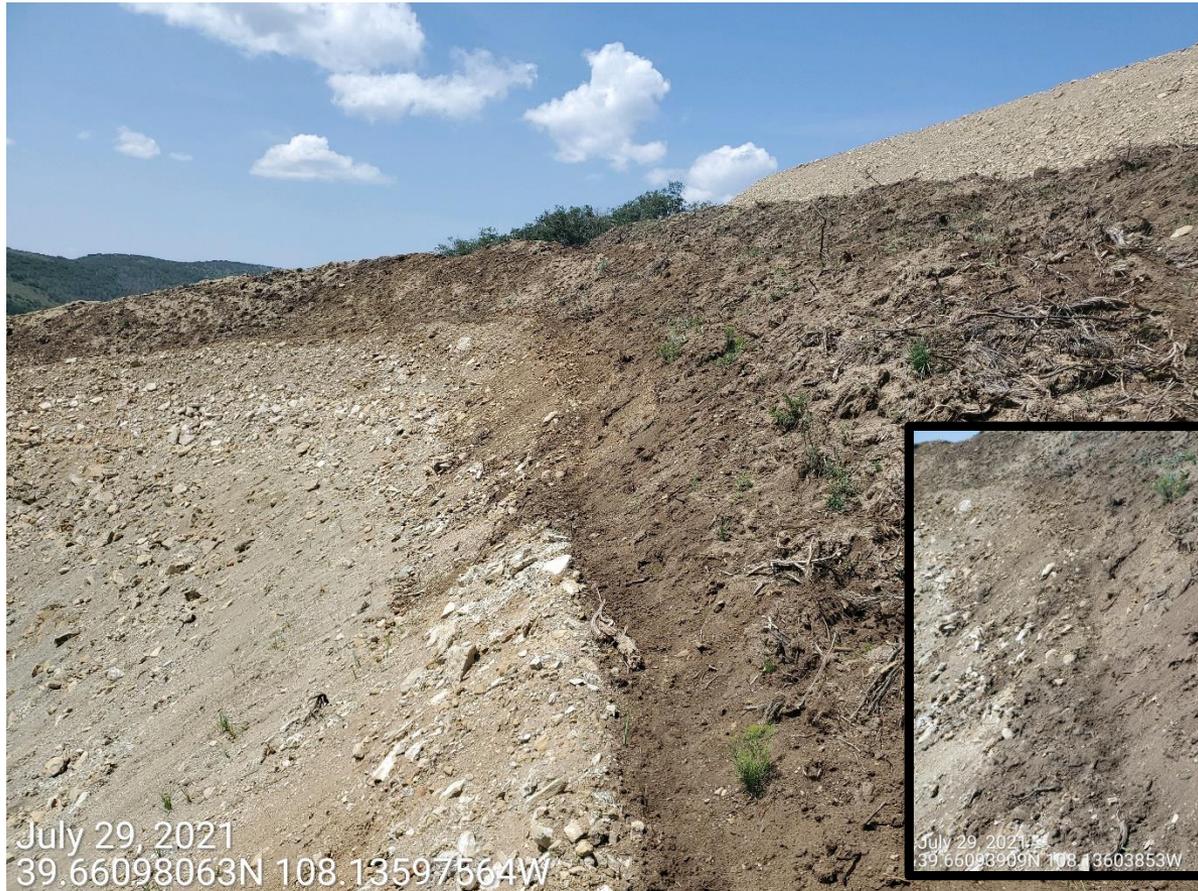
Photo 3: Photo taken on the North end of the Location. Photo shows example of slopes on the Location (cut/fill, and topsoil), where BMPs remain missing or insufficient to protect/stabilize. Darker soils on right is topsoil stored above a cut slope; hydromulch on topsoil no longer in proper functioning condition.

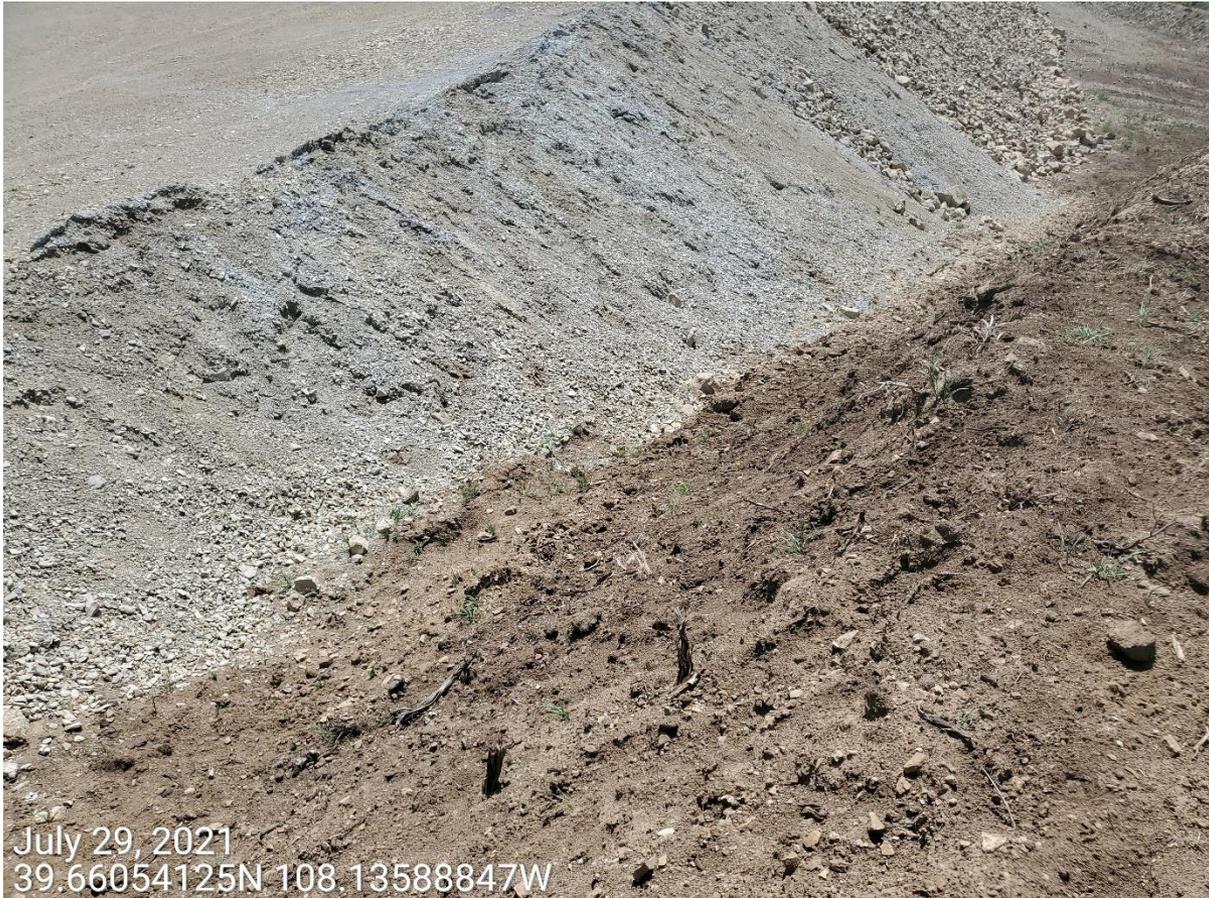
Photo 4: Photo taken from the topsoil stockpile on the west end of the Location. Photo shows control measures to protect/stabilize slopes remain missing or insufficient. Photo also shows topsoil has been utilized at the base of the fill slopes/subsoils of the Location, as a berm and sediment trap/pond to manage stormwater. See photo 5.

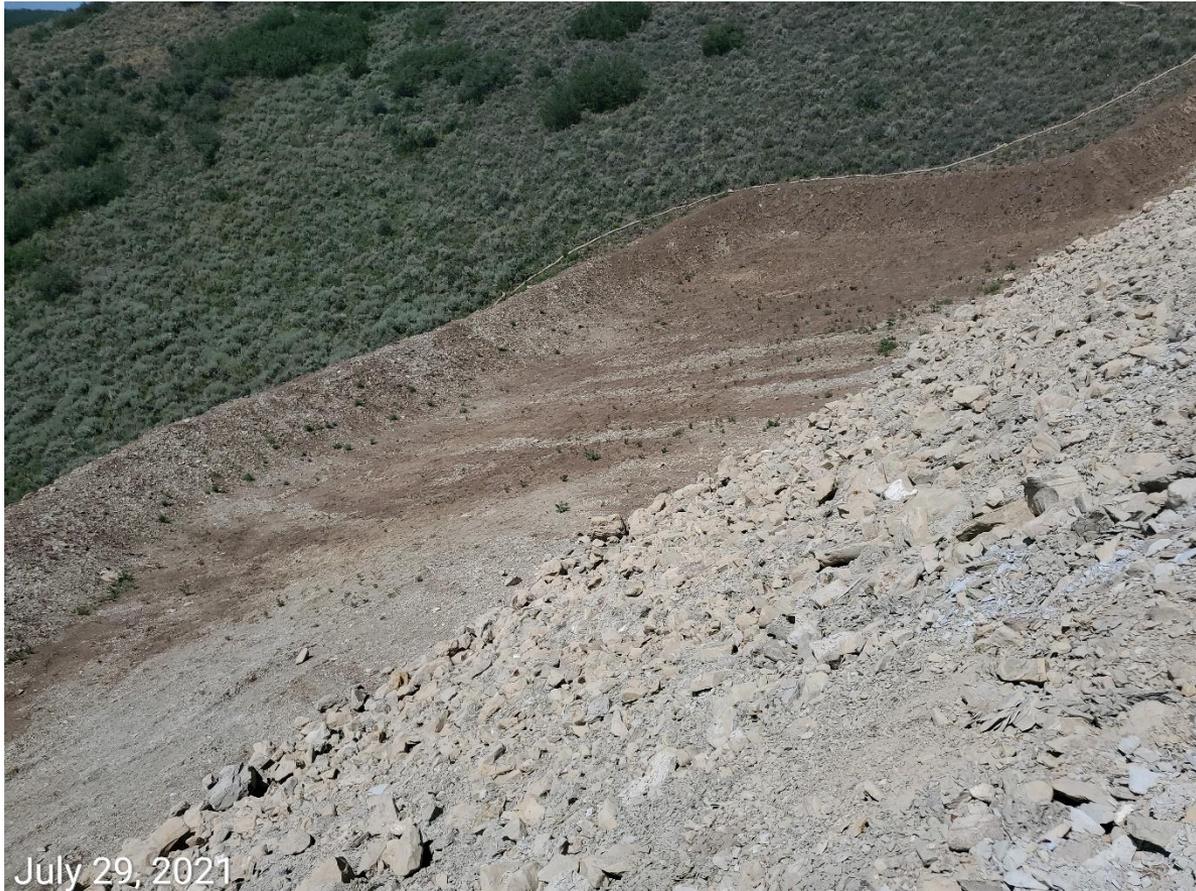
Photo 5: Photo taken from the the west end of the Location. Photo shows control measures to protect/stabilize slopes remain missing or insufficient. Photo also shows example where topsoil has been utilized at the base of the fill slopes/subsoils of the Location, as a berm and sediment trap/pond to manage stormwater. Photo shows Topsoil has not been properly separated and protected, is being mixed with subsoil, and is at risk for loss due to stormwater discharge displacing the topsoil. A second trap/pond exists on the east end of the Location.

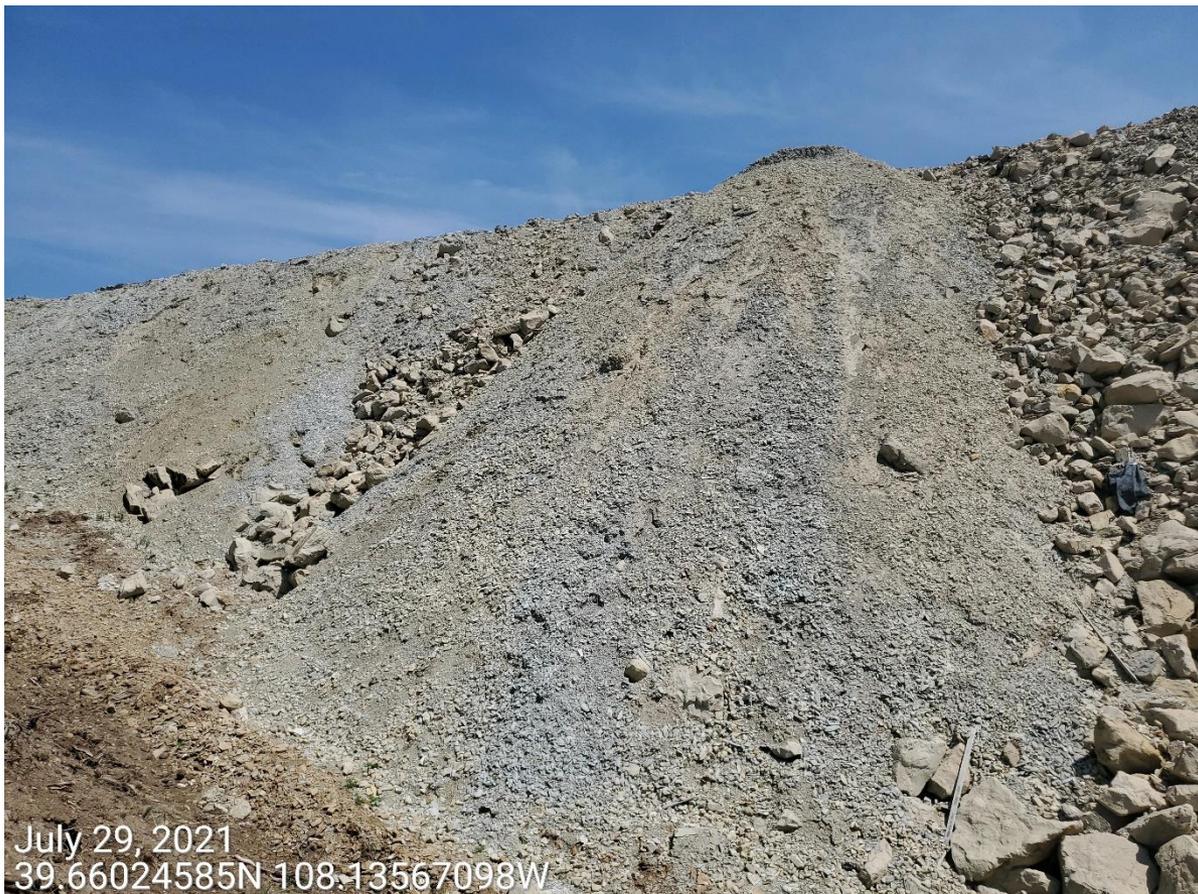
Photo 6: Photo shows example of fill slopes on the Location; BMPs to protect/stabilize slopes remain missing or insufficient.

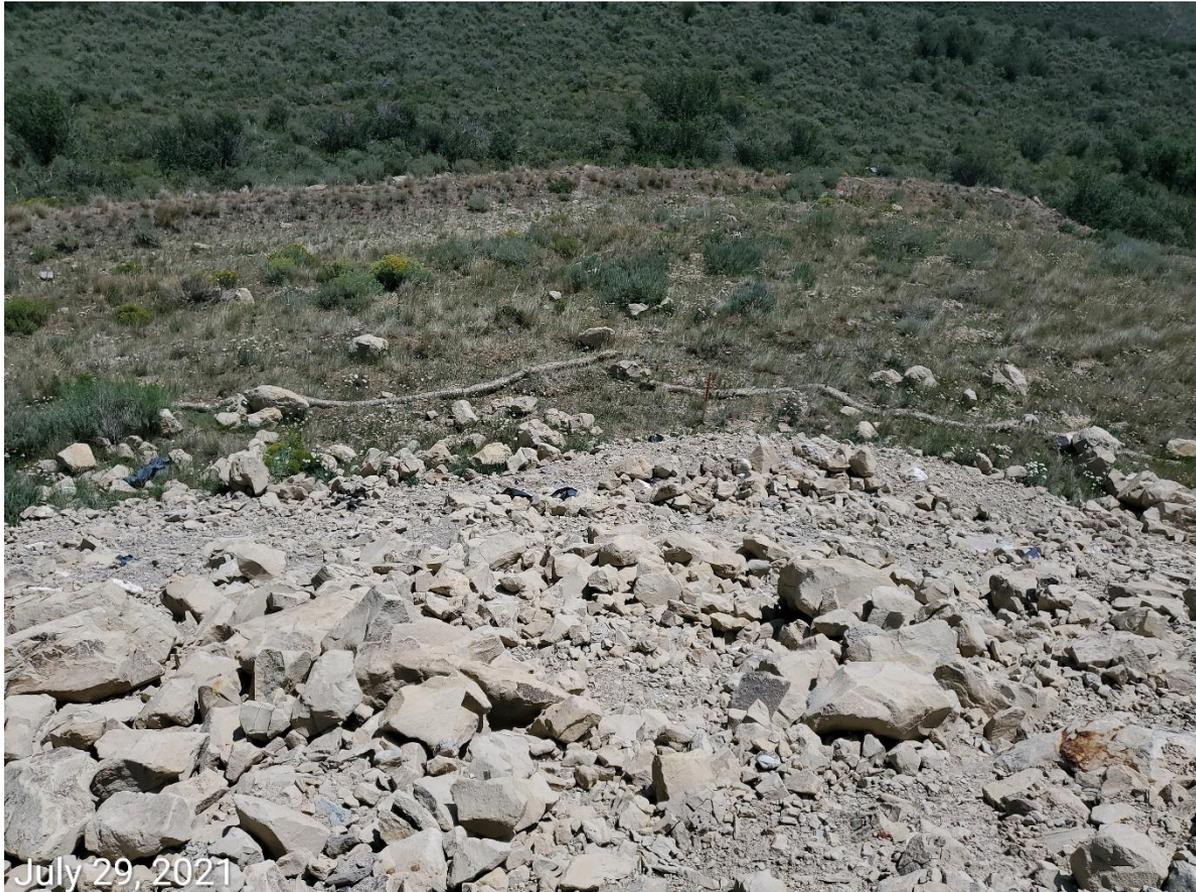
Photo 7: Photo taken from the south end of the Location, facing southeast. Photo shows example of wattles along the perimeter that have not been installed in accordance with good engineering practices, or maintained in proper functioning condition. Photo also shows example of fill slopes where BMPs to protect/stabilize slopes remain missing or insufficient.
