Inspection Photos
Operator: Logos
API: 067-05515
Date: 7/29/2015

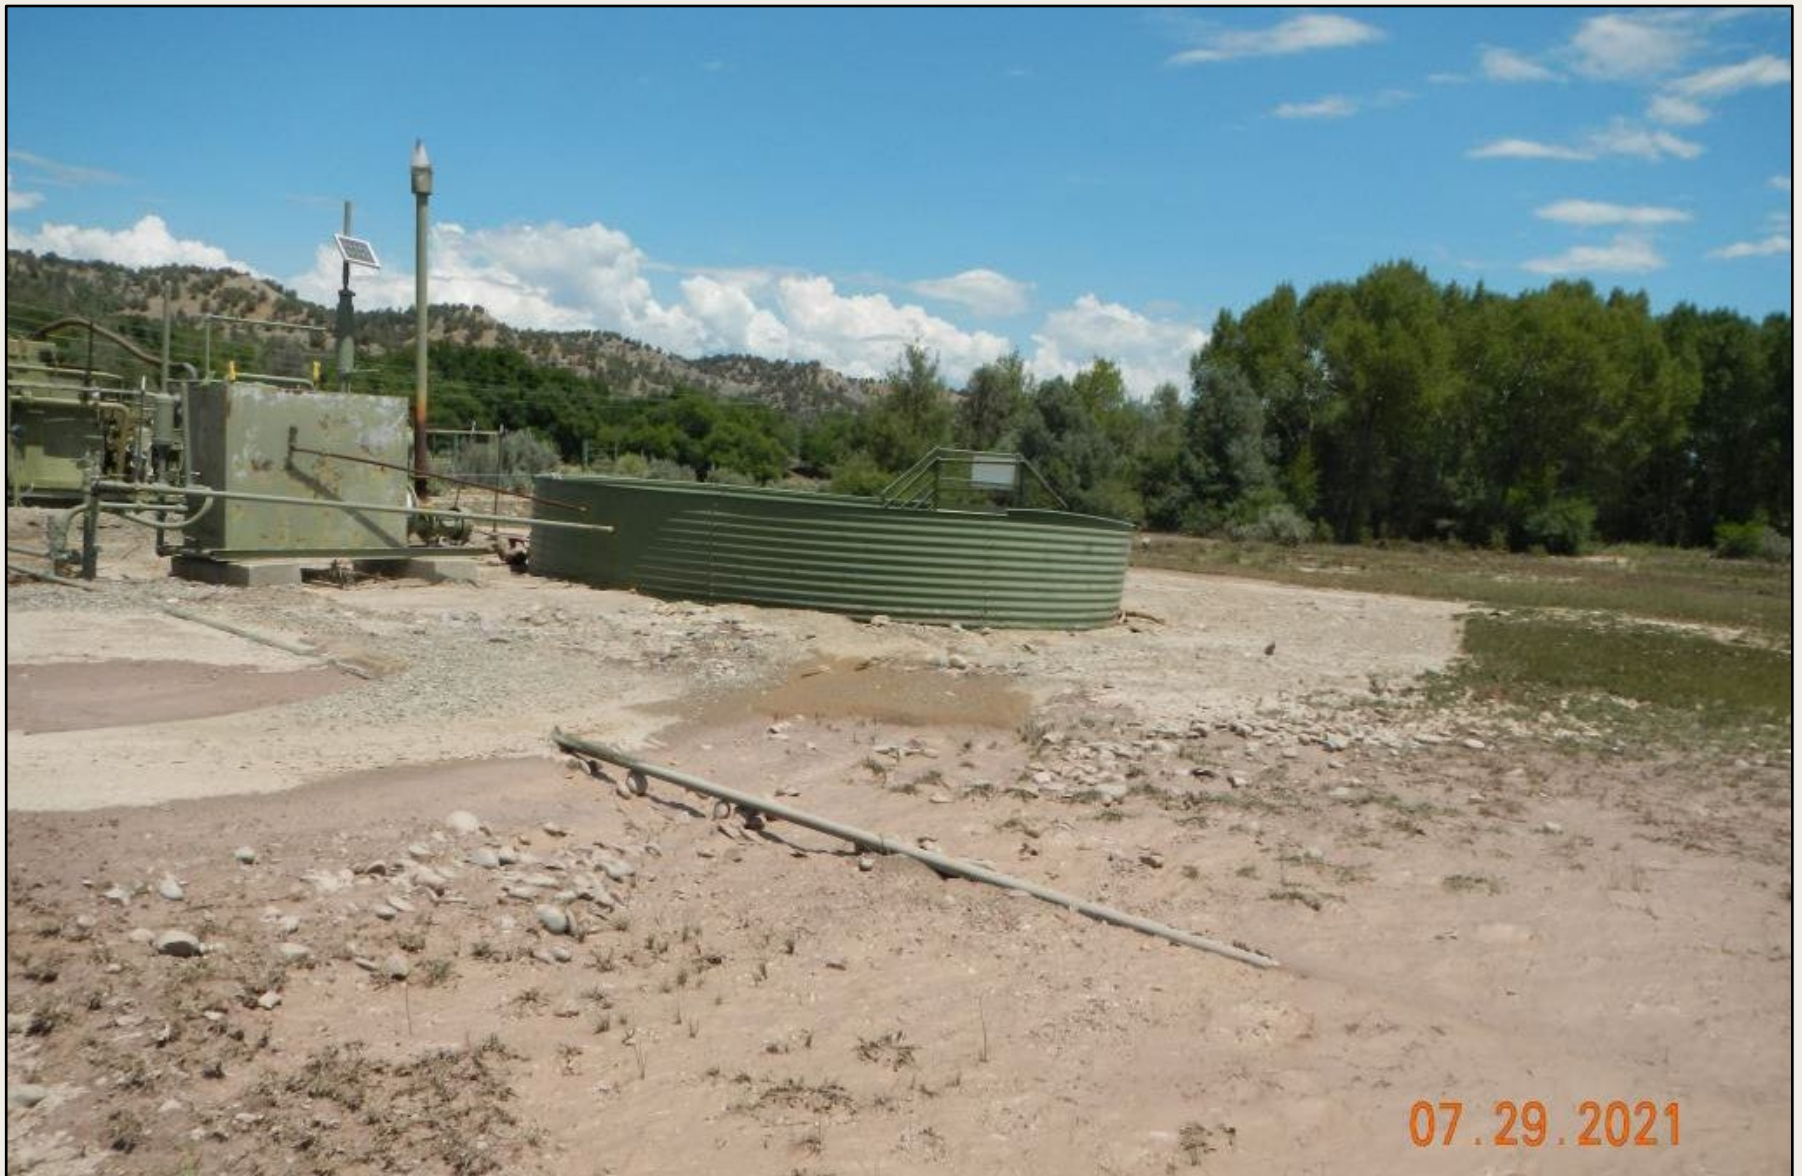
Photo 3. Another view of equipment facing upslope. Gravel is largely washed offsite.

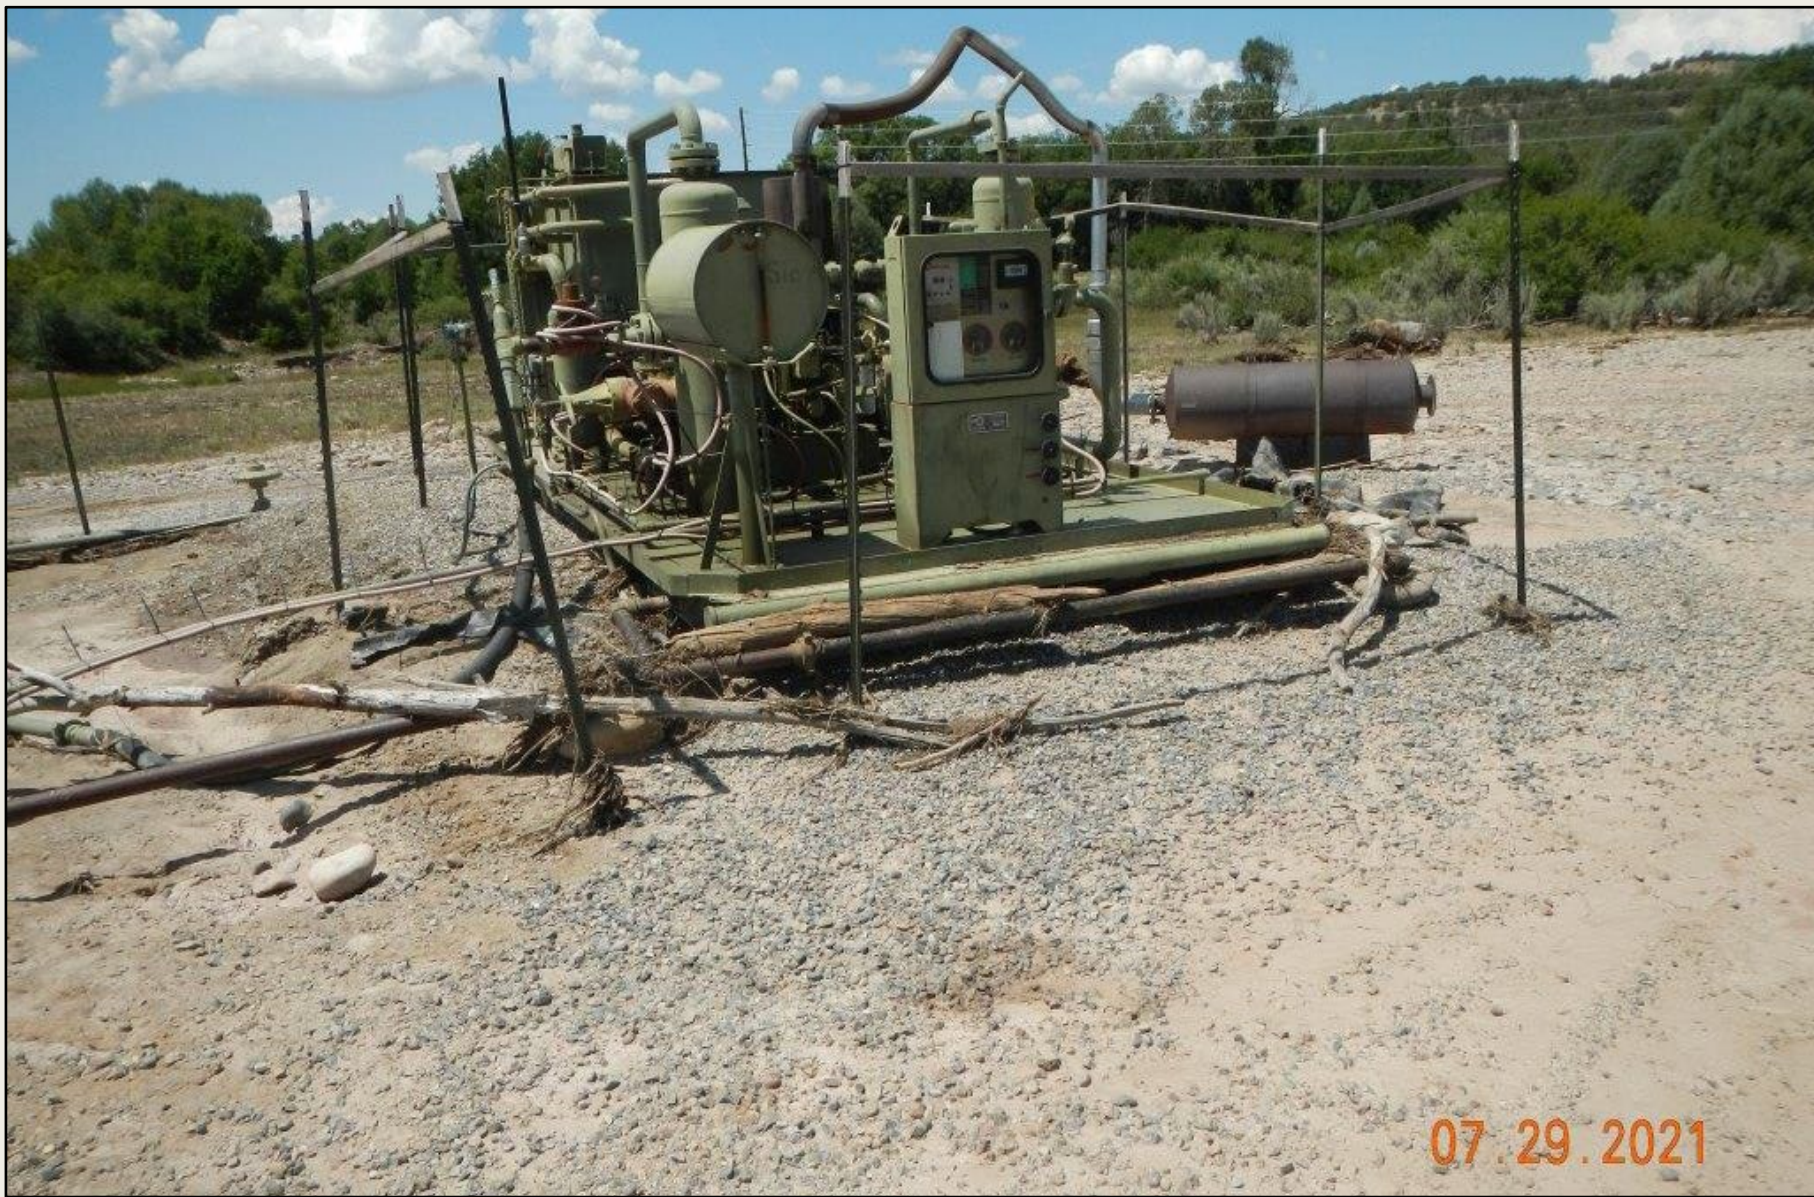
Photo 10. Another view of scoured surface and woody debris.
