Inspection Photos

API: 071-08854

Operator: EVERGREEN NATURAL RESOURCES

Inspection Date: 7/27/2021

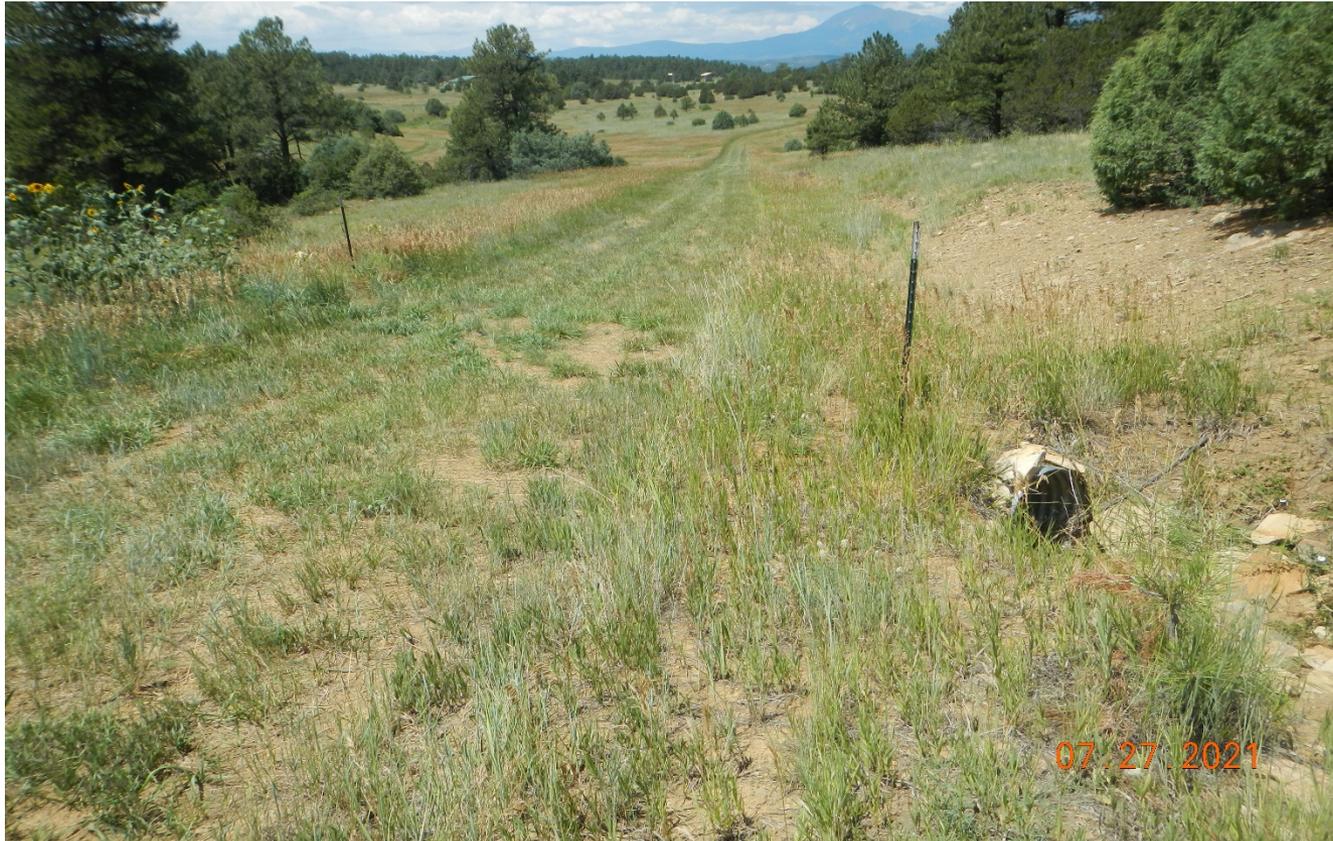
Photo 1. Facing northwest along the former access road. There are culverts that remain along the road.

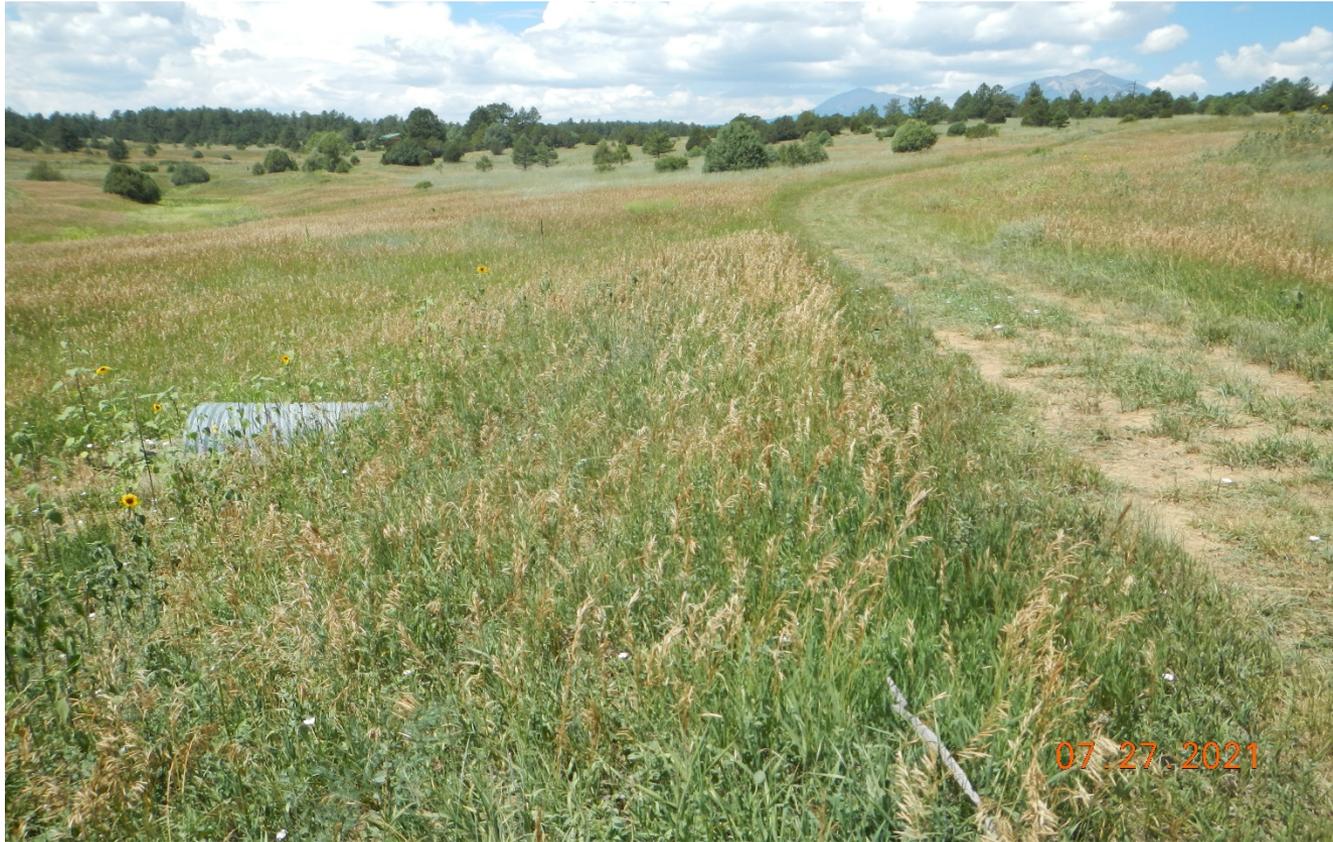
Photo 2. Facing northwest along the former access road. There are culverts that remain along the road.

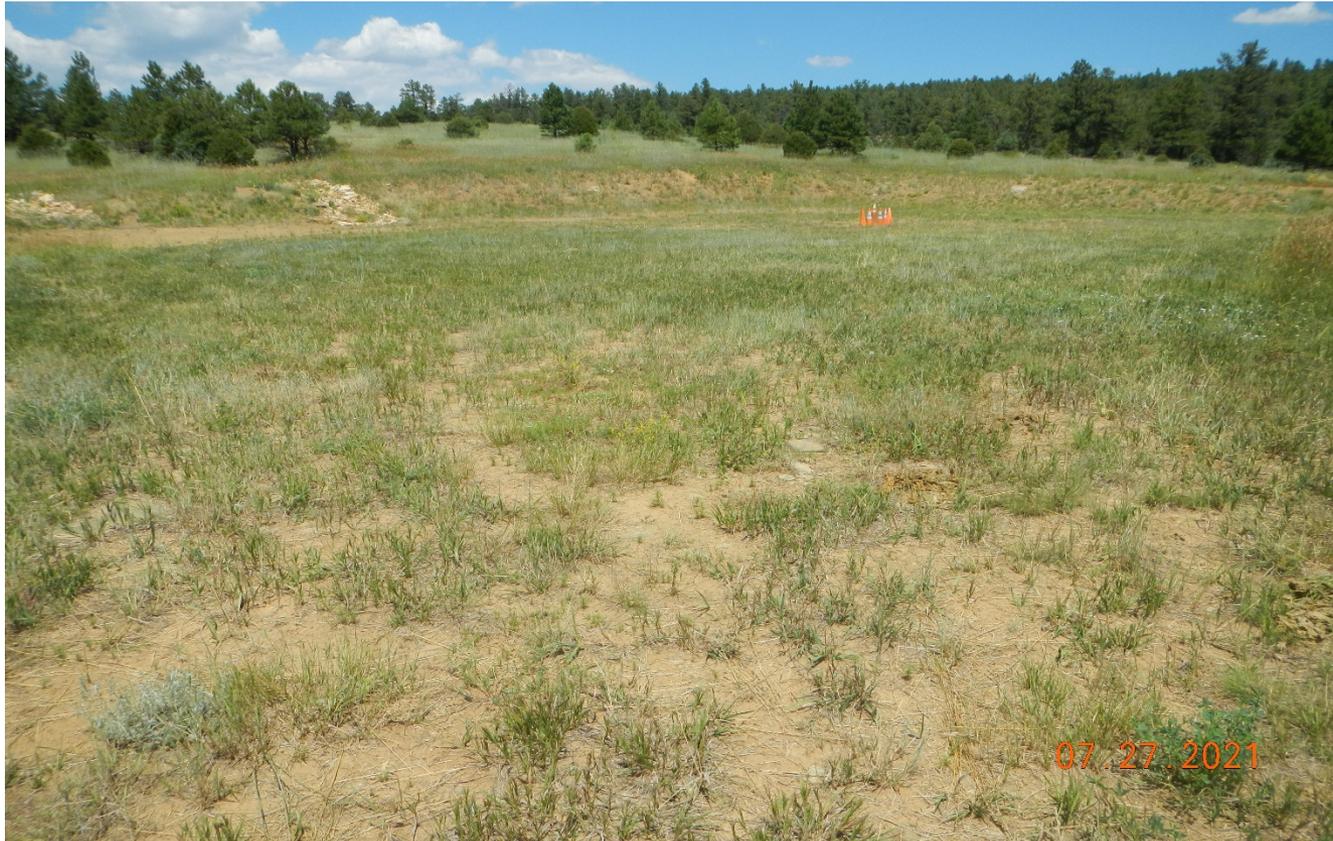
Photo 3. Facing north toward the location which has not been recontoured.

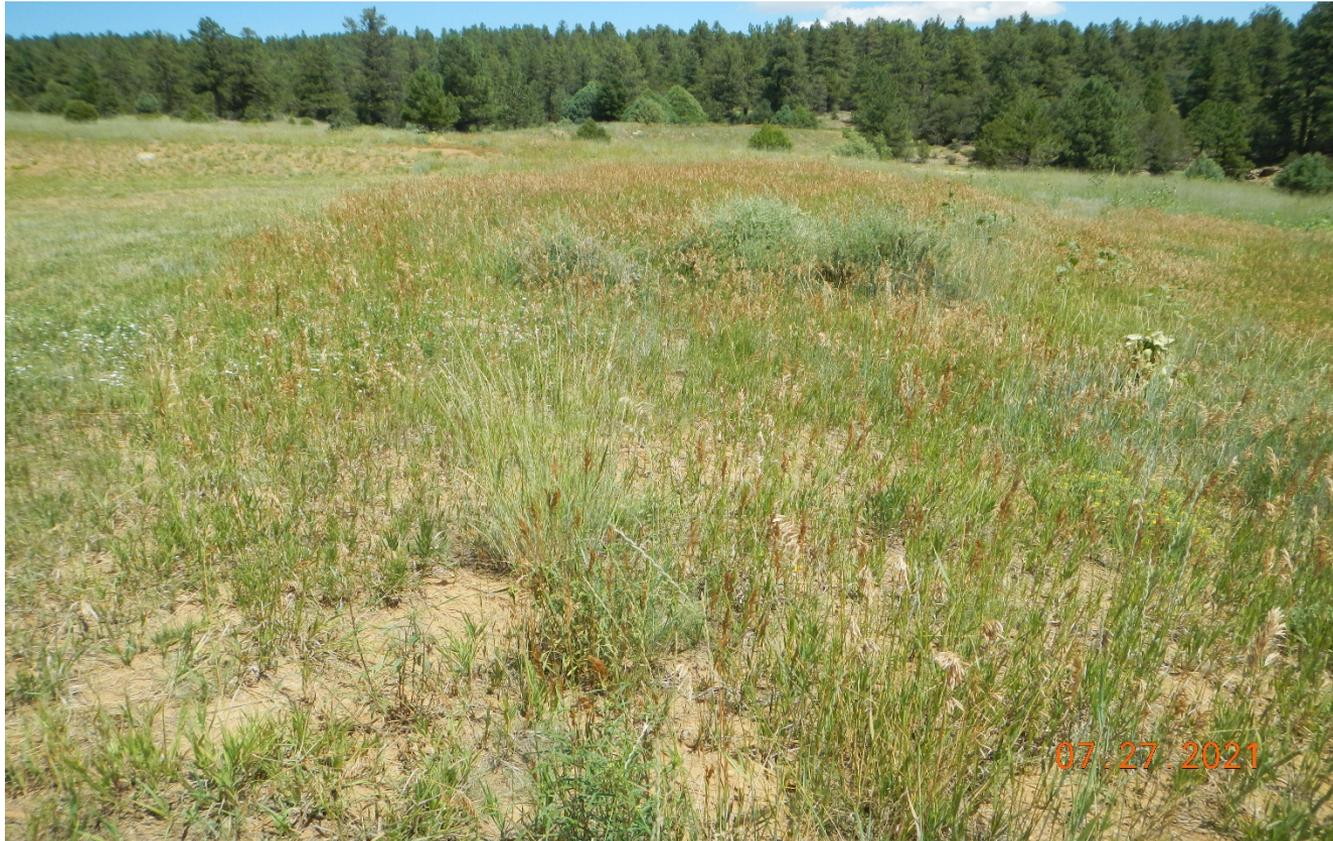
Photo 4. Facing northeast toward the fill slope.

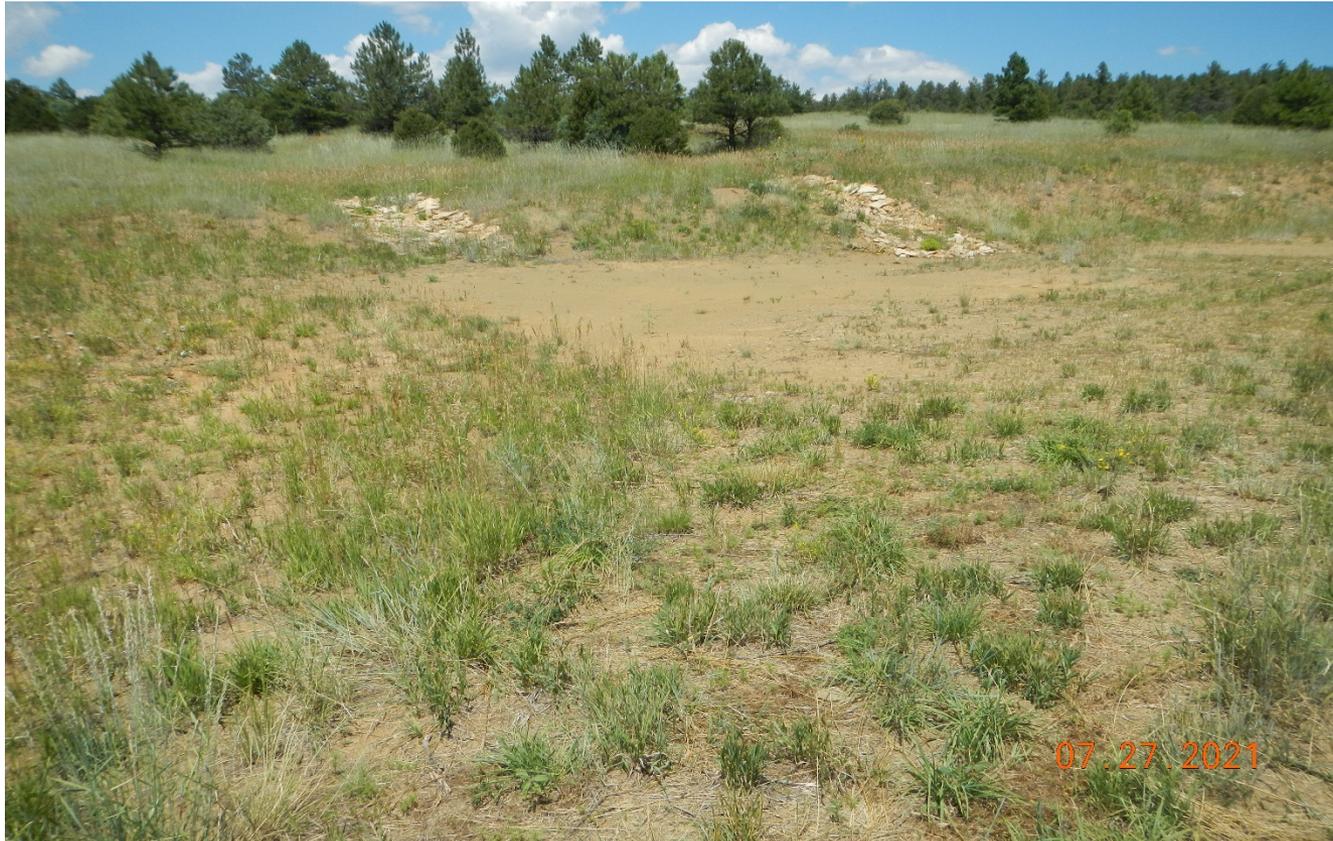
Photo 5. There are rock rip/rap stormwater controls along the cut slope. This area along the cut slope has sparse vegetation cover.

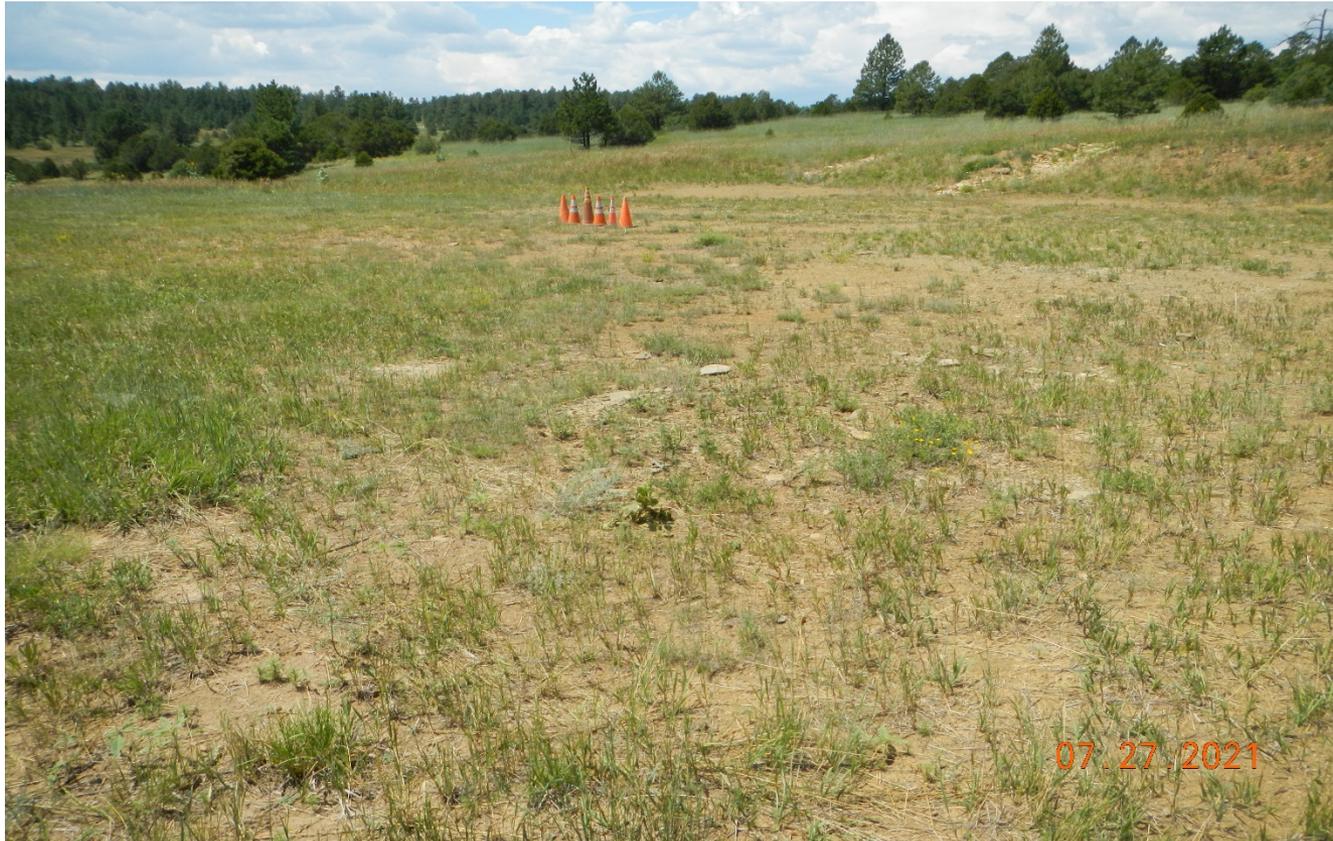
Photo 6. Facing northwest toward the location.
