Inspection Photos

081-07227

REM 19550

Spill 479587

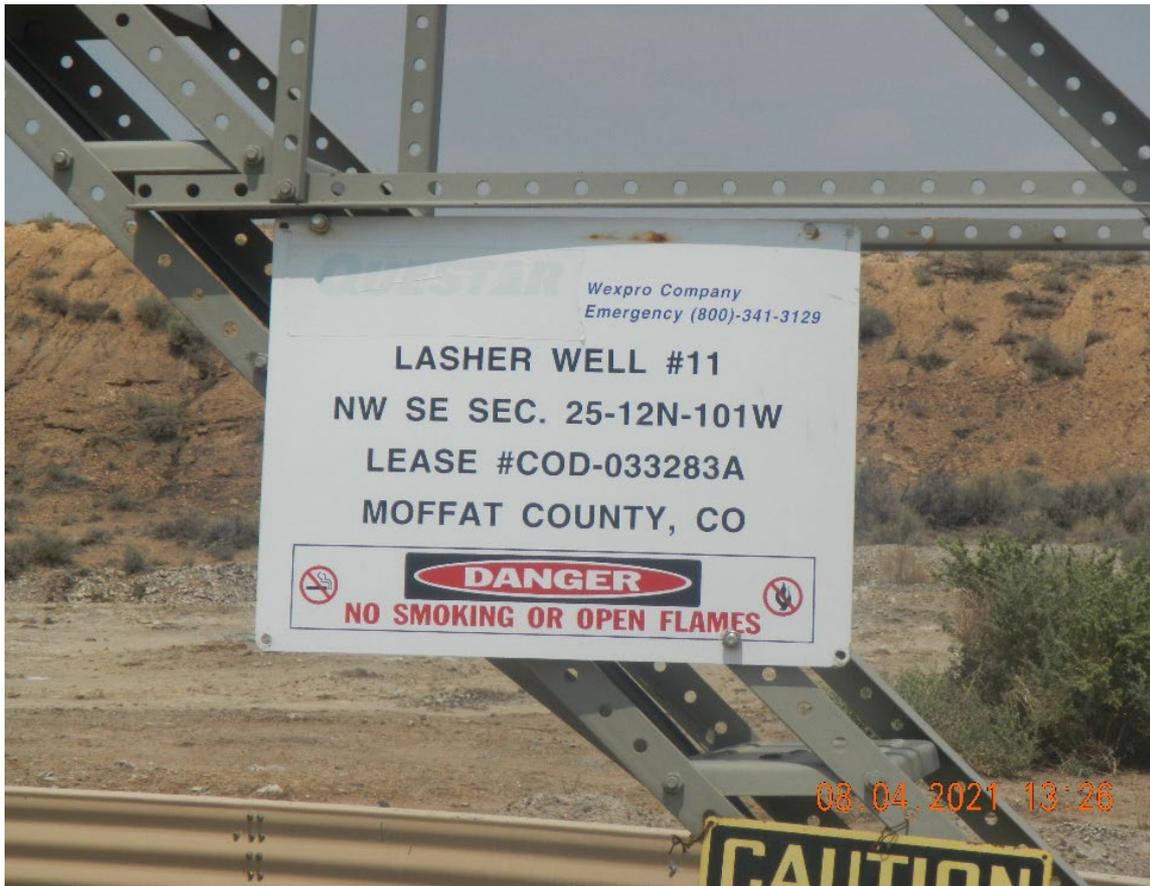
Photo #1 sign on tank battery

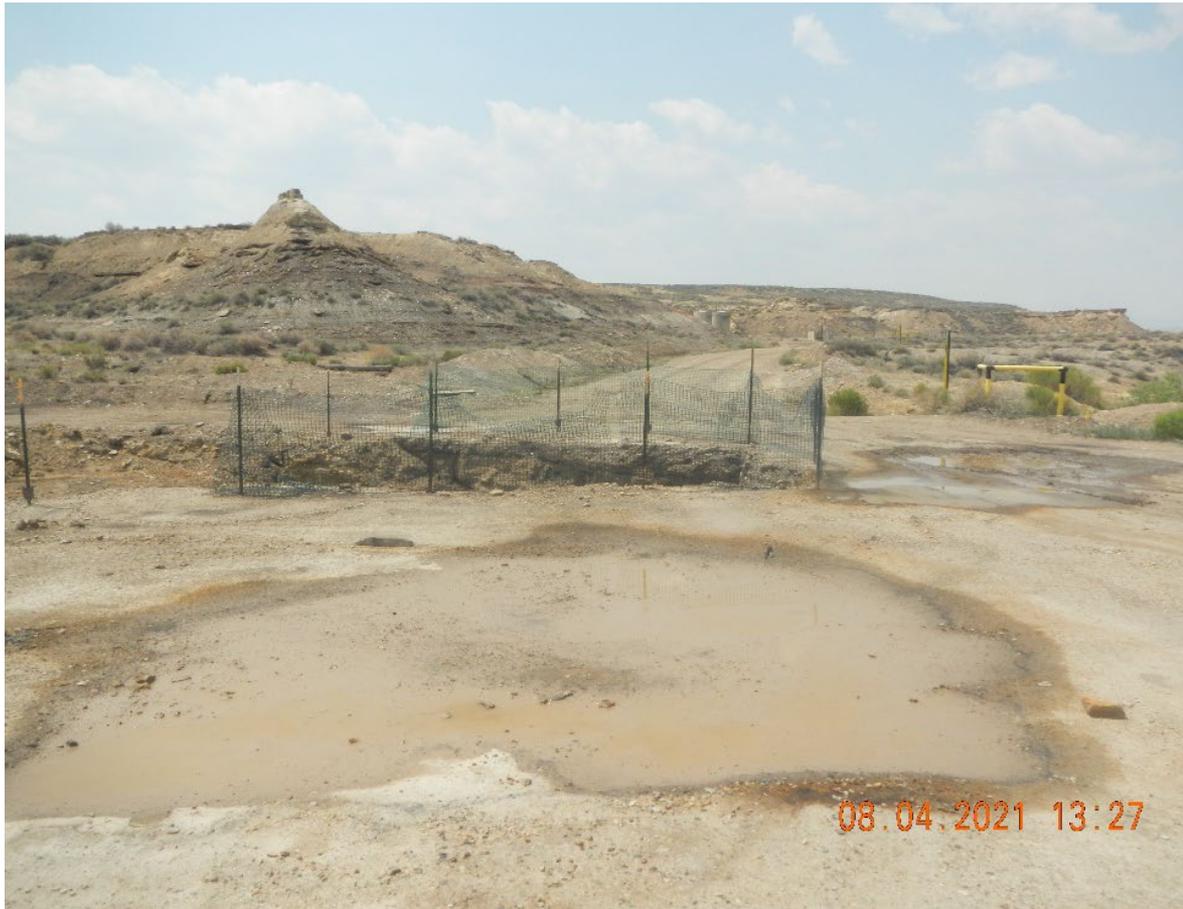
Photo #2 pad, looking west. The wet spot is believed to be from recent heavy rain. The excavated part of the pit is primarily in the fenced in area

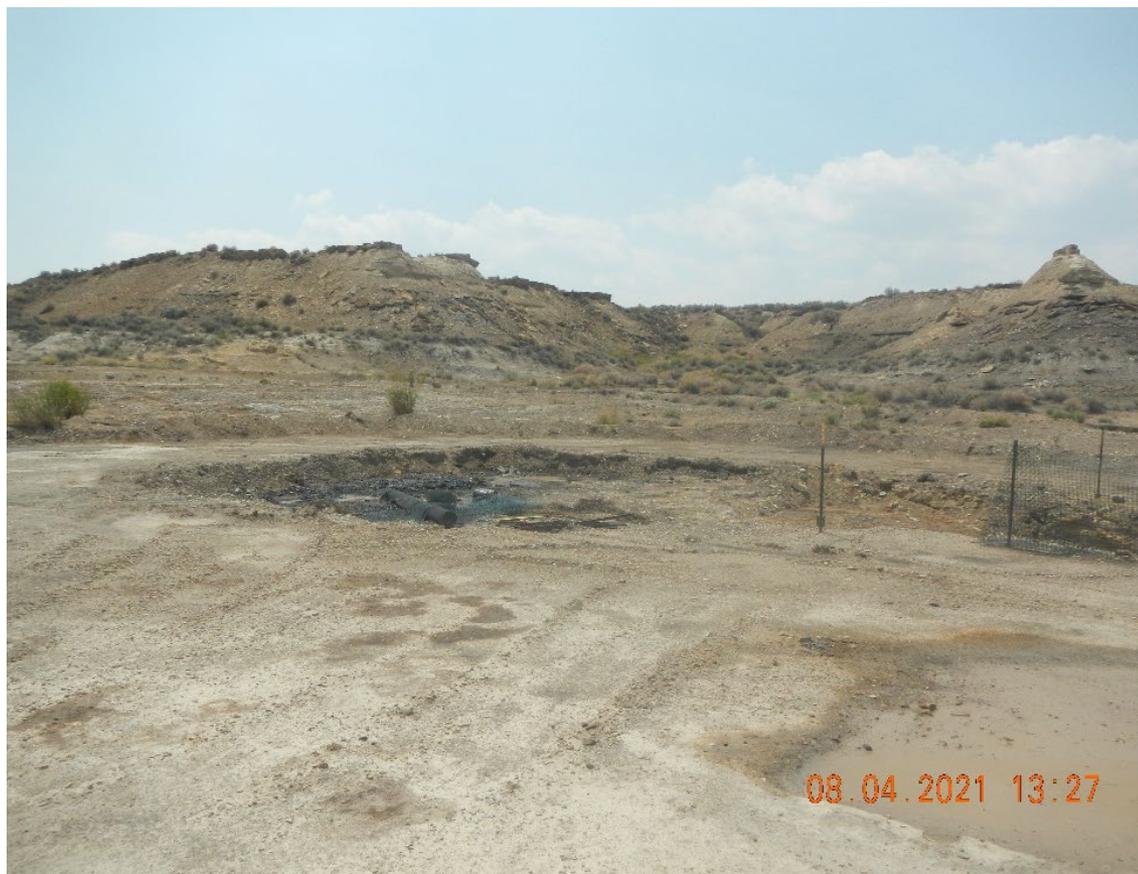
Photo #3 area of investigation

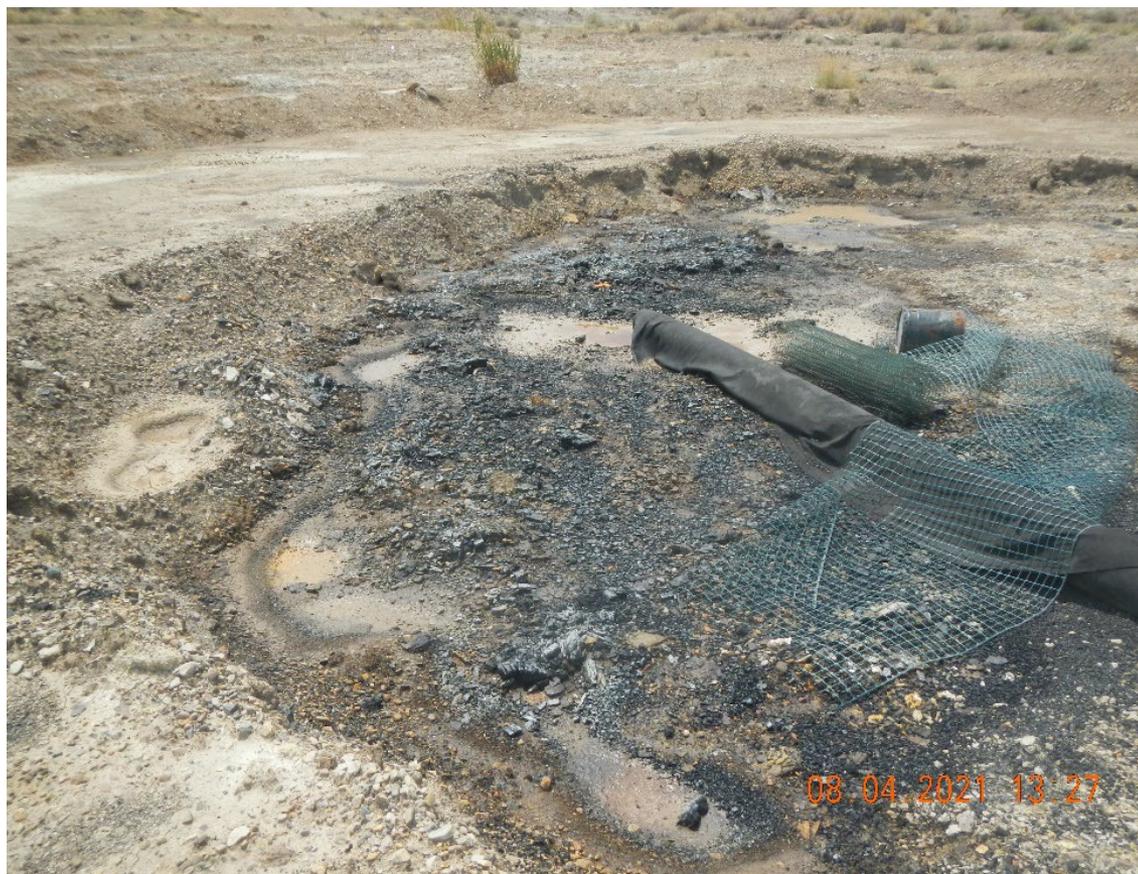
Photo #4 Area of investigation

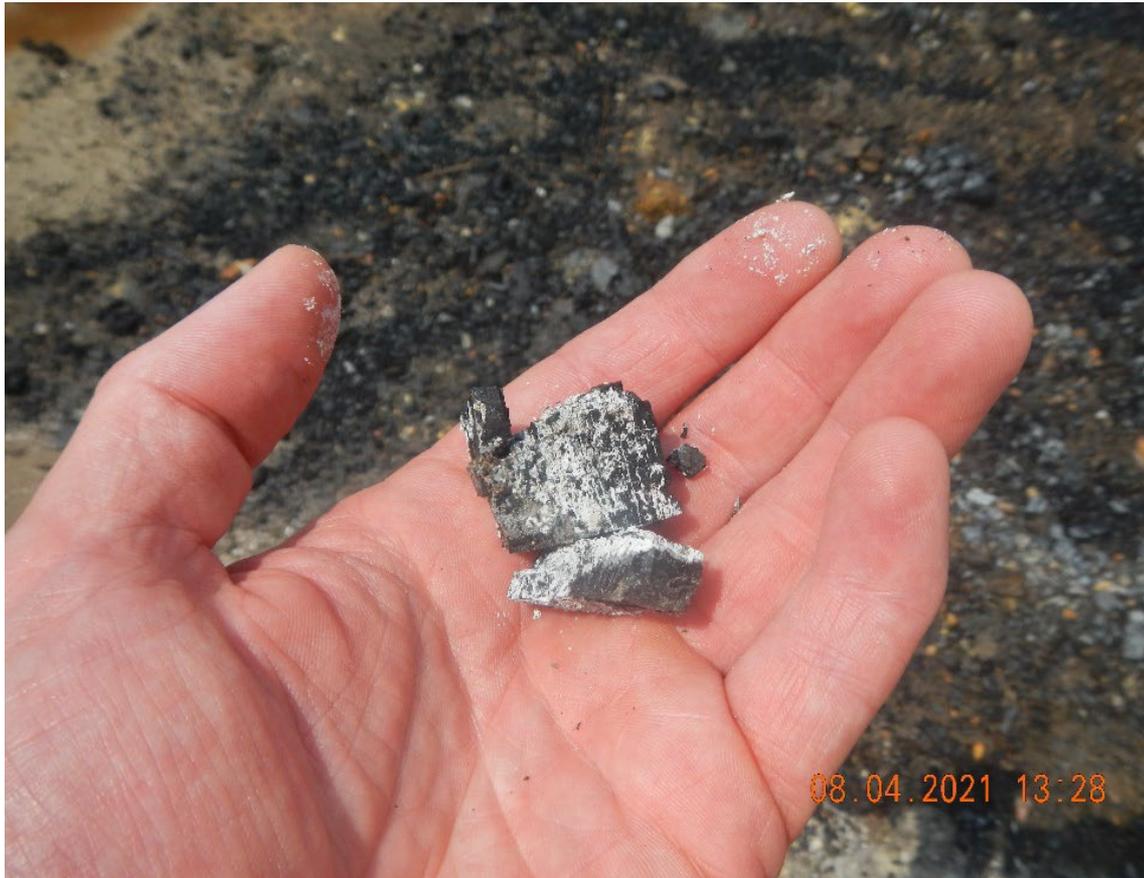
Photo #5 close up of debris inside of area of investigation.

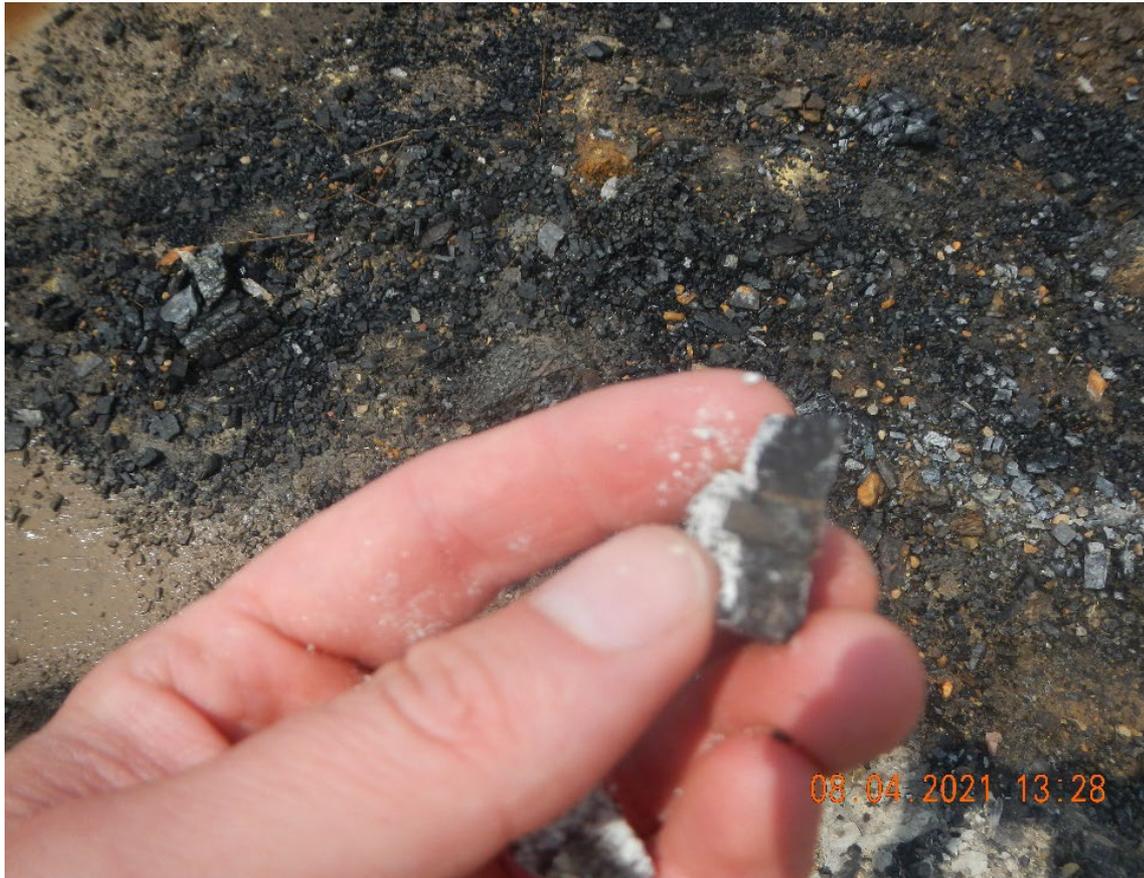
Photo #6 close up of debris inside of area of investigation.

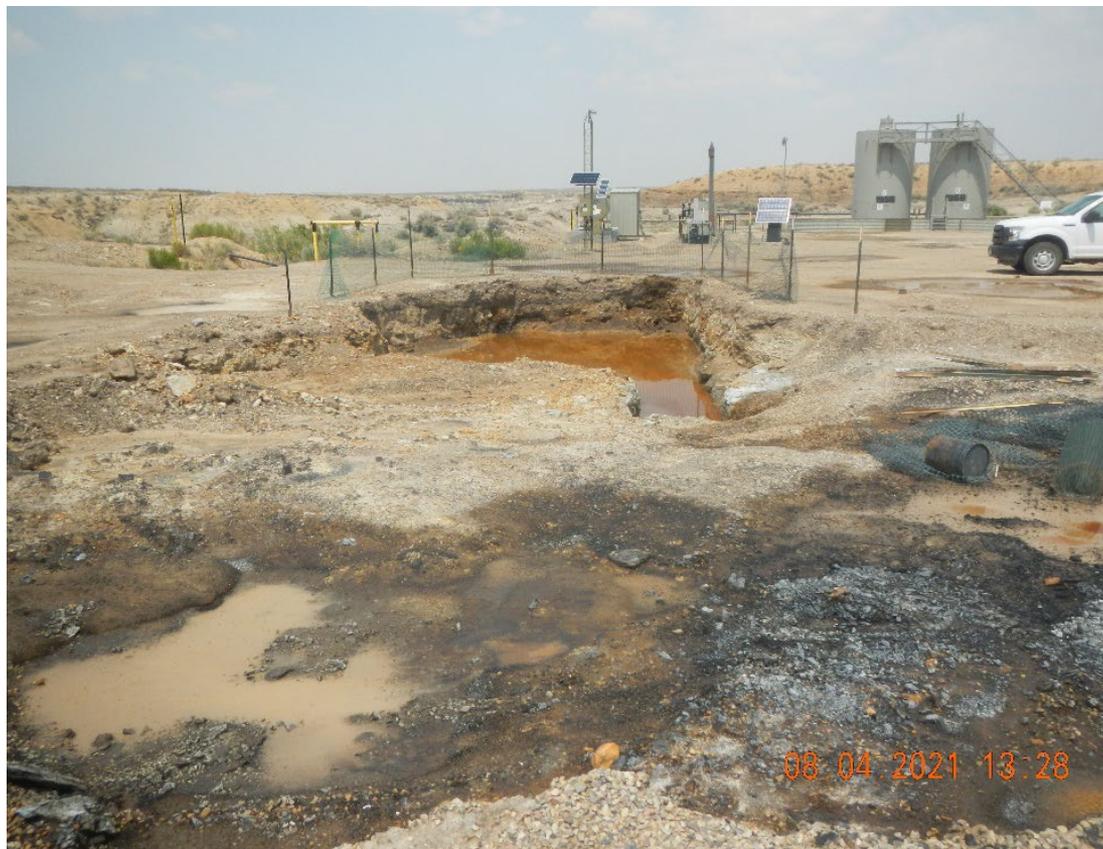
Photo #7 Area of investigation.

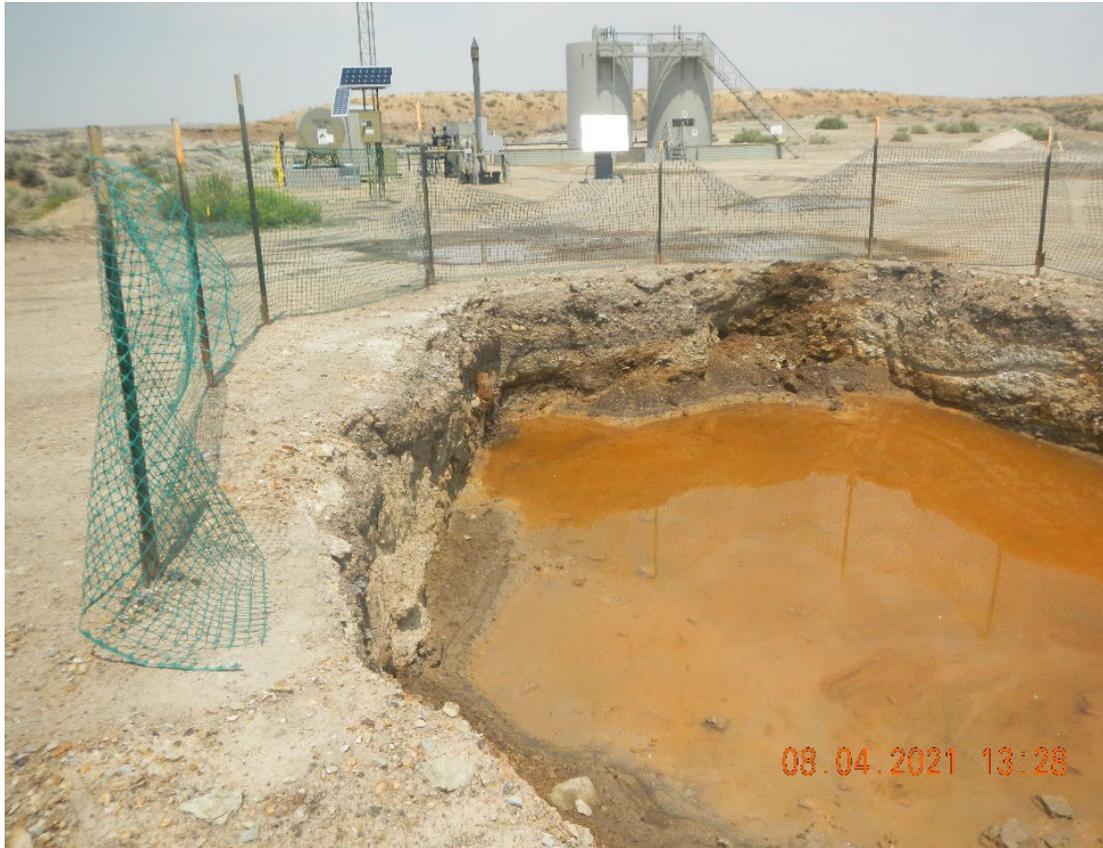
Photo #8 7 Area of investigation

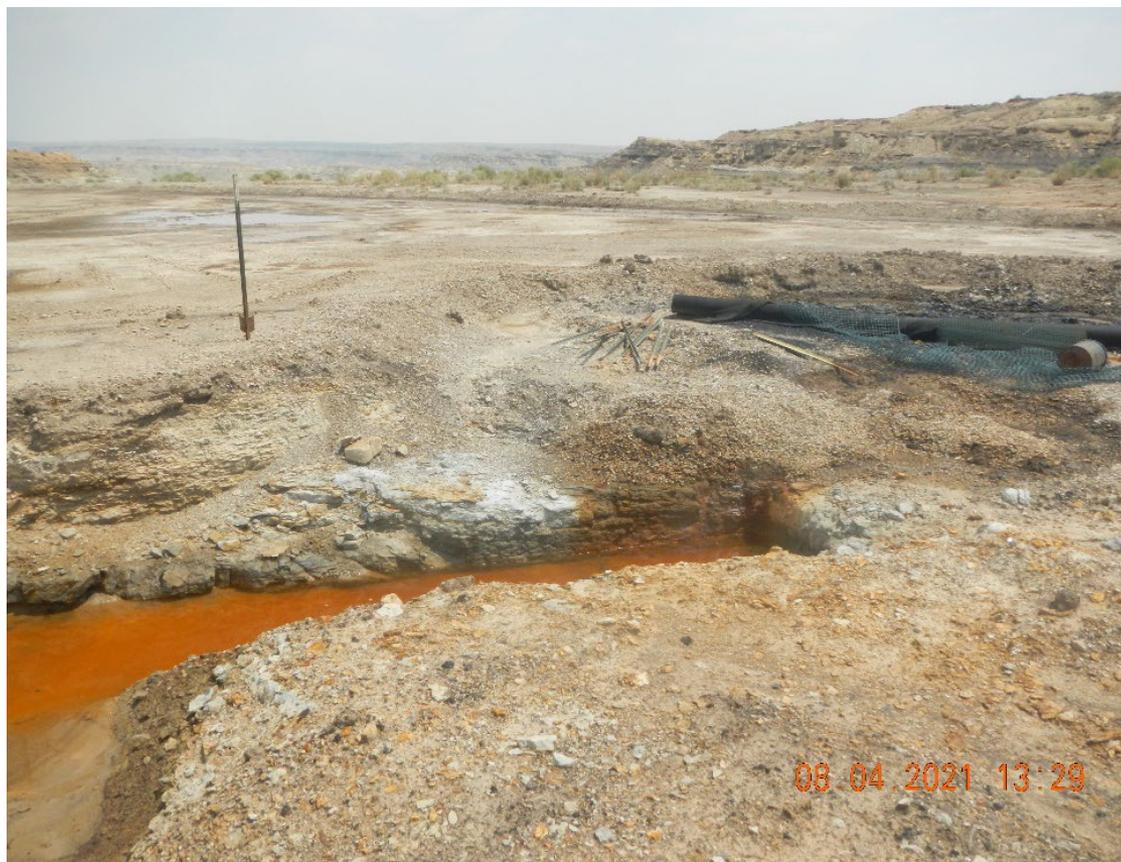
Photo #9 7 Area of investigation

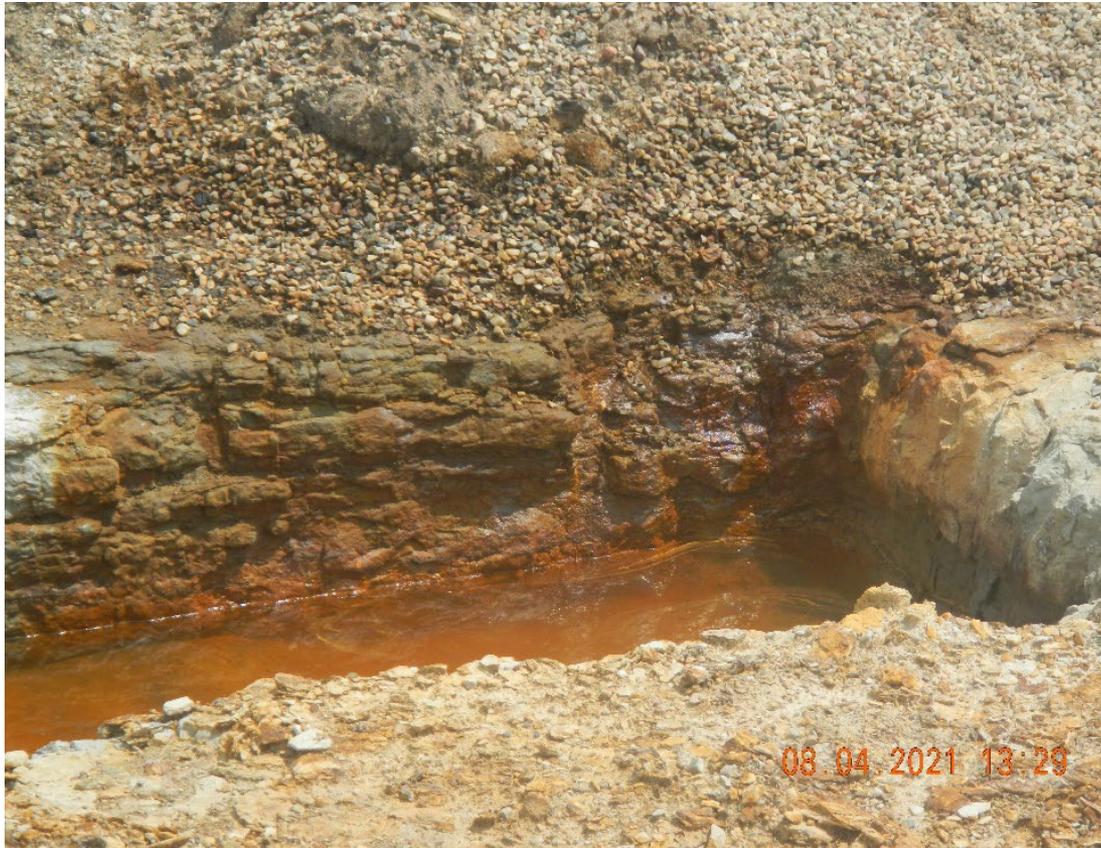
Photo #10 South side of Area of investigation, it appears that surface water is weeping into excavation. Fluid shall be handled as E&P waste.

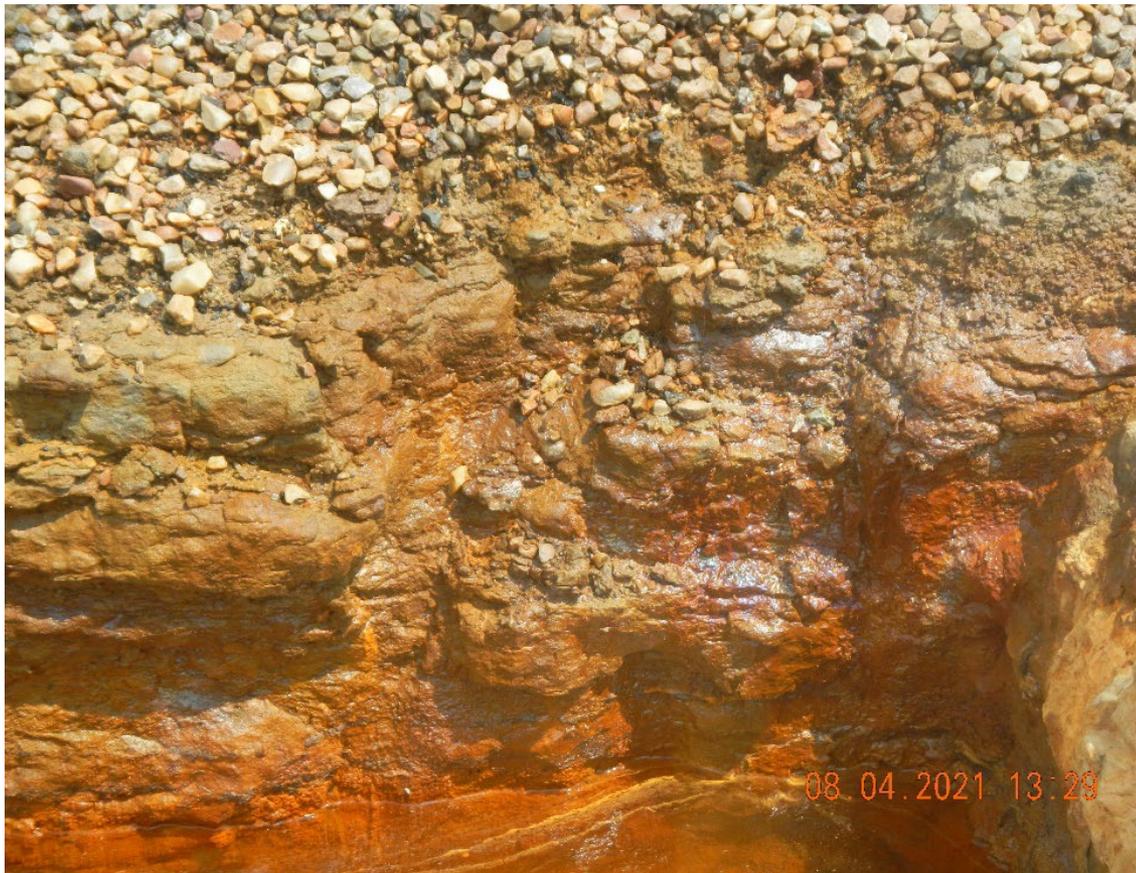
Photo #11 close up of Photo #10, South side of Area of investigation, it appears that surface water is weeping into excavation. Fluid shall be handled as E&P waste.

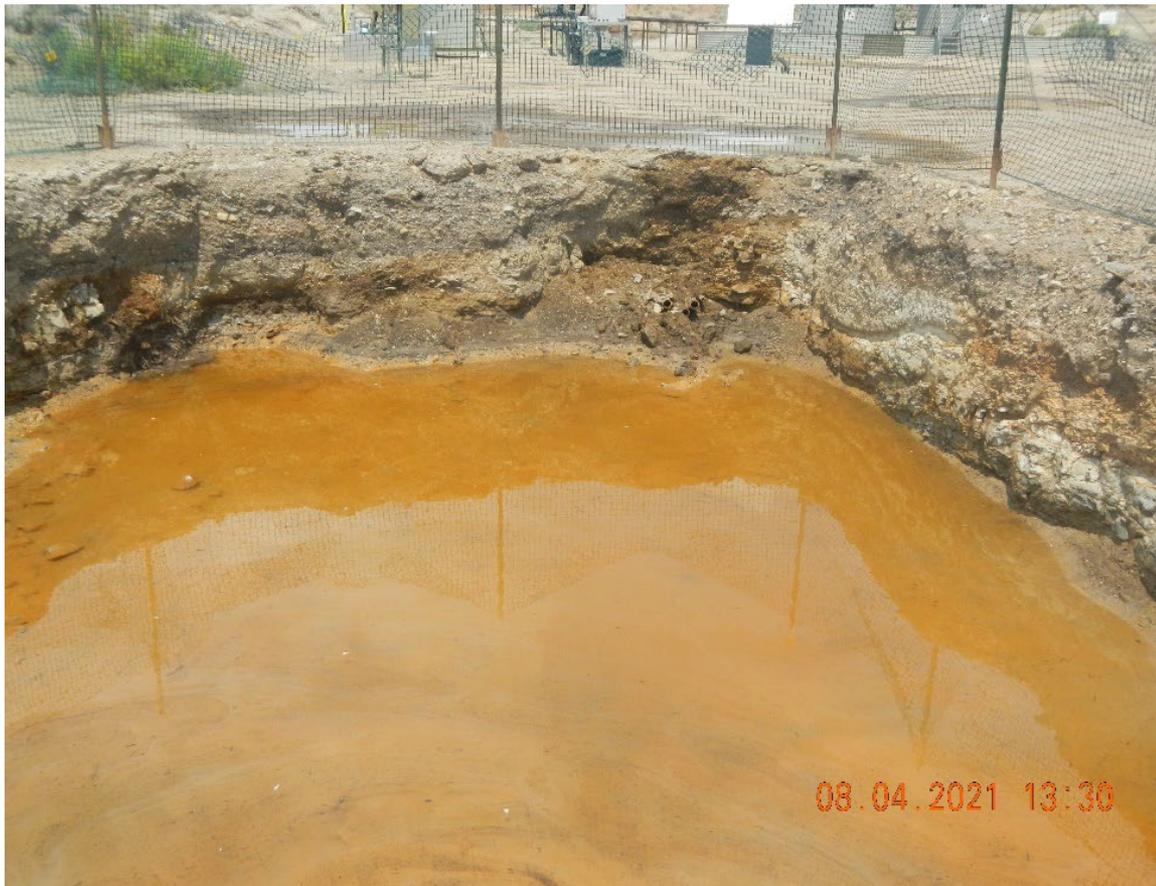
Photo #12 Area of investigation.

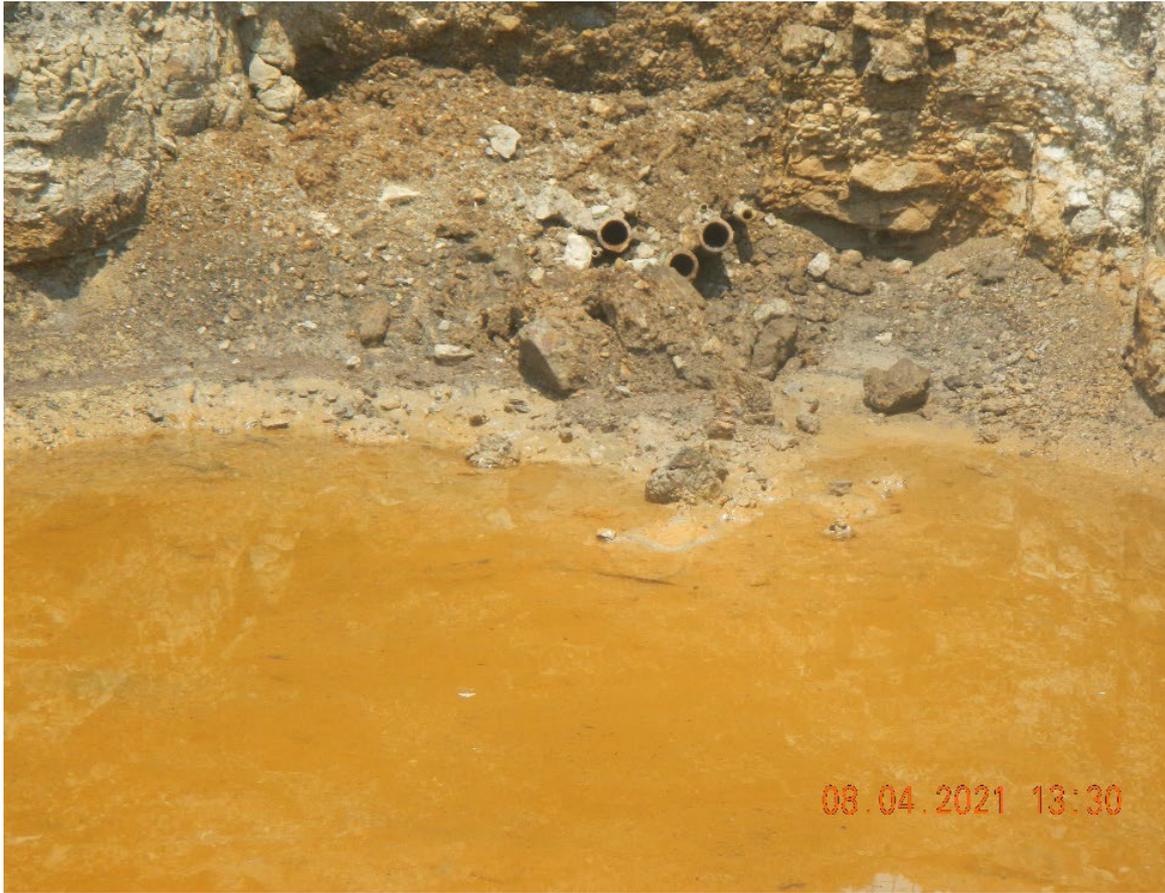
Photo #13 Area of investigation.

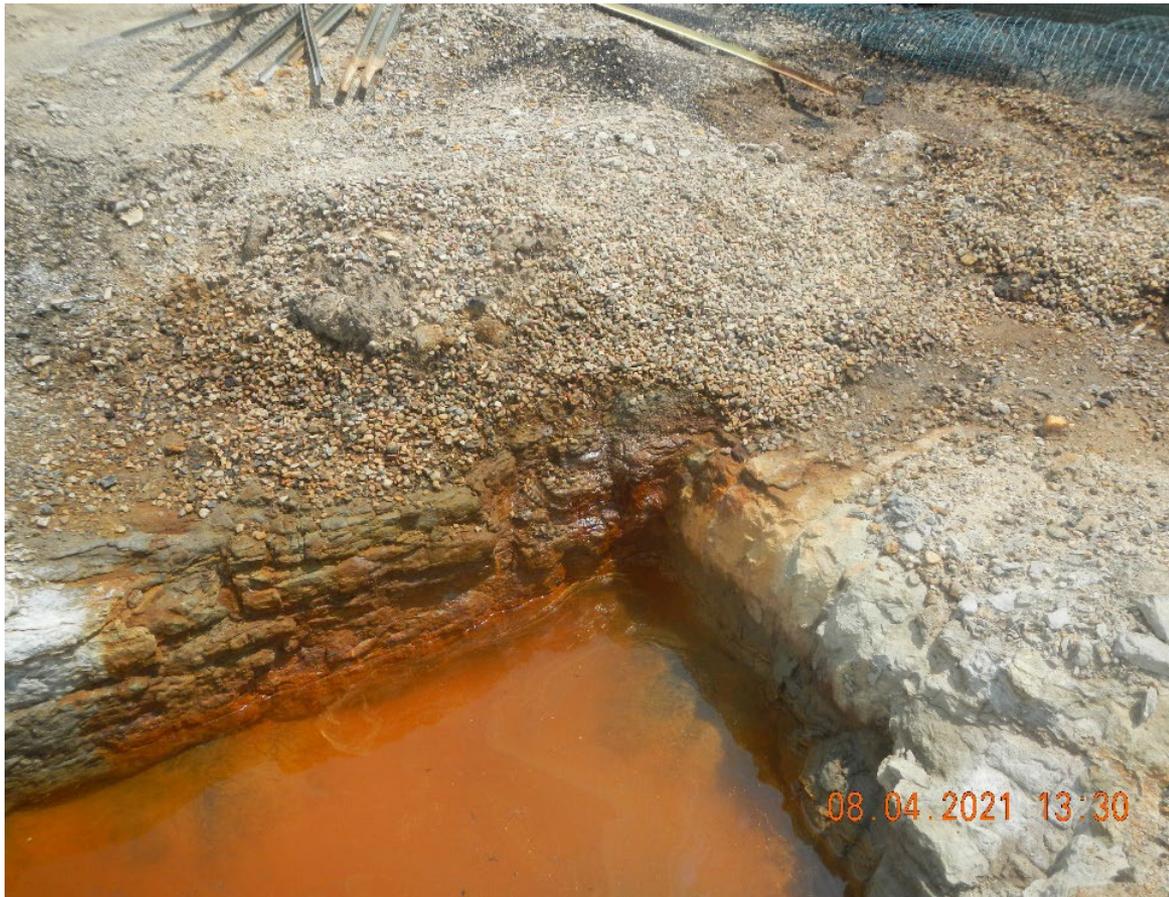
Photo #14 Area of investigation, similar to Photo 10 and 11.

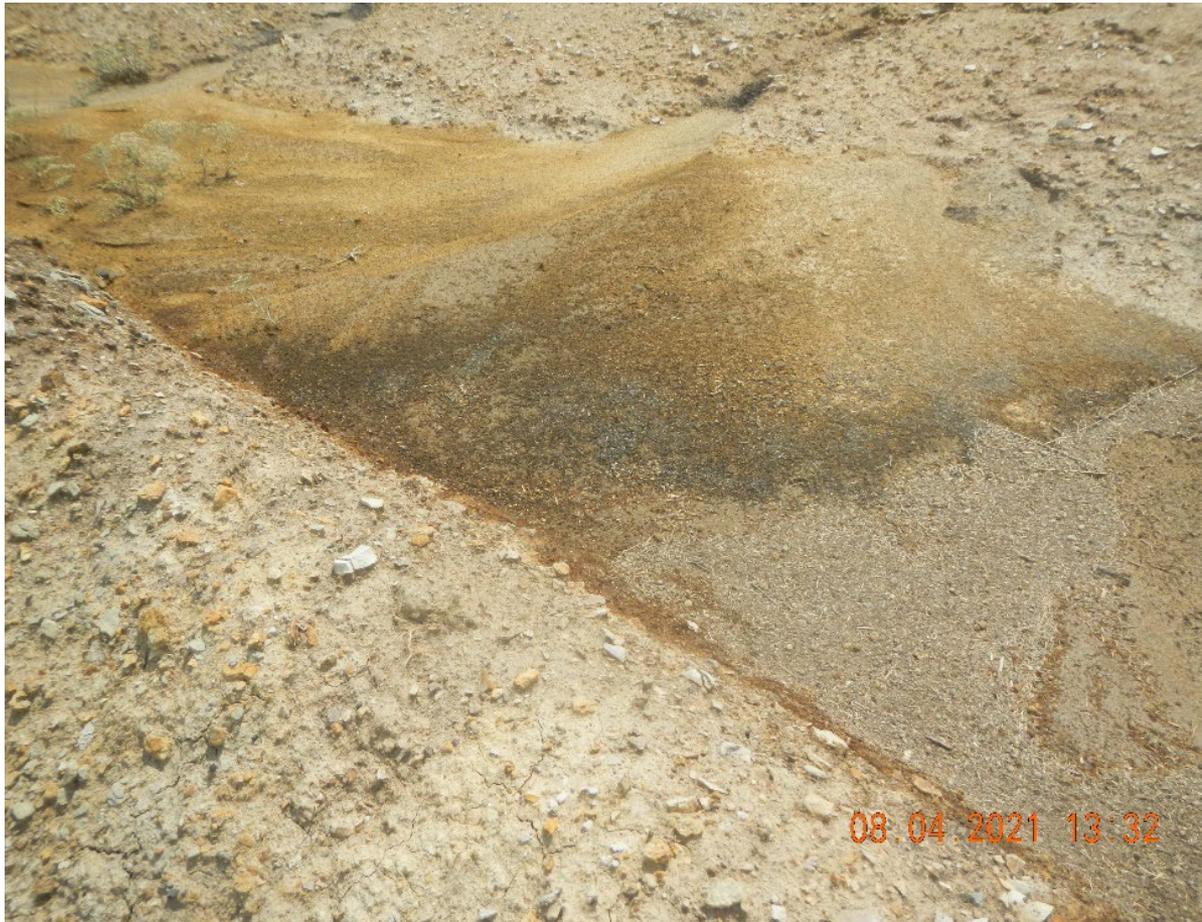
Photo #15 18 undisturbed adjacent soil, had mobile sediment that was observed in adjacent outcropping.

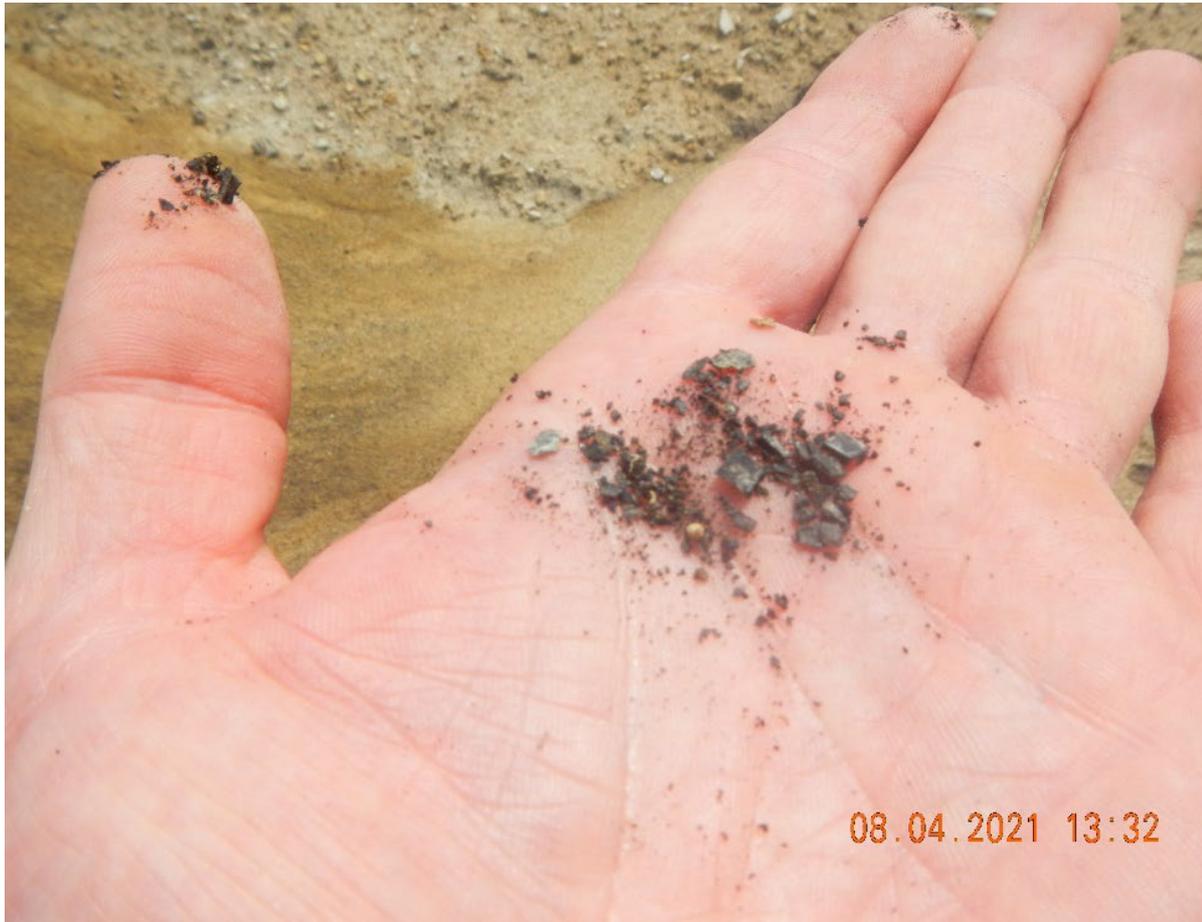
Photo #16 undisturbed adjacent soil, had mobile sediment that was observed in adjacent outcropping.

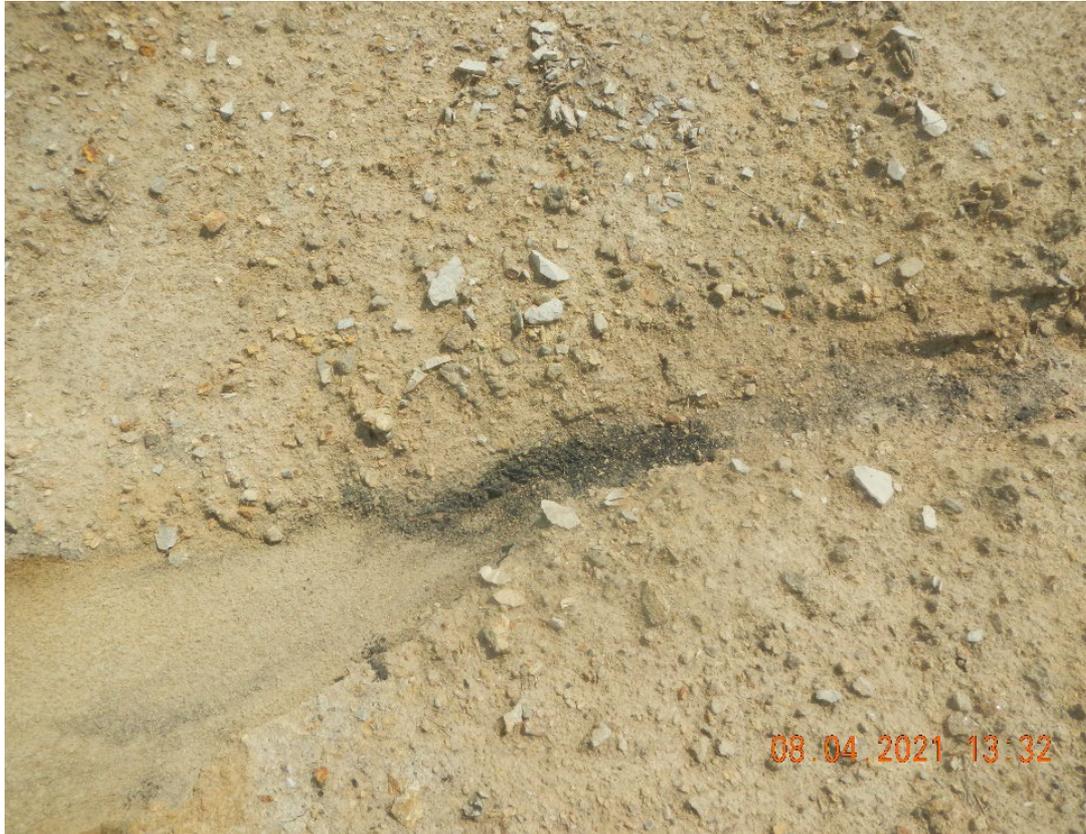
Photo #17 undisturbed adjacent soil, had mobile sediment that was observed in adjacent outcropping.

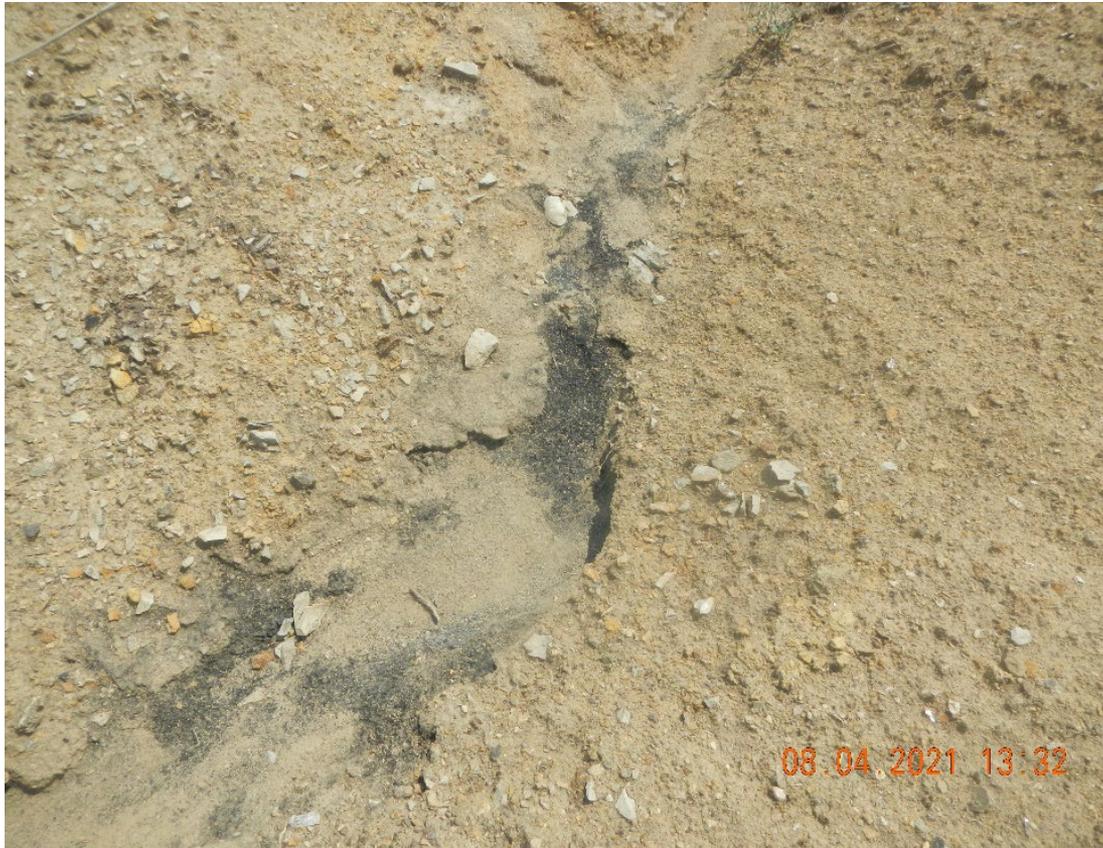
Photo #18 undisturbed adjacent soil, had mobile sediment that was observed in adjacent outcropping.

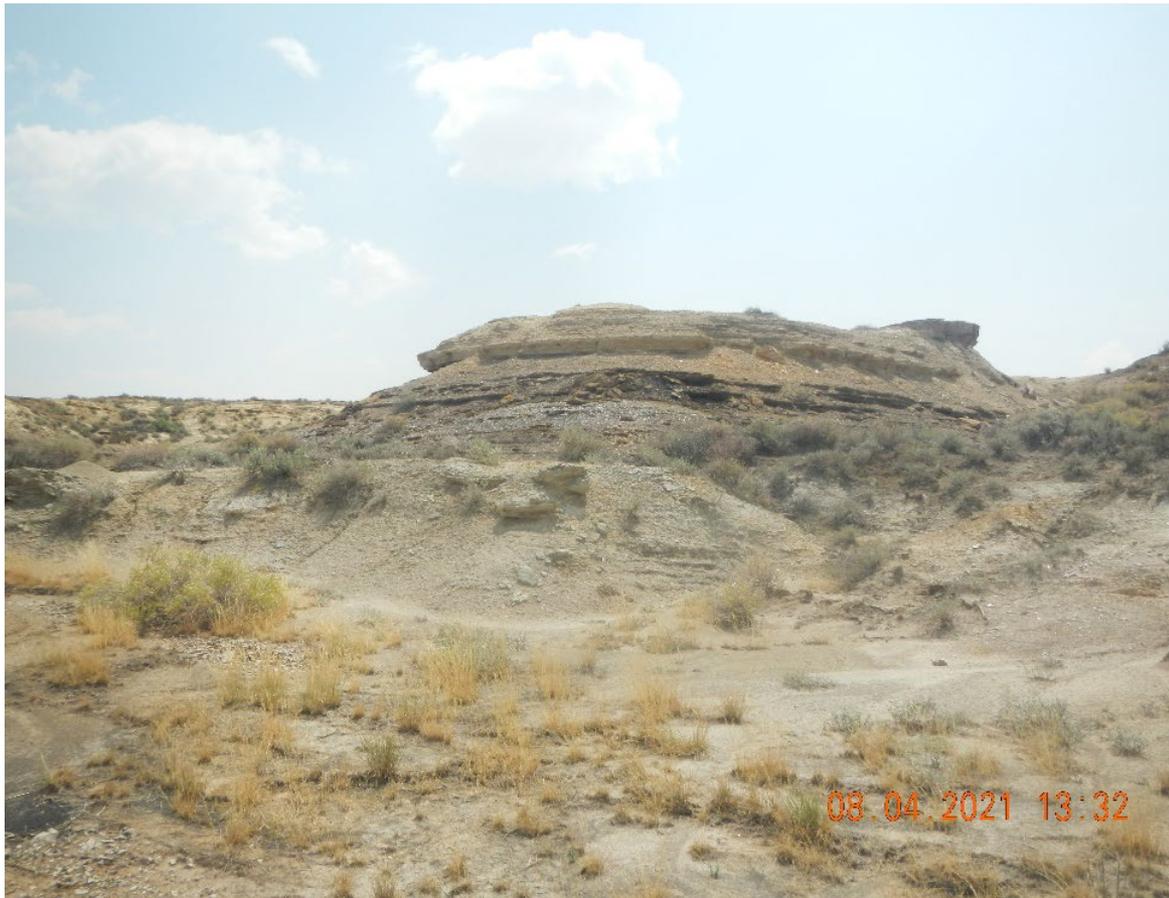
Photo #19 adjacent undisturbed soil

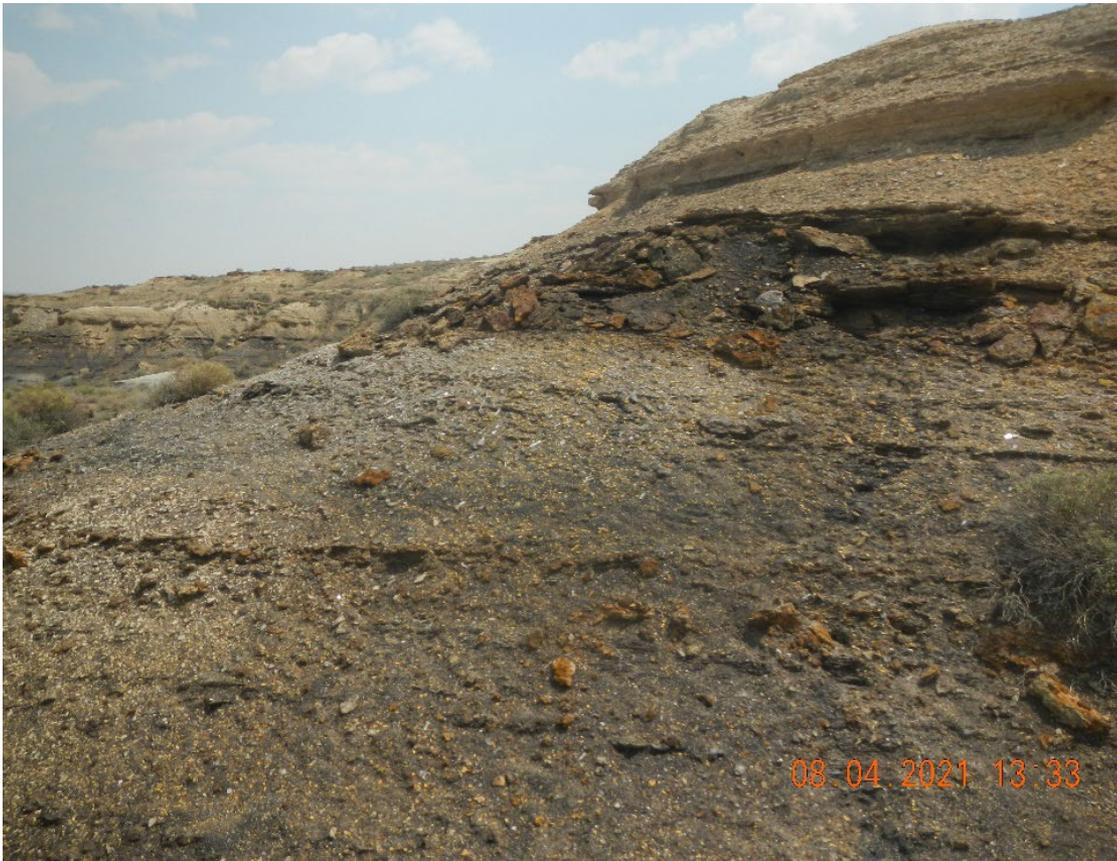
Photo #20 adjacent undisturbed soil

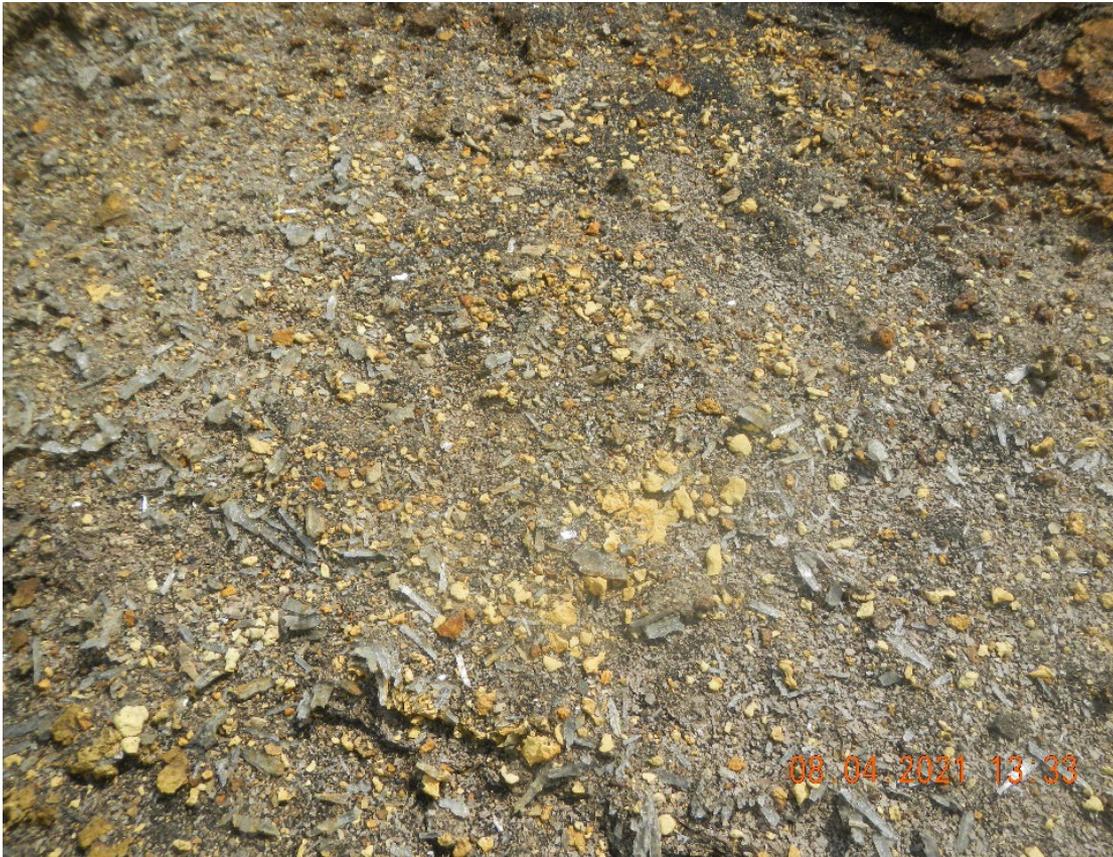
Photo #21 close up of adjacent undisturbed soil

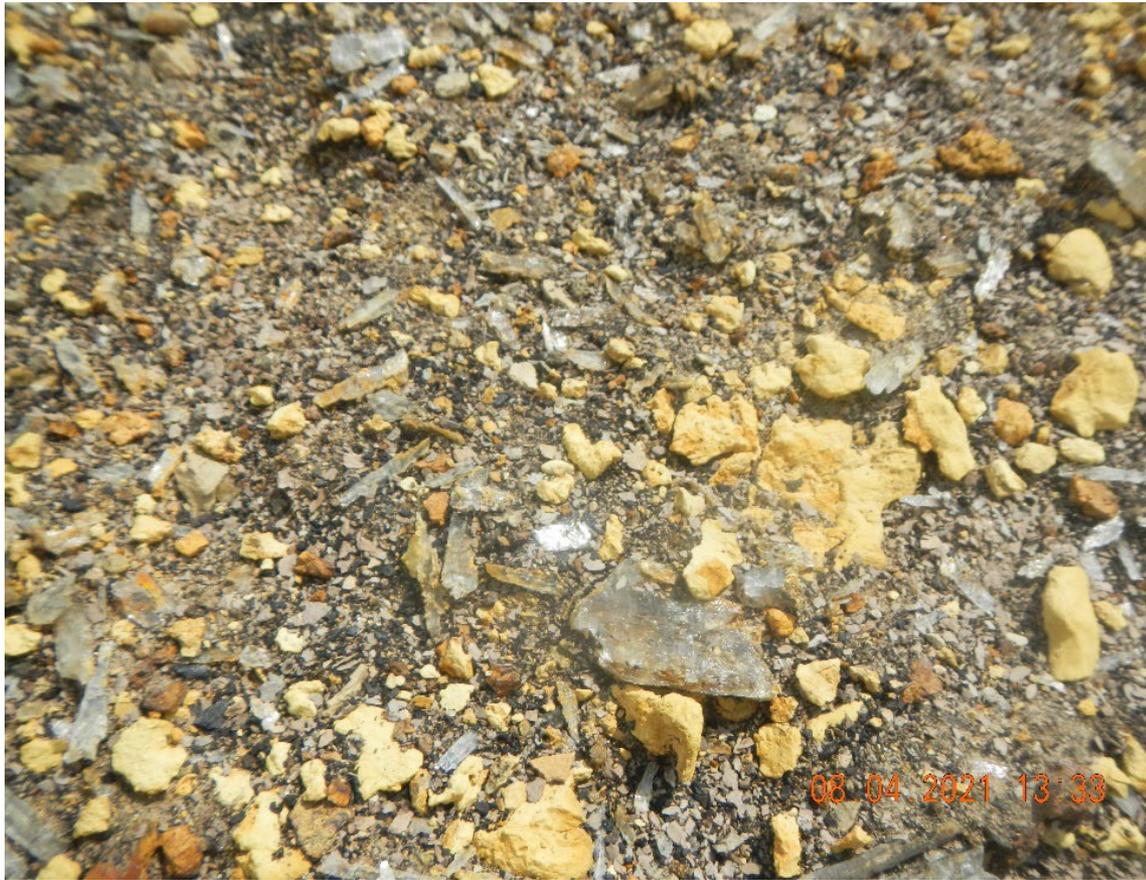
Photo #22 close up of adjacent undisturbed soil

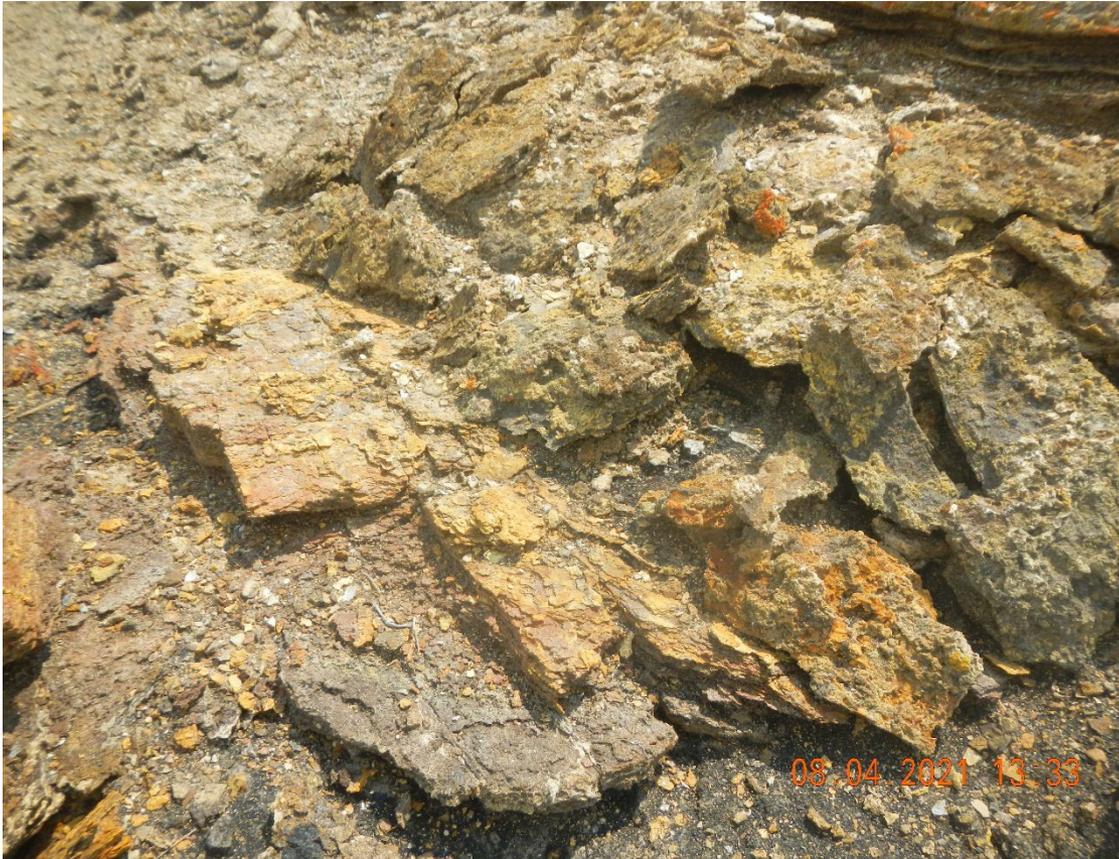
Photo #23 close up of adjacent undisturbed soil
