Inspection Photos

081-07227

REM 19550

Spill 479587

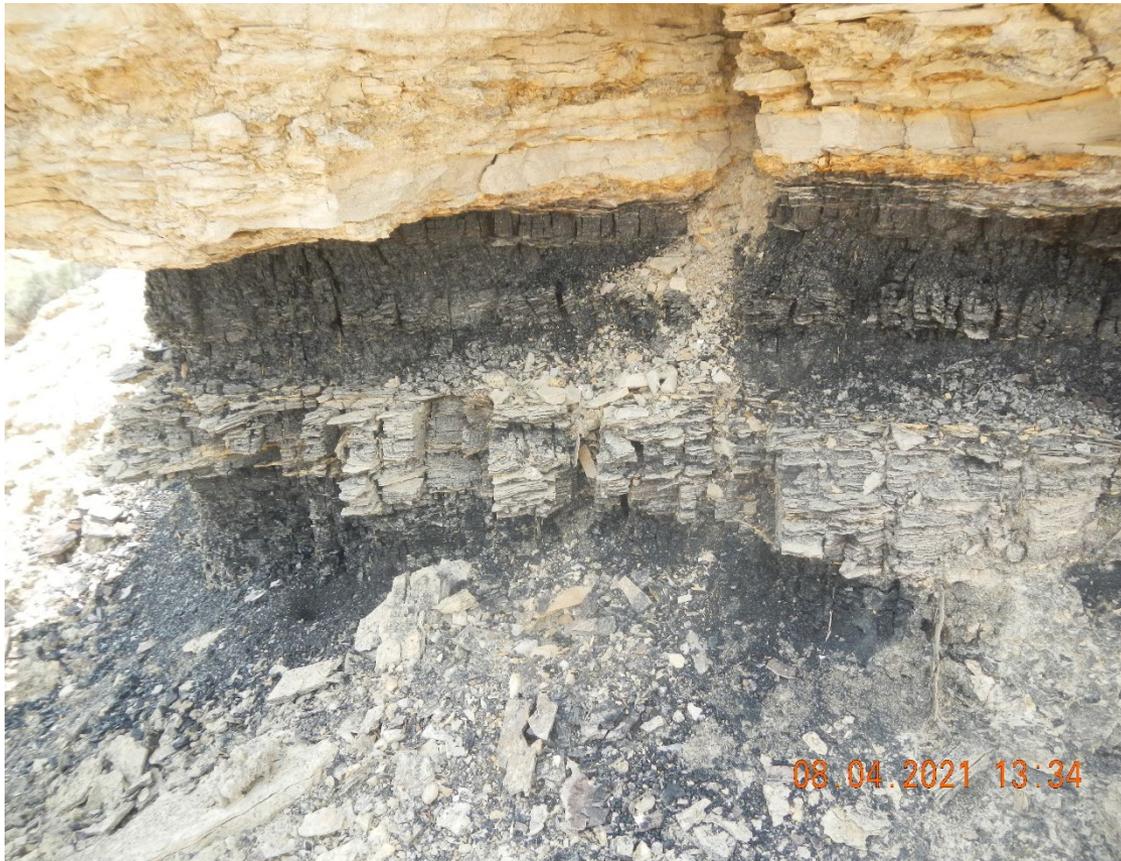
Photo #25 close up of adjacent undisturbed soil

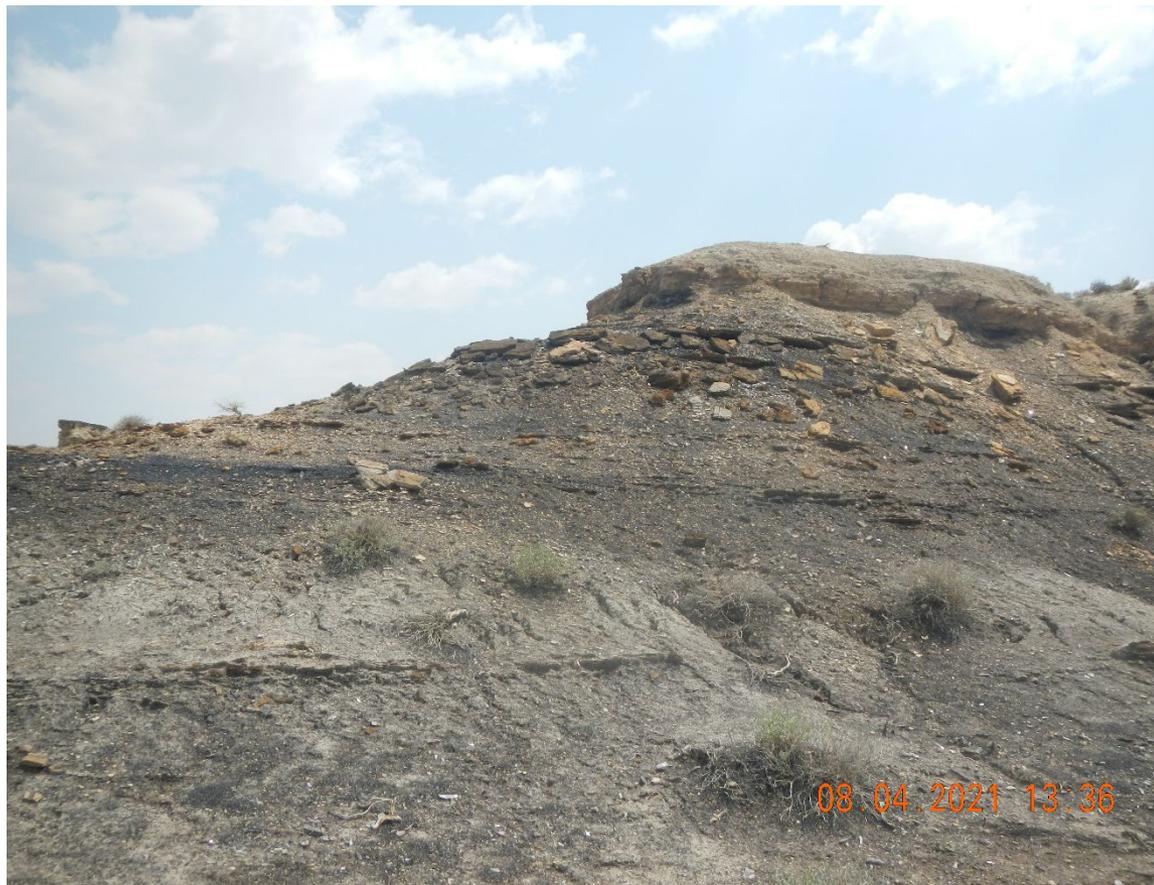
Photo #26 adjacent undisturbed soil

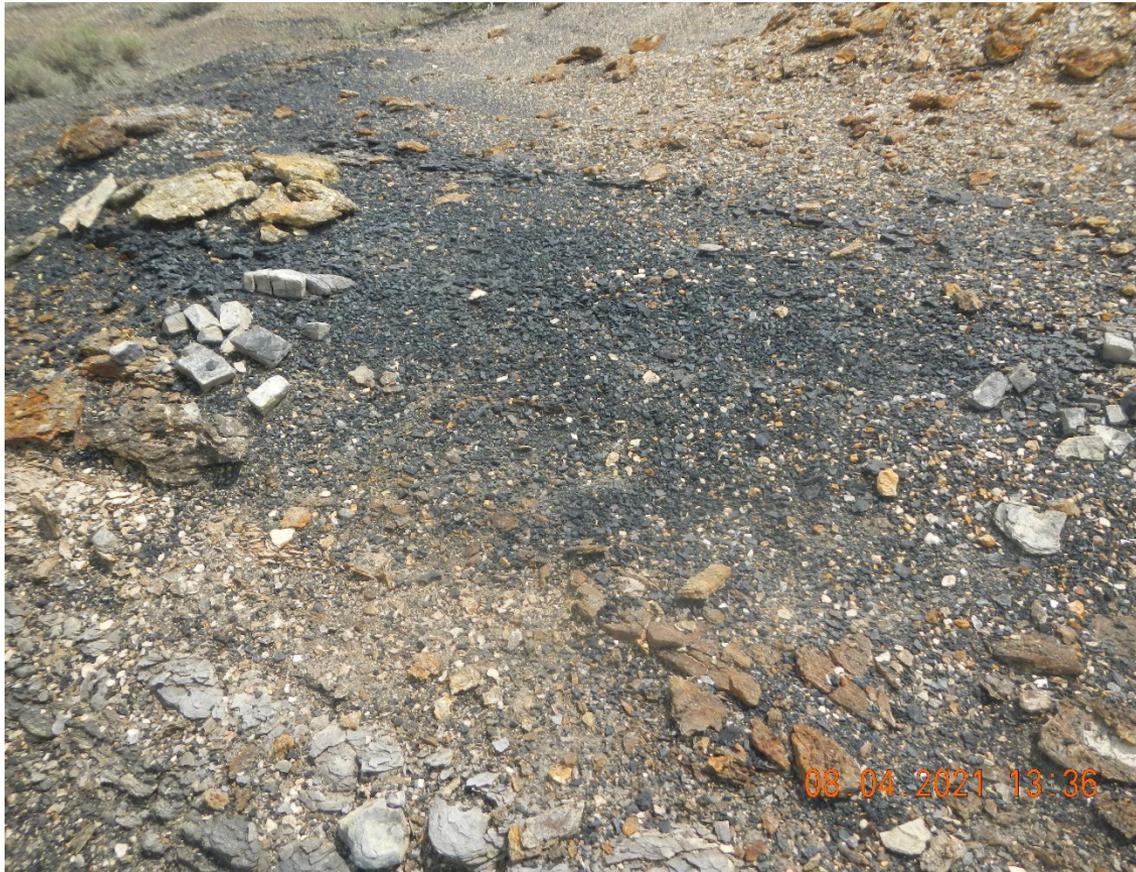
Photo #27 close up of adjacent undisturbed soil

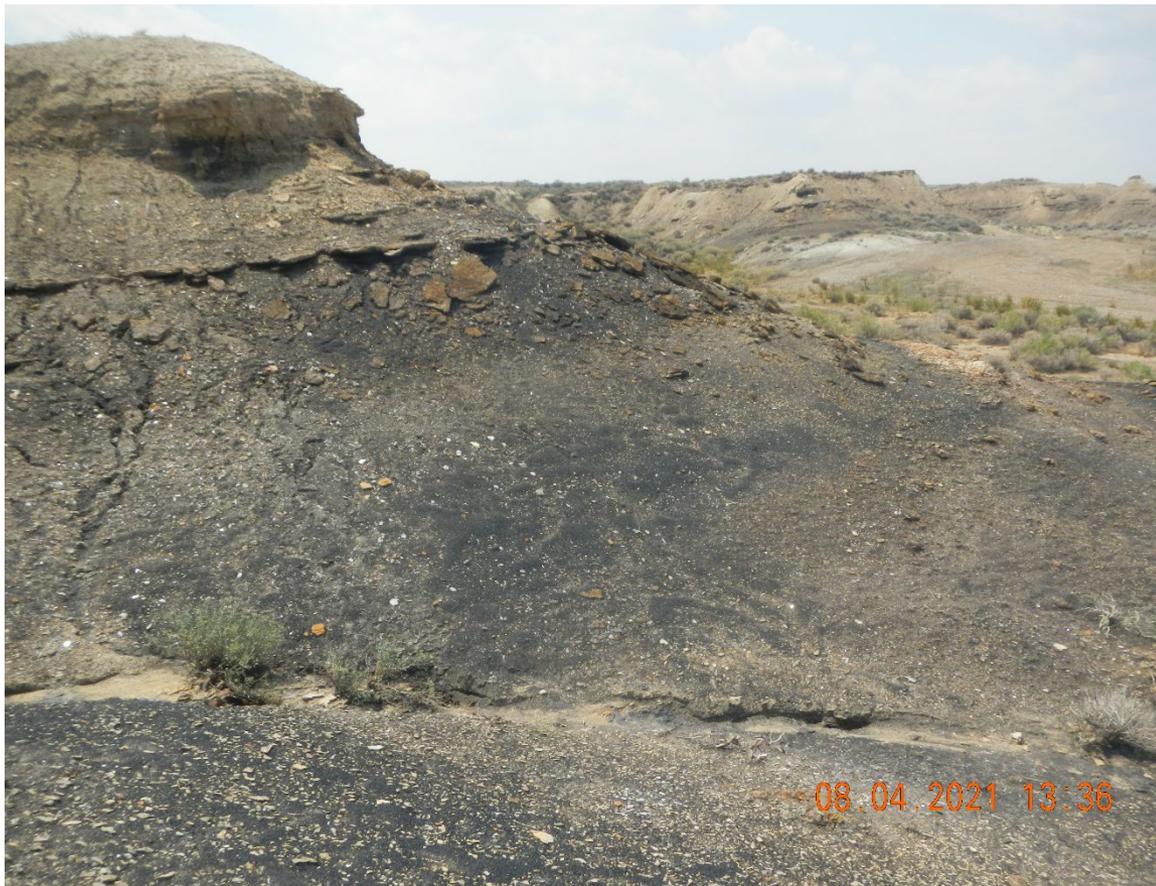
Photo #28 outcropping near pad

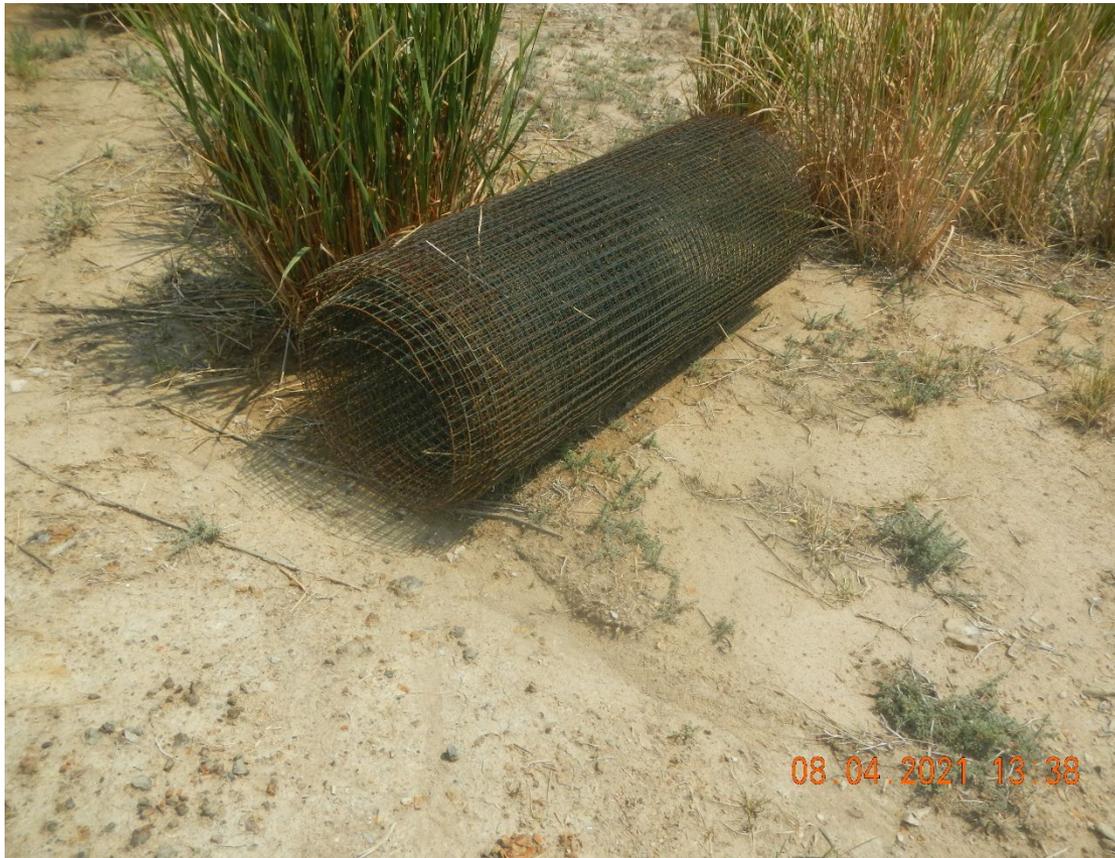
Photo #29 roll of chicken wire in area of interim reclamation to the east of pad.

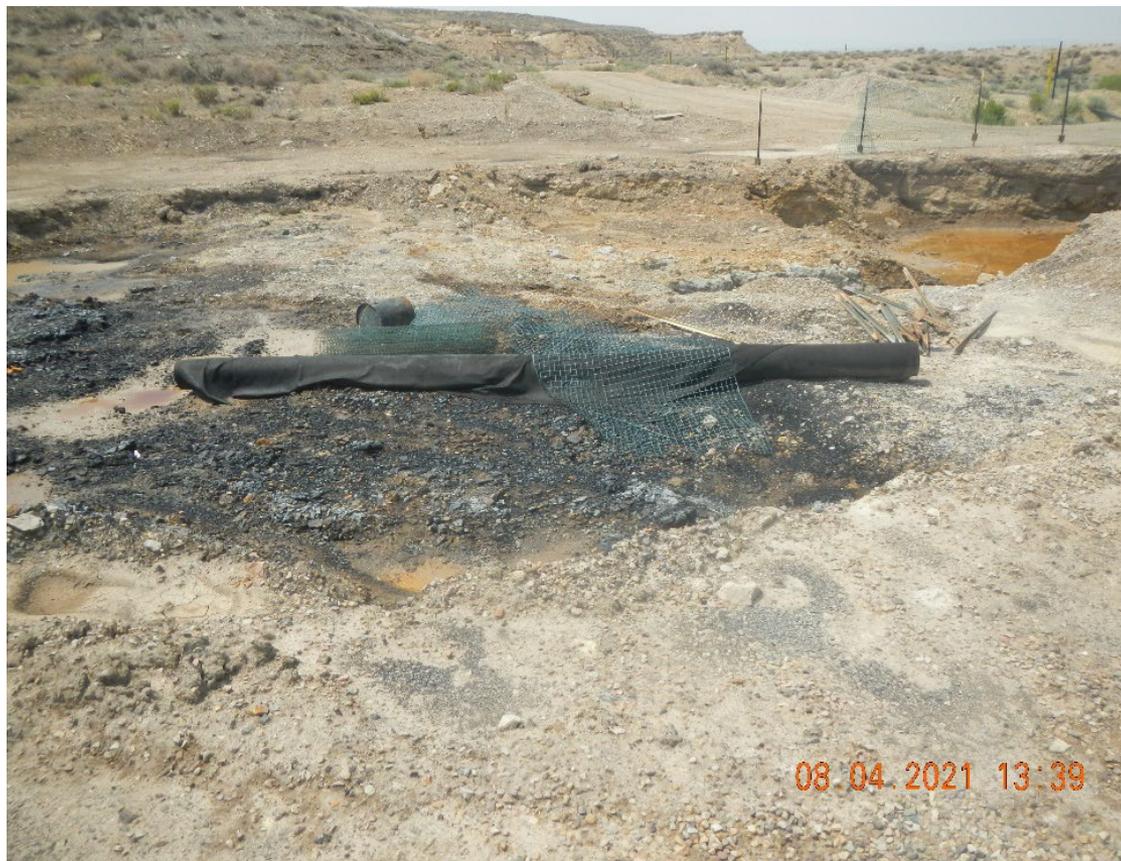
Photo #30 area near pit
