Inspection Photos

API: 071-08840

Operator: EVERGREEN NATURAL RESOURCES

Inspection Date: 8/10/2021

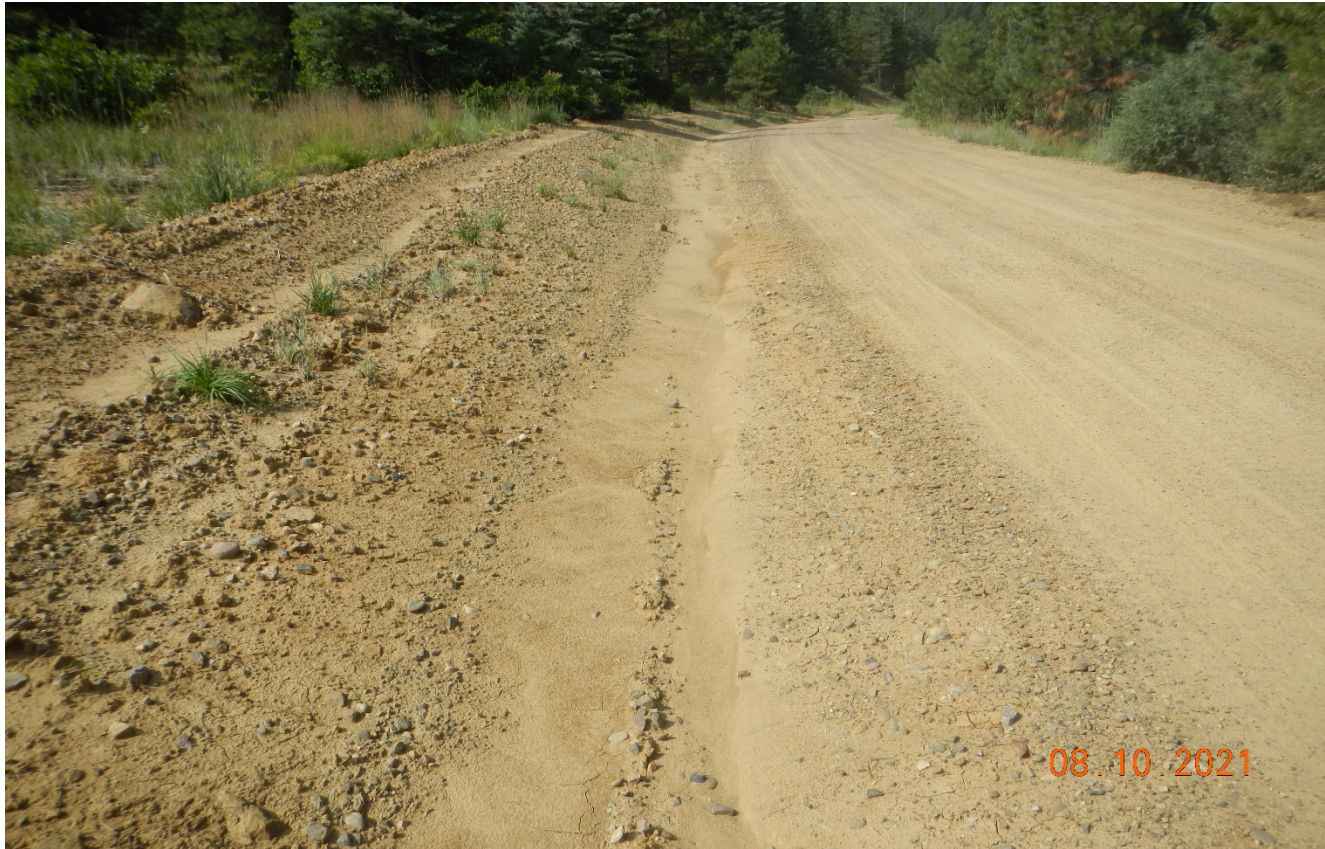
Photo 1. Facing west along the main access road. The road has been regraded.

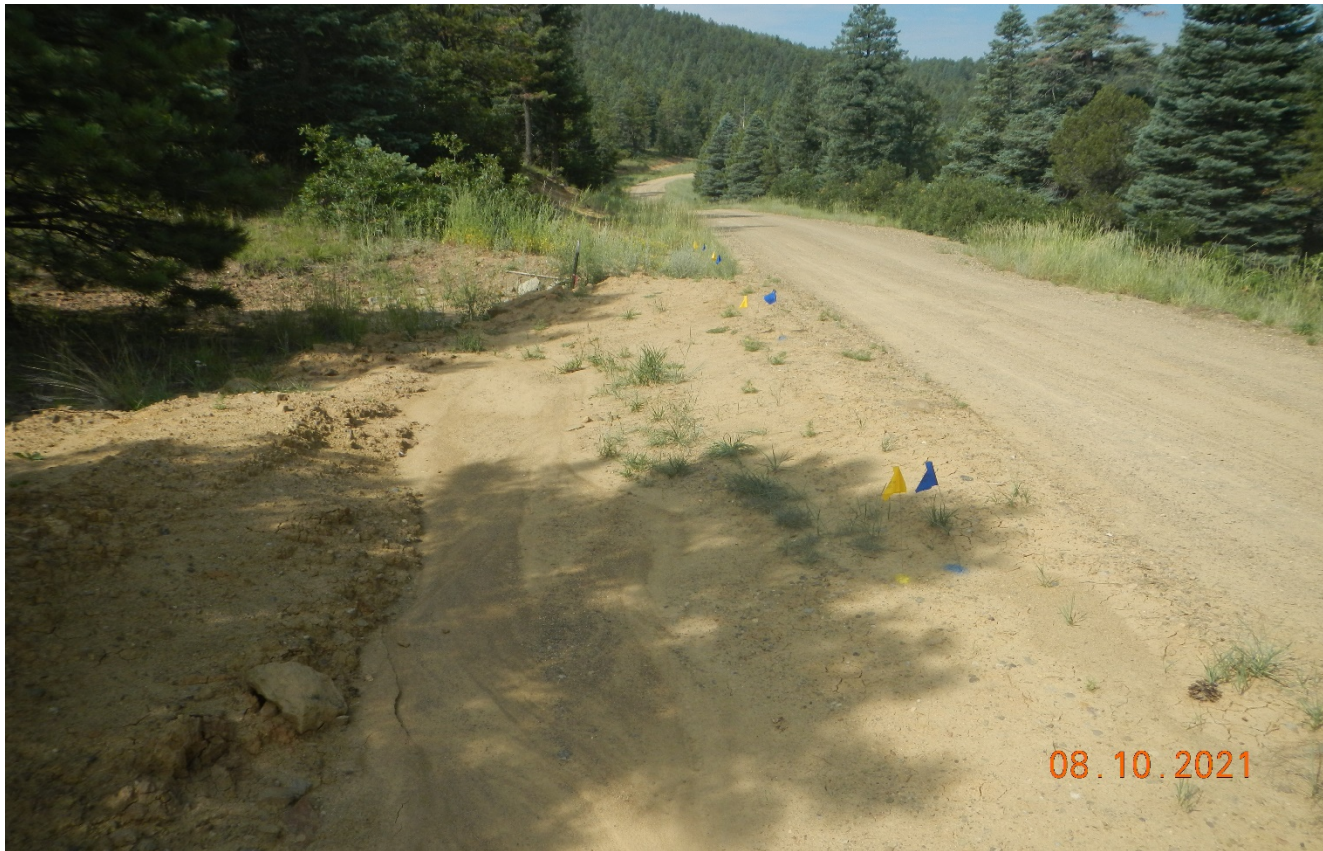
Photo 2. The culvert has been cleaned out and grading was performed to direct stormwater toward the culvert.

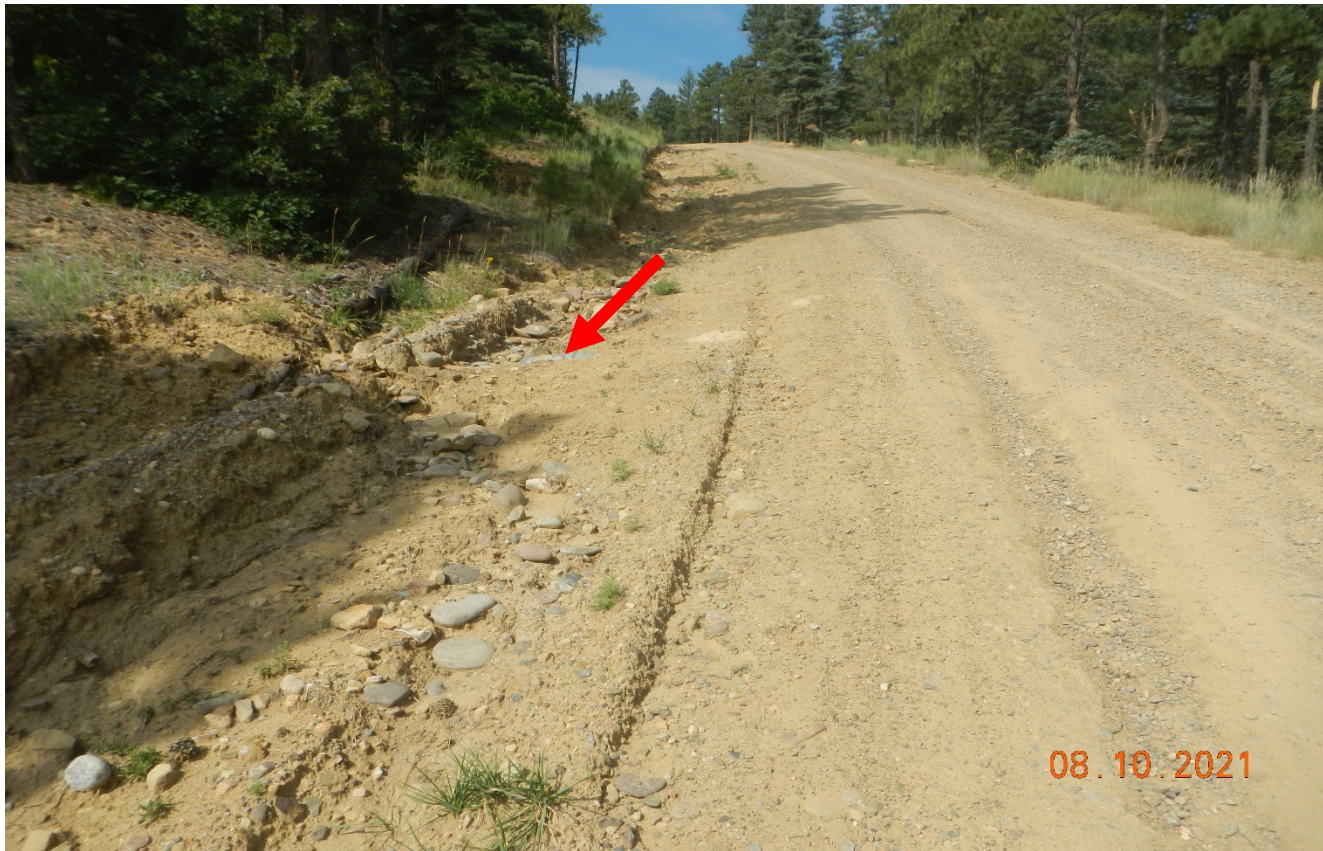
Photo 3. The erosion along the side of the road was repaired but no BMP's were installed to prevent erosion. Arrow points to a buried culvert that would help control erosion if repaired.

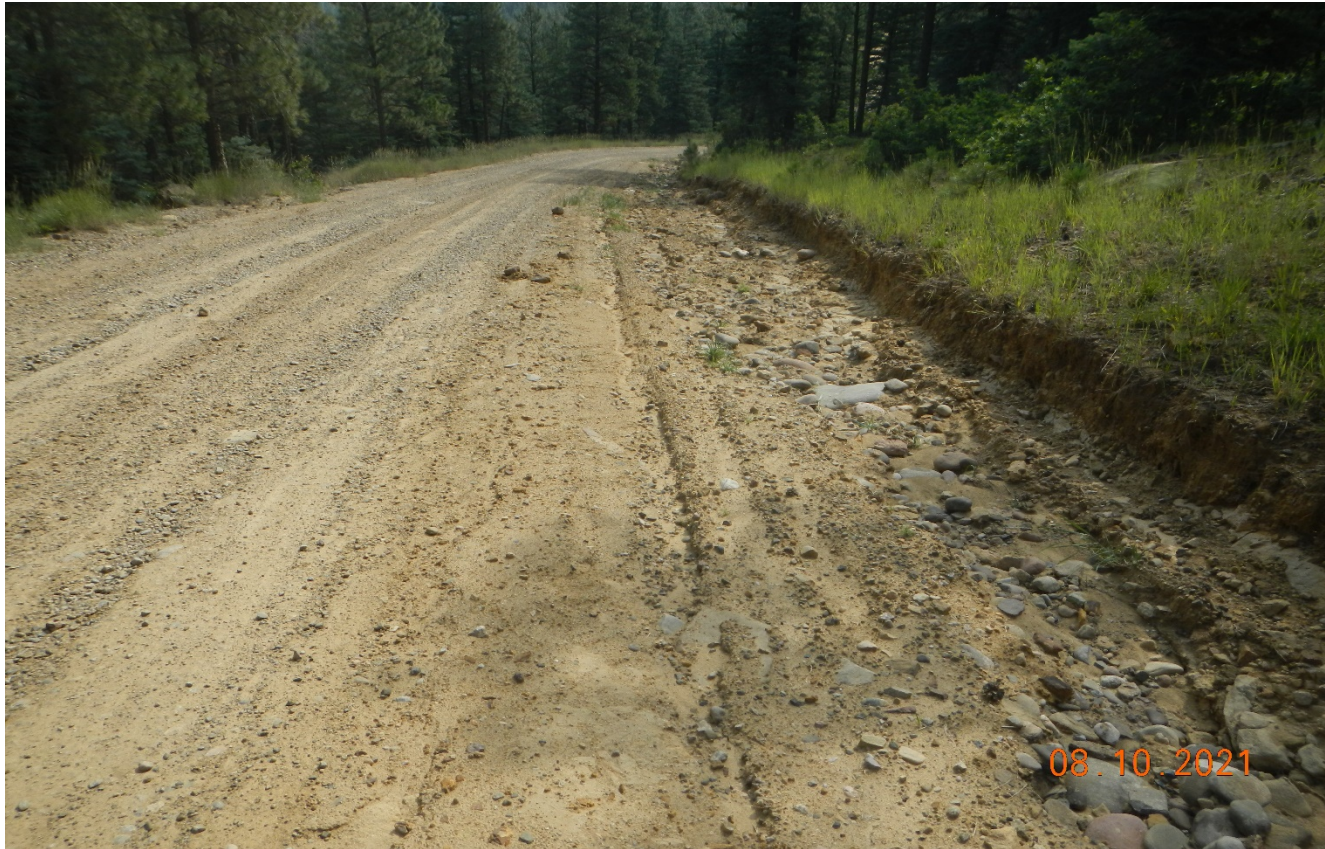
Photo 4. Facing back down the road. The erosion along the road was graded but no BMP's were installed on the long stretch of road to prevent erosion from reoccurring.

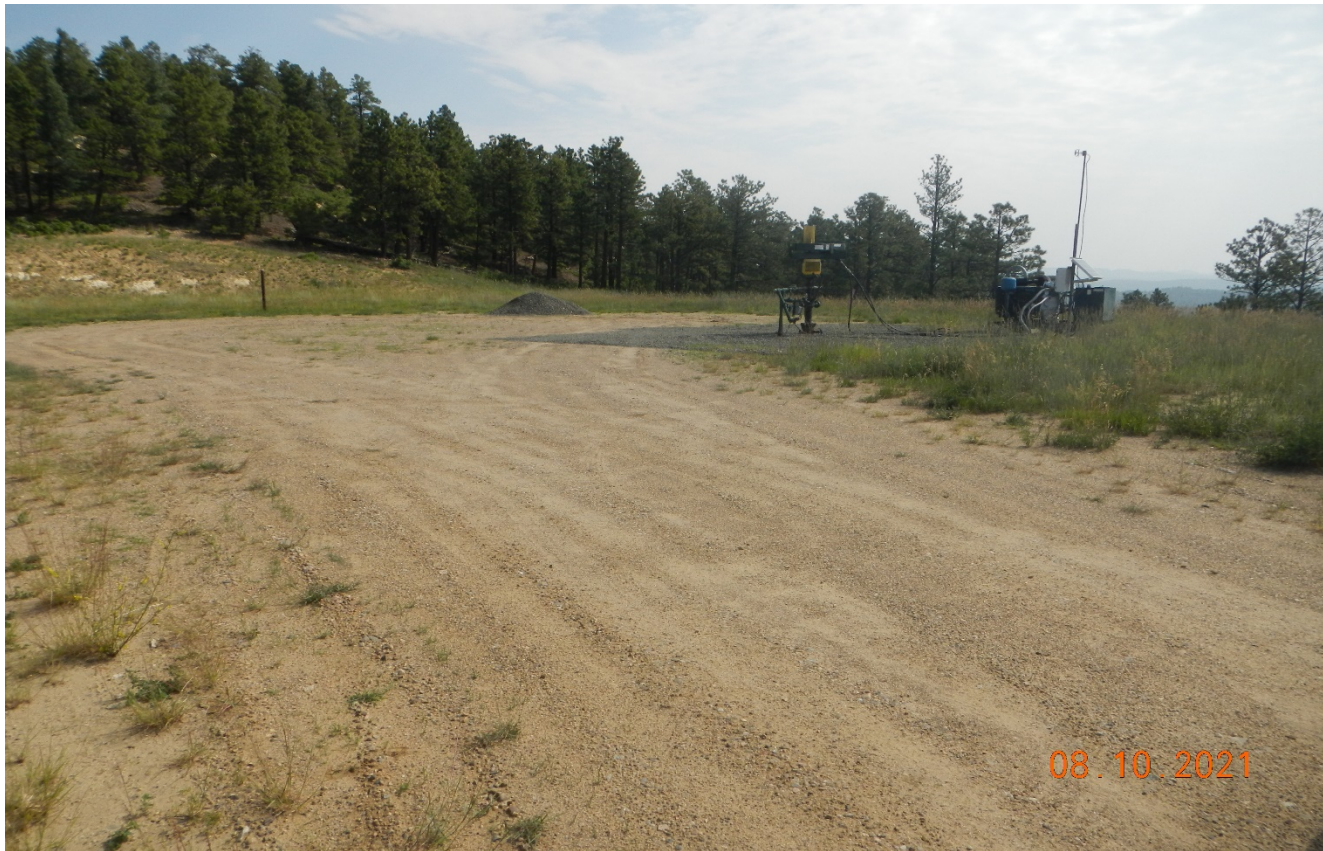
Photo 5. Facing toward the location.
