Inspection Photos

Operator: Advanced Wireless
API: 067-09751
Date: 8/6/2021

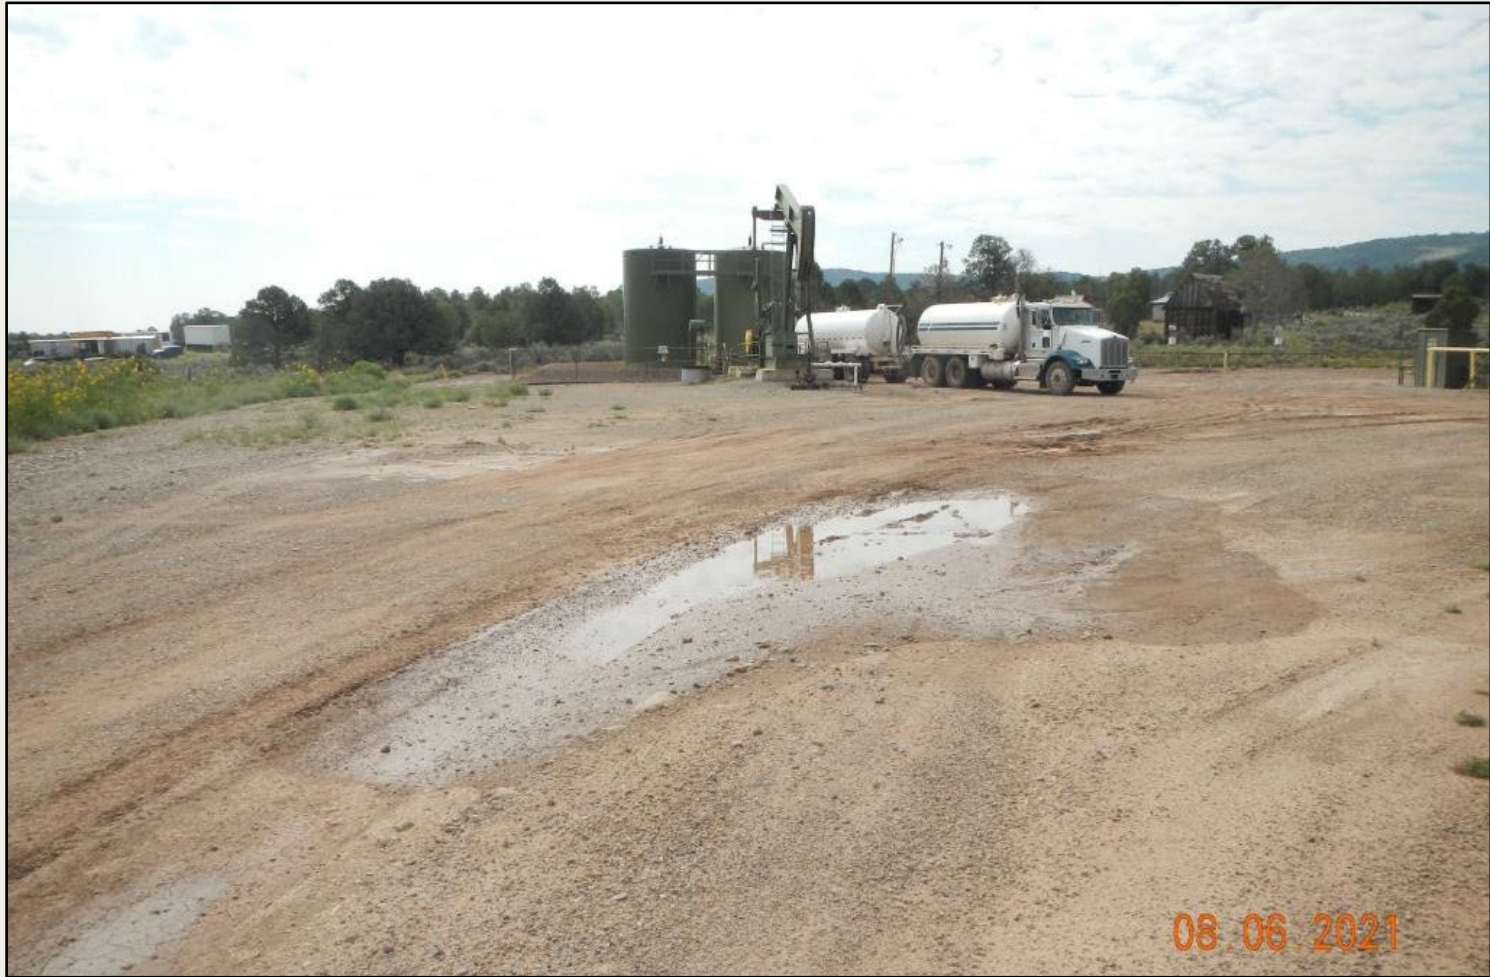
Photo 1. View of the project area from the well pad entrance facing center.

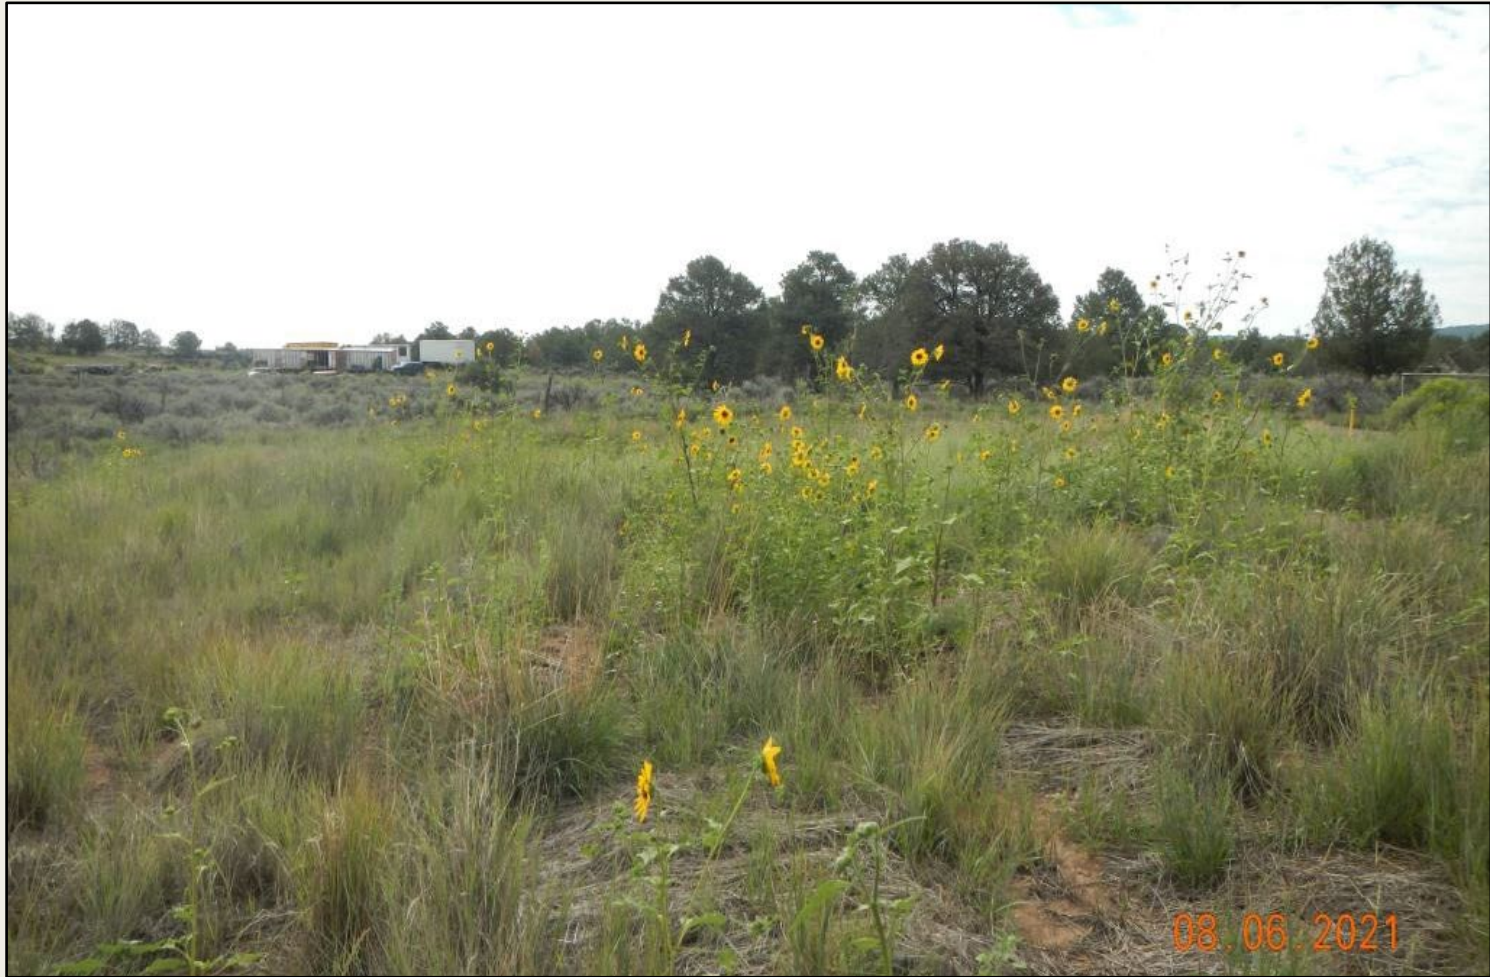
Photo 2. View of the eastern project area from the northeastern corner facing southward. Revegetation is progressing here, as described in July 2021 inspection.

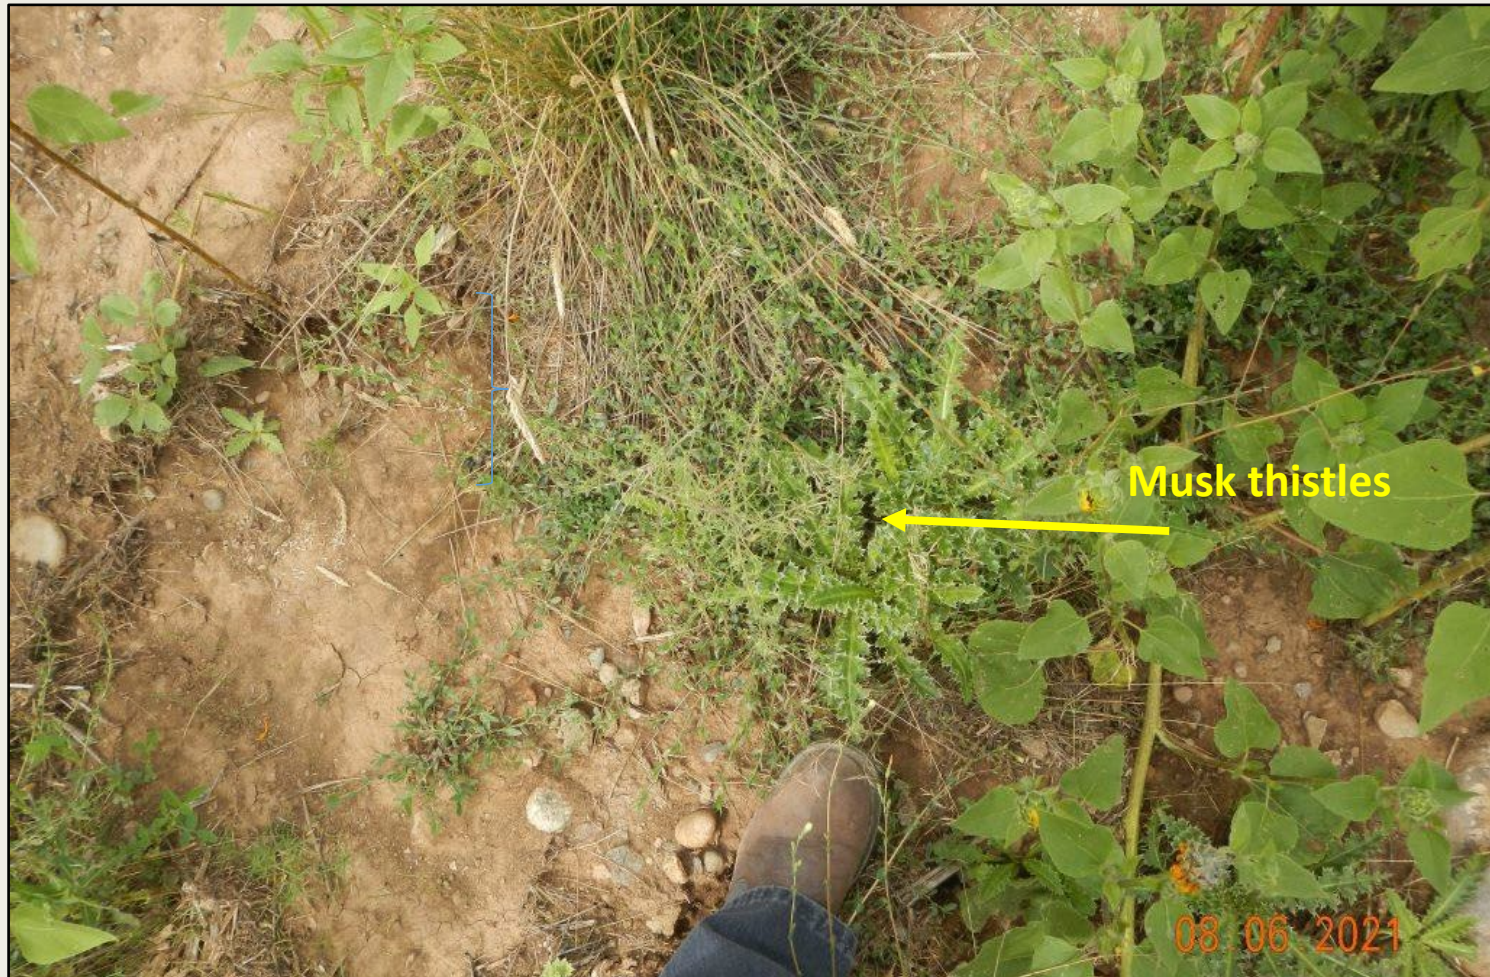
Photo 3. View of musk thistle rosettes remaining untreated within the interim reclamation area. Approximately 100 individuals observed.
