Inspection Photos
Operator: Arkoma/Catamount
API: 067-05379
Date: 8/6/2021

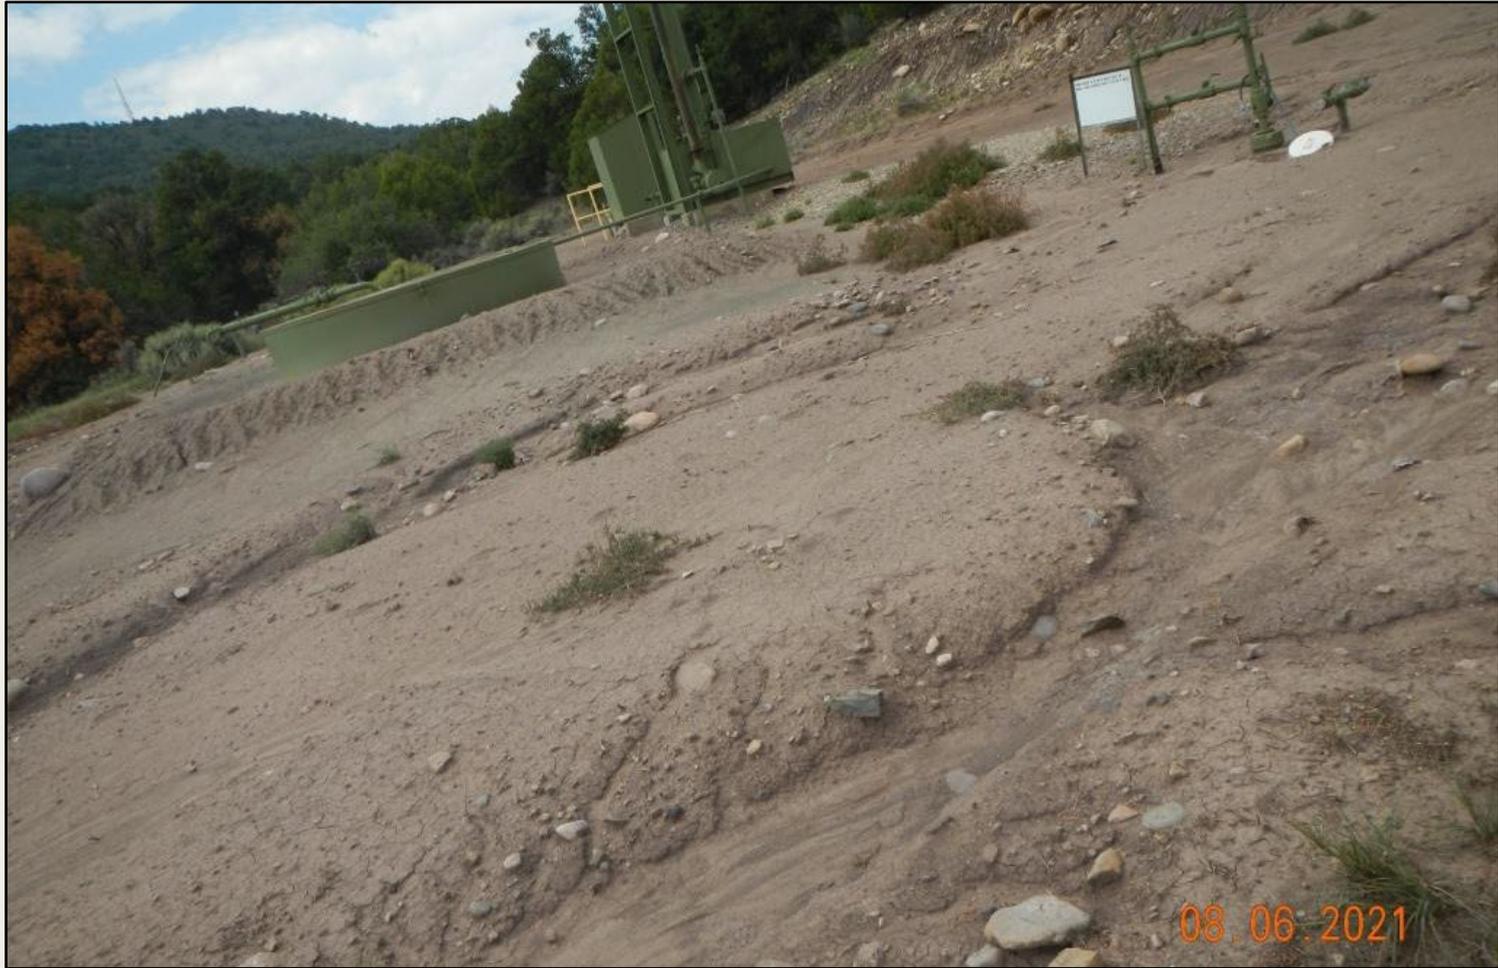
Photo 1. View of the project area from the well pad entrance facing center.

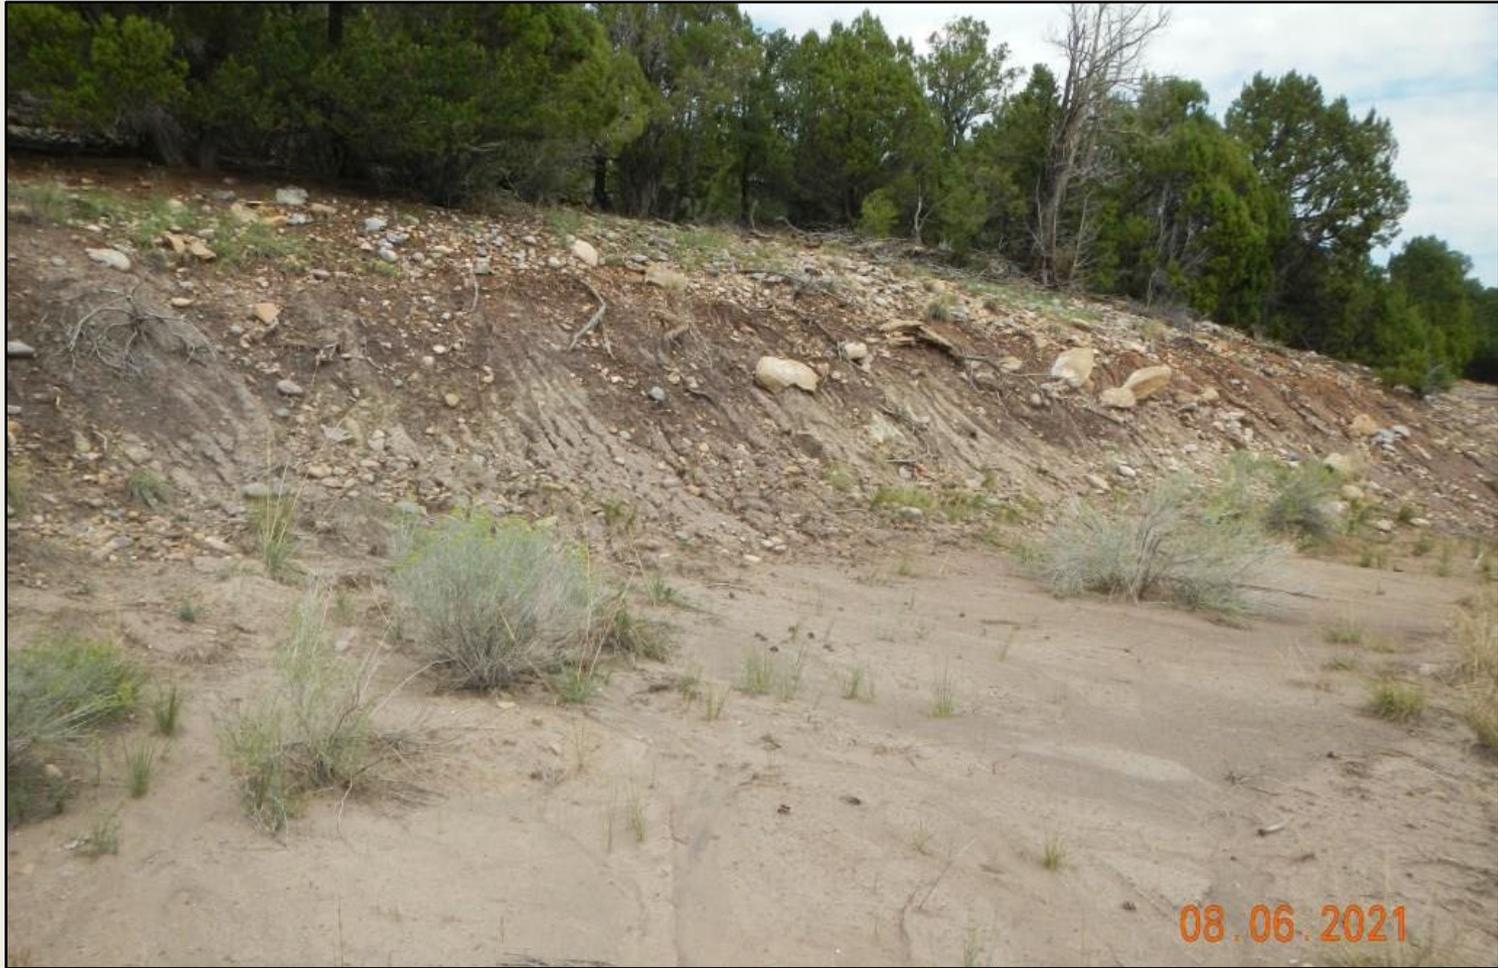
Photo 2. View of erosional rilling and sediment deposition within the western cut-slope. Area needs erosion controls, run-on, and sediment controls installed and maintained until stabilized with long term perennial vegetation.

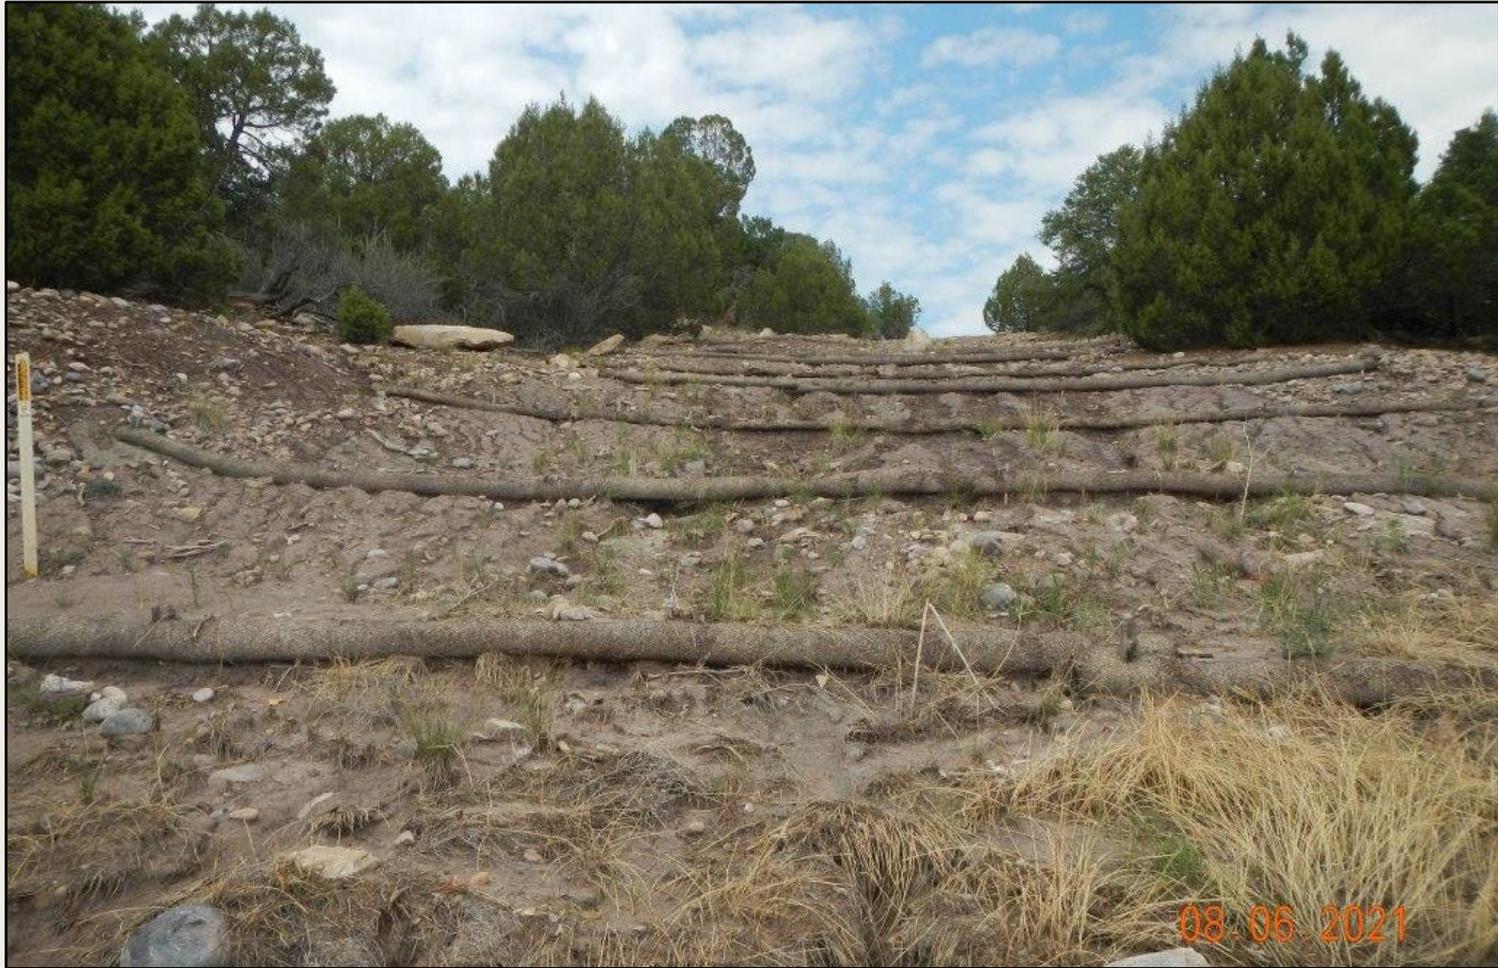
Photo 3. View of erosional channeling and rilling where flowline right of way overlaps the northwestern cut-slope. Wattles are not functioning and are not an adequate BMP in this area.

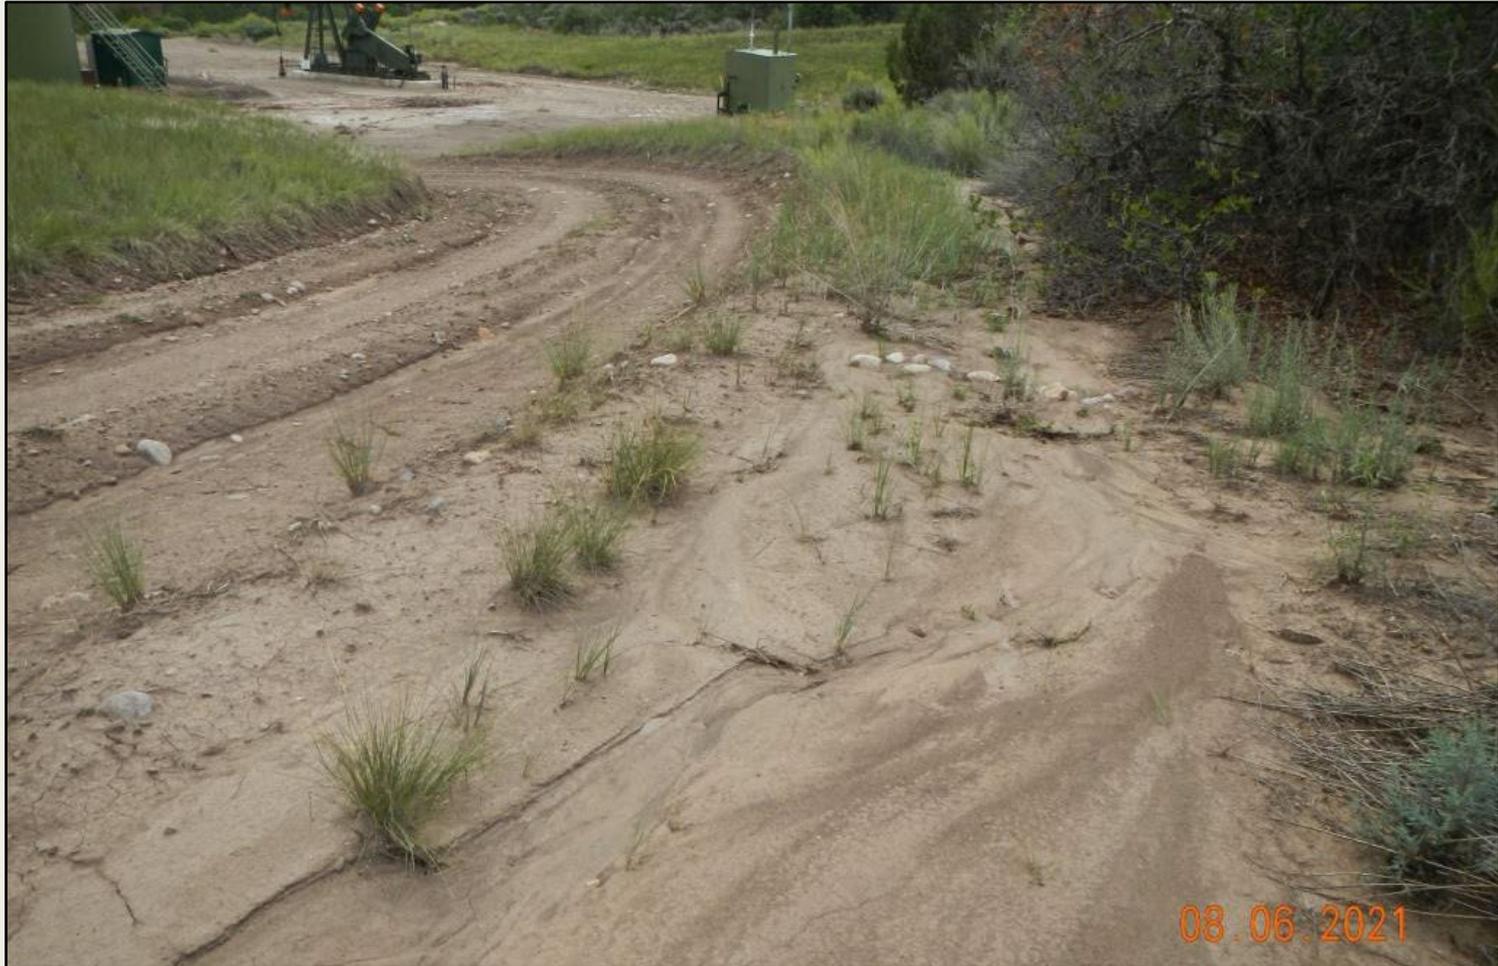
Photo 4. View of sediment discharge along the access road and cobble BMPs inundated with sediment. These cobble BMPs are not adequate for this area.

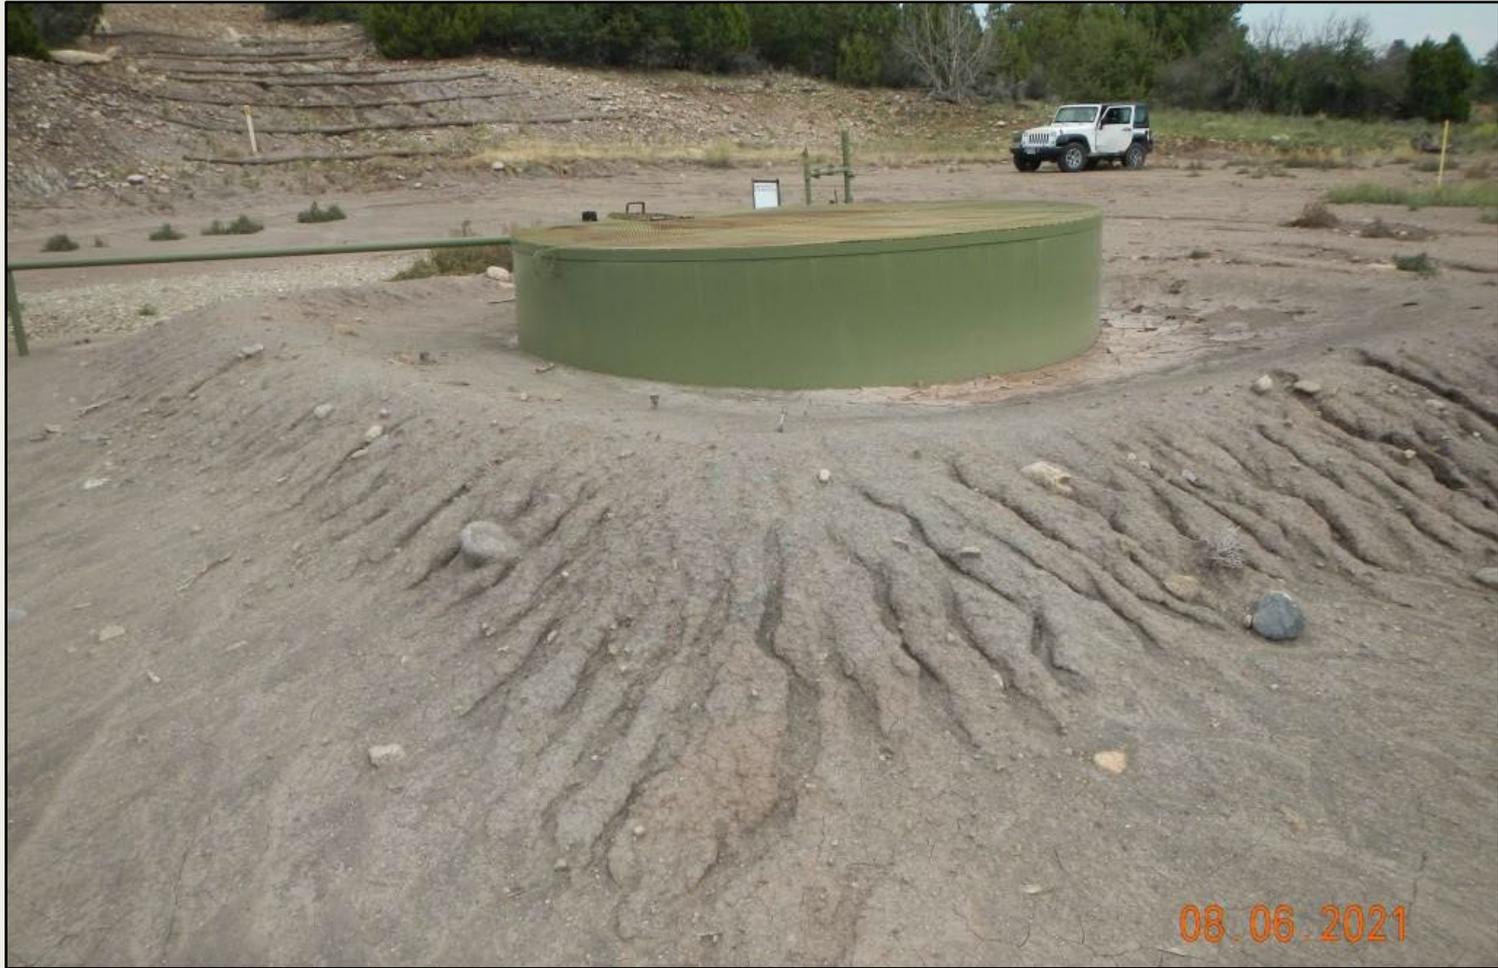
Photo 5. View of eroding berms and in tank containment. Sediment accumulation within containment is resulting in reduced and inadequate containment volume. Berms are not stabilized.

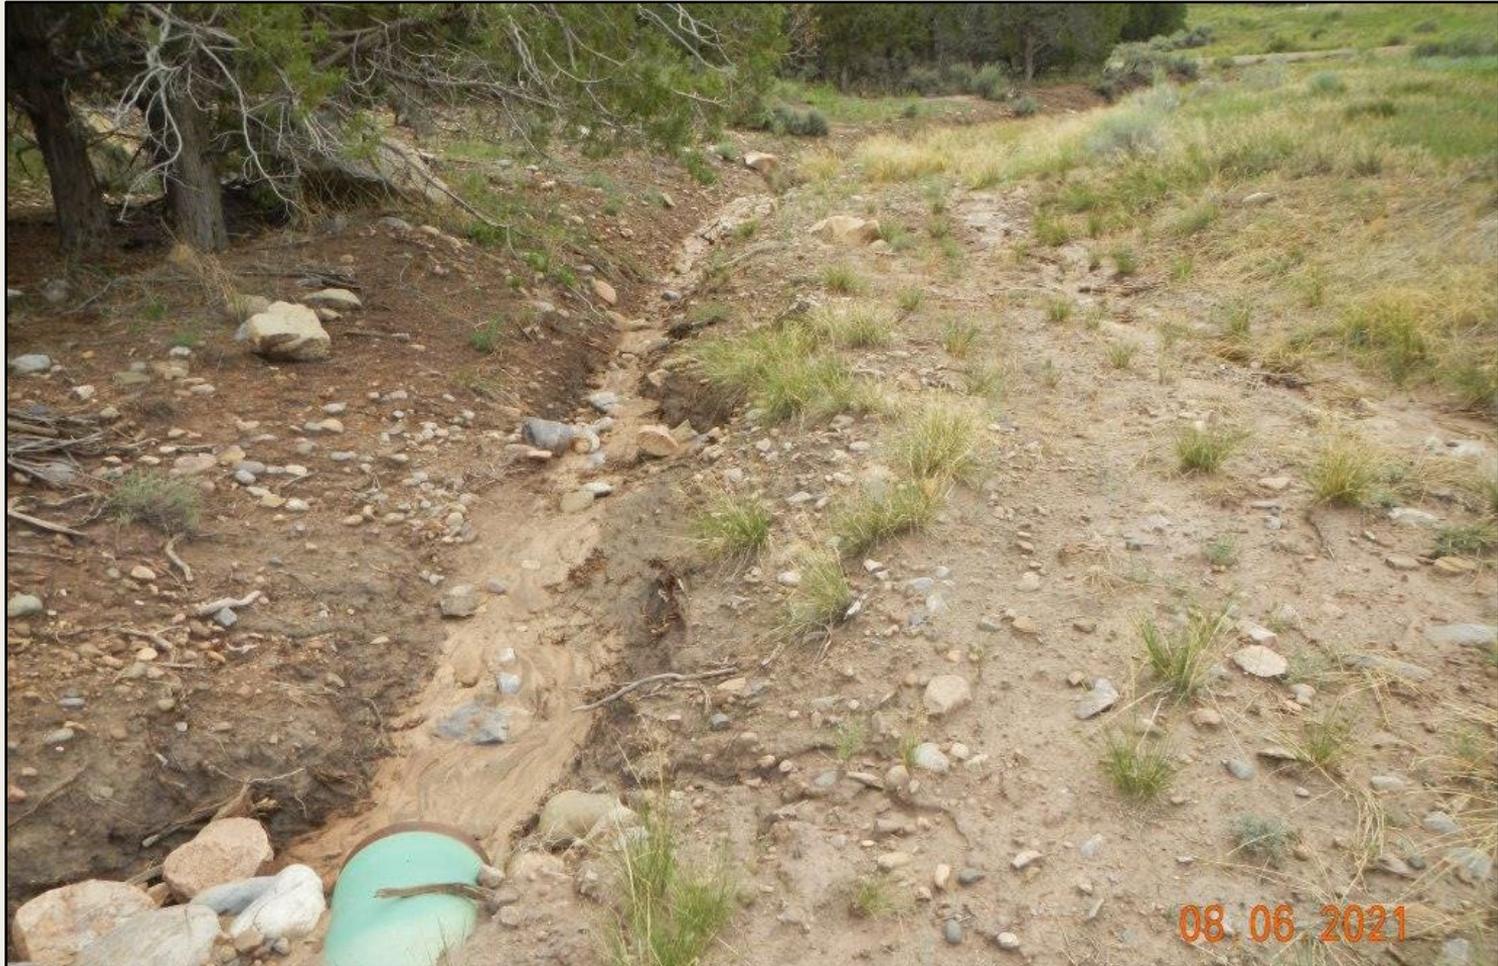
Photo 6. View of stormwater diversion within the northeastern well pad. Stormwater controls are needed to reduce velocity and stabilize soils when stormwater flows exit the culvert and flows down-slope away from the project area.

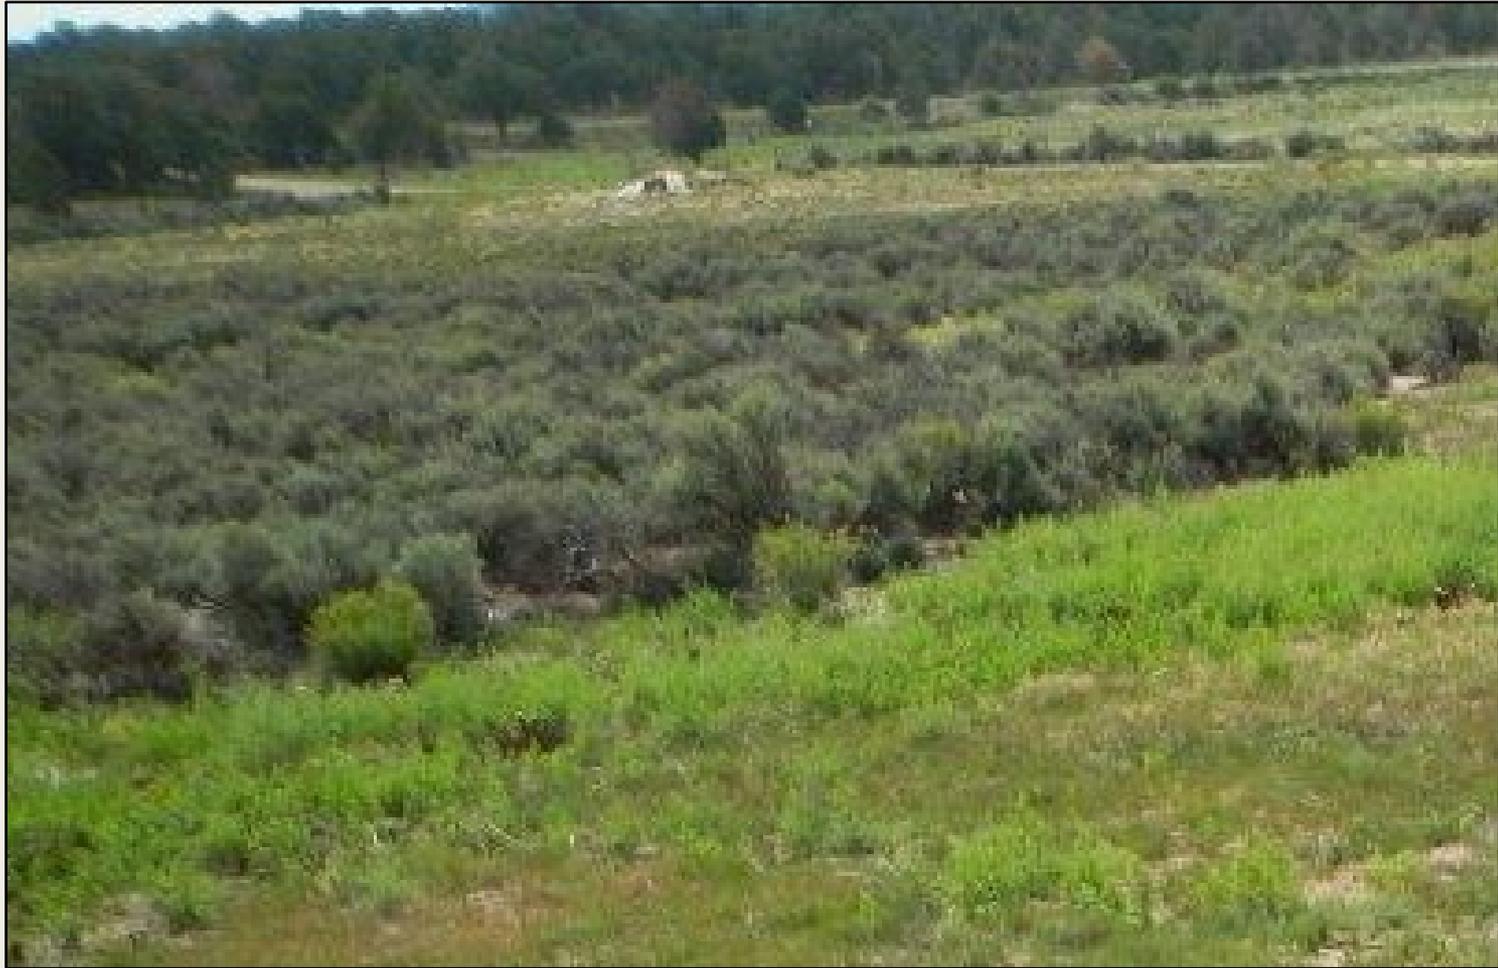
Photo 7. View of reference area comprised of sagebrush shrubland, open grass field, and pinyon and juniper woodland mosaic, with grasses and forbs such as western wheatgrass, James galleta, matt penstemon, and goldenaster.
