Inspection Photos
Operator: Arkoma/Catamount
API: 067-05335
Date: 8/6/2021

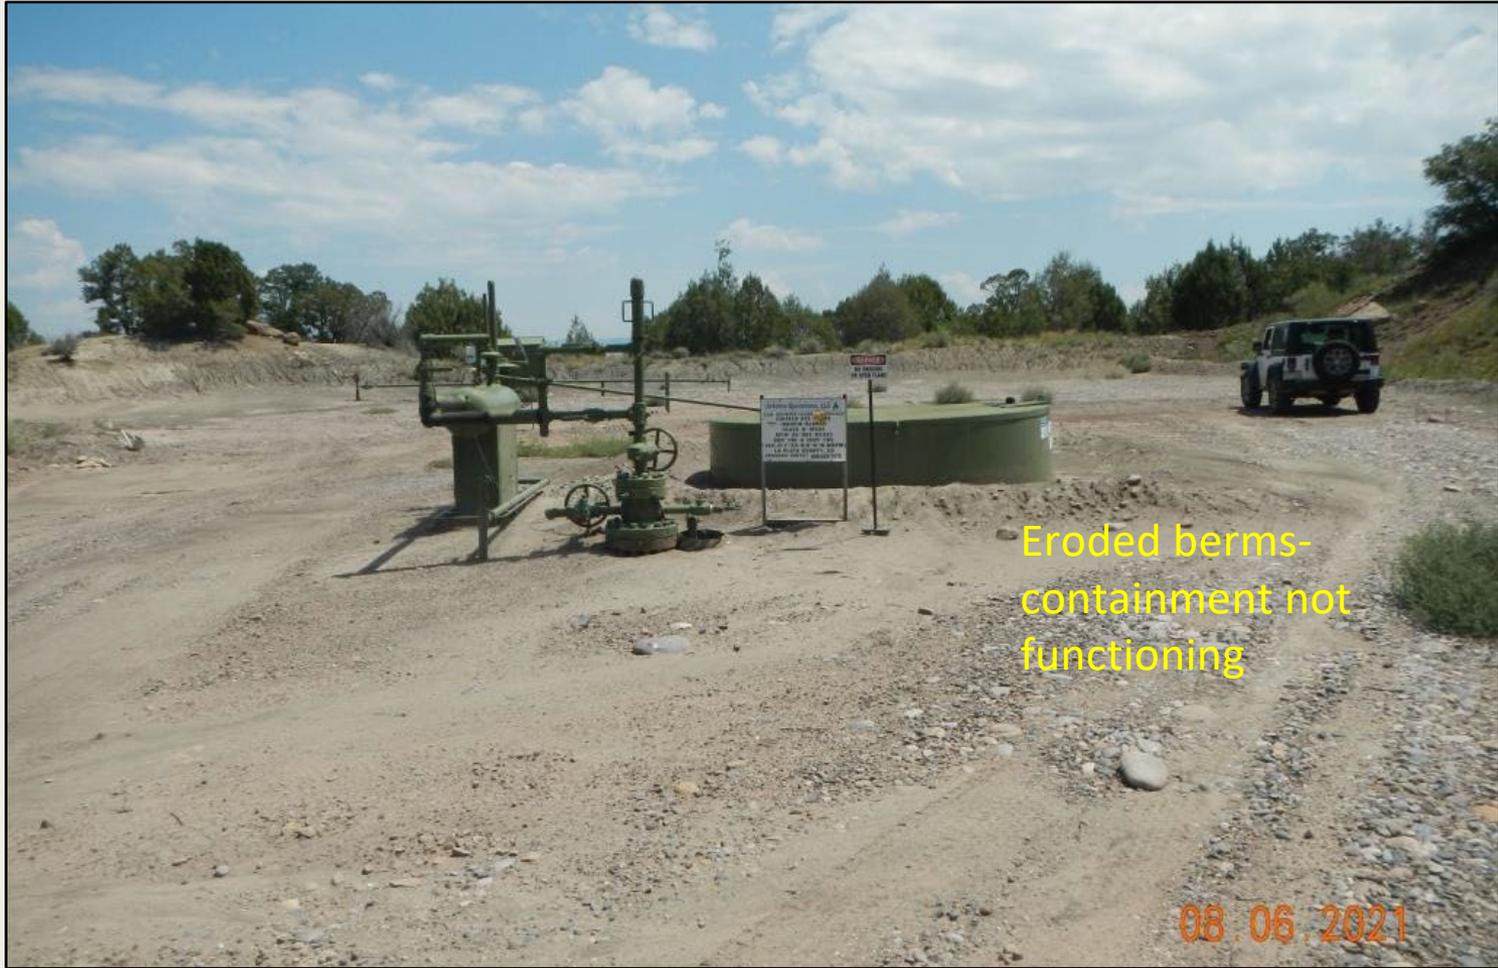
Photo 1. View of the project area from the well pad entrance facing center. Containment berms around submerged tank are eroded and no longer functioning.

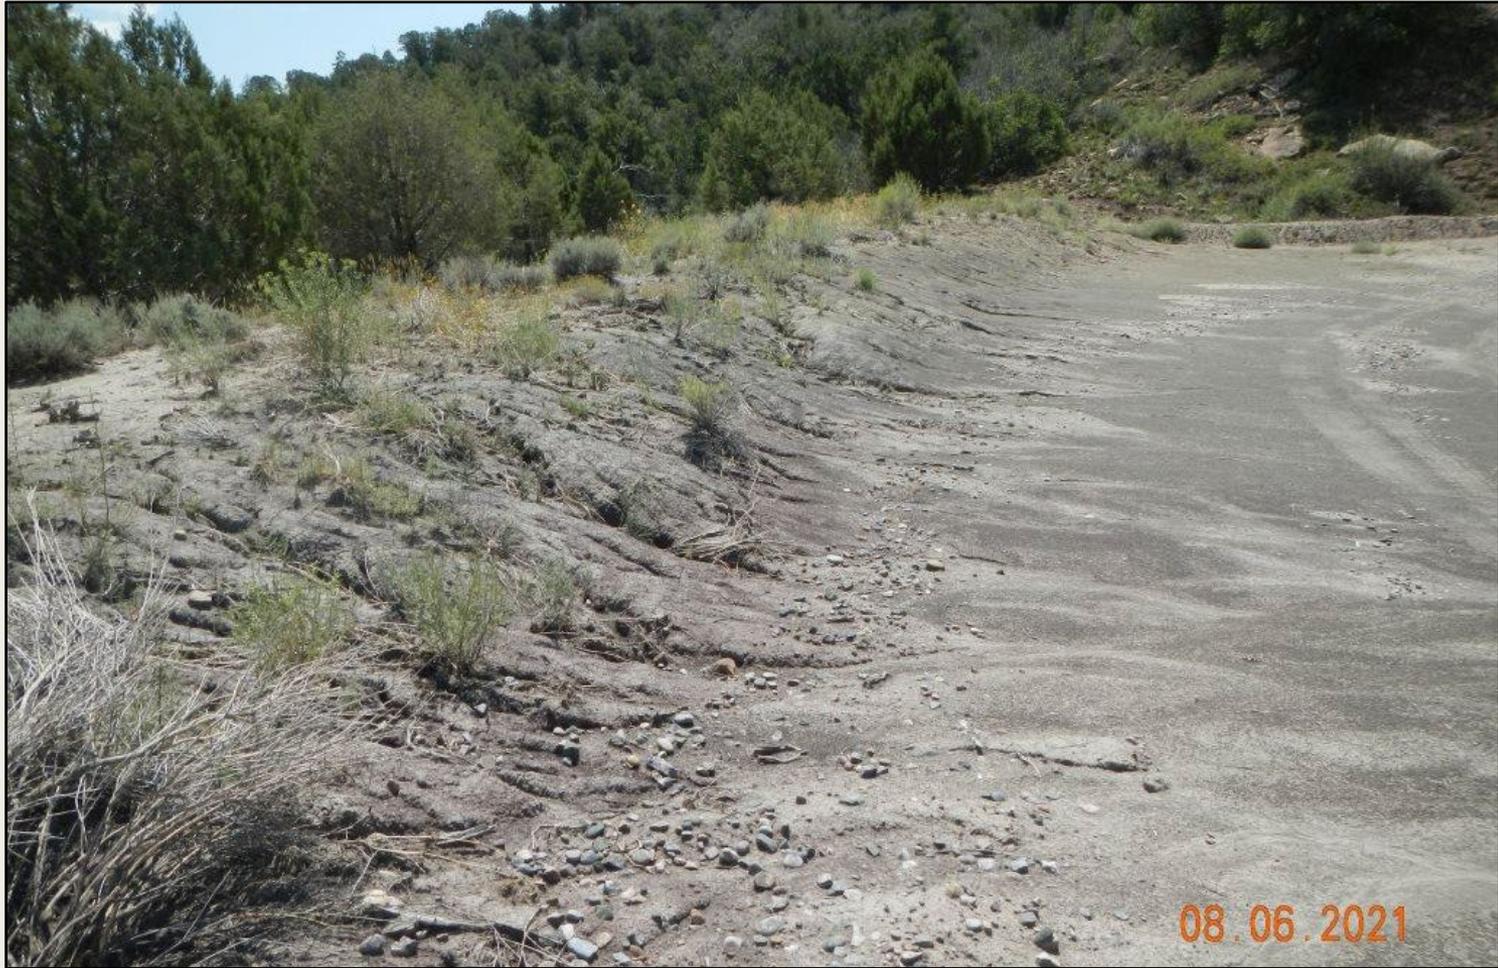
Photo 2. View of the eastern cutslope facing southward. Erosional channeling and rilling up to 1-foot deep observed, with sediment deposition at the toe of the unstabilized slope.

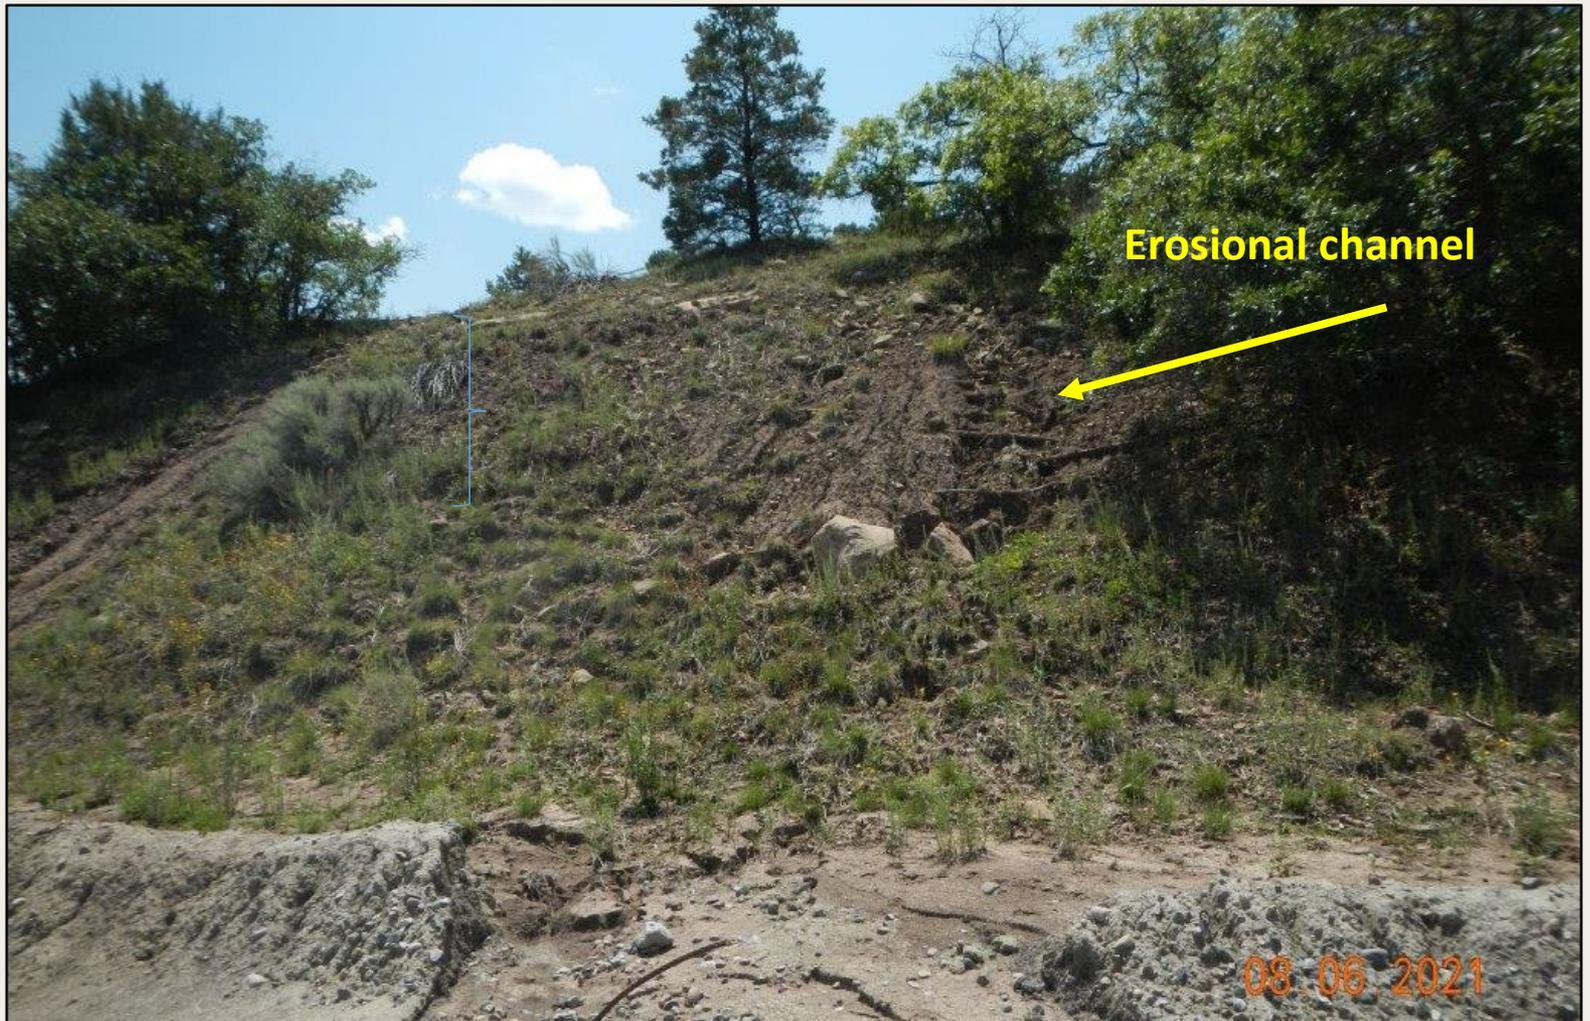
Photo 3. View of erosional channel within the southern project area, and area where diversion berm is breached. Rilling observed across slope and diversion channels are full of sediment.

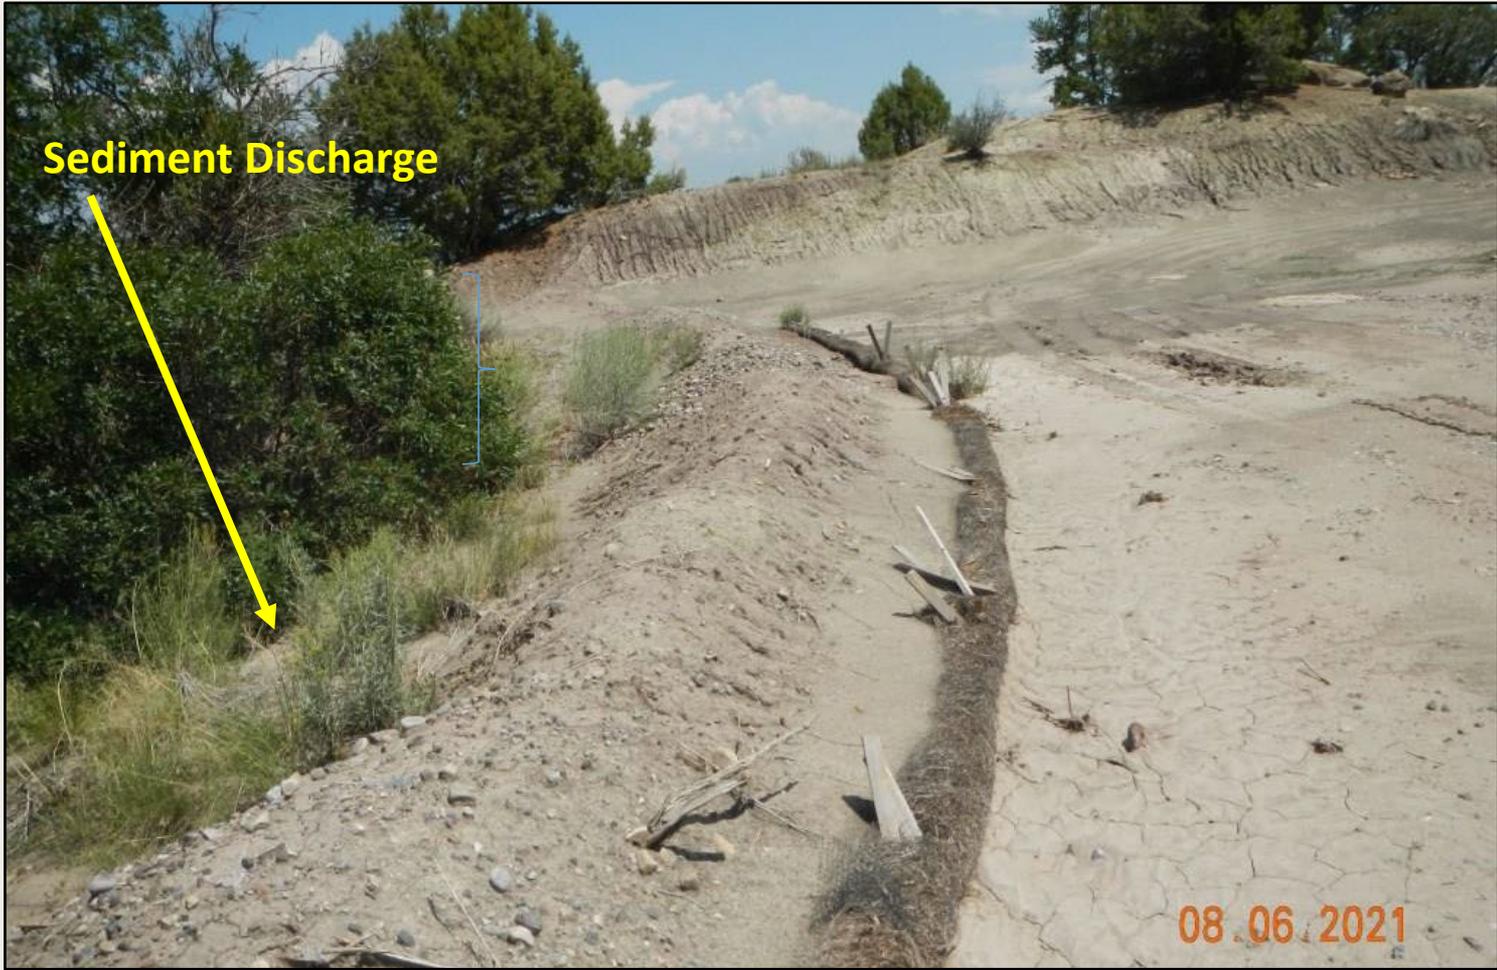
Photo 4. View of berms and wattles within the northern project area. Berms are not stabilized and sediment is discharging down slope (offsite).

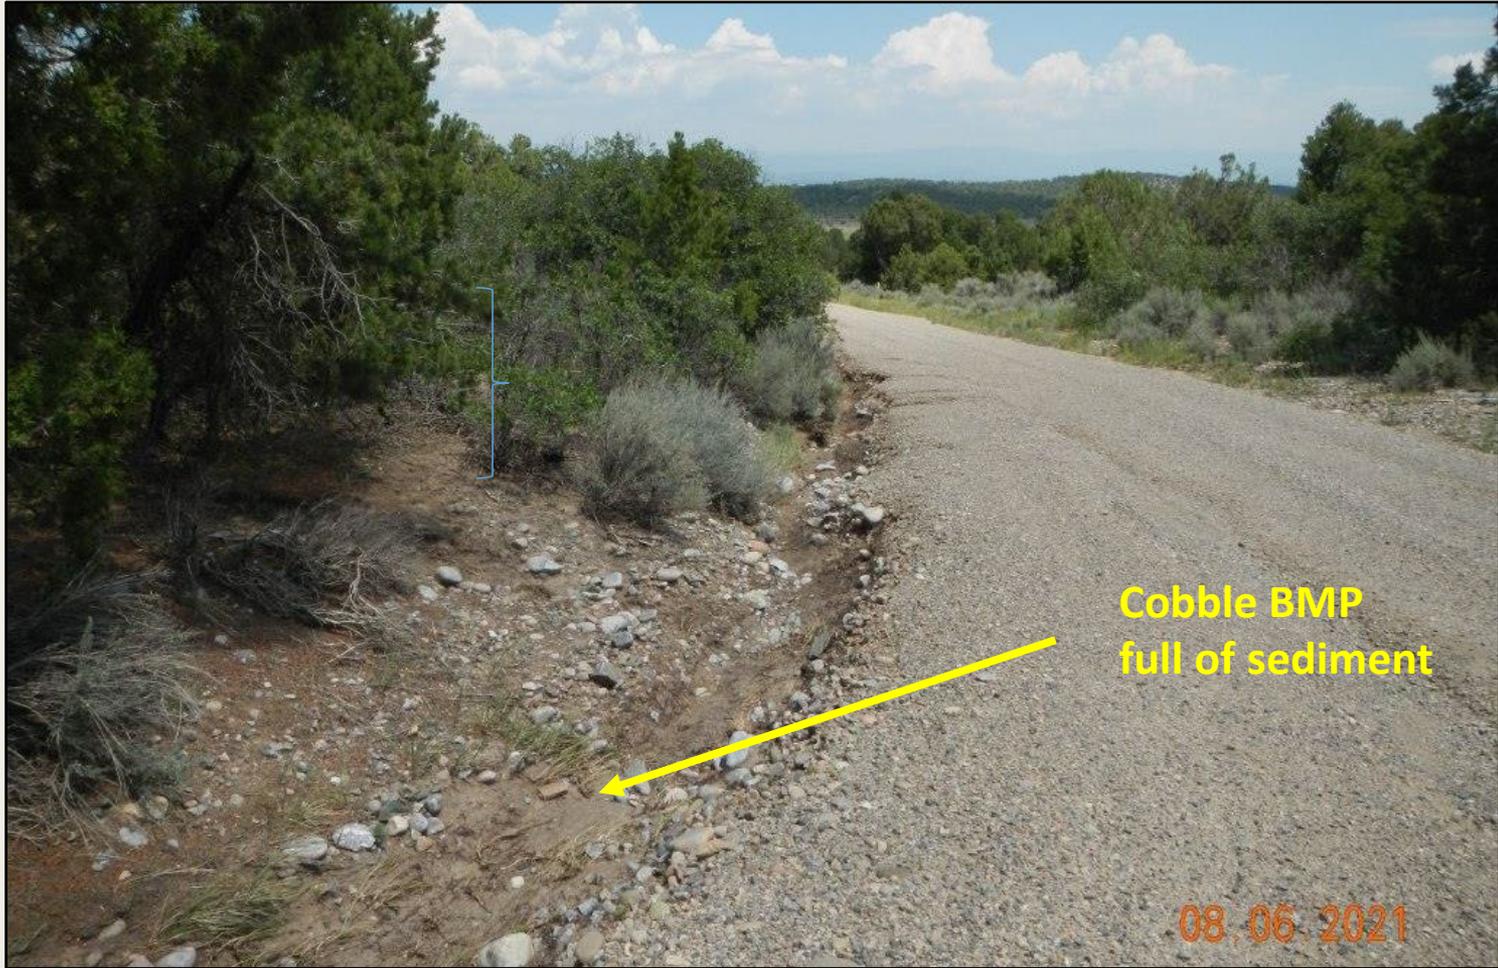
Photo 5. View of area along the access road where cobble BMPs are full of sediment and scouring is occurring. These BMPs are not adequate here.

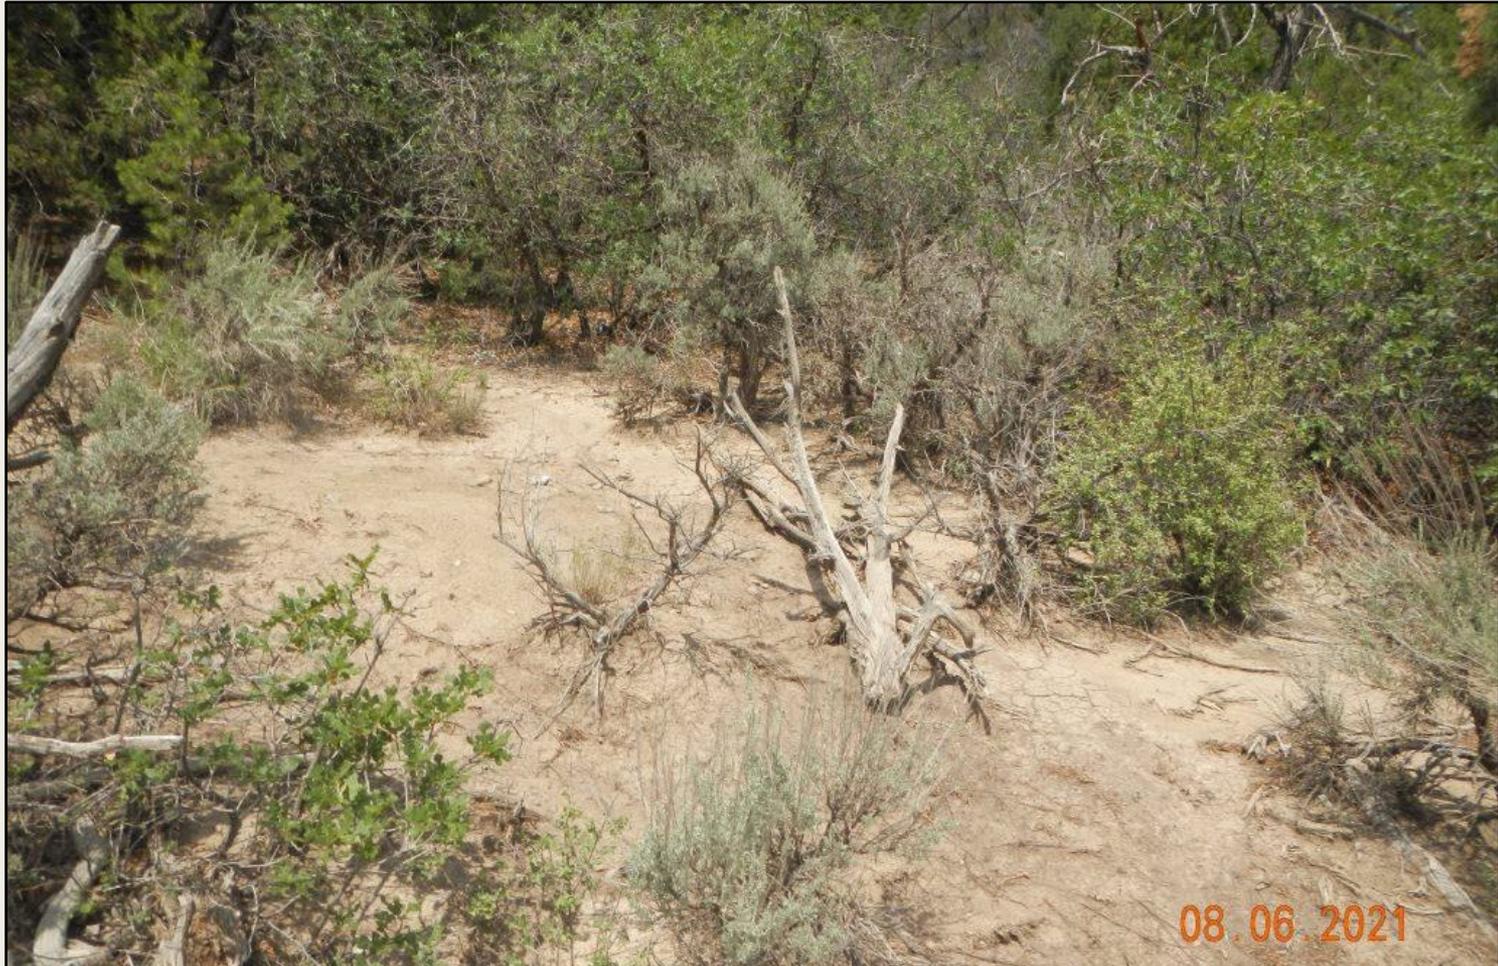
Photo 6. View of the reference area comprised of pinyon and juniper and gambel oak woodland, with understory of sagebrush, mountain mahogany, Indian ricegrass, and antelope bitterbrush.
