Inspection Photos

API: 071-09331

Operator: RED RIVER RANCH HOLDINGS LLC

Inspection Date: 8/11/2021

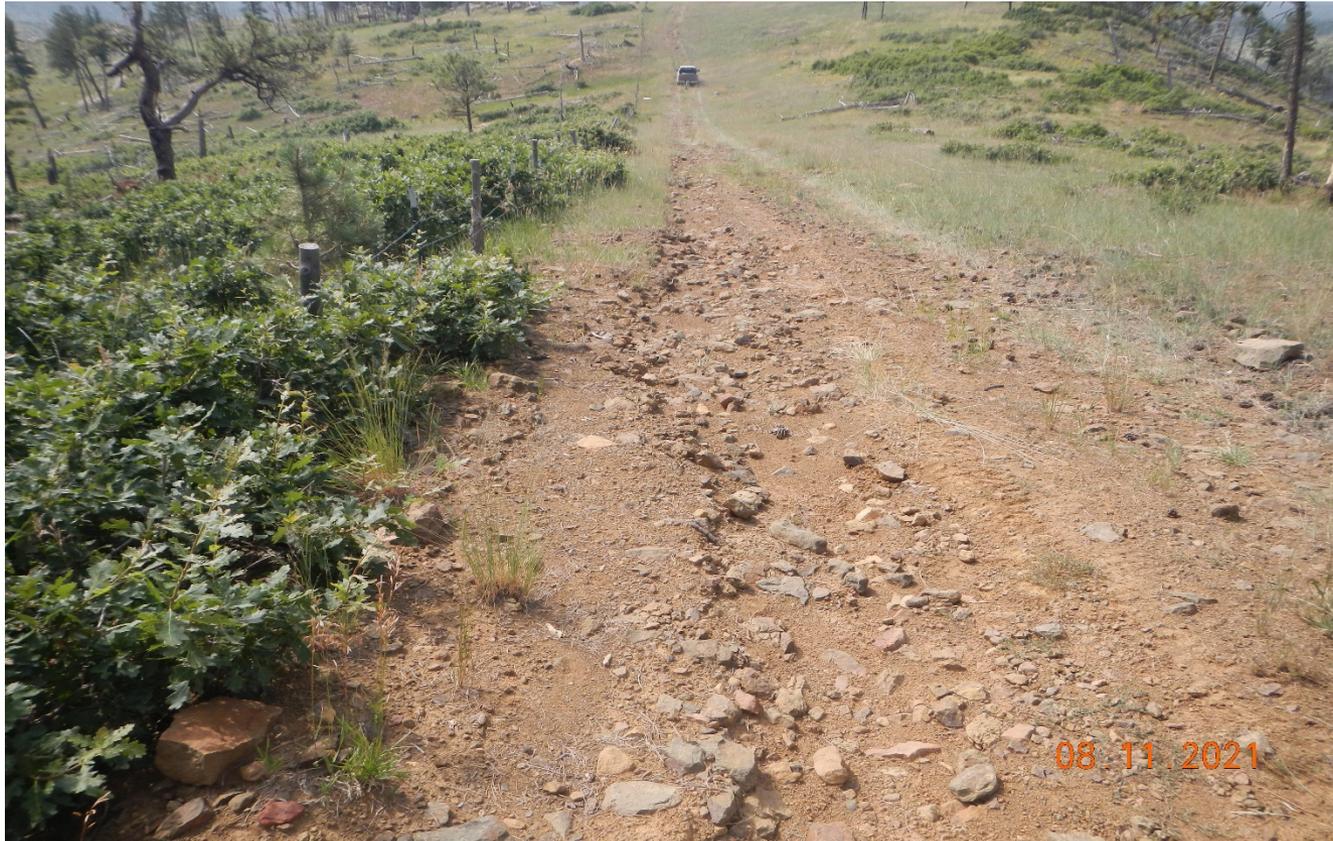
Photo 1. Facing south along the pre-existing access road. There is erosion occurring down the road. Stormwater is not being diverted off the road which will continue to cause erosion. BMP's are needed to control stormwater erosion in this area..

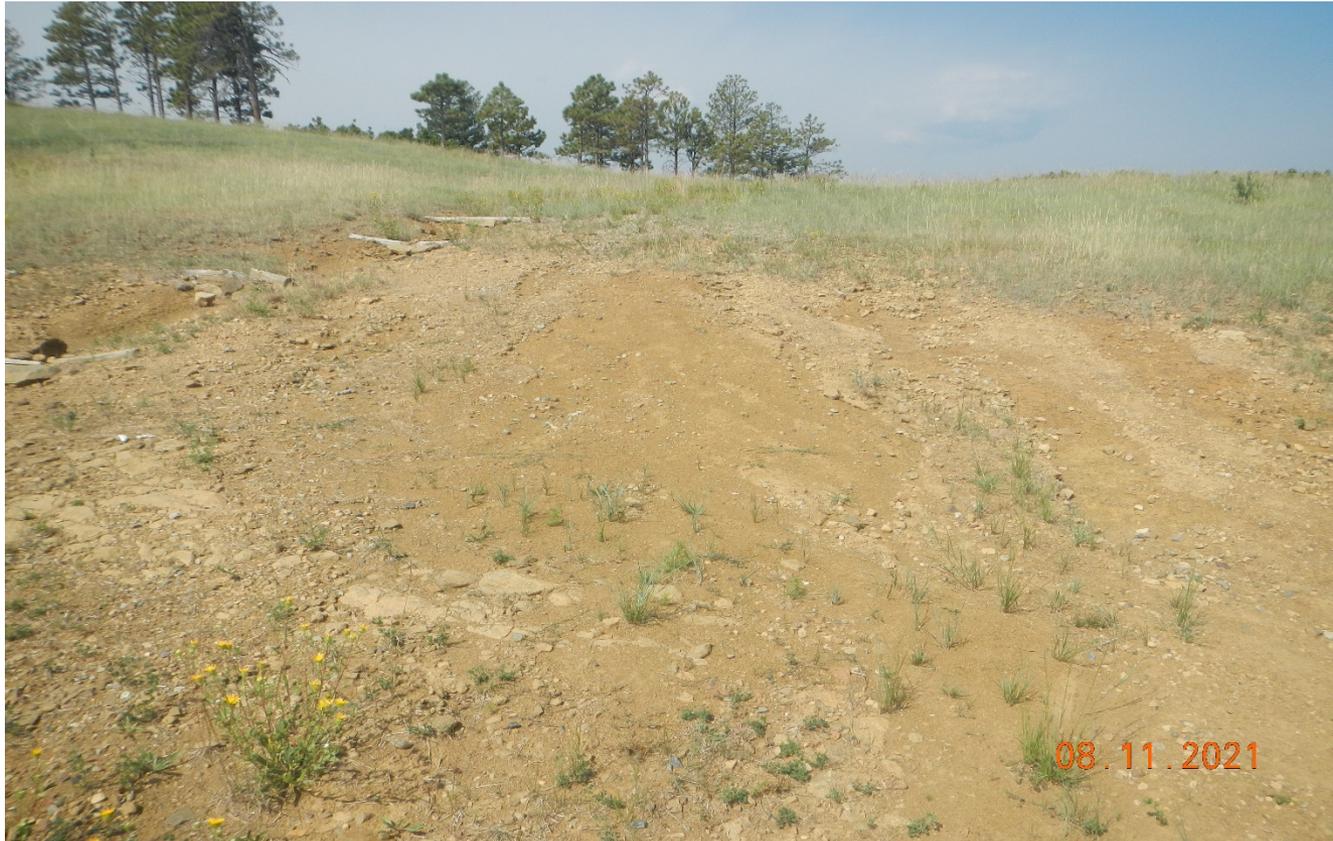
Photo 2. Facing west toward the location. This area is not stabilized and revegetated.

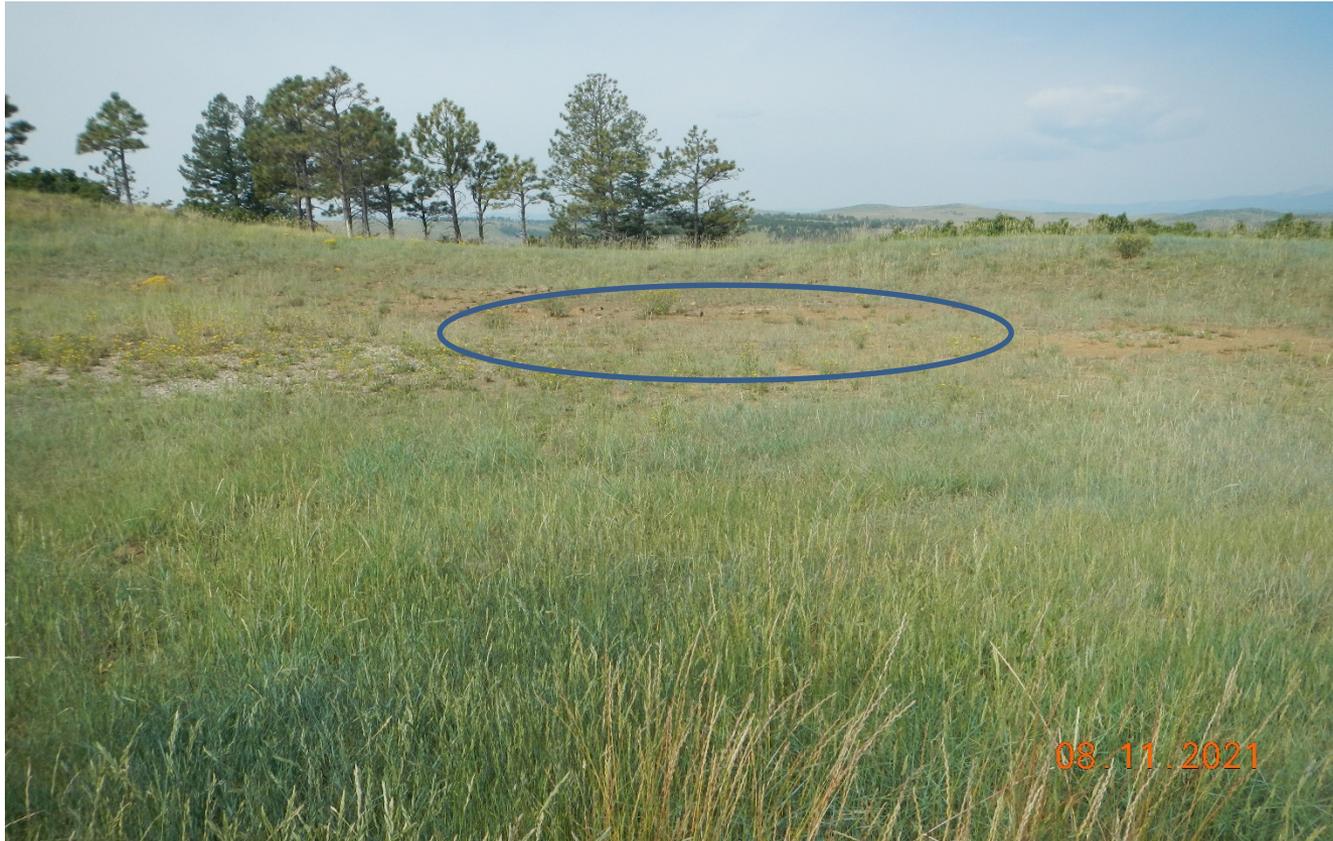
Photo 3. Facing southwest toward the location. There is an area where vegetation has not established at the circled area.
