Caerus Piceance LLC
RA 1
Location # 334747

COLORADO
Oil & Gas Conservation
Commission
Department of Natural Resources

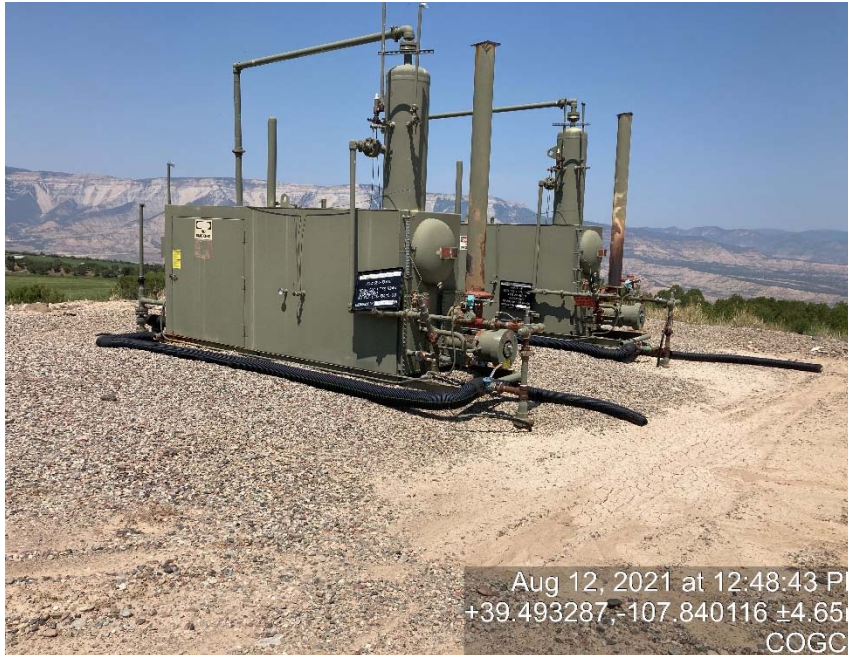
Location/lack of separator bath signage

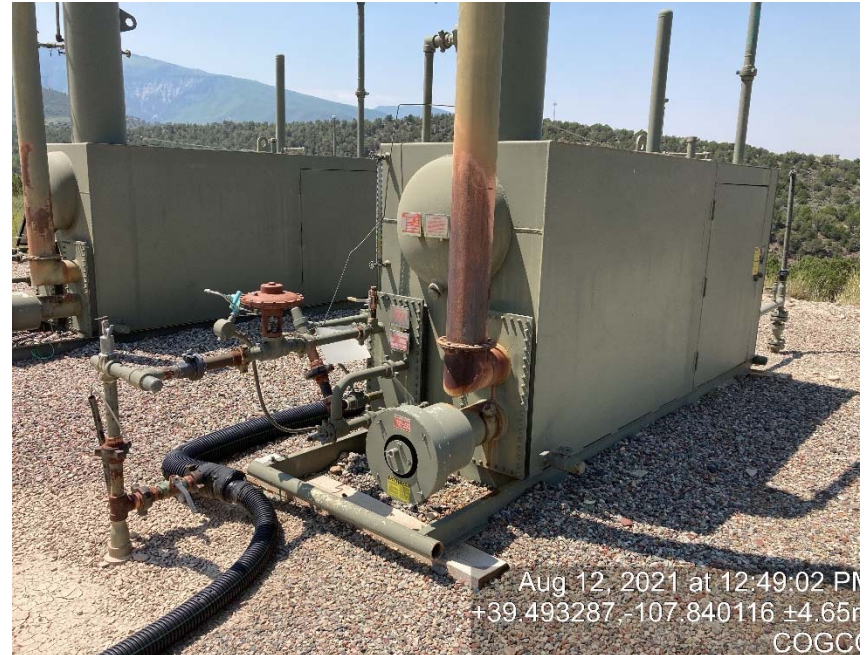
Location/lack of separator bath signage

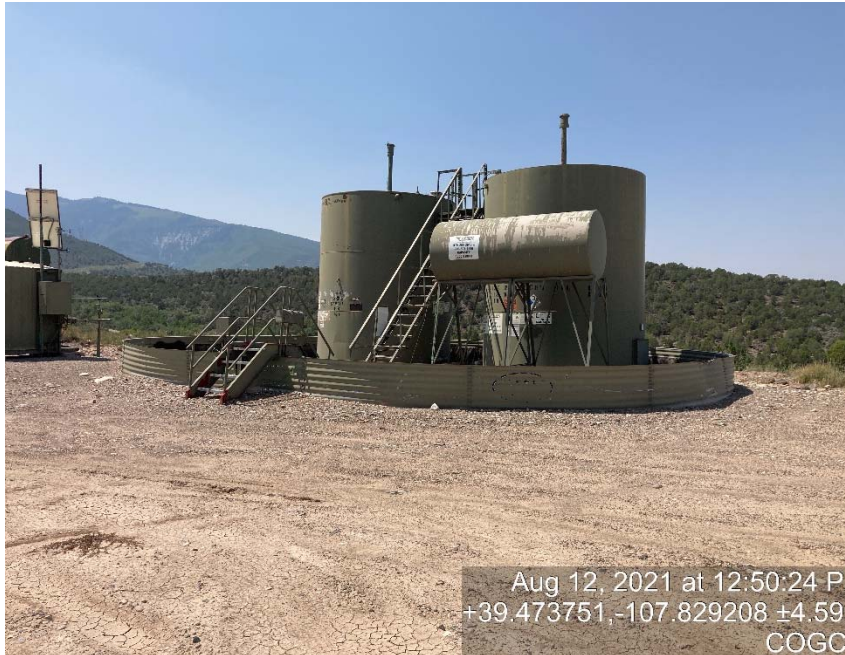
Location/lack of battery signage

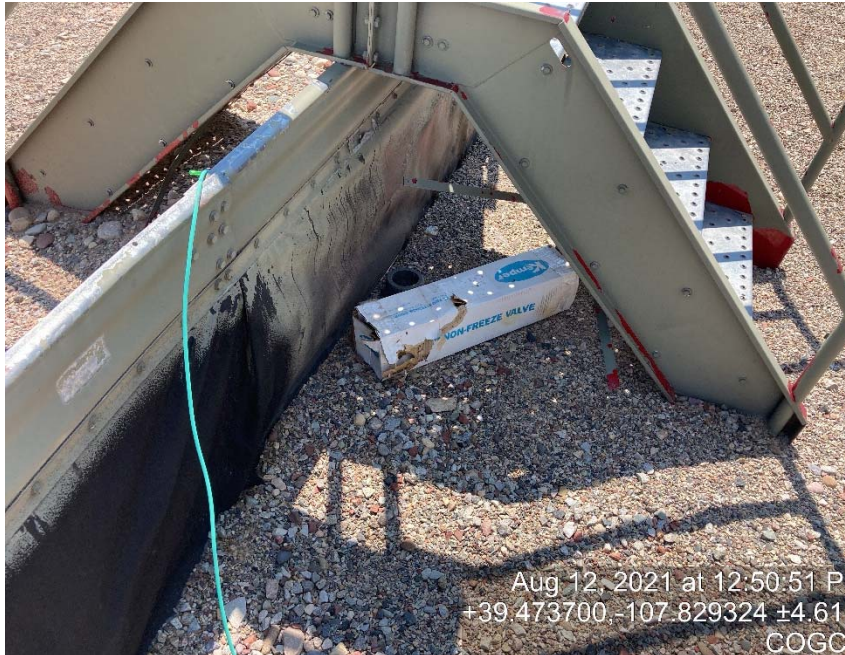
Debris

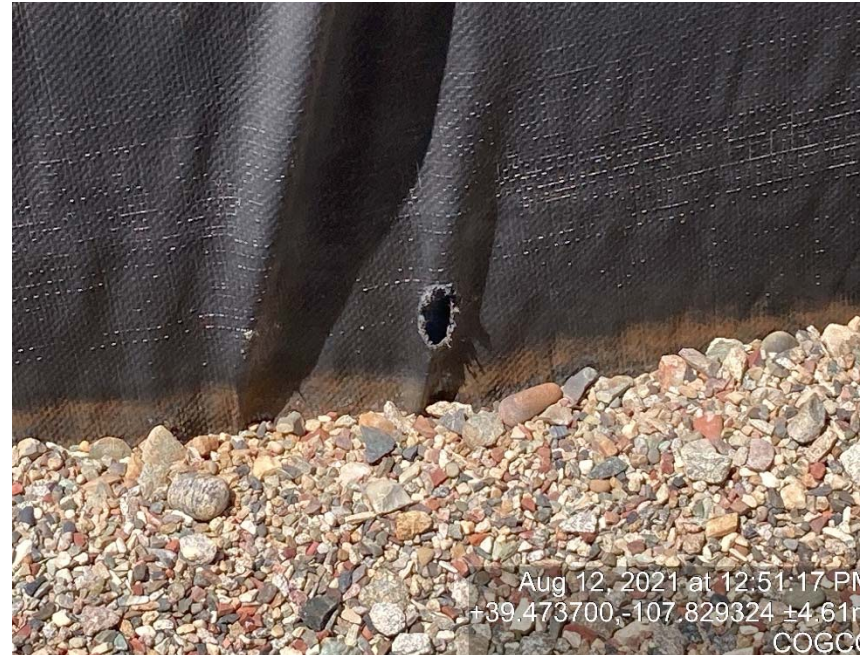
Hole in containment

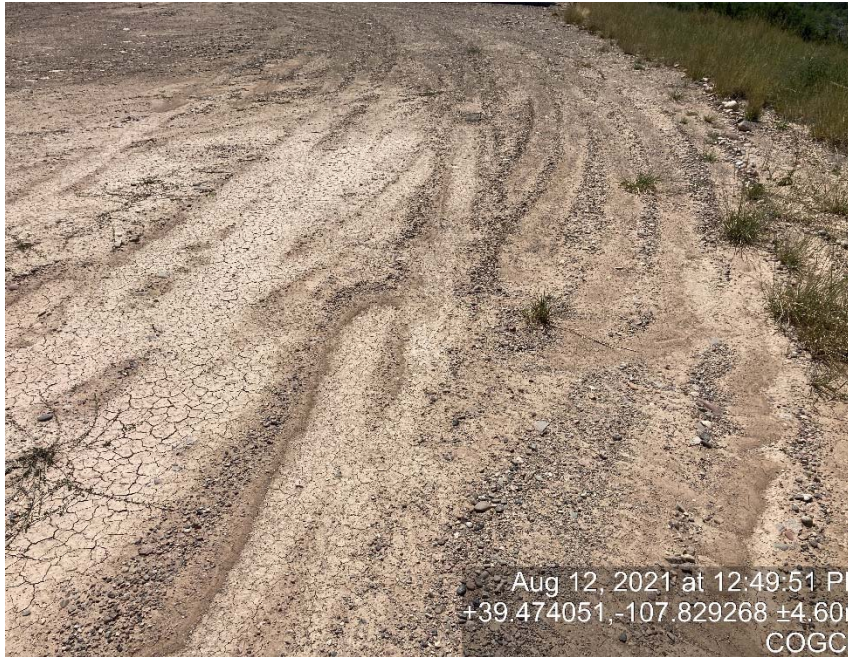
Lack of stabilization/compaction

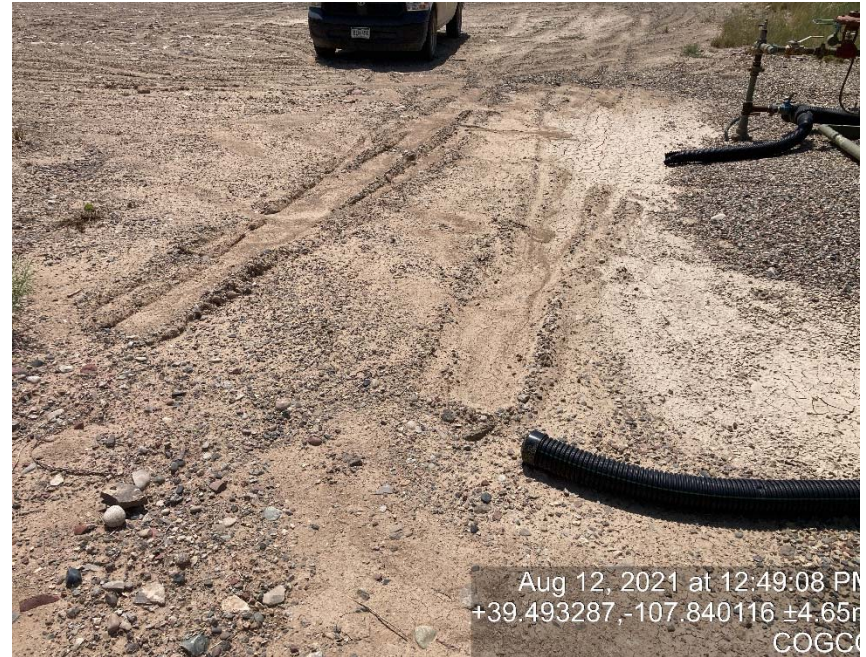
Lack of stabilization/compaction

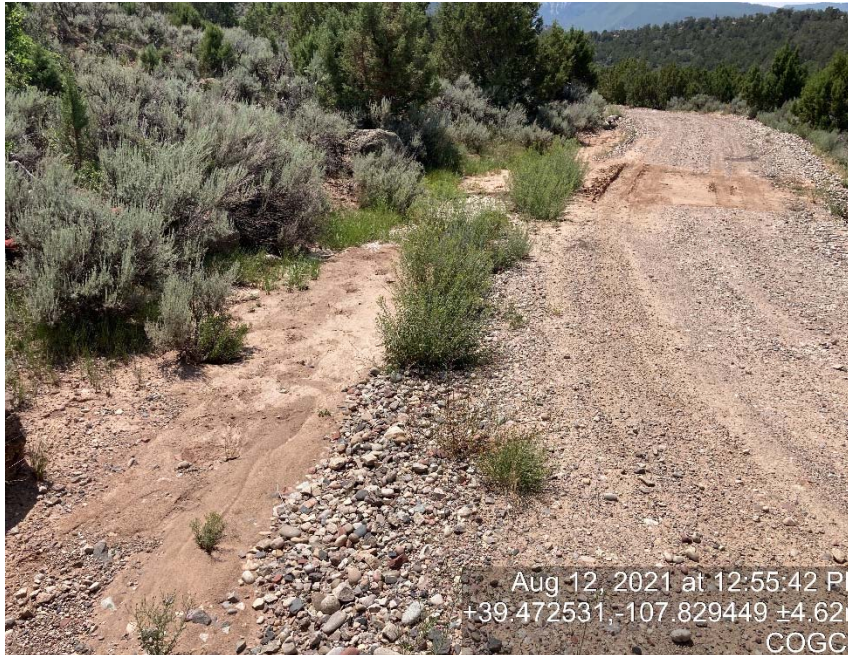
**Lack of stabilization/compaction/sediment
migration/failing ditch**

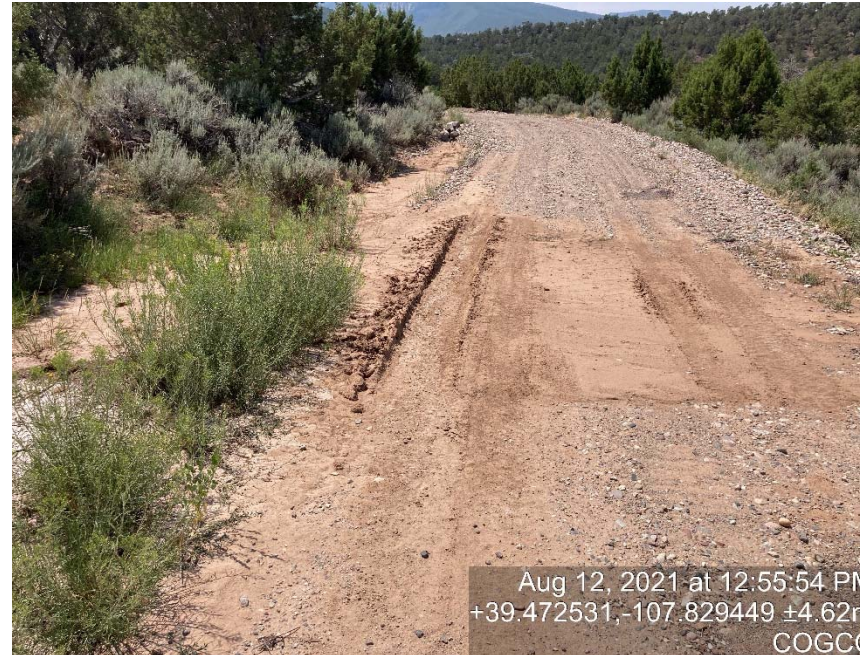
**Lack of stabilization/compaction/sediment
migration**

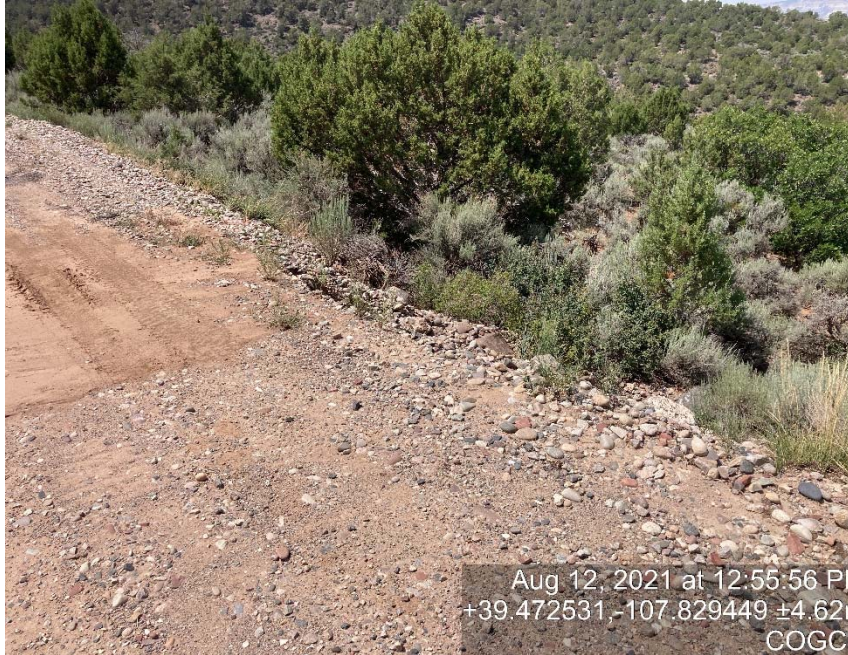
Lack of stabilization/compaction/sediment migration

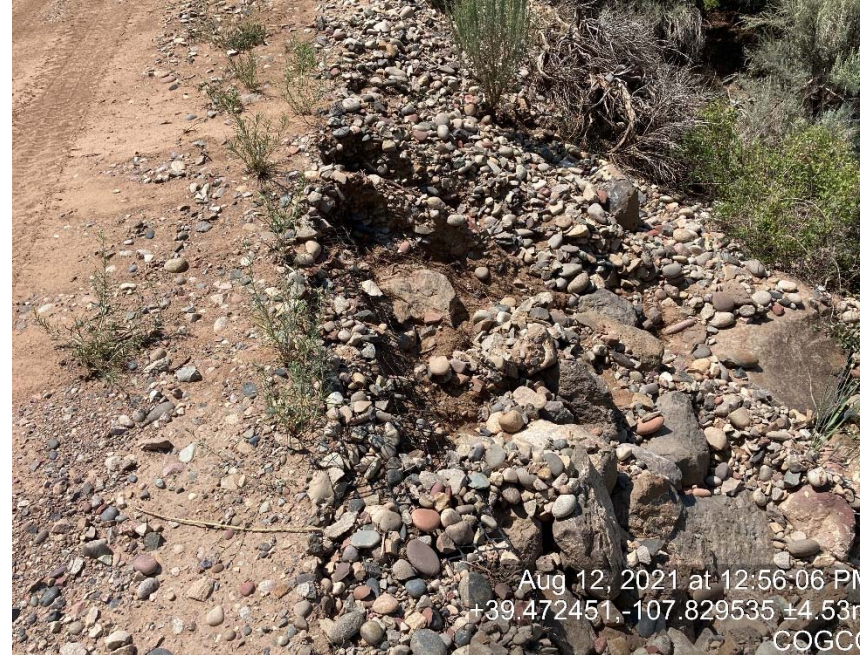
Lack of stabilization/compaction/sediment migration

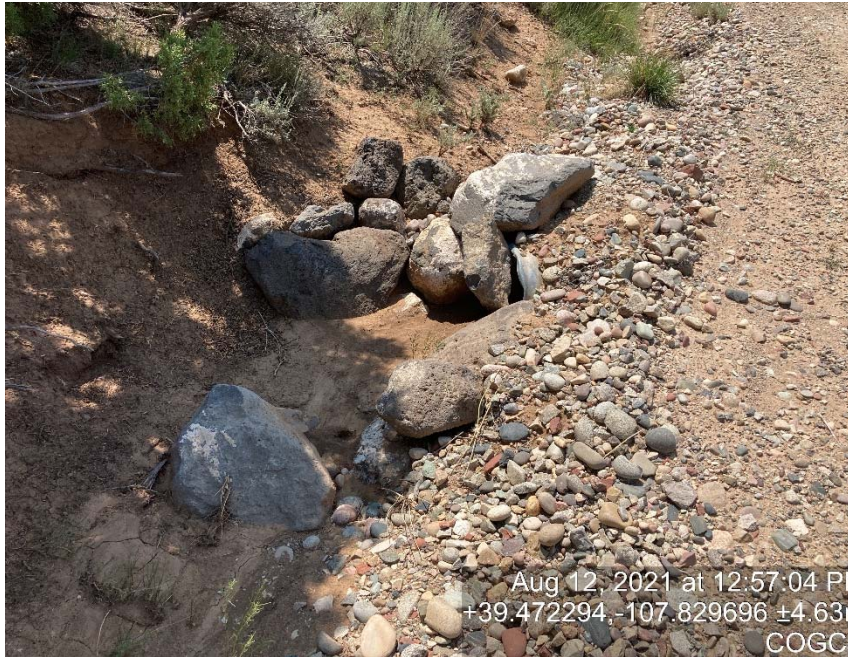
Failing culvert

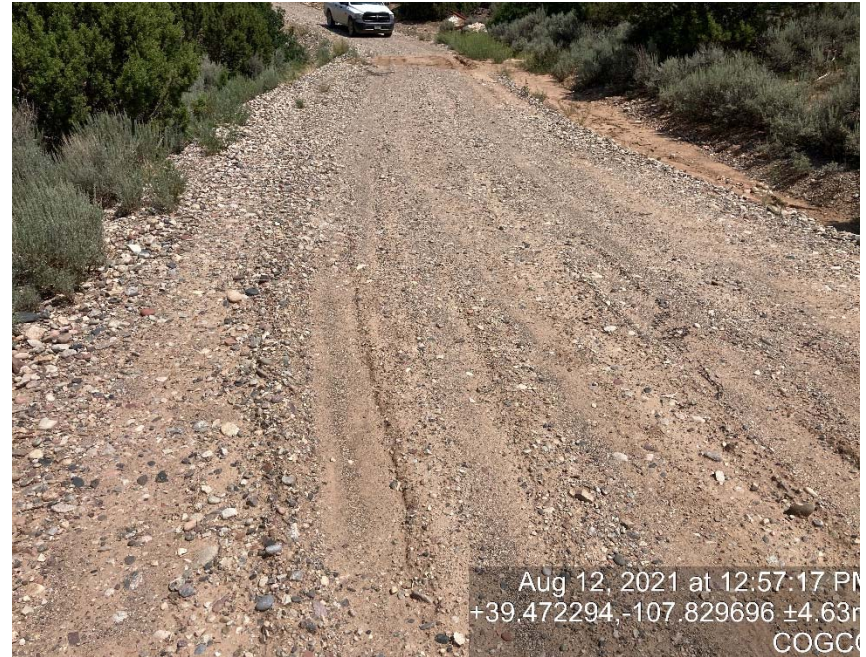
Lack of stabilization/compaction

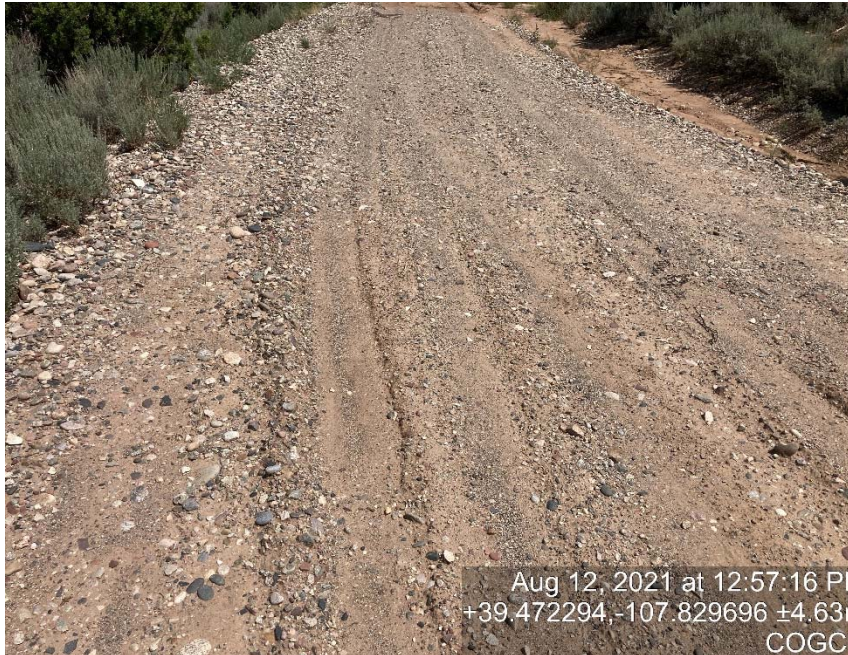
Lack of stabilization/compaction

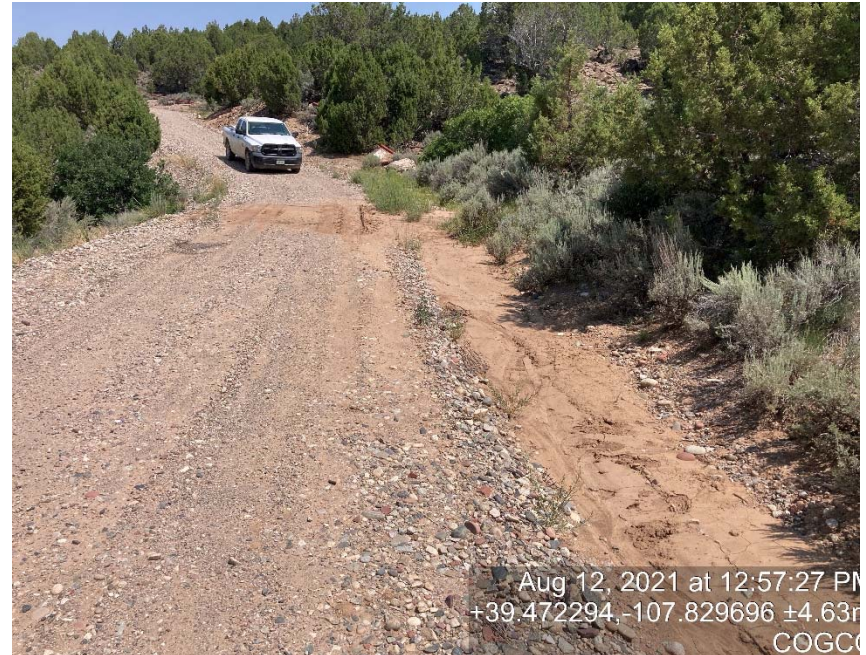
Lack of stabilization/compaction/failing ditch
