# Final Reclamation Inspection

August 13, 2021

Operator: FOUNDATION ENERGY MANAGEMENT LLC- #10112

Inspection Photos  
Location Name: D.O.C. SHOWERS #32-12-10  
Location ID: 330667

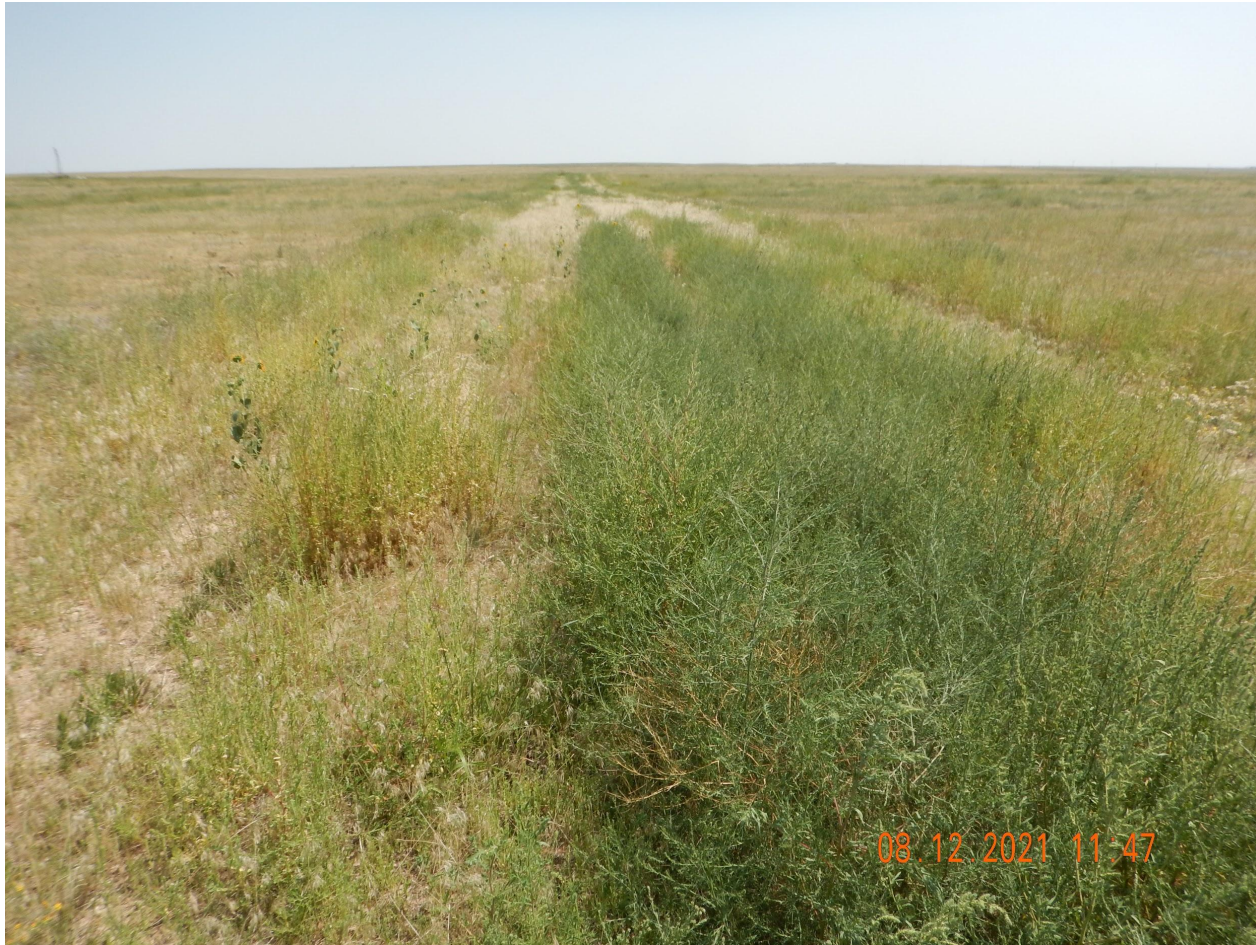
**Photo 1.** Photo taken from the entrance of the well location access road, facing East. Photo illustrates Operator has performed final reclamation activities; however, the access road consists mostly of annual vegetation, not reflective of reference perennial vegetation.

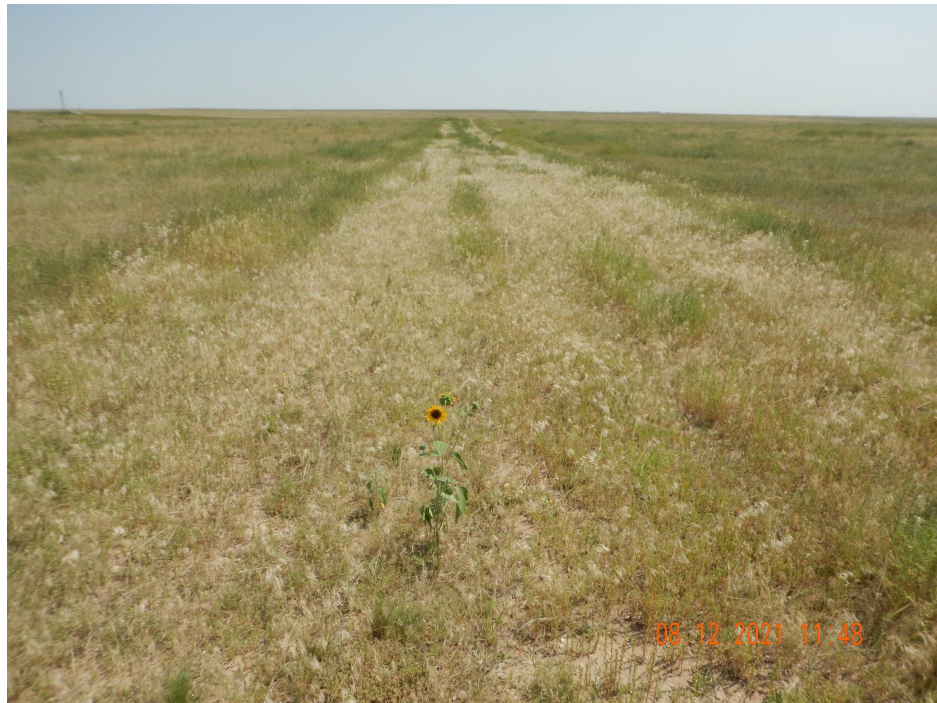
**Photo 2.** Photo taken from a portion of the well location access road, facing East. This photo illustrates this portion of the access road and most of the access road consists of cheatgrass.

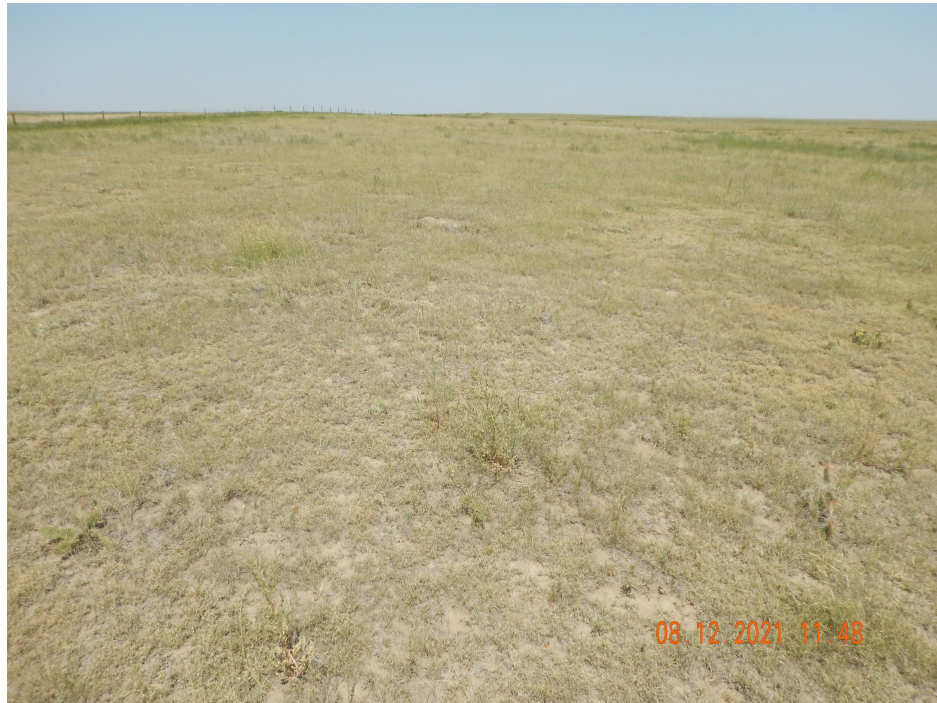
**Photo 3.** Reference photo taken from the well location access road, facing North. Photo illustrates the reference area vegetation of blue grama and buffalo grass.

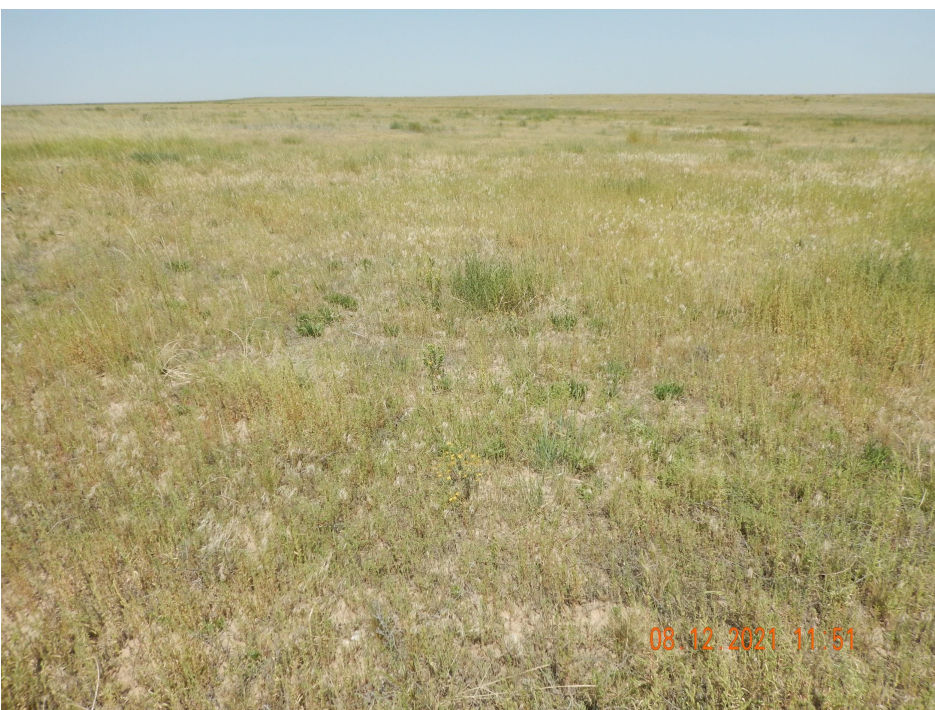
**Photo 4.** Photo taken from the well location, facing North. It is difficult to illustrate with the photo but there was some establishment of desirable perennial plant species- prairie sandreed, blue gramma, sand dropseed and purple three-awn.

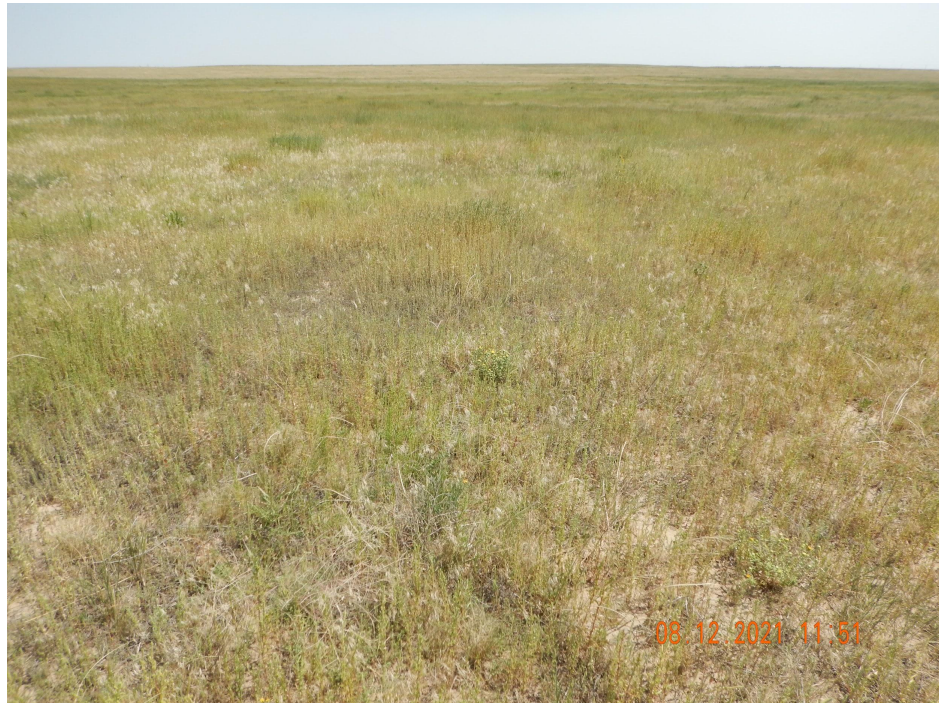
**Photo 5.** Photo taken from the well location, facing East. See comments under Photo 4.

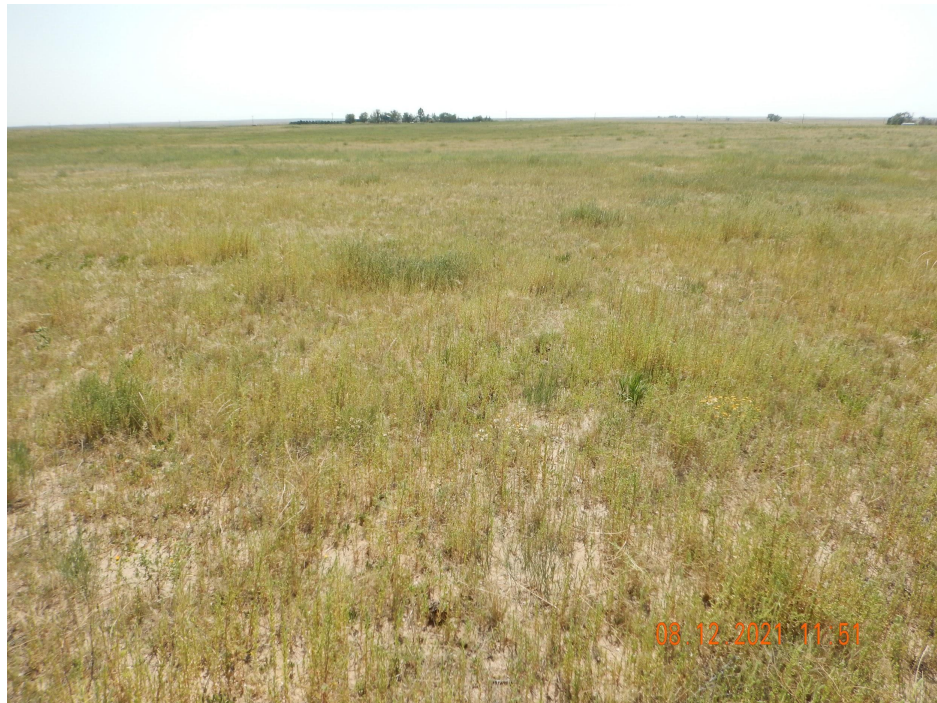
**Photo 6.** Photo taken from the well location, facing South. See comments under Photo 4.

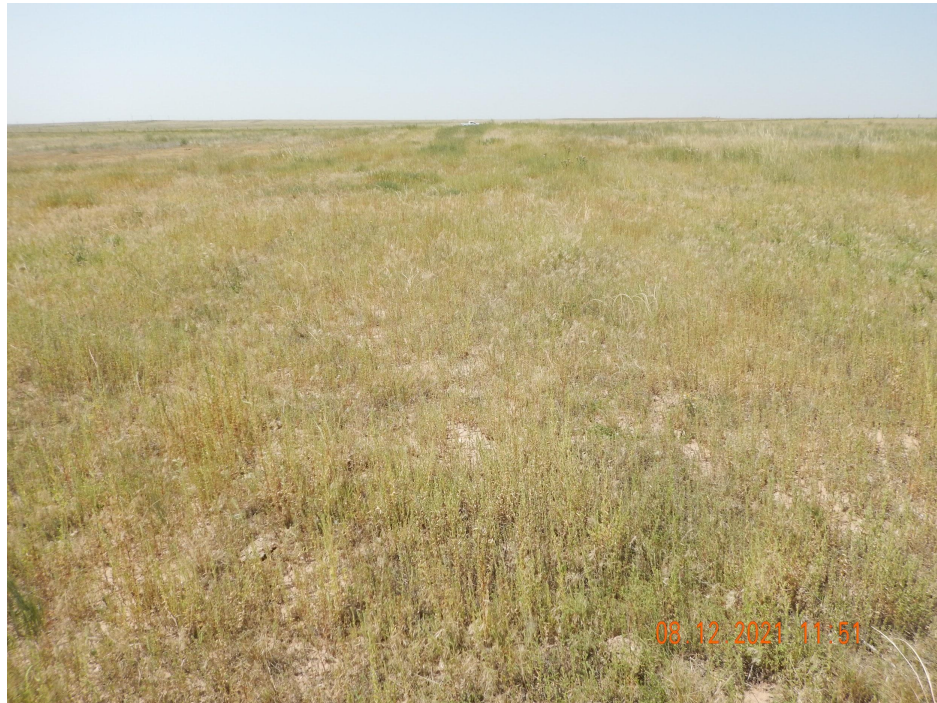
**Photo 7.** Photo taken from the well location, facing West. See comments under Photo 4.

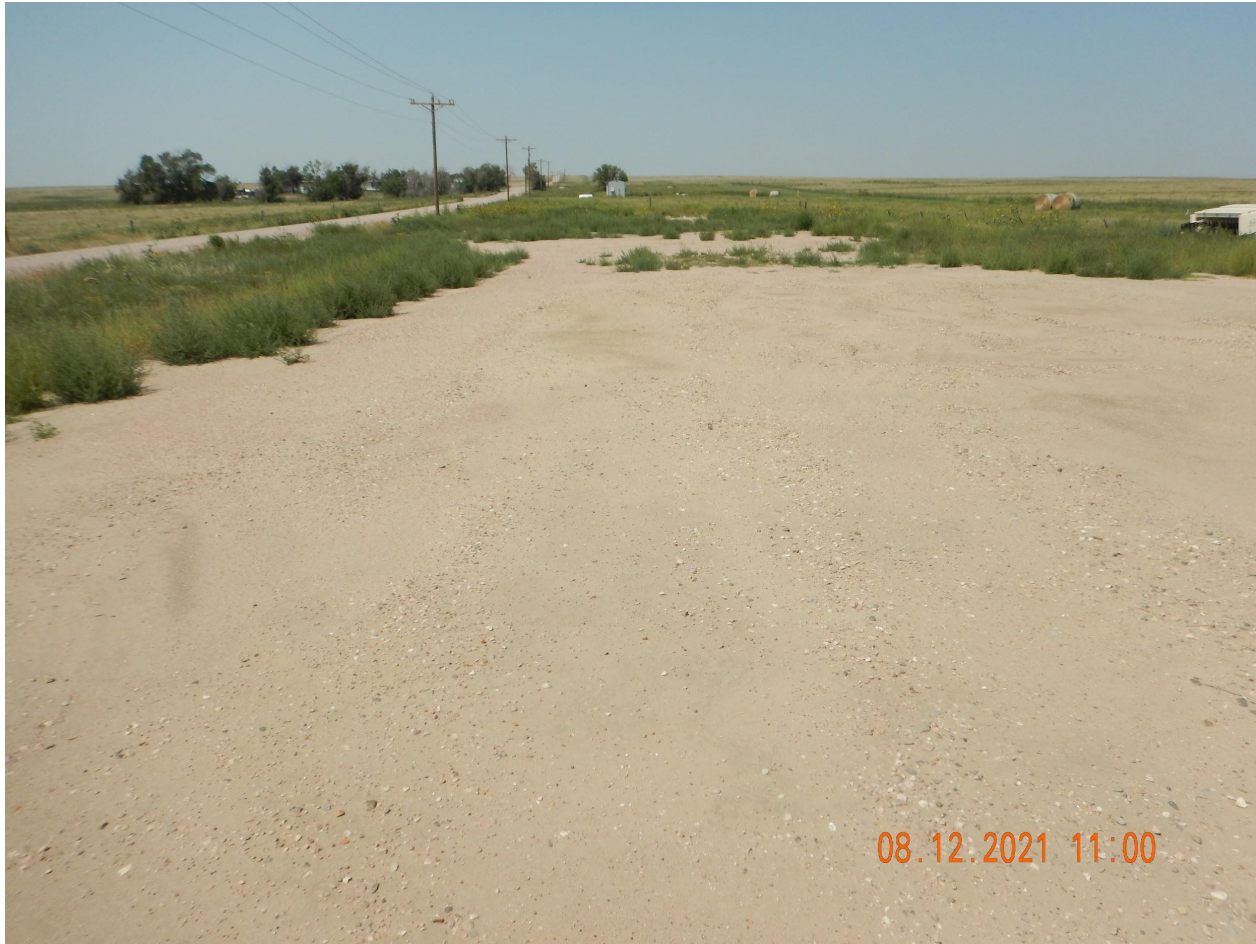
**Photo 8.** Photo taken from the associated offsite tank battery, facing West. The tank battery is being addressed under a separate inspection.
