Inspection Photos

Operator: Hilcorp Energy
API: 067-07248
Date: 8/10/2021

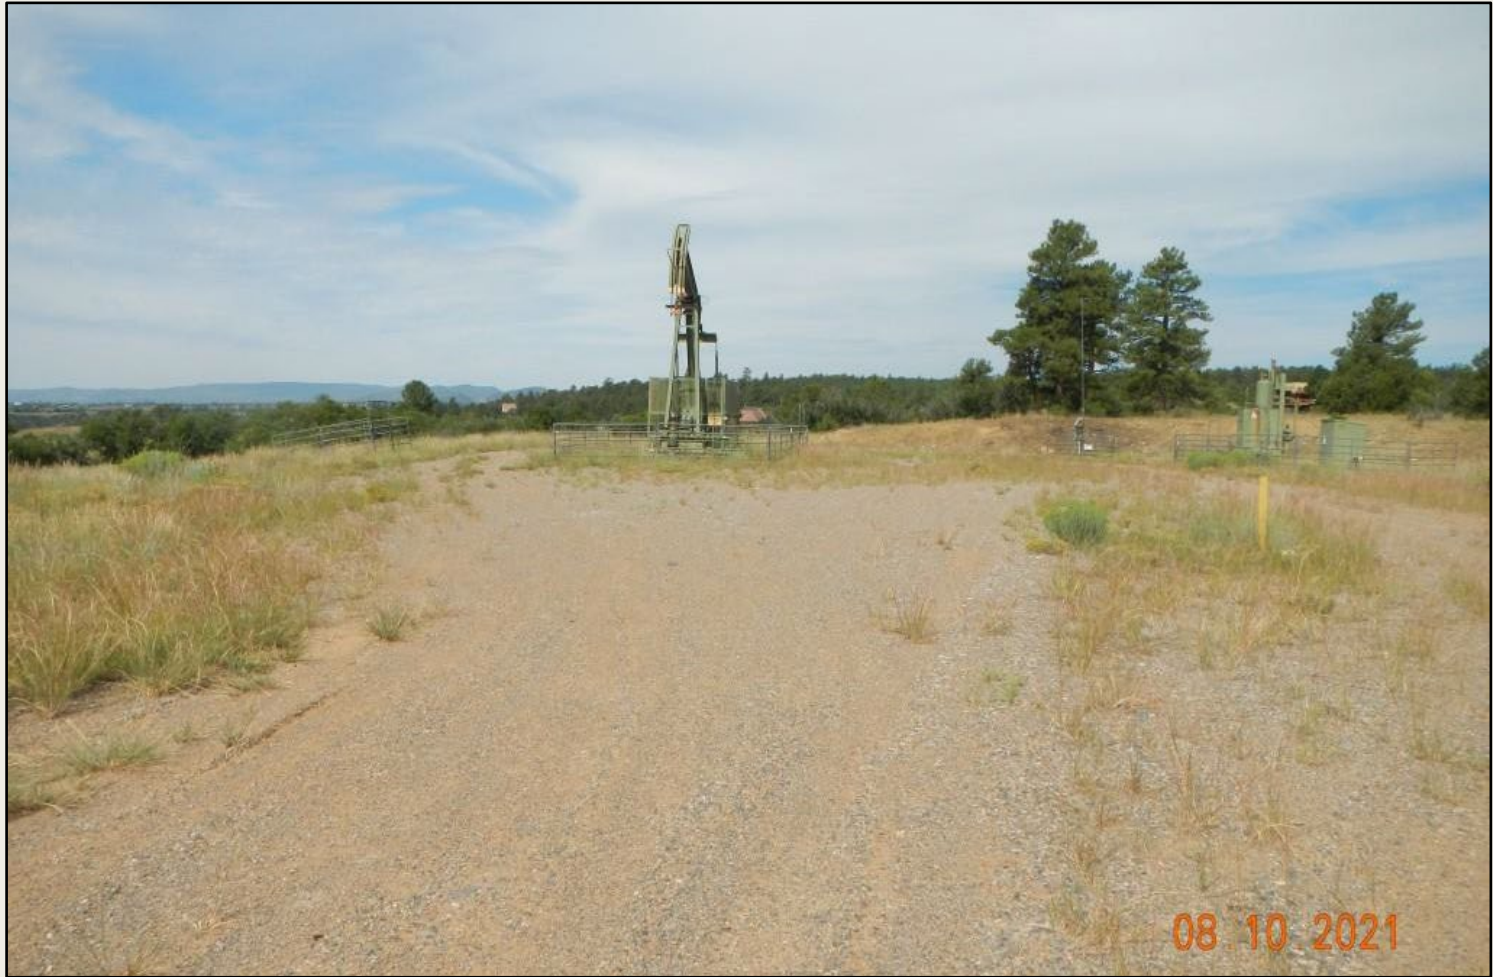
Photo 1. View of the project area from the well pad entrance facing center.

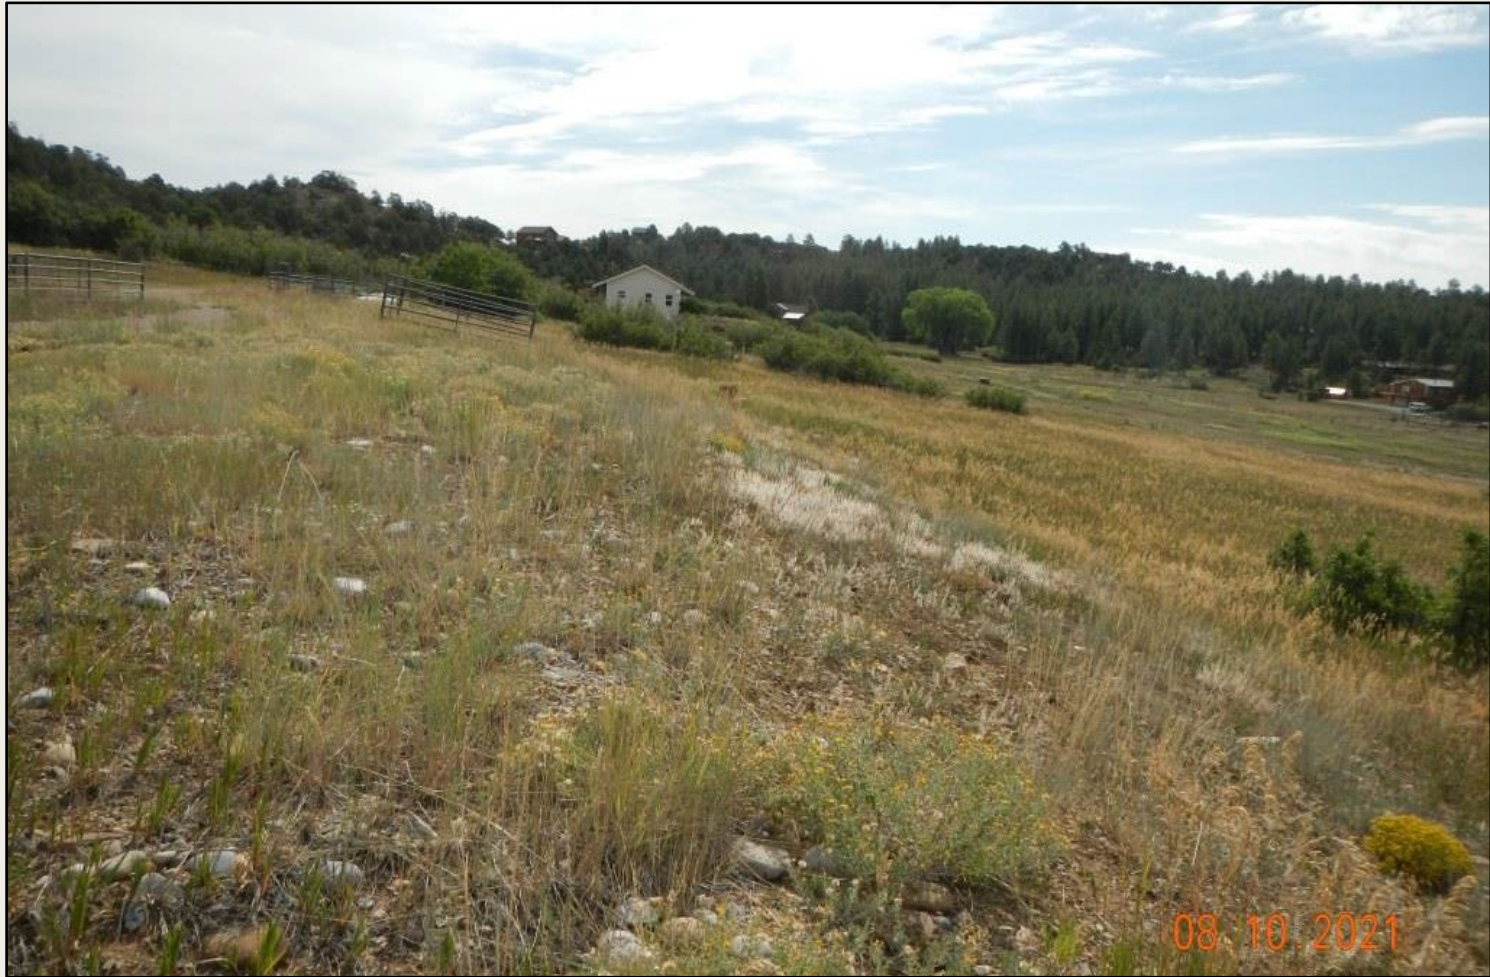
Photo 2. View of the southern fill slope from the southwestern corner facing eastward. Revegetation is progressing with western wheatgrass, sand dropseed, hairy goldenaster, and smooth brome.

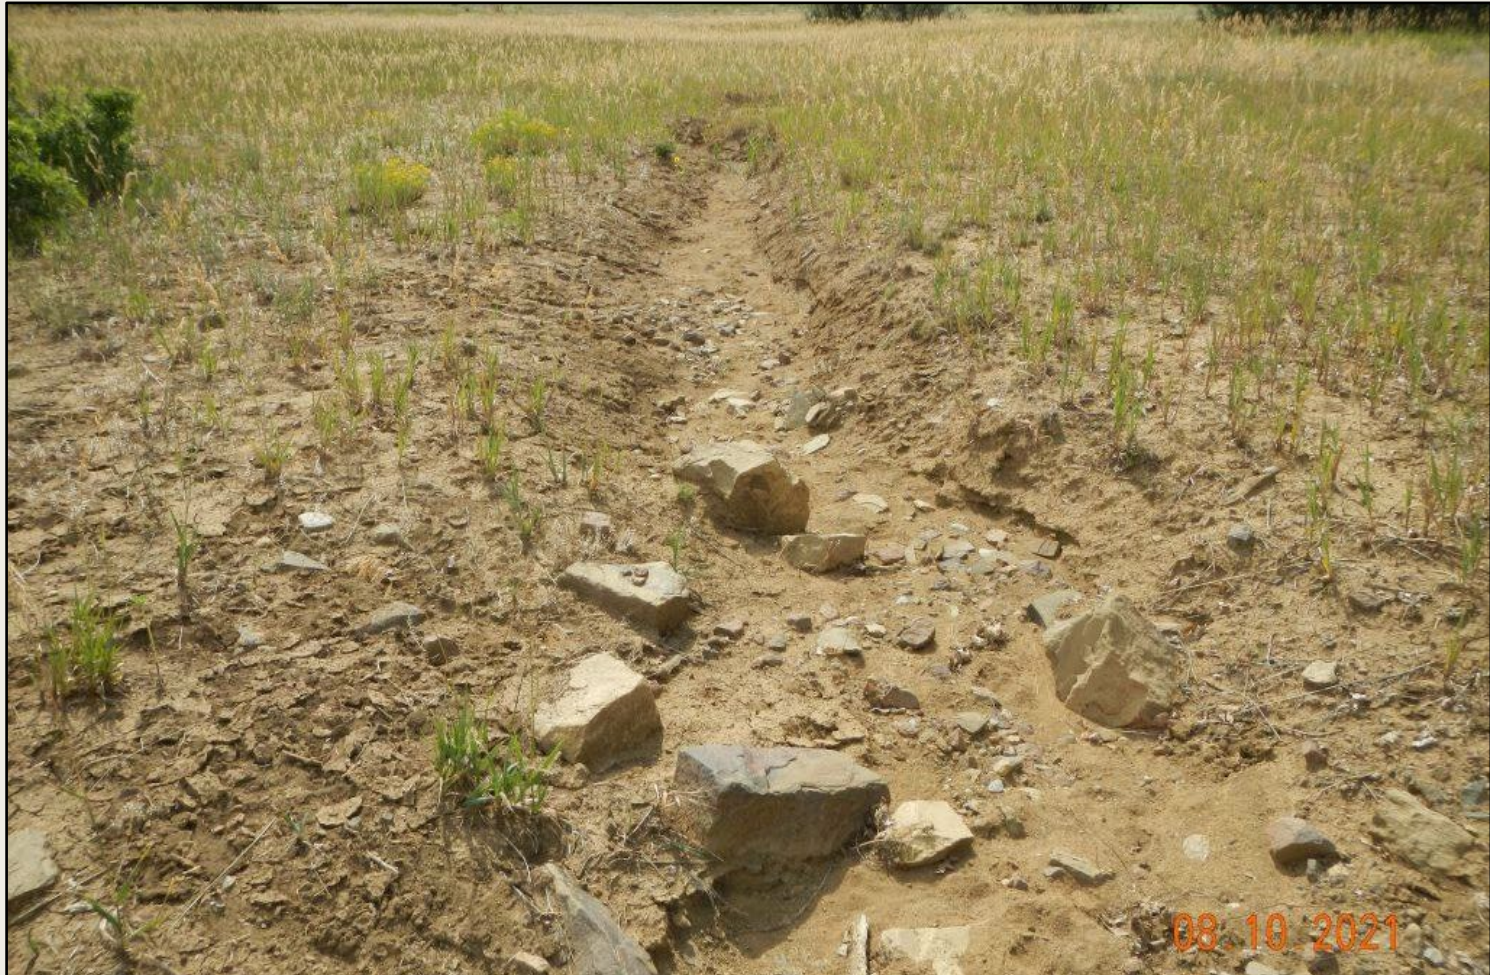
Photo 3. View of southwestern diversion channel, where erosional down-cutting is occurring. Stabilization measures are needed here.

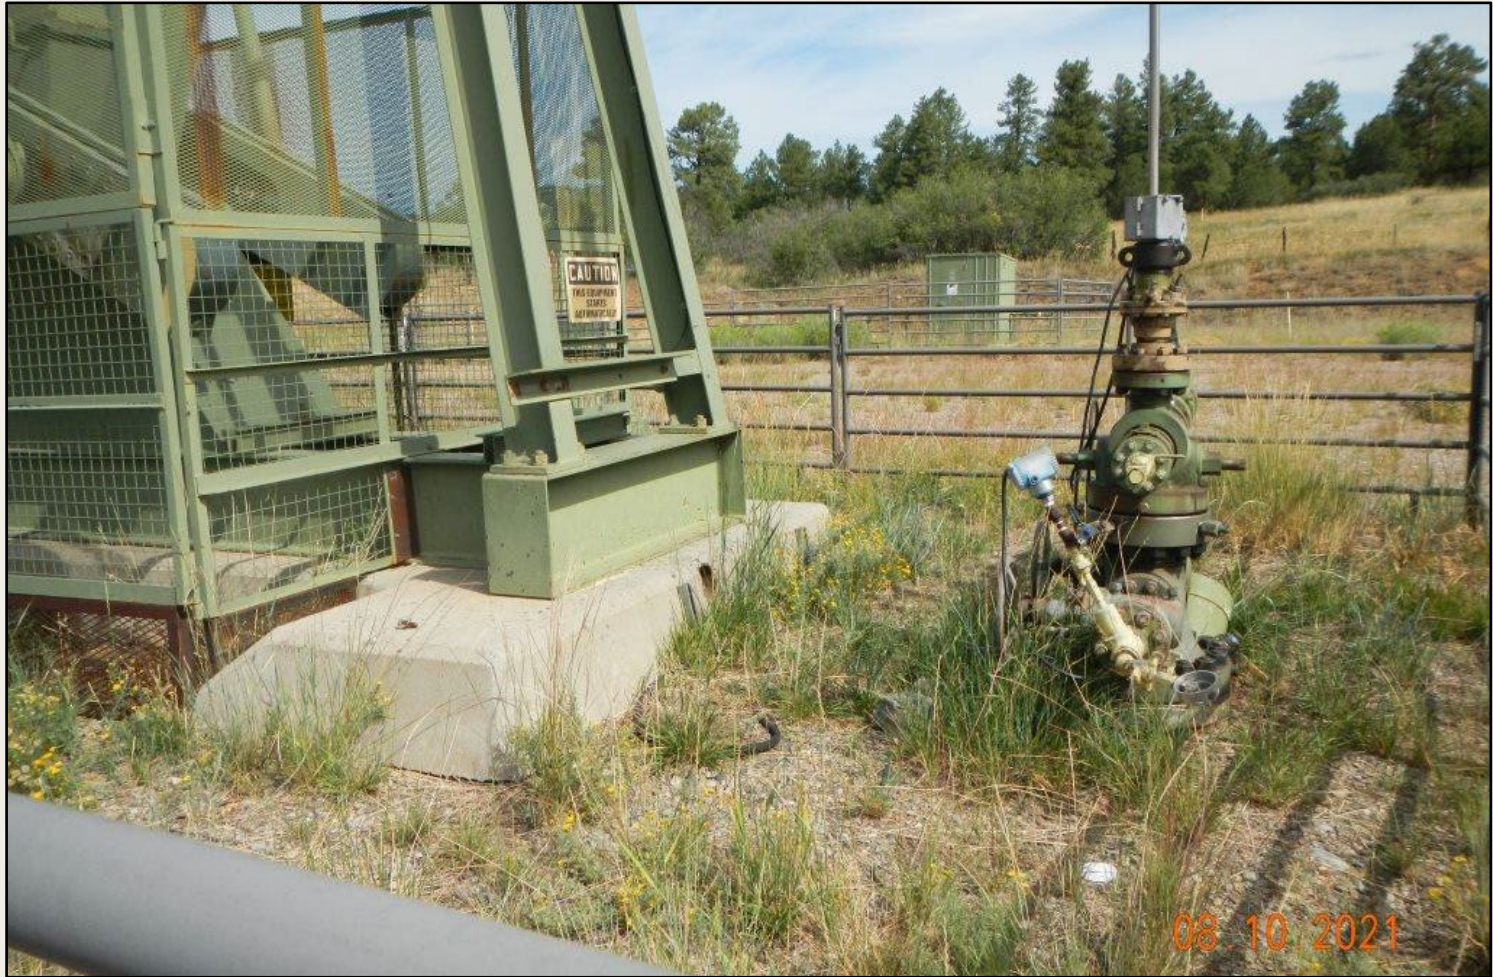
Photo 4. View of vegetation observed around the wellhead needs to be managed (ie: mowed).

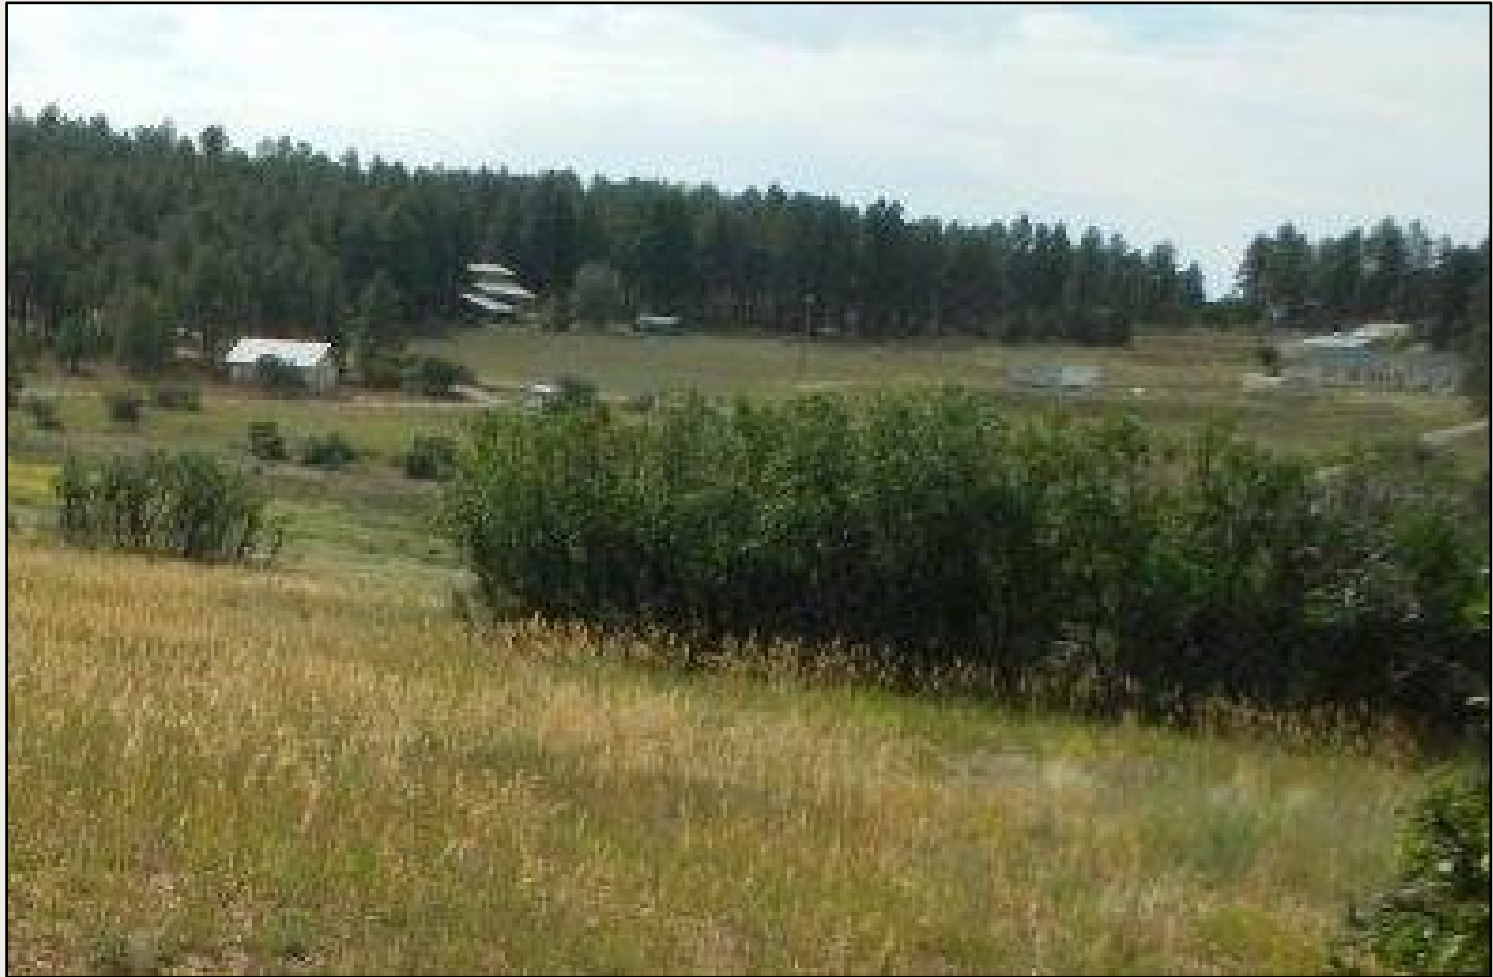
Photo 5. View of the reference area comprised of open grass field and gambel oak woodland with smooth brome, western whatgrass, and hairy goldenaster.
