Inspection Photos

API: 071-08083

Operator: EVERGREEN NATURAL RESOURCES

Inspection Date: 8/16/2021

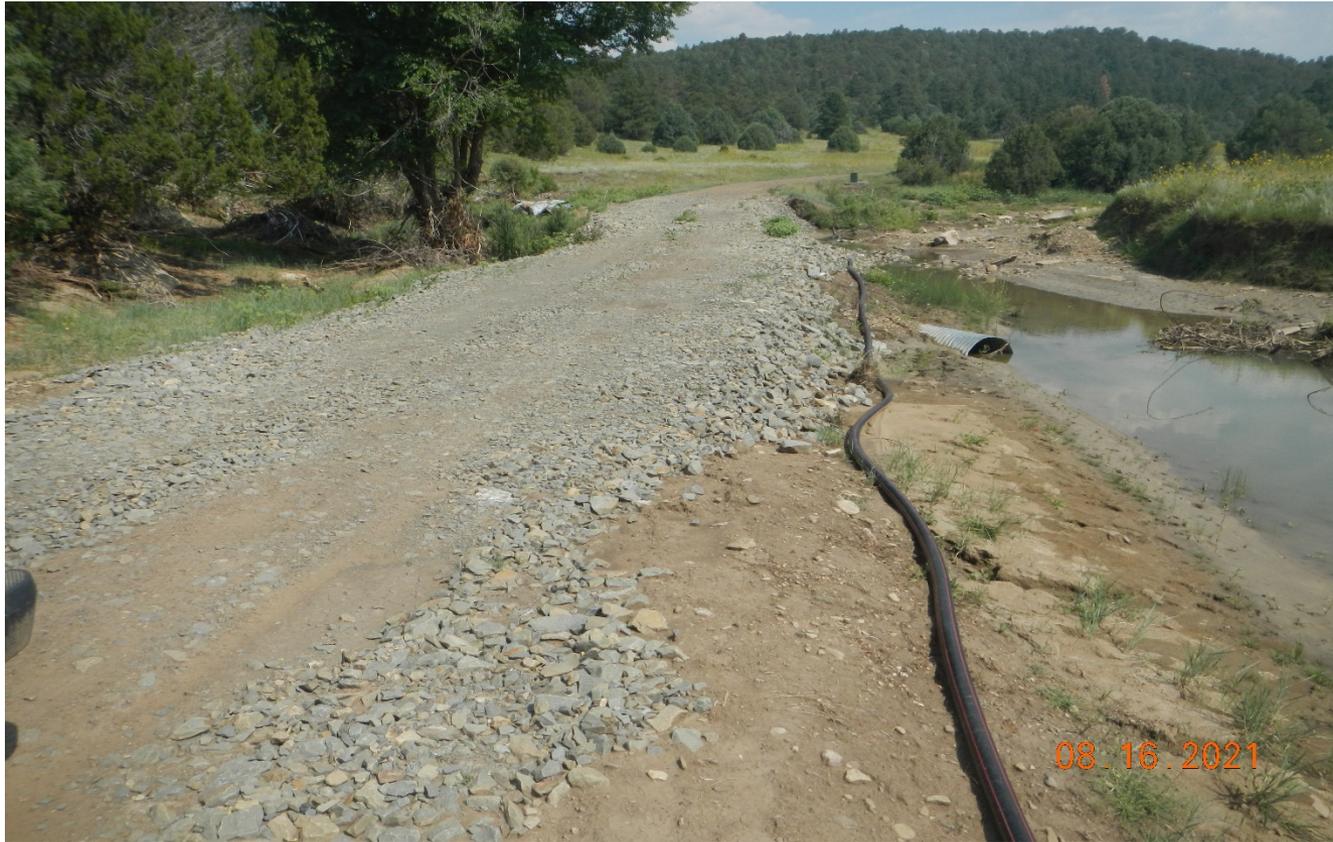
Photo 1. Facing southeast along the main access road. This area of the road has been reconstructed.

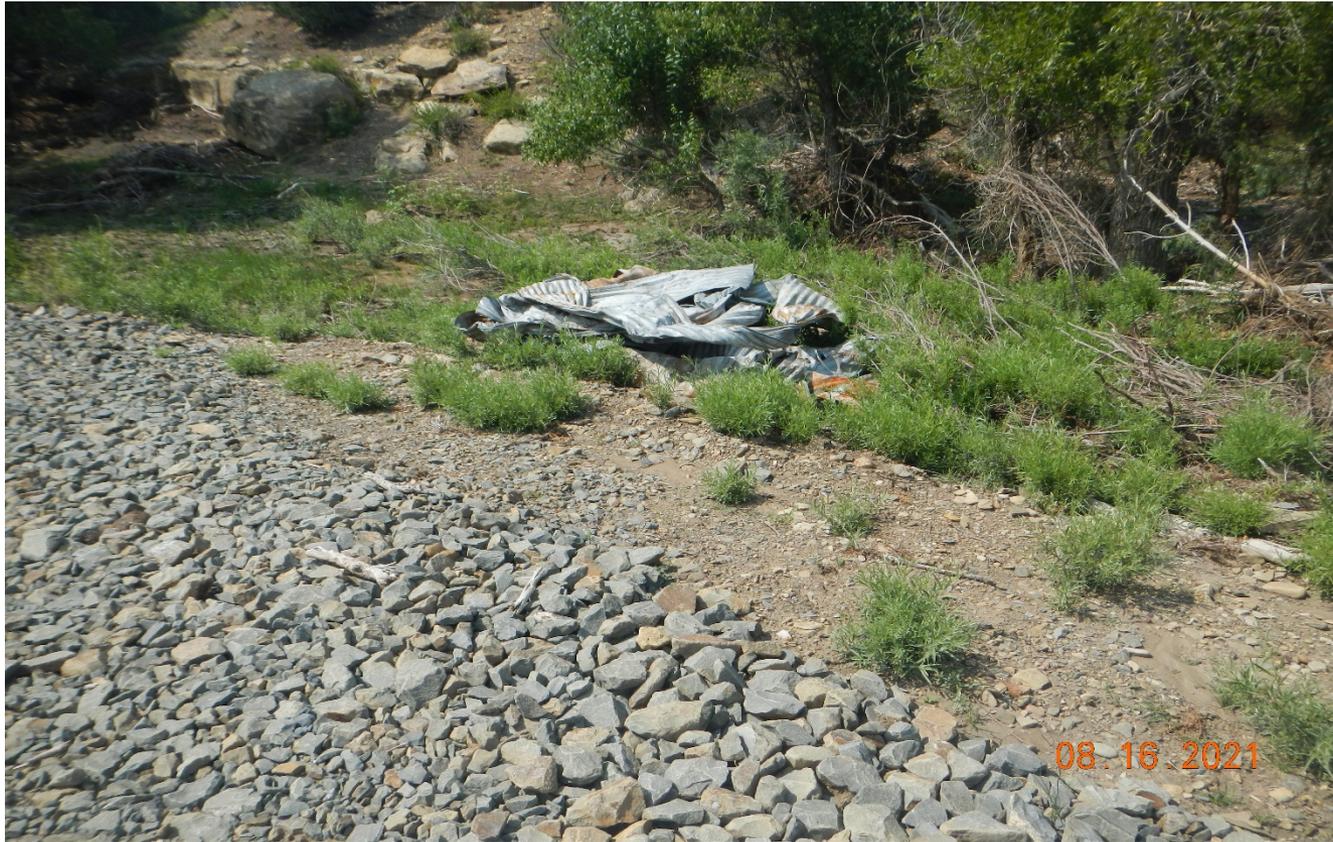
Photo 2. The damaged culverts need to be removed.

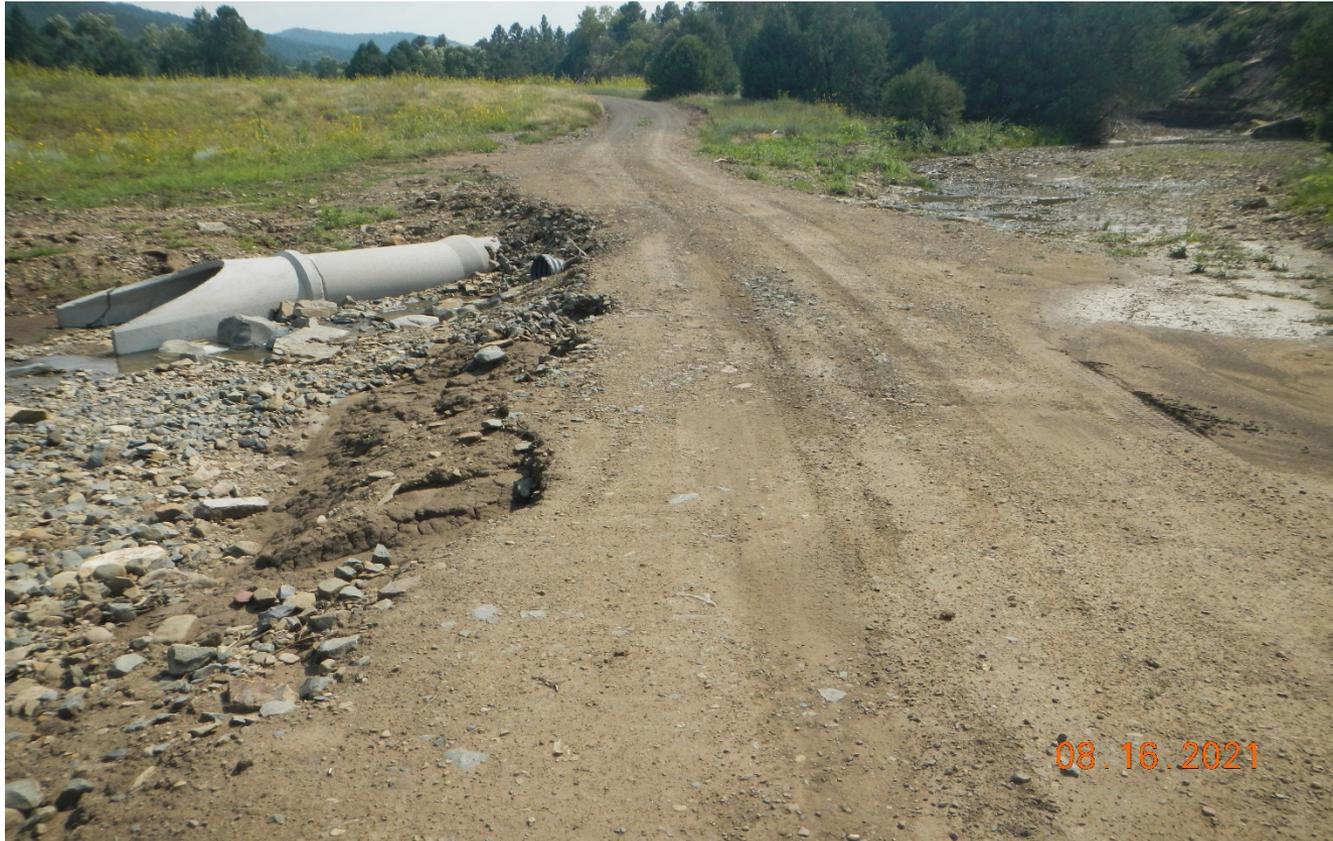
Photo 3. Facing southwest along the main road. There is a culvert installed for temporary passage. An engineered size culvert will be needed along with bank and inlet/outlet protection.

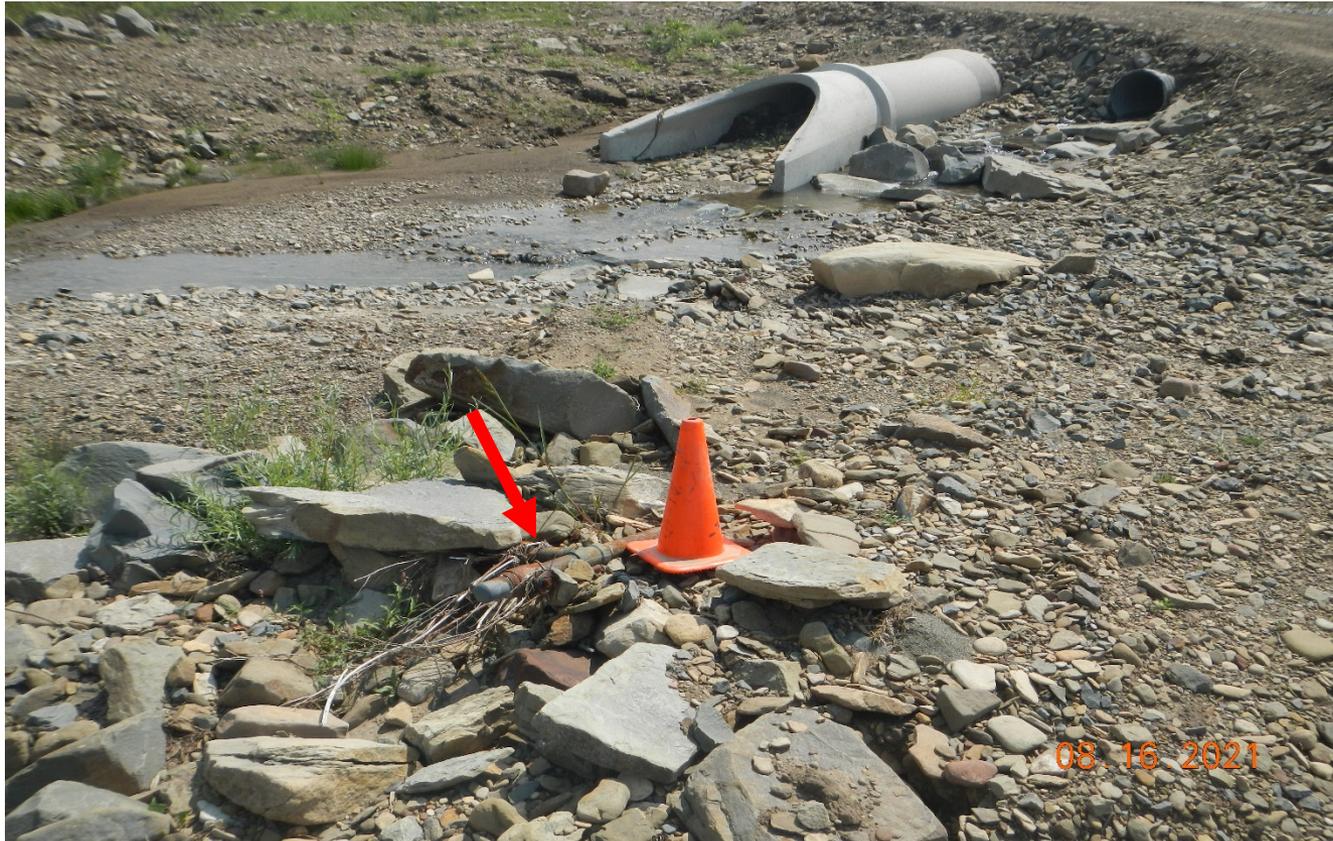
Photo 4. There is a produced water line that is bent over on the ground near the stream drainage which needs to be repaired.

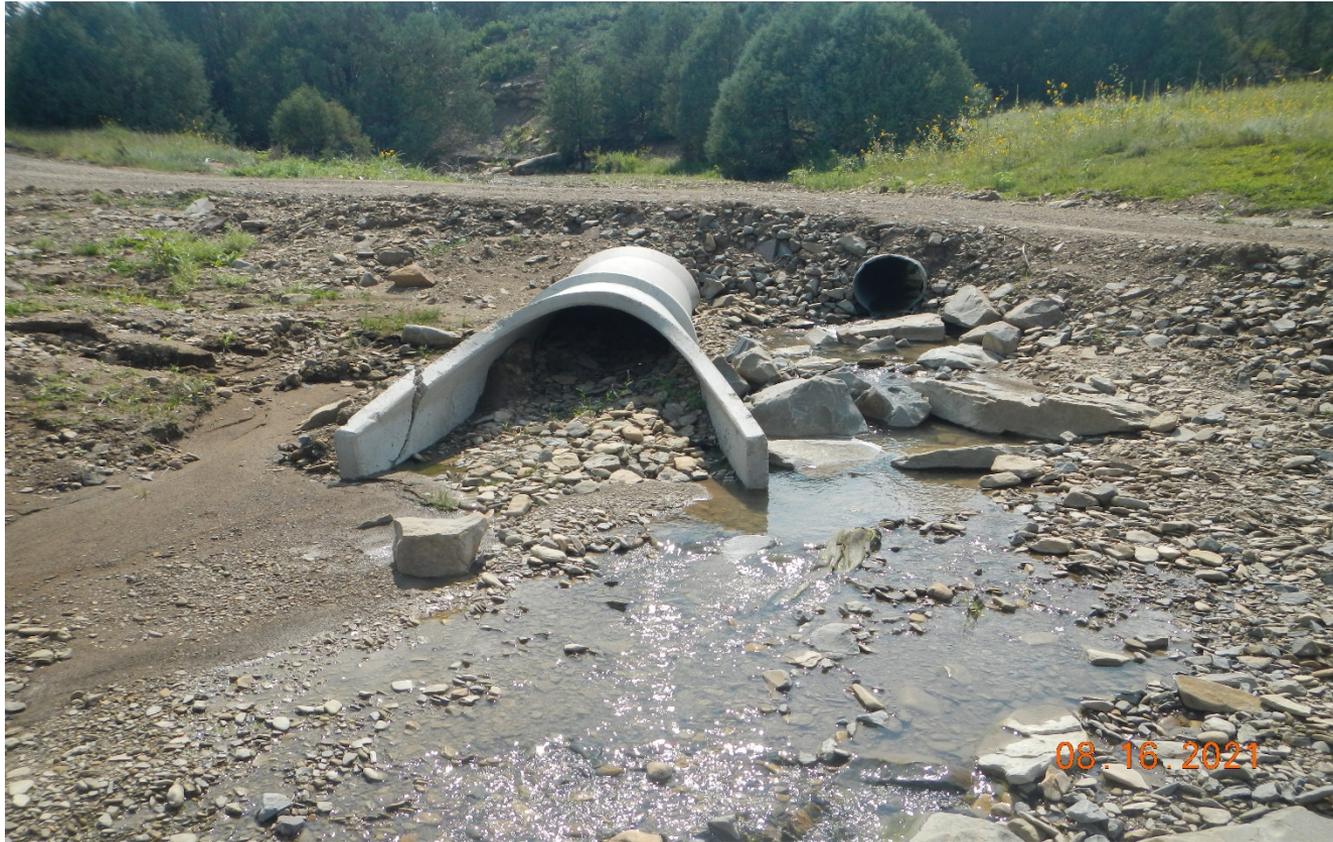
Photo 5. The cement culvert is completely filled in with material. The culvert installed is not sufficient as shown by the size of the previous culvert.

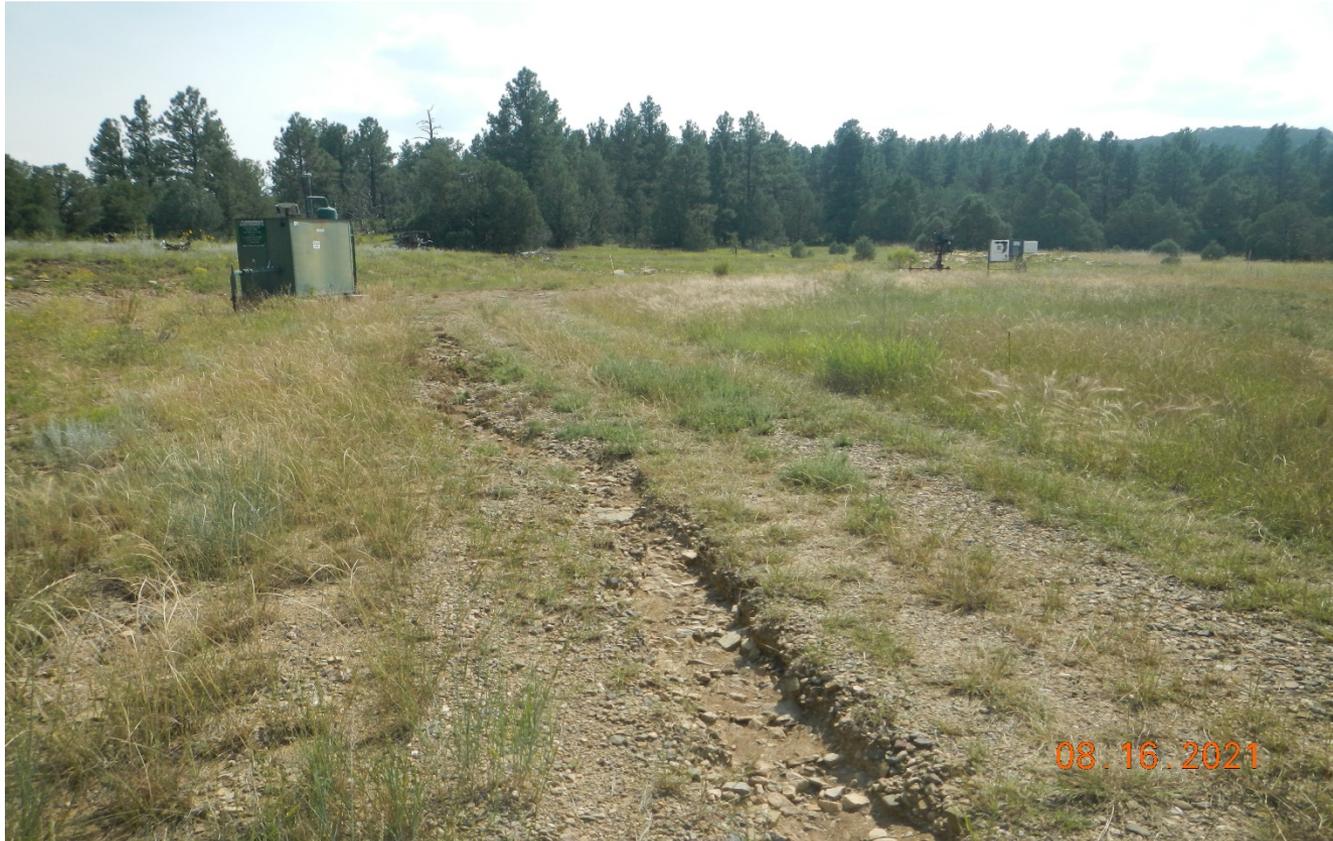
Photo 6. Facing toward the well site.
