Inspection Photos

Operator: Arkoma/Catamount
API: 067-08767
Date: 8/12/2021

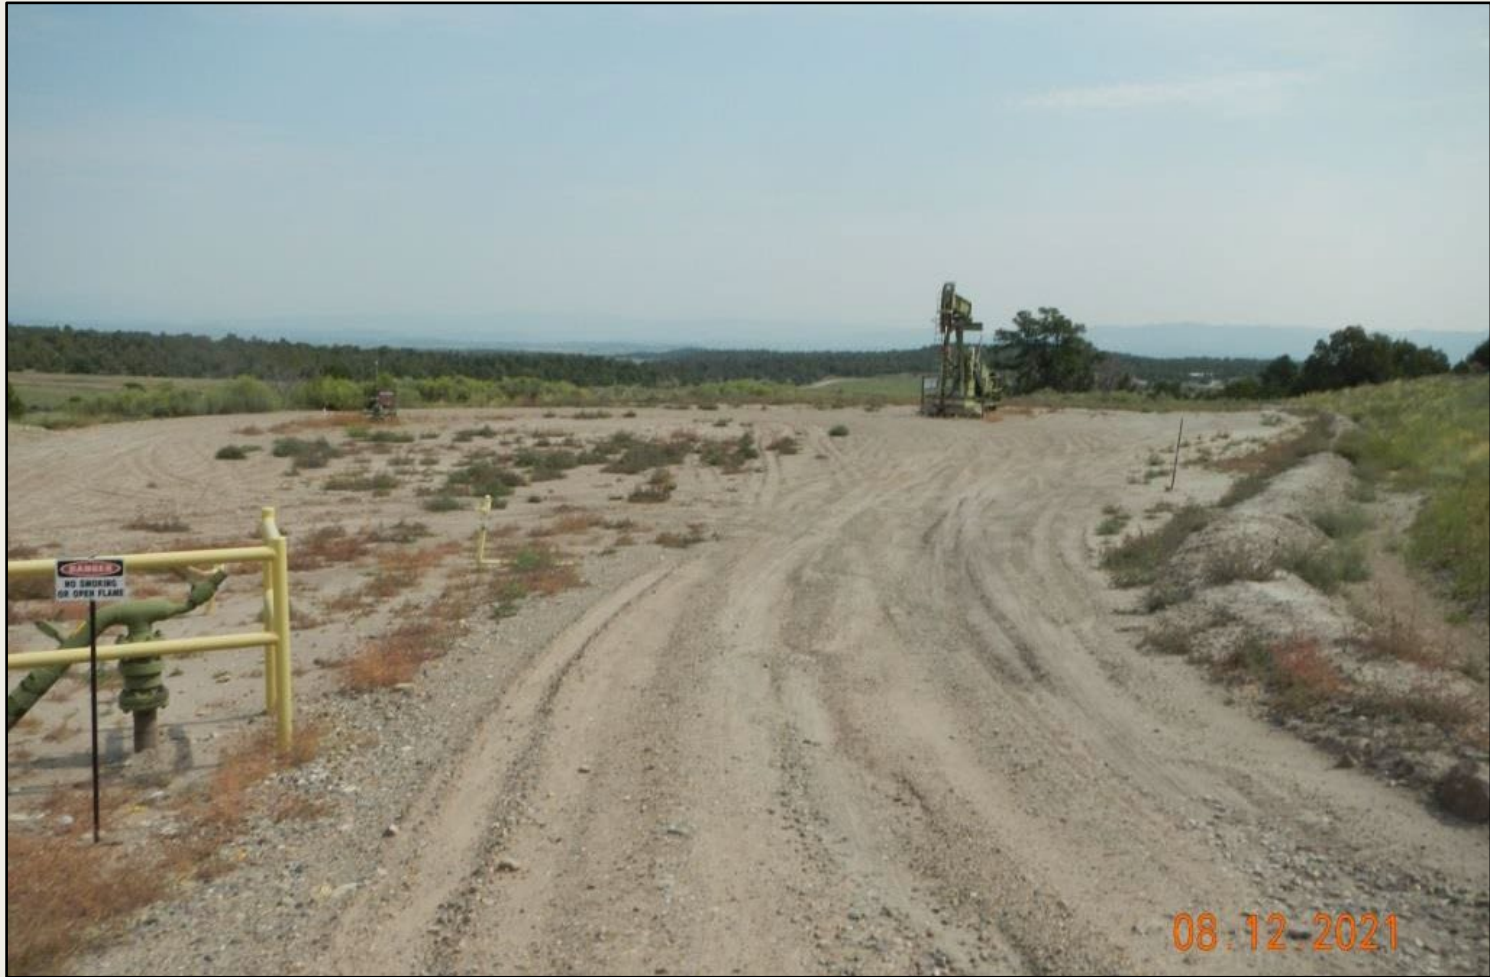
Photo 1. View of the project area from the well pad entrance facing center.

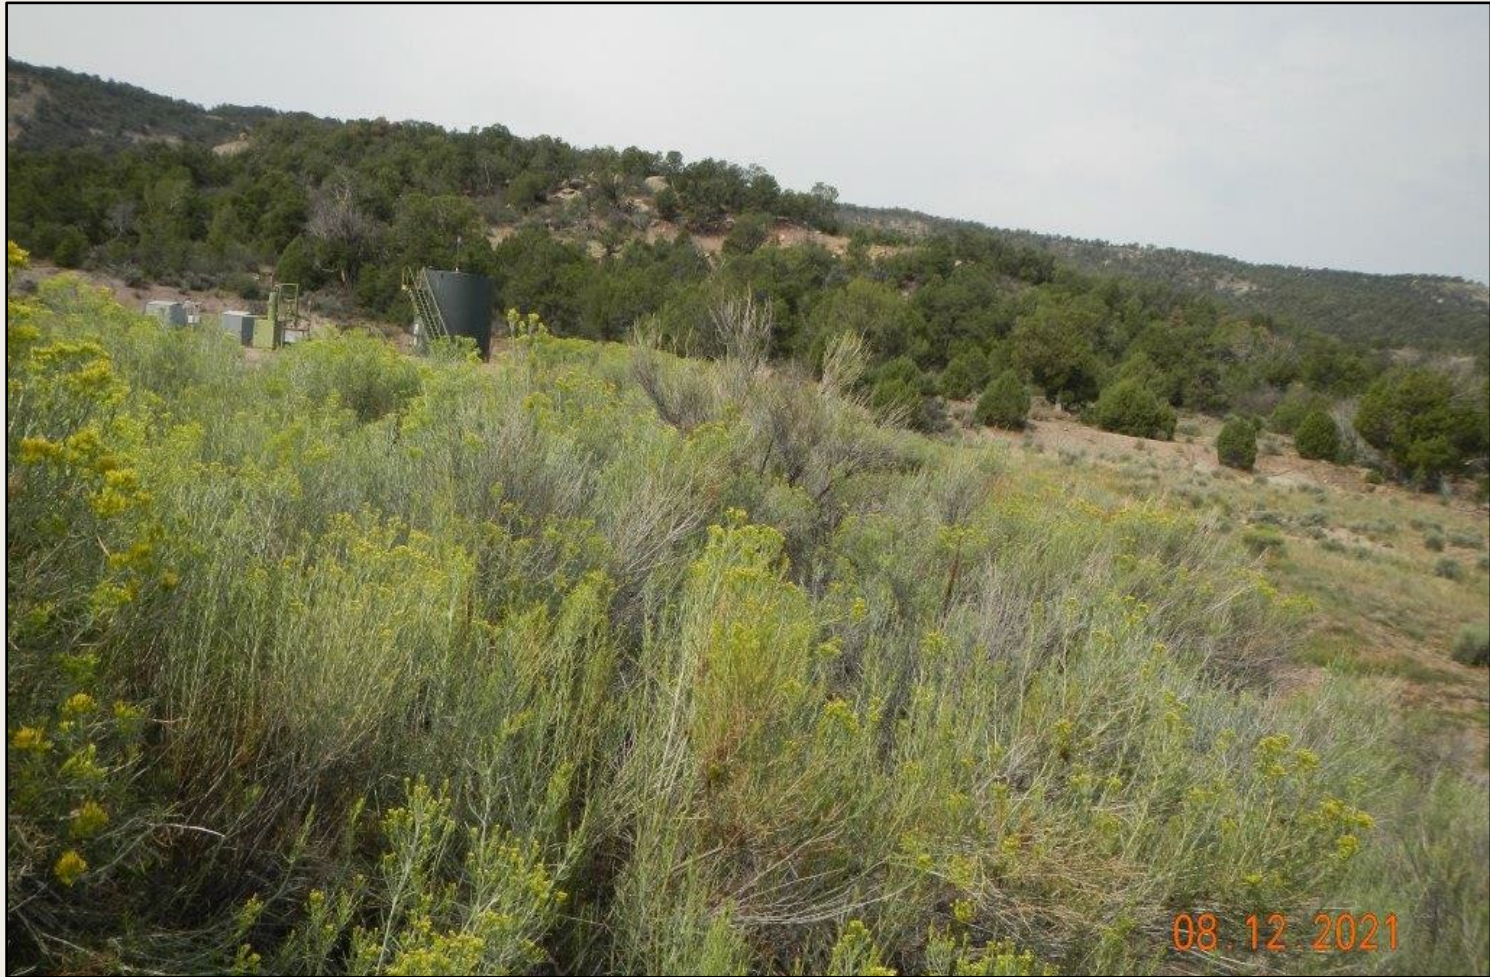
Photo 2. View of the northern project area from the northeastern corner facing westward. Revegetation is progressing here with dense rubber rabbitbrush, smooth brome, crested wheatgrass, and western wheatgrass.

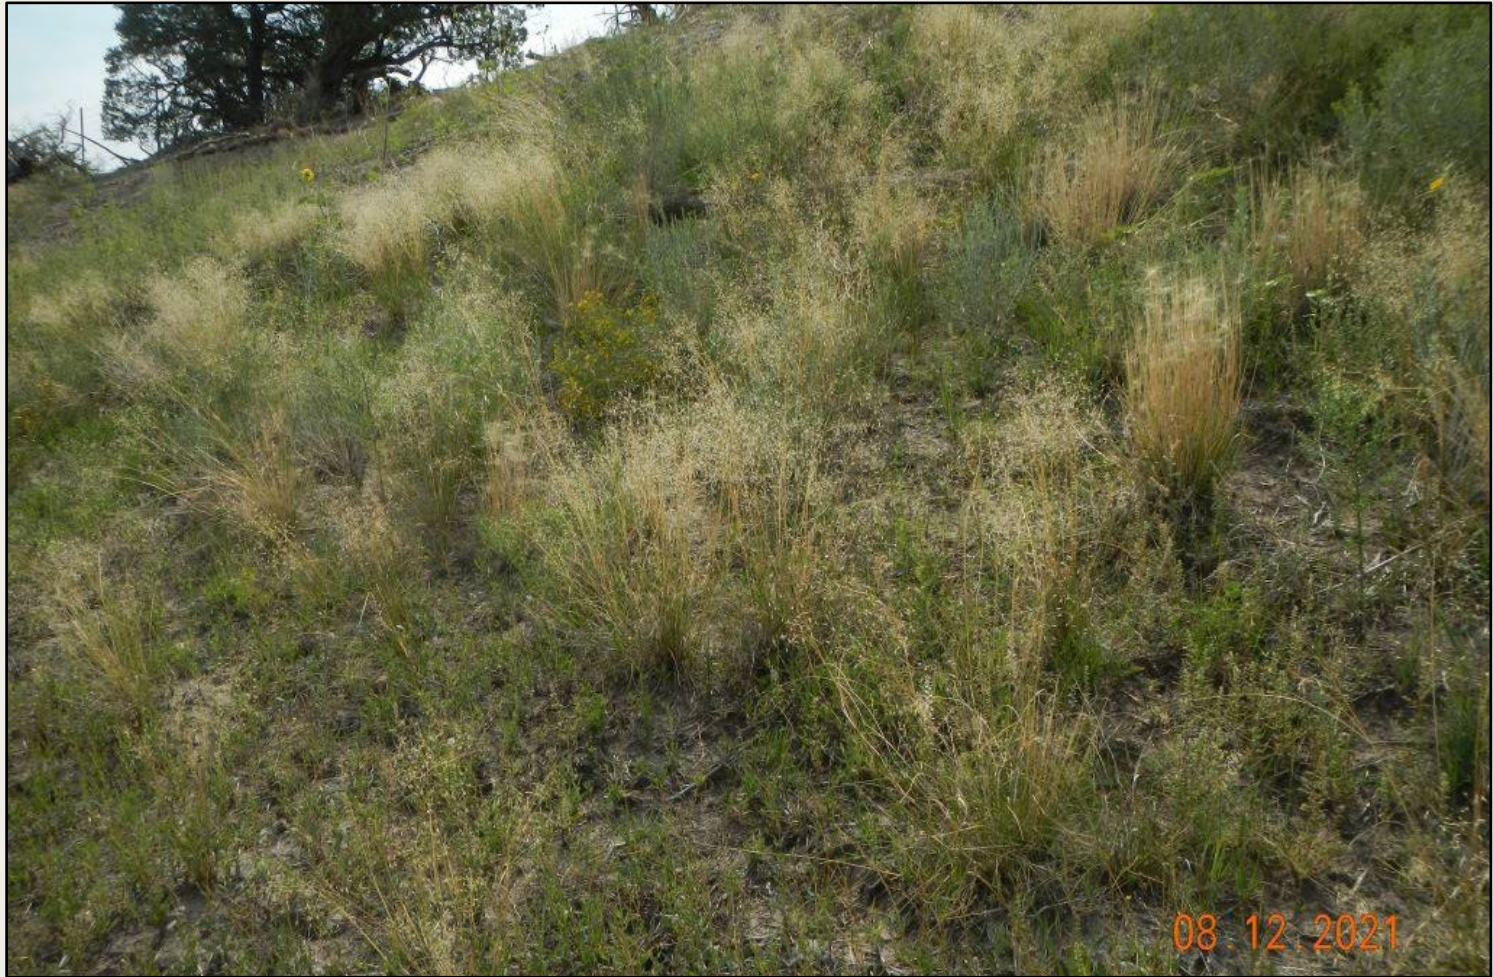
Photo 3. View of revegetation area in the southern cut-slope appears to be progressing.

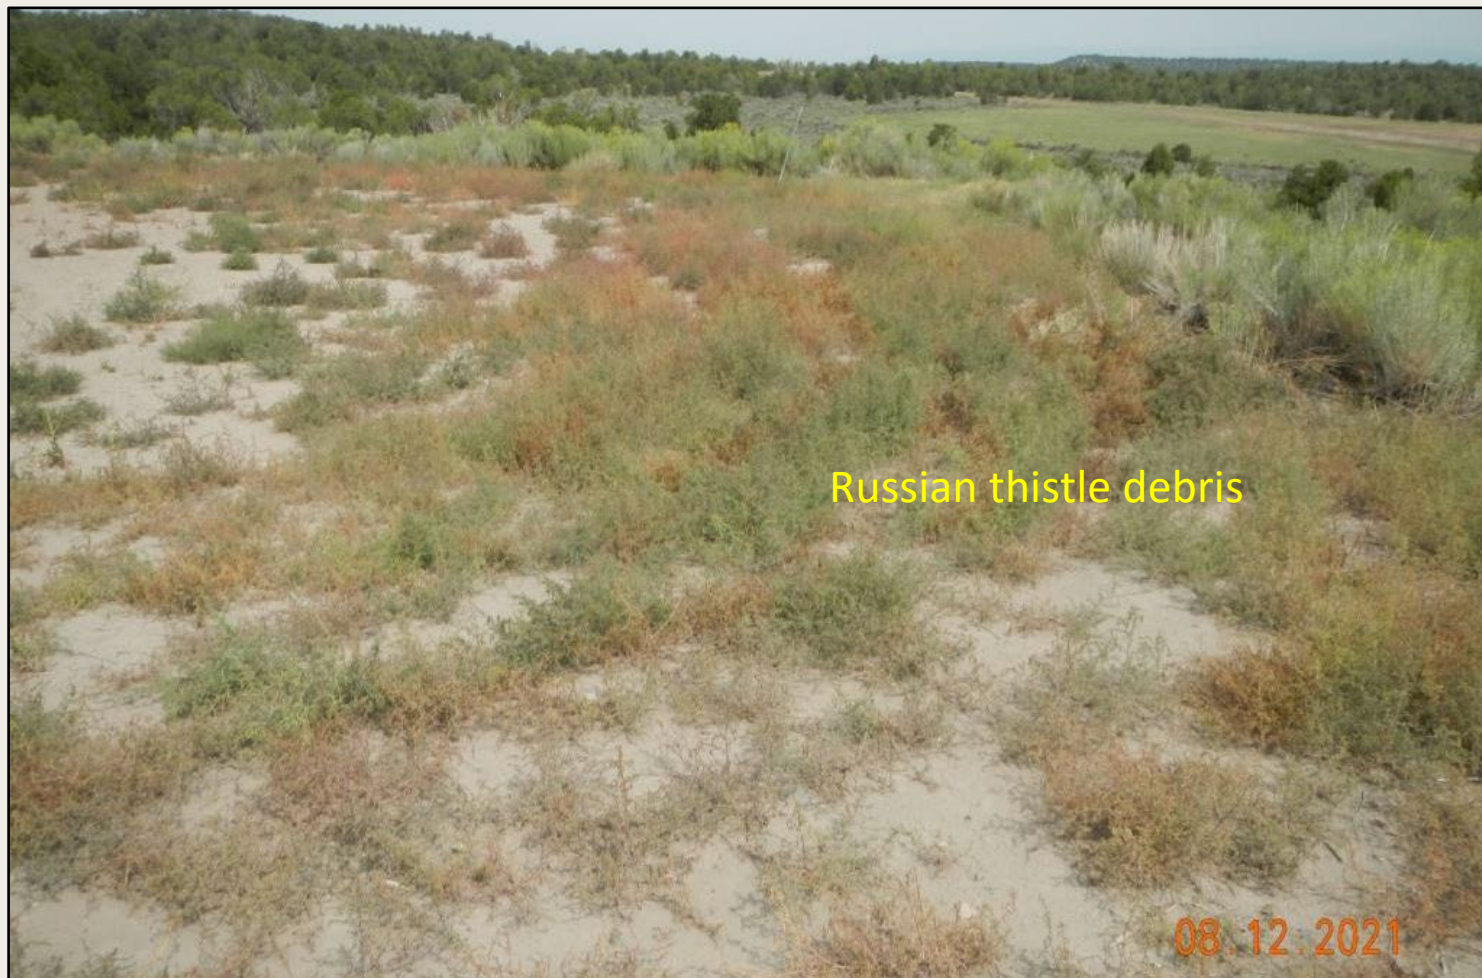
Photo 4. View of dense Russian thistle weeds drying and will soon become debris, in the eastern well pad area. .

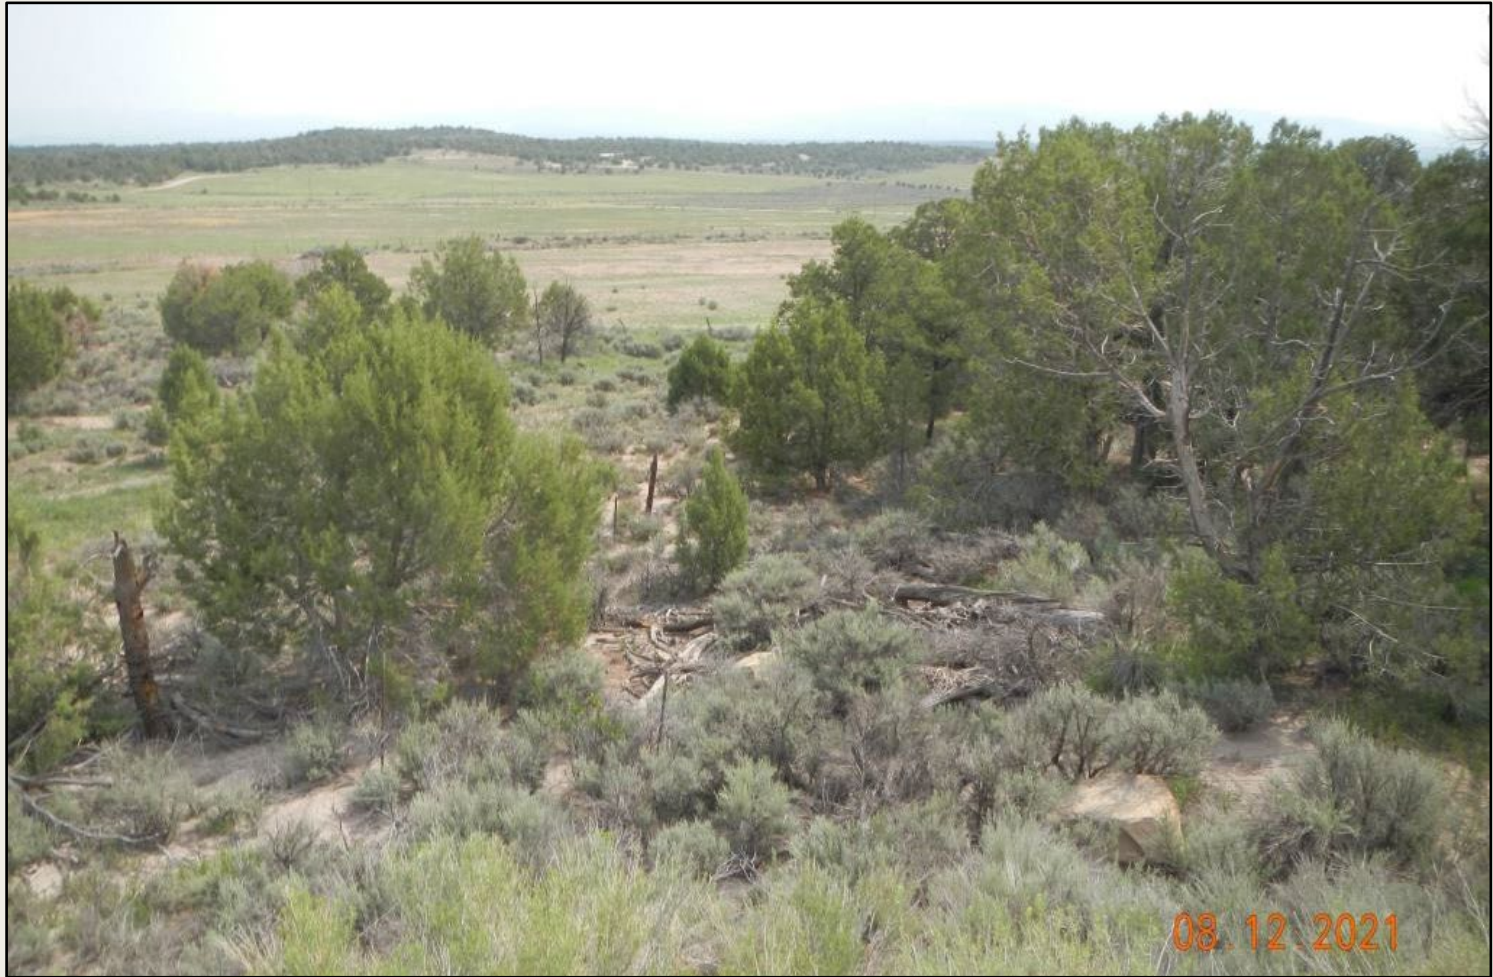
Photo 5. View of the reference area comprised pinyon and juniper woodland with understory of gambel oak, sagebrush, antelope bitterbrush, and squirreltail.
