Inspection Photos

Location Name: CAERUS PICEANCE LLC CASS-GARBER-68S96W /1NWNE

Location ID: 334129

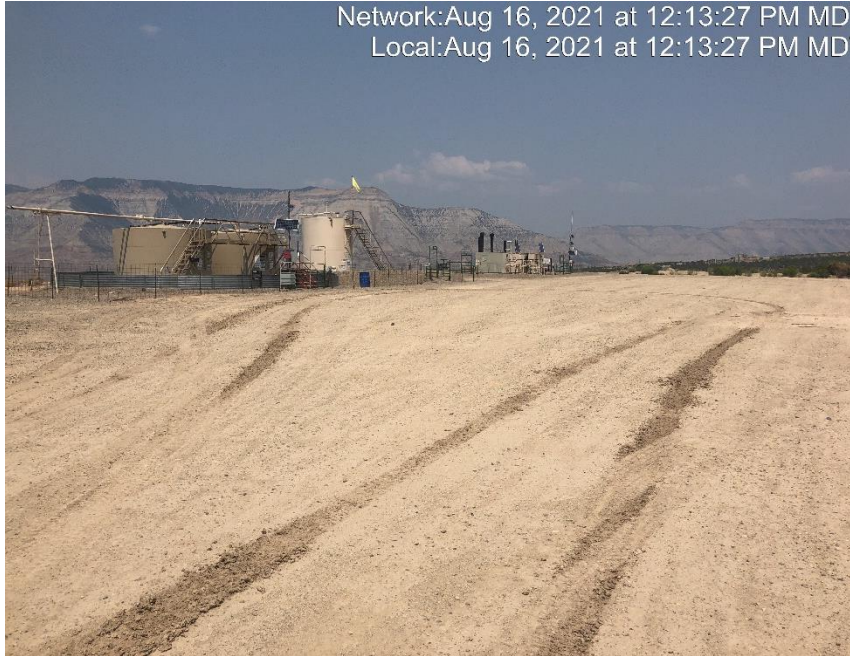
Photo #4804 from entrance to location.

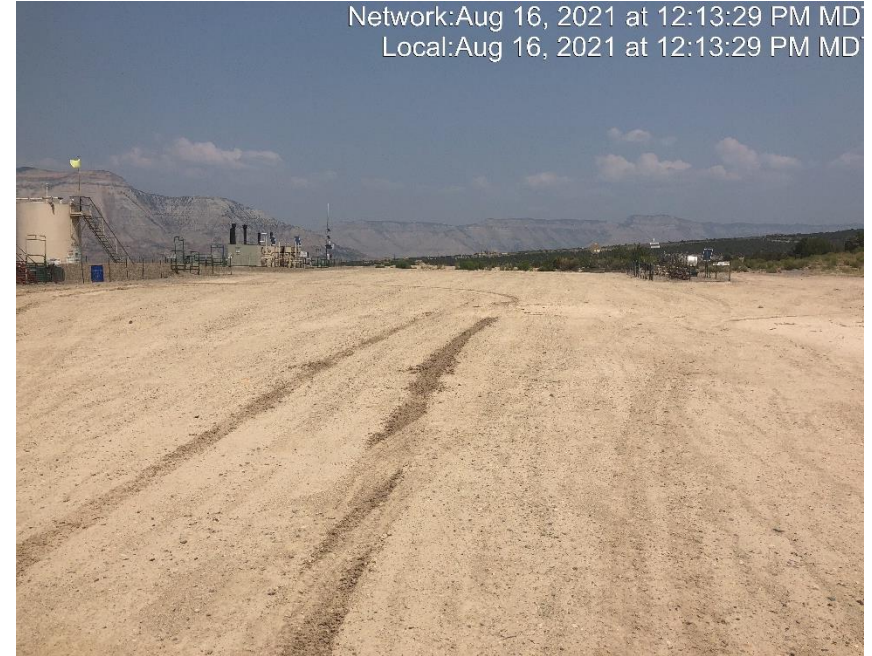
Photo #4805 from entrance to location.

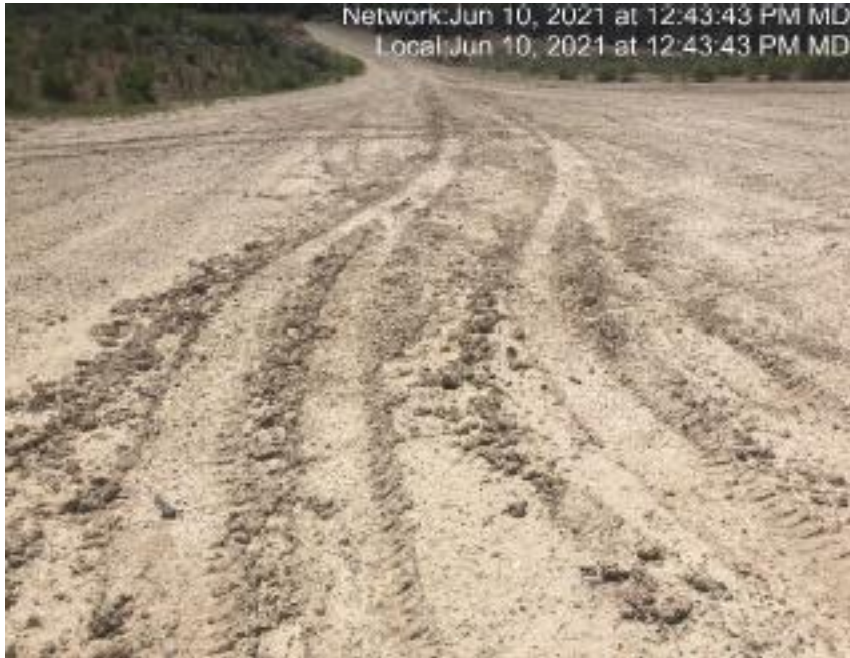
Photo #4052 from inspection #699803221 conducted on 6/10/21.

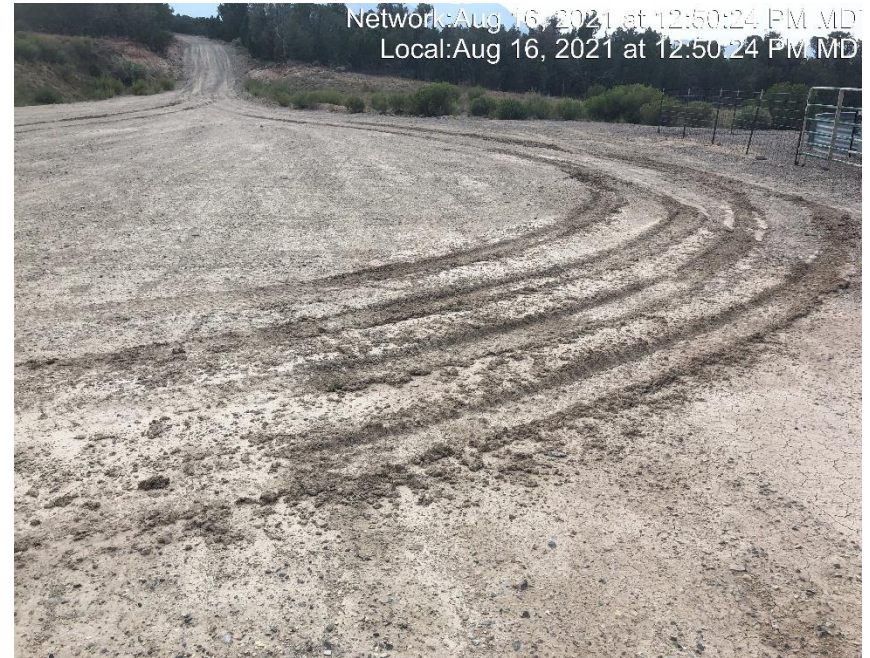
Photo #4806 Location lacks stabilization.

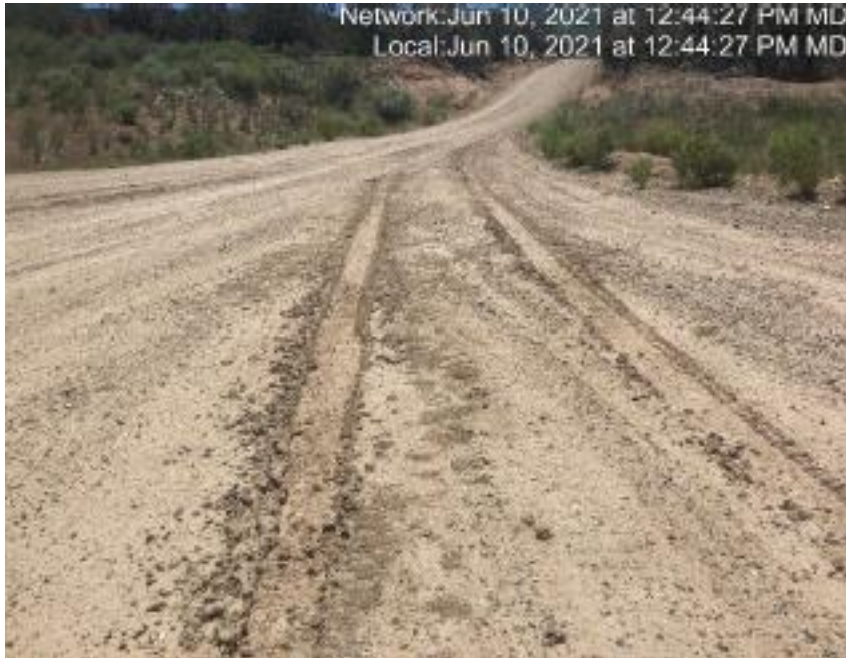
Photo #4054 from inspection #699803221 conducted on 6/10/21.

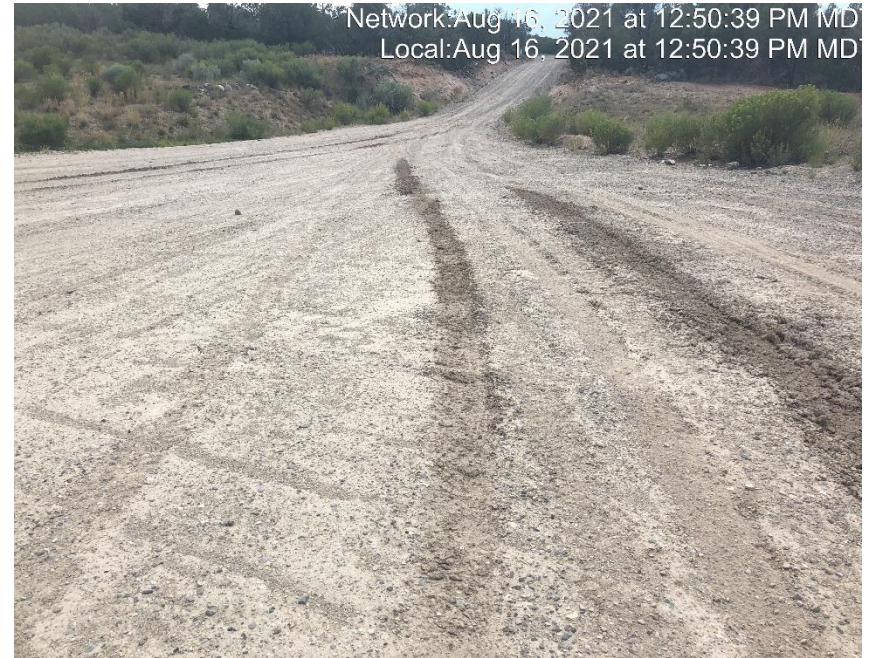
Photo #4807 No form of tracking BMP located at the entrance to location.
