Caerus Piceance LLC
I11W
Location # 334561

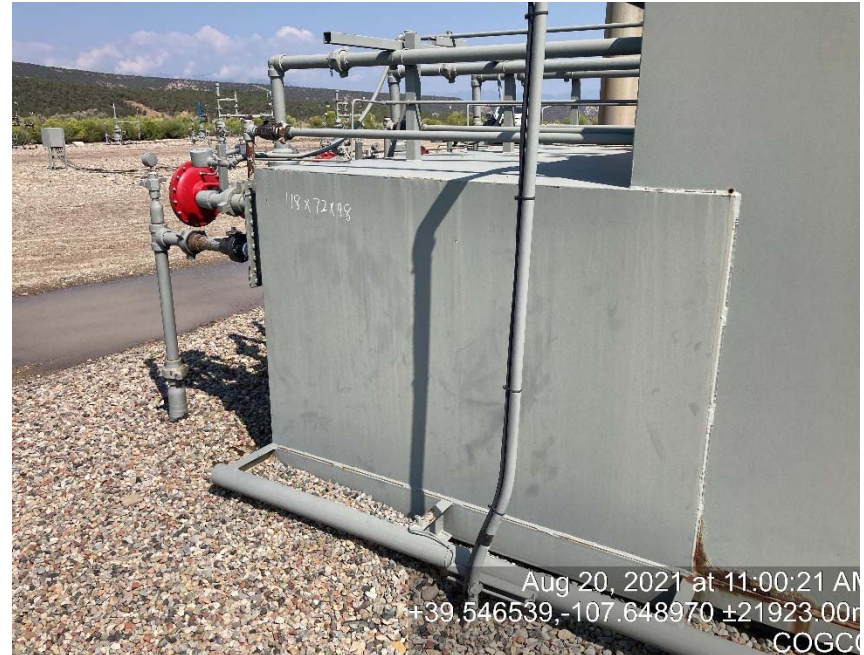
Location/lack of separator bath signage/dimensions
of bath

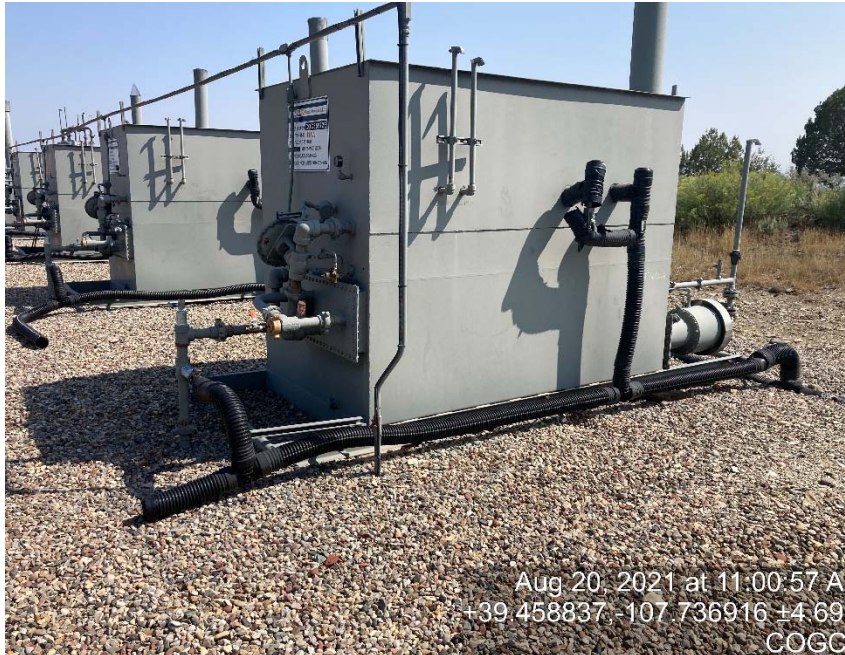
Location/lack of separator bath signage

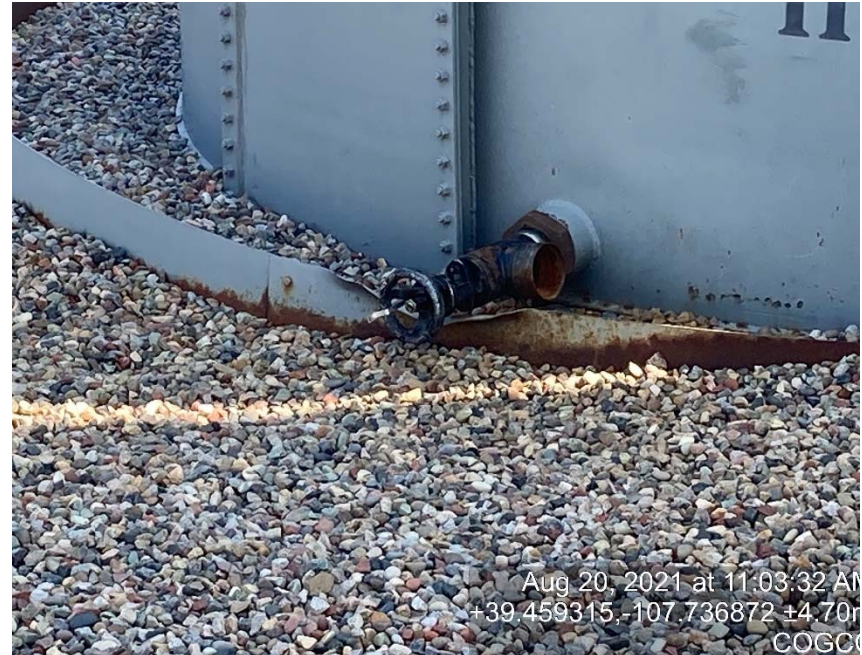
Missing cap/bull plug

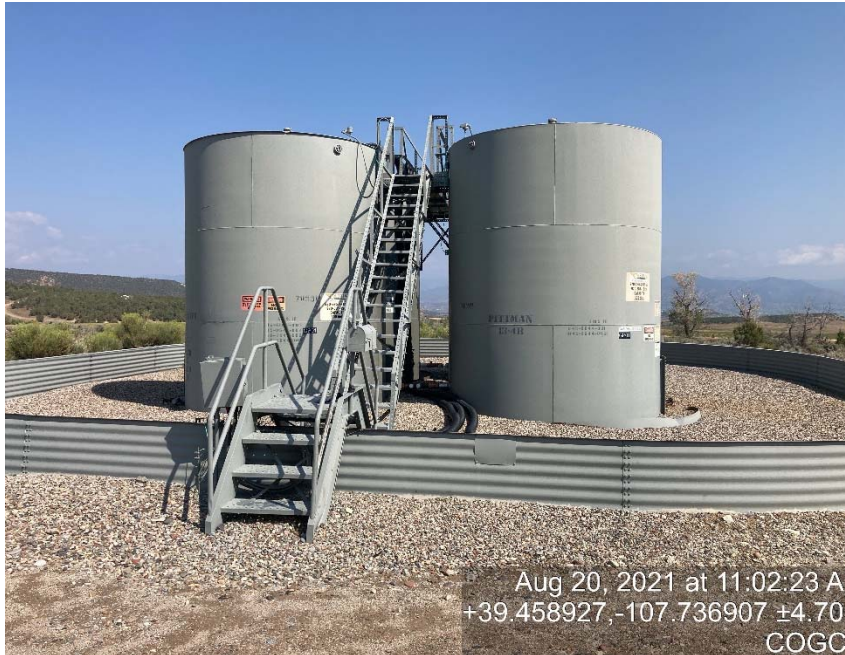
Location/ lack of battery signage

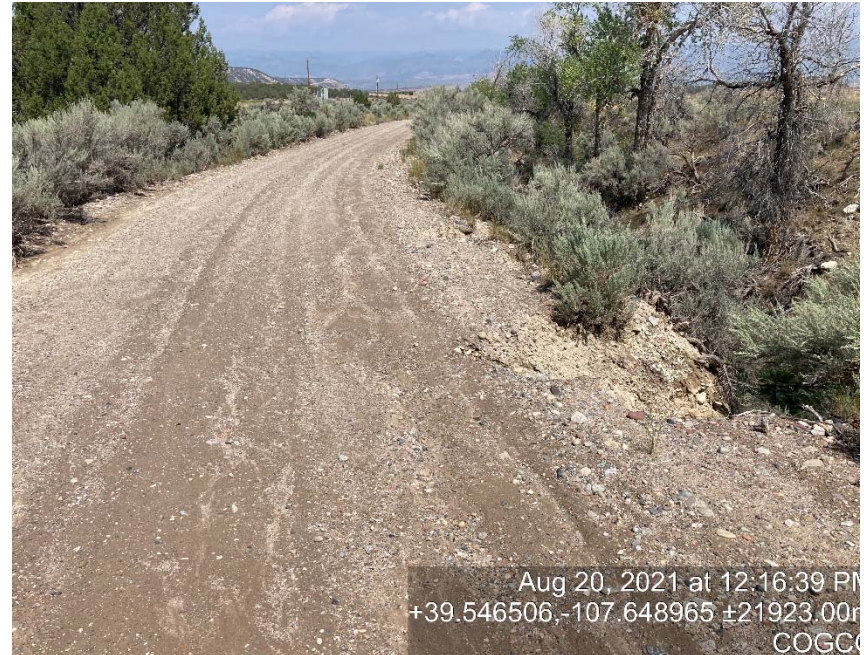
Access road erosion

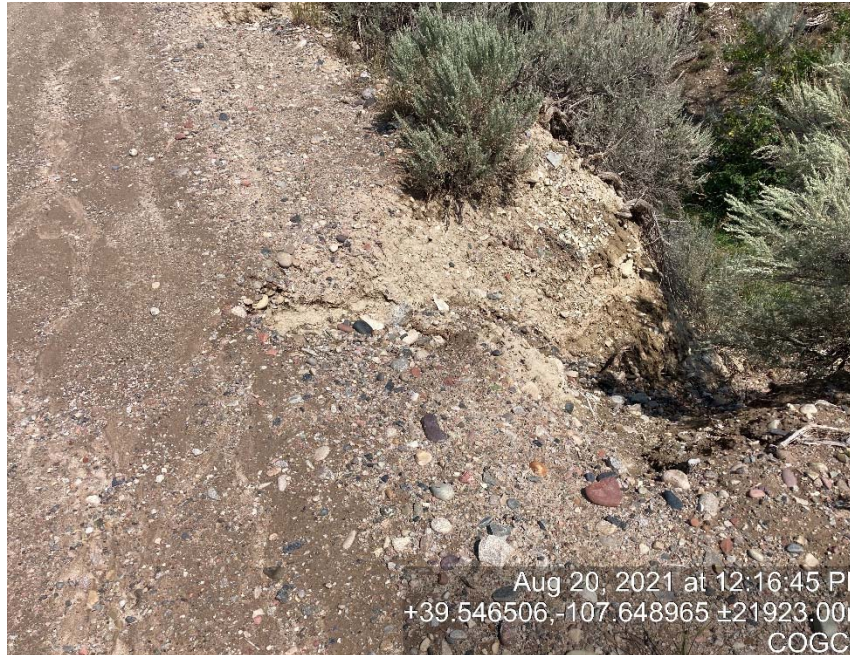
Access road erosion

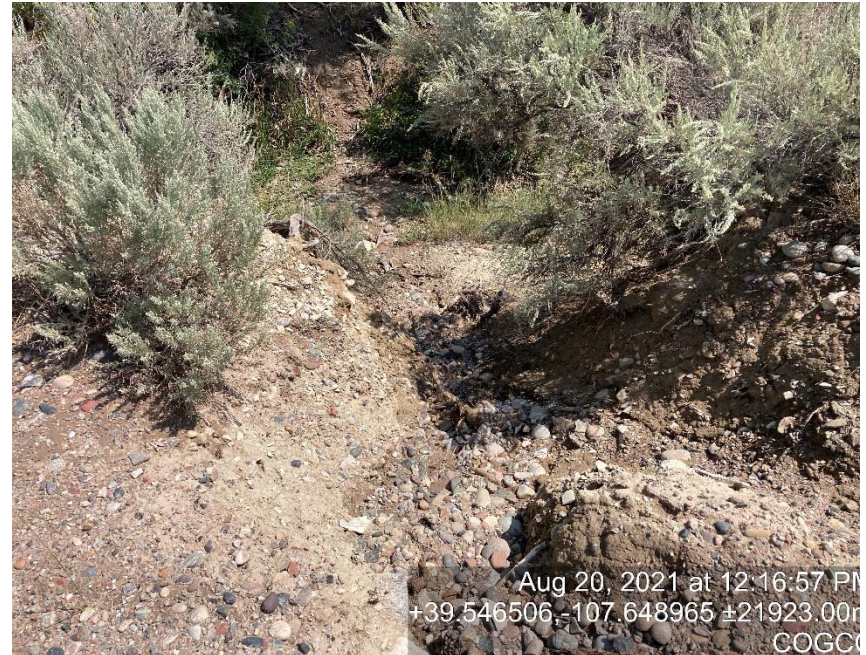
Access road erosion

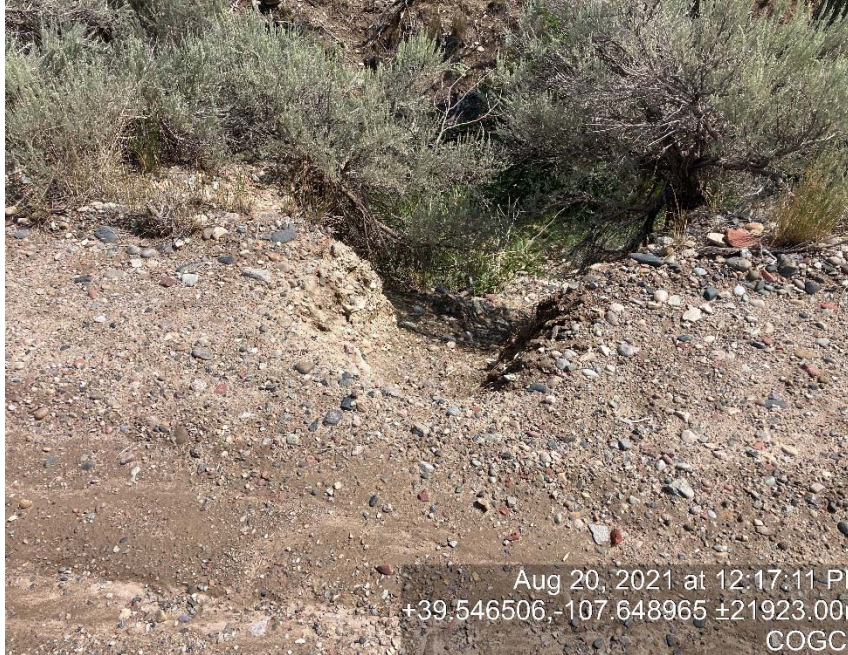
Access road erosion

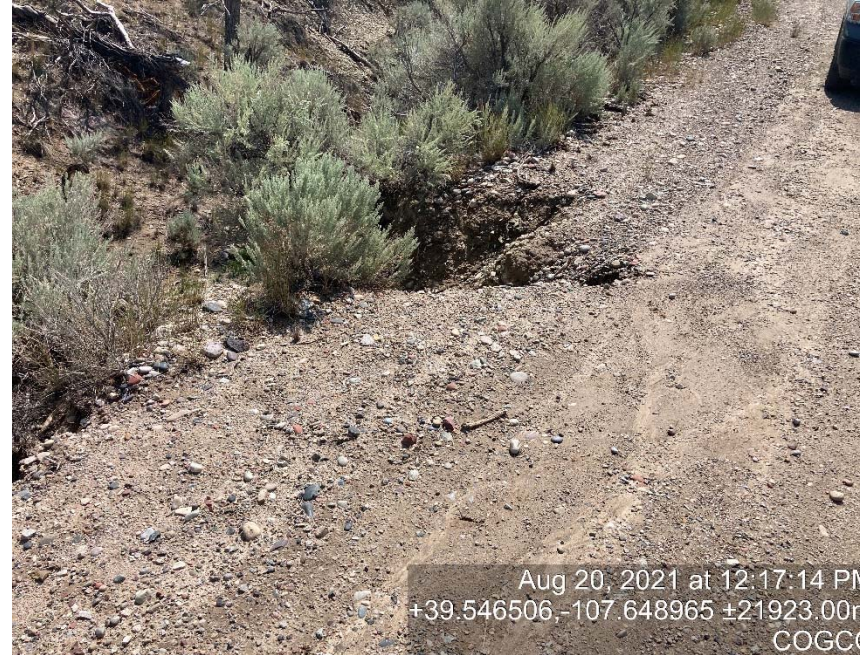
Access road erosion
