Inspection Photos

Operator: Hilcorp Energy
API: 067-08036
Date: 8/17/2021

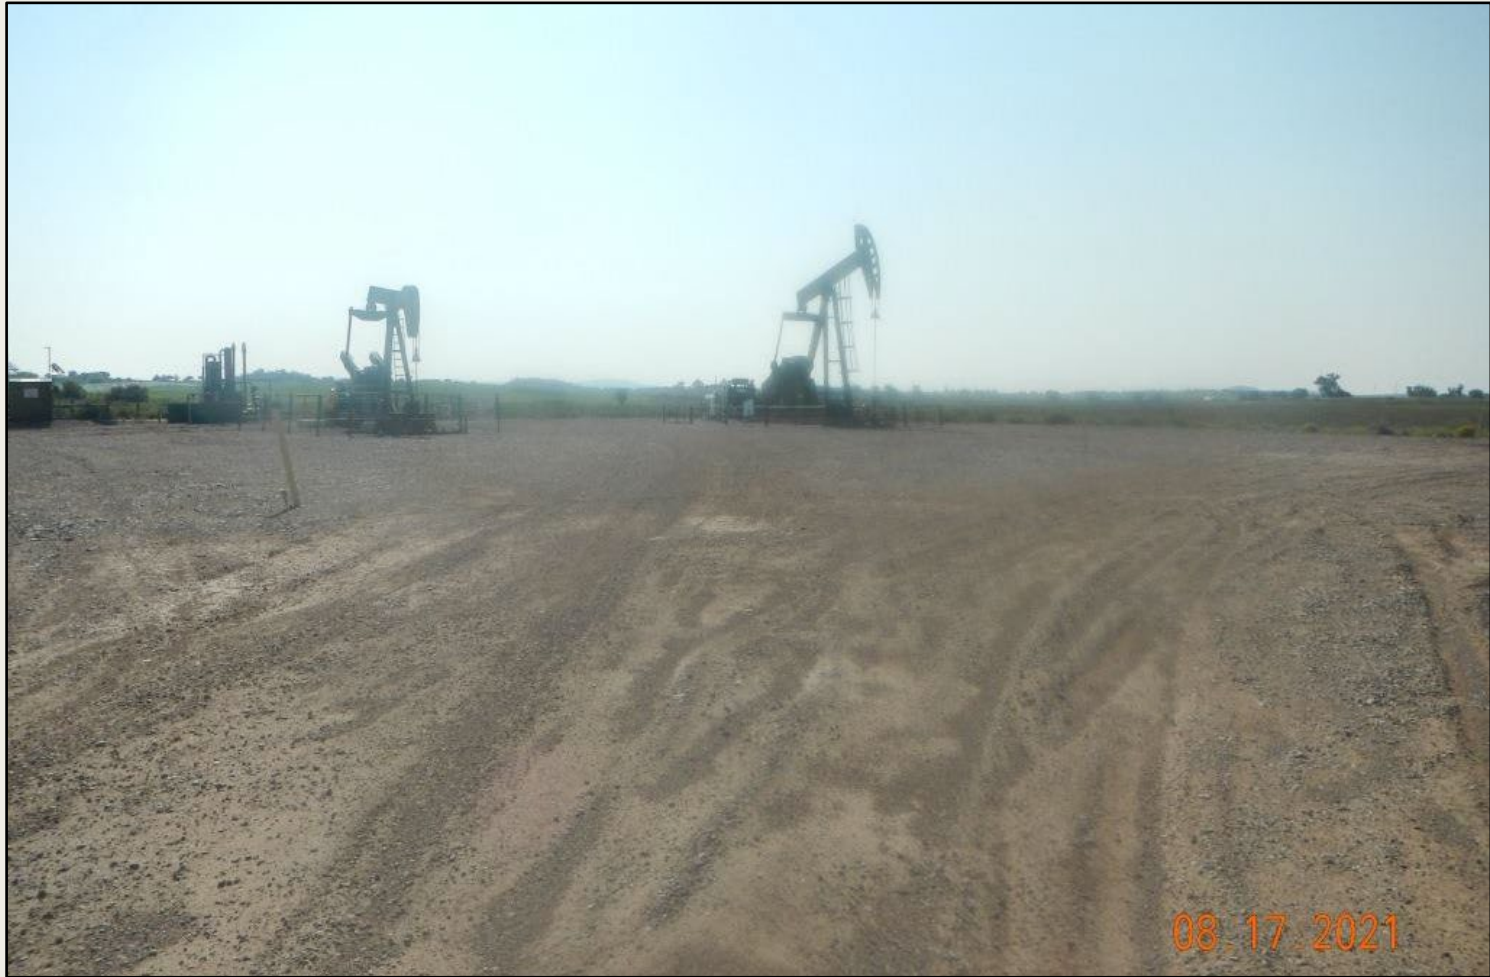
Photo 1. View of the project area from the well pad entrance facing center.

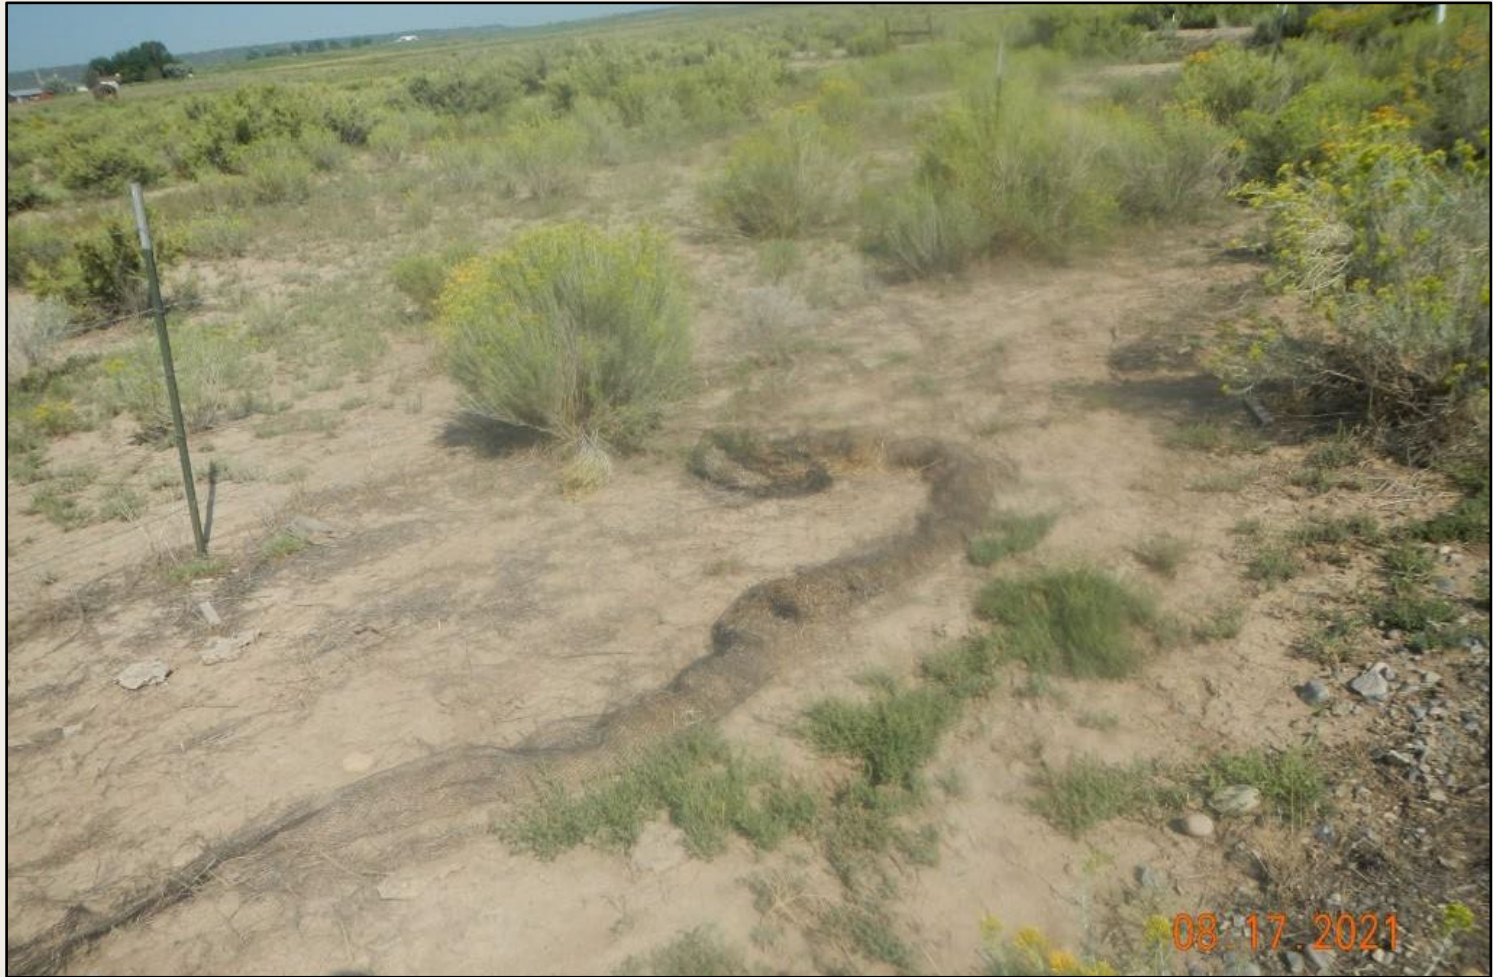
Photo 2. View of perimeter wattles that are no longer functioning and have become debris. .

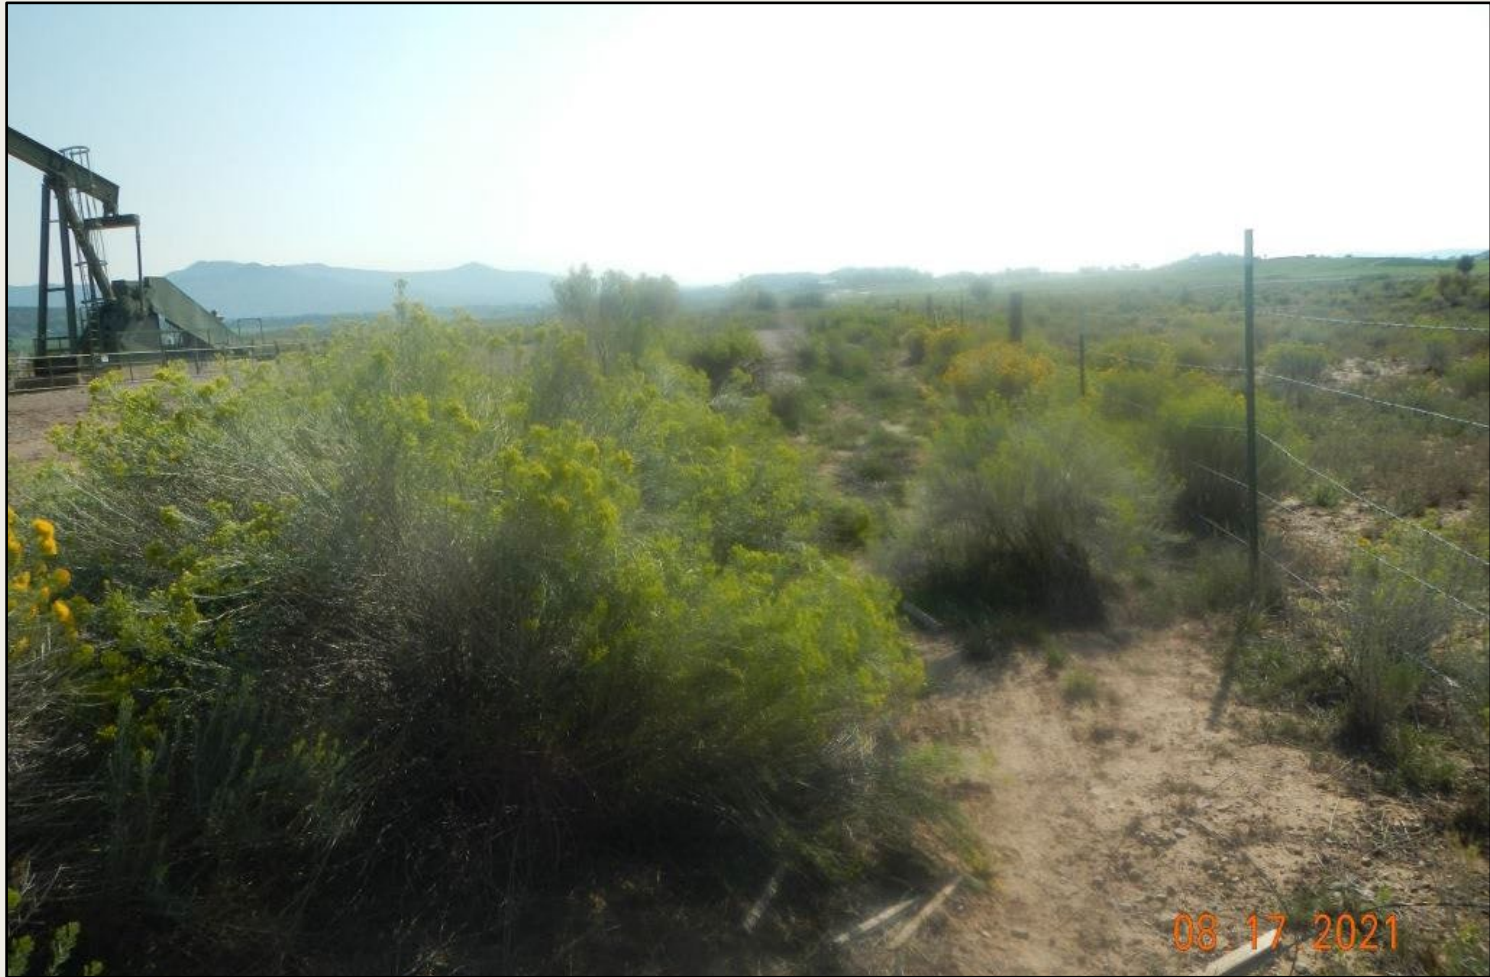
Photo 3. View of the southern project area from the southwestern corner facing eastward. Revegetation is progressing with rubber rabbitbrush, greasewood, and crested wheatgrass.

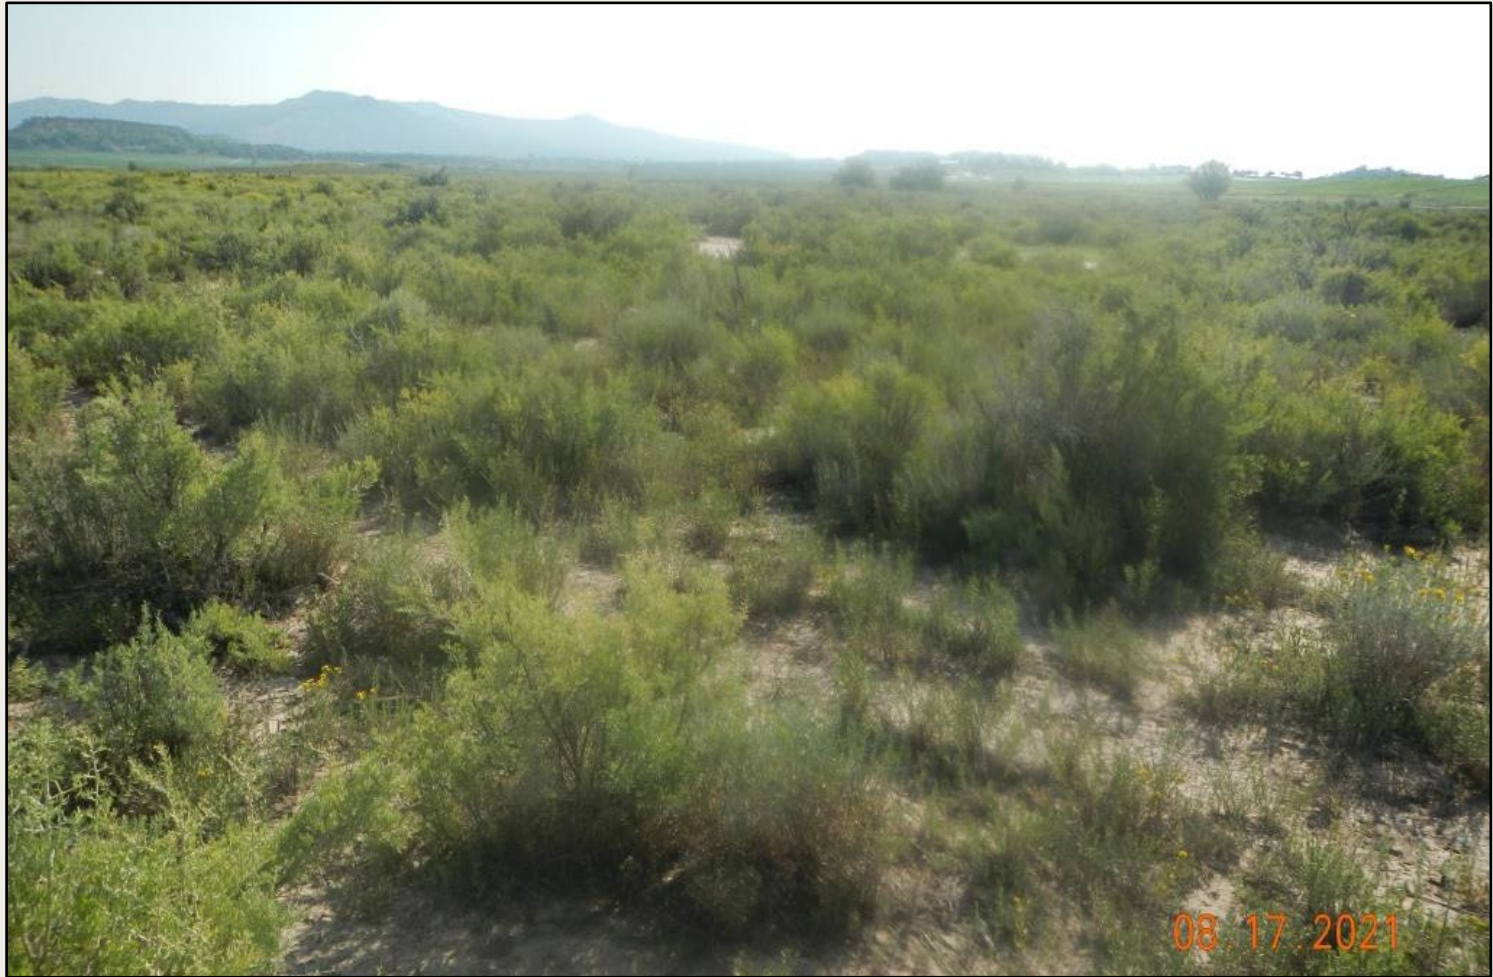
Photo 4. View of the reference area comprised of greasewood and saltbush shrubland with James galleta, and sand dropseed.
