KP Kauffman - COGCC Inspection Photos
Location: Nessu Constolidation OLF Release
Spill ID # 476987 Date 8/23/2021

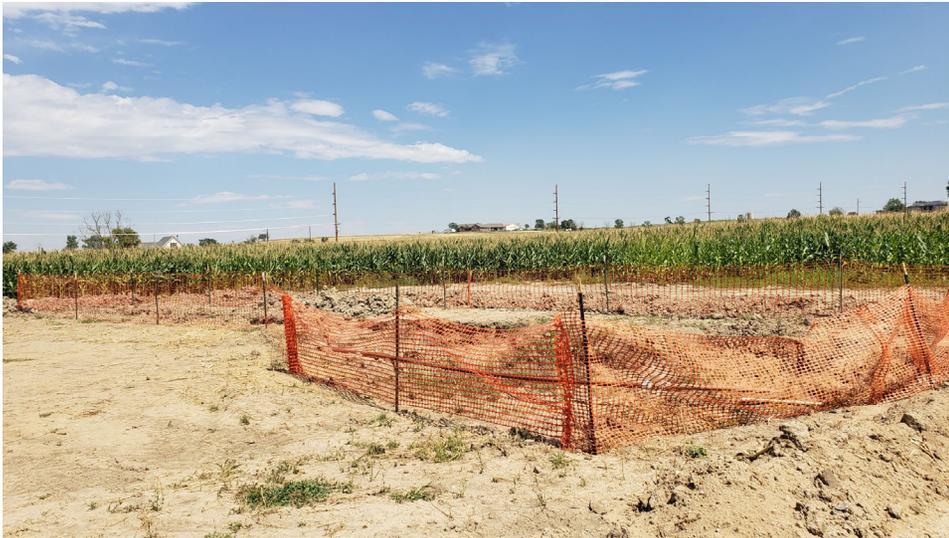
View of excavation observed at spill ID #476987; to the northeast.

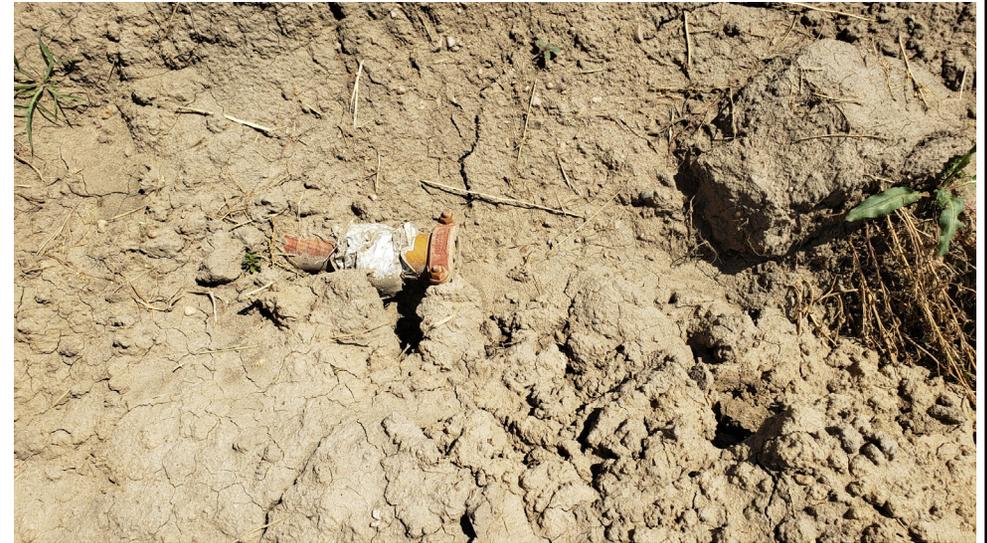
View of capped 3" fiberglass flowline to the northeast edge of the larger excavation area.

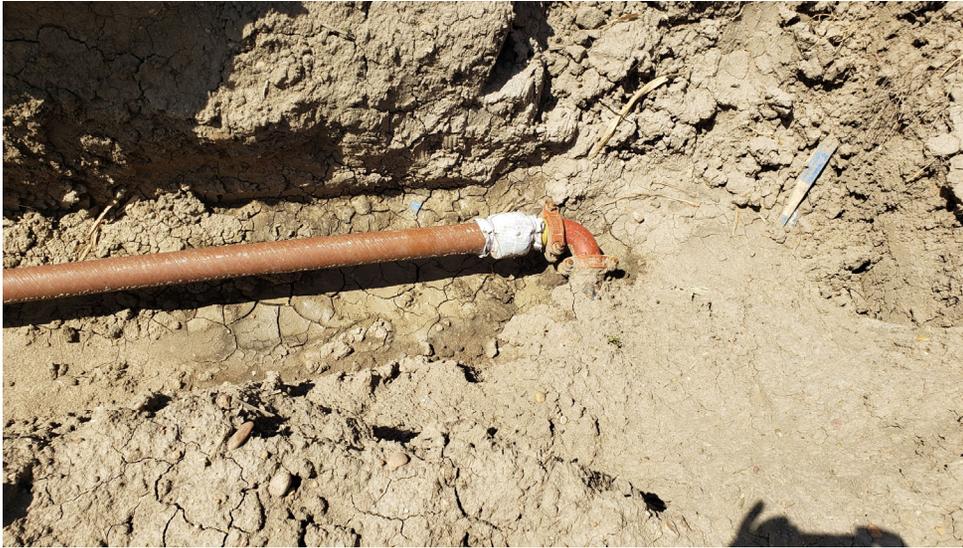
View of north tie-in to an existing 3" (perceived) carbon steel line.

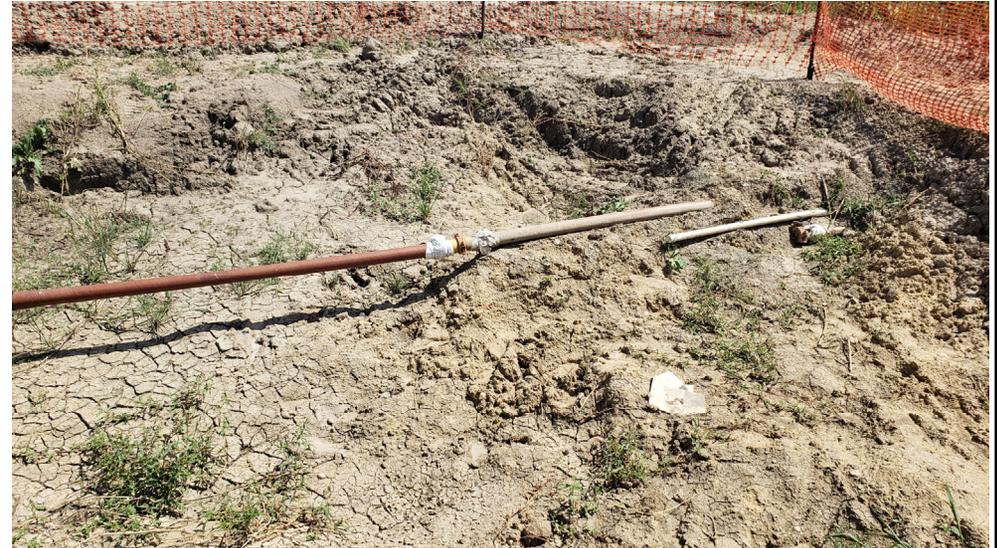
View of capped 3" fiberglass and 1.5" PVC abandoned flowlines adjacent to repaired 3" fiberglass line southern tie-in.

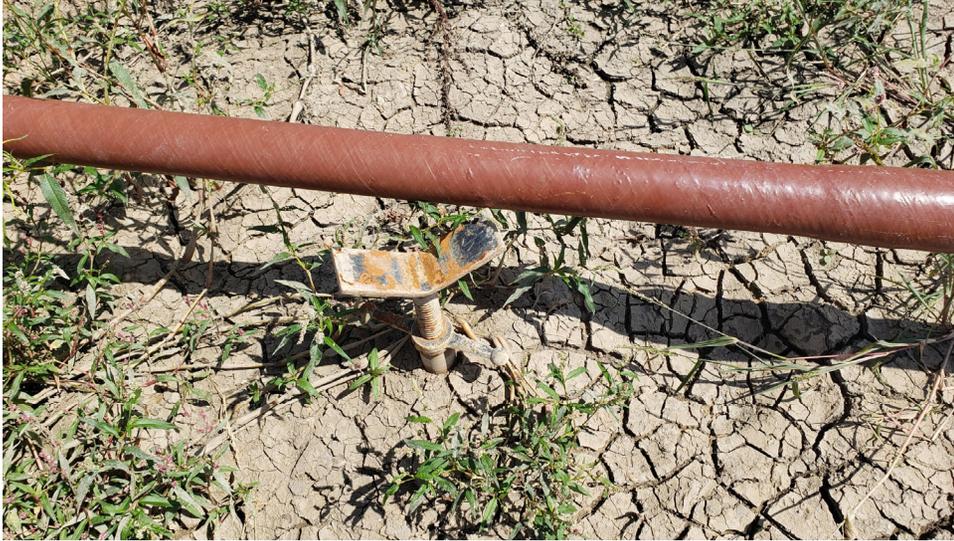
View of fiberglass line that appears to have slipped off pipe support within the deeper portion of the excavation.

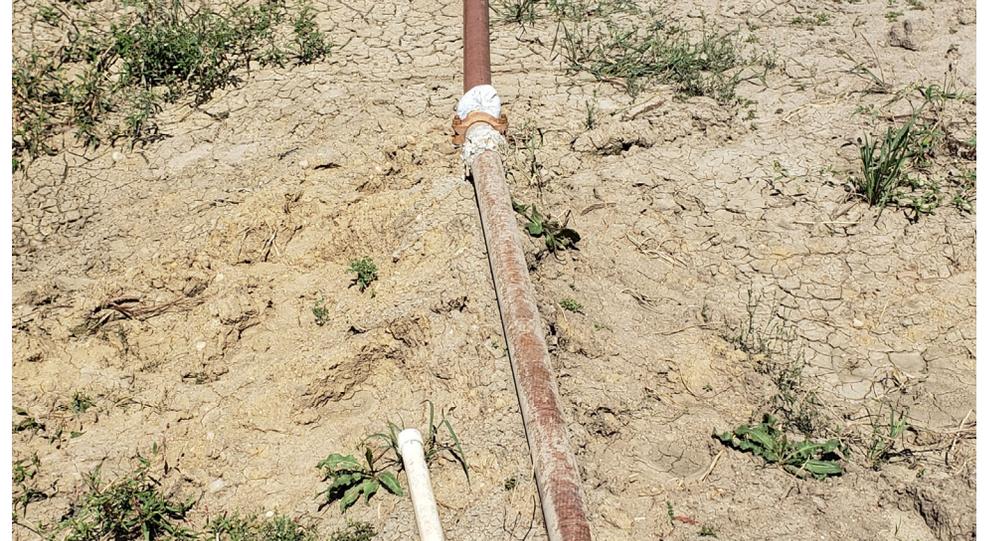
View of slight bowing at the southern tie-in with stub end.

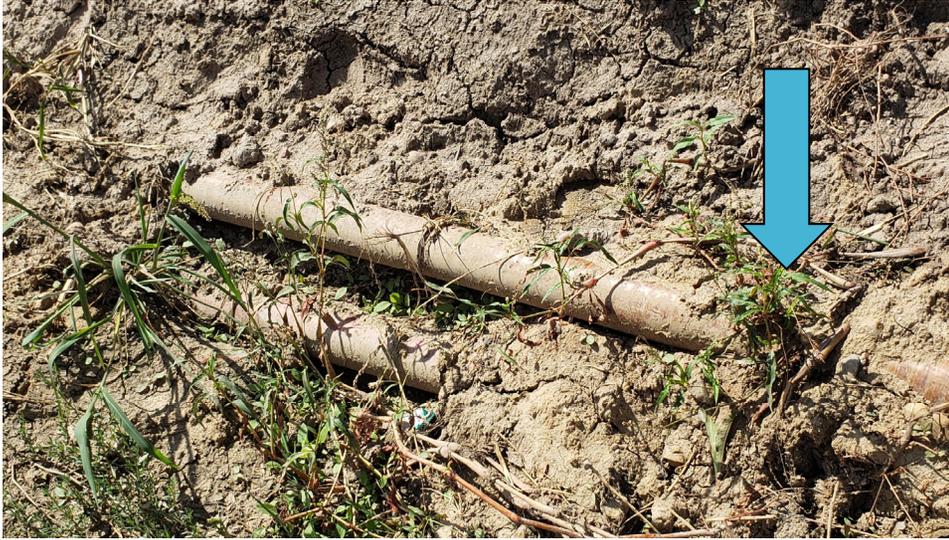
View of (2) improperly abandoned flowlines along the west edge of the larger excavated area. Blue arrow indicates cut end of flowline.

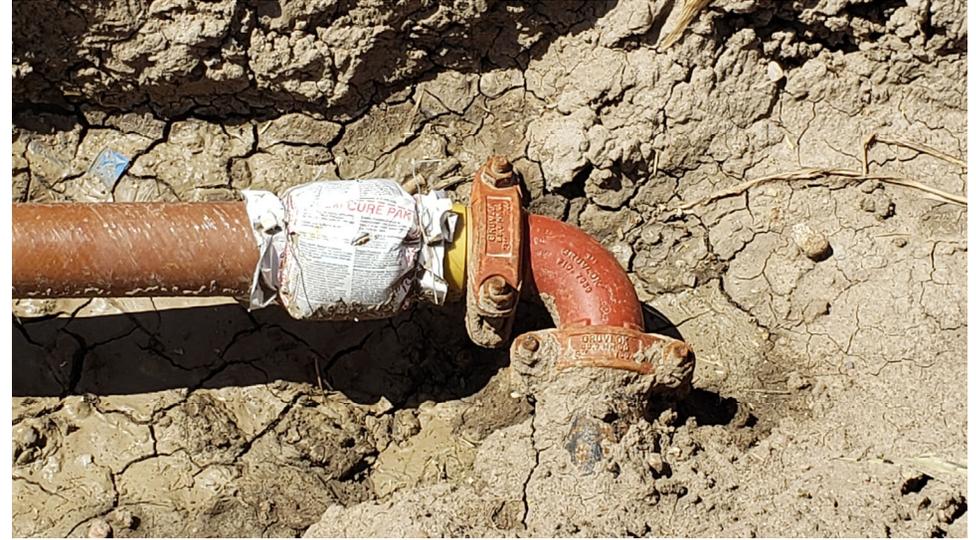
View north tie-in using buried Gruvlok clamped 90° elbow. Surface rust on bolts and on existing carbon steel pipe, where light loss of coating has occurred.
