Paul Heinze #1 Flowline Spill IDs: 479232, 480128 Remediation: 18954

**Paul Heinze Flowline
Spill IDs: 479232, 480128
Remediation: 18954**

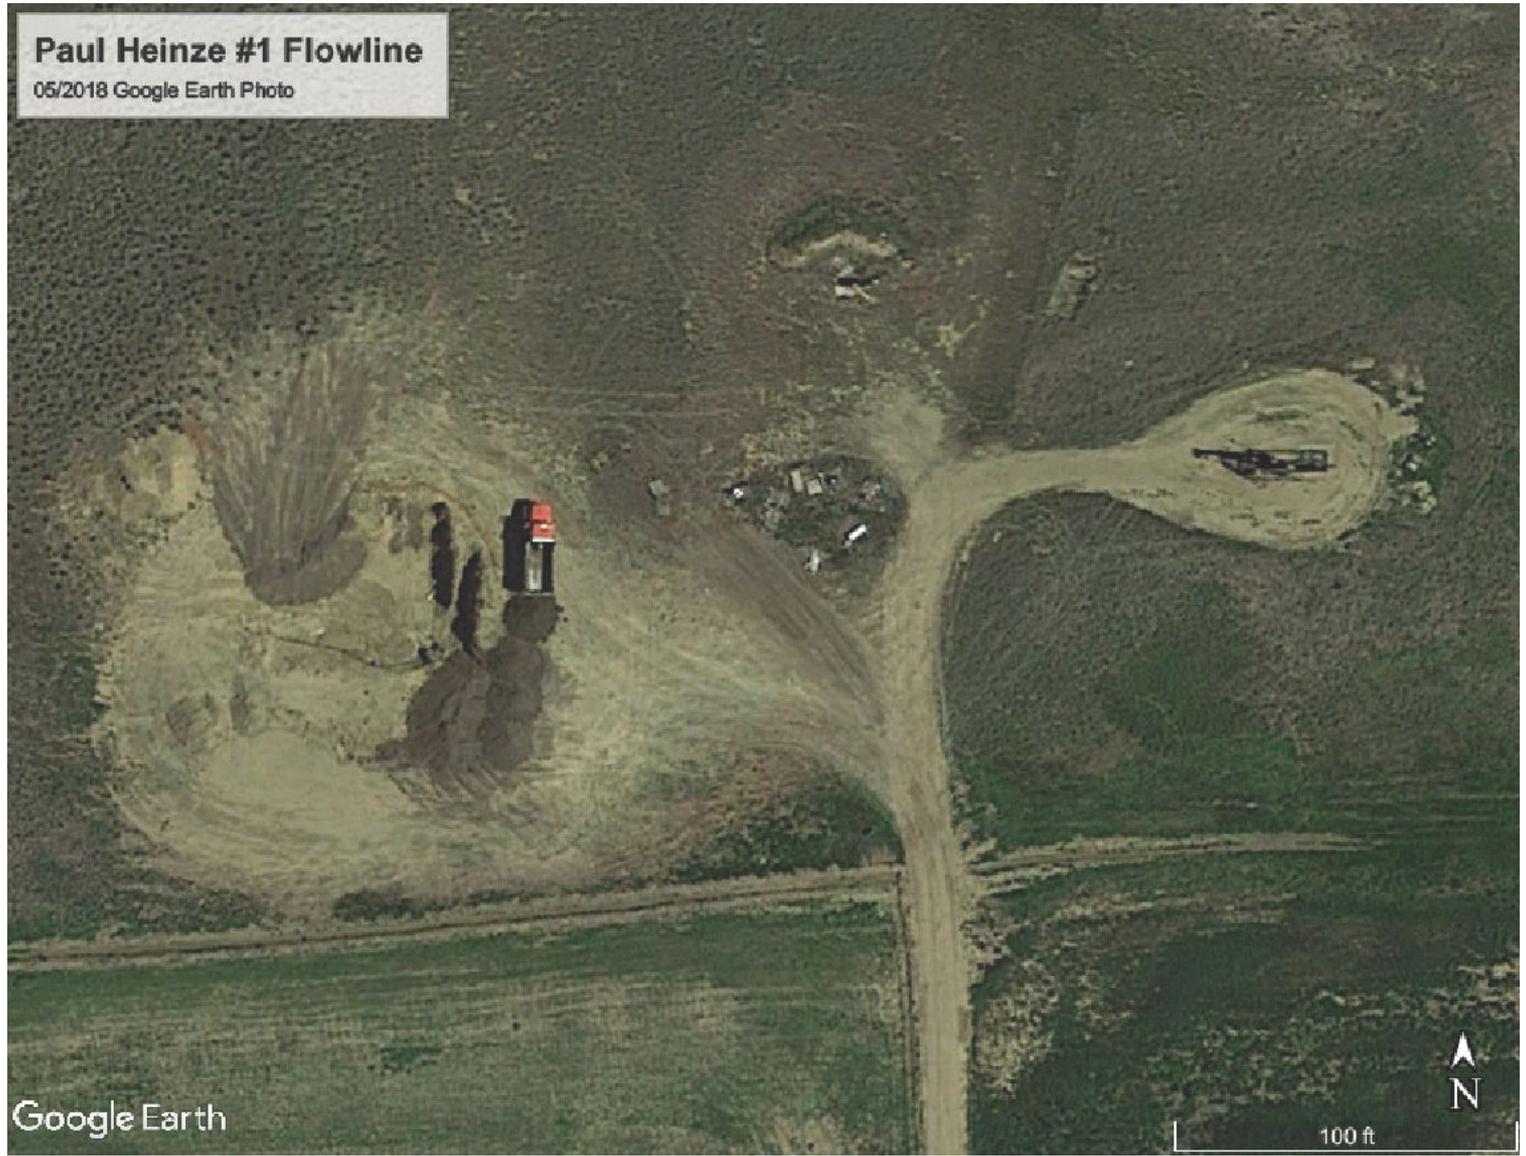
Excavation footprint and backfill of unreported spill

Spill Volume Calculation

Table 900-3 Conversion for Sand			
Excavation Length	Excavation Width	Excavation Depth	Excavation Total Cubic Feet 1890
Conversion to cubic yards (total cubic feet/27)			70
High Retention Factor			0.2
Low Porosity			0.35
Conversion Factor: cubic yards/bbl			0.21
Assumed overburden			0.25
Estimated barrels released			6

Table 900-3 Conversion for Silt/Clay			
Excavation Length	Excavation Width	Excavation Depth	Excavation Total Cubic Feet 1890
Conversion to cubic yards (total cubic feet/27)			70
High Retention Factor			0.13
Low Porosity			0.25
Conversion Factor: cubic yards/bbl			0.21
Assumed overburden			0.25
Estimated barrels released			3

****Volumes based on soil staged in Google Earth aerial imagery dated 05/2018 ****

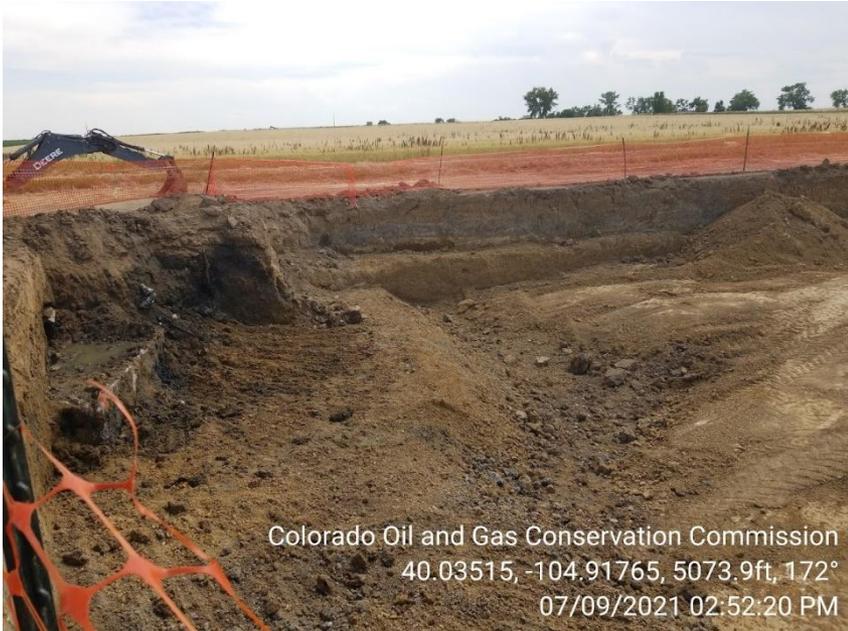
**Photo 8 – COGCC inspection 7/9/2021 showing
produced water vault location**

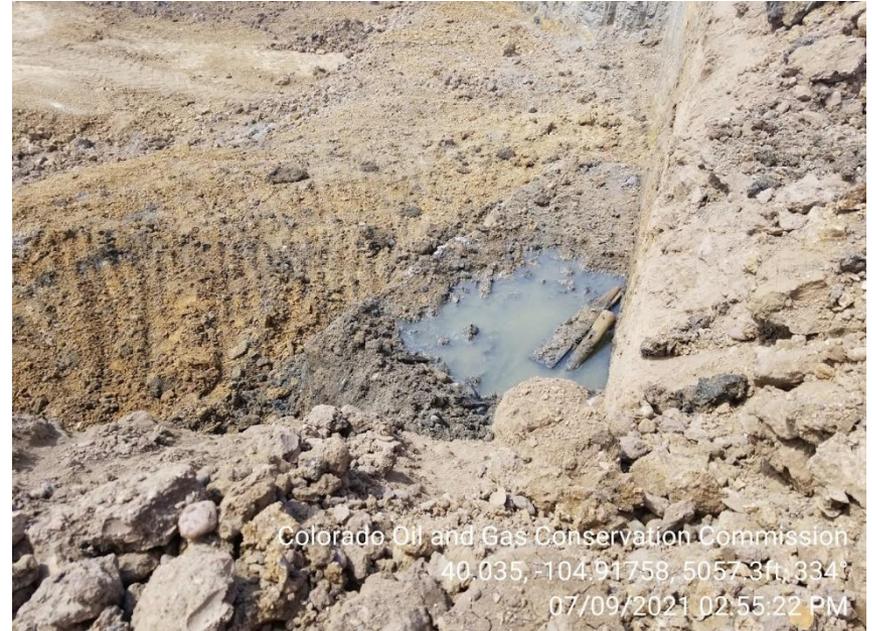
**Photo 9 – COGCC inspection 7/9/2021 showing
produced water vault location and impacts on top of
vault.**
