Inspection Photos

API: 05-041-06072

Operator: HILCORP ENERGY COMPANY

Inspection and Photo Date: 8/23/2021

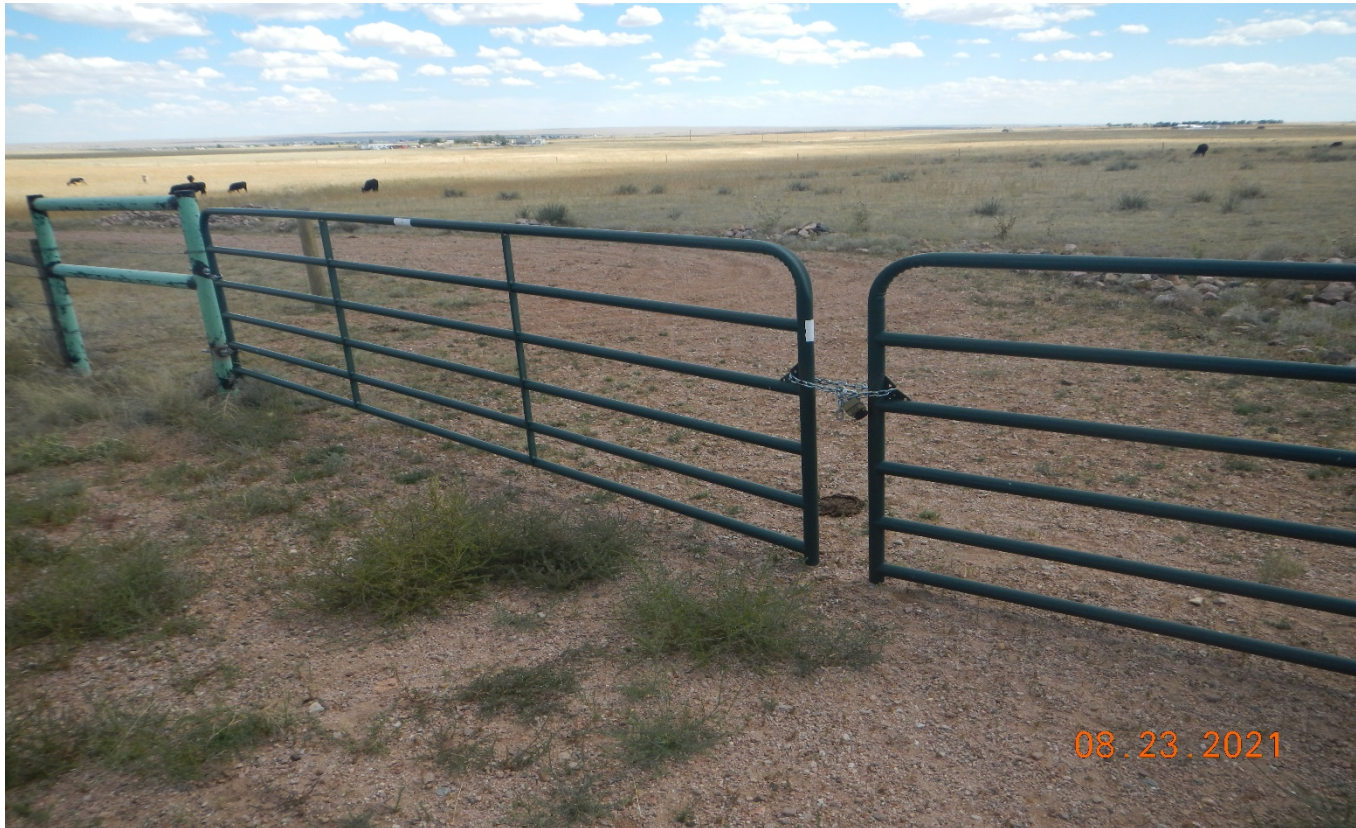
Photo 1. Facing southeast on the access road at the double gates. The access road from the gates which turns to the east (left) has an approved variance to remain. See Exhibit 1.

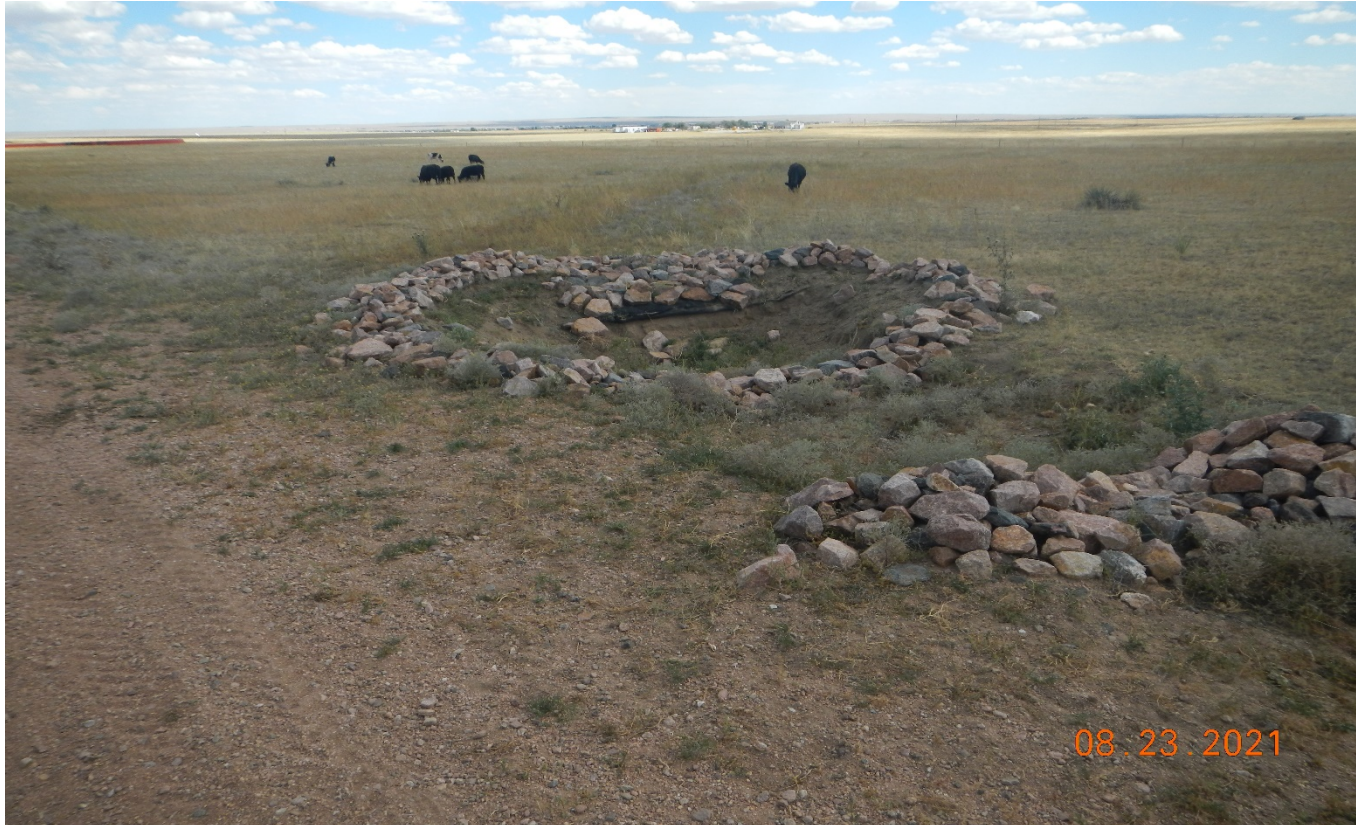
Photo 2. Facing southeast toward the sediment trap. The sediment trap and rock check dams are functional and maintained.

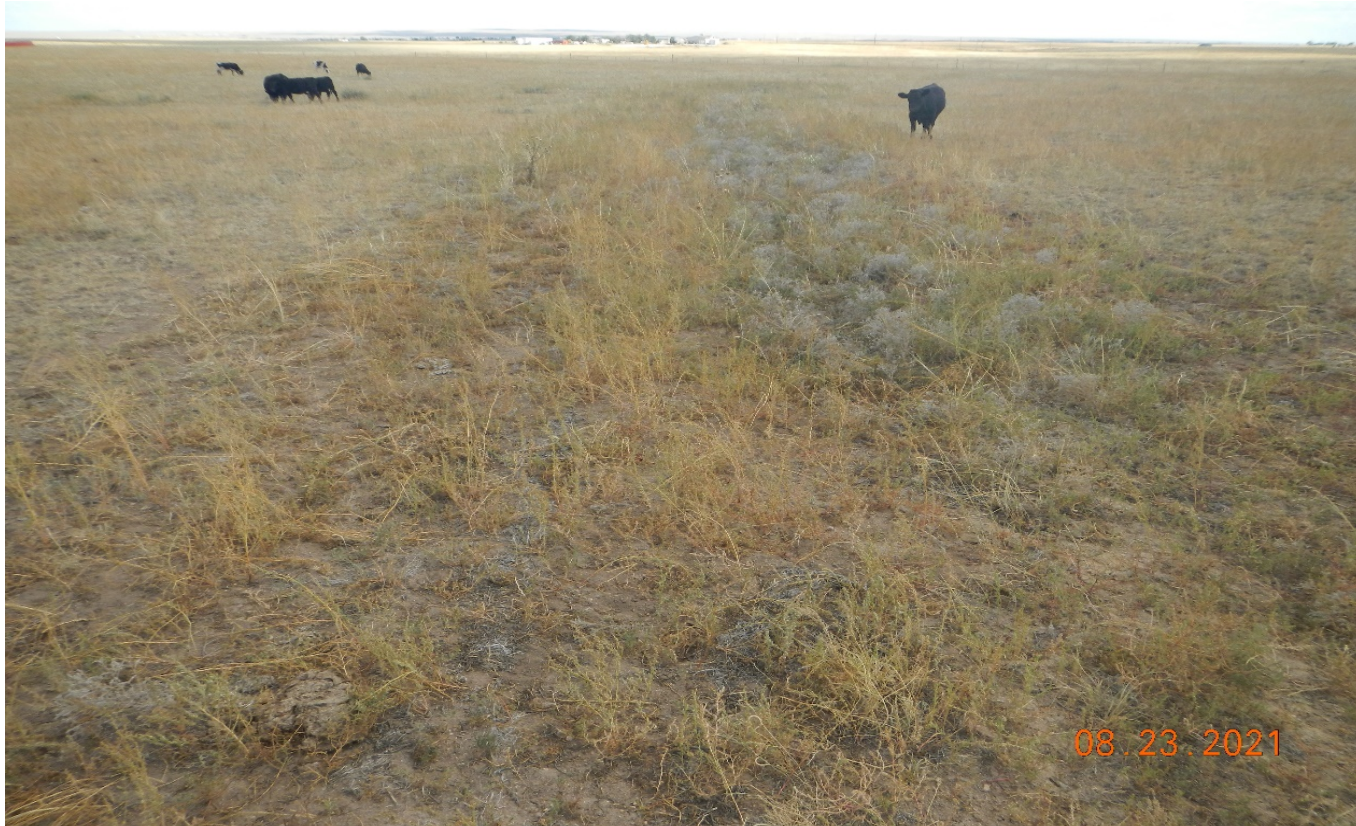
Photo 3. The erosion area which extended out beyond the sediment trap was repaired but has not met the revegetation standard and consists of undesirable weeds. Additional reseeding needs to be performed in this area.

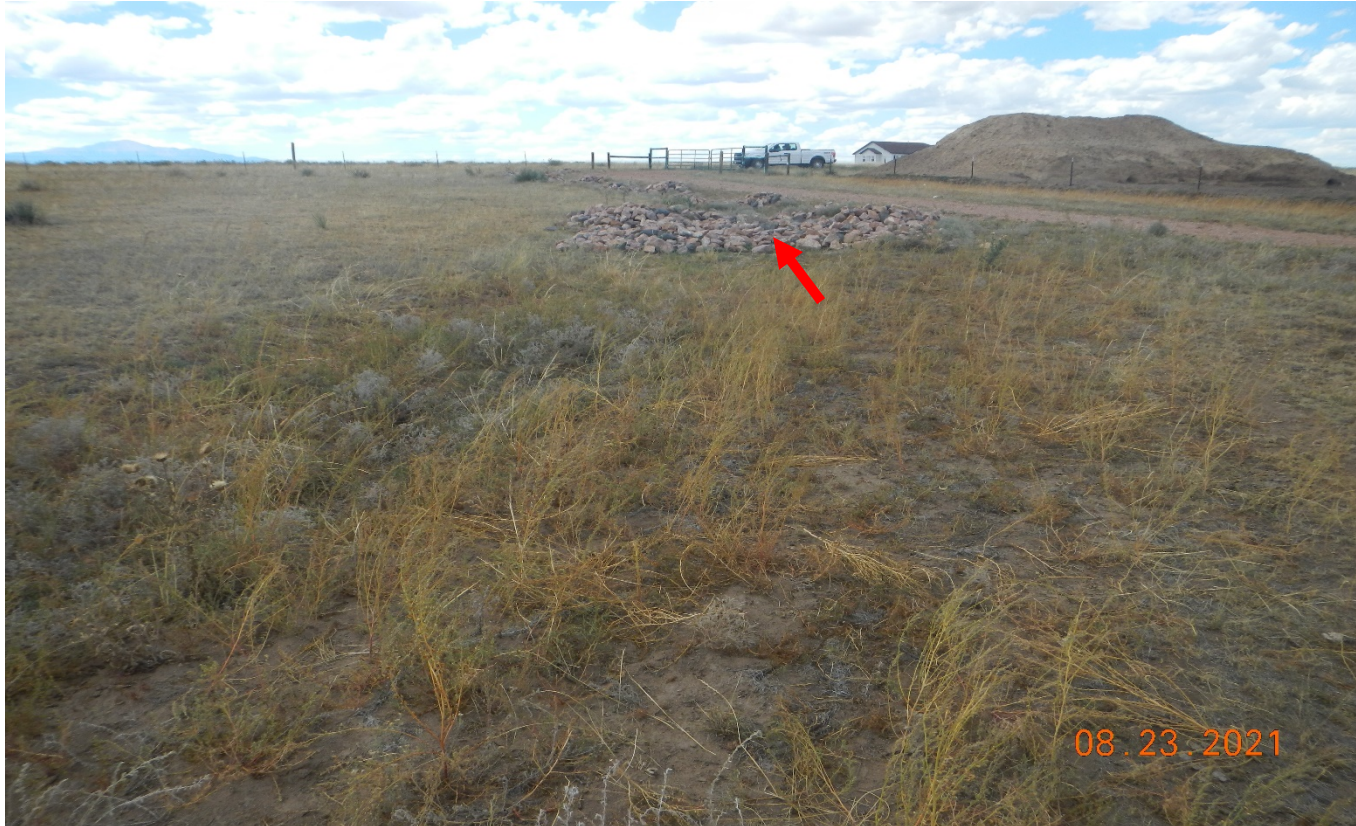
Photo 4. Facing northwest toward the road. Sediment trap is located at red arrow. The rock check dams are installed further up along the road toward the double gate.

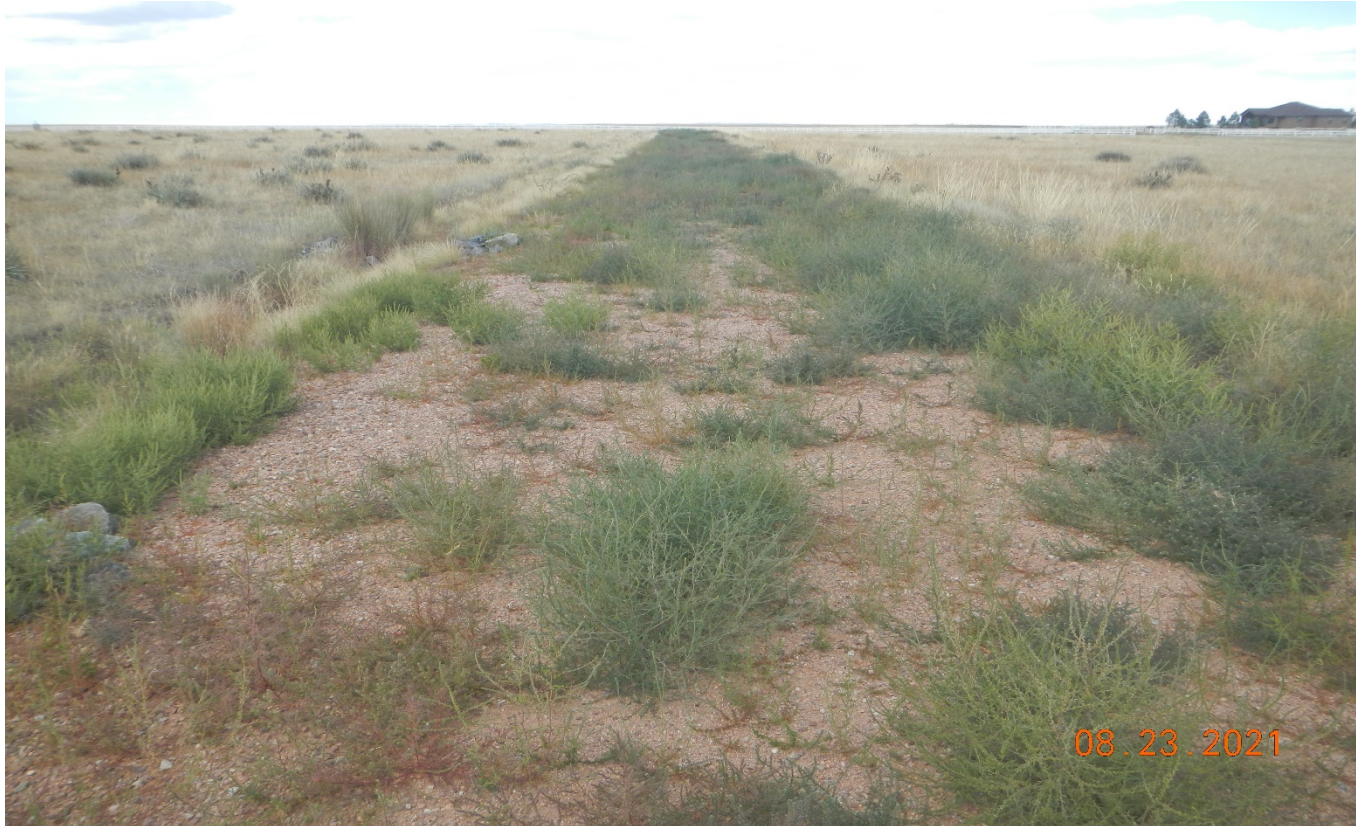
Photo 5. Facing north at the double gates shown at photo 1. This portion of the road has not received an approved variance of reclamation (See Exhibit 1). The dark green vegetation along the road is undesirable weeds (Russian thistle). The weeds can spread to surrounding pasture and must be controlled.

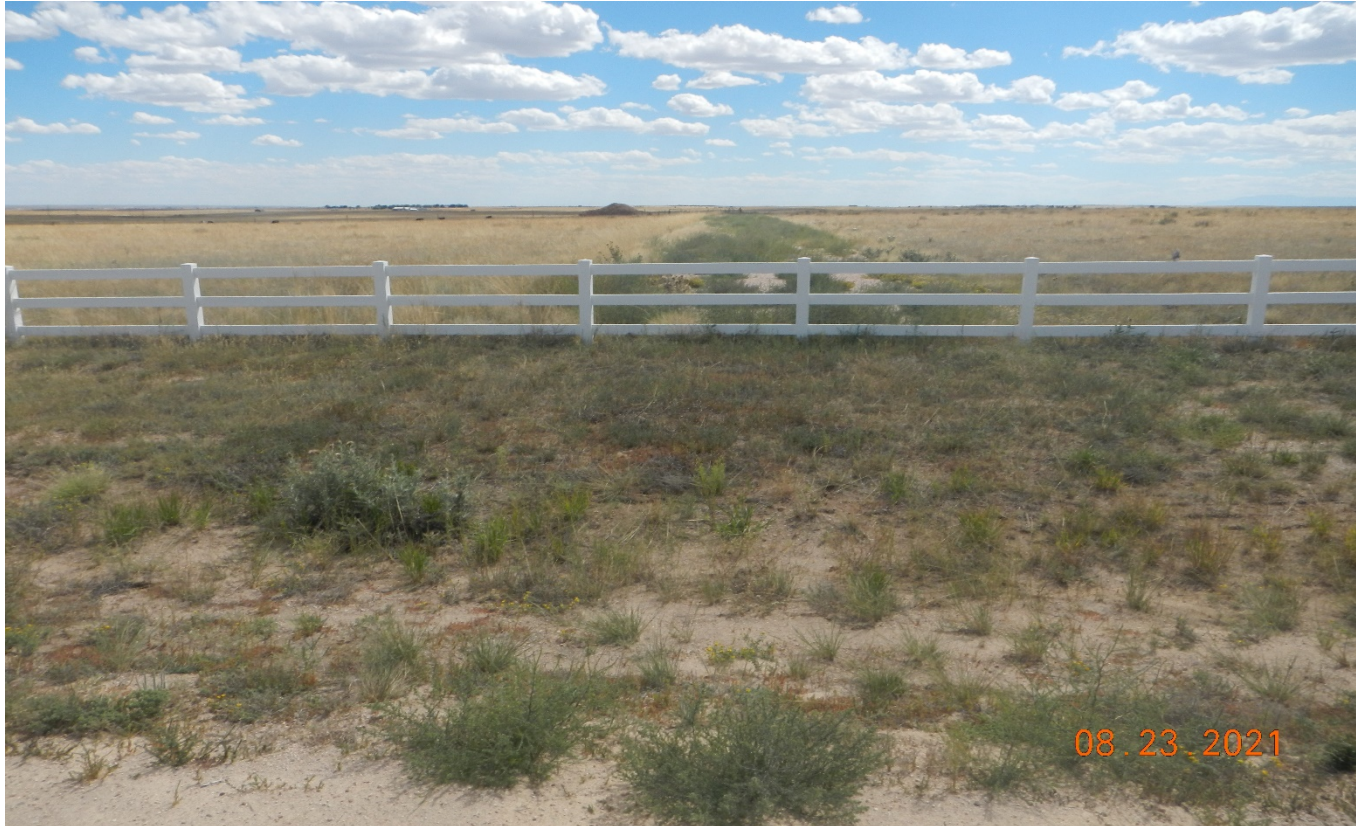
Photo 6. Standing on the subdivision road looking south toward the access road shown in previous photo. The subdivision road now intersects the well site access road. It does not appear that the former access road running north/south serves a purpose and should be reclaimed.

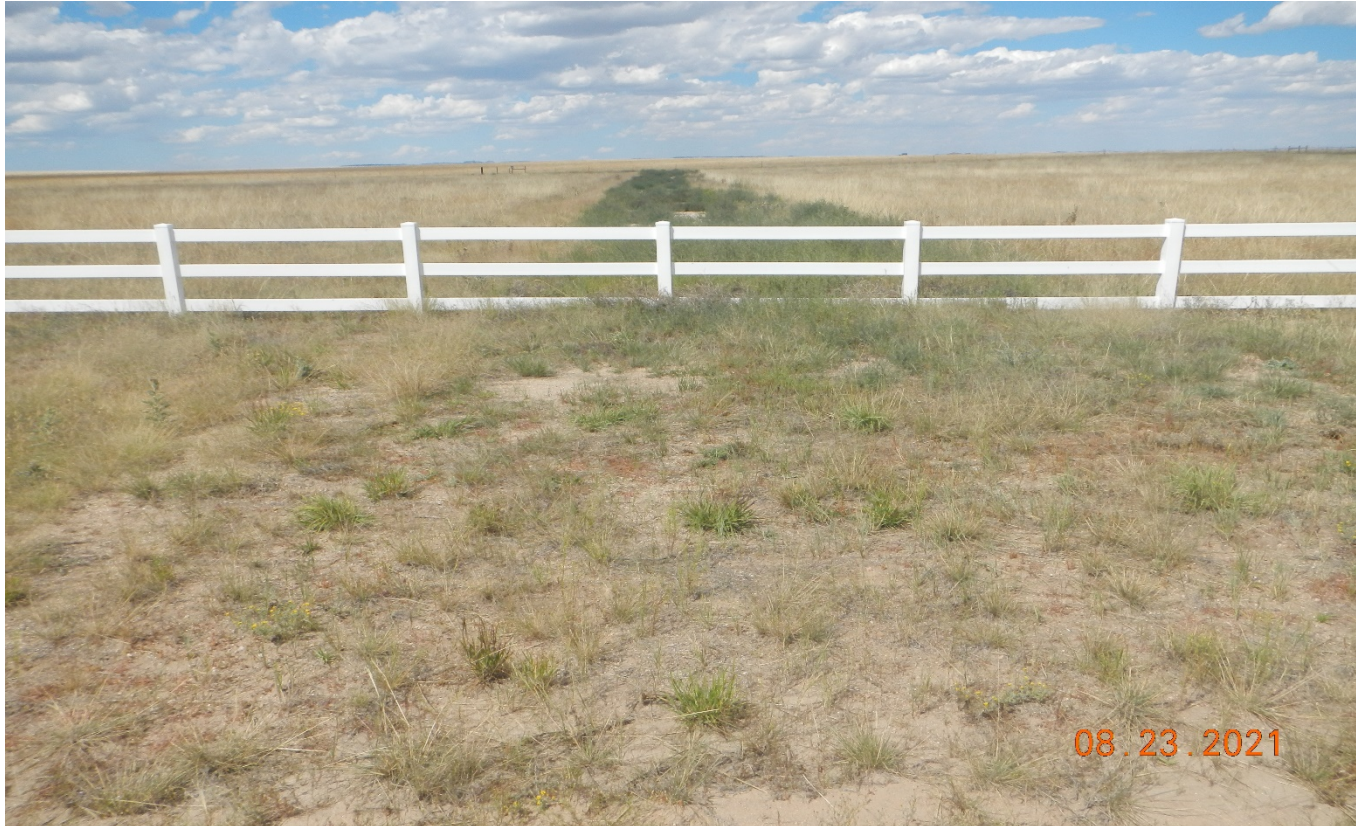
Photo 7. Standing at the same point as previous photo on the subdivision road. The subdivision road now intersects the well site access road. It does not appear that the former access road running north/south serves a purpose and should be reclaimed.

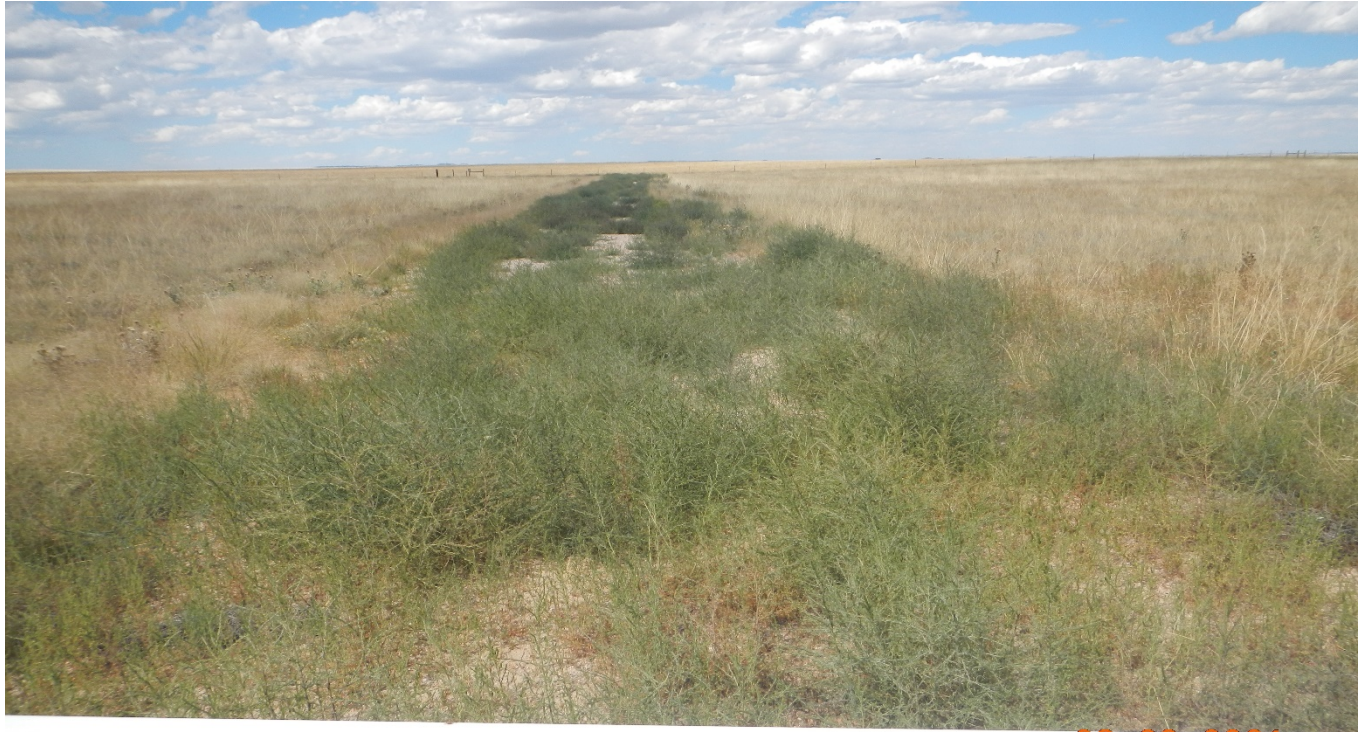
Photo 8. Facing north at the access road shown I previous photo. This portion of the road has not received an approved variance of reclamation (See Exhibit 1). The dark green vegetation along the road is undesirable weeds (Russian thistle). The weeds can spread to surrounding pasture and must be controlled.

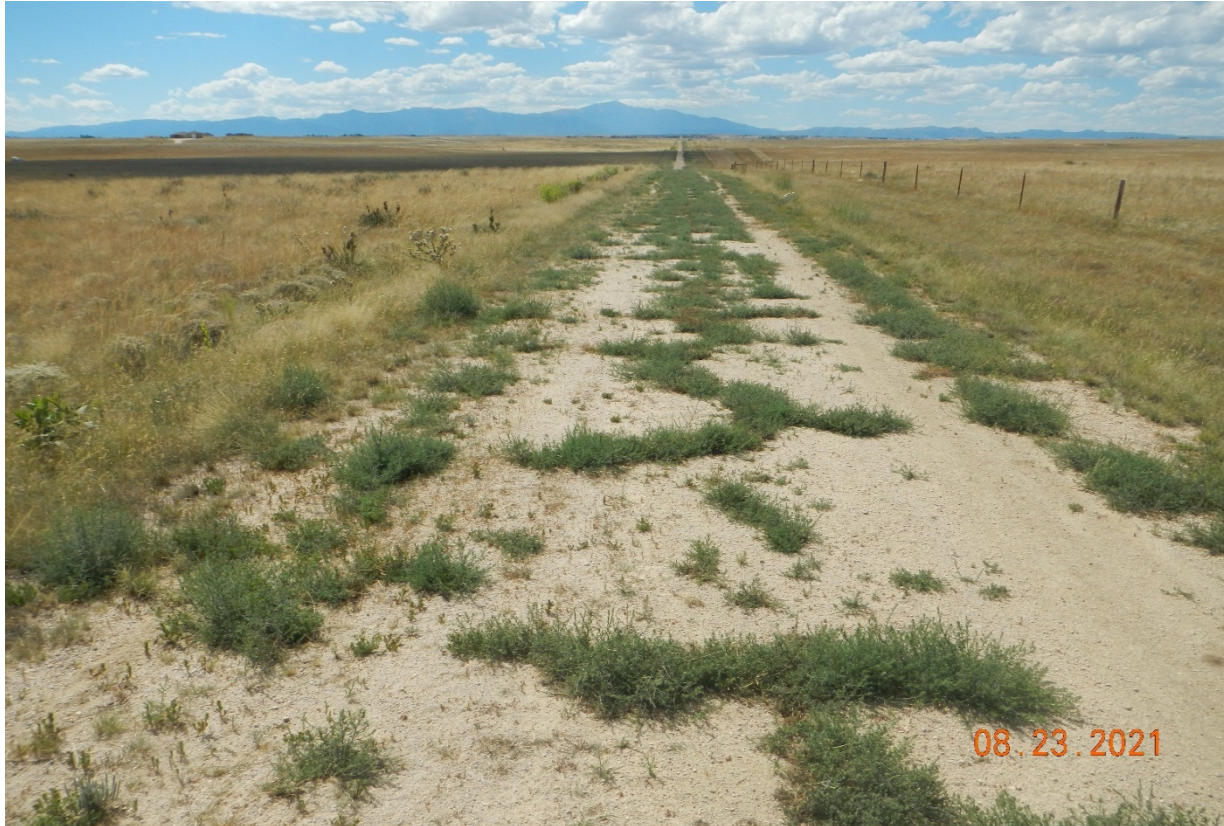
Photo 9. Facing west along the access road. This portion of the road all the way toward the well site has also not received an approved variance of reclamation (See Exhibit 1).

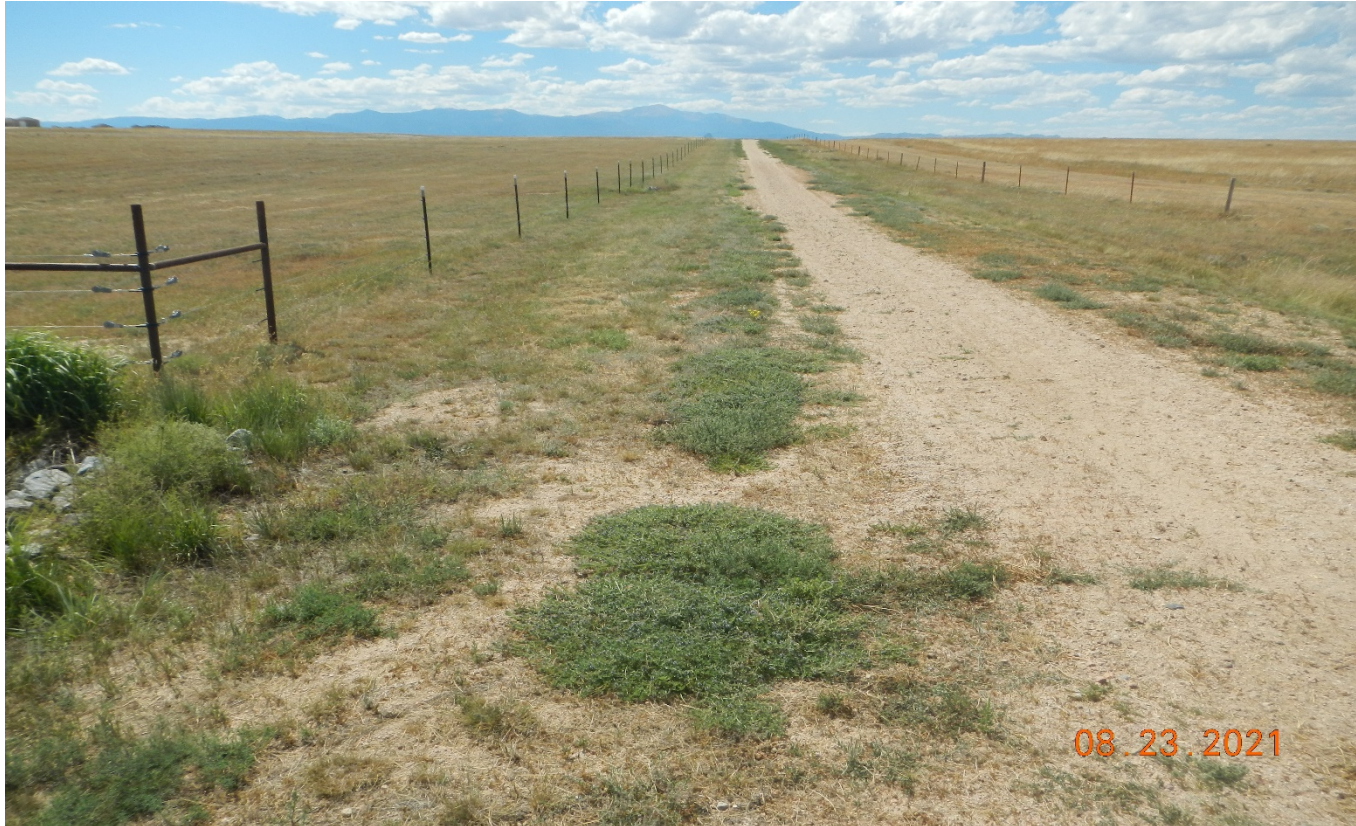
Photo 10. Facing west further along the access road. BMP's are maintained along the road.

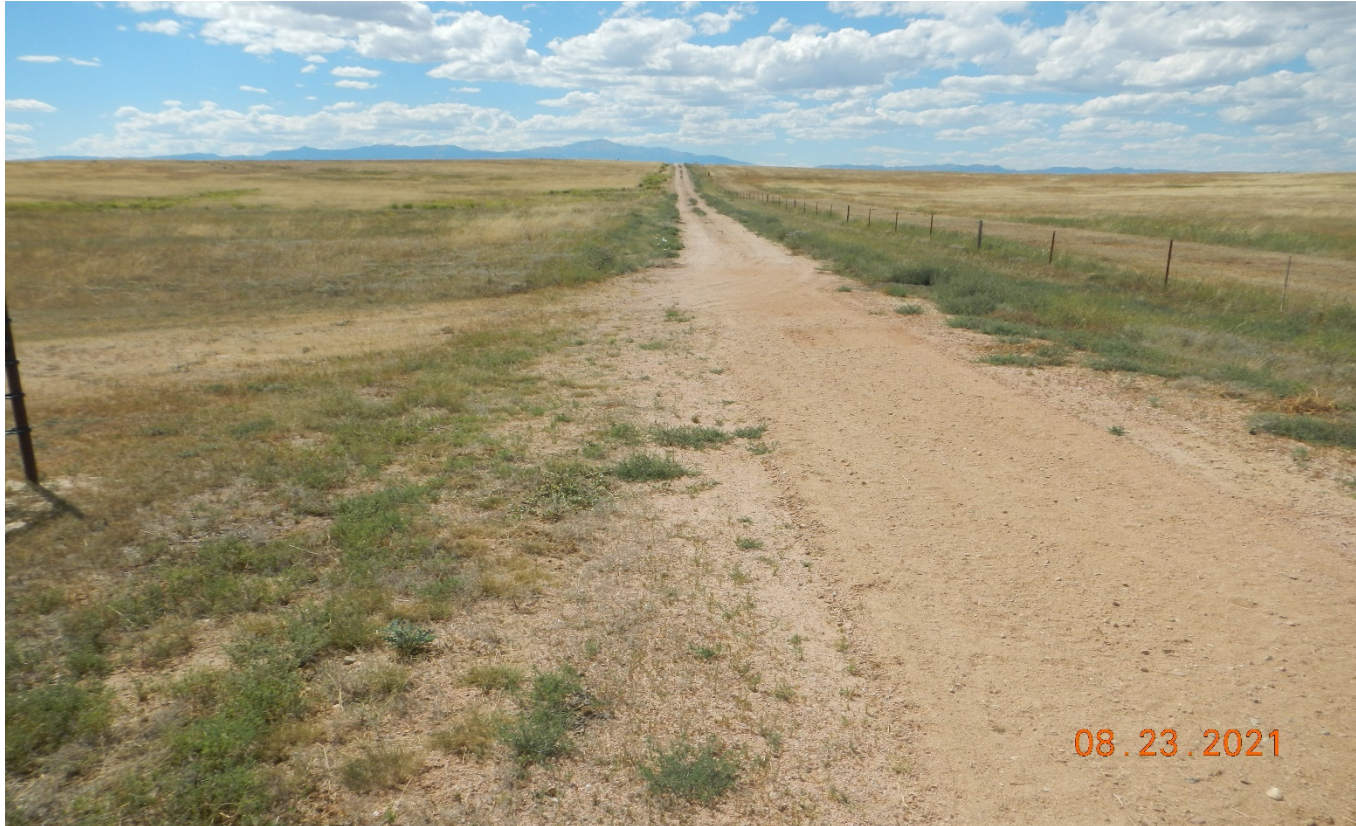
Photo 11. Facing west further along the access road.

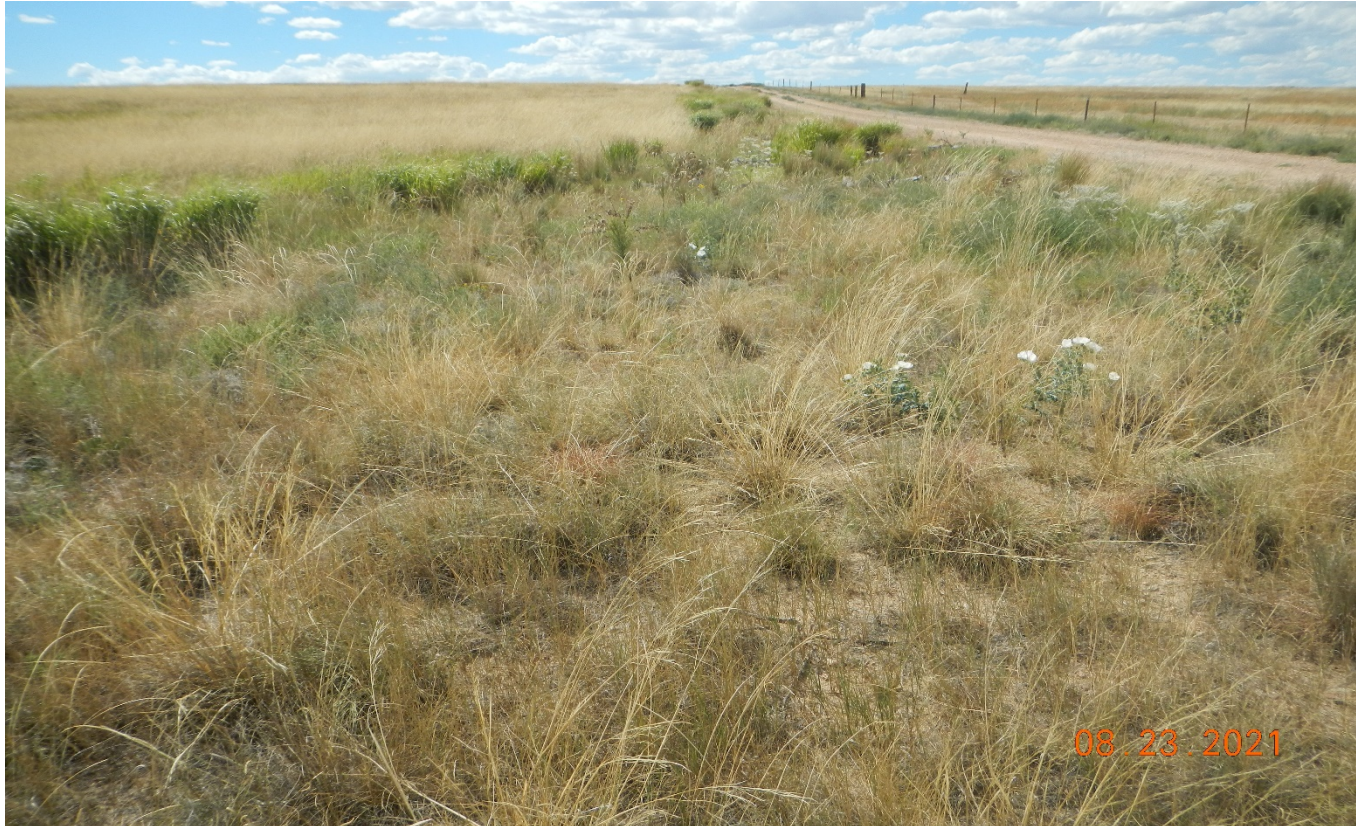
Photo 12. Facing west along the main road where seeding was previously performed. The vegetation has established along this area of the road.

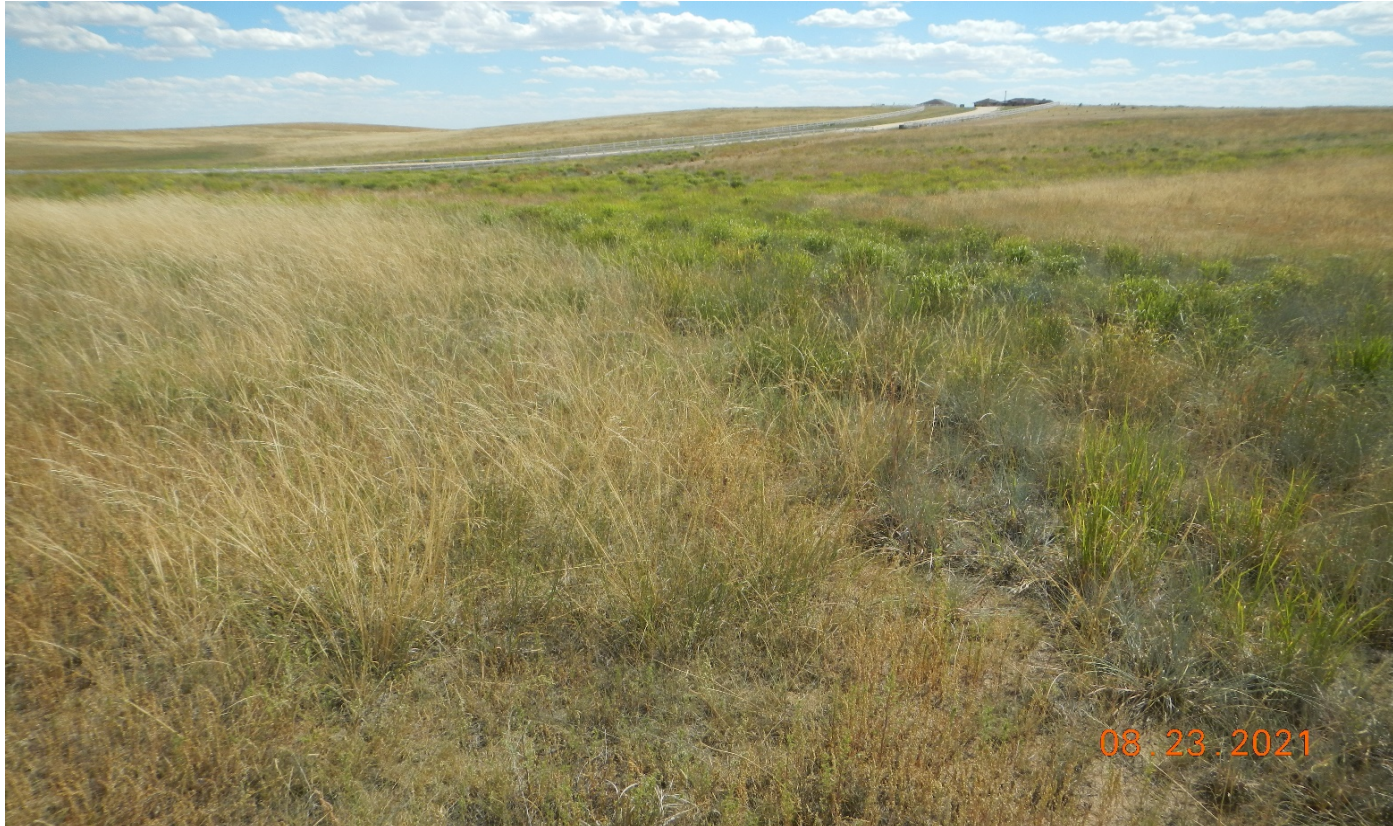
Photo 13. Facing southwest at the location. The vegetation has established at least 80% vegetation cover of reference area levels throughout the location.

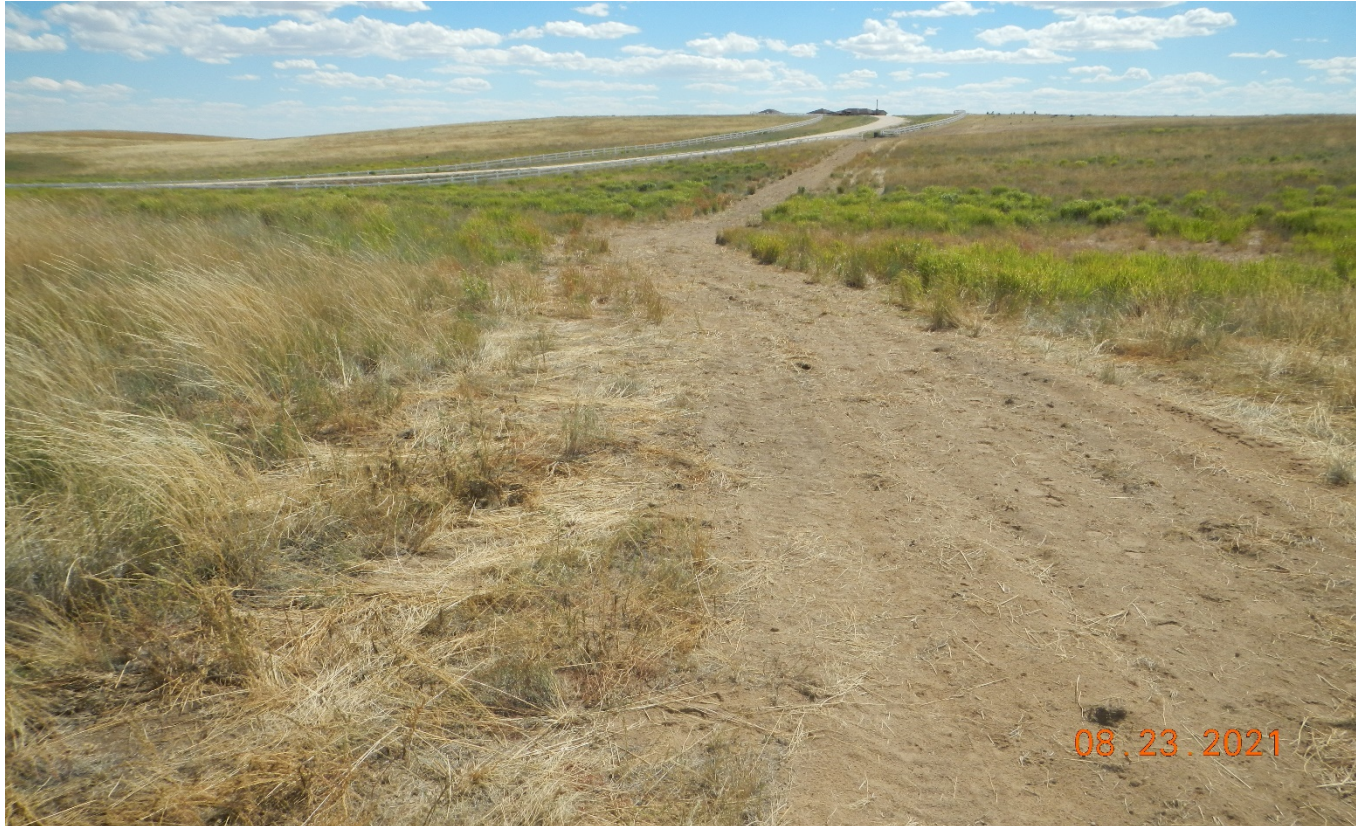
Photo 14. This area at the location was disturbed due to development utility installation. Previous inspection documented this area of the location had established 80% vegetation cover.

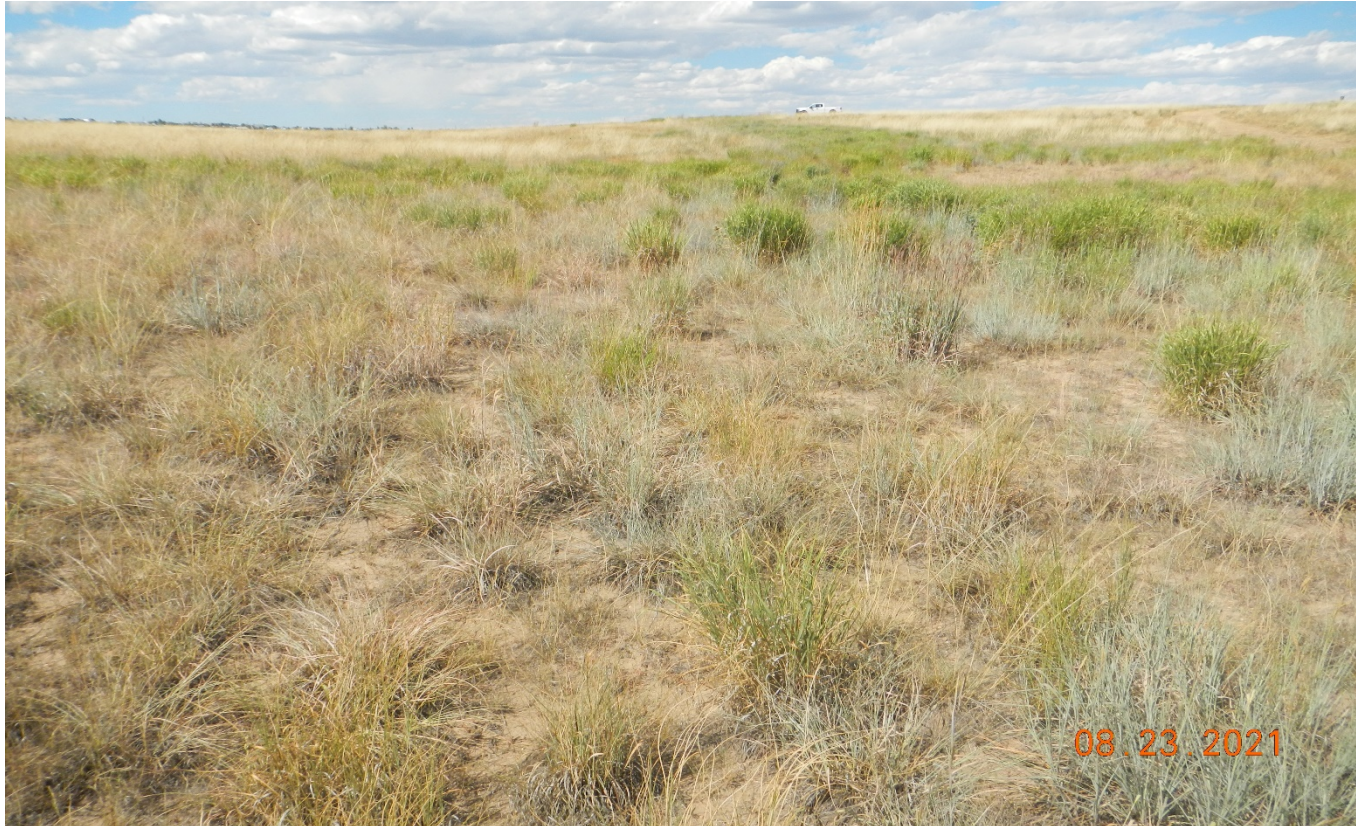
Photo 15. Facing north at northern portion of the location. The vegetation has established at least 80% vegetation cover of reference area levels throughout the location.

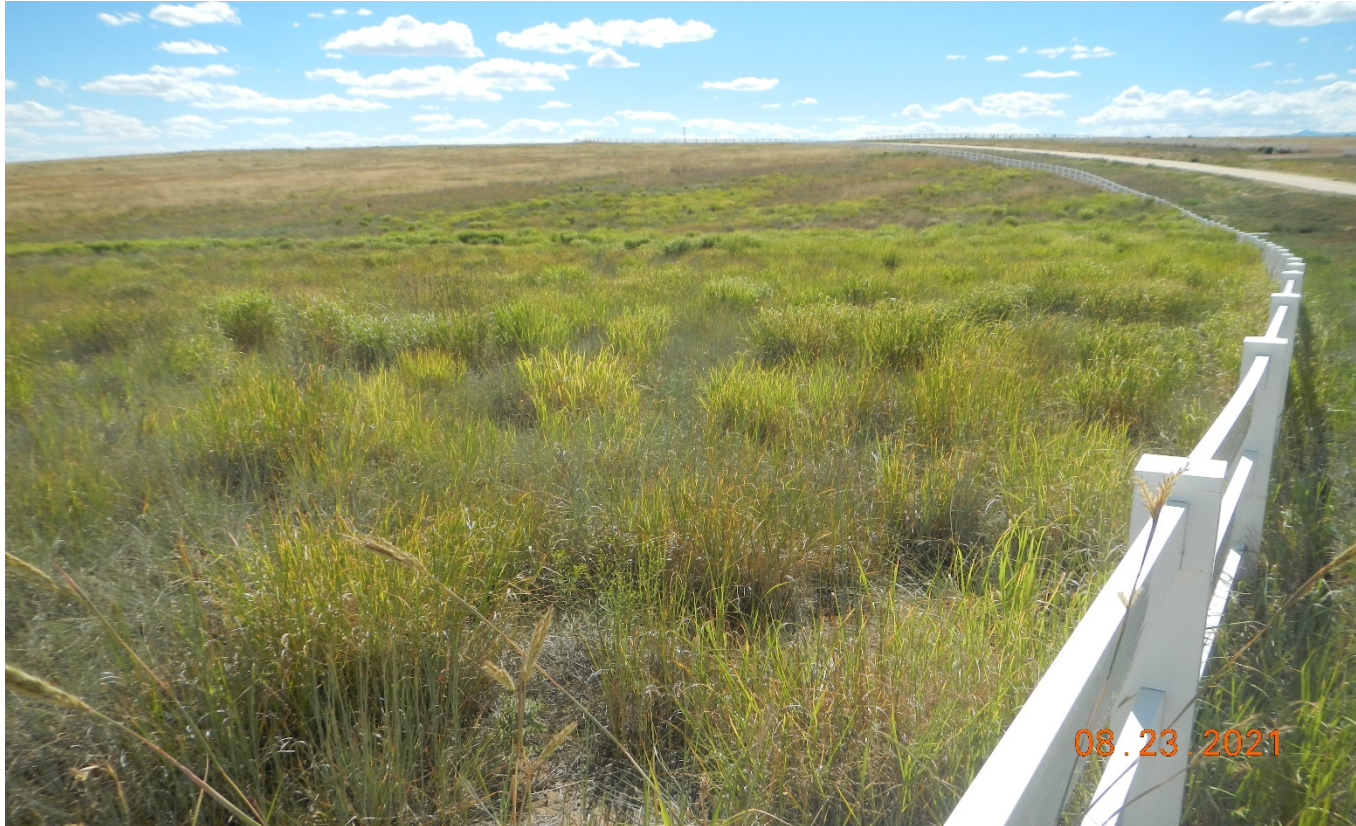
Photo 16. Facing southwest toward the southern portion of the location. The white fence was installed by the land developer. The vegetation has established at least 80% vegetation cover of reference area levels throughout the location.

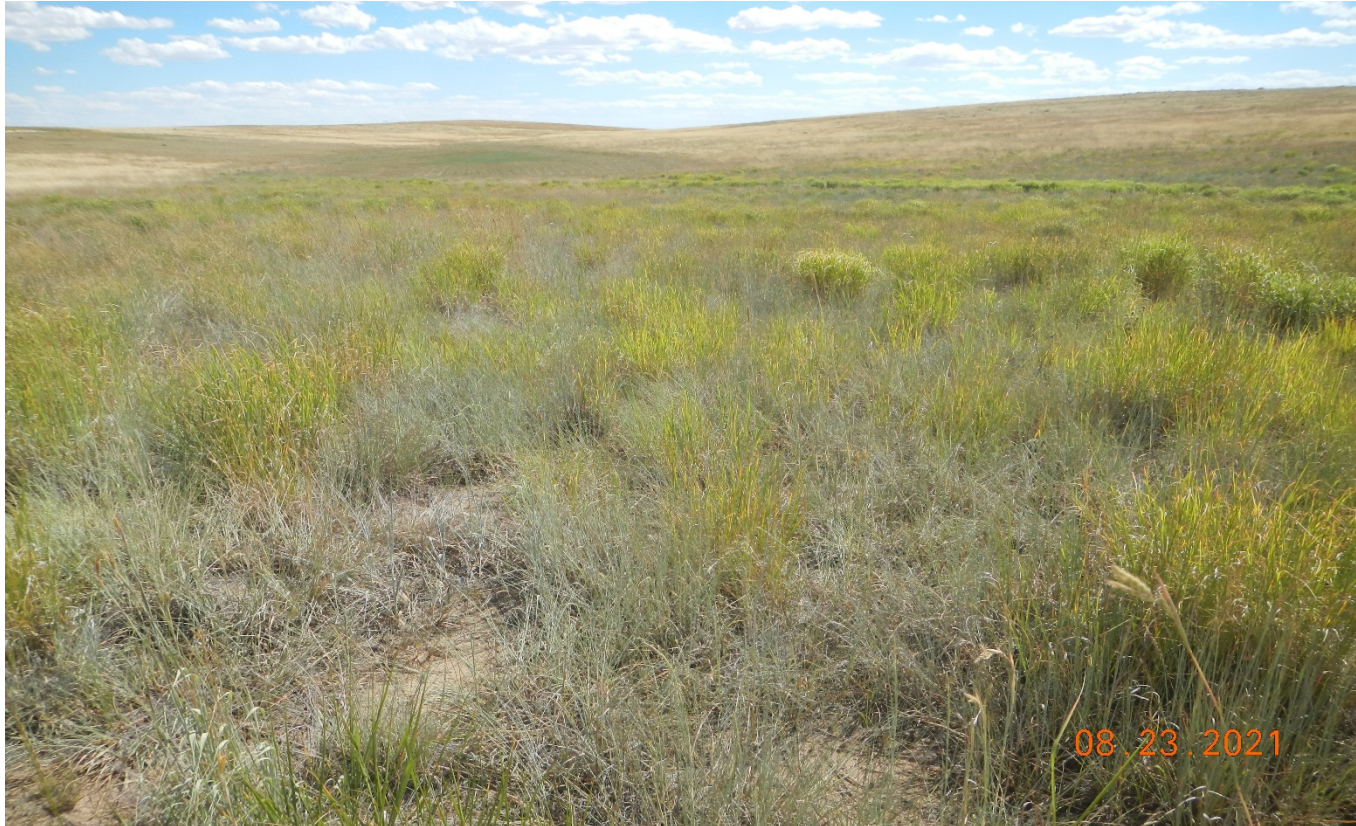
Photo 17. Facing south at the southern portion of the location. The vegetation has established at least 80% vegetation cover of reference area levels throughout the location.
