# Inspection Photos

Operator: Hilcorp Energy  
API: 067-05707  
Date: 8/17/2021

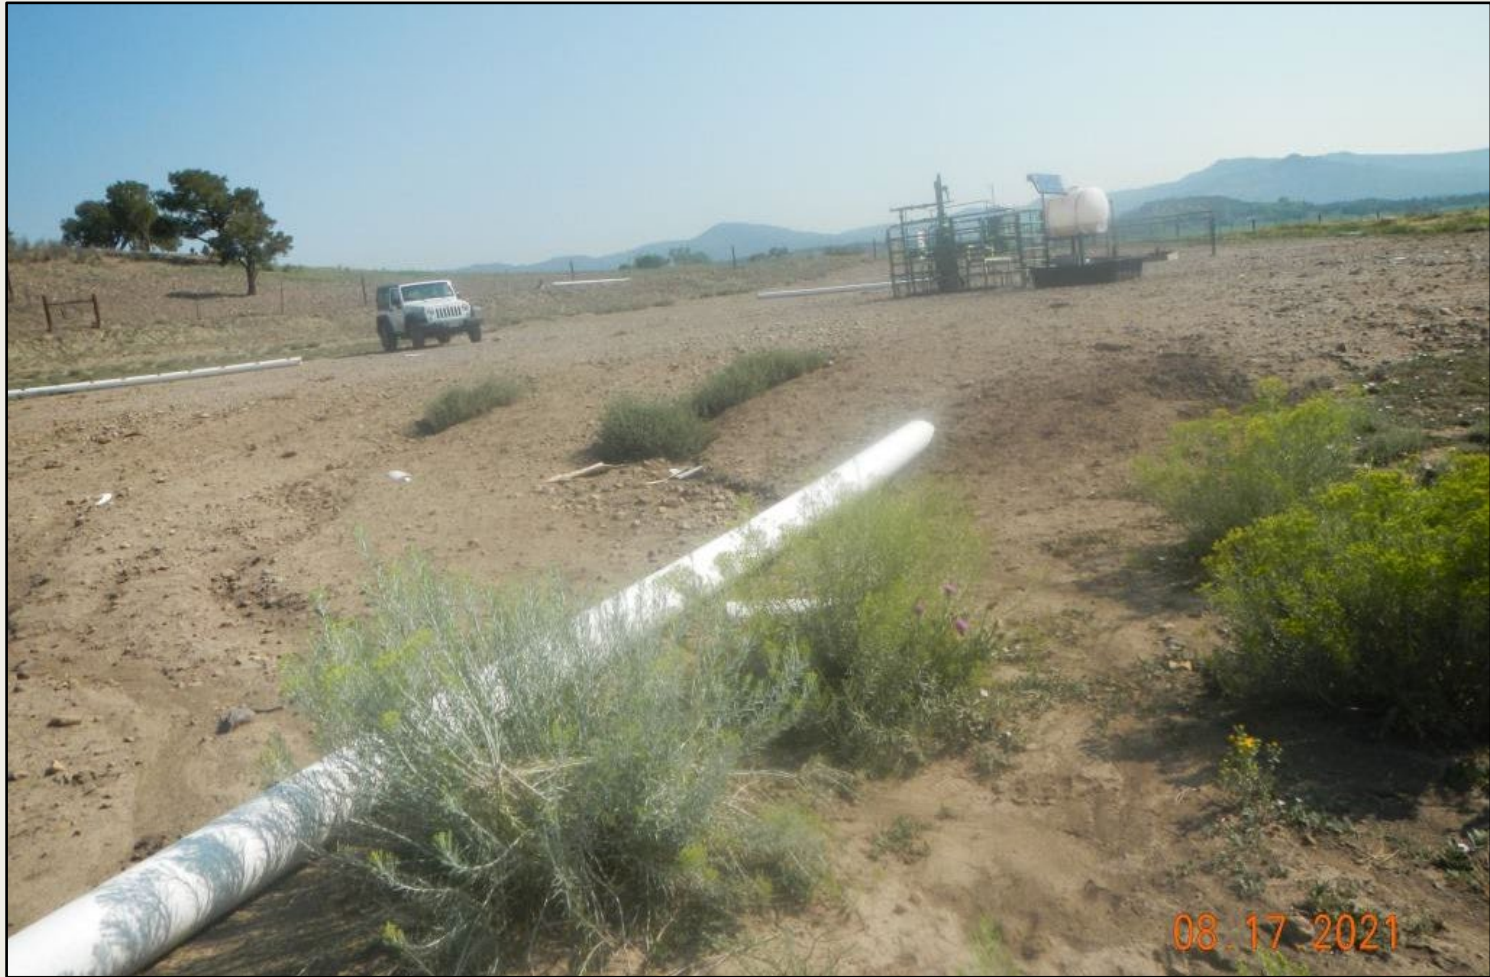
Photo 1. View of the project area from southwestern corner facing center.

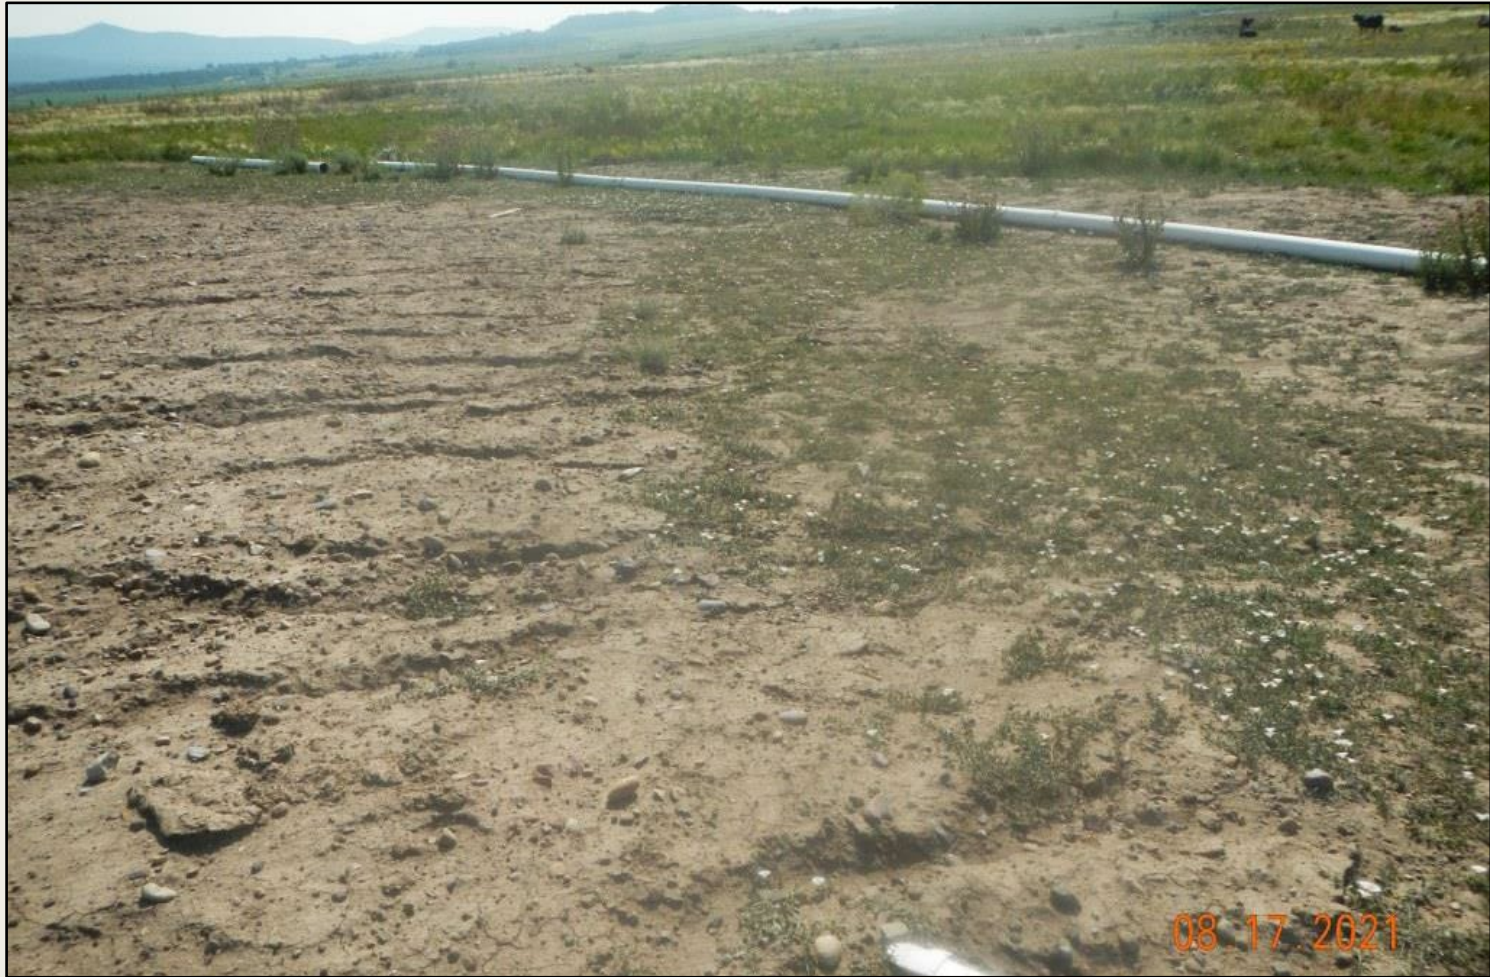
Photo 2. View of the southern project area facing eastward. Little desirable vegetation present within the interim reclamation areas. Rilling and erosional channeling is occurring across the fill slope.

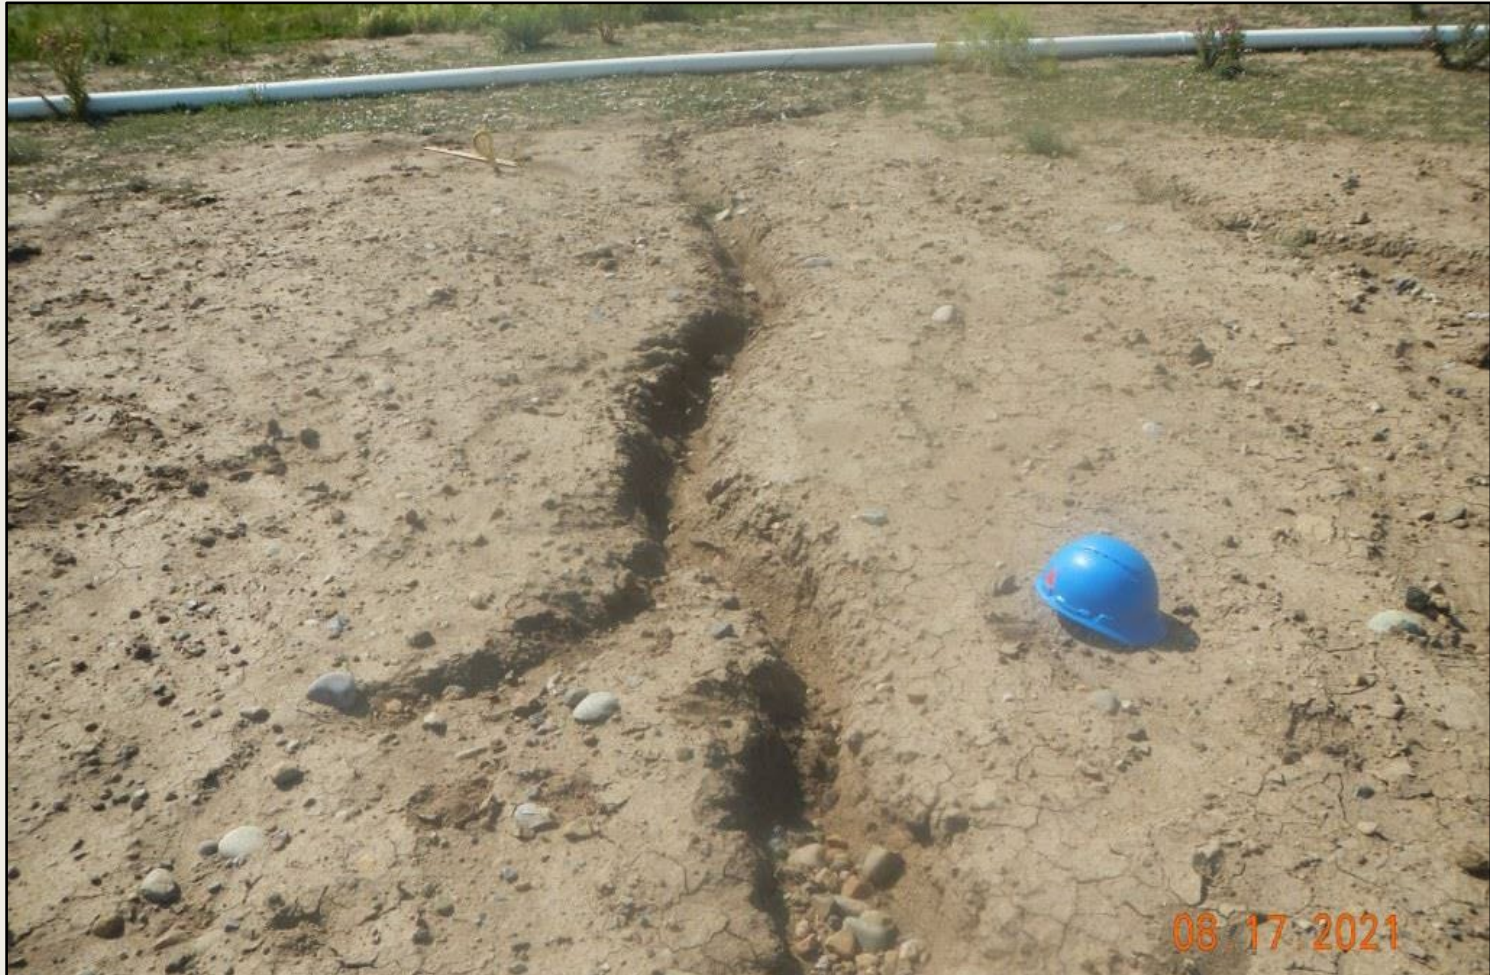
Photo 3. View of erosional channel forming within the southern project area, approximately 1-1.5ft wide and deep. Hard hat in place for scale.

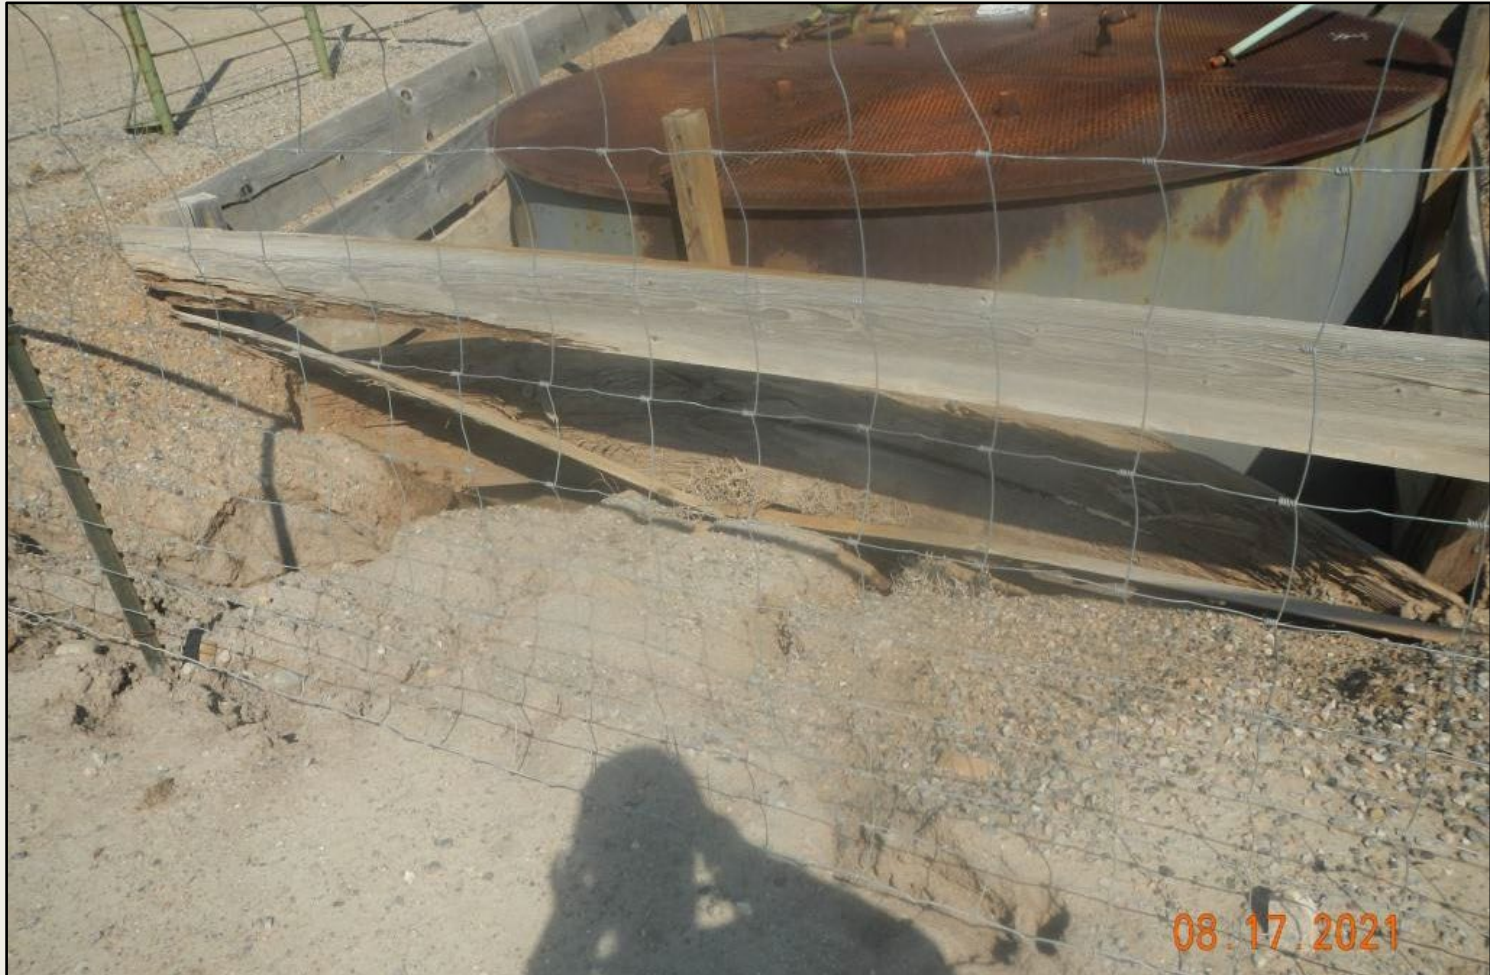
Photo 4. View of erosion occurring around submerged vessel. Area around the vessel is holding water and is not adequate containment.

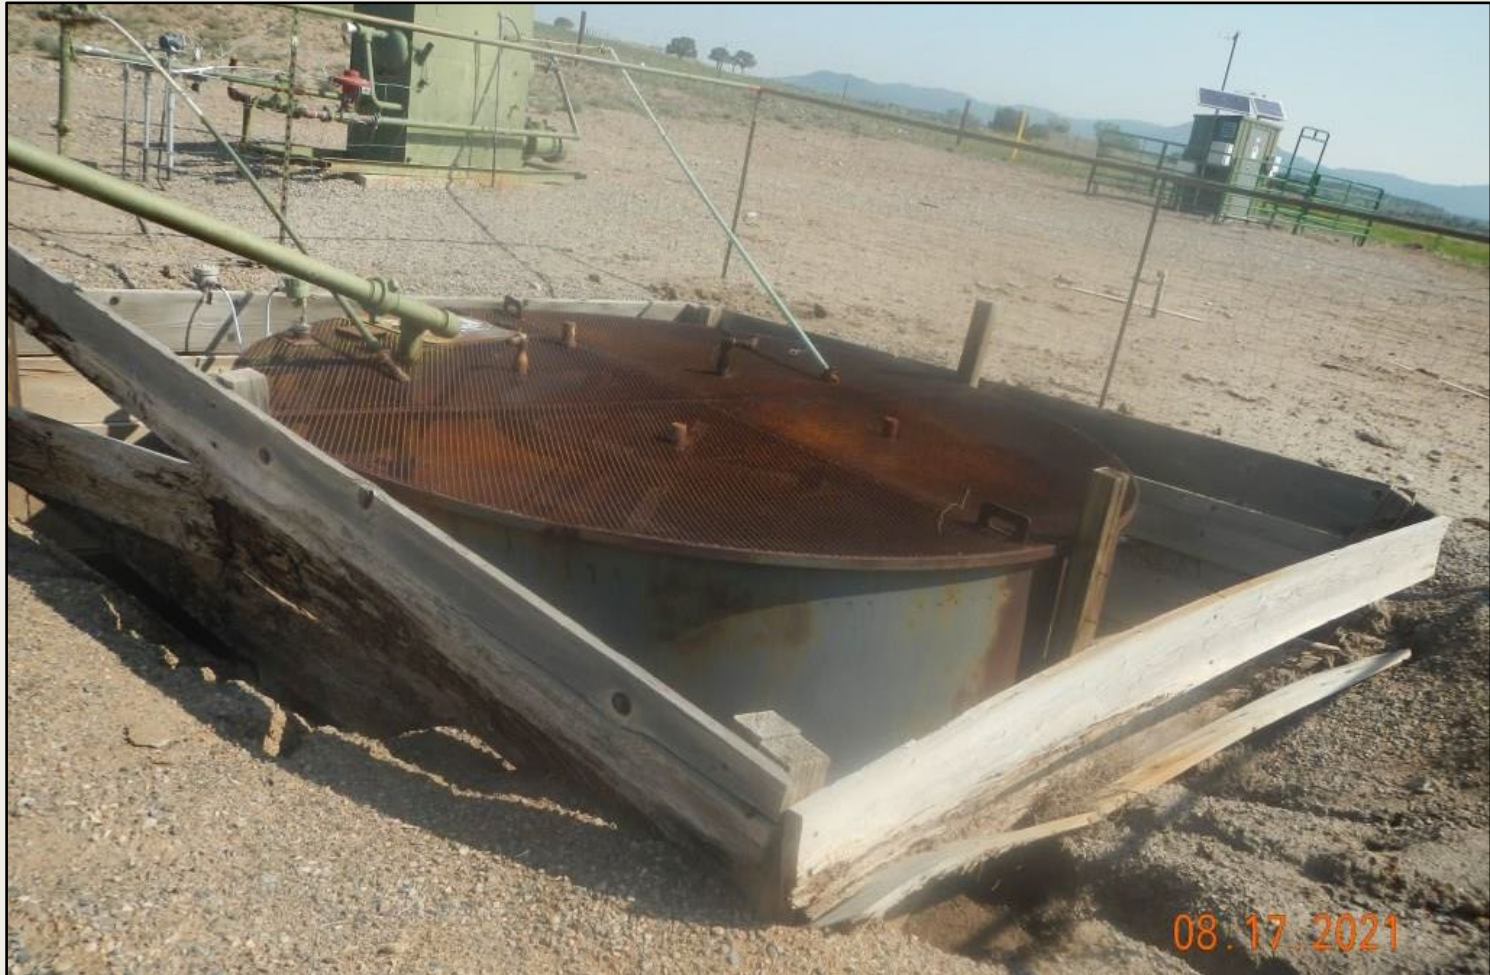
Photo 5. Another view of damaged and eroding containment around submerged vessel.

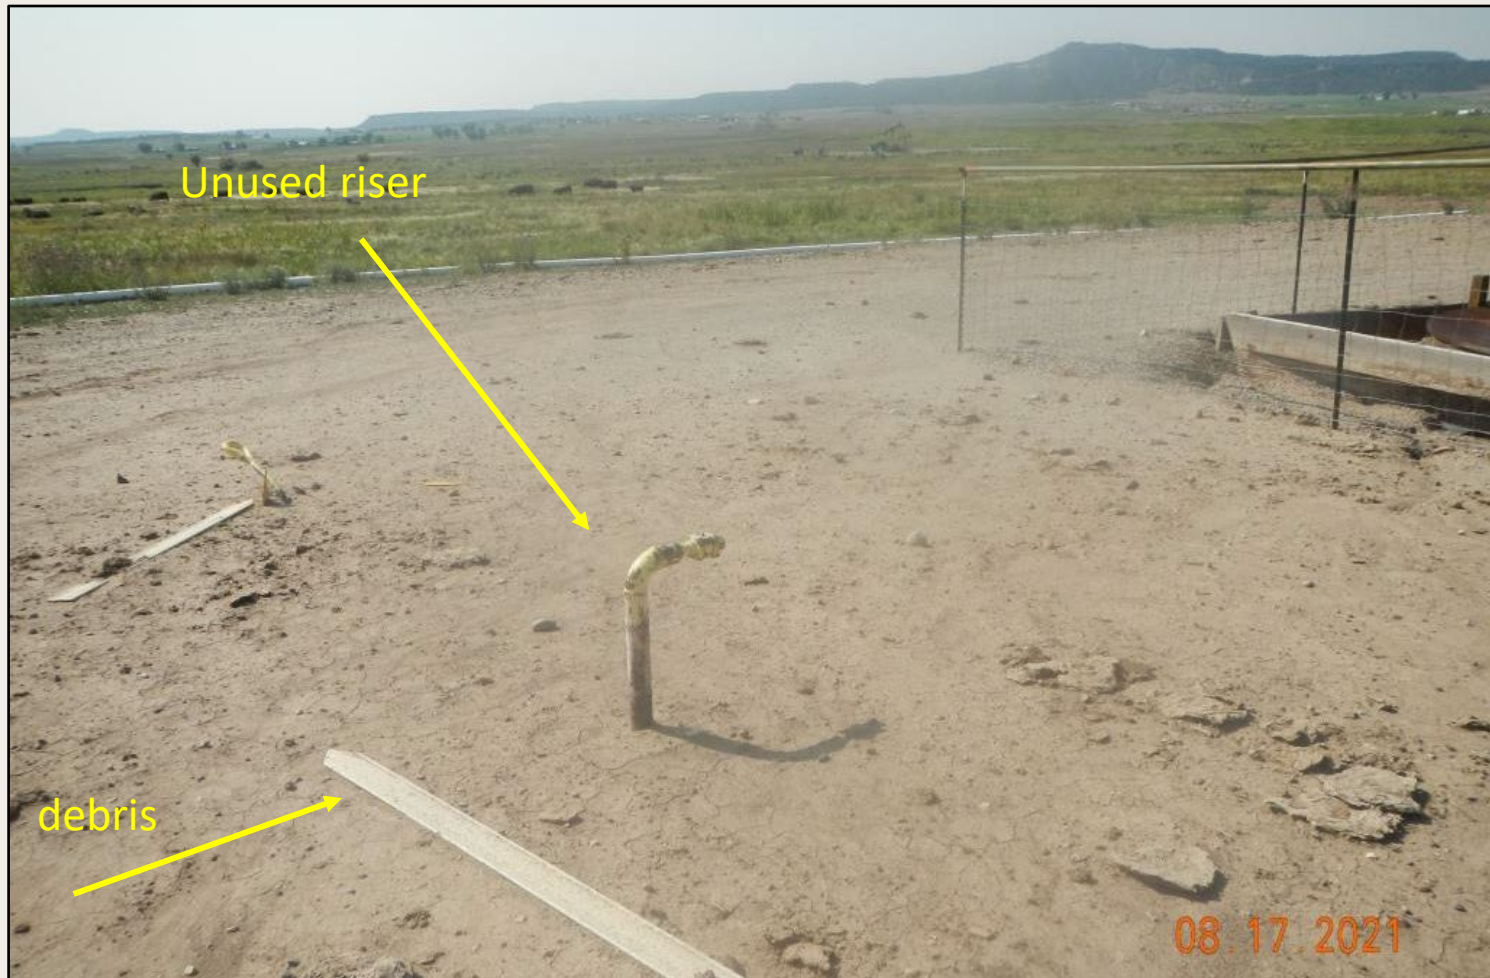
Photo 6. View of unused riser and marker debris within the eastern project area. Rig anchor needs to be properly marked.

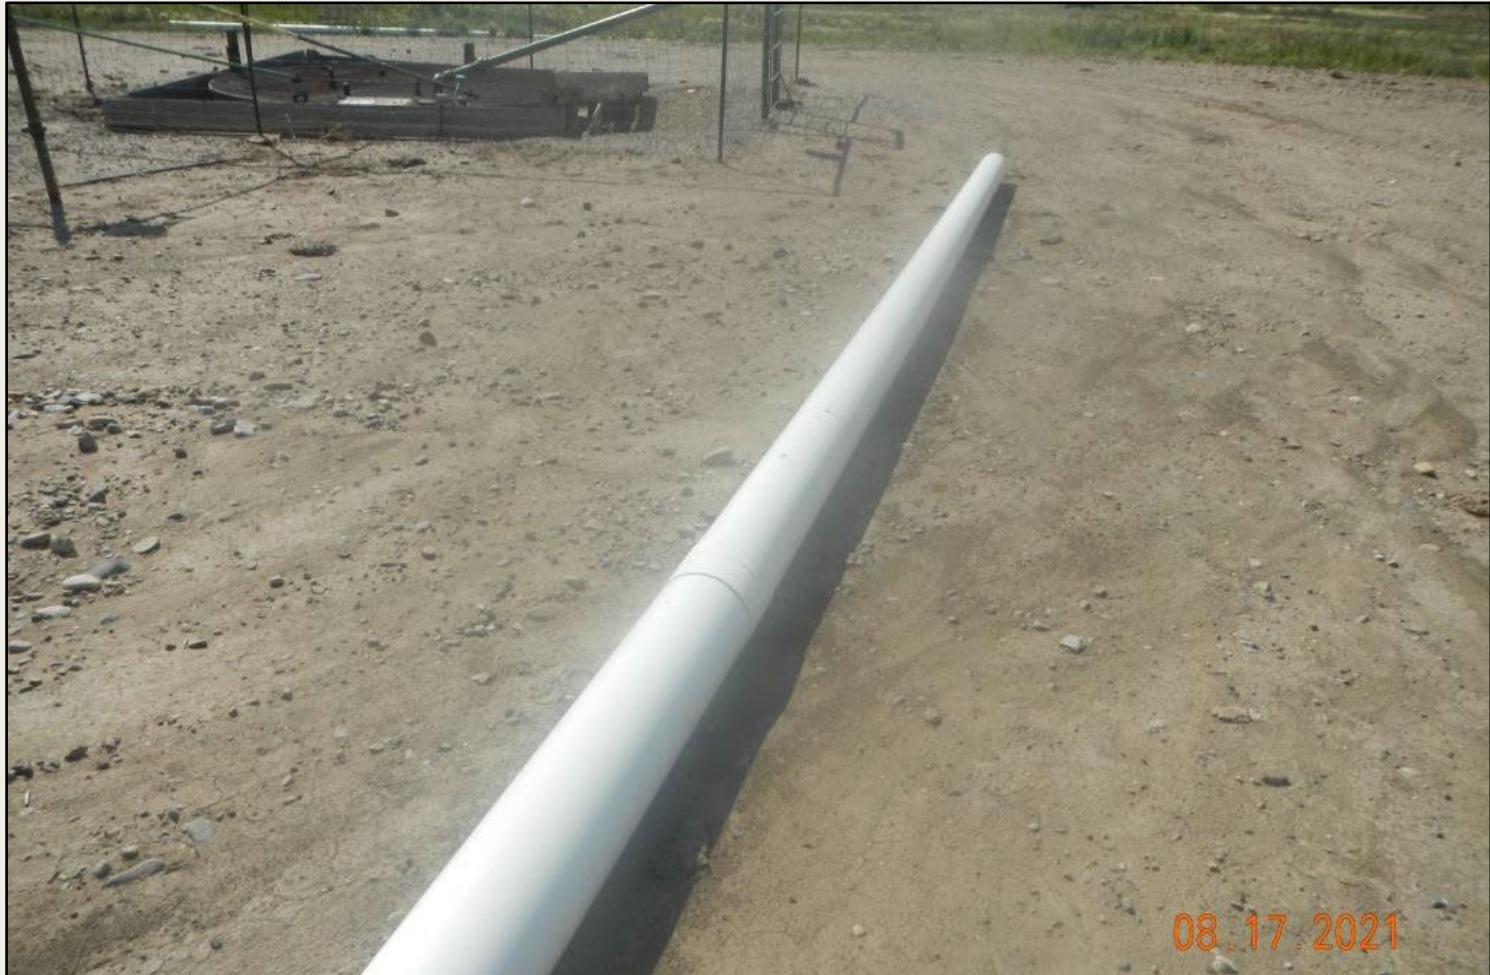
Photo 7. View of irrigation pipe on the well pad, needs to be removed. Additional pieces of broken pipe and other debris also observed.

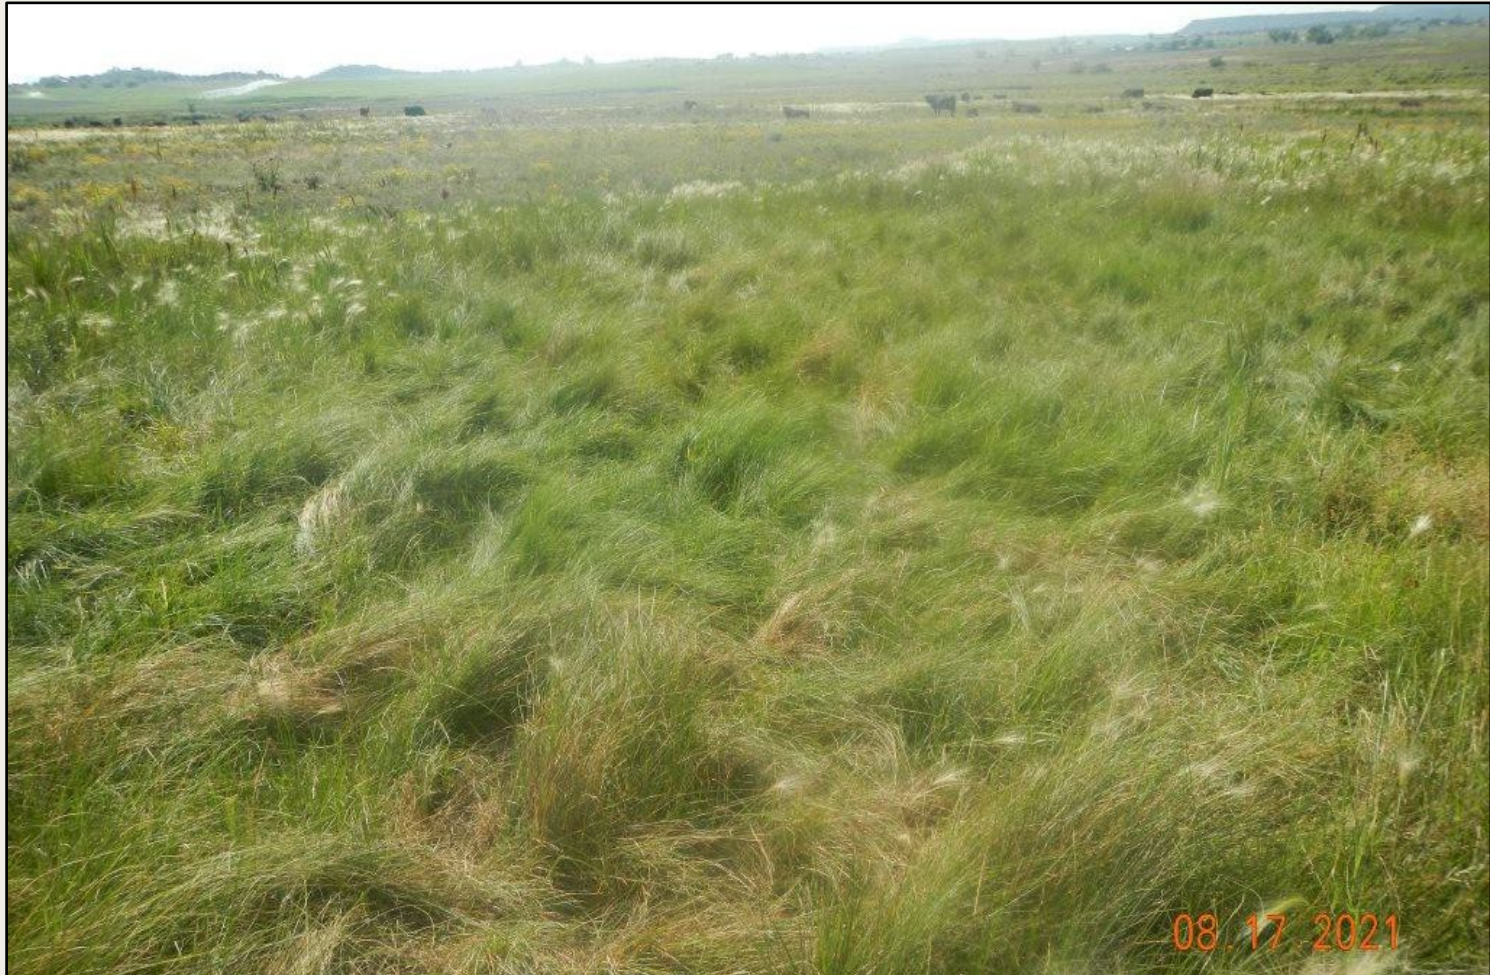
Photo 8. View of the reference area comprised of irrigated grass field with foxtail barley, Baltic rush, and curly doc.
