Inspection Photos

Operator: Rim Operating
API: 067-09185
Date: 8/17/2021

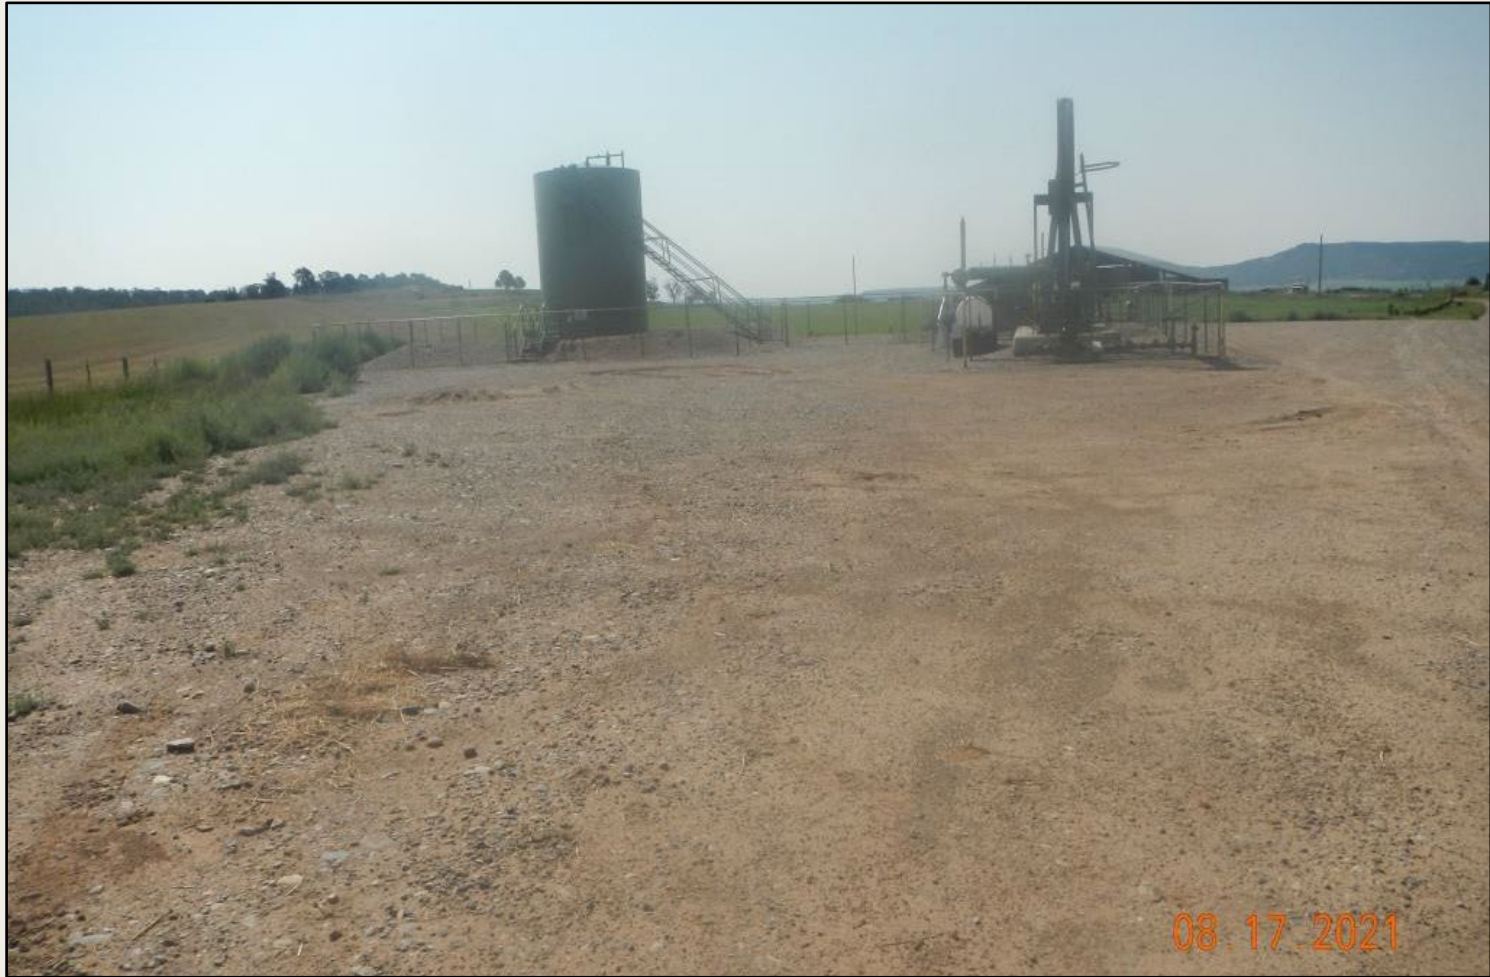
Photo 1. View of the project area from the well pad entrance facing center.

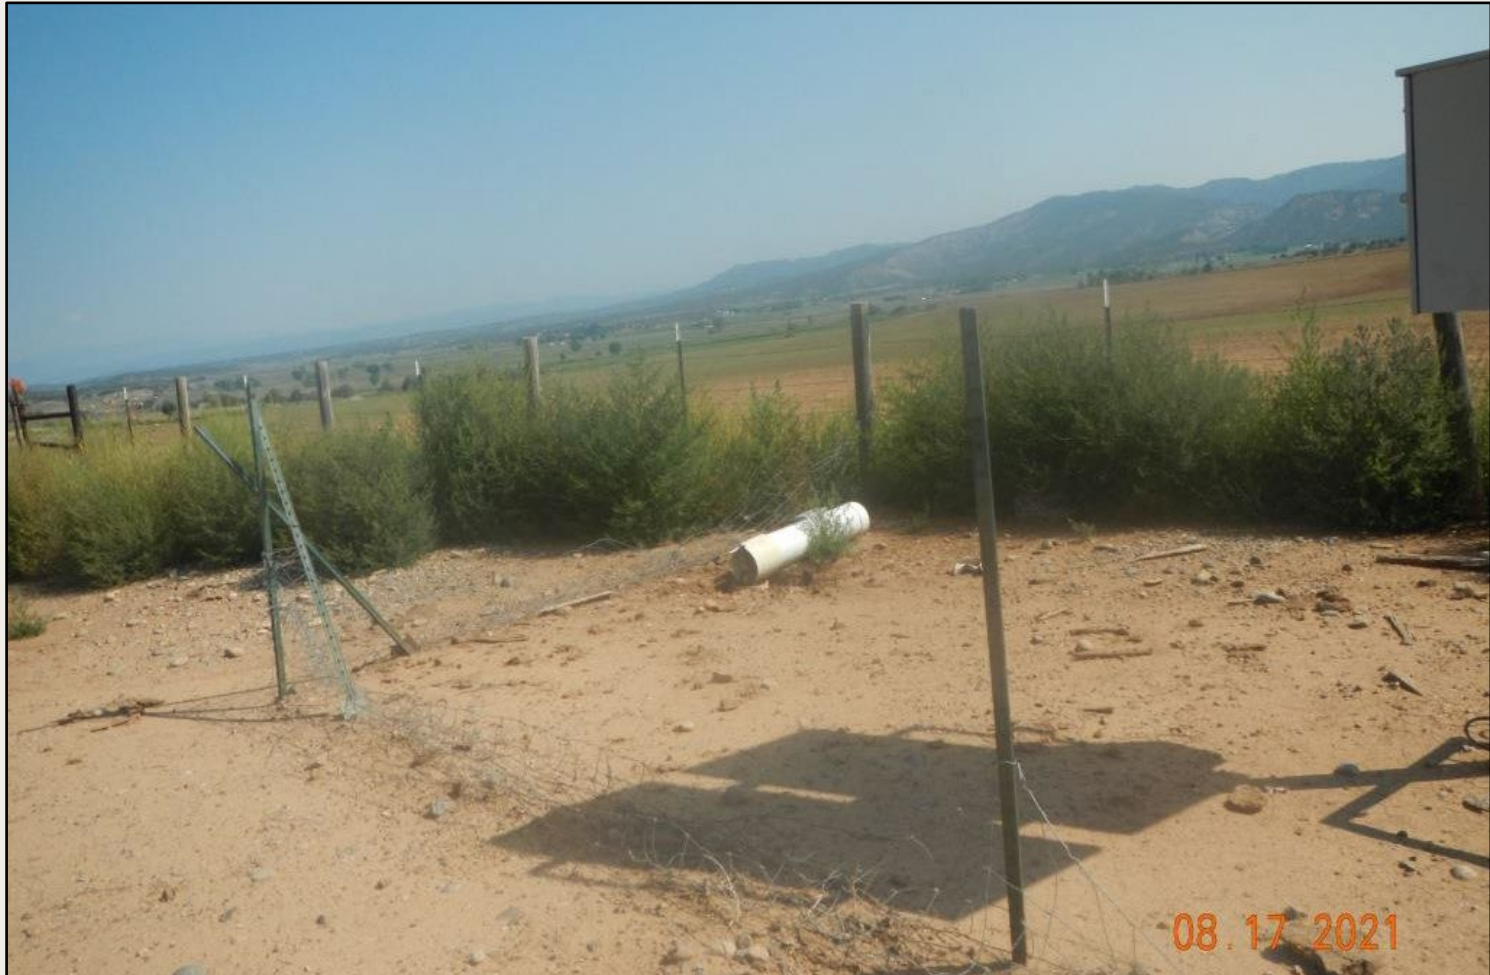
Photo 2. View of damaged fencing and debris within the northern project area.

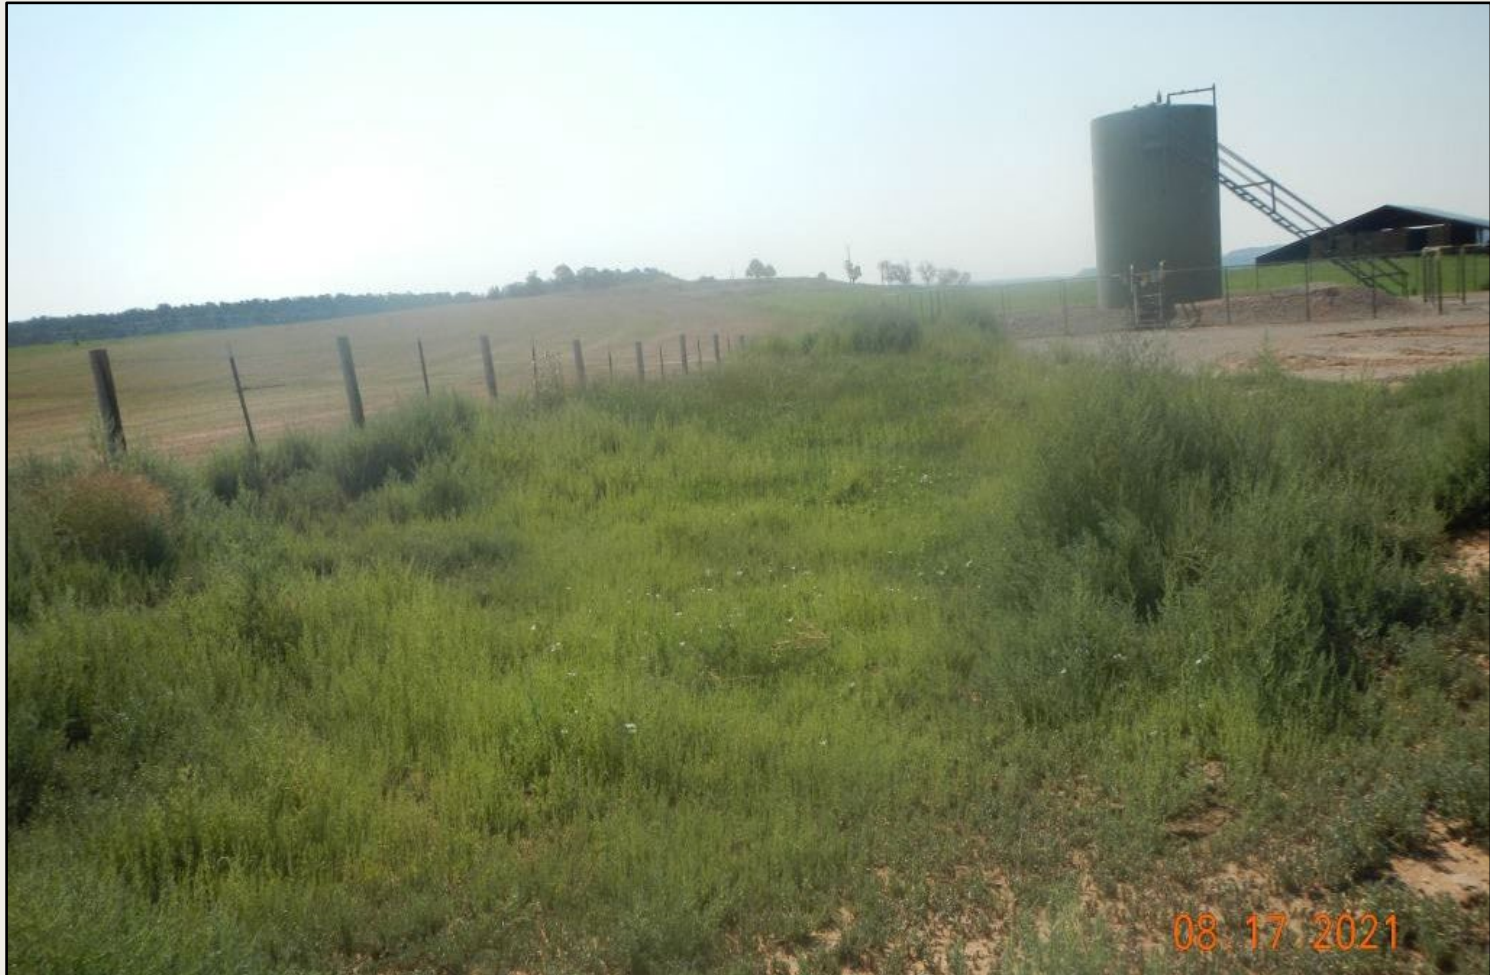
Photo 3. View of the eastern project area facing southward. Dense kochia is present and needs to be managed. Revegetation is progressing, largely with smooth brome.

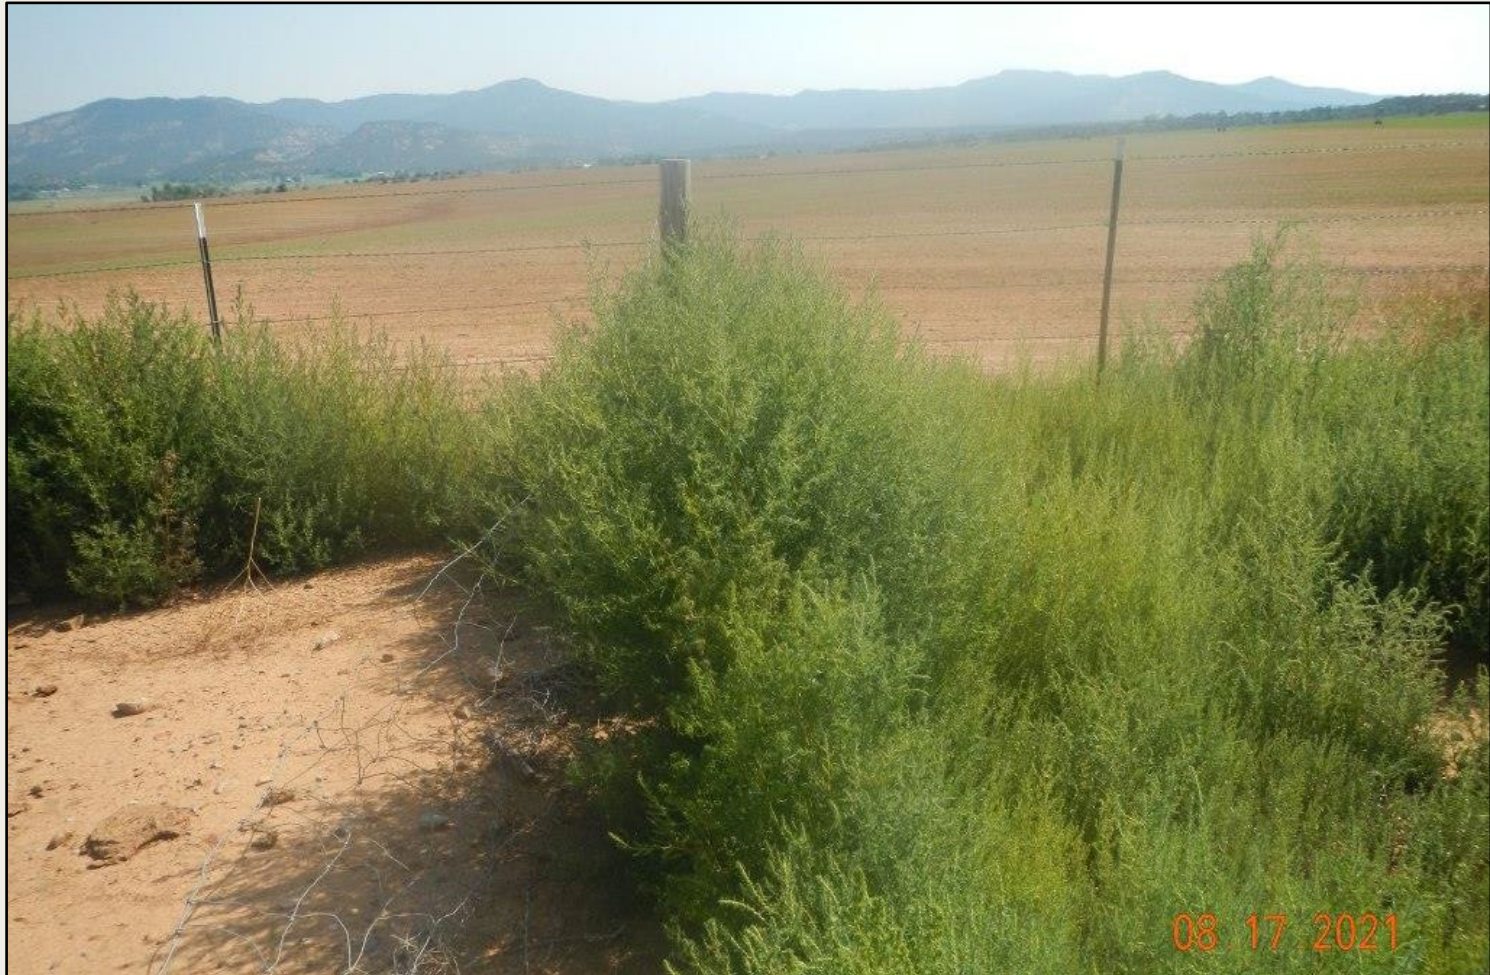
Photo 4. View of kochia up to 4-ft high, within the eastern project area.

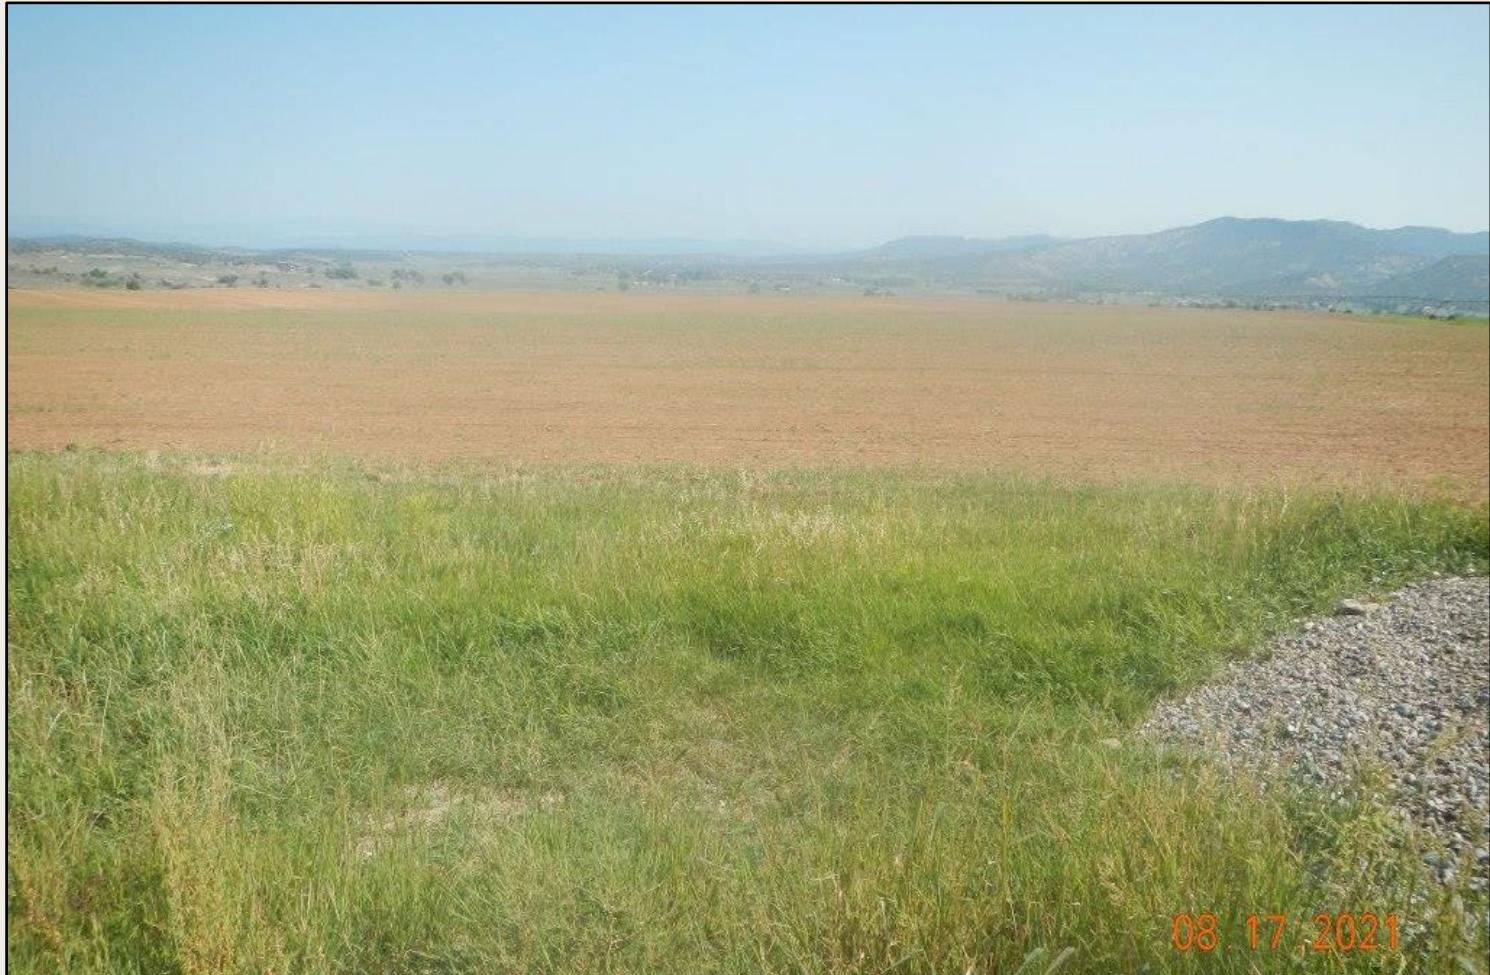
Photo 5. View of the reference area (in background) is comprised of irrigated crop grasses such as smooth brome and orchard grass.
