# Inspection Photos

Operator: Rim Operating  
API: 067-09184  
Date: 8/17/2021

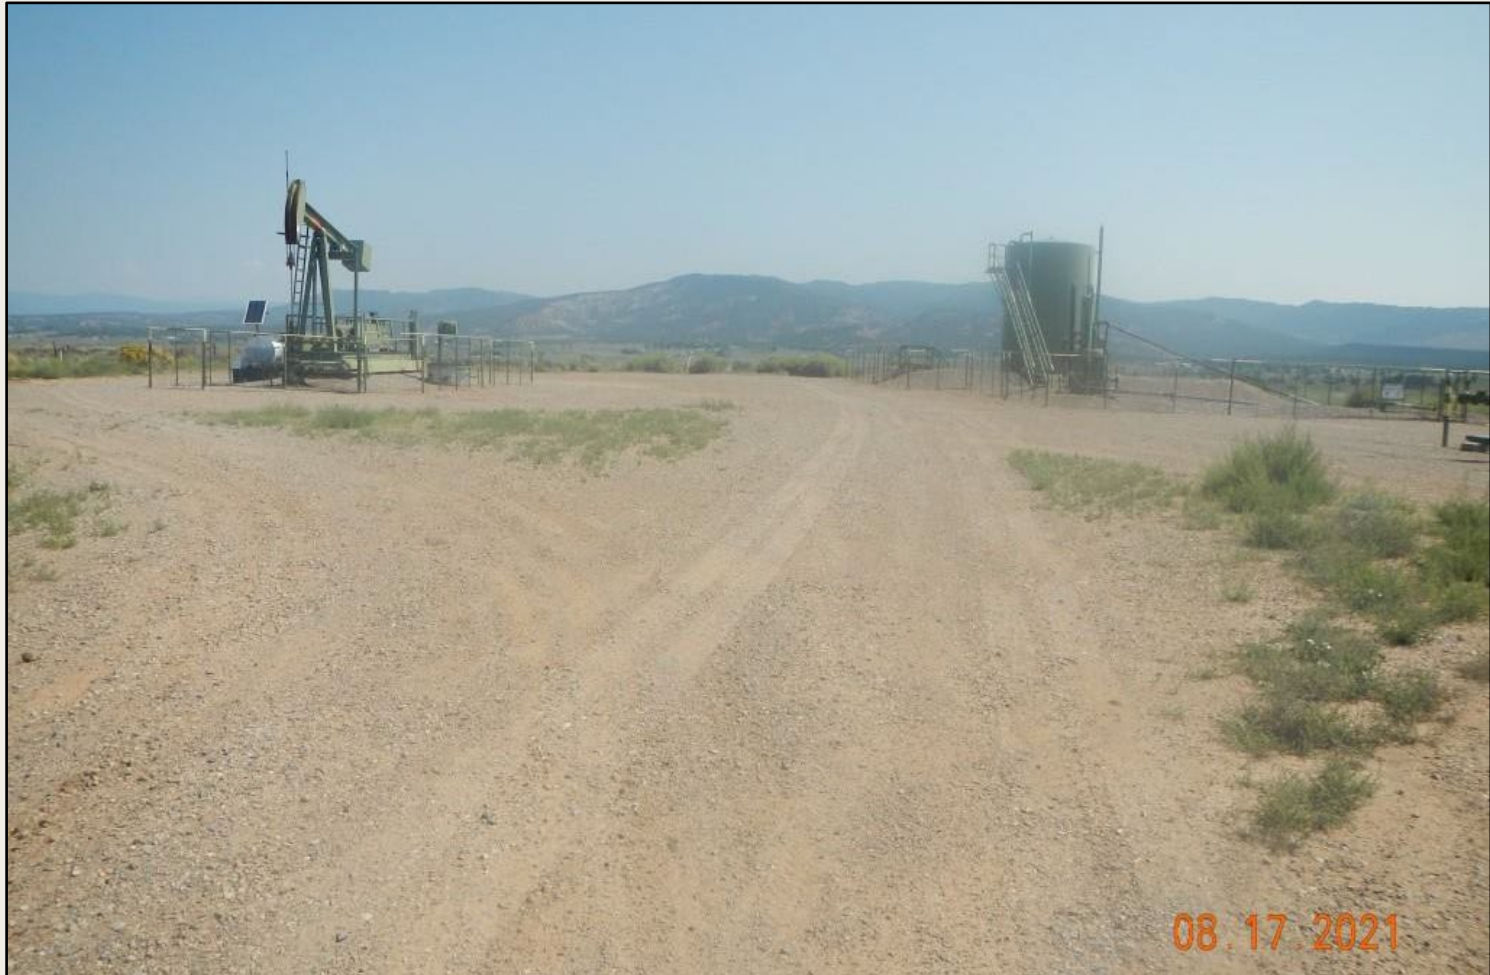
Photo 1. View of the project area from the well pad entrance facing center.

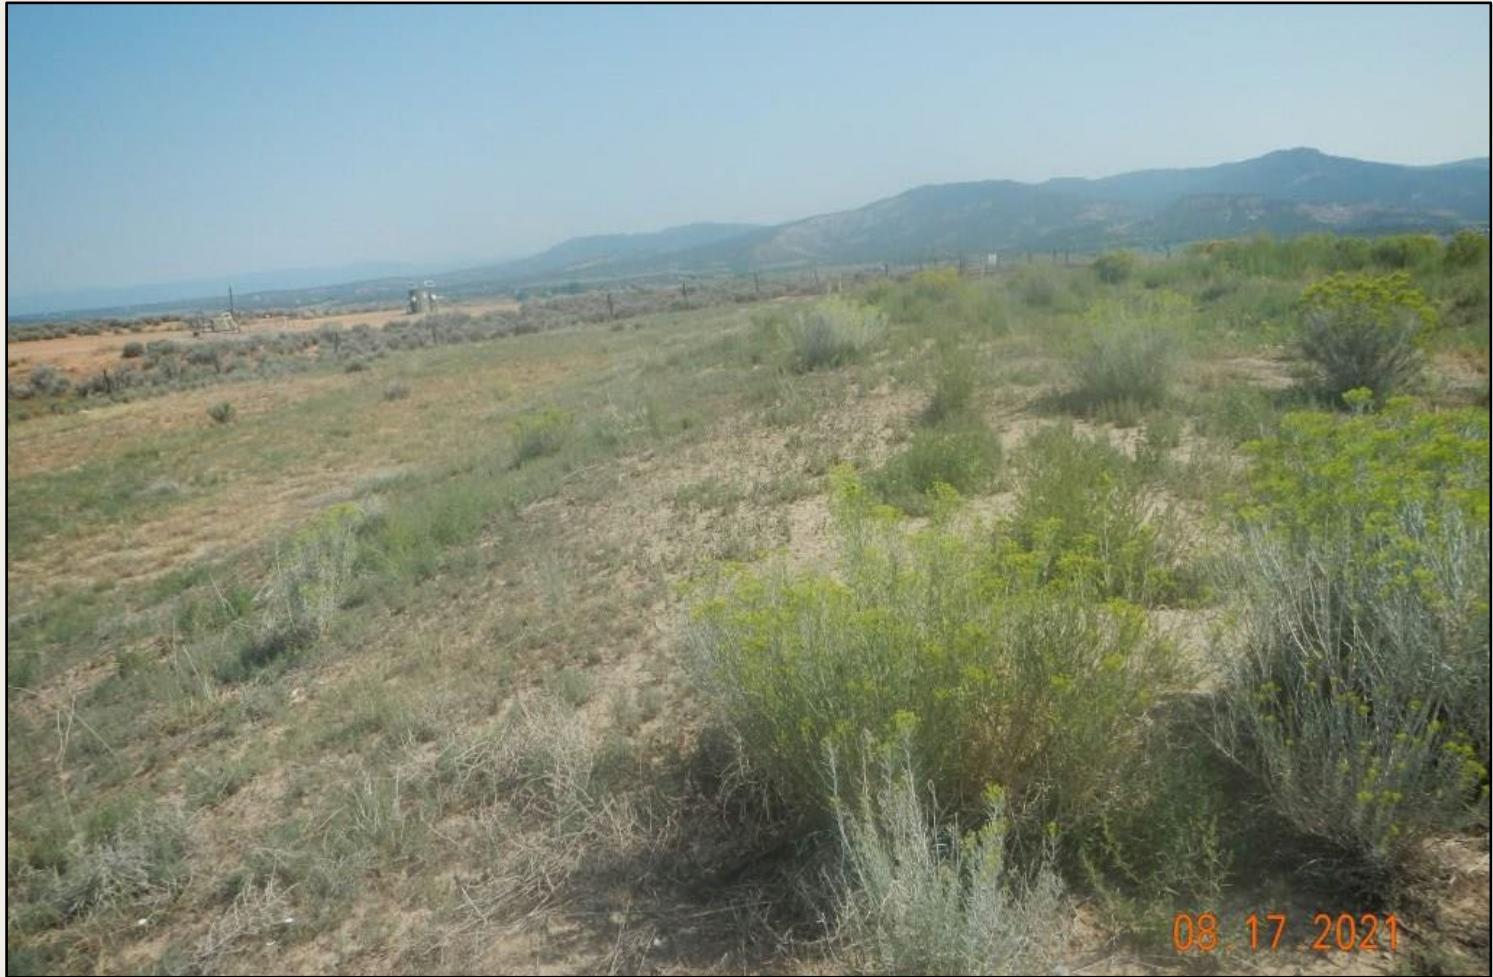
Photo 2. View of the northern project area from the northwestern corner facing eastward.

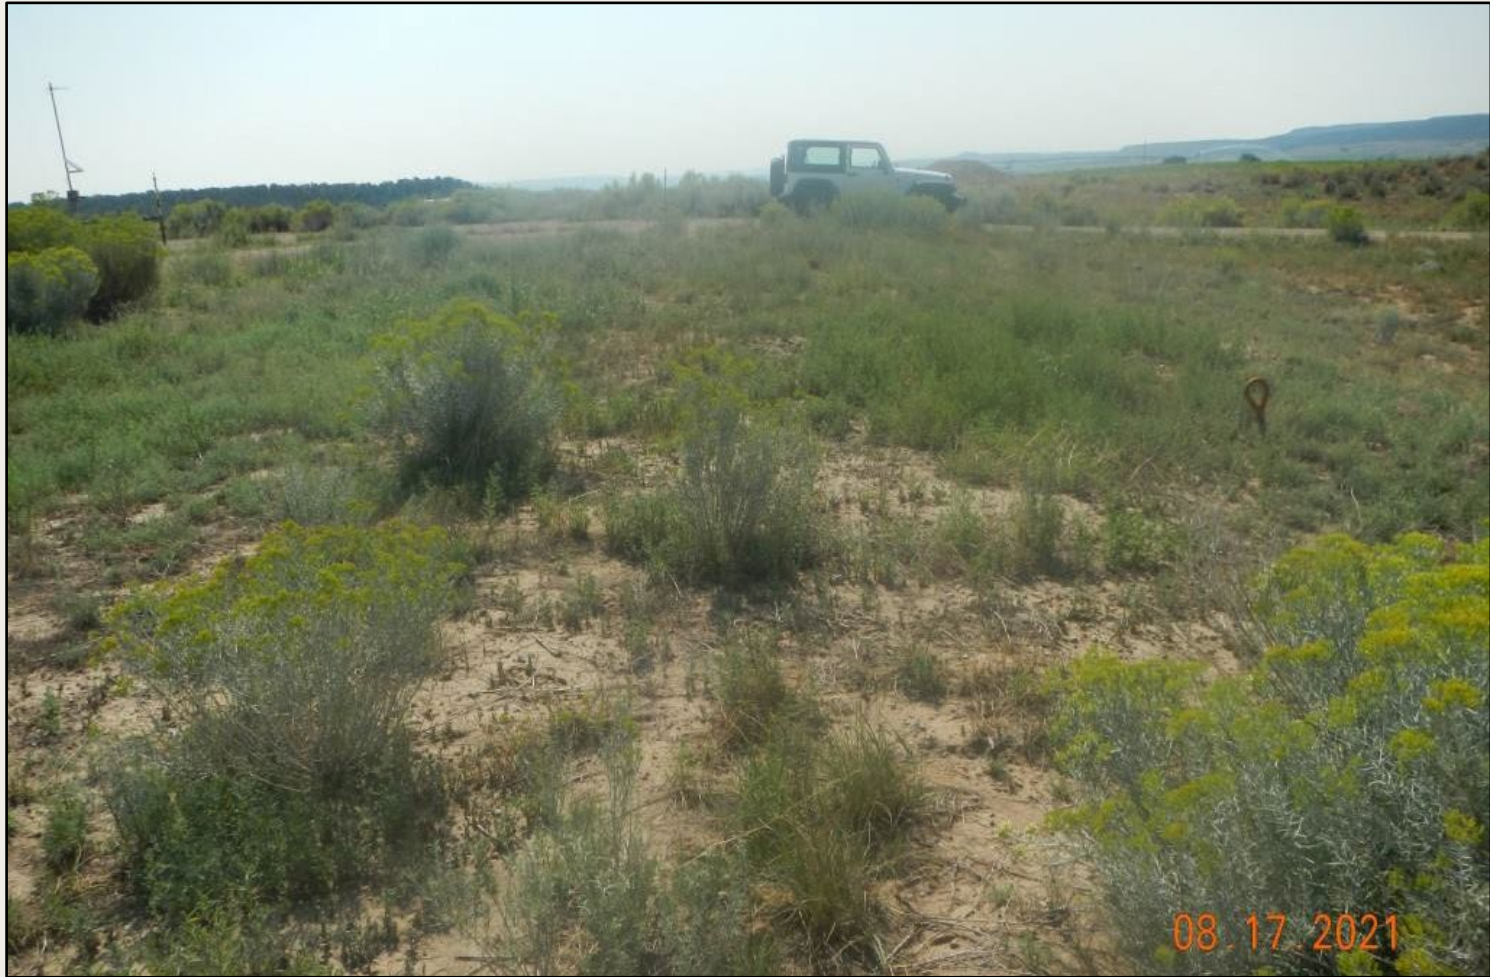
Photo 3. View of the southern project area facing eastward.

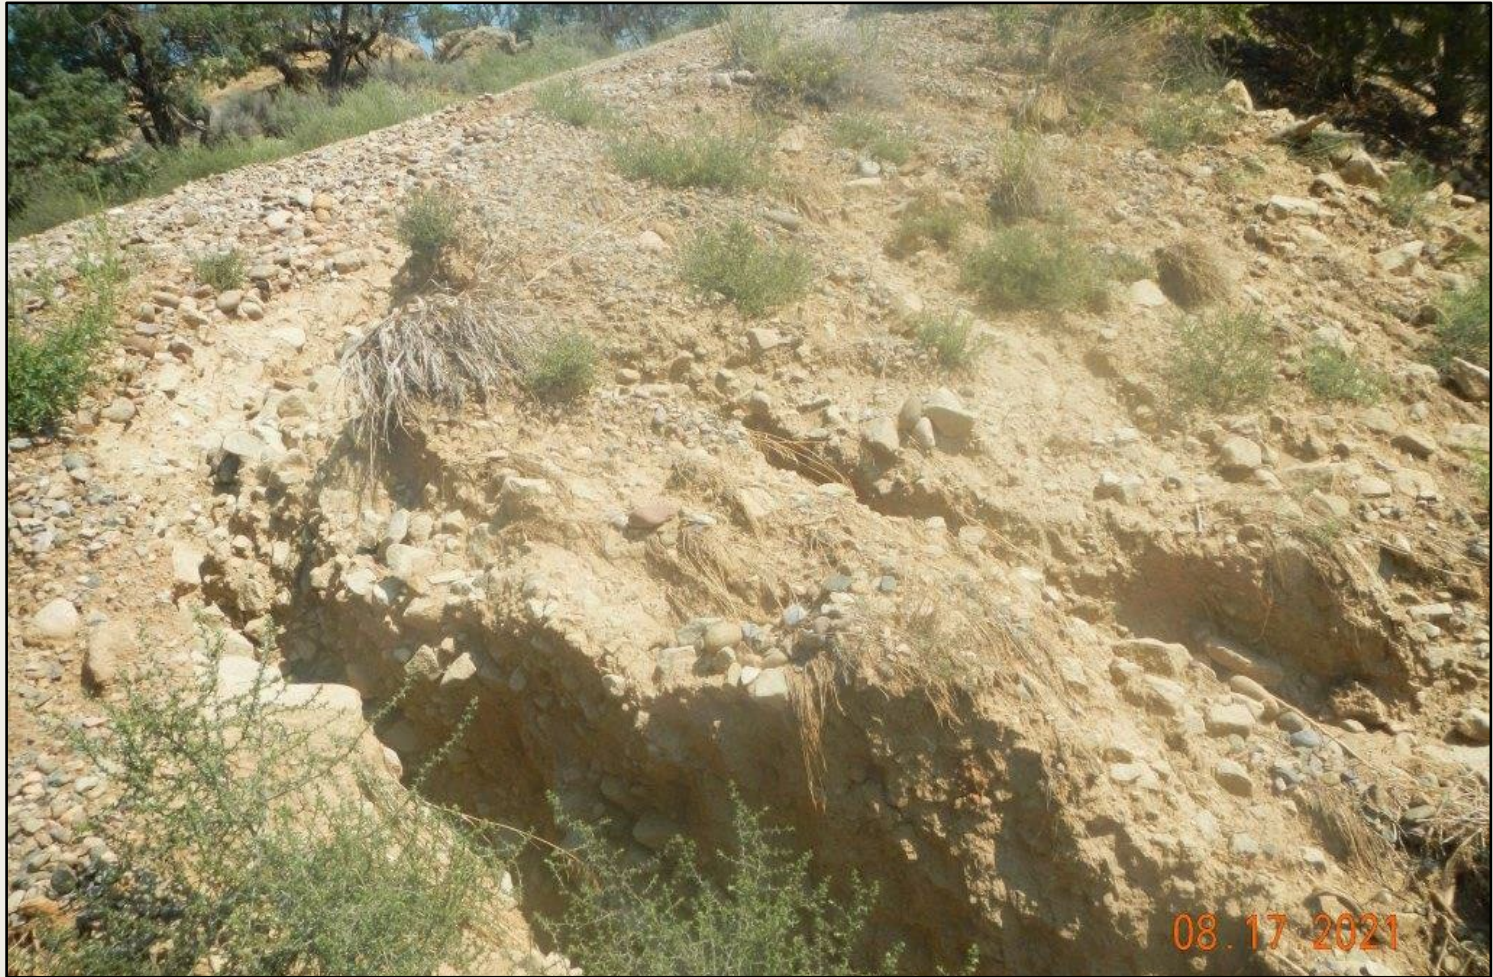
Photo 4. View of erosional rilling and channeling along the access road, up to 2ft wide and deep.

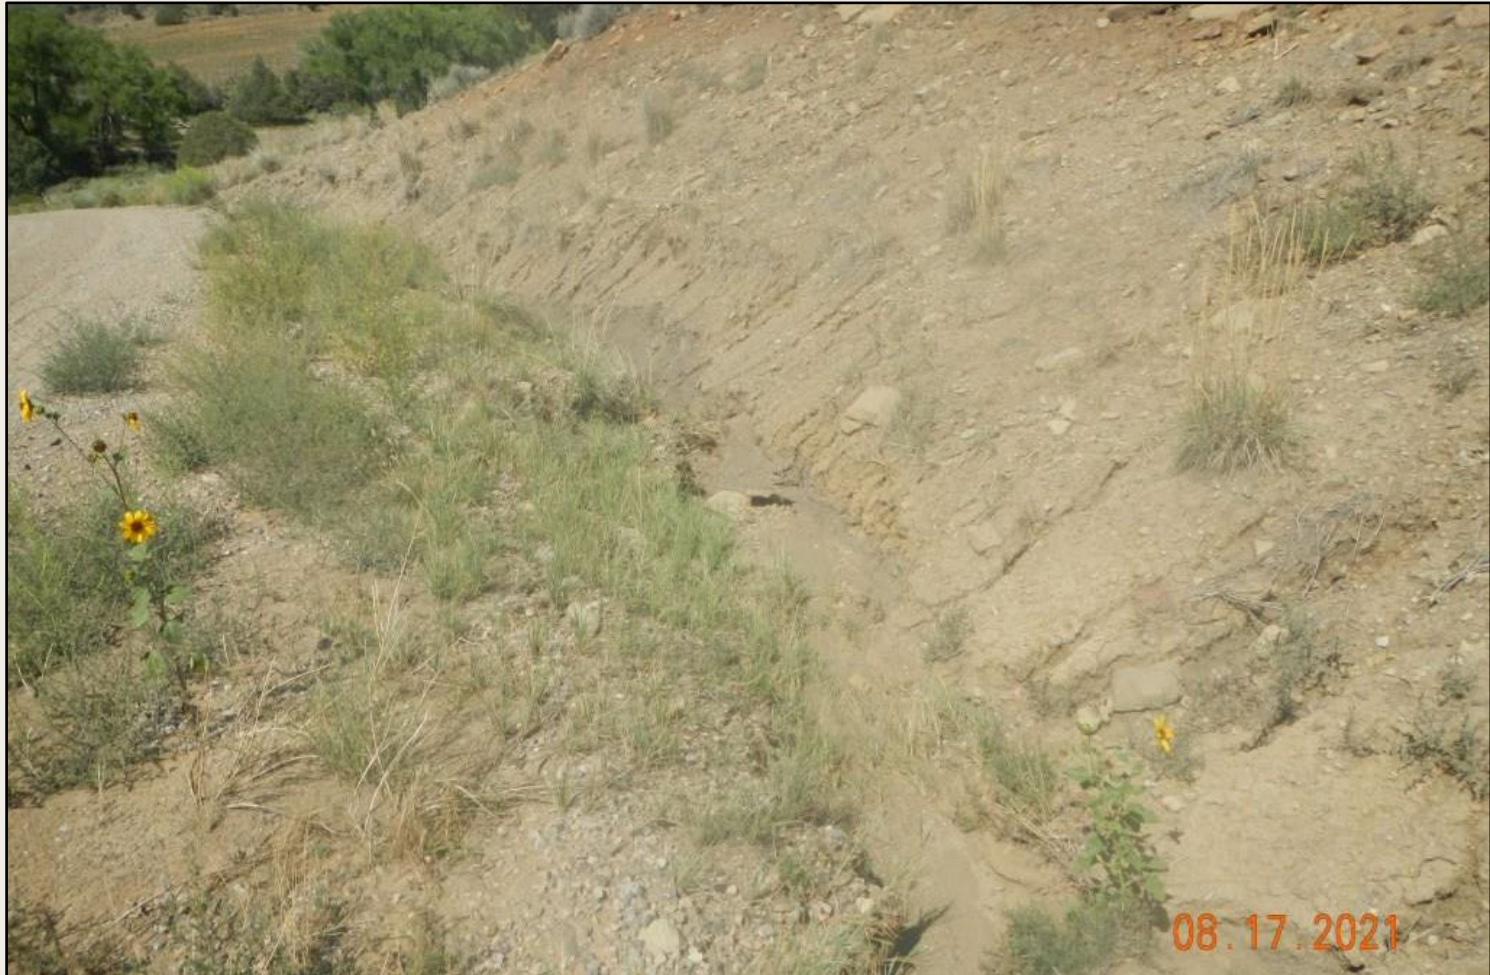
Photo 5. View of roadside erosion, BMPs are full of sediment and no longer functioning. Cut banks are not stabilized.

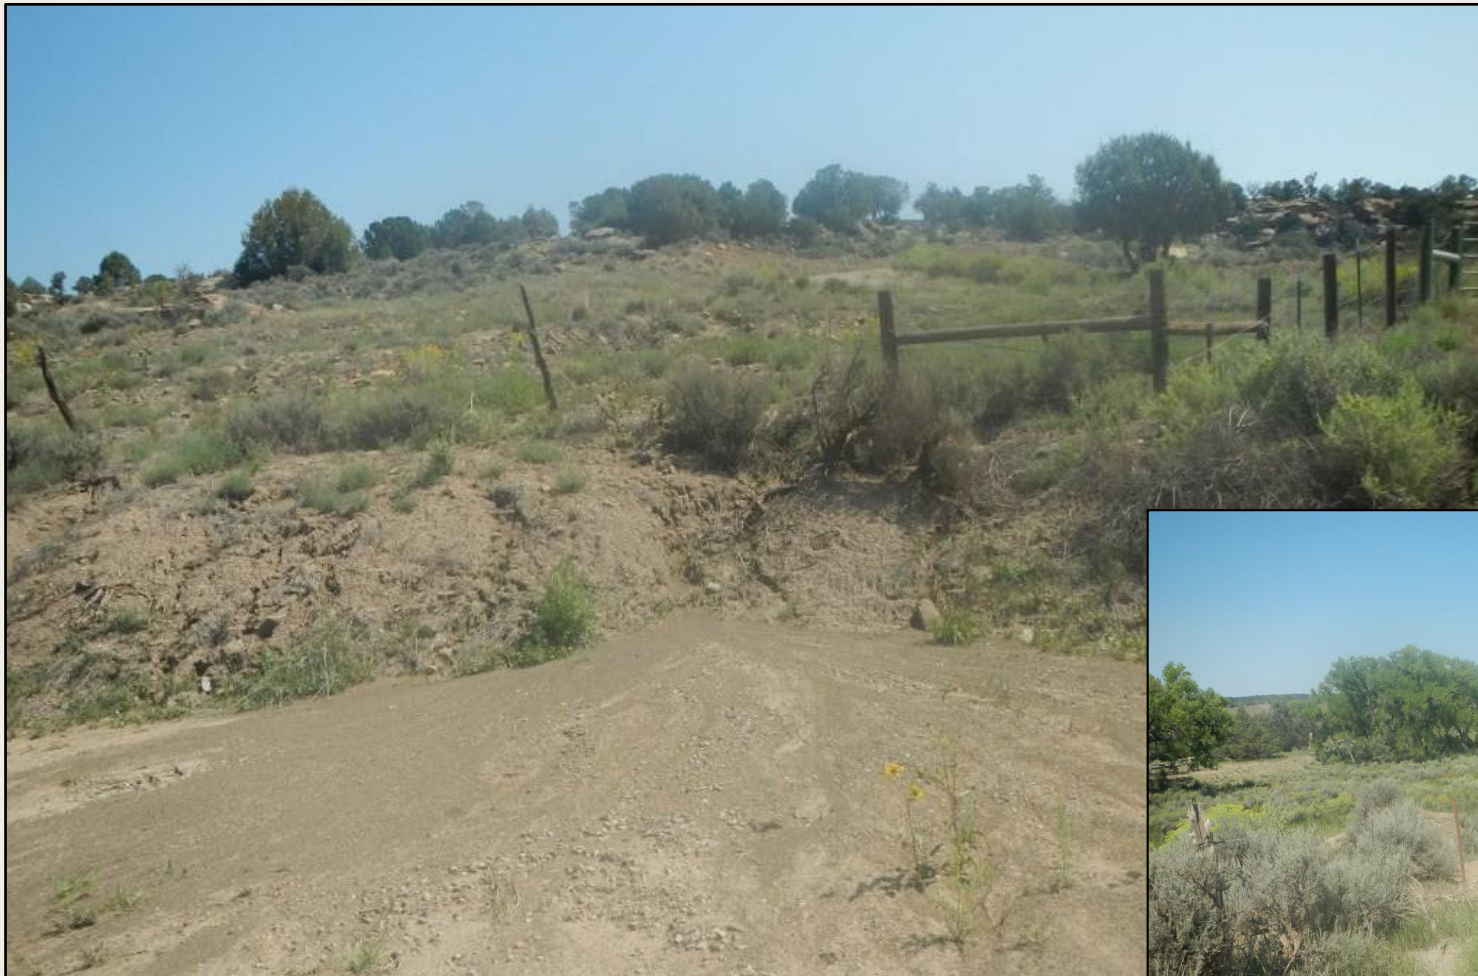
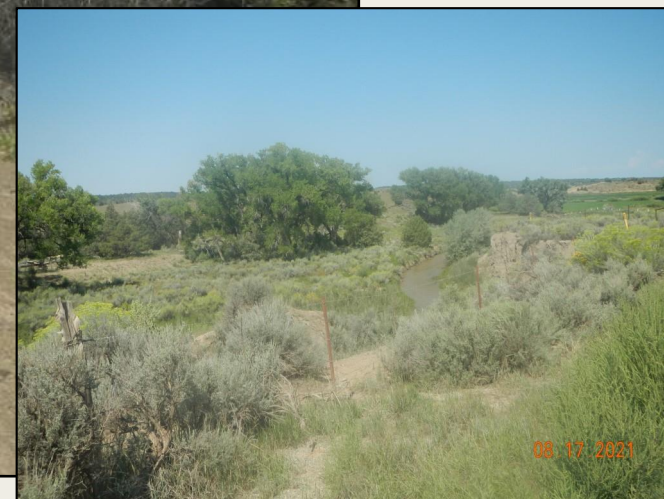
Photo 6. View of area where sediment discharges from the access road and flowing toward Spring Creek (across the road in inset).

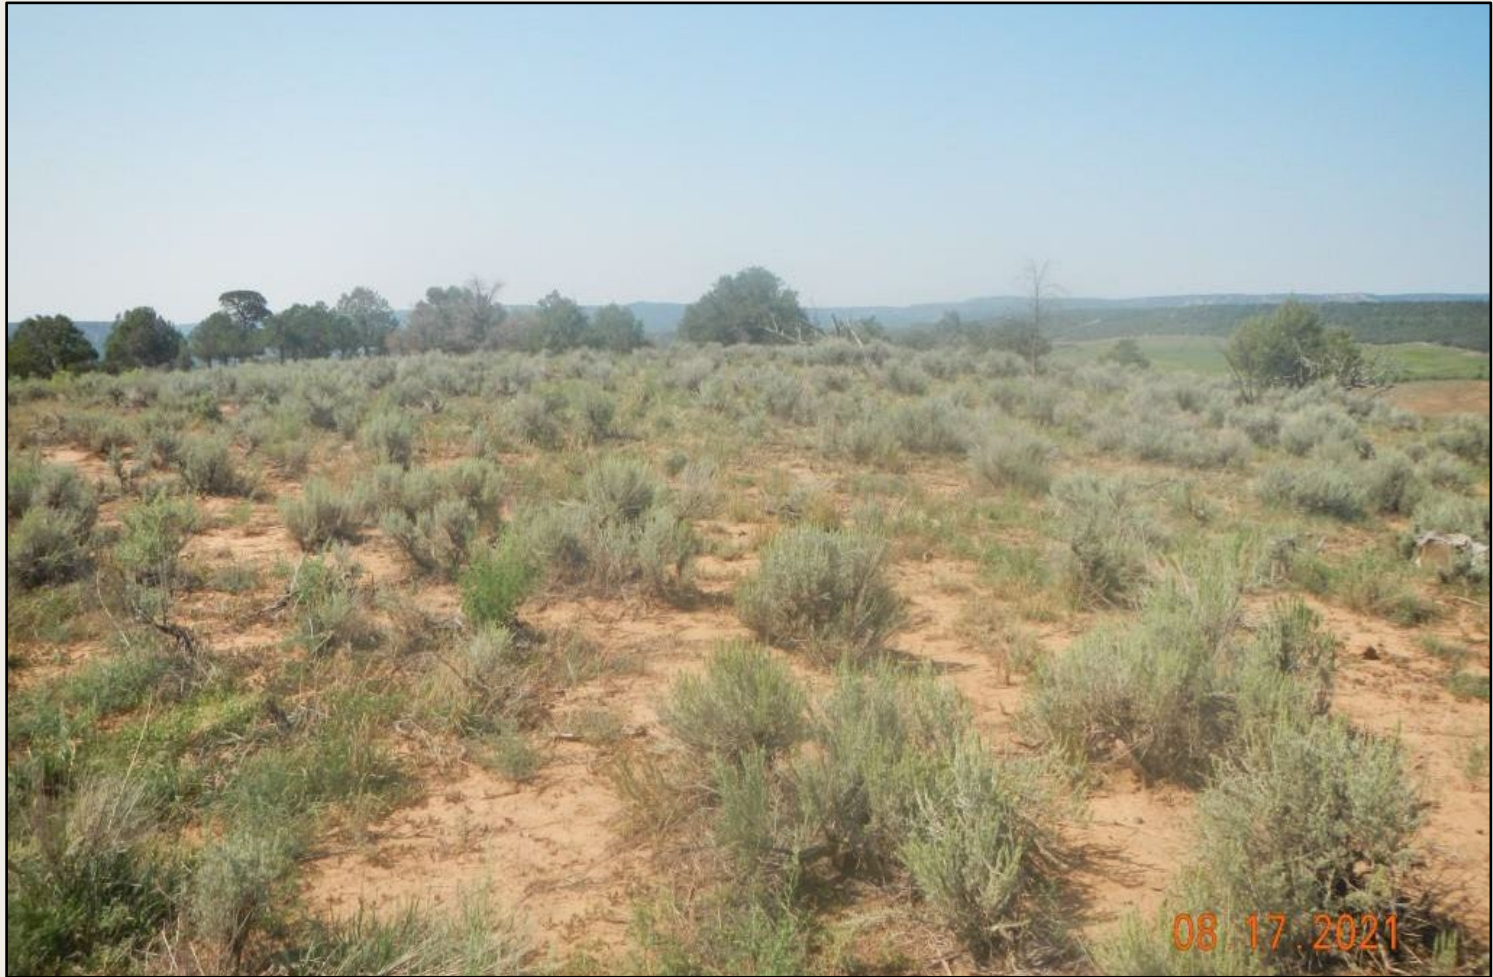
Photo 7. View of the reference area comprised of sagebrush shrubland with squirrel tail, James galleta, and penstemon.
