Interim Reclamation and Stormwater Inspection

July 8, 2021 & August 23, 2021

Operator: EDGE ENERGY II LLC- #10671

Location ID: 456286

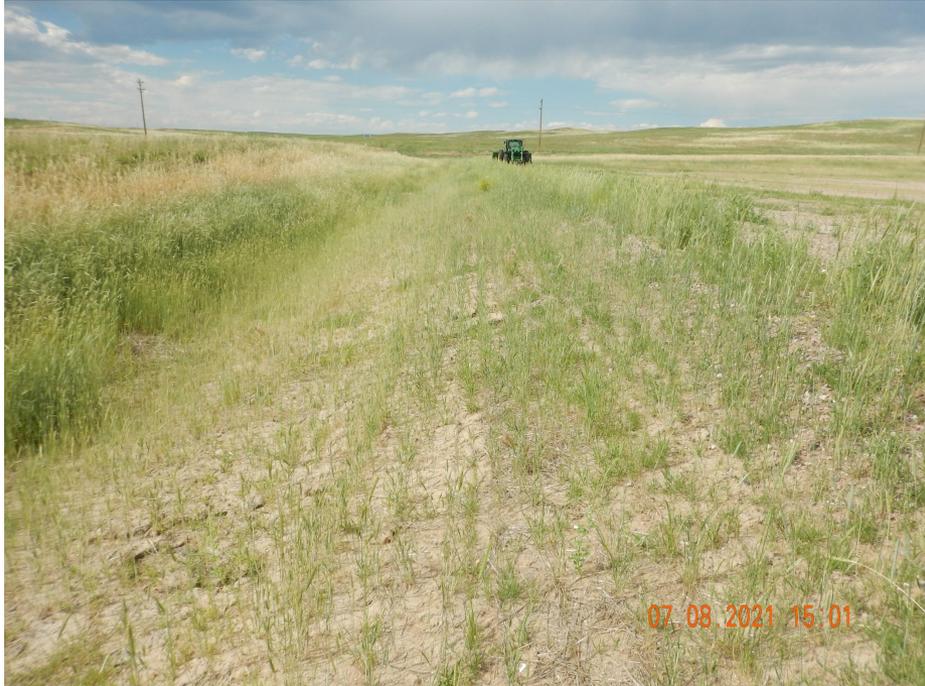
Photo 1. Photo taken from the southwestern location, facing North. Photo illustrates Common rye (*Secale cereale*) and Wheat (*Triticum aestivum*) throughout the interim reclamation areas, which is not the approved surface owner seed mix.

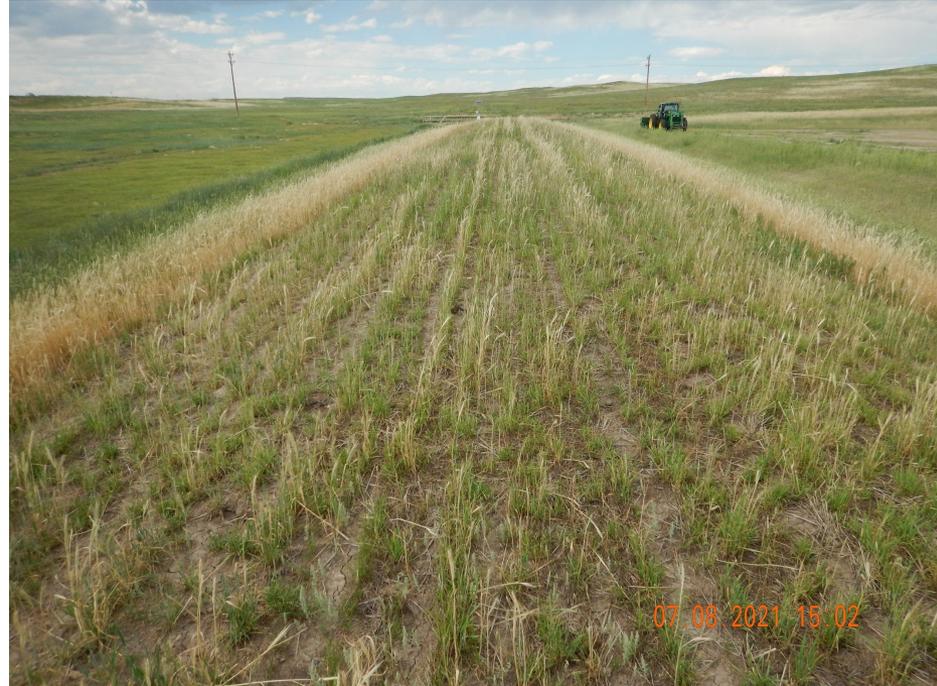
Photo 2. Photo taken from the topsoil stockpile along the southwestern location, facing North. See comments under Photo 1.

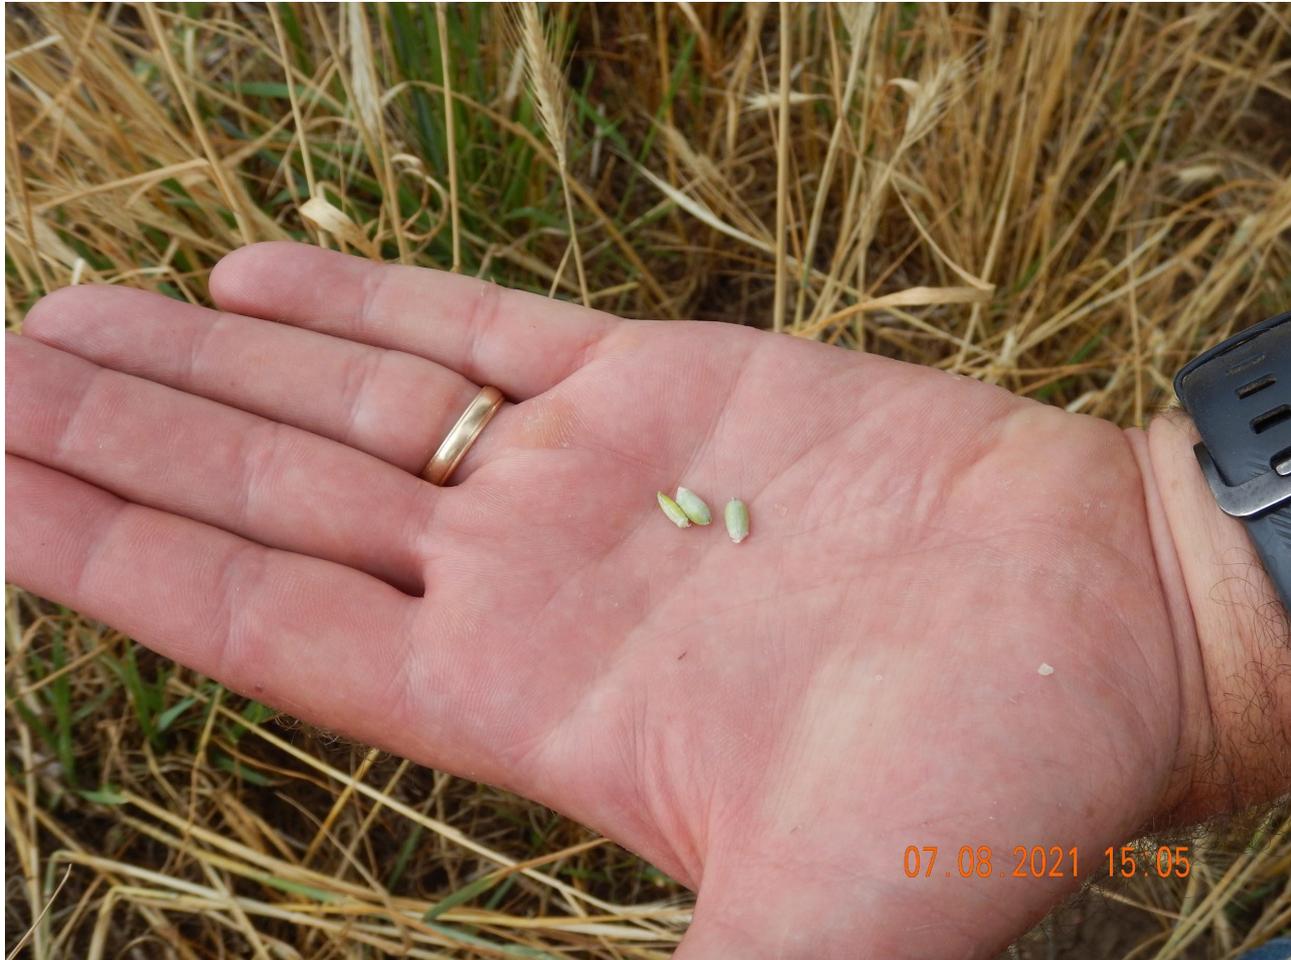
Photo 3. Photo illustrates a Common rye seed (far left, slender seed) and Wheat seeds (far 2 right, bigger seeds).

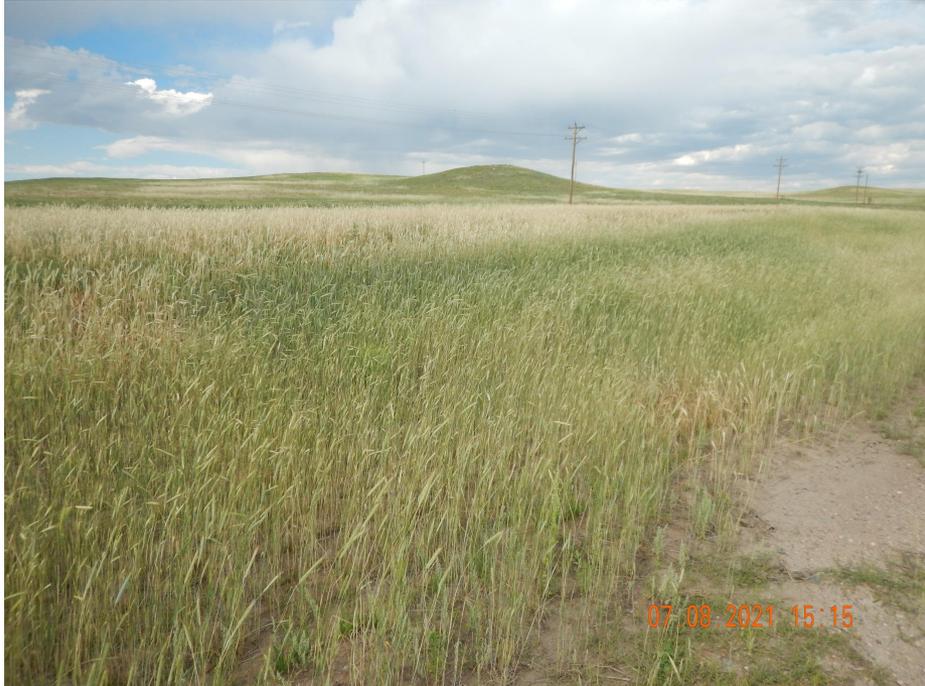
Photo 4. Photo taken from the northwestern location, facing Northeast. See comments under Photo 1.

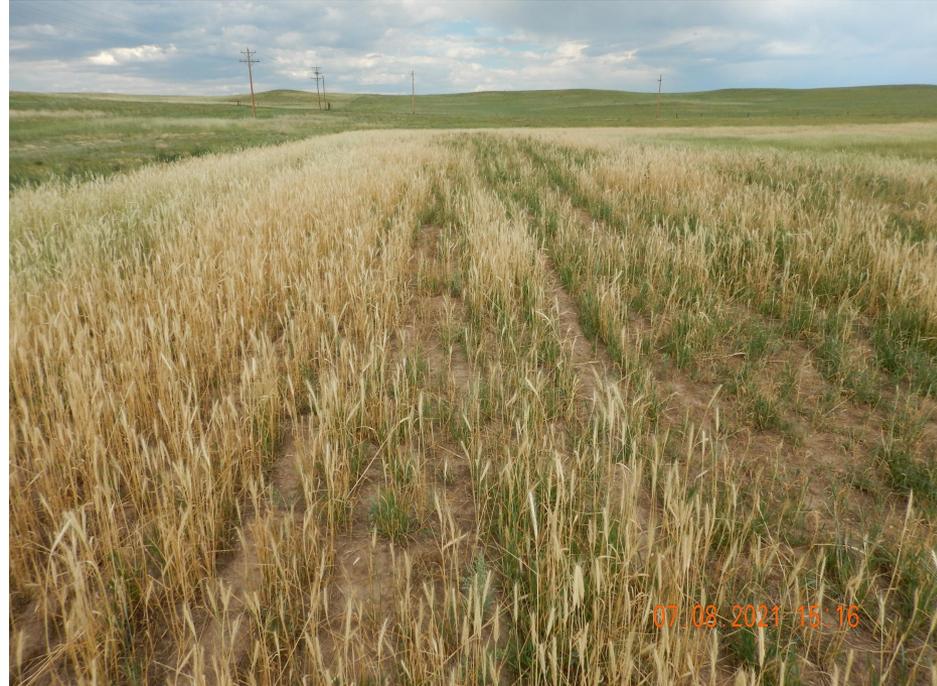
Photo 5. Photo taken from the northern location, facing East. See comments under Photo 1.

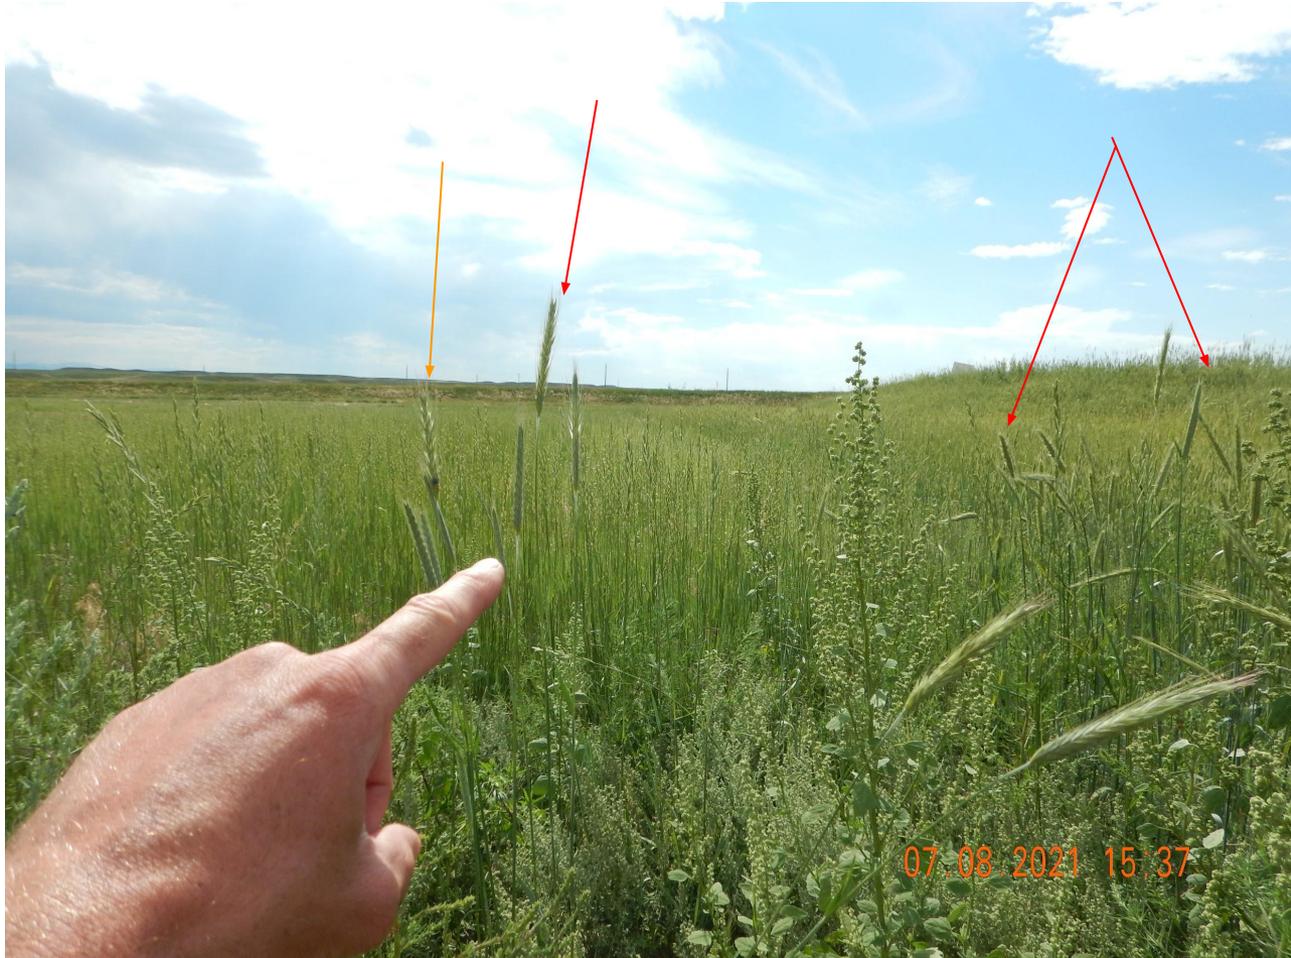
Photo 6. Photo taken south of the location, facing West. Photo illustrates Common Rye (red arrows) and Wheat (orange arrow) that has escaped off the interim reclamation areas and onto the adjacent reference area. It was also observed along the adjacent eastern and northwestern reference areas.

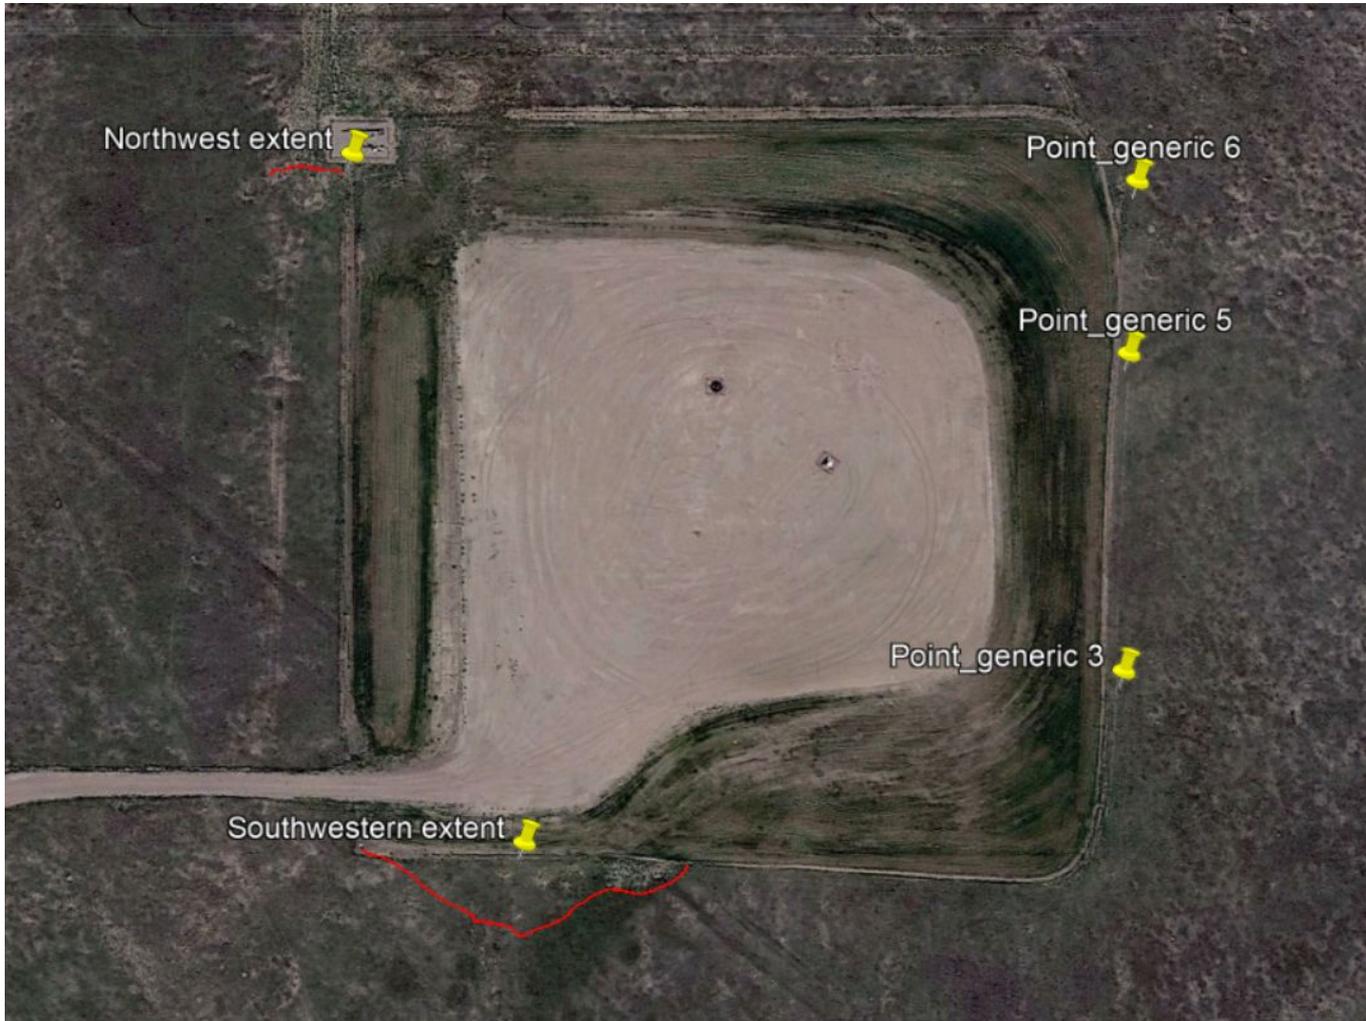
Photo 7. Google Earth aerial imagery from 6/11/2021. Photo illustrates the extent of Common rye and Wheat on 8/23/2021 that has escaped off the interim reclamation areas and onto the adjacent reference area. The extent was observed along the northwest, southwest and east. Note- interim reclamation has been performed but not in compliance with Rule 1003.

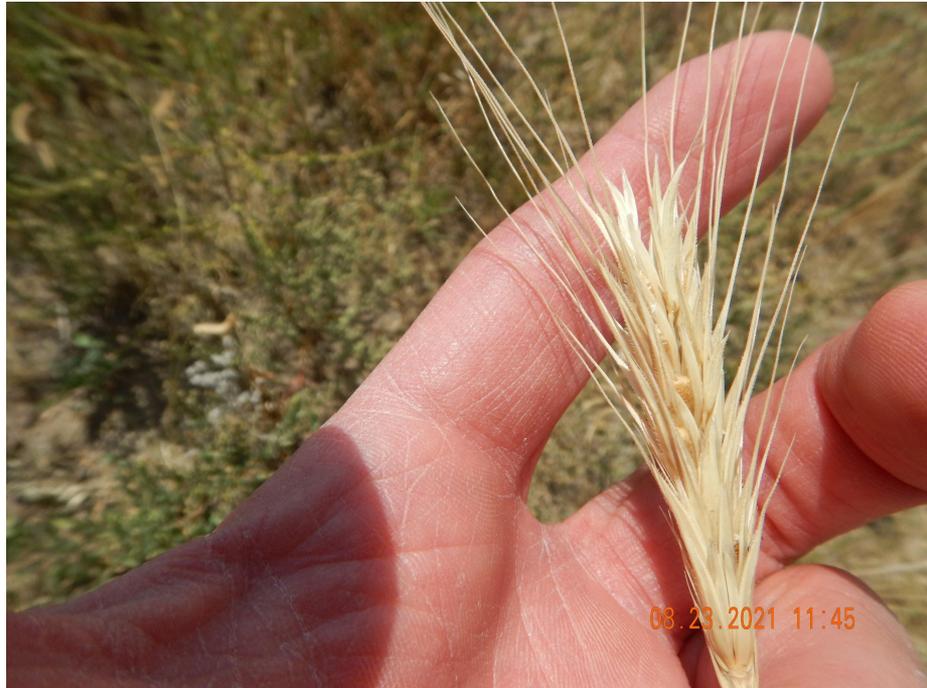
Photo 8. Photo taken from the southwestern extent within the adjacent reference area. Photo illustrates a Common rye plant that has started to seed out.

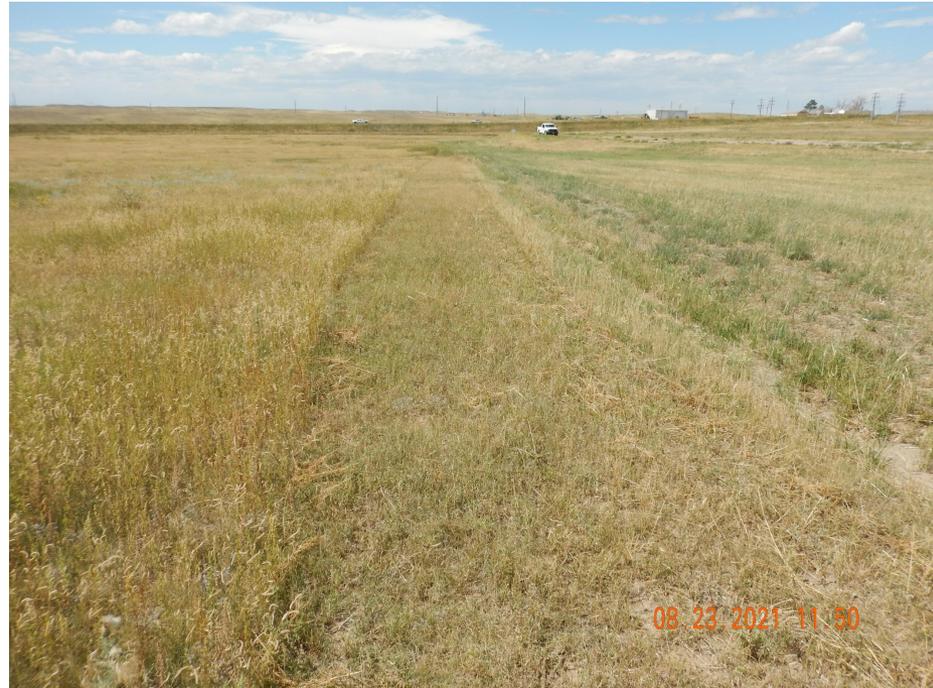
Photo 9. Photo taken from just outside of the southeastern location, facing West. Photo illustrates the Operator mowed interim reclamation areas back in July and also mowed ~6' outside of the perimeter ditch and berm BMP.

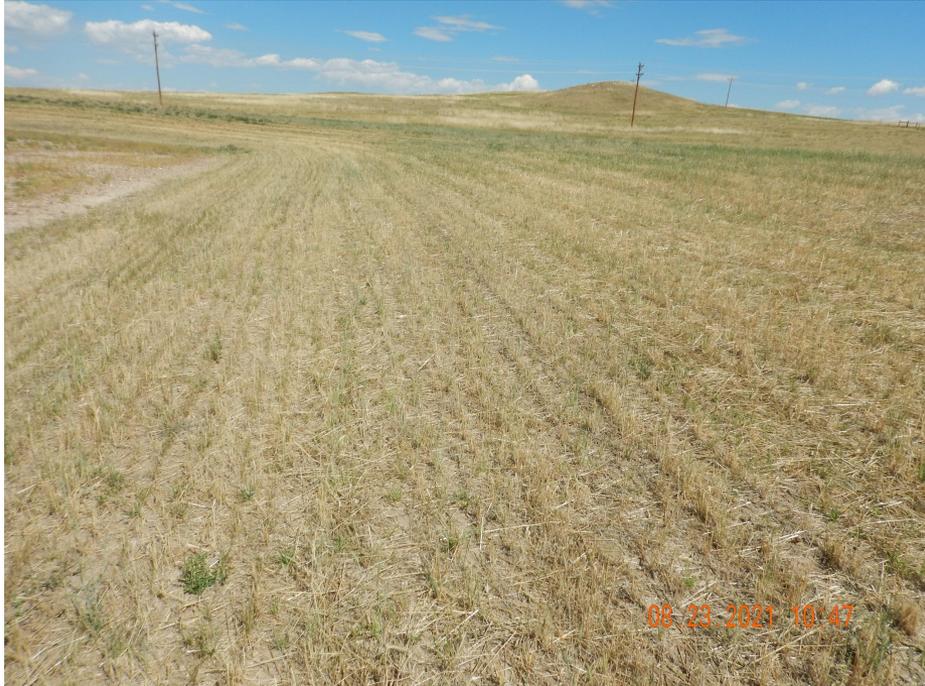
Photo 10. Photo taken from the eastern interim reclamation area, facing North. Photo illustrates Operator mowed interim reclamation areas. Common rye and Wheat are ~12-16" tall.

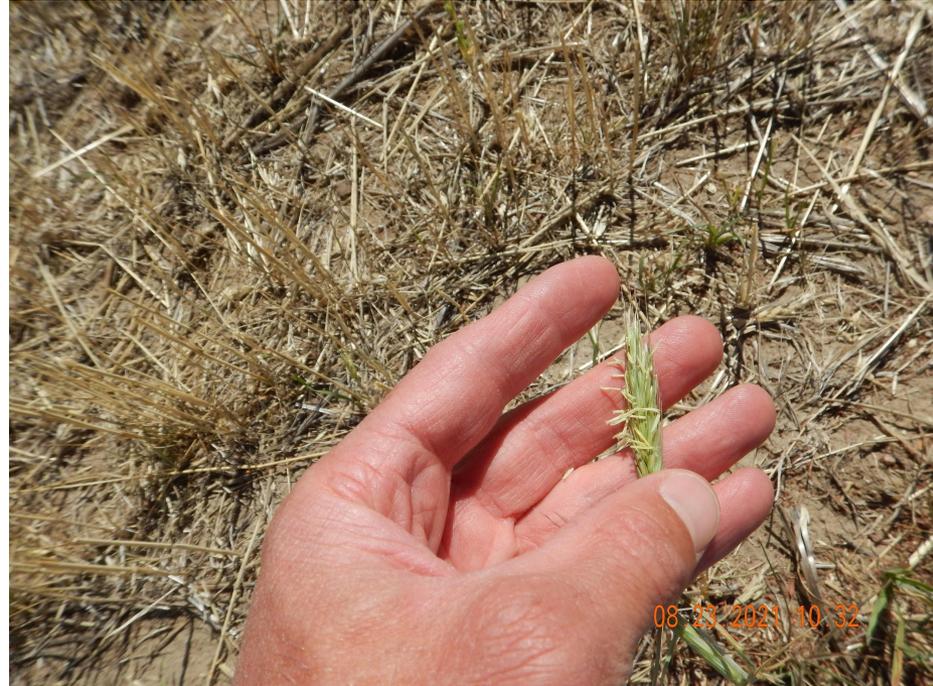
Photo 11. Photo taken with the reclamation area illustrates Common rye has started to flower. Not all Common rye was observed flowering within the reclamation areas, which indicates it has just started.

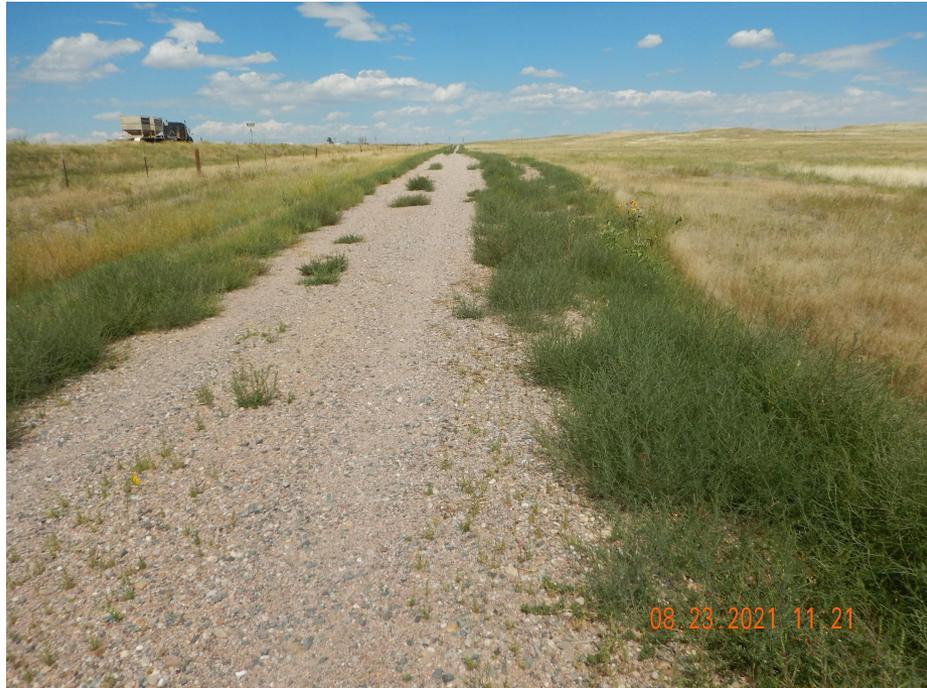
Photo 12. Photo taken from the southern access road, facing North. Photo illustrates 2-3' weeds that need to be managed. It appears the access road was recently mowed, likely back in July.

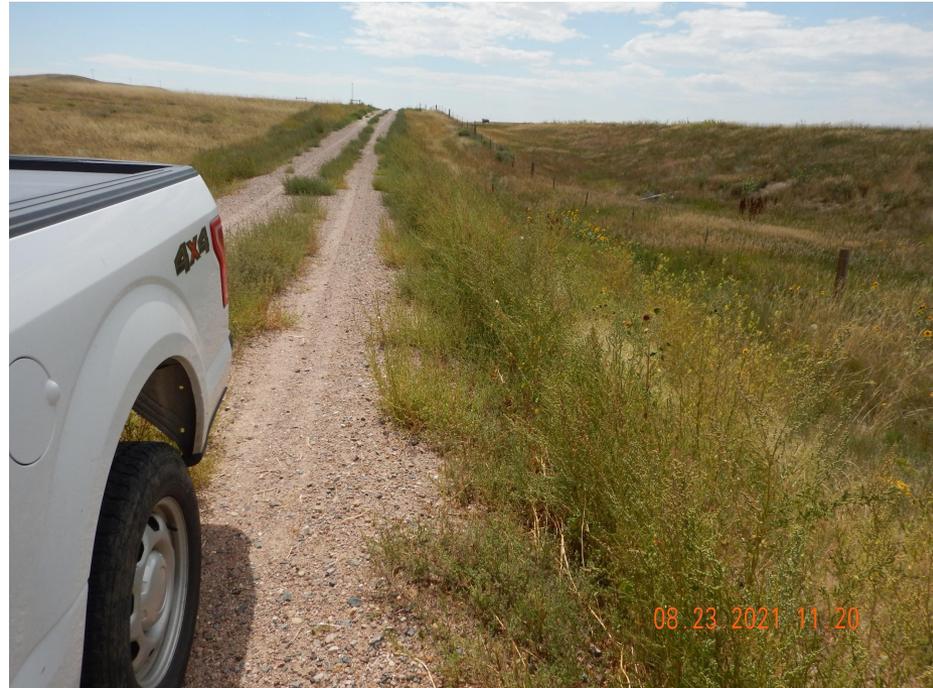
Photo 13. Photo taken from the southern access road, facing South. See comments under Photo 12.

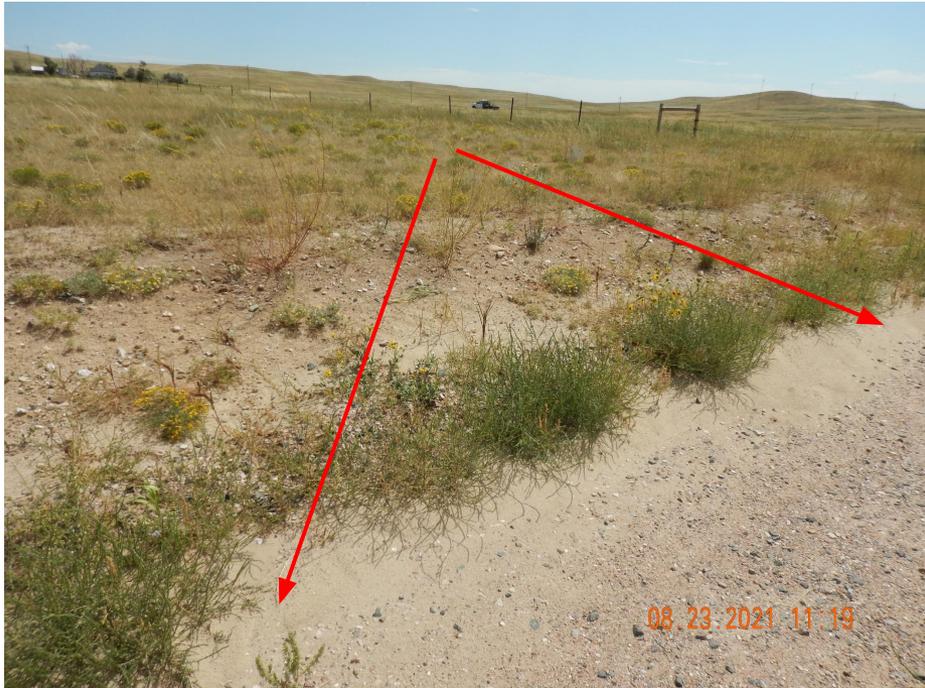
Photo 14. Photo taken from the southern access road, facing Southeast. Photo illustrates a cut slope that has not been properly stabilized and erosion is evident (red arrows).

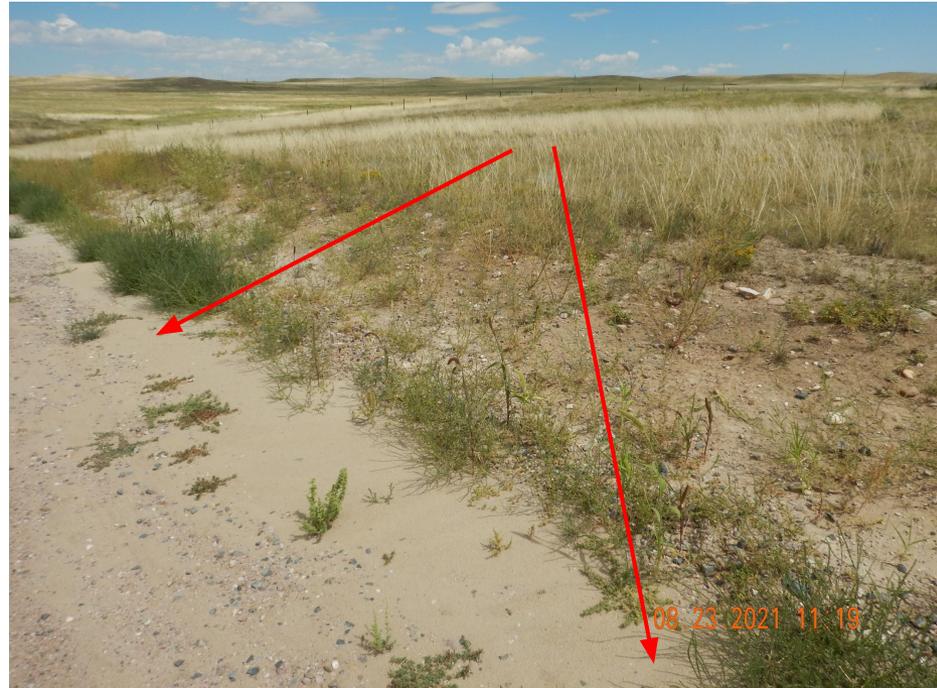
Photo 15. Photo taken from the southern access road, facing Northeast. See comments under Photo 14.

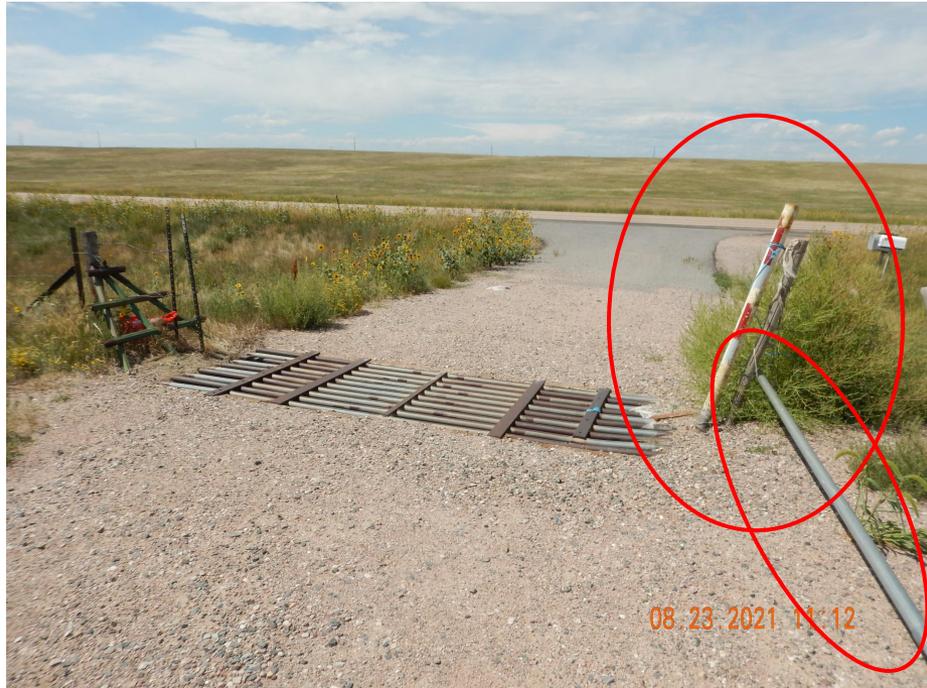
Photo 16. Photo taken from the entrance of location, facing West. Photo illustrates the cattle guard has been damaged, as one wing is missing and the gate has been replaced with a pipe and rope.

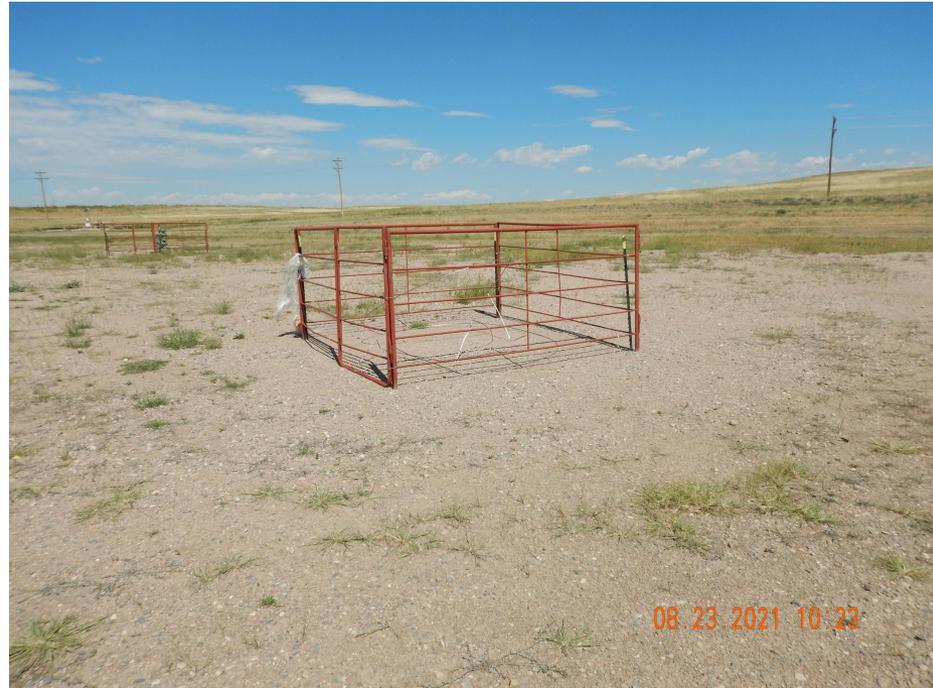
Photo 17. Photo taken from the well location, facing North. Photo illustrates unused equipment.
