Inspection Photos

API: 071-06094

Operator: AMOCO PRODUCTION COMPANY

Inspection Date: 8/27/2021

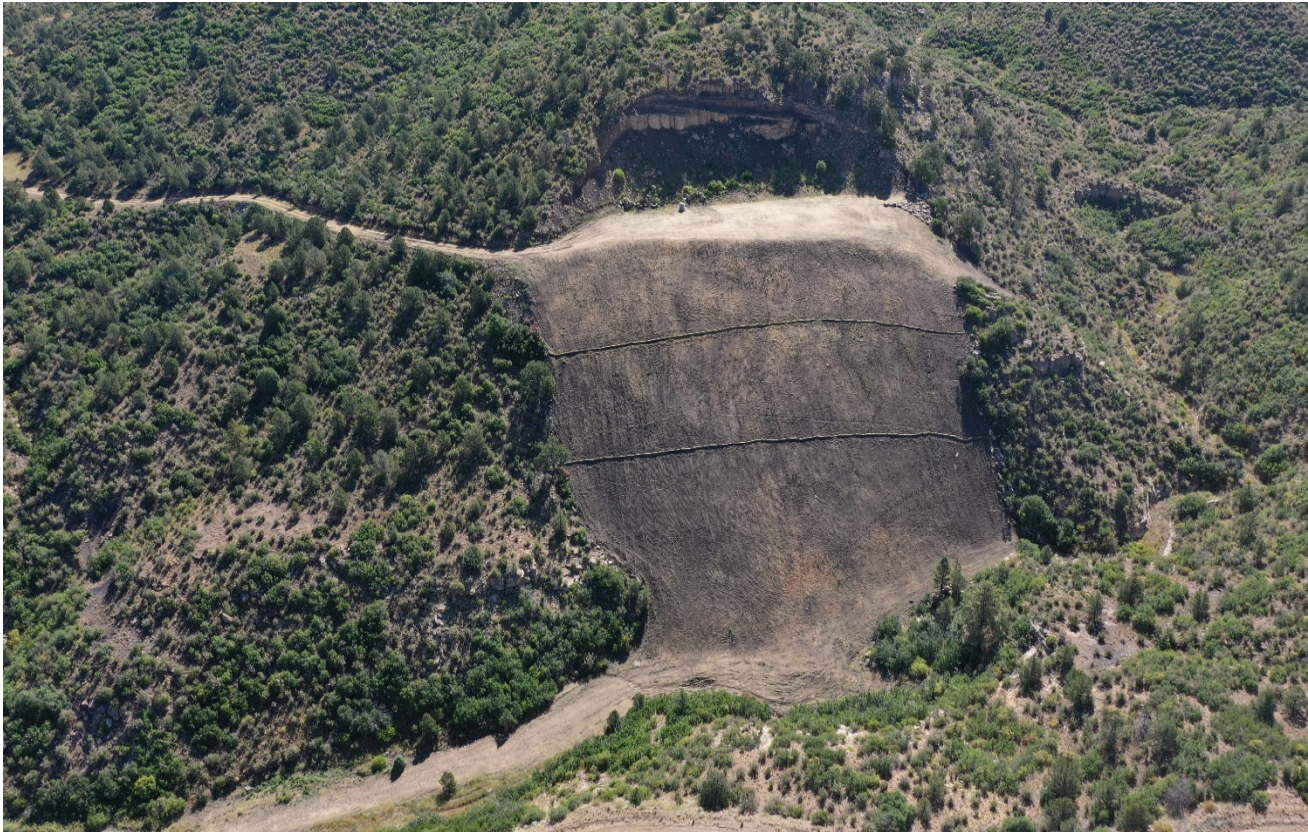
Photo 1. Drone aerial photo facing east toward the well site location. The access road and pad remain and were not recontoured back to the original condition per the rules.

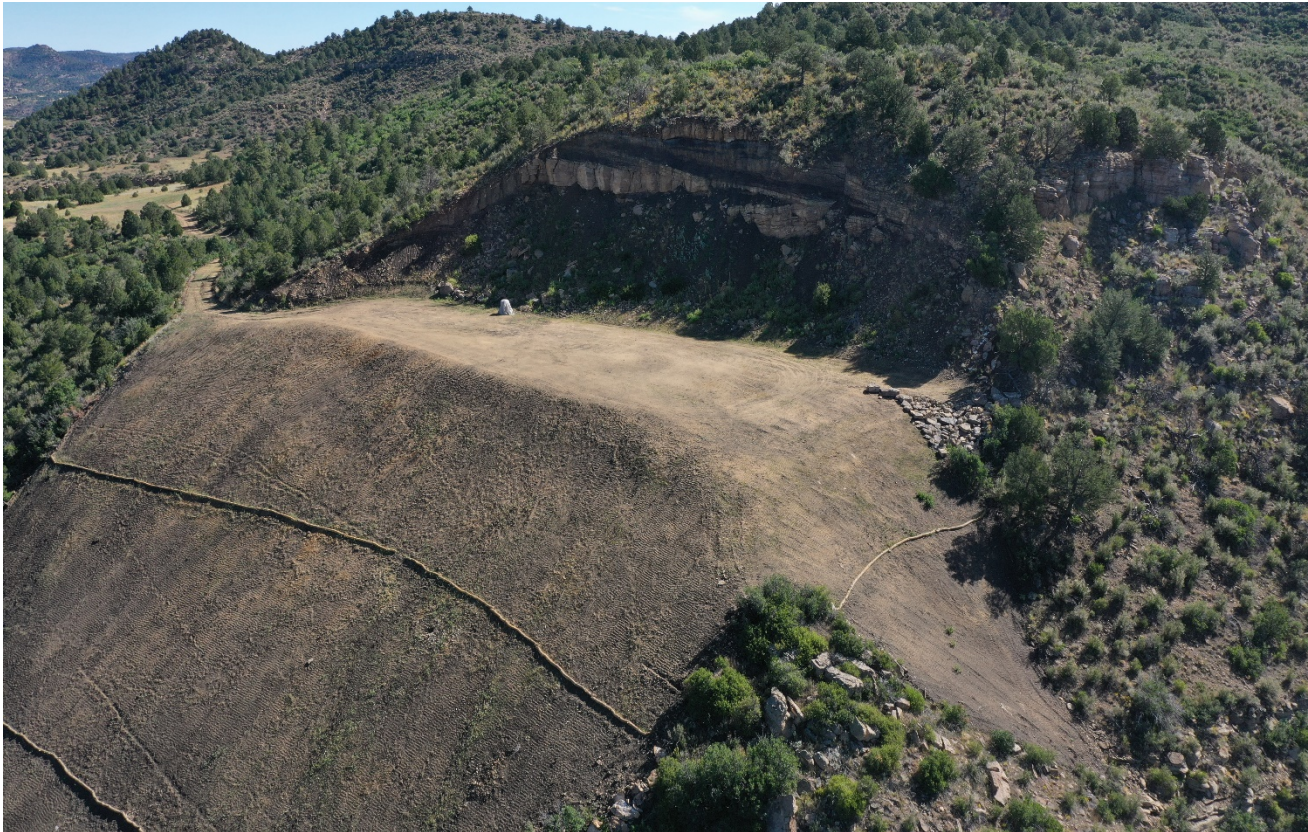
Photo 2. Facing northeast toward the location. A vertical unstable cut slope still remains. The fill slope material was not resloped back to the cut slope.

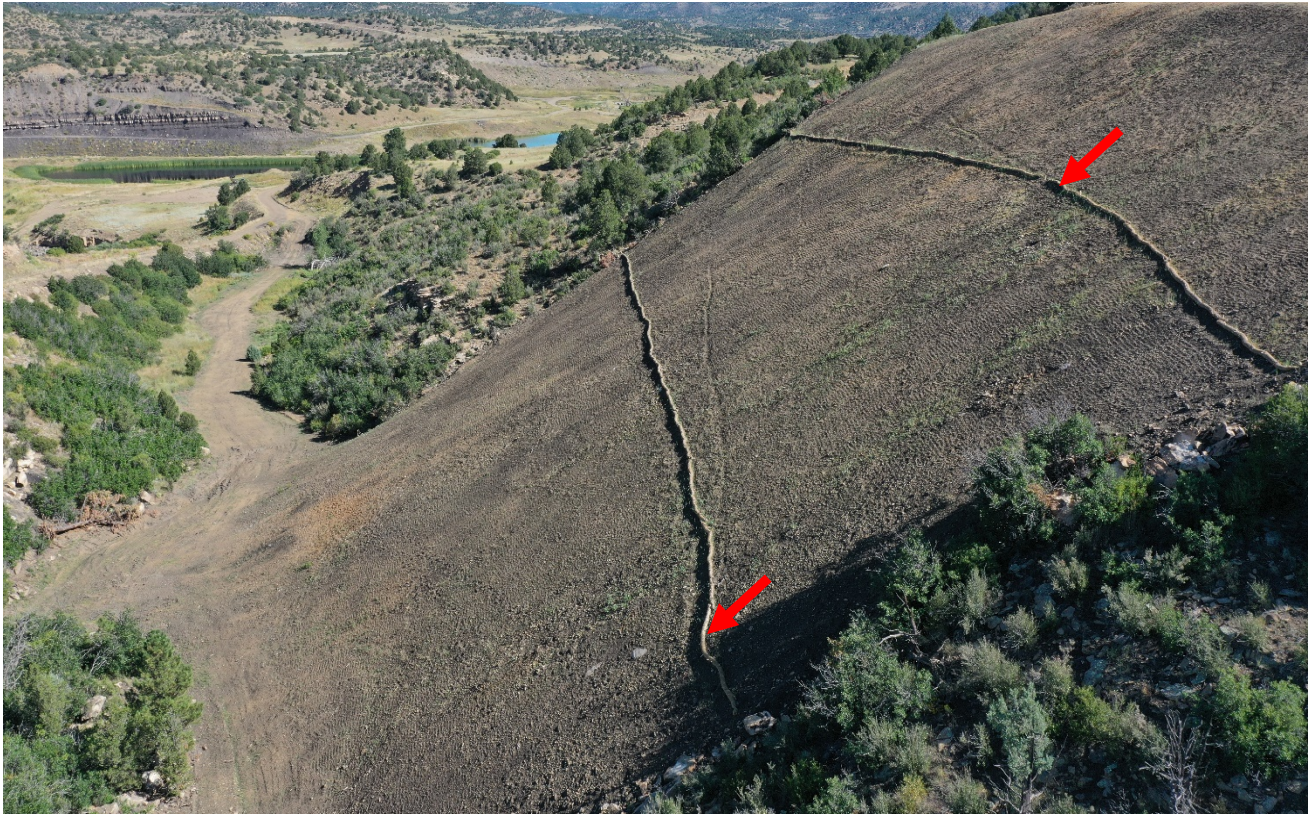
Photo 3. Facing north toward the fill slope. There does not appear to be sufficient stormwater controls along the fill slope. The red arrow points to two wattles that are displaced and have not been repaired since previous inspection.

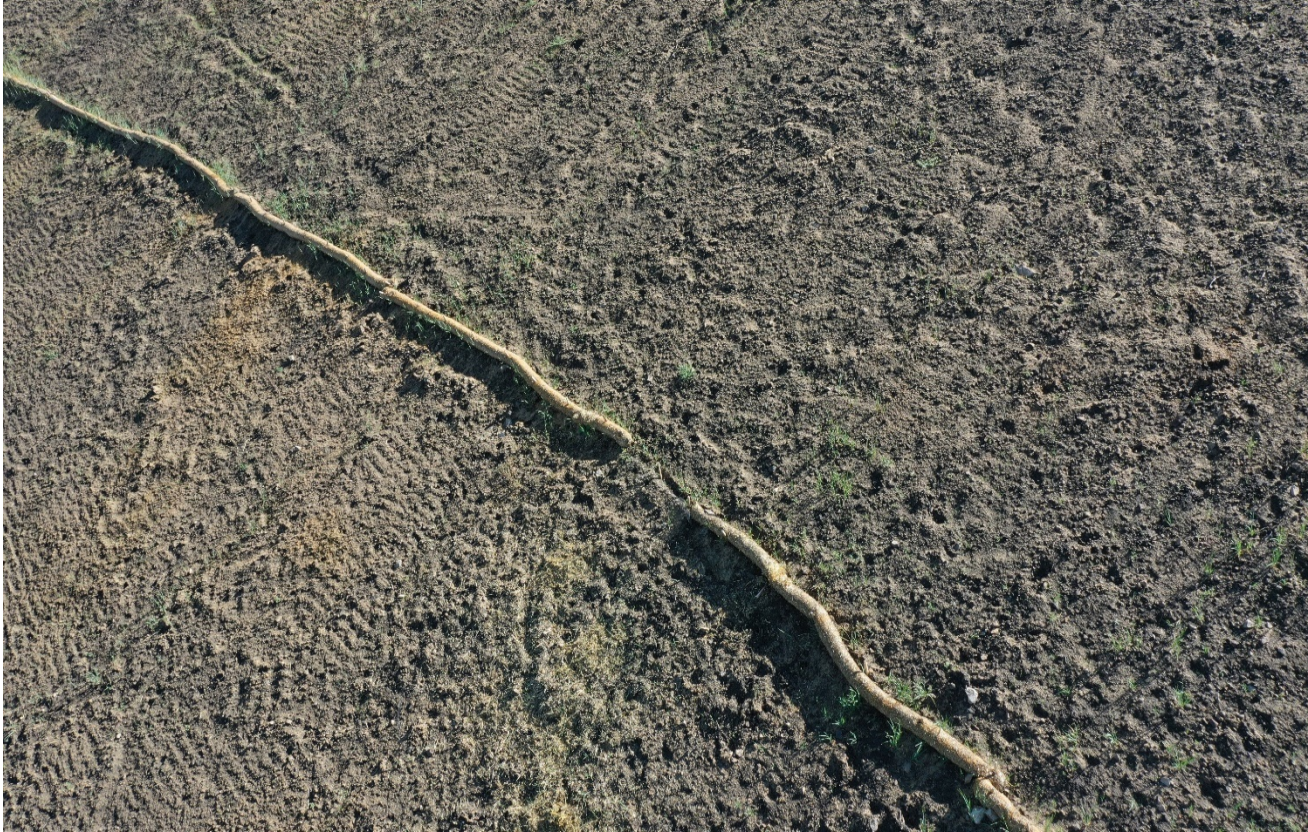
Photo 4. The straw wattles along the cut slope are displaced and not maintained. Previous corrective action was not performed.

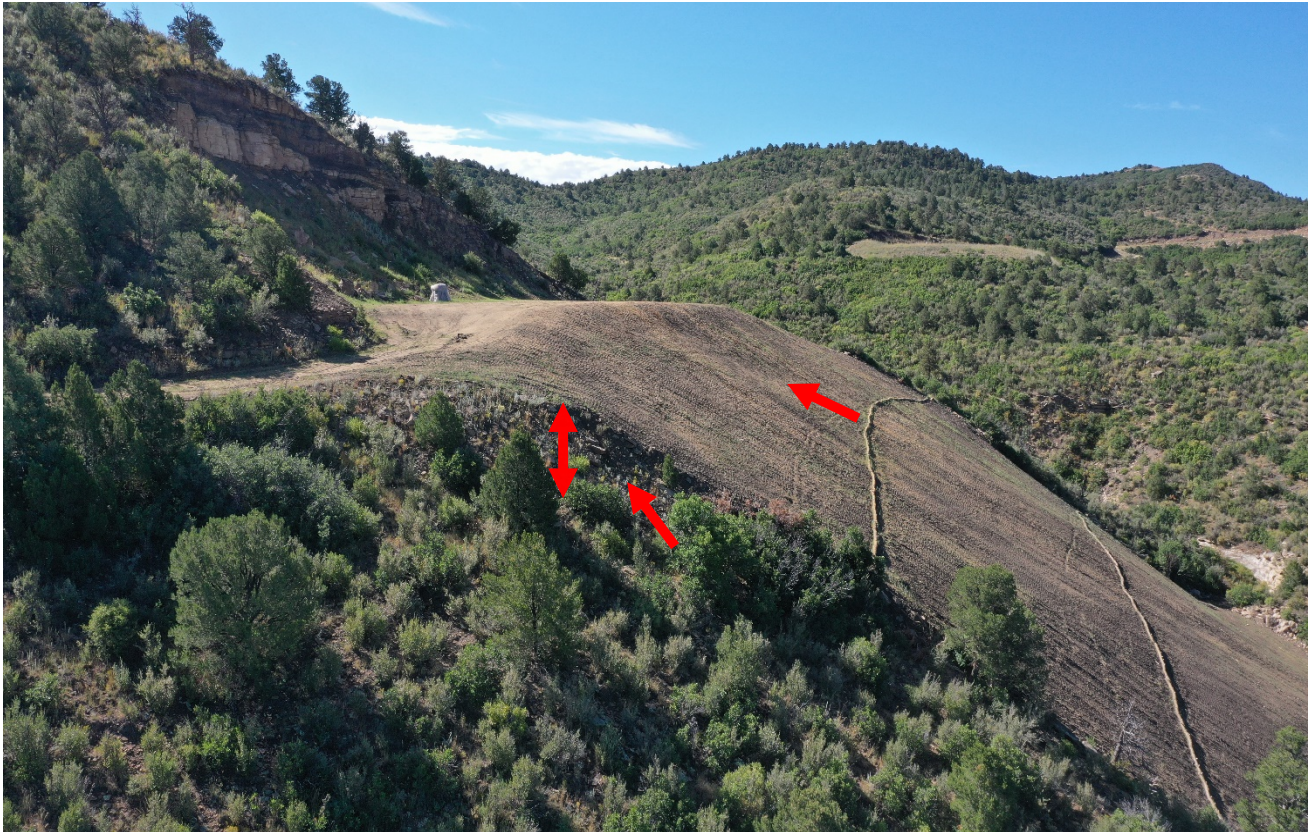
Photo 5. Facing southeast toward the location which was not recontoured per the rules. The red arrows point to fill material which could have been pushed back to original contour. The double are shows fill material which is about 20ft. from the original grade.

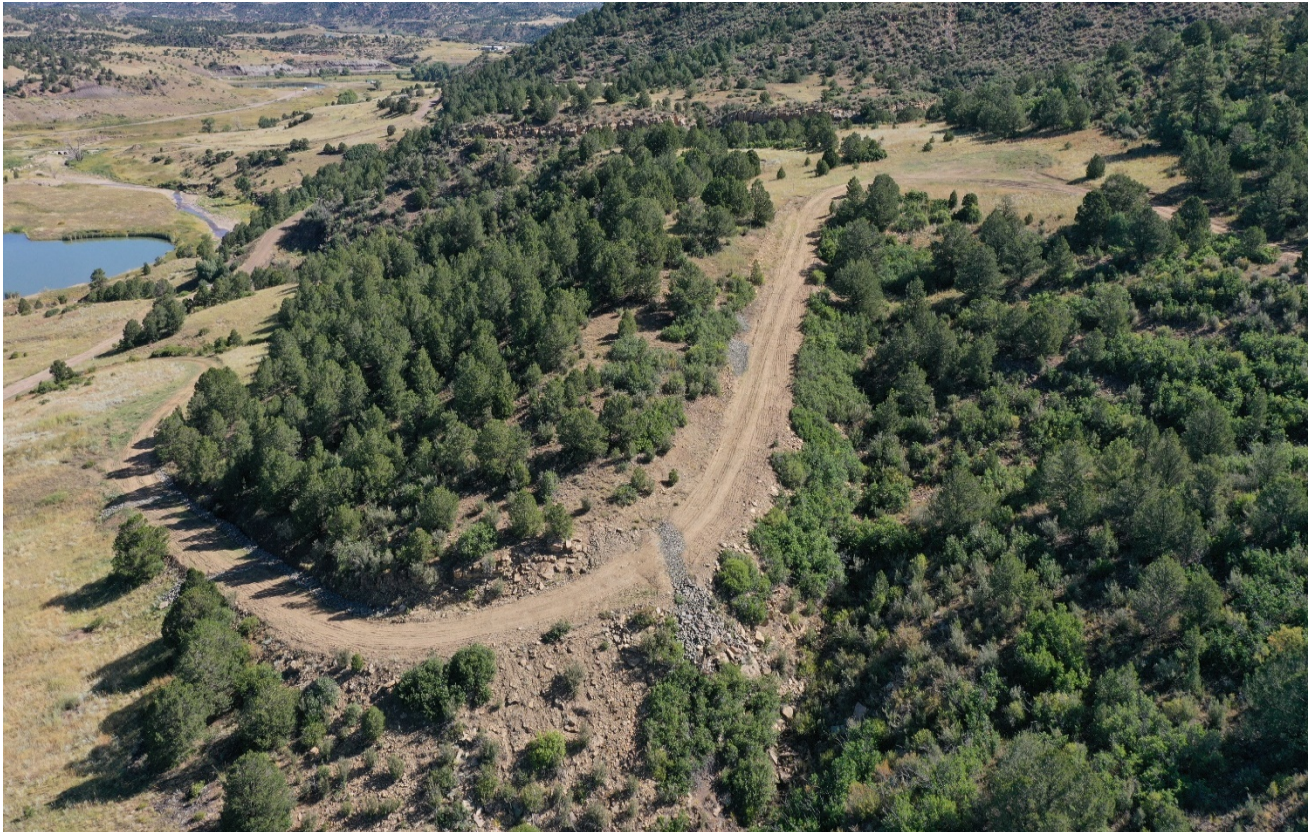
Photo 6. Facing northeast toward the access road which was not recontoured and reclaimed. The access road switches back toward the location and dead ends.

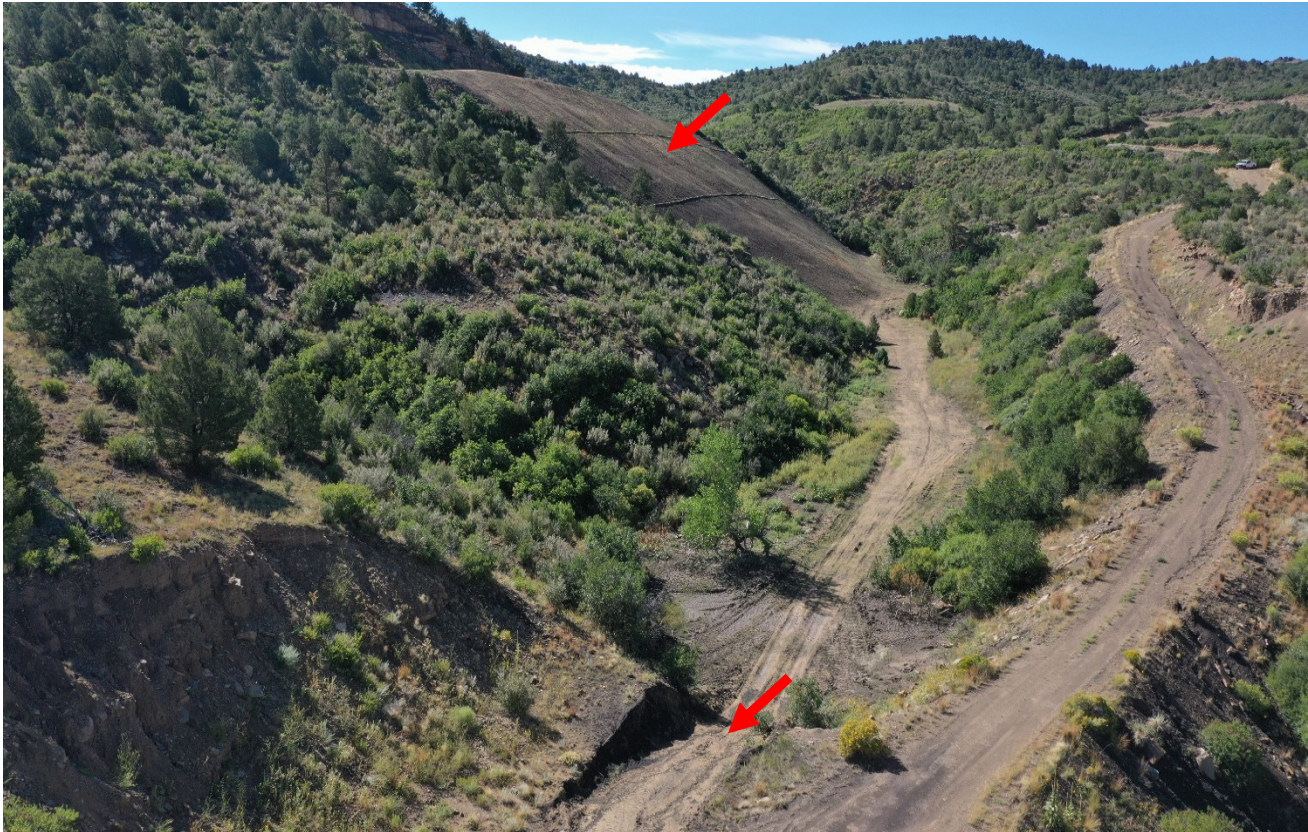
Photo 7. Facing south toward the location and canyon bottom which was disturbed by the Operator. Red arrow points to the location and road cut to access the canyon bottom shown in the next photo.

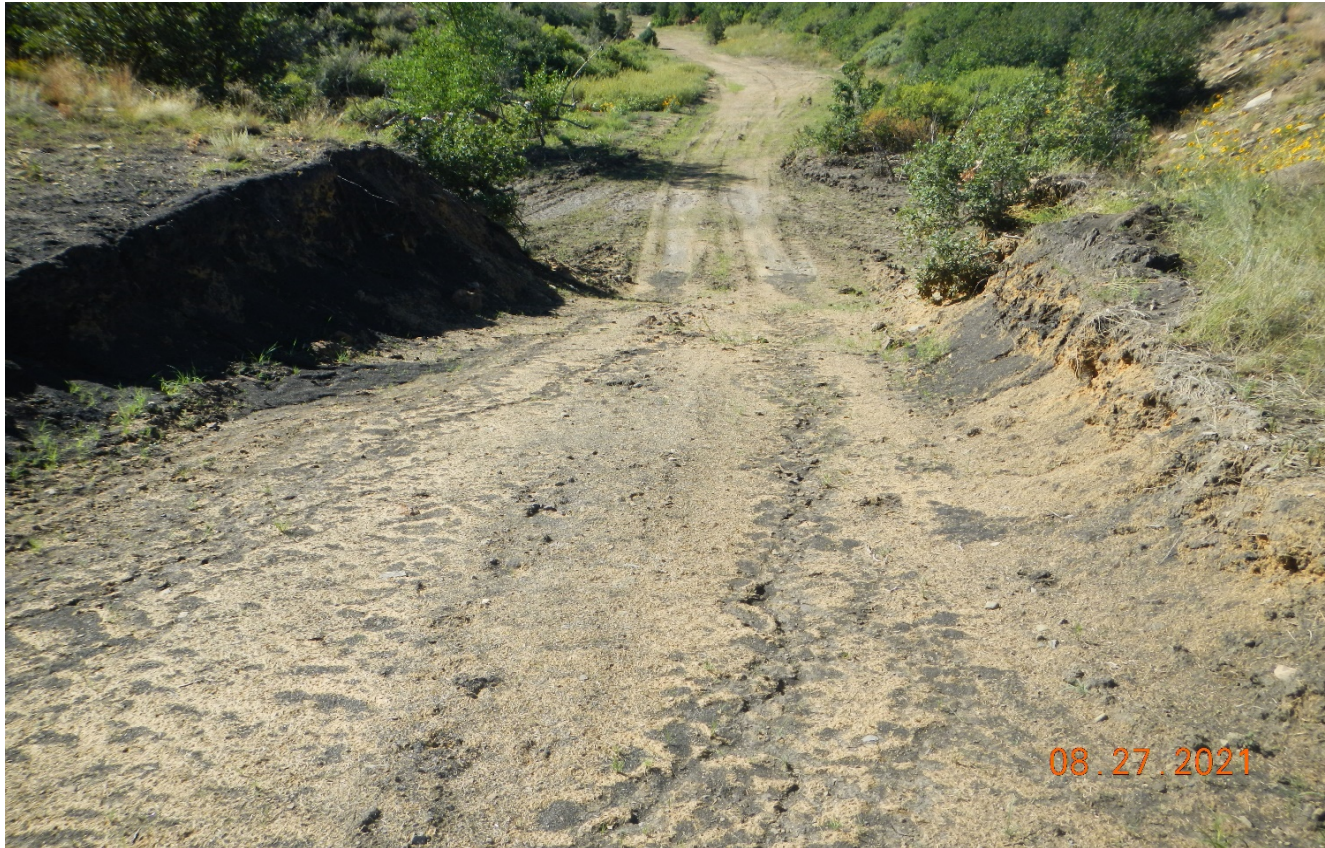
Photo 8. The road that was cut to access the canyon bottom was not recontoured and reclaimed.

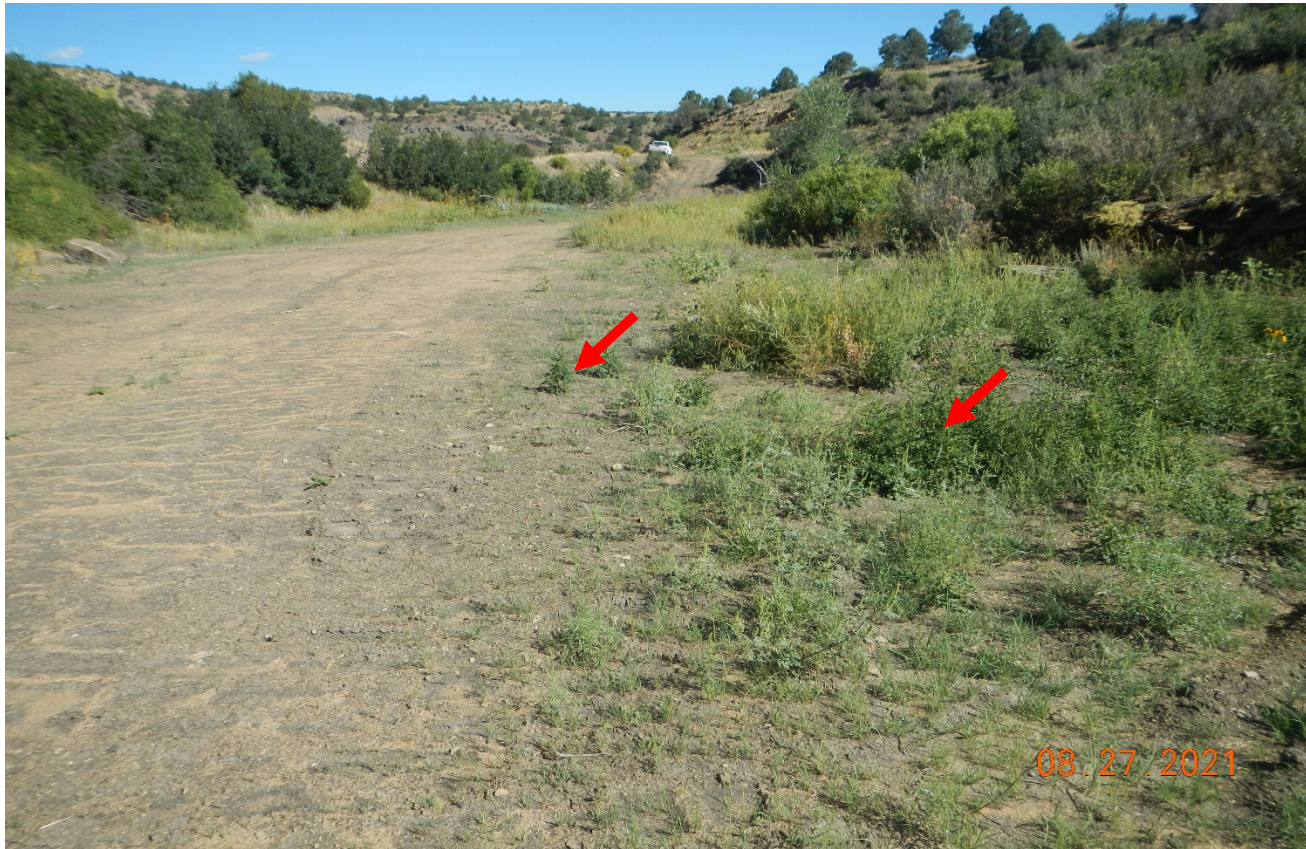
Photo 9. Facing back toward the disturbance along the canyon bottom. There are noxious weeds shown at red arrows which will need to be controlled to prevent weed infestation into the disturbance area. Canada thistle and Scotch thistle observed.

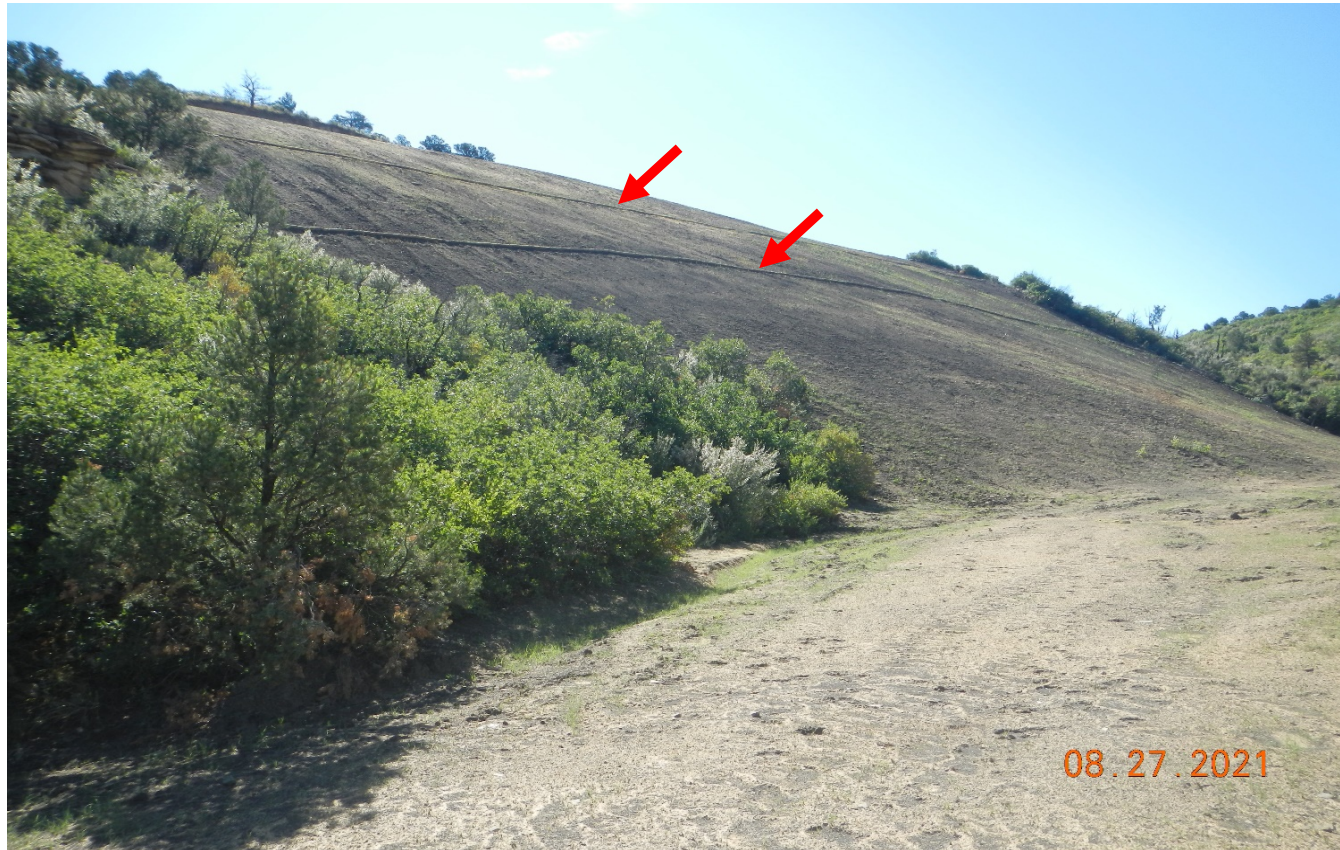
Photo 10. Standing at the bottom of the canyon facing east toward location. The fill slope was graded, seeded, and hydromulched. There does not appear to be sufficient stormwater controls along the fill slope. The red arrows point to two rows of wattles along the approximate 250 ft. slope.

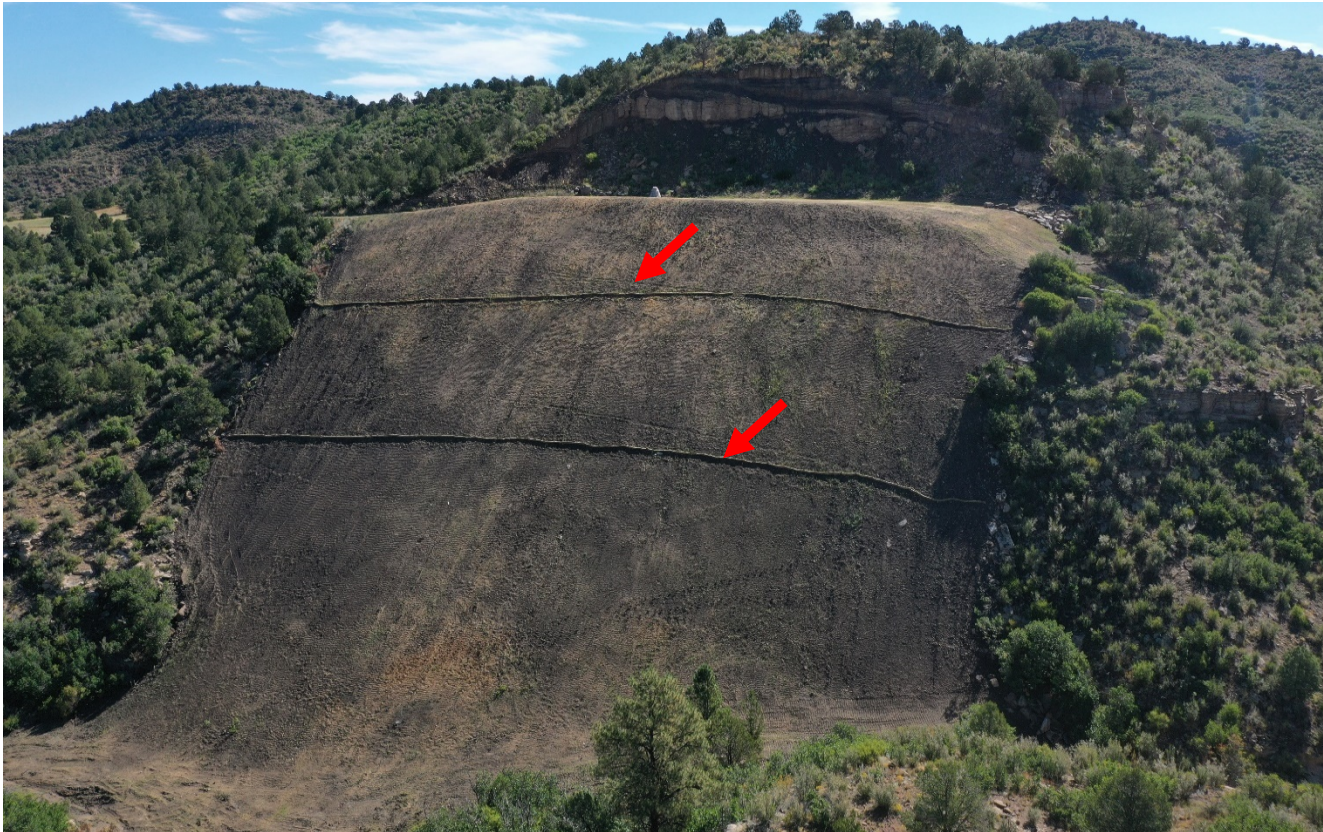
Photo 11. Facing east toward the location from across the canyon. There does not appear to be sufficient stormwater controls along the fill slope. The red arrows point to two rows of wattles along the approximate 250 ft. slope.
