## Stormwater Inspection Report

<b>Operator:</b>	Laramie Energy, LLC
<b>Project:</b>	Buzzard Creek
<b>Location:</b>	Elk Ranch 17-22D Pad
<b>Date:</b>	Tuesday, August 24, 2021
<b>Weather:</b>	Clear, Calm, 86°, Lo 53°

<b>Operator:</b>	Laramie Energy, LLC
<b>Project:</b>	Buzzard Creek
<b>Location:</b>	Elk Ranch 17-22D Pad
<b>Date:</b>	Wednesday, August 25, 2021
<b>Weather:</b>	Clear, Calm, 87°, Lo 57°

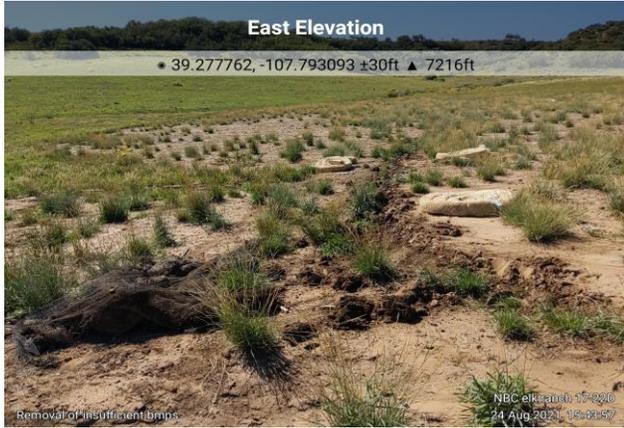
**Photo 1**

*Deteriorated BMP Removal on Elk Ranch 17-22D Pad*

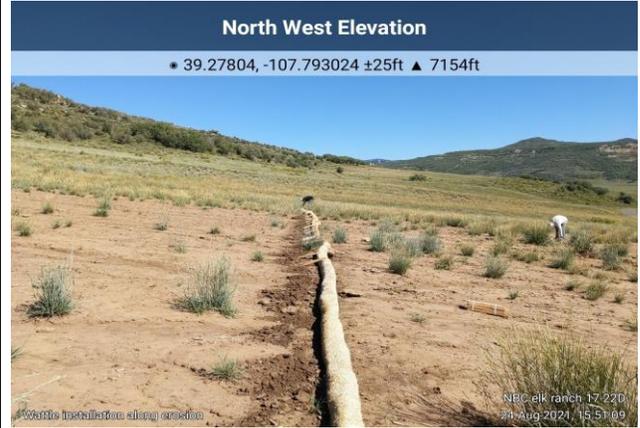
**Photo 2**

*New Excelsior Wattle Installation on the Elk Ranch 17-22D Pad*

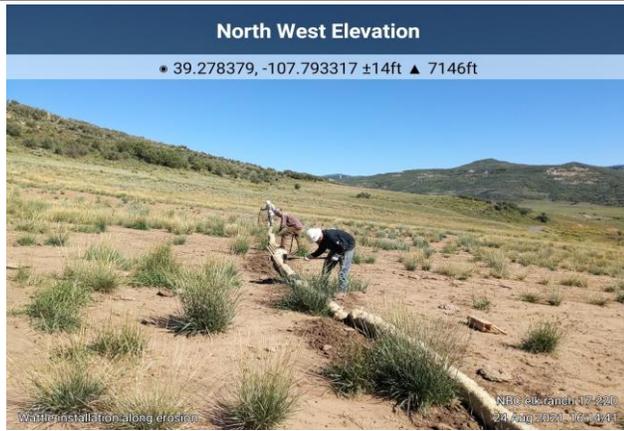
**Photo 3**

*Installing Excelsior Wattle on the Elk Ranch 17-22D Pad*

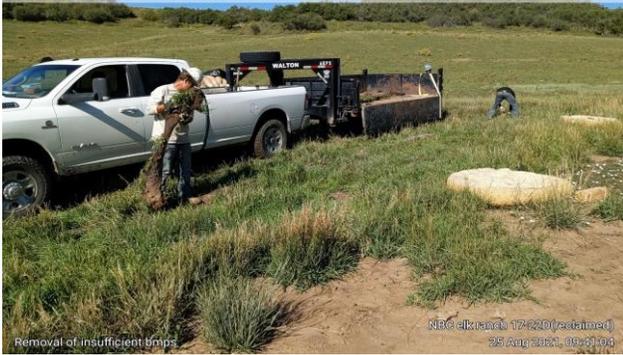
**Photo 1**

Removal of insufficient bins

**Removing Old Deteriorated Wattle on the Elk Ranch 17-22D Pad**

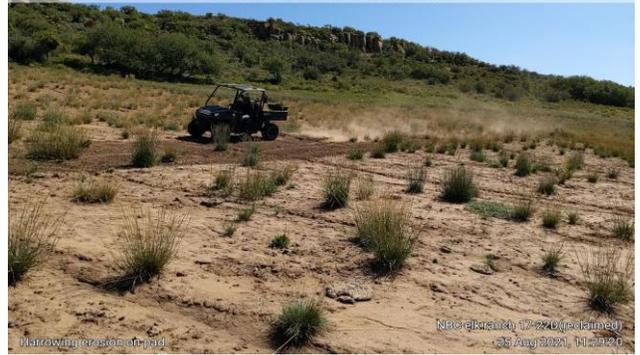
**Photo 2**

Harrowing erosion of pad

**Harrowing the Elk Ranch 17-22D Pad to Remove Erosion Features**

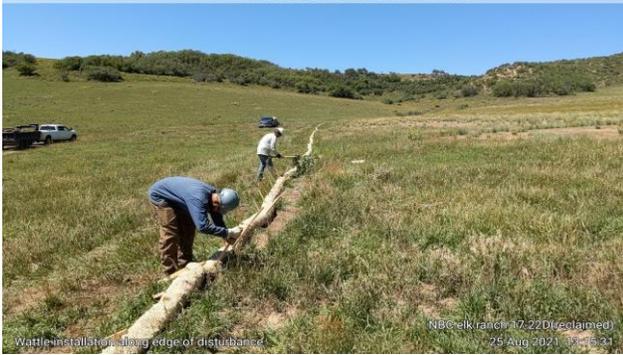
**Photo 3**

Wattle installation along edge of disturbance

**Installing Excelsior Wattle on the Elk Ranch 17-22D Pad**

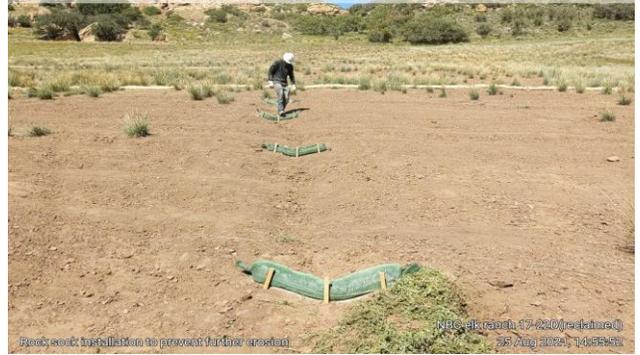
**Photo 4**

Rock sock installation to prevent further erosion

**Installing Rock Sock Checks on the Elk Ranch 17-22D Pad**
