Inspection Photos  
Location Name: Dungan 32-5 #5-1  
API: 05-007-06196

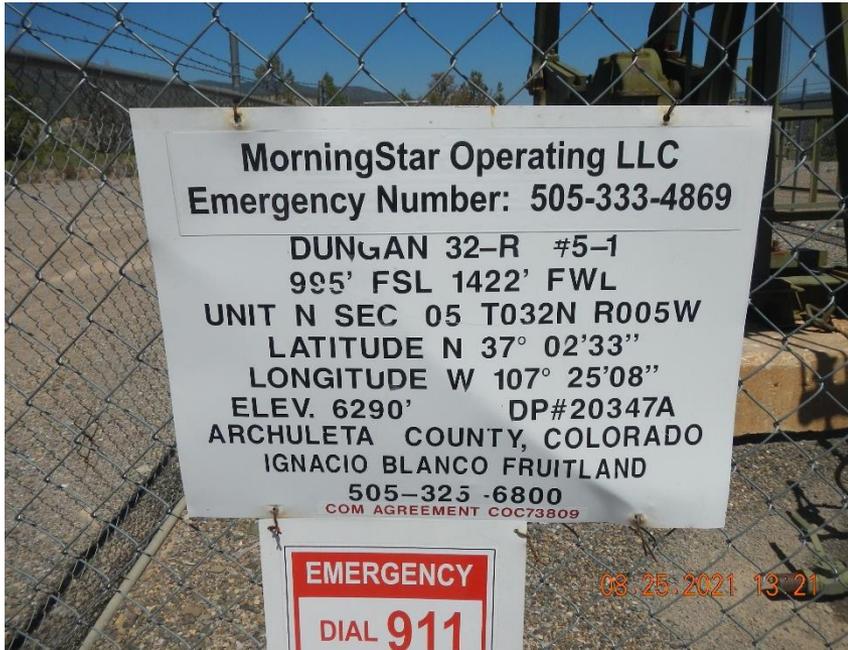
Well sign does not meet the requirements of Rule 605.d.

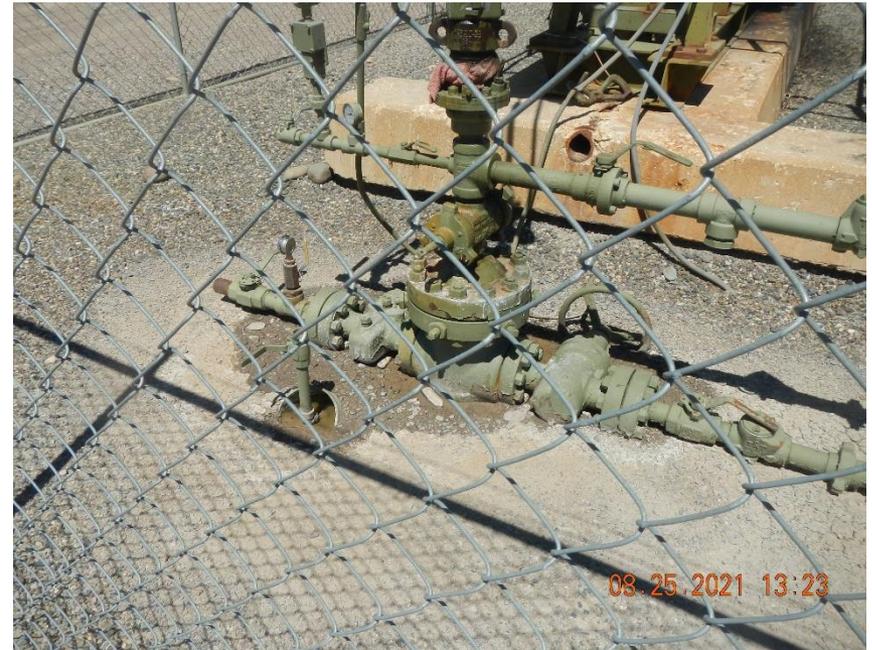
Standing water observed around well head. No other standing water was observed during this inspection.

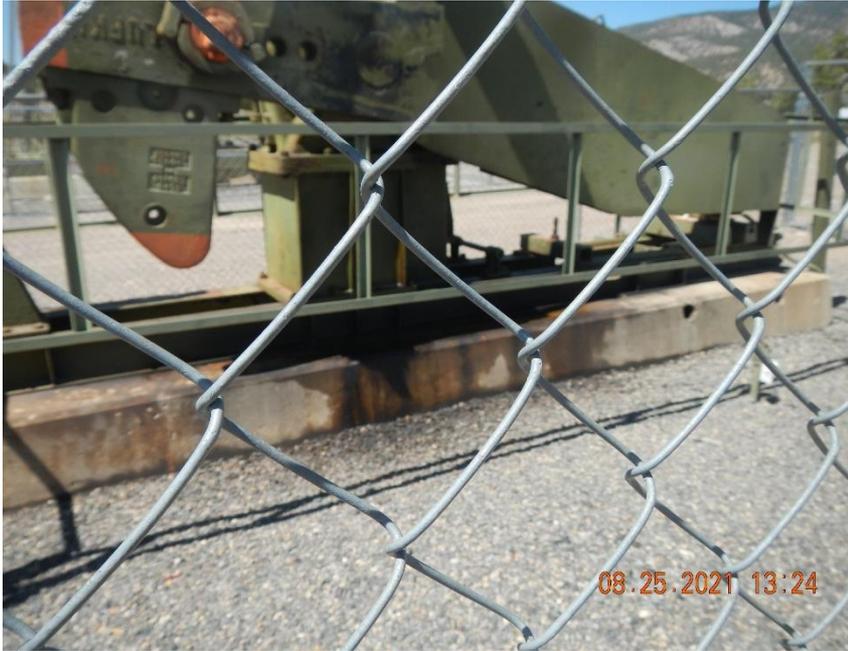
**Concrete pad and surrounding gravel are stained.**

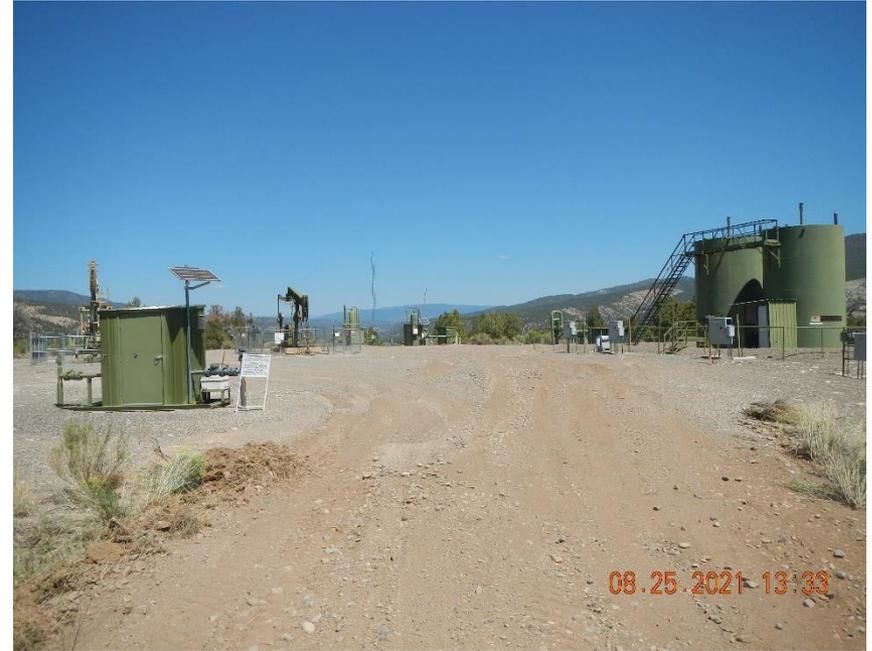
**Dungan 32-5 #5-1 location photo.**

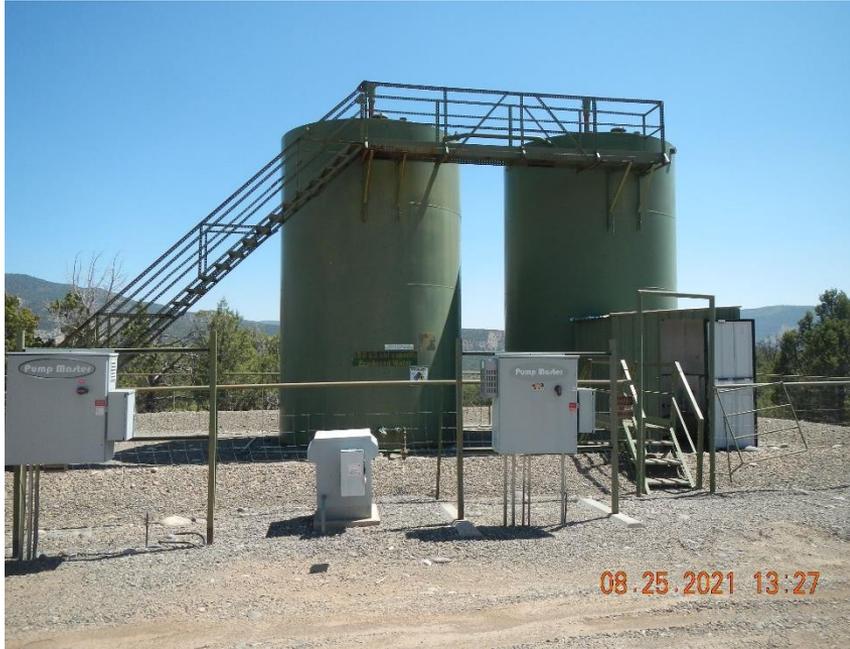
AST signs list previous operator.

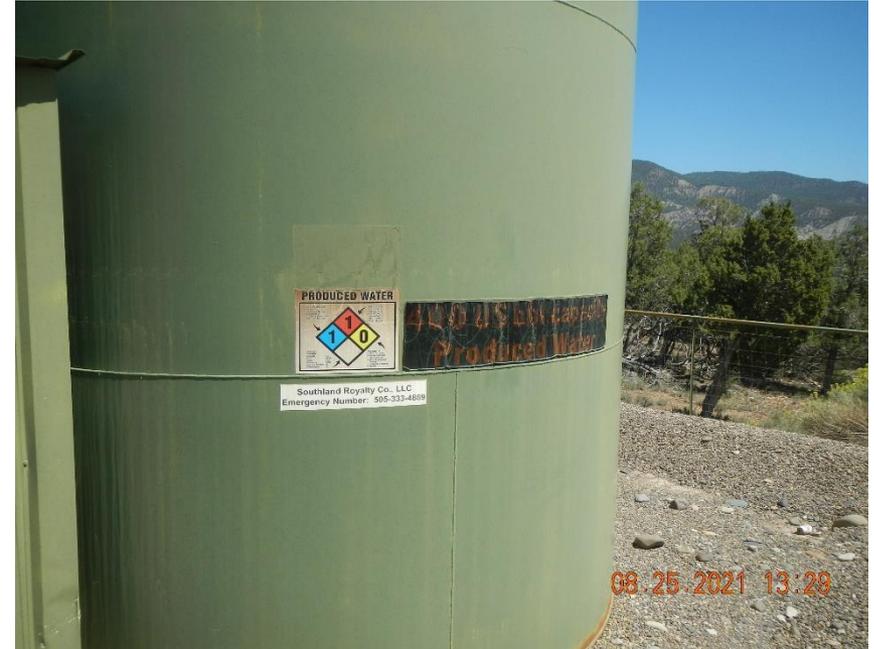
Southern AST has illegible labels.
