Inspection Photos

Operator: Kinder Morgan
API: 083-06573
Date: 8/31/2021

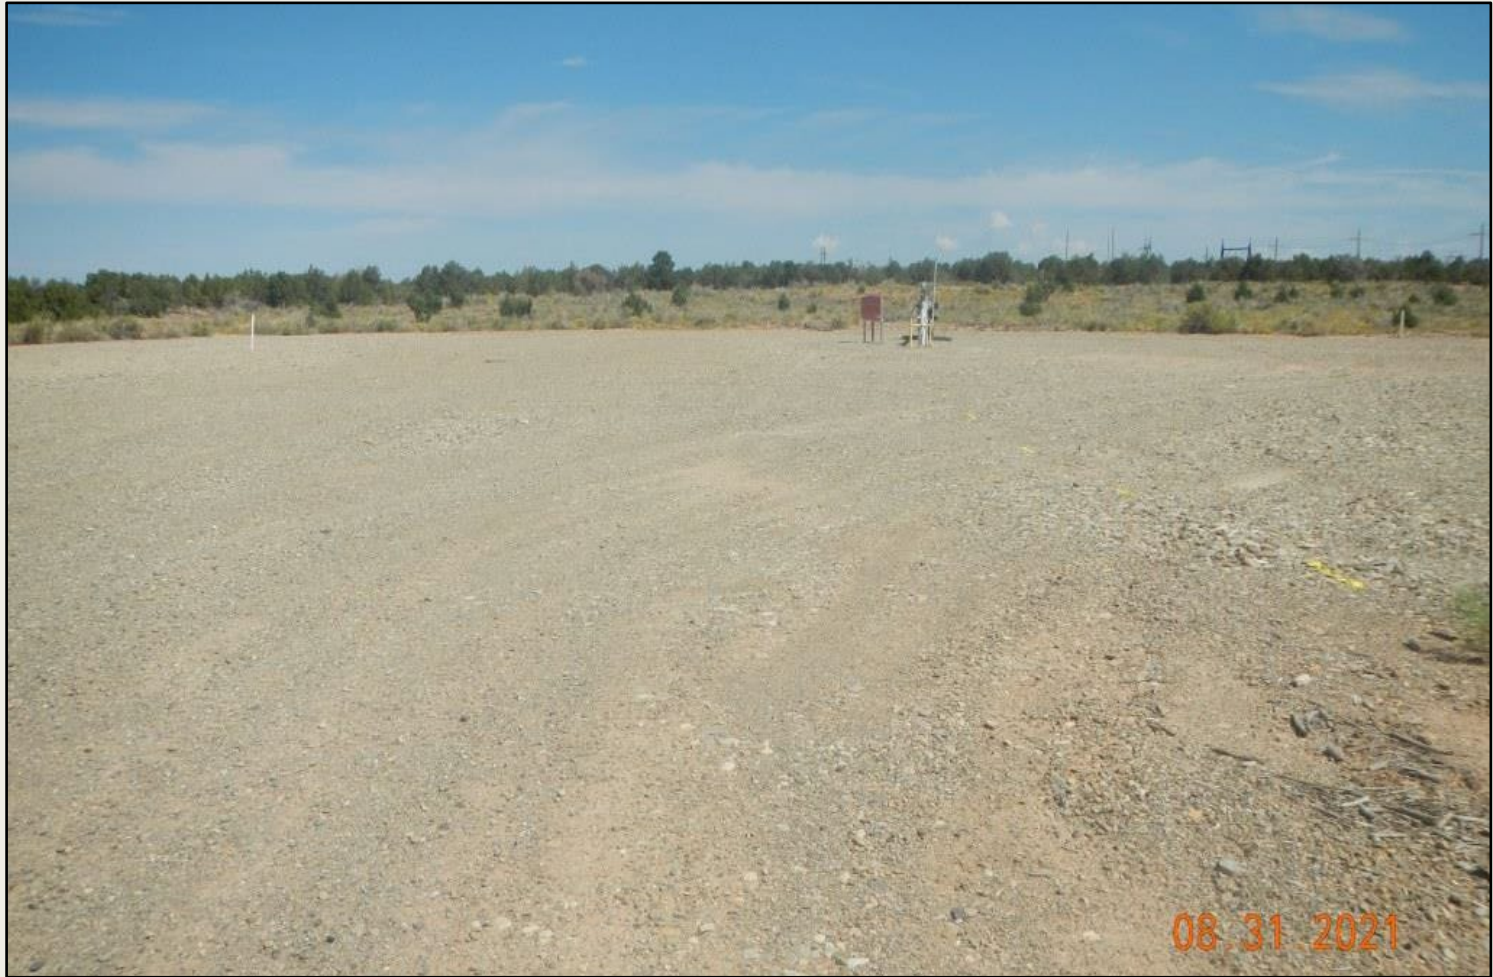
Photo 1. View of the project area from the well pad entrance facing center.

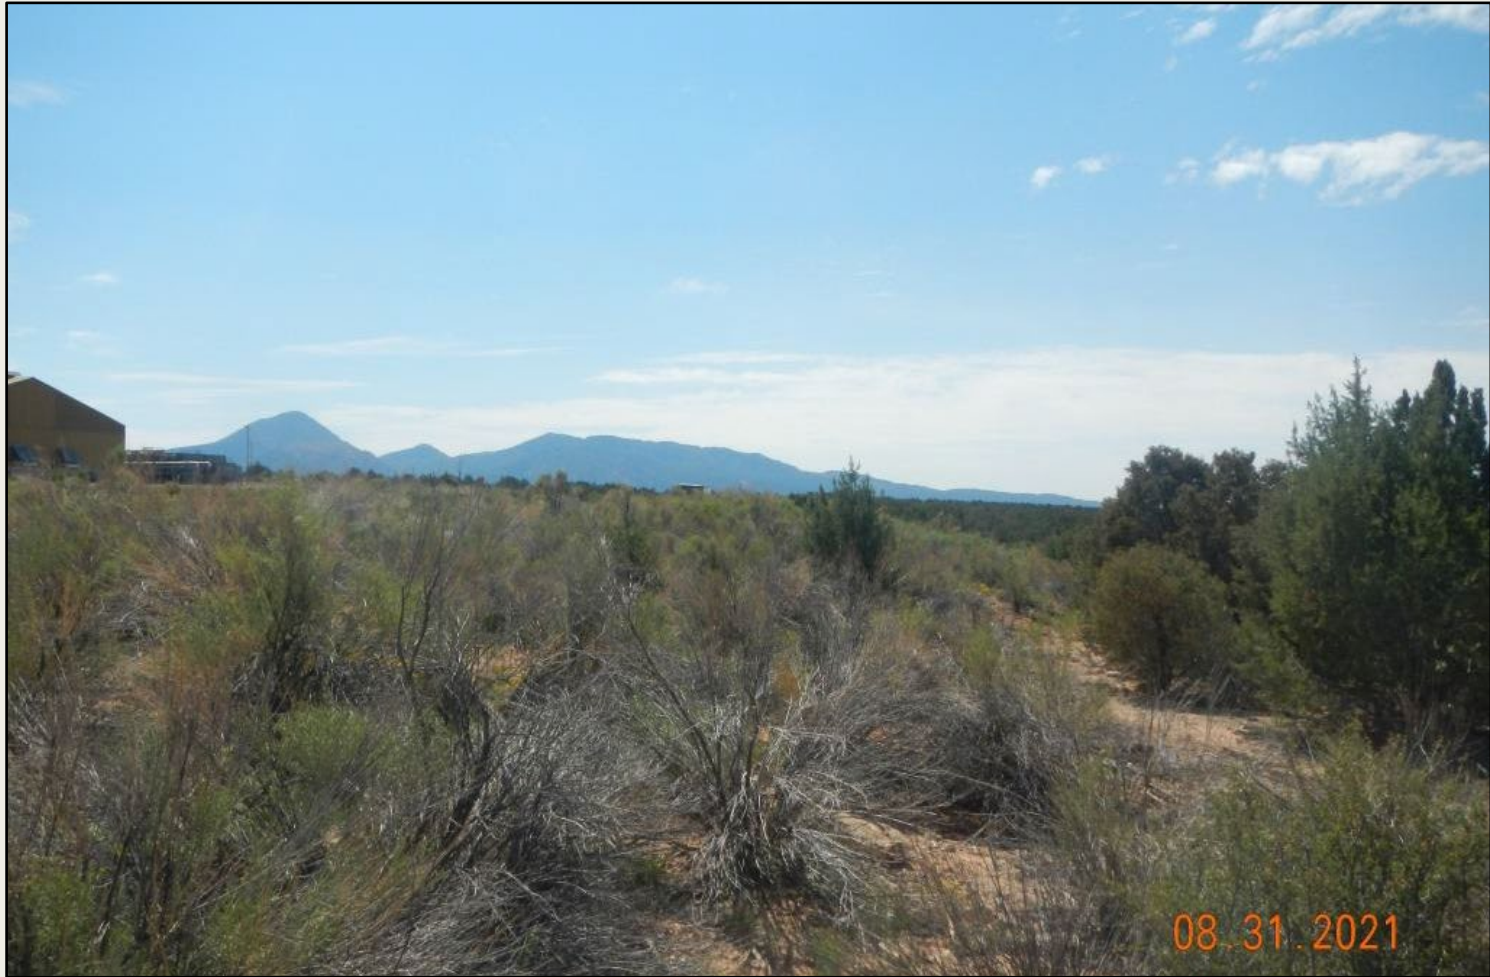
Photo 2. View of the western project area from the northwestern corner facing southward. Revegetation is progressing with rubber rabbitbrush, Indian ricegrass, snakeweed, and western wheatgrass.

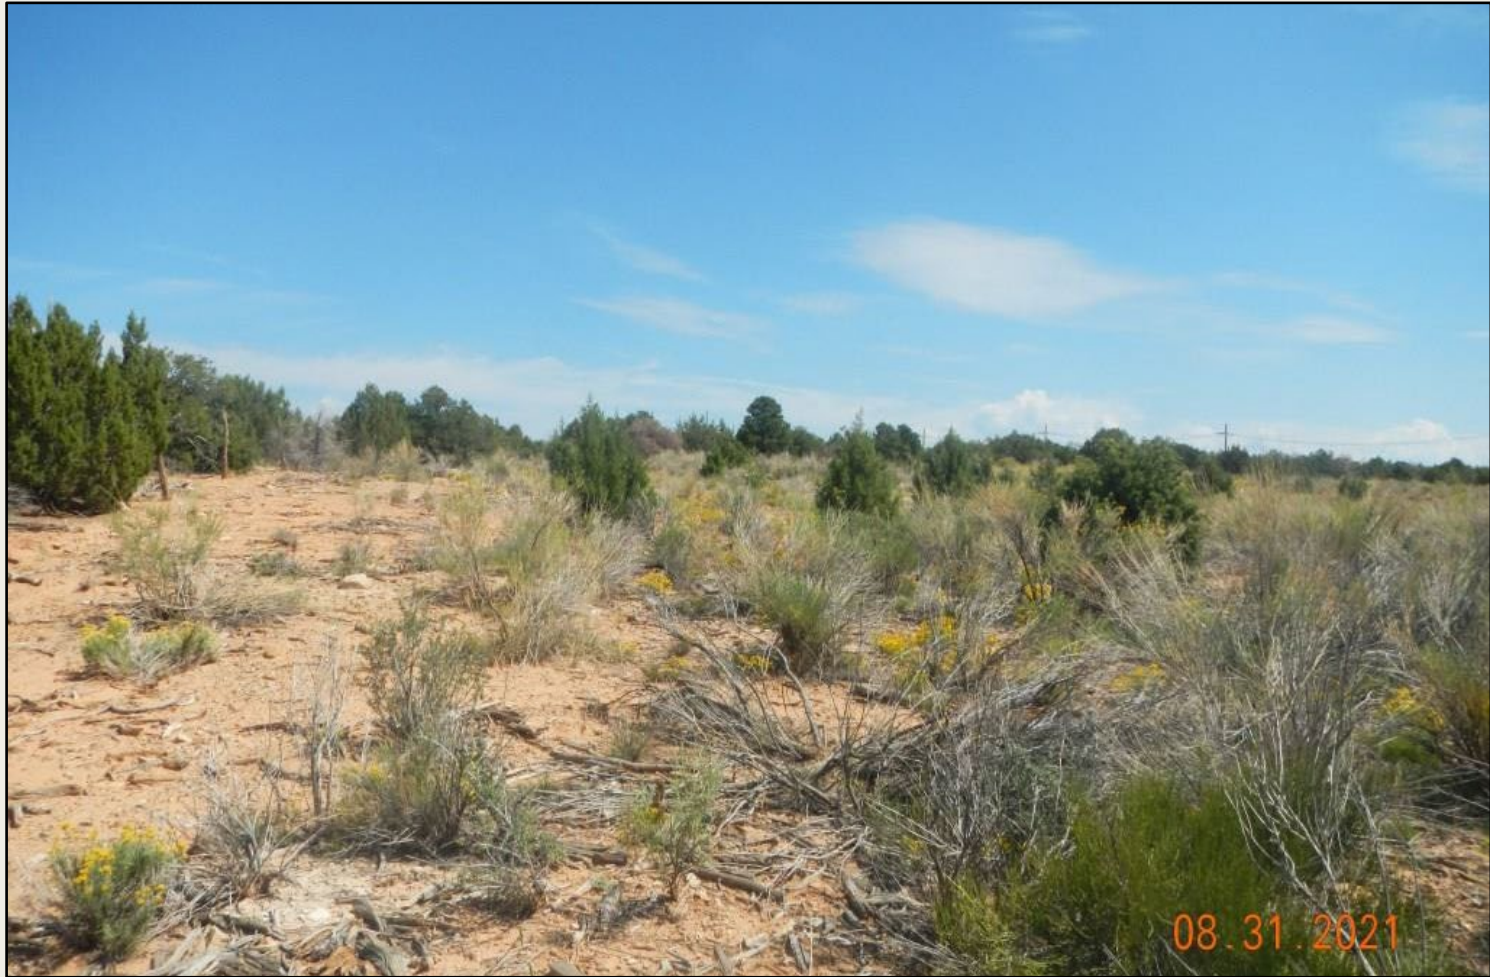
Photo 3. View of the northern project area from the northwestern corner facing eastward.

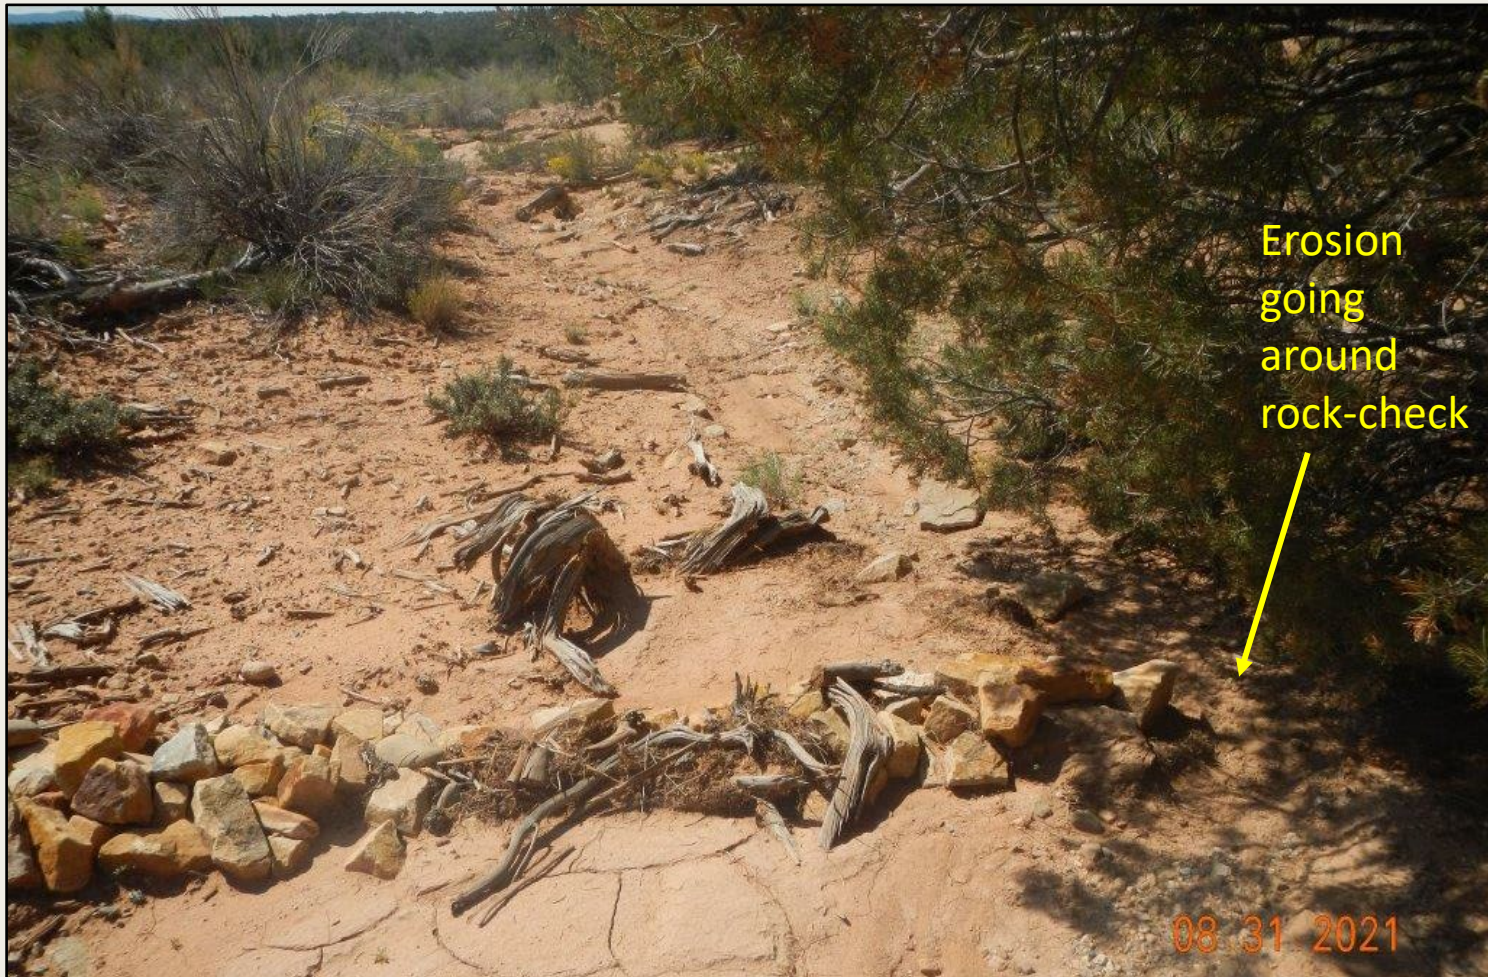
Photo 4. View of rock BMP in the northwestern project area (facing downslope), that is full of sediment and eroding around the rock-check is occurring.

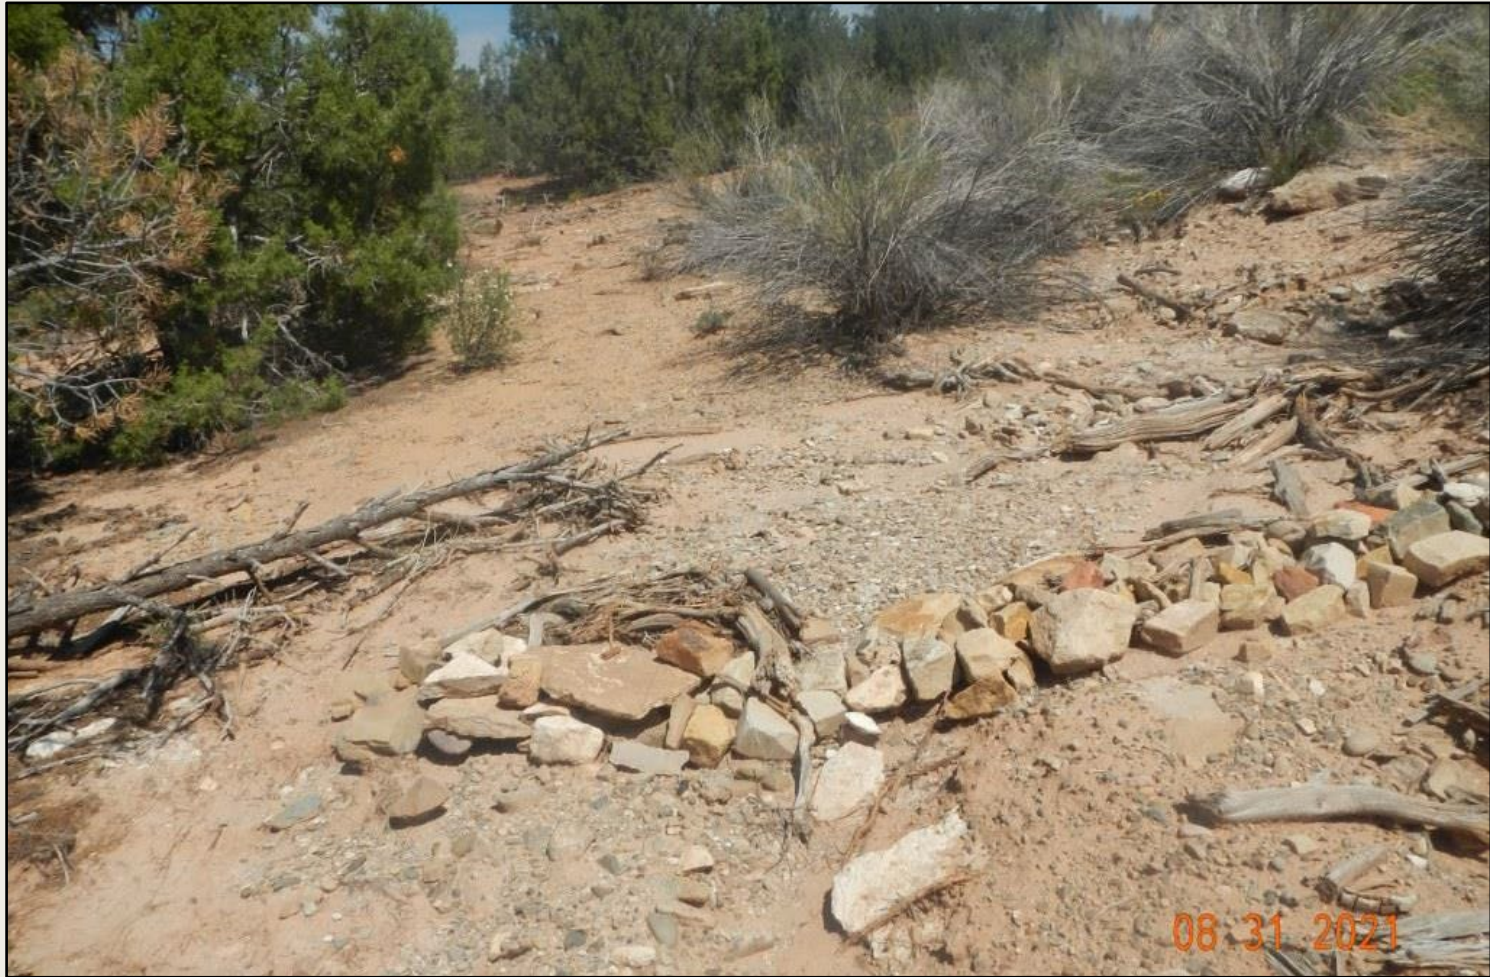
Photo 5. View of another area where rock-check is overflowing and no-longer functioning.

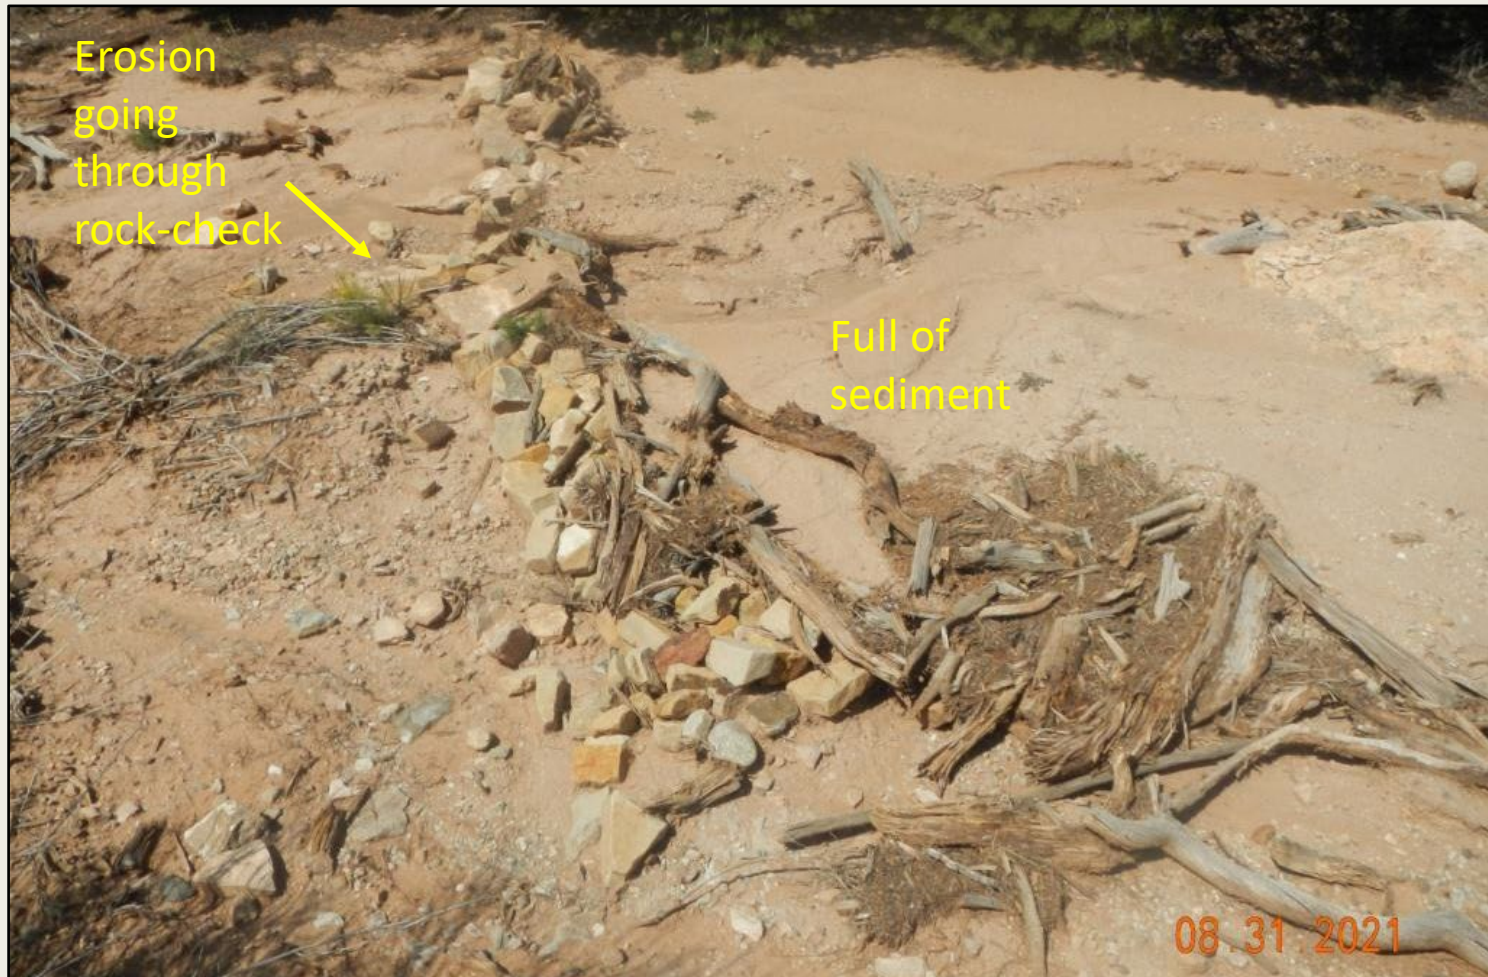
Photo 6. View of another failed rock-check full of sediment with erosion continuing within channel.

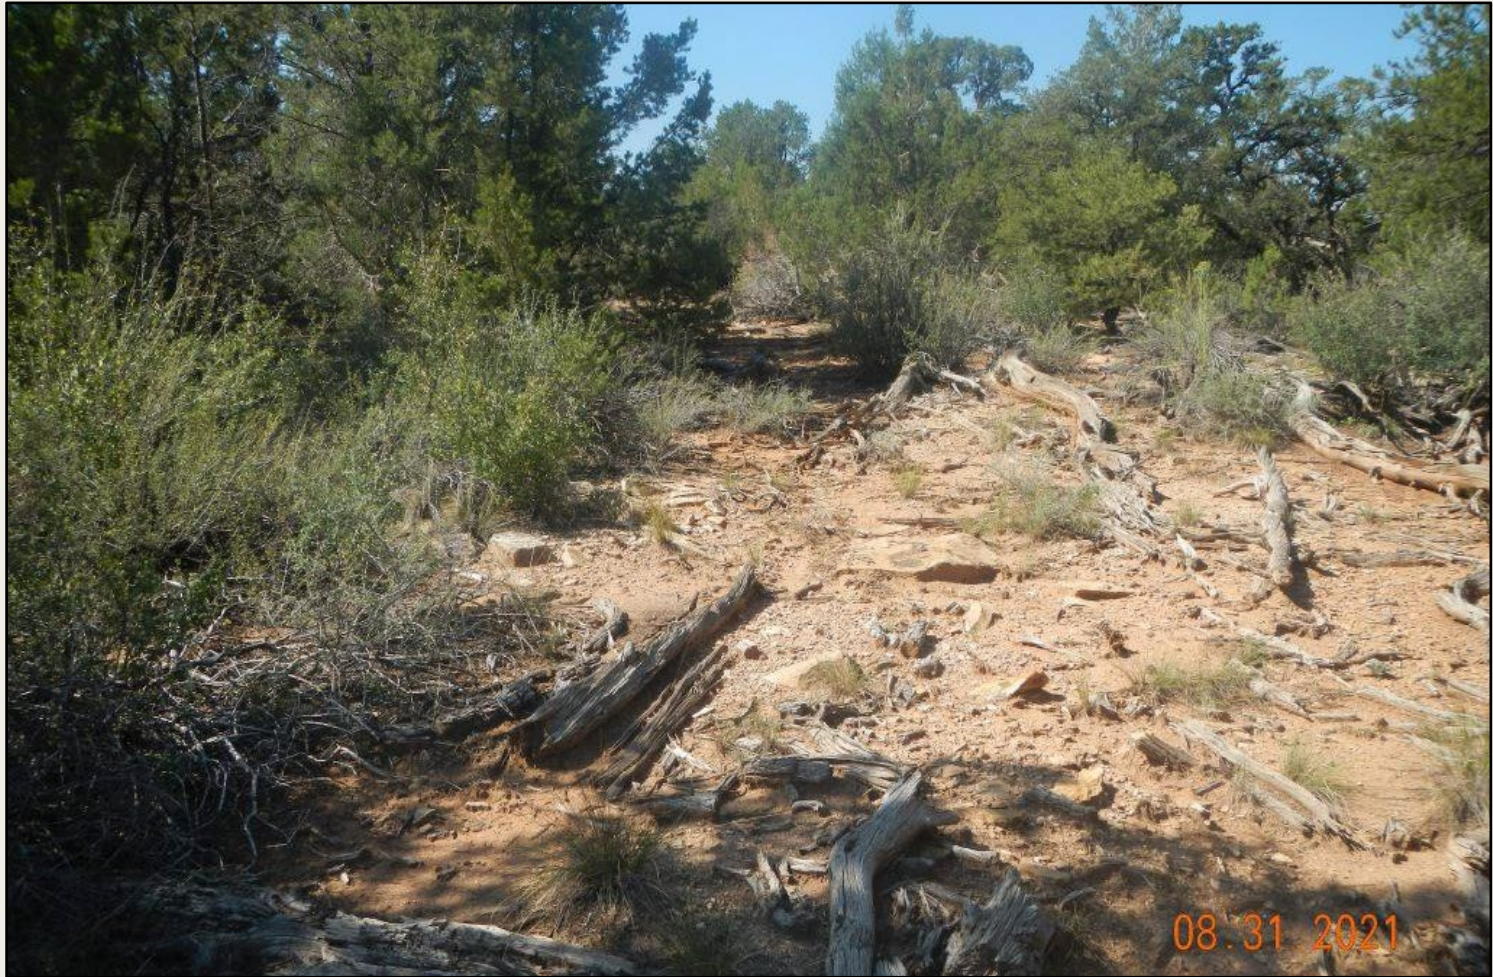
Photo 7. View of reference area comprised of pinyon and juniper woodland with cliffrose, serviceberry, Indian ricegrass, Eaton's penstemon, and gambel oaks.
