Inspection Photos
Location Name: Burnett #2-1
API: 05-067-07769

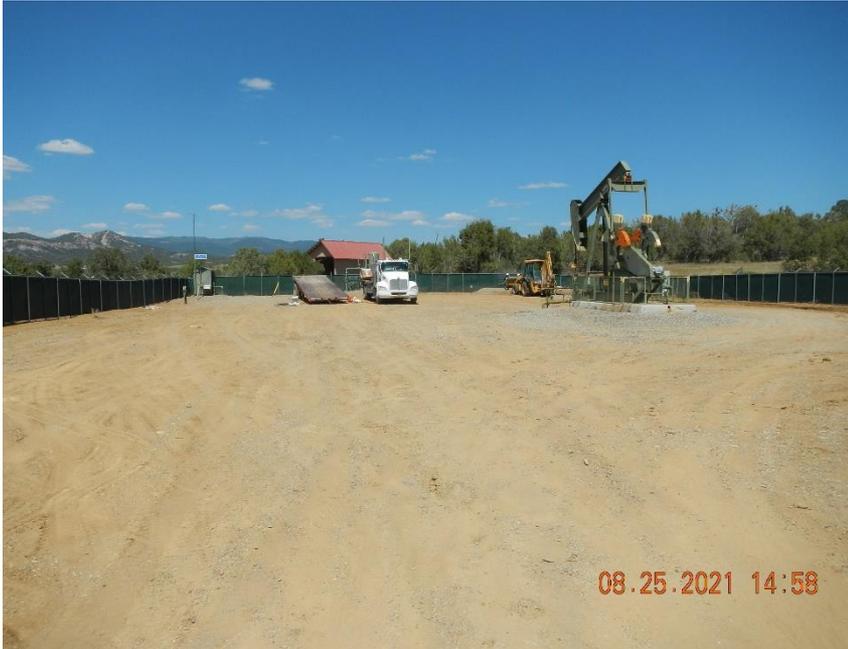
Burnett #2-1 location photo.

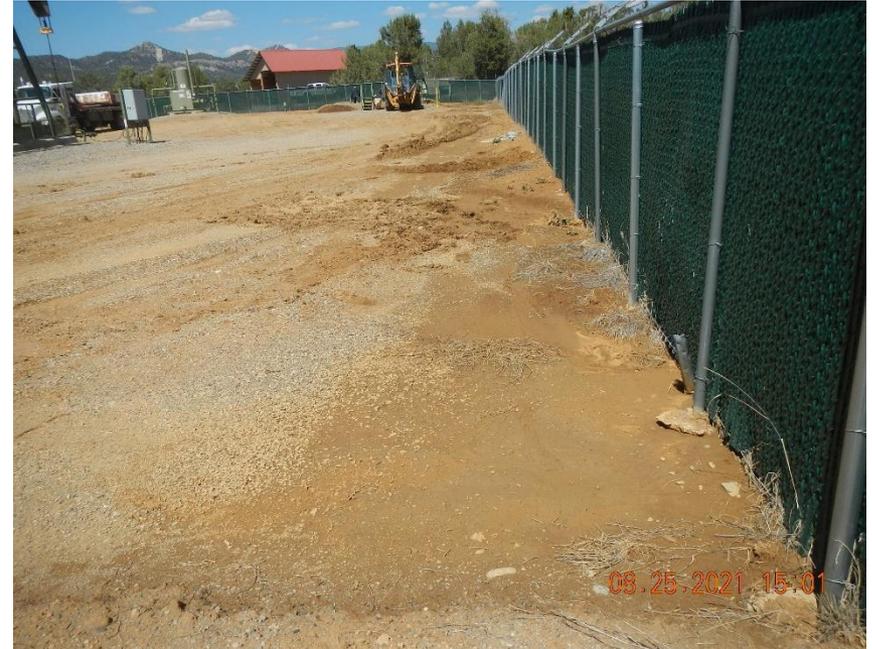
Damp soil along eastern edge of location.

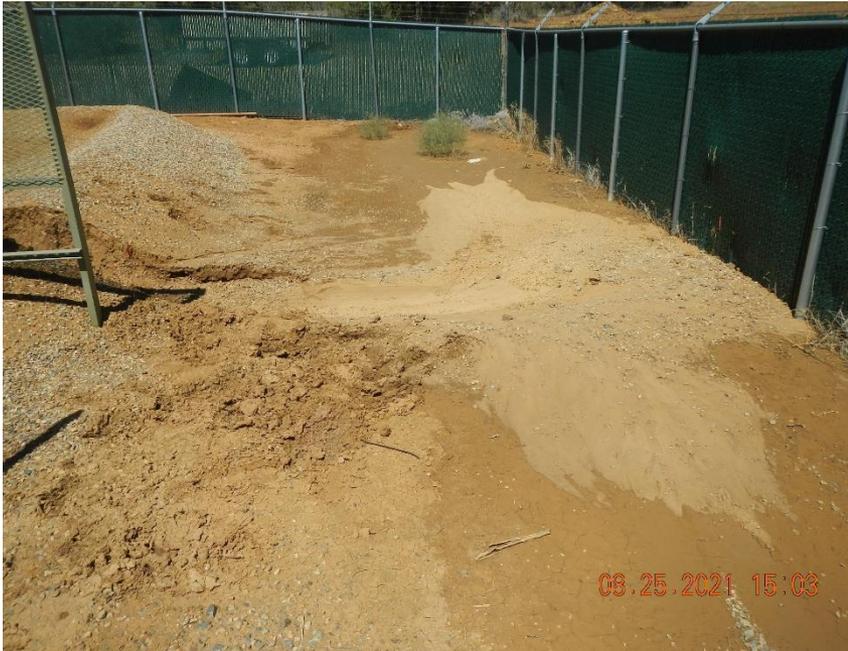
Area where Spill/Release Point ID #480579 breached secondary containment berm.

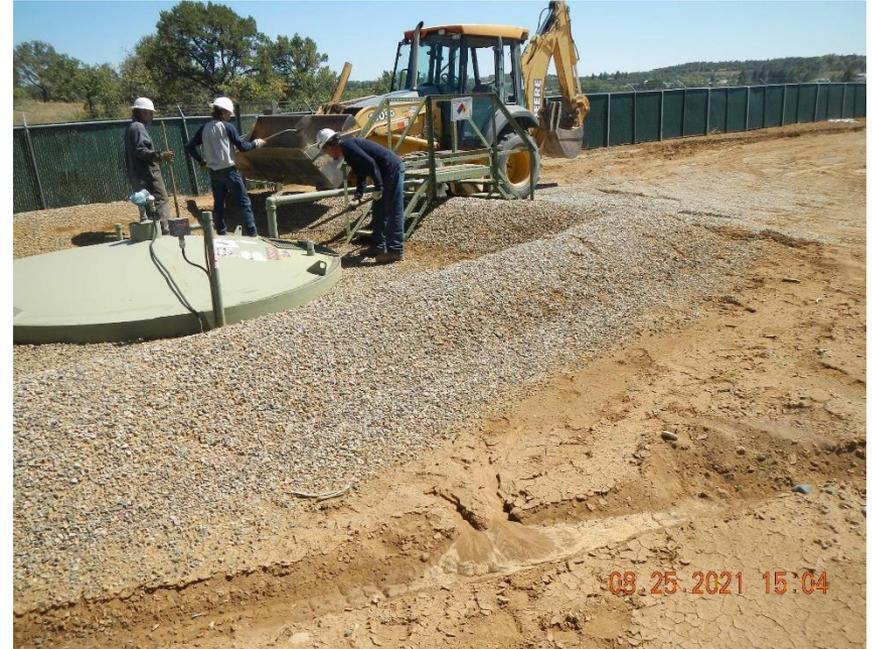
Crew working within secondary containment berm.

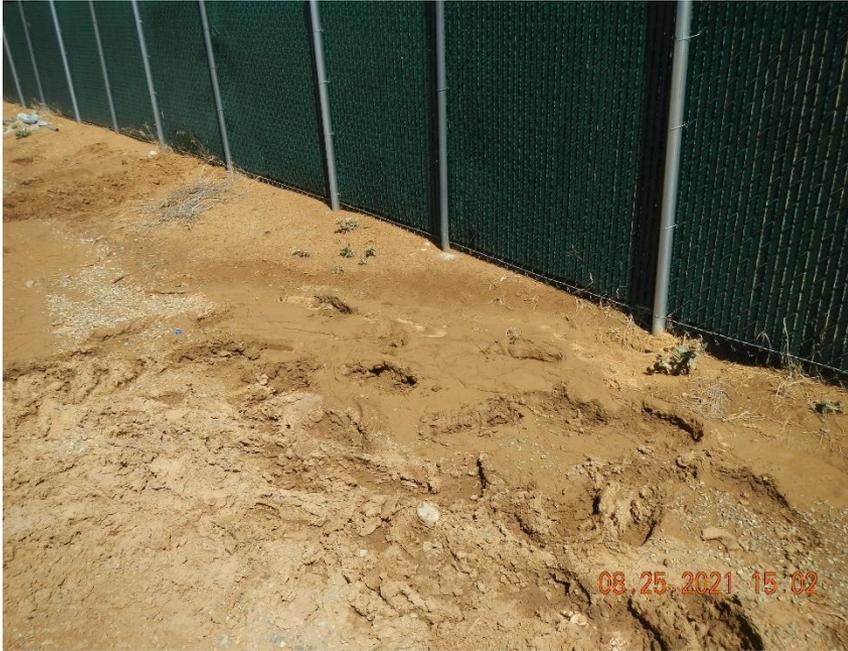
Damp soil extends beyond location fence.

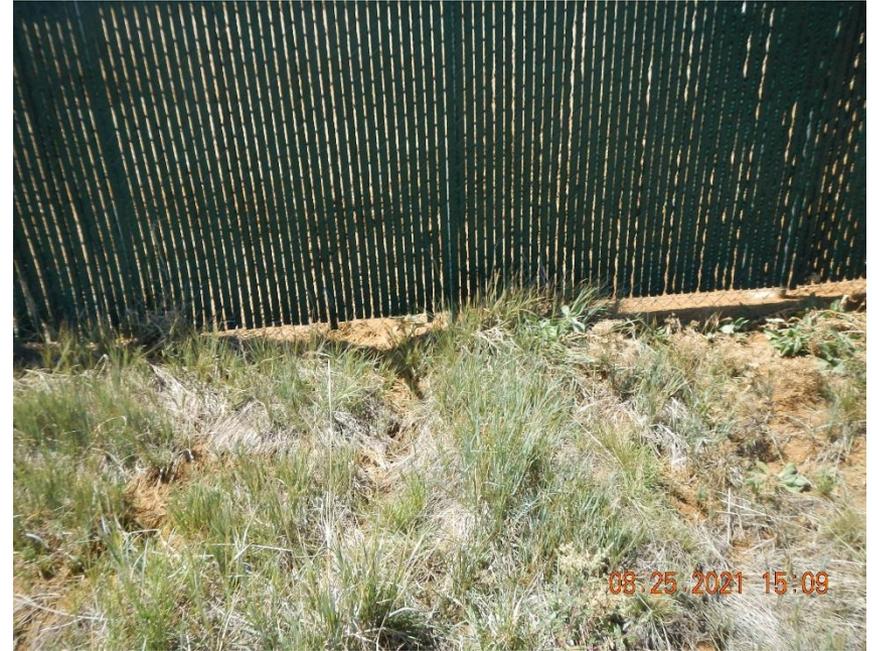
Damp soil and staining along eastern edge of location.

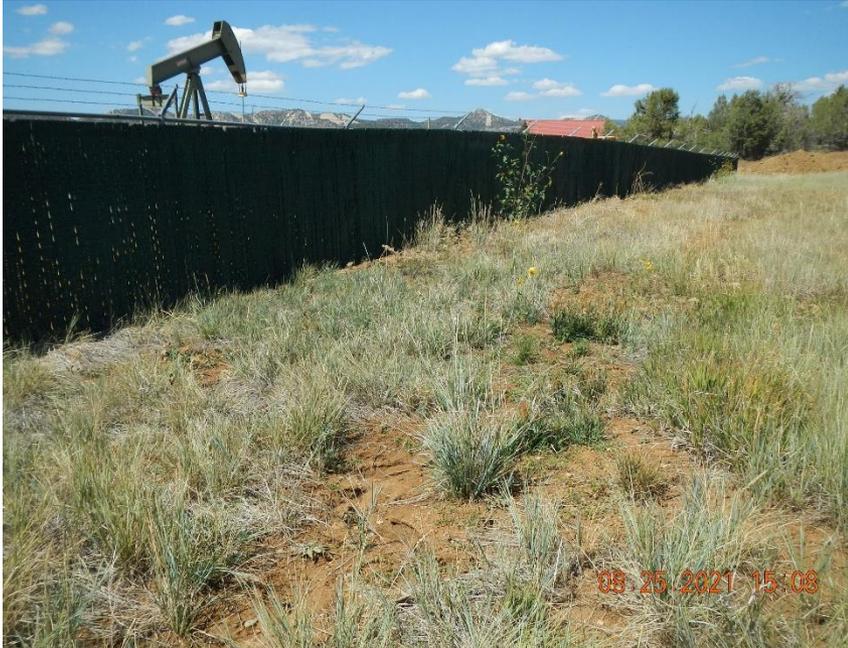
Areas along eastern edge of location are damp and stained.

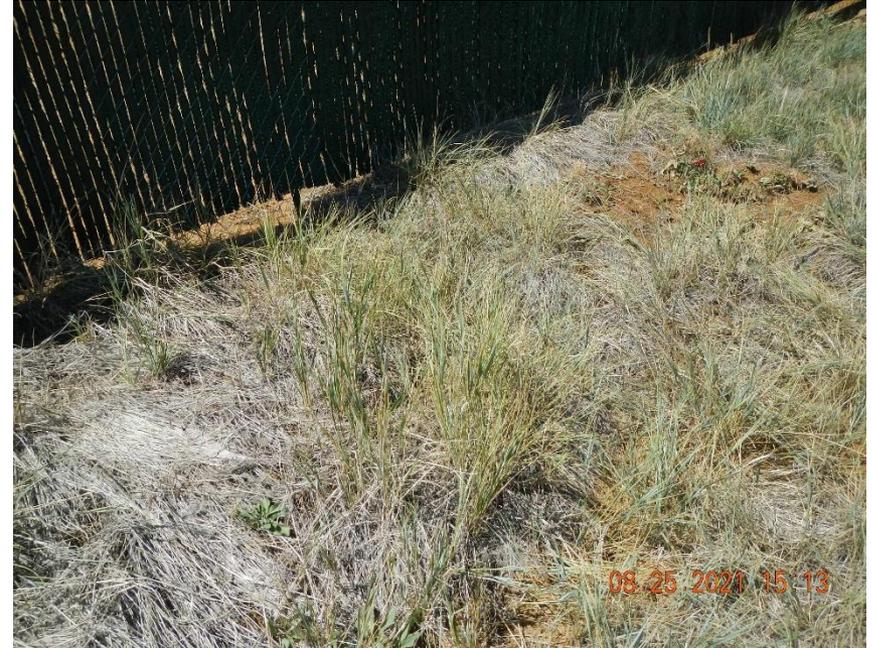
Stained vegetation and damp soil along eastern edge of the location.
