**LOCIN OIL CORPORATION**  
**N. DOUGLAS CREEK-61S101W 33NENW**  
**Location # 315416**

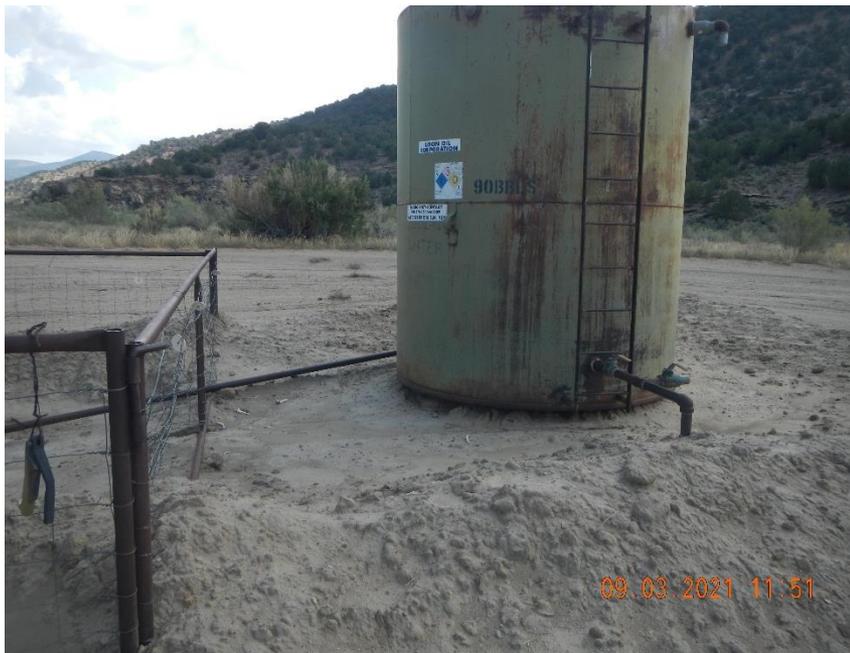
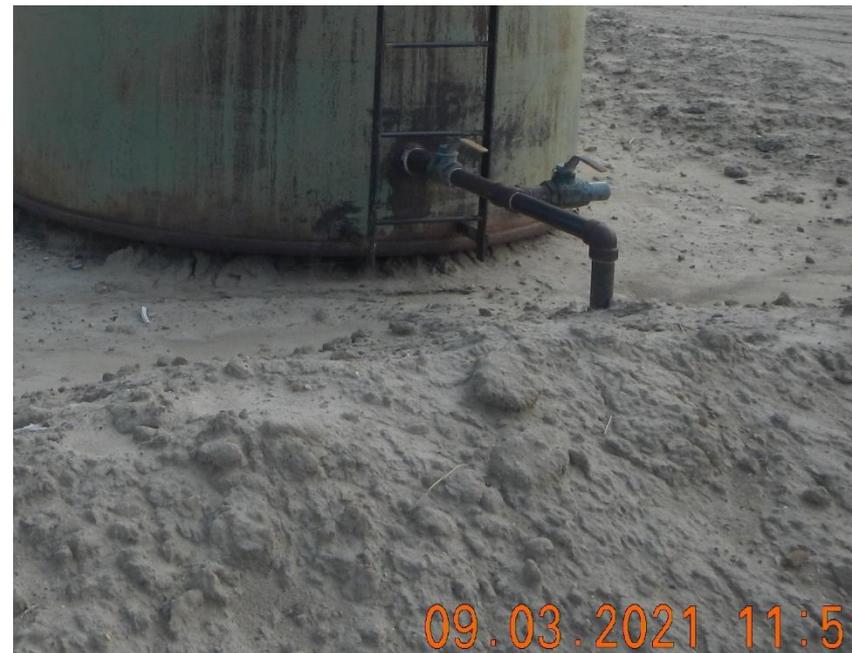
**Erosion of berm ground base and under cutting ground under the tank.**

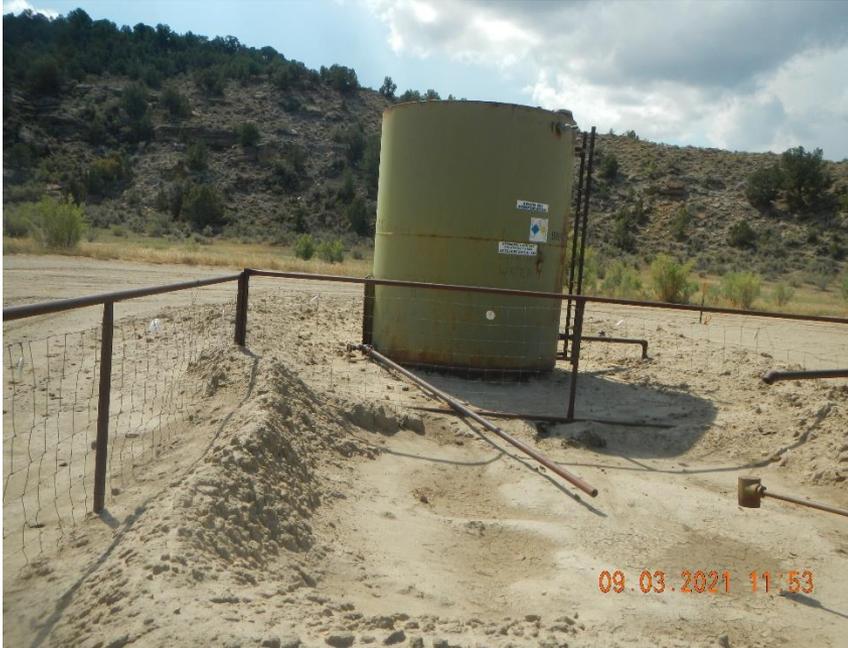
**Contents faded and not visible from distance.**

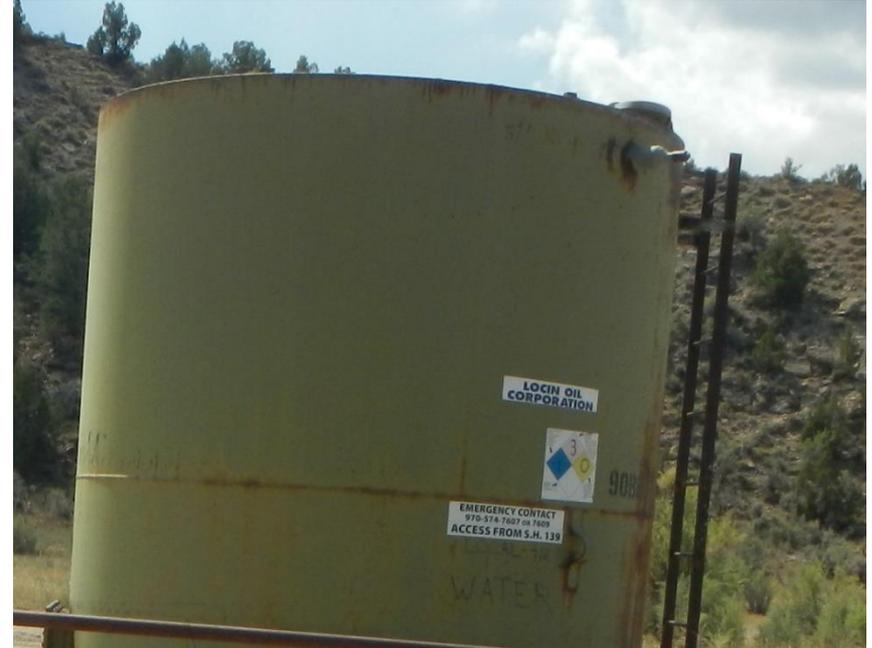
**Water not a proper content name.**

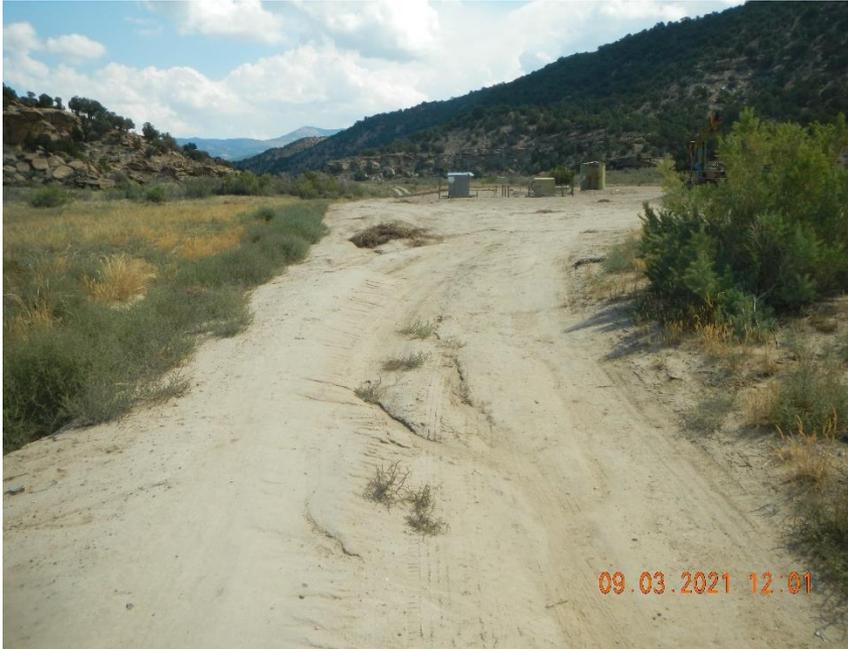
**Access road has storm water erosion and sediment back filled ditches.**

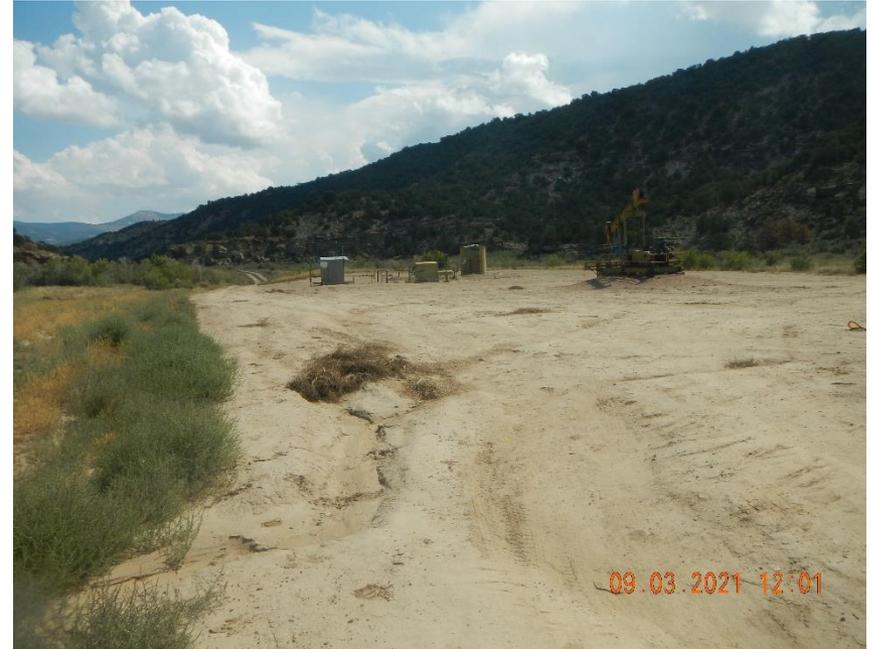
**Dead weed debris on location and roadway.**

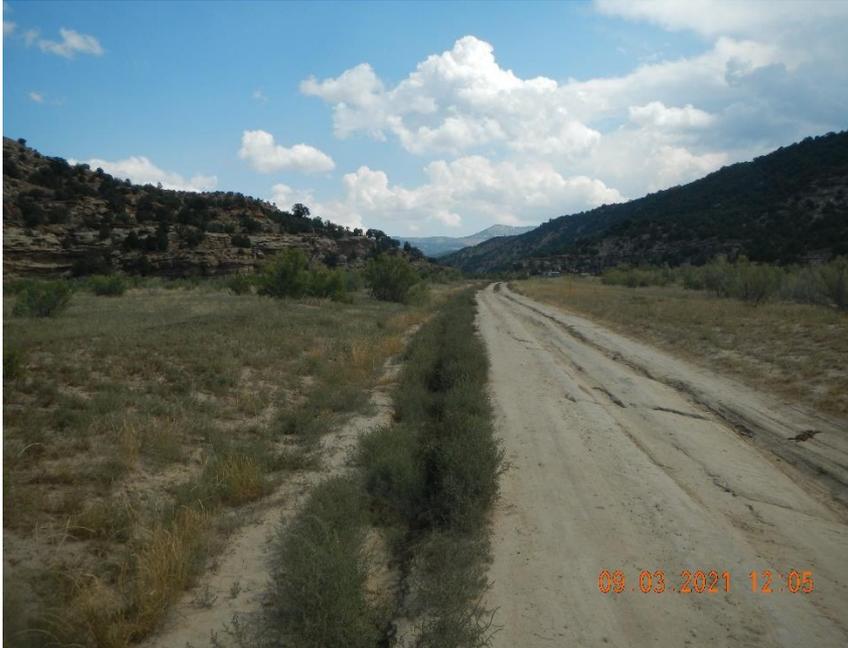
**Access road has storm water erosion and sediment back filled ditches.**

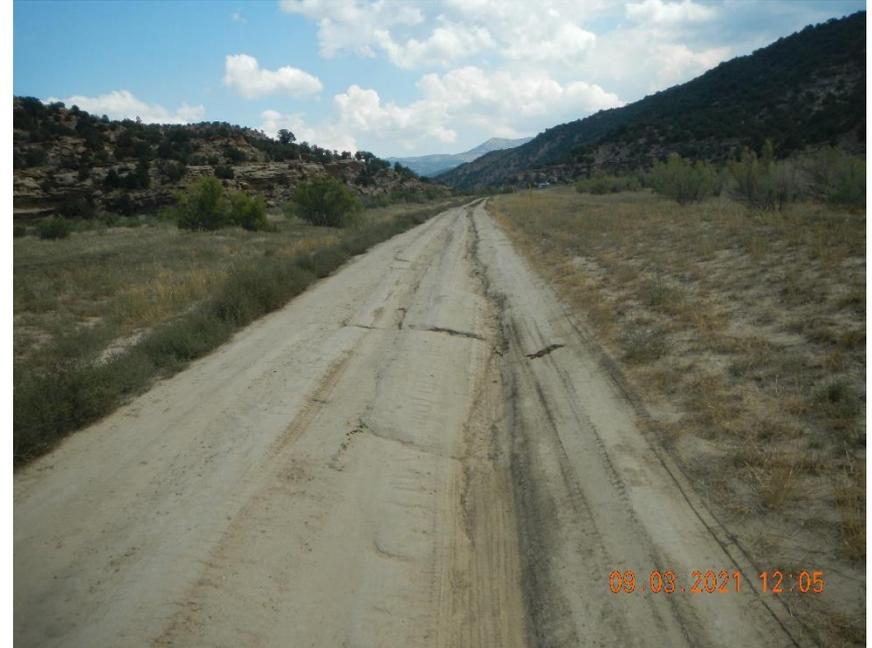
**Access road has storm water erosion and sediment back filled ditches.**
