Inspection Photos

API: 071-07414

Operator: OGRIS OPERATING LLC

Inspection Date: 9/3/2021

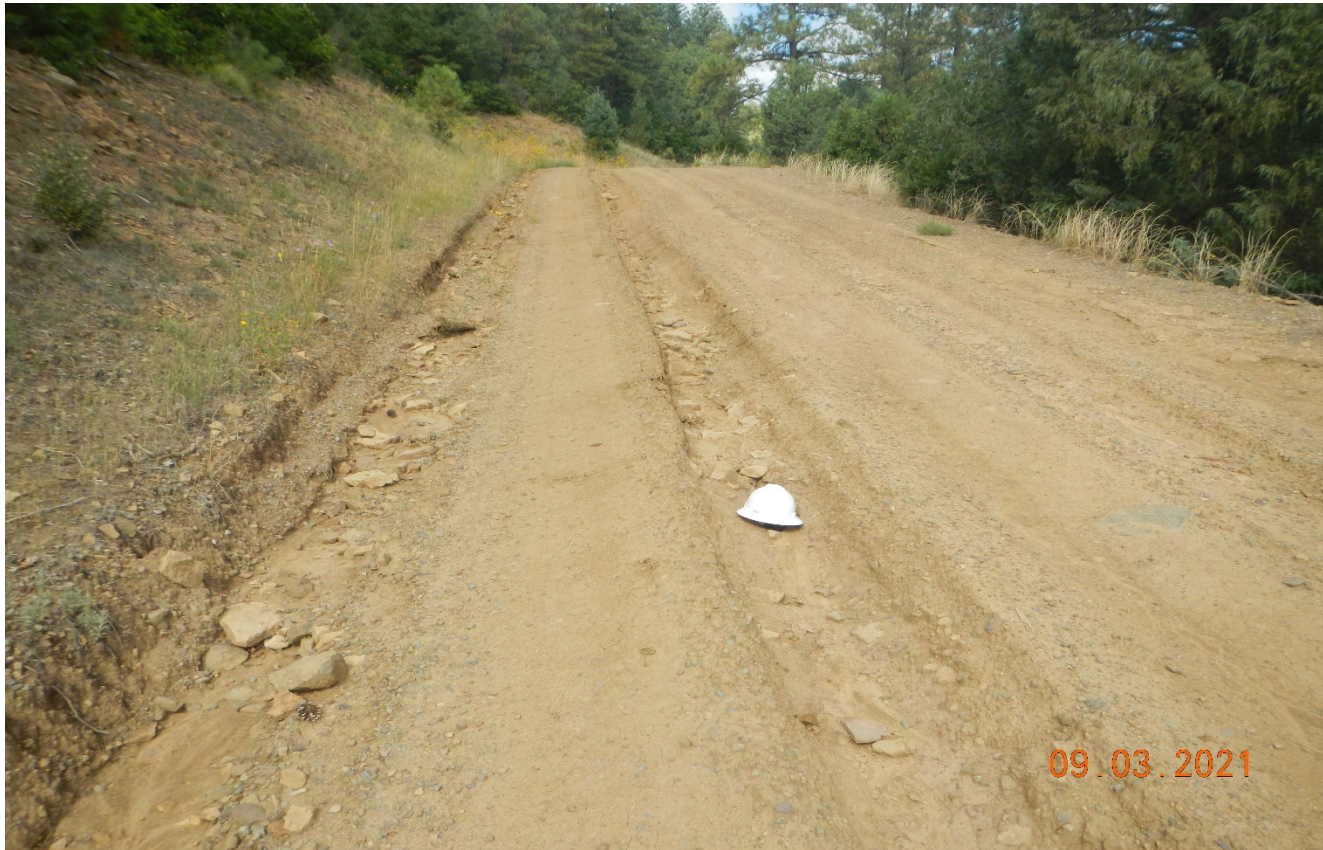
Photo 1. There is vehicle rutting and erosion along the road. The white hard hat is placed in the vehicle rut for scale. Previous corrective action was not performed.

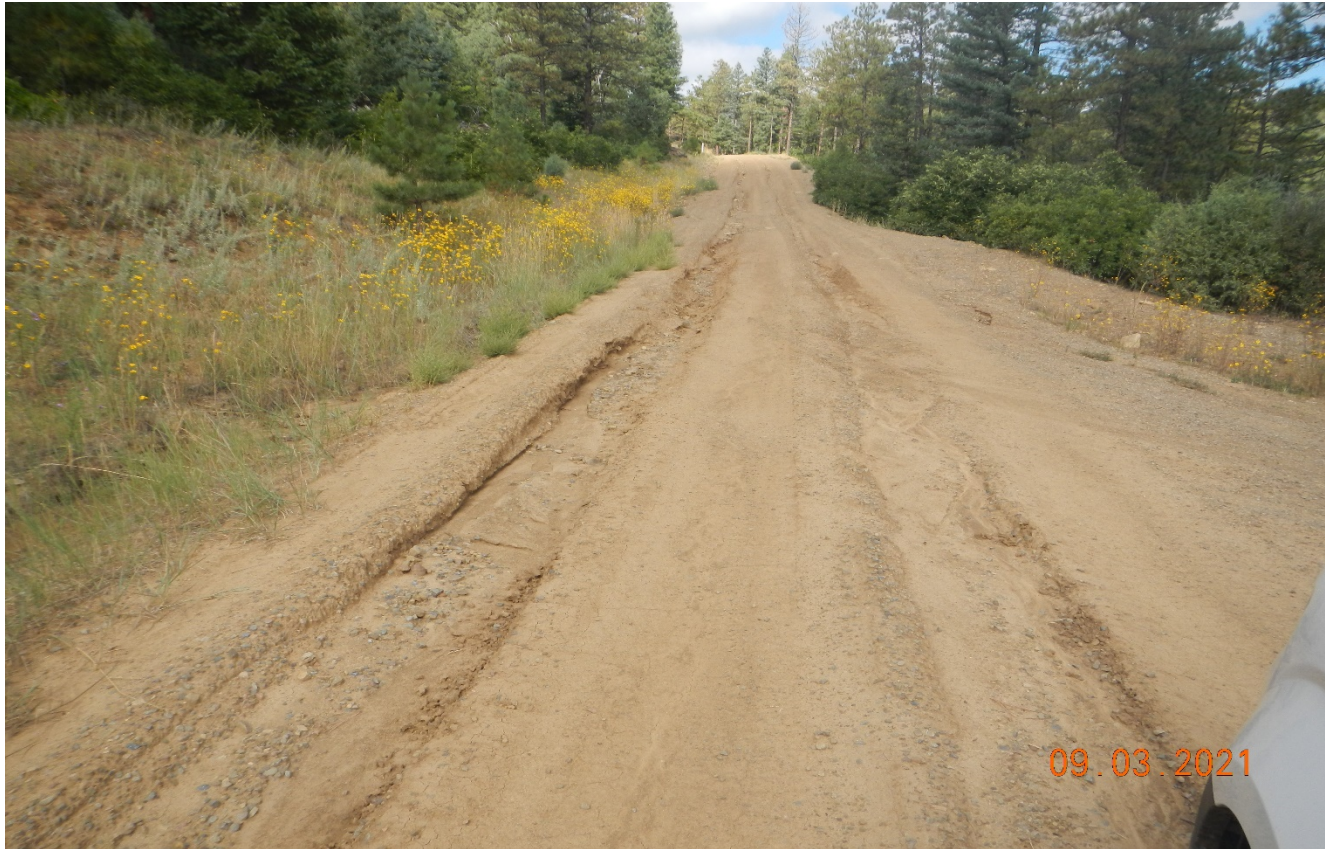
Photo 2. There is vehicle rutting and erosion along the road. Previous corrective action was not performed.

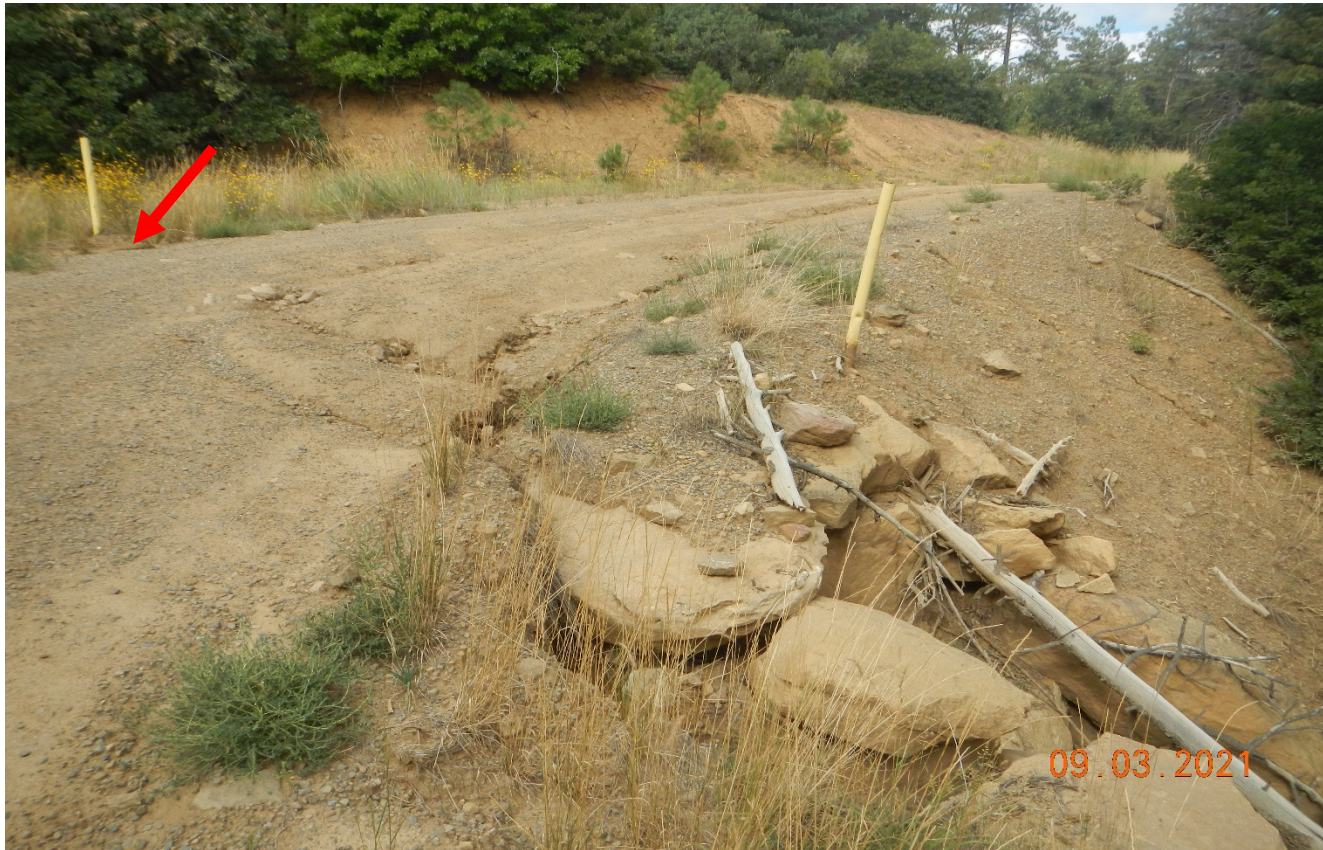
Photo 3. Stormwater is not being diverted toward the culvert (red arrow) and is flowing across the road causing erosion. Previous corrective action was not performed.

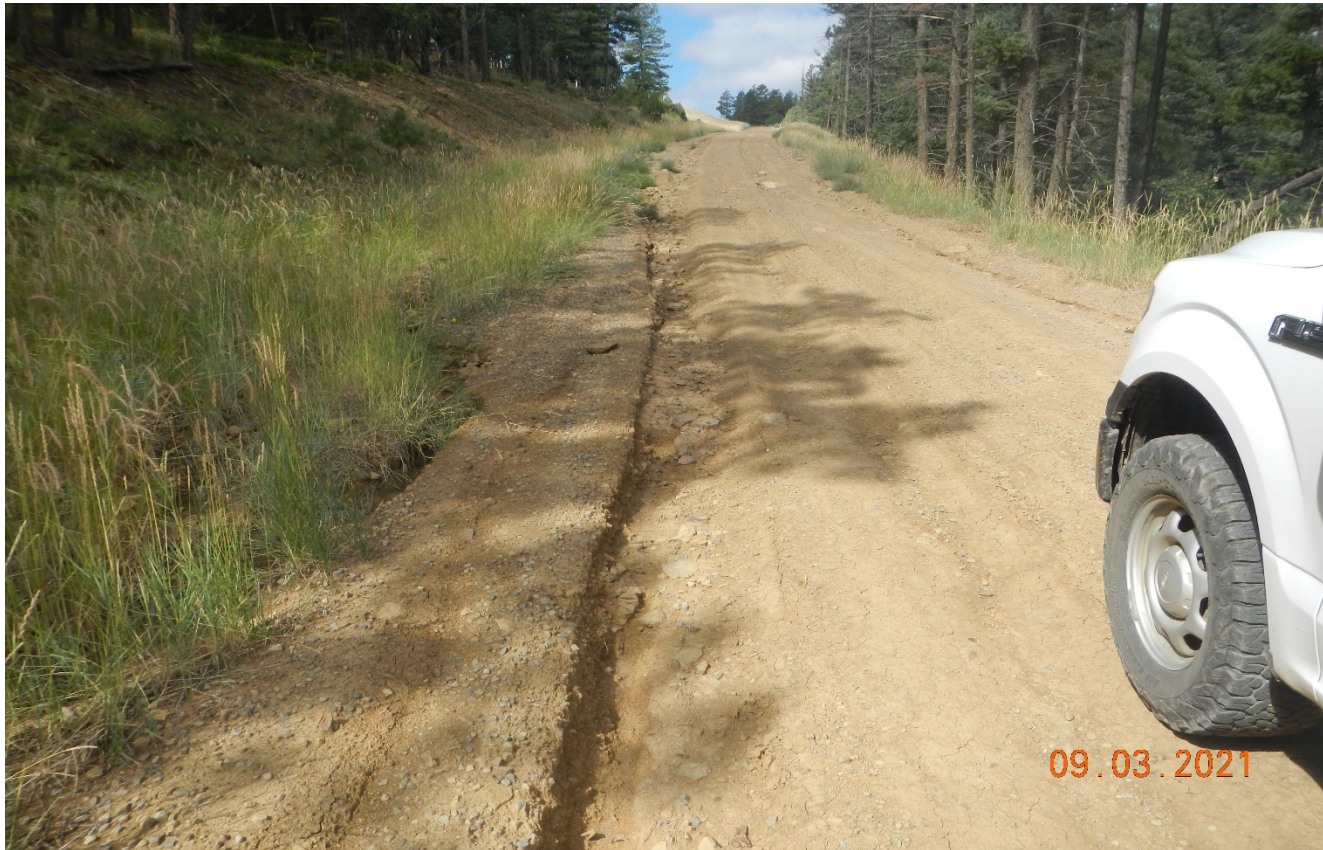
Photo 4. There is vehicle rutting occurring along the road which will only worsen if not repaired. The roads need to be maintained. Previous corrective action was not performed.
