Inspection Photos

API: 071-07412

Operator: OGRIS OPERATING LLC

Inspection Date: 9/3/2021

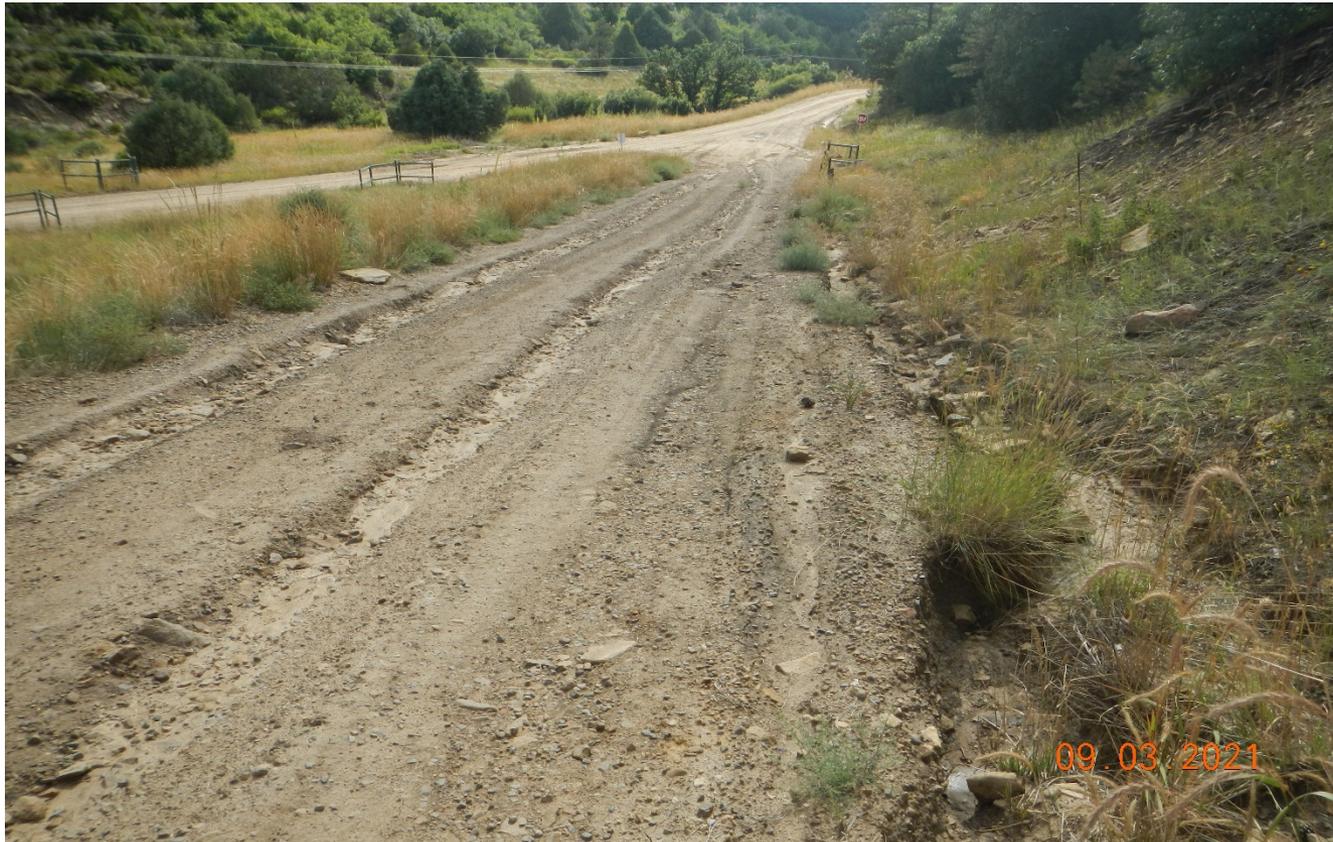
Photo 1. Facing back down the access road shows vehicle rutting and erosion. This issue has previously been documented and needs to be repaired and prevented. Previous corrective action was not performed.

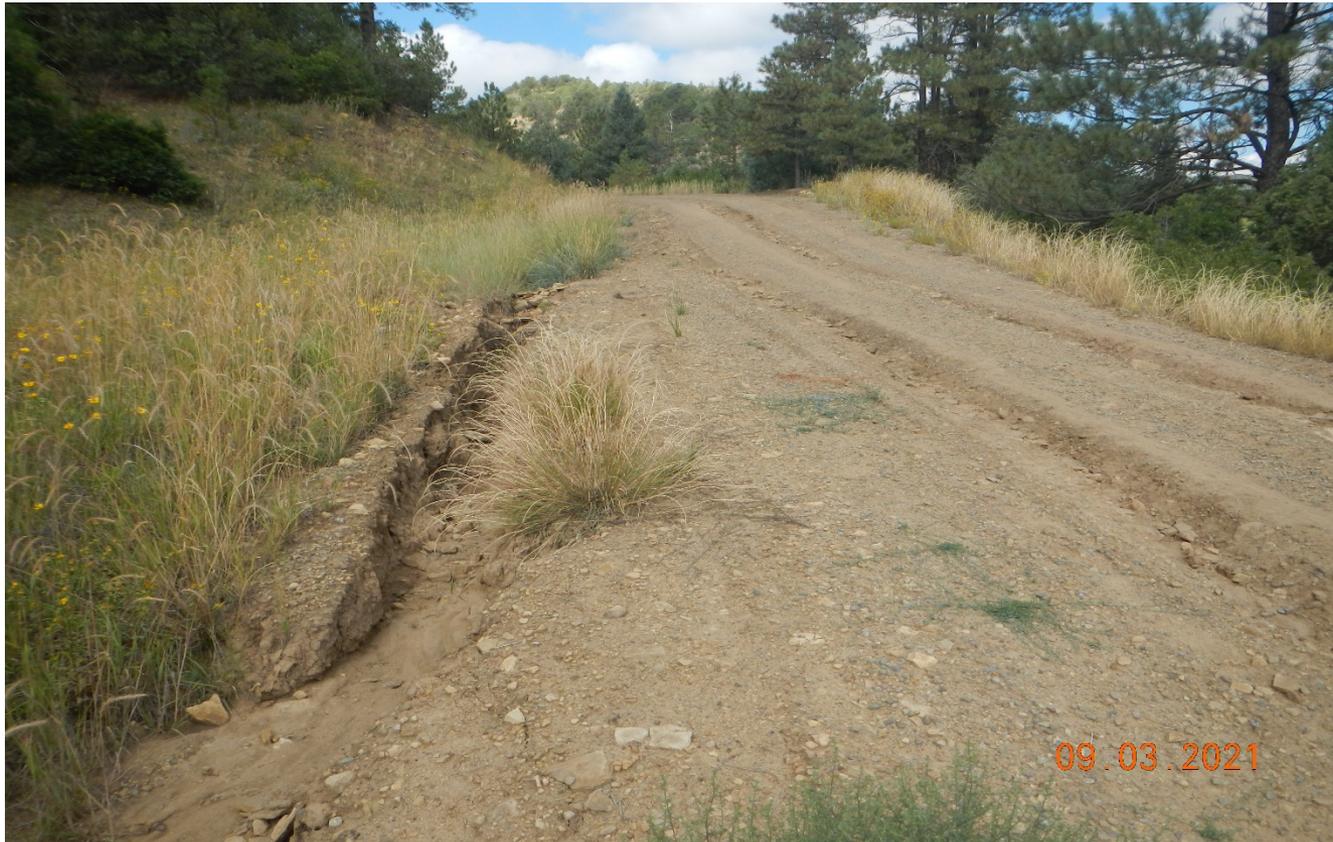
Photo 2. Storm water erosion is occurring down the side of the road. BMP's need to be installed to prevent erosion. Previous corrective action was not performed.

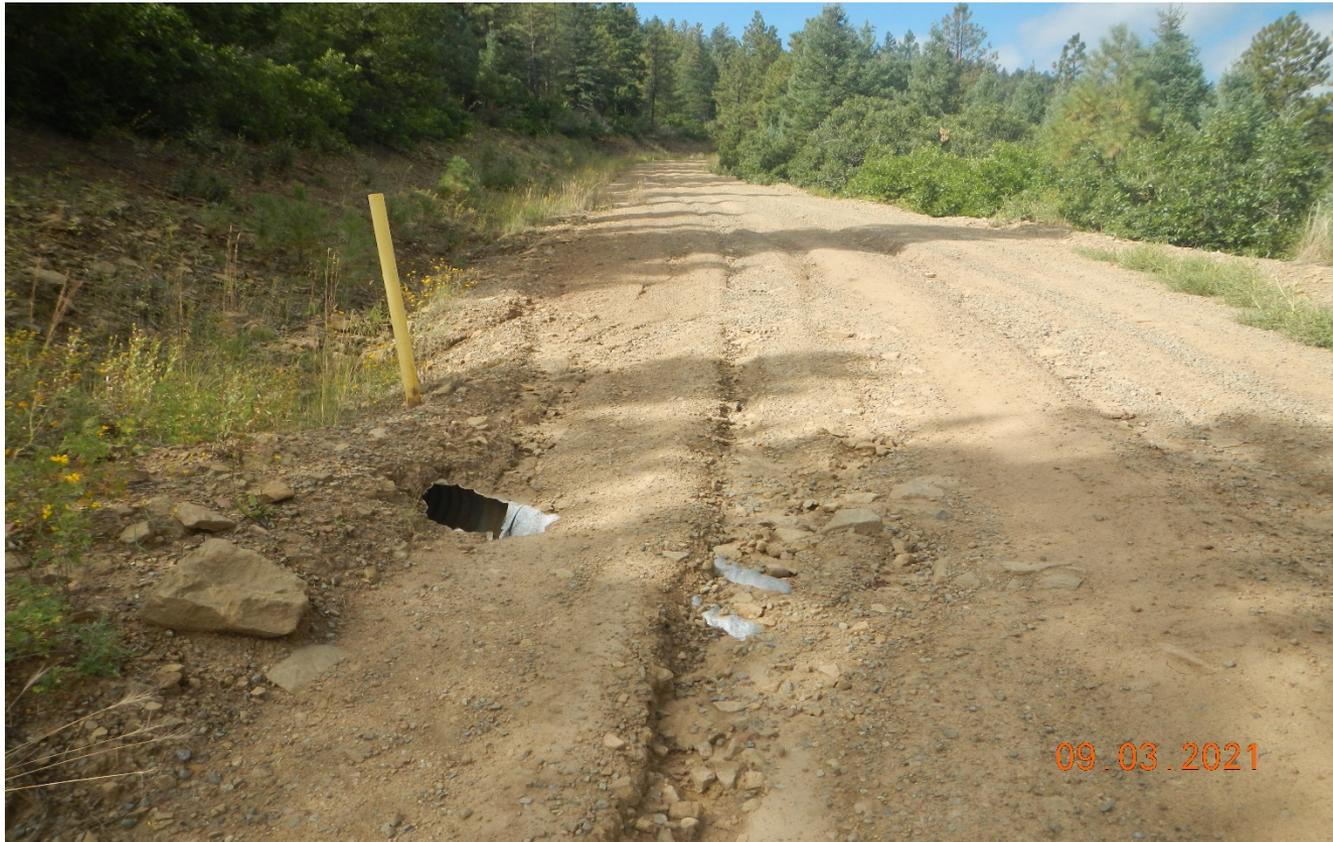
Photo 3. Storm water is not directed toward the culvert and the culvert is damaged.

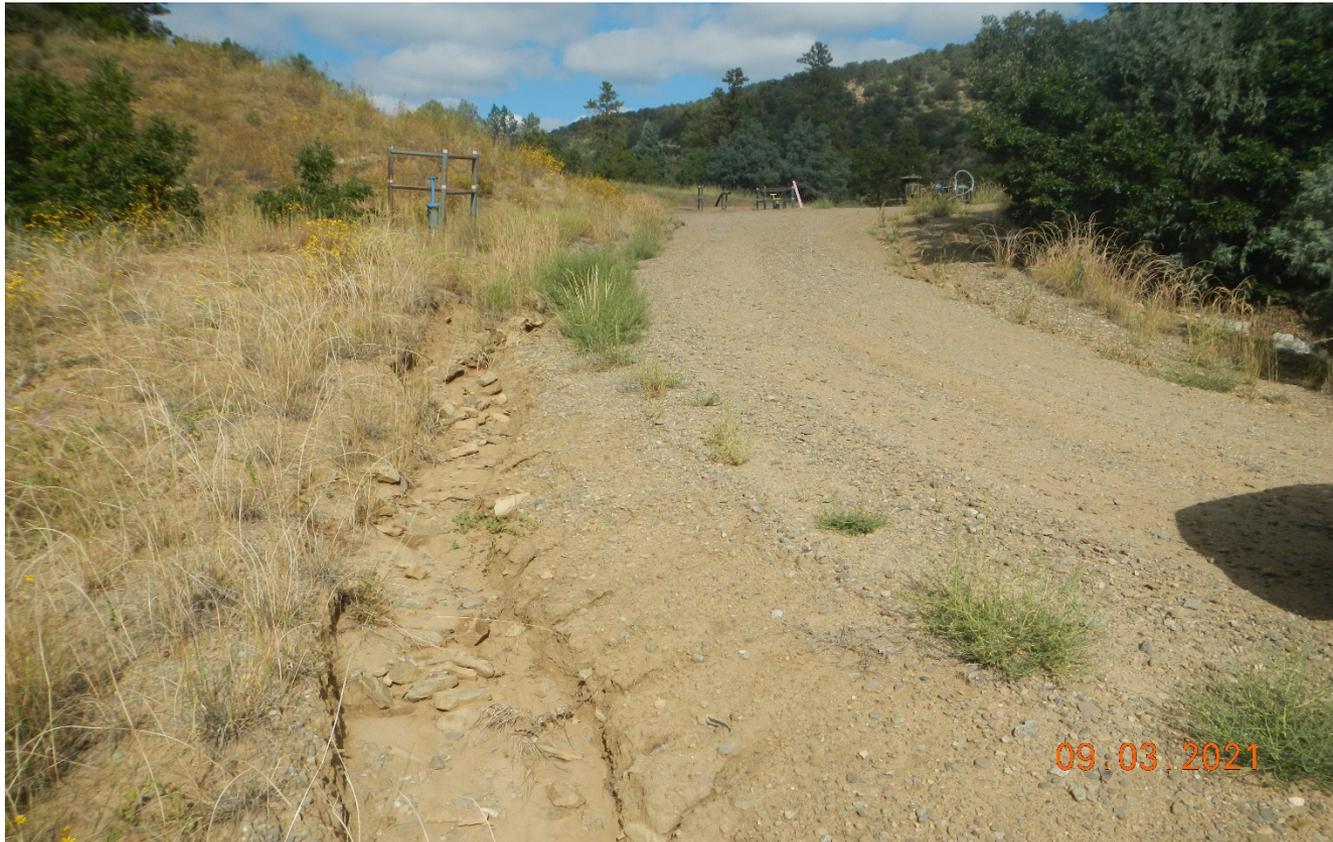
Photo 4. Facing along the access road toward the location. Storm water erosion is occurring down the side of the road. BMP's need to be installed to prevent erosion. Previous corrective action was not performed.

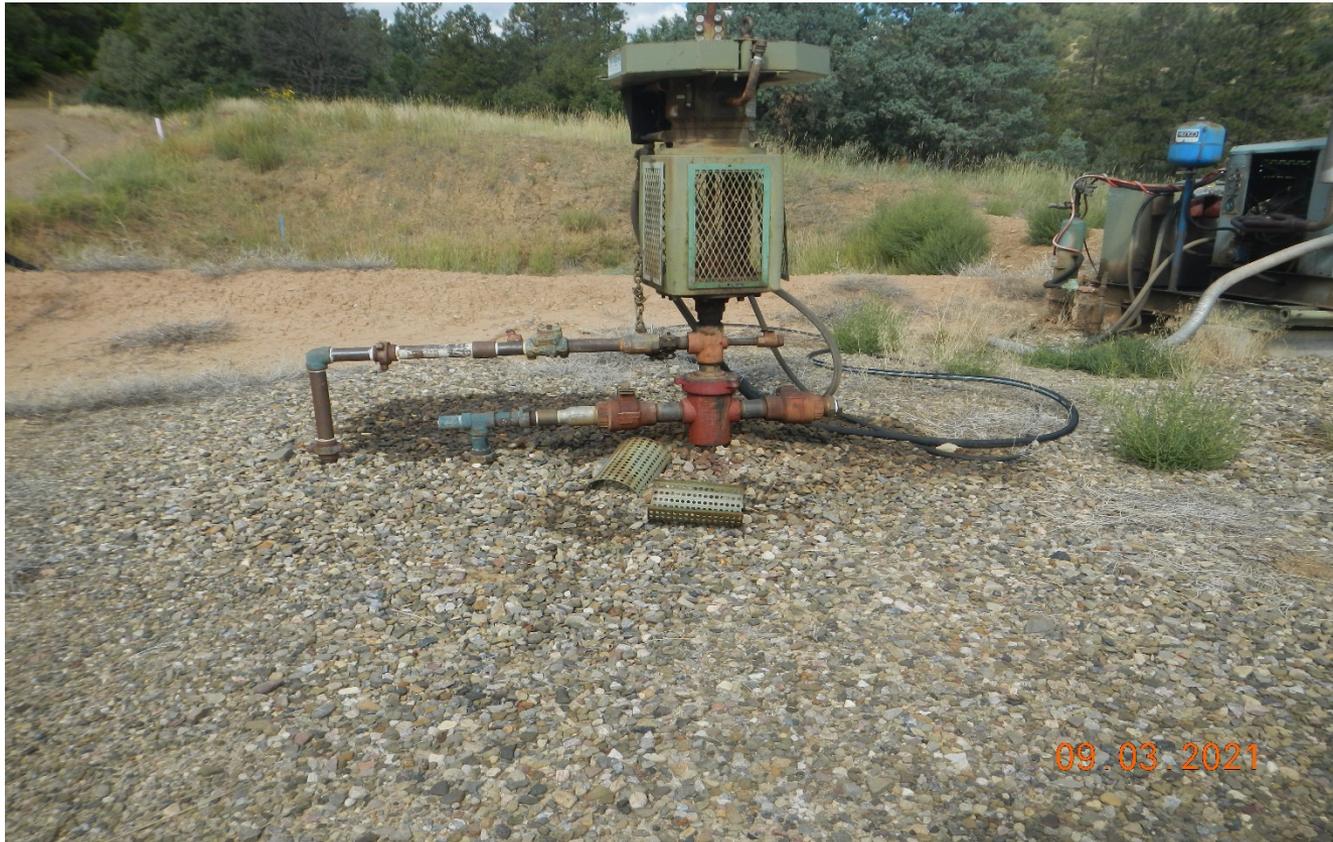
Photo 6. There is stained gravel around the wellhead indicating a previous leak. This area needs to be cleaned up.
