Inspection Photos

API: 071-06130

Operator: OGRIS OPERATING LLC

Inspection Date: 9/3/2021

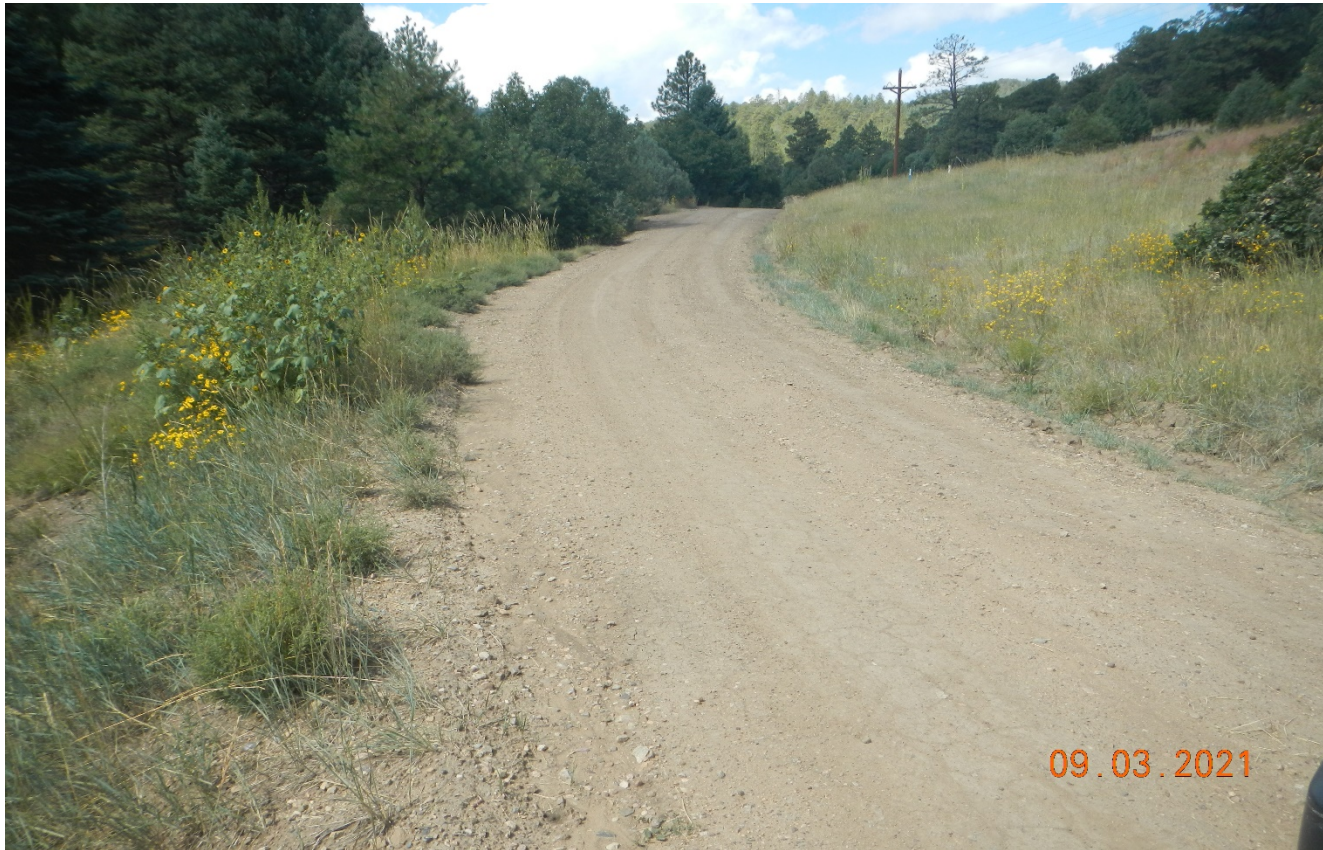
Photo 1. Facing southwest along the main road. The road has been regraded since the previous inspection.

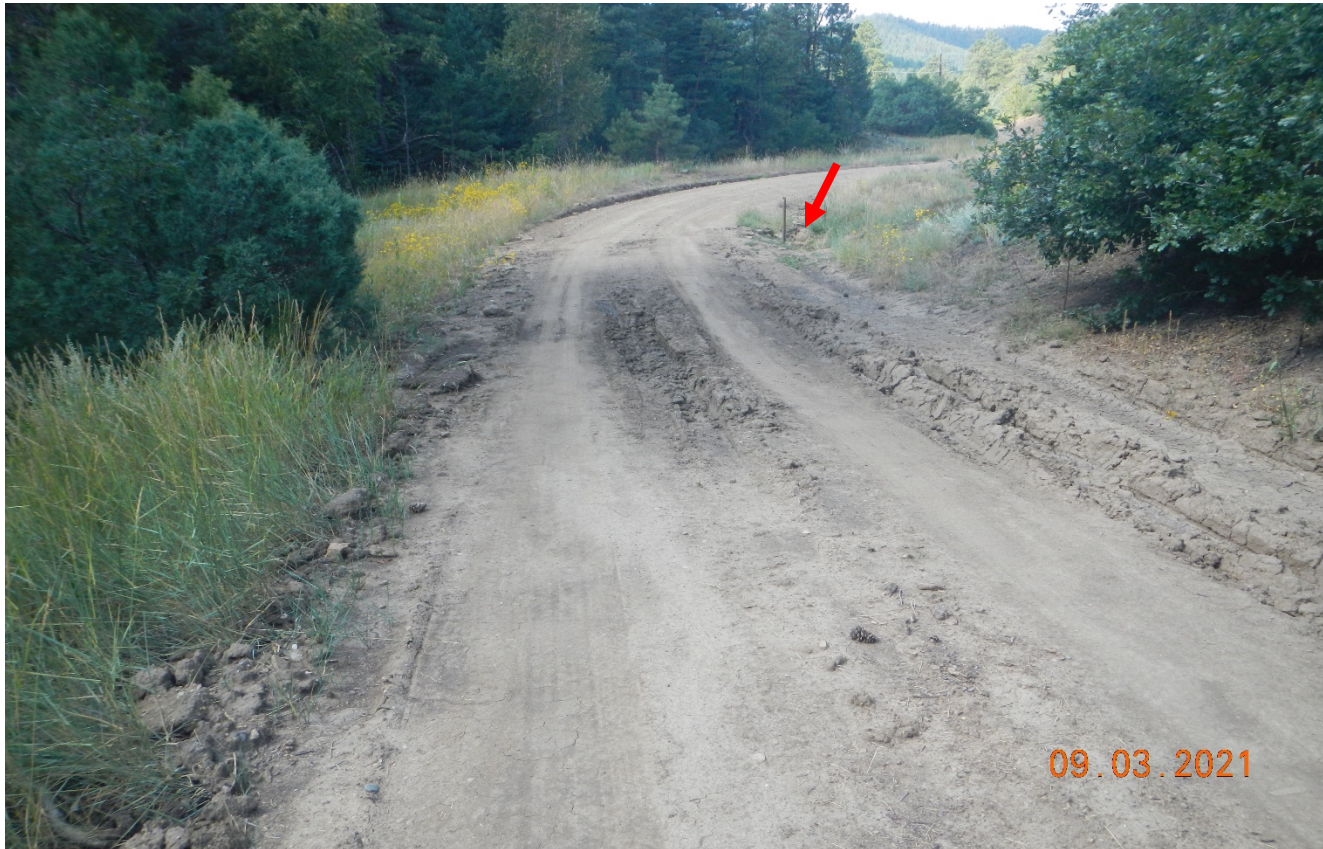
Photo 2. There are areas of the road that are still not stabilized after recent grading operations. There is vehicle rutting and stormwater is not directed toward the culvert shown at red arrow. Areas of rutting need to be stabilized. Previous corrective action was not completed.

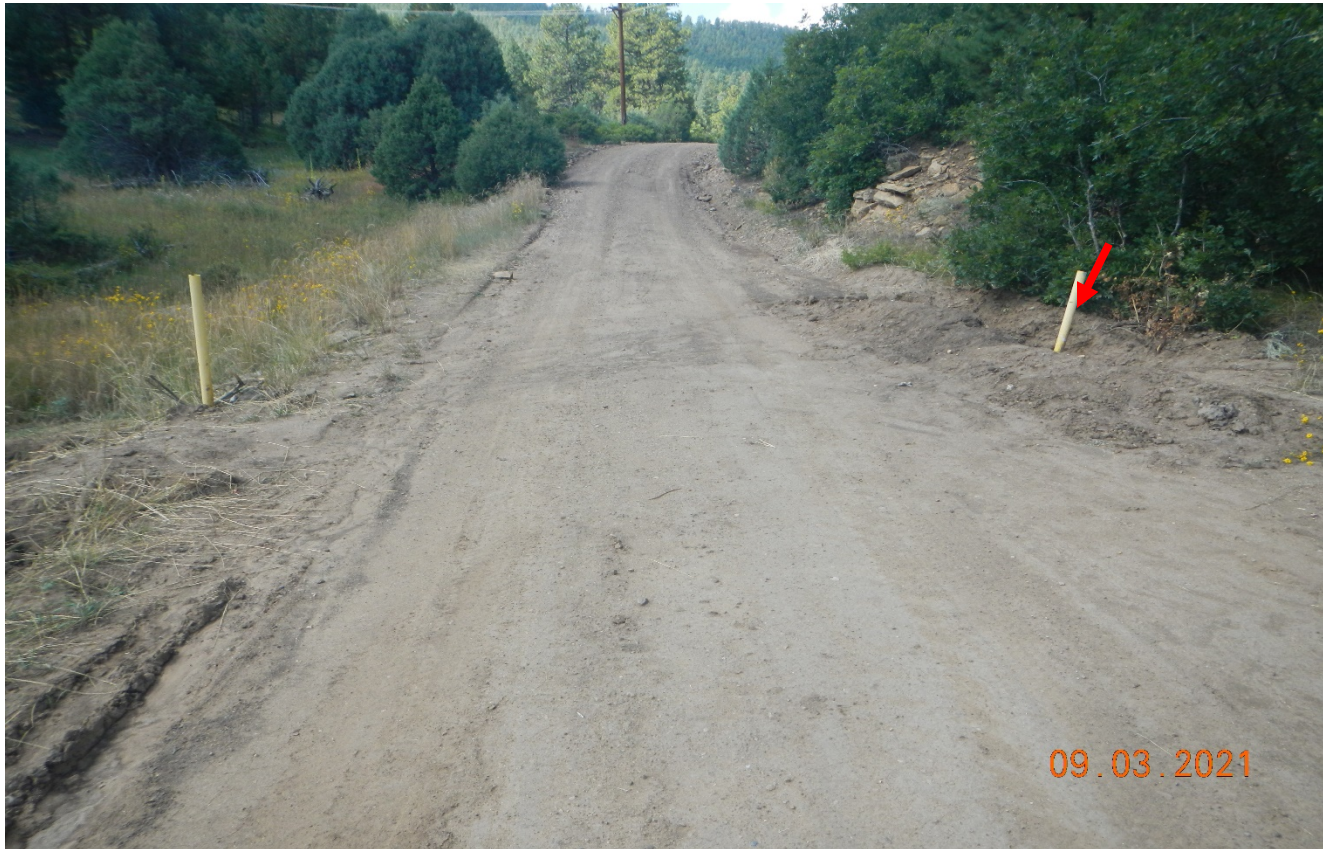
Photo 3. This culvert along the road was repaired since previous inspection.

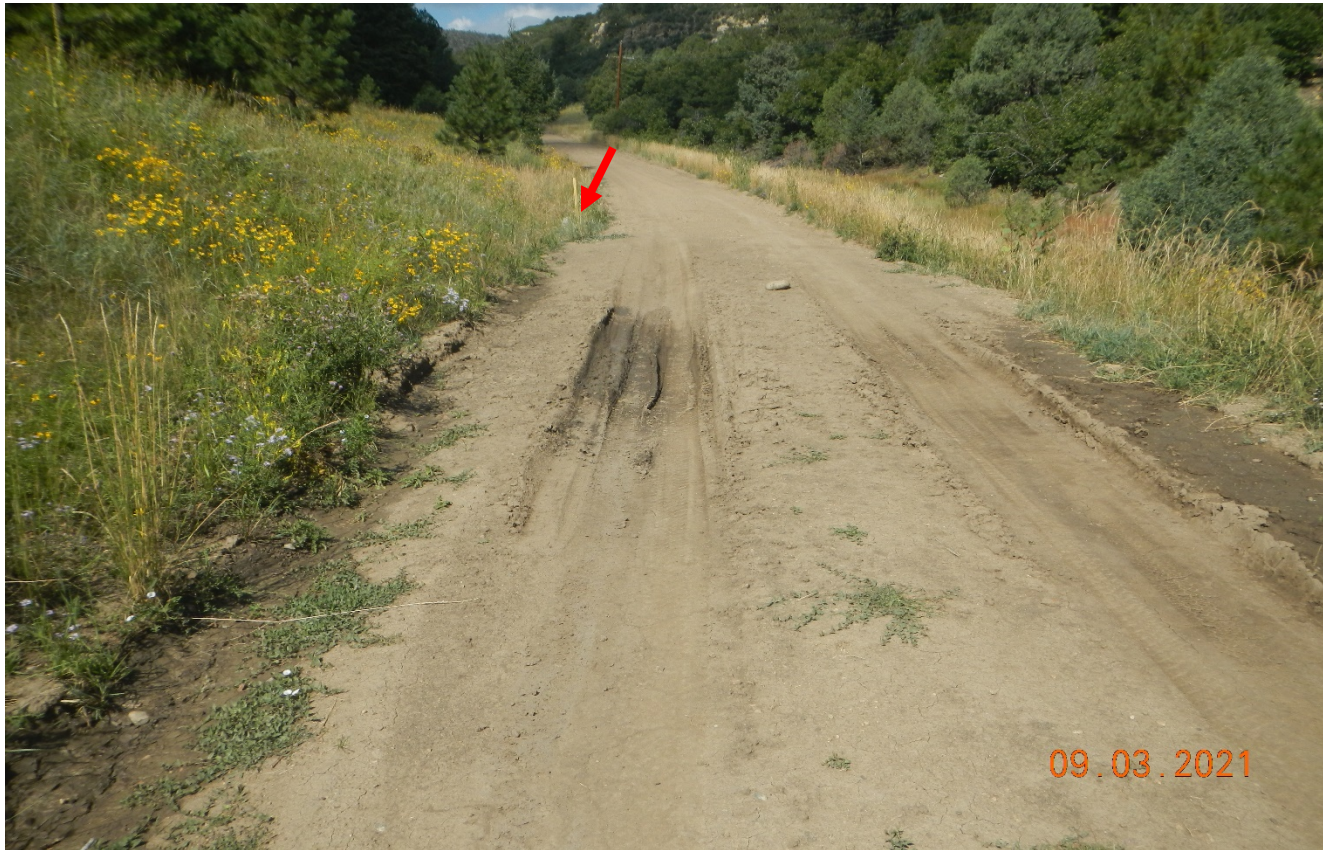
Photo 4. Stormwater is not directed toward the culvert (at red arrow) causing stormwater to accumulate on the road. Areas of rutting need to be stabilized. Previous corrective action was not performed.

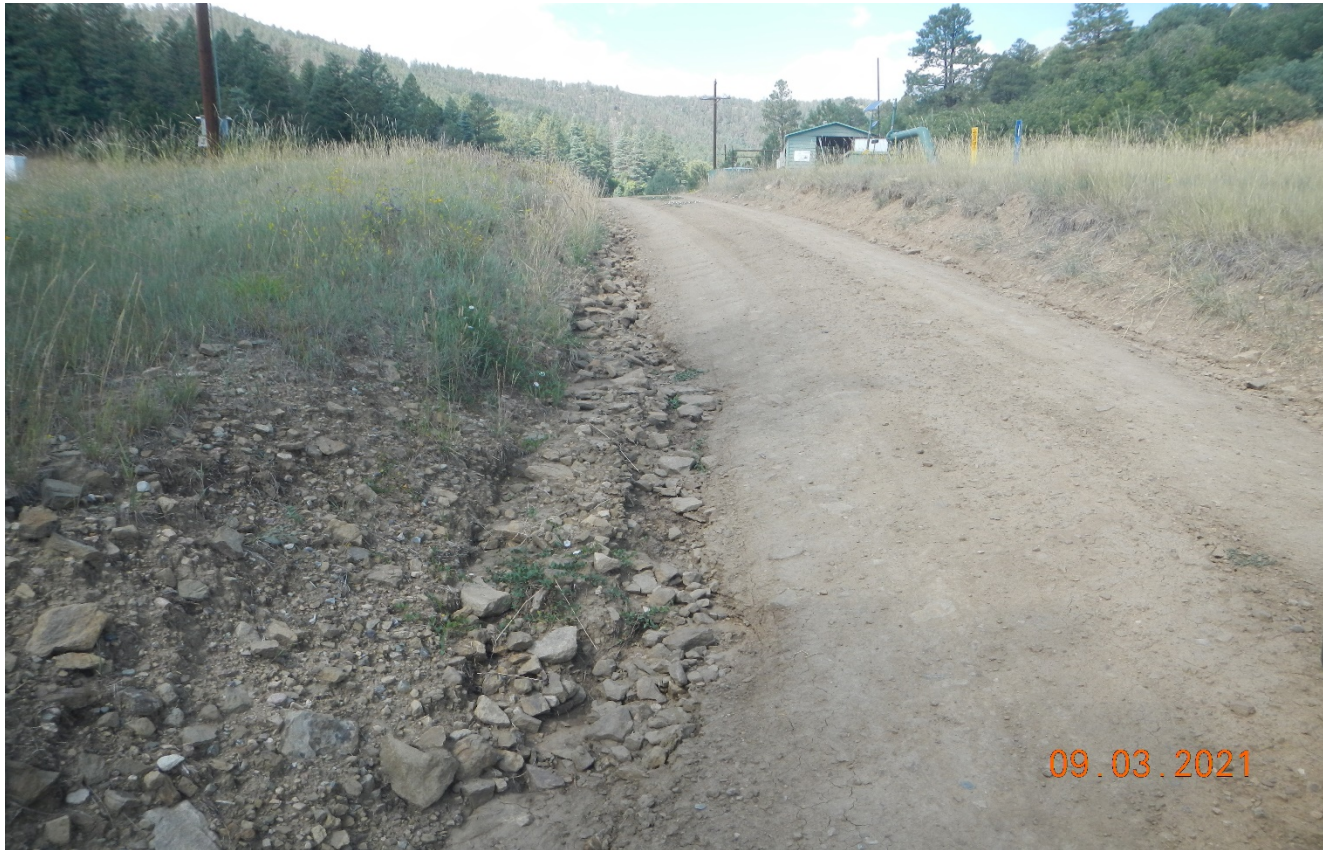
Photo 5. Facing toward the location. Erosion is occurring along side of the road at the location.

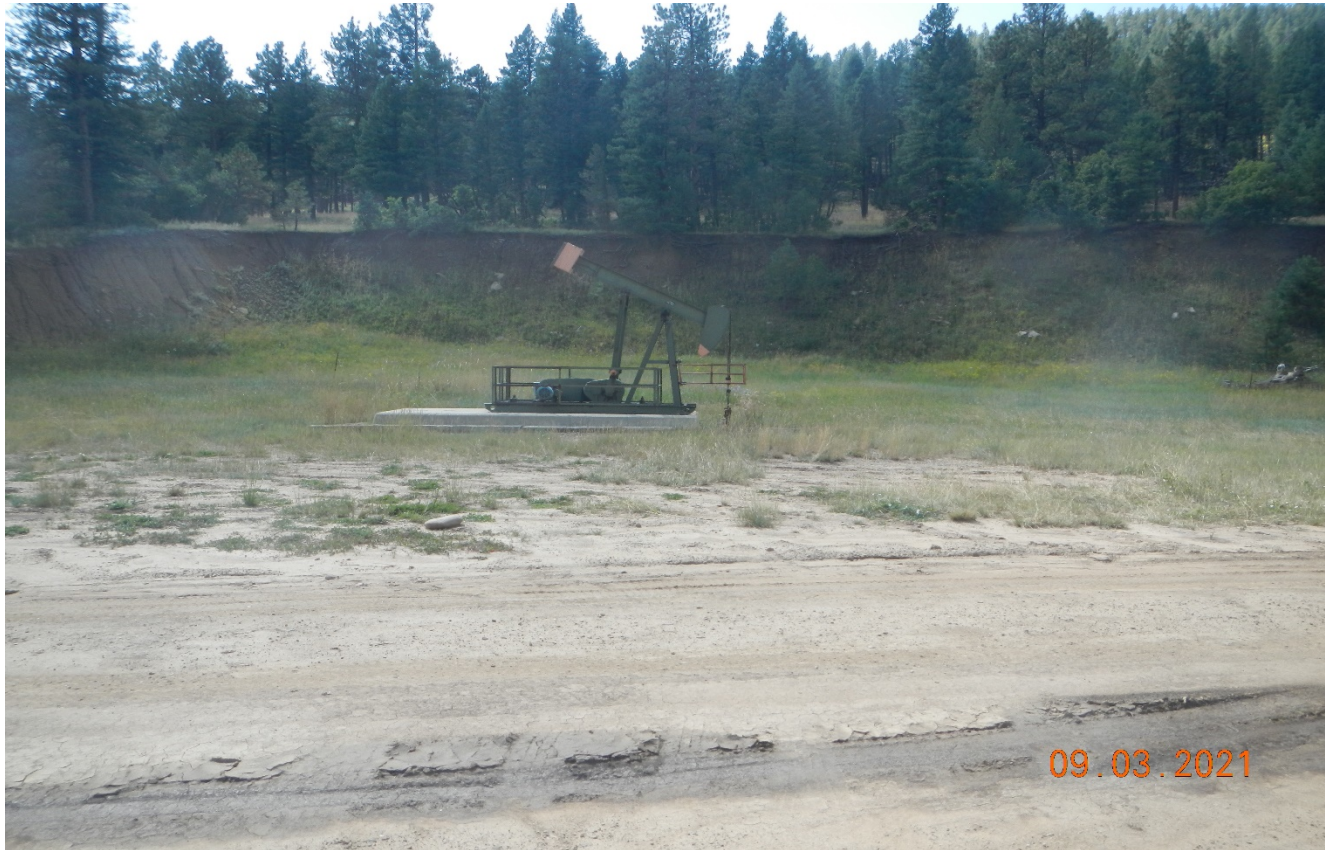
Photo 6. Facing toward the well site.
