Final Reclamation Inspection

August 31, 2021

Operator: TOP OPERATING COMPANY - 39560

Location ID: 317954

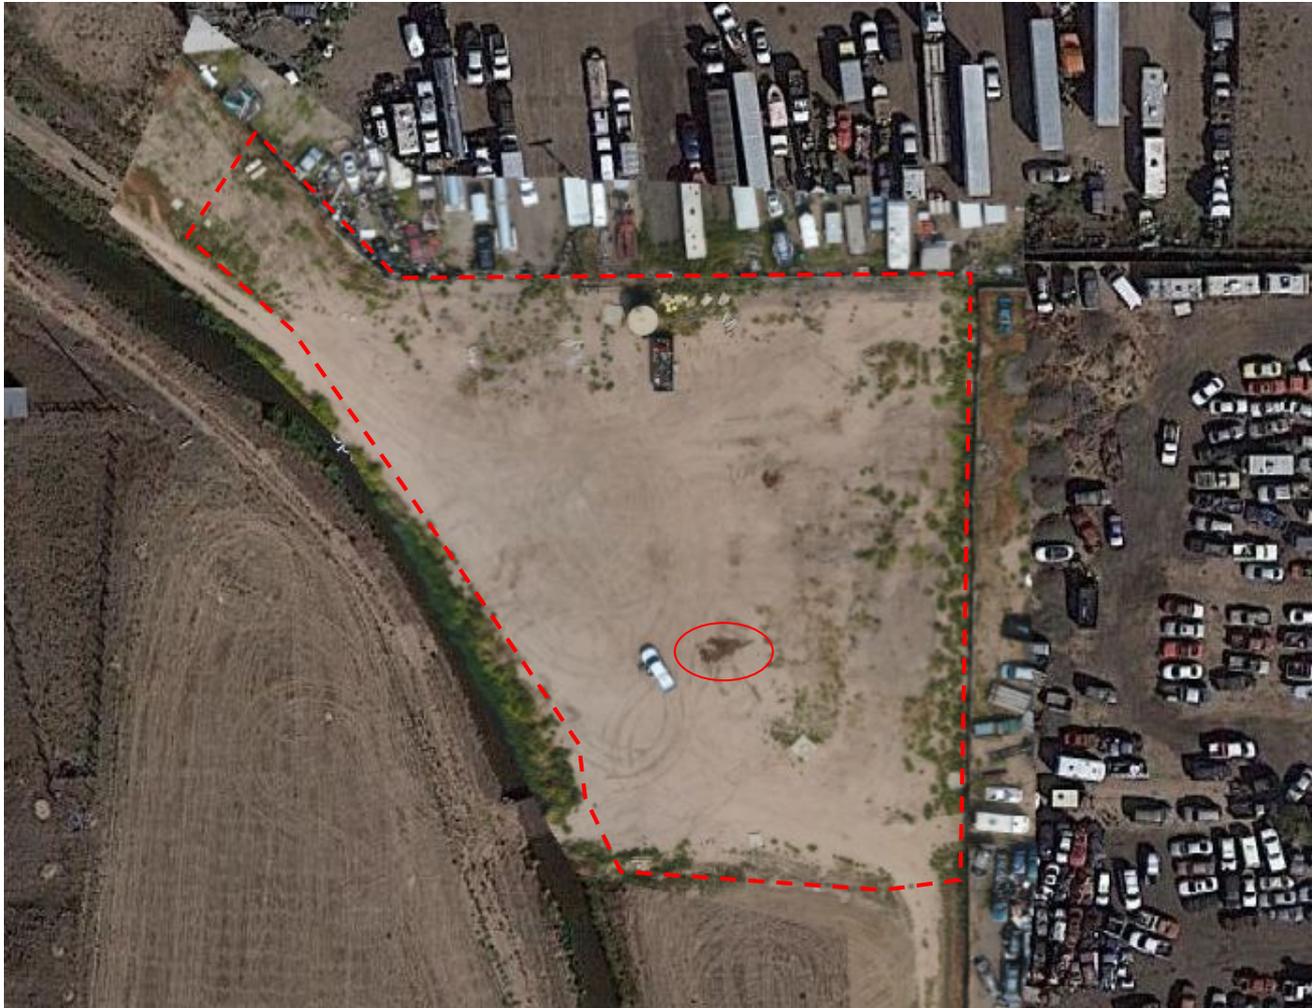
Photo 1. Drone aerial imagery of the Counter #2 well location and associated production facility (red-dashed line). Operator has failed to remove all equipment and perform final reclamation activities. Red circle is documenting a spill next to the work truck.

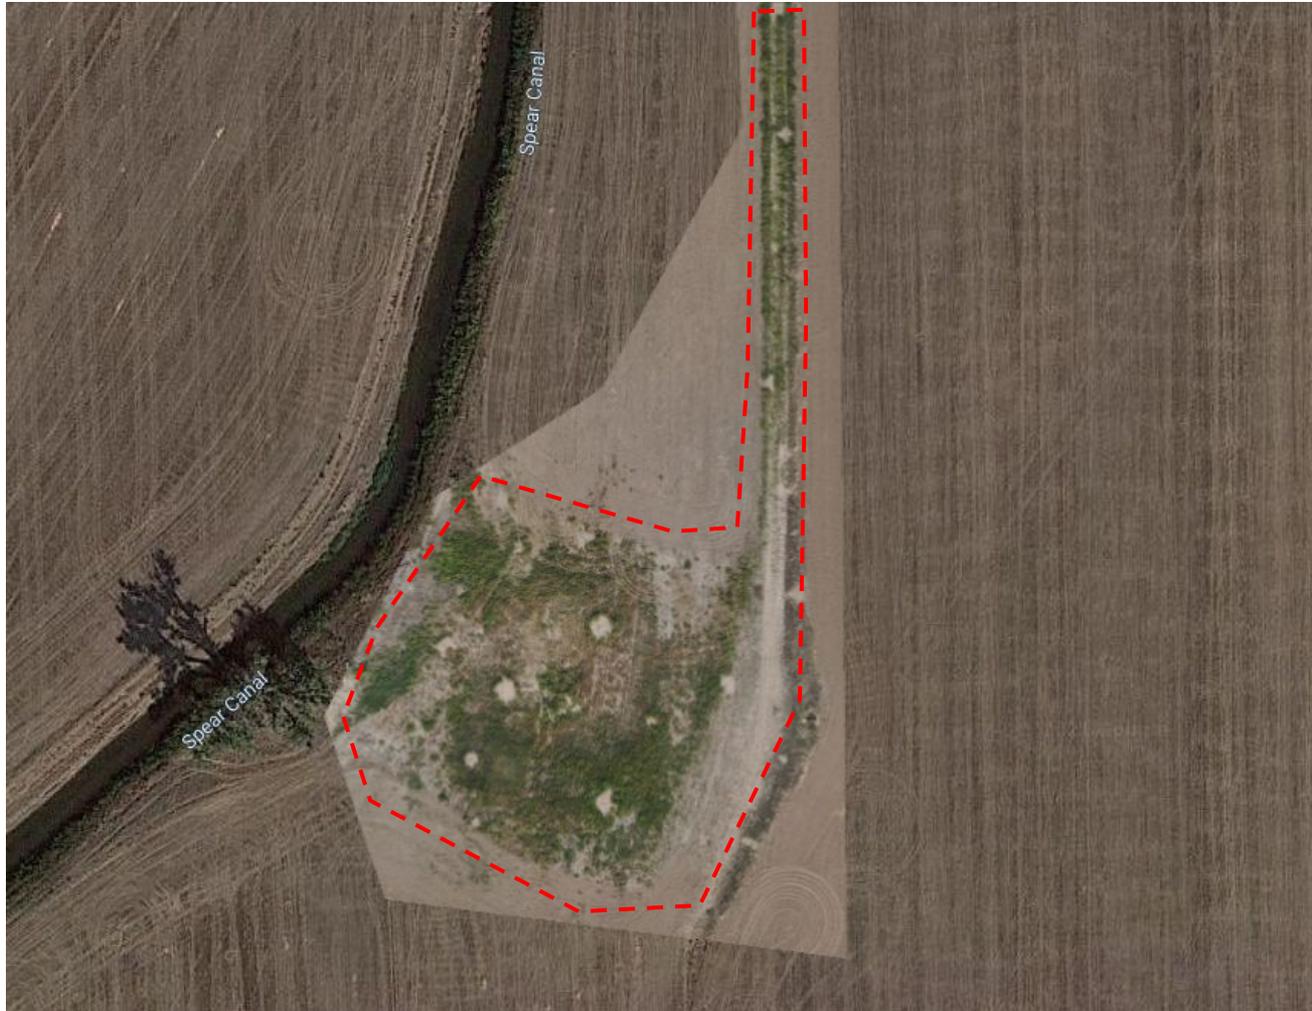
Photo 2. Drone aerial imagery of the Counter #3 well location and associated access road (red-dashed line). Operator has failed to perform final reclamation activities. Note- the access road from the Counter #2 to the Counter #3 well location has not been reclaimed and not fully pictured in the above image.

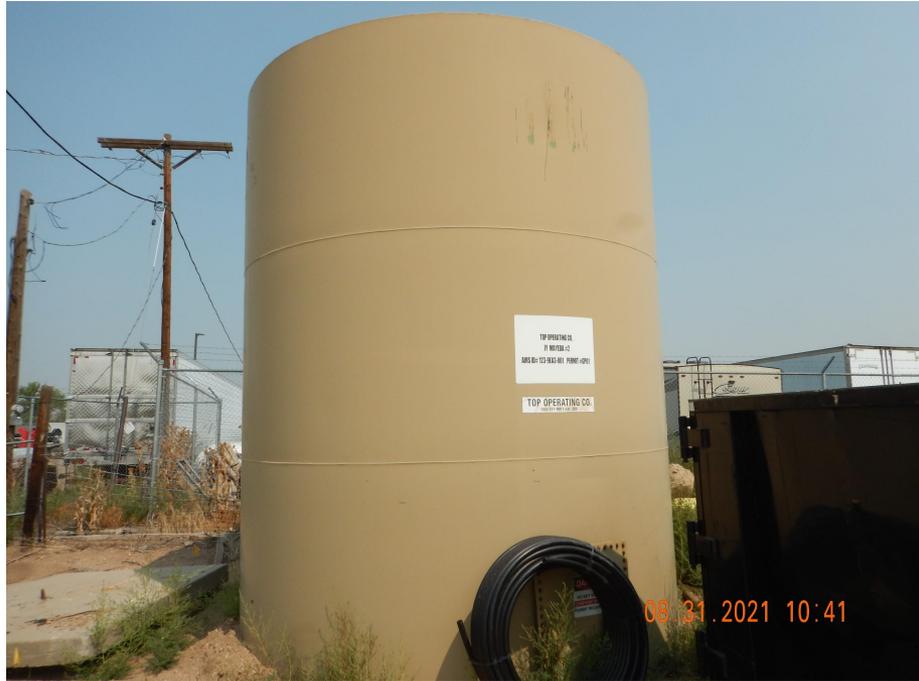
Photo 3. Photo taken from the northern production facility, facing North. Photo illustrates not all equipment has been removed.

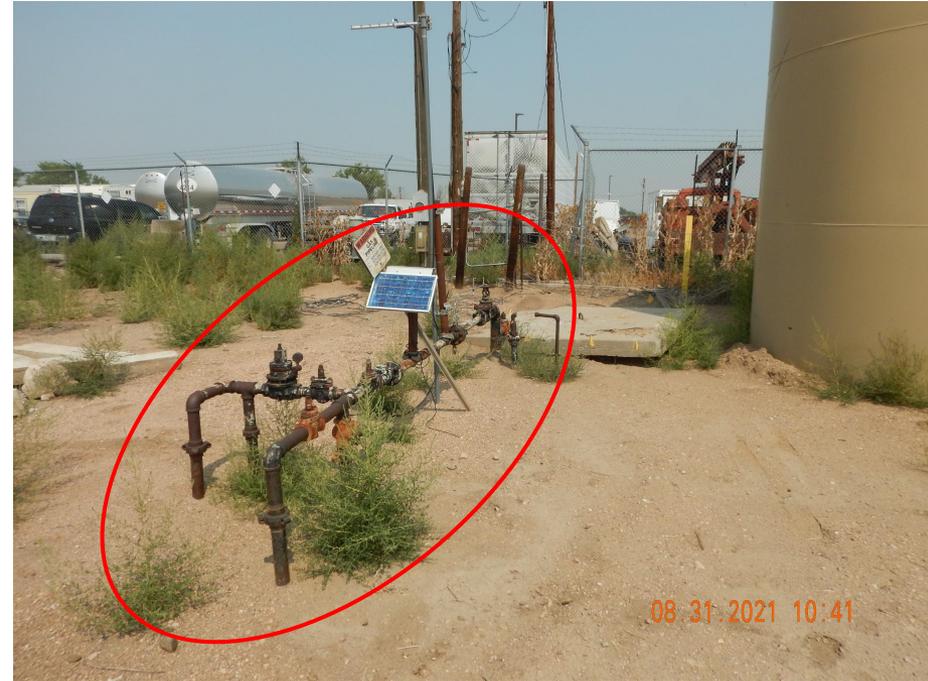
Photo 4. Photo taken from the northern production facility, facing North. See comments under Photo 3.

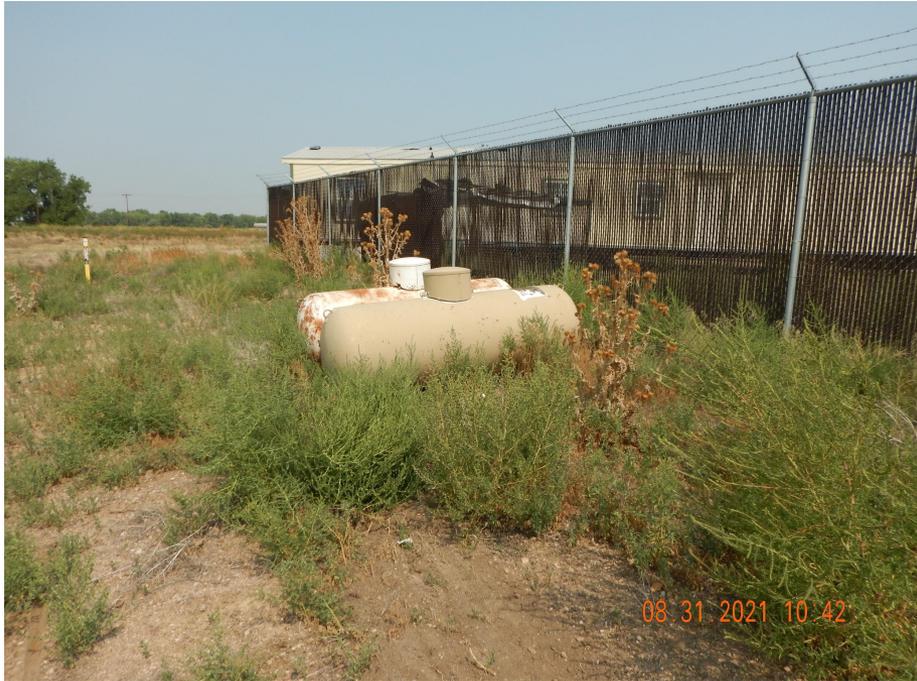
Photo 5. Photo taken from the northwestern production facility, facing North. See comments under Photo 3. Photo also illustrates unmanaged weeds, both undesirable and noxious weeds.

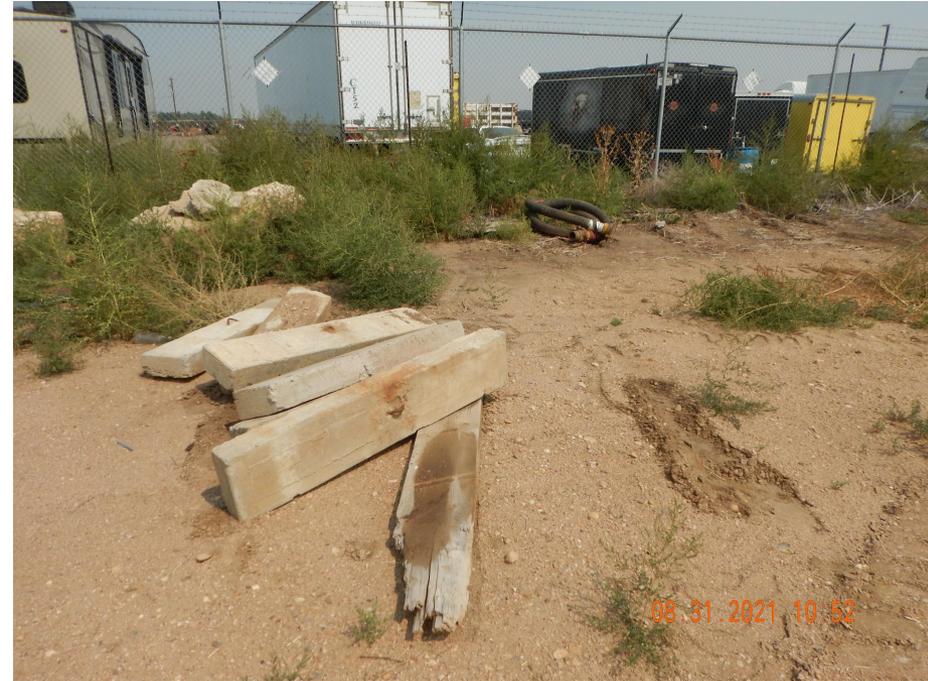
Photo 6. Photo taken from the northern production facility, facing North. See comments under Photo 3. Photo also illustrates unmanaged weeds, both undesirable and noxious weeds.

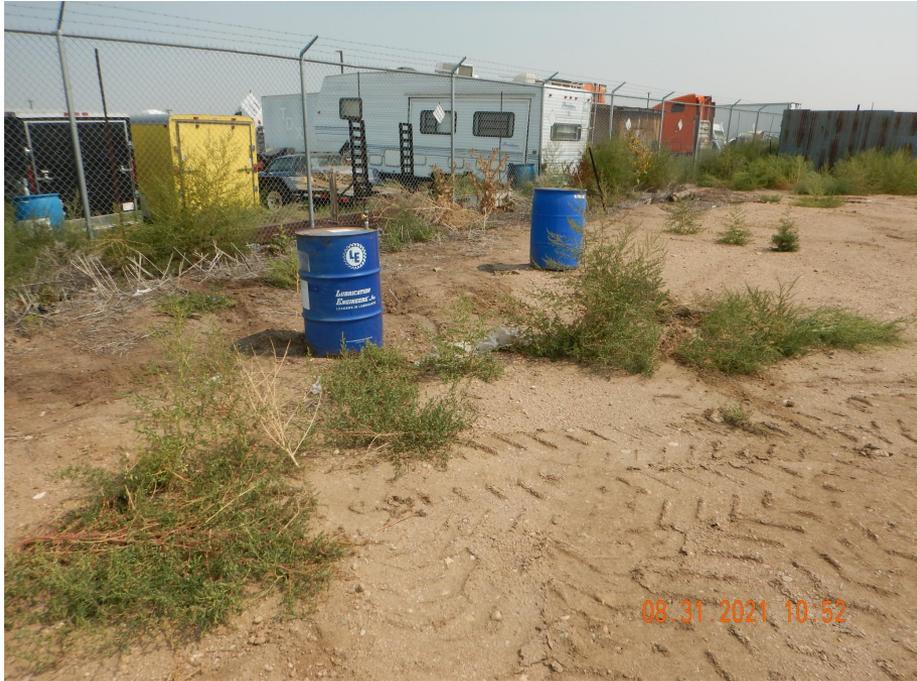
Photo 7. Photo taken from the northeastern production facility, facing Northeast. See comments under Photo 3. Photo also illustrates unmanaged weeds, both undesirable and noxious weeds.

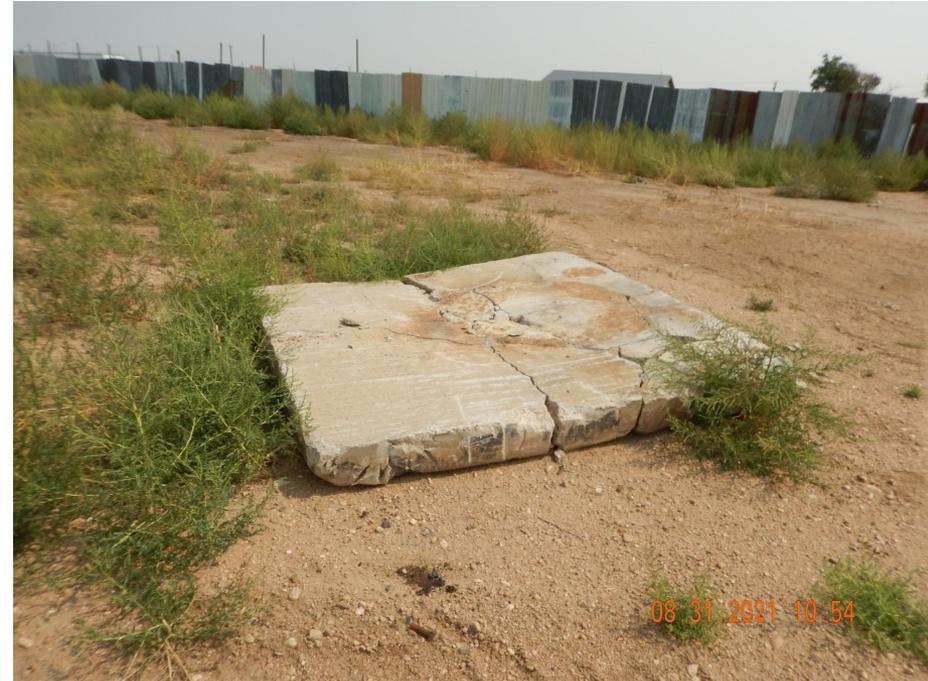
Photo 8. Photo taken from the southern production facility, facing Northeast. See comments under Photo 3. Photo also illustrates unmanaged weeds, both undesirable and noxious weeds.

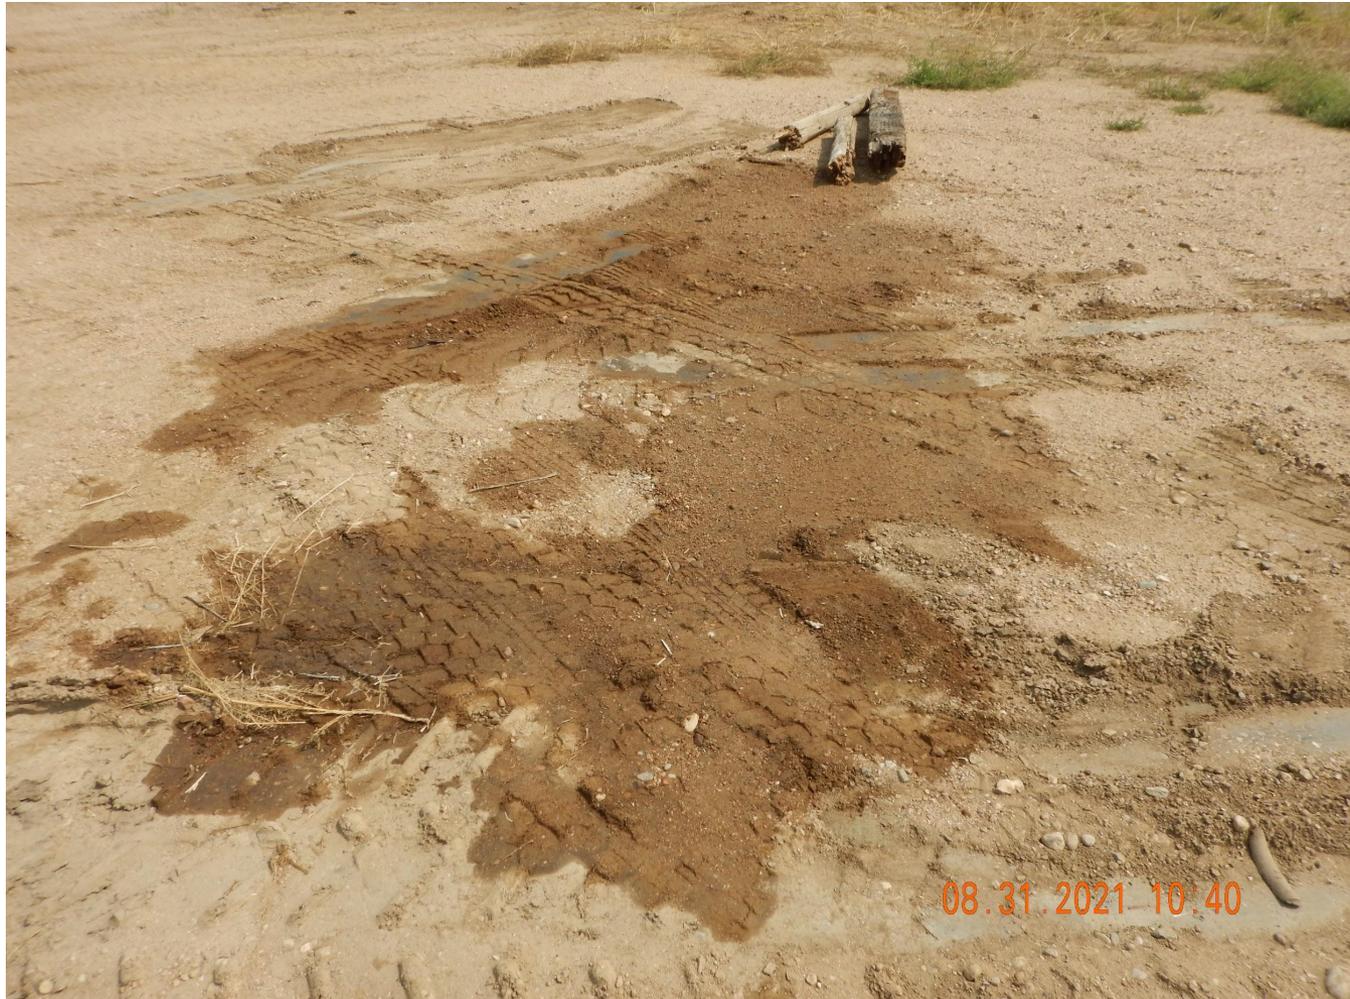
Photo 9. Photo taken from the southern production facility. Photo illustrates a spill that had smelt like hydrocarbons. Spill was approximately the size of a work truck- see Photo 1.

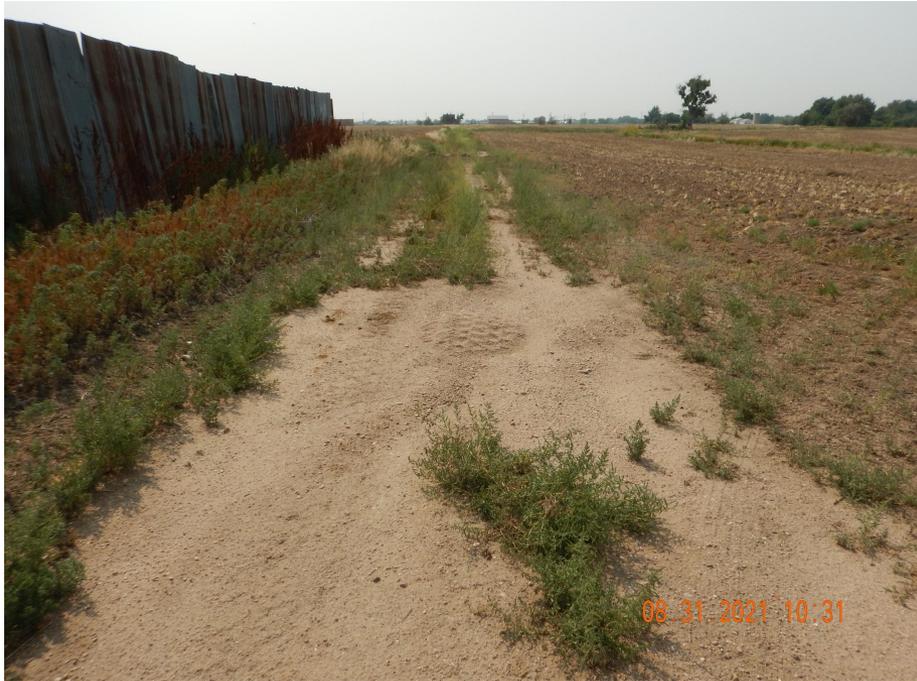
Photo 10. Photo taken from the northern well location access road utilized for the Counter #3 well, facing South. Photo illustrates Operator has failed to remove gravel and perform final reclamation activities.

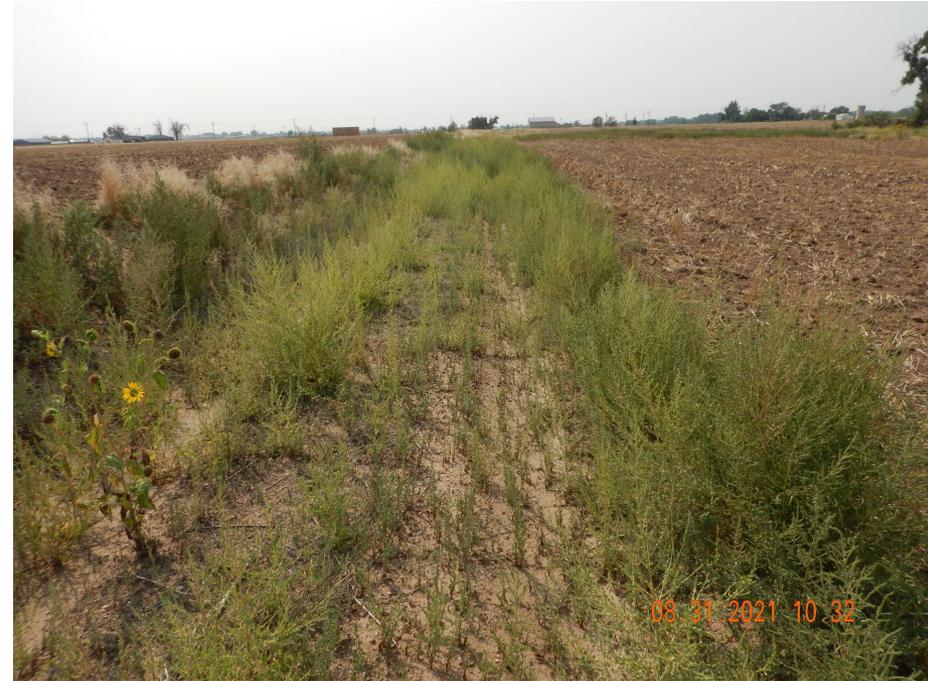
Photo 11. Photo taken along a portion of the well location access road utilized for the Counter #3 well, facing South. See comments under Photo 10.

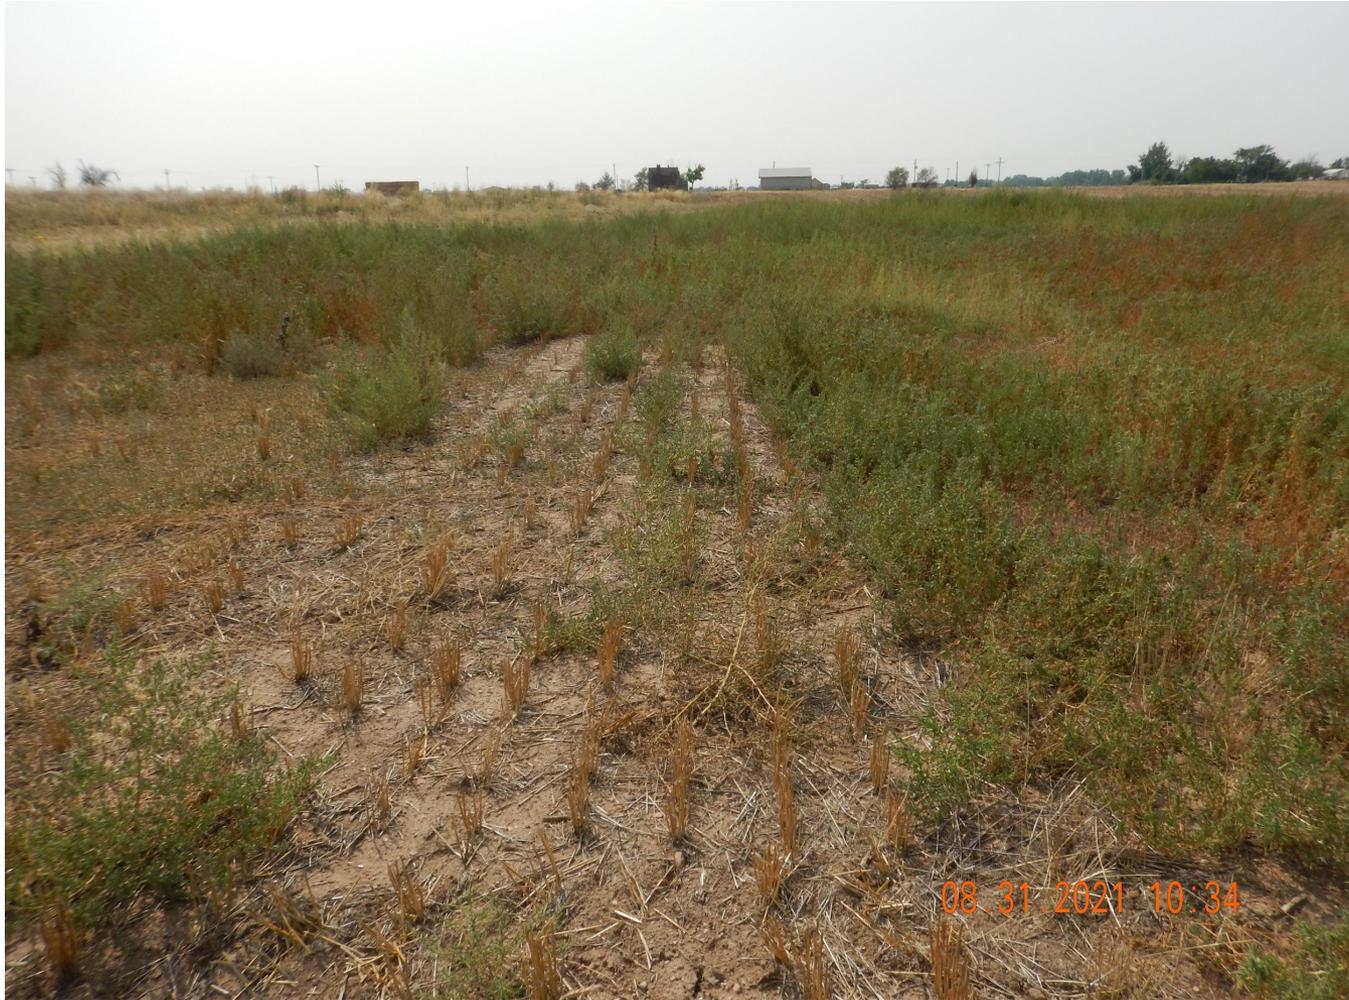
Photo 12. Photo taken from the Counter #3 well location, facing South. Photo illustrates tenant farmer attempted to plant into well location; however, it was a failed attempt because the Operator has not performed final reclamation activities like decompaction.
