Inspection Photos

9/03/2021

Operator: CAERUS ENERGY SERVICES LLC -
10668

Location ID: 479149
Garfield County, CO

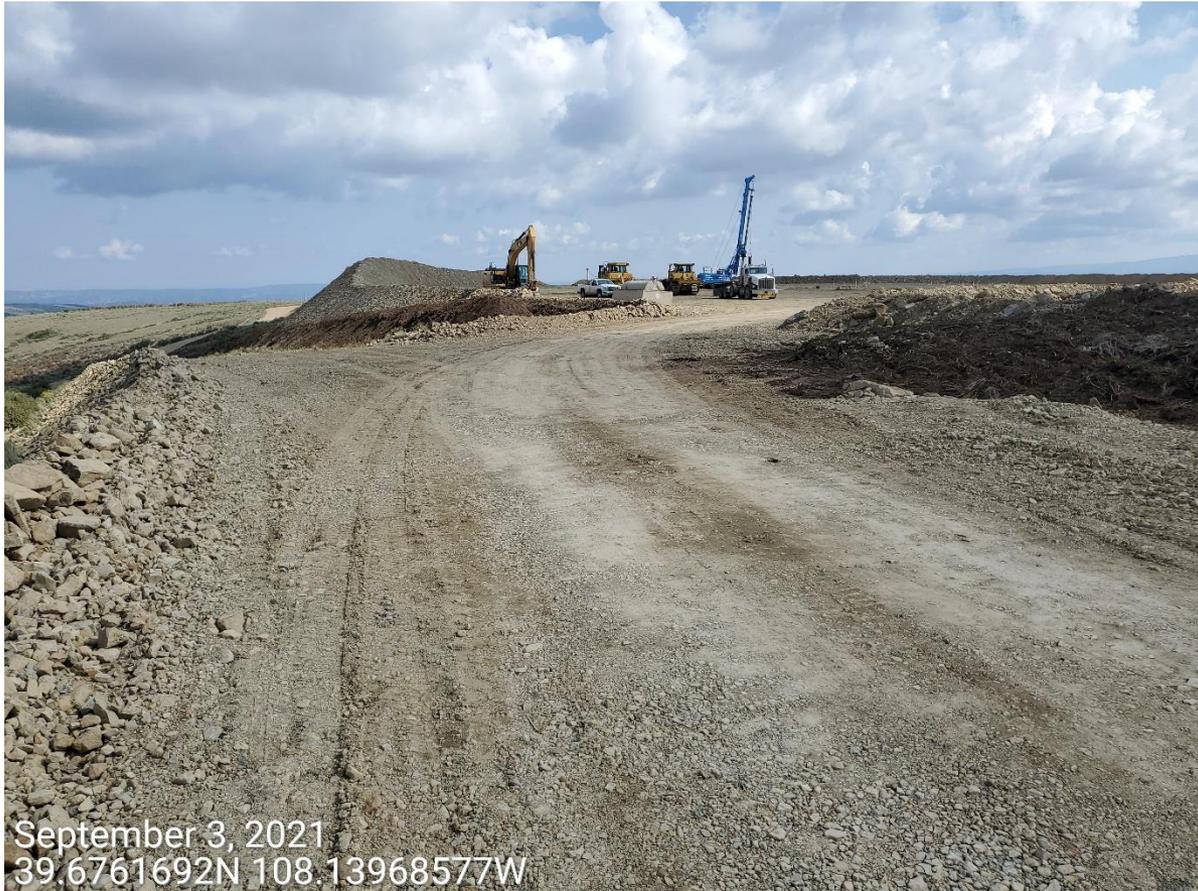
Photo 1: Photo taken from the Location entrance. Photo shows sign at Location entrance remains missing.

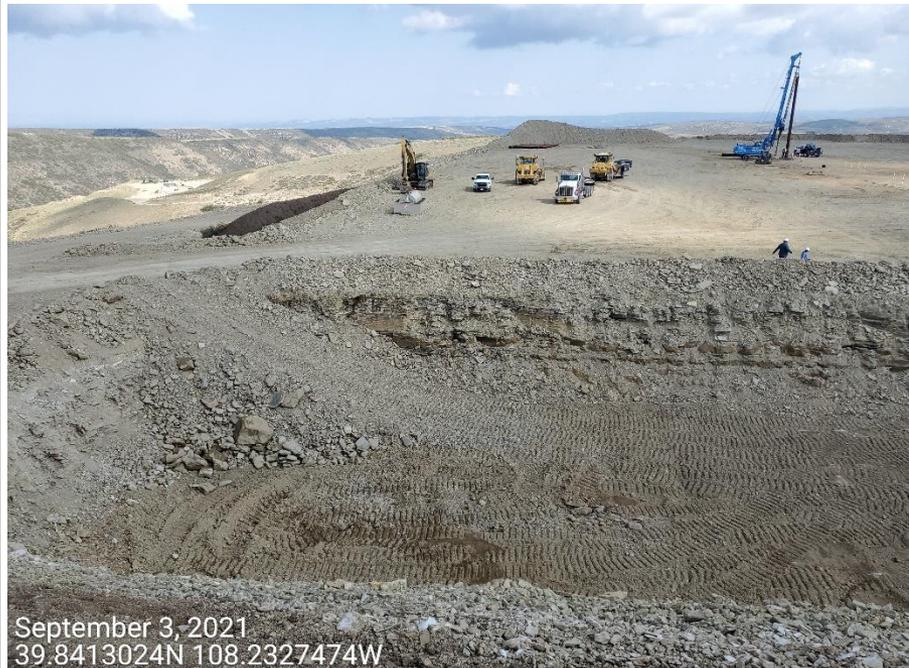
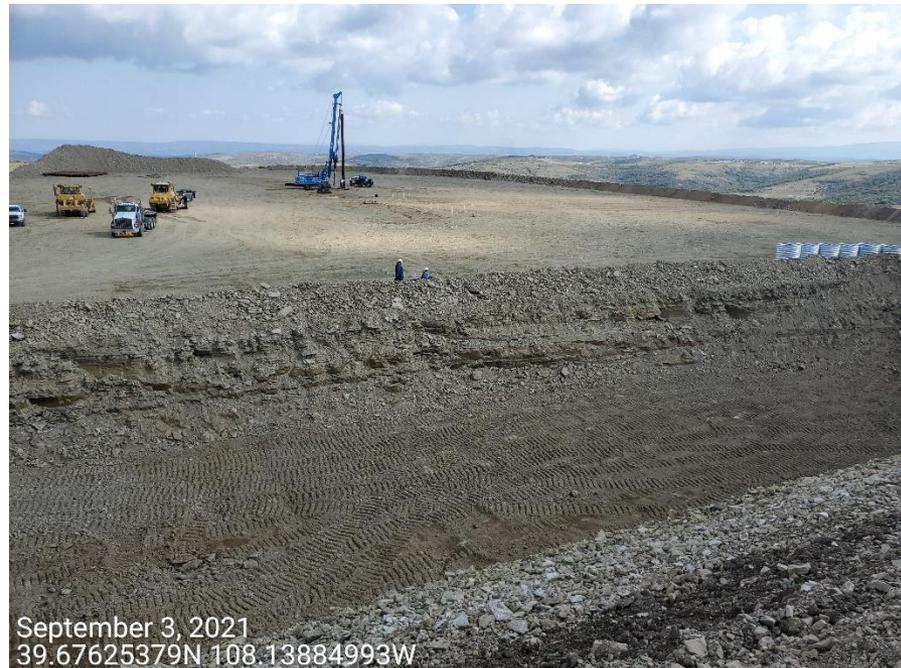
Photo 2: Photos taken from the south end of the Location, facing northwest/northeast. Photos provide overview of the Location; construction operations completed.

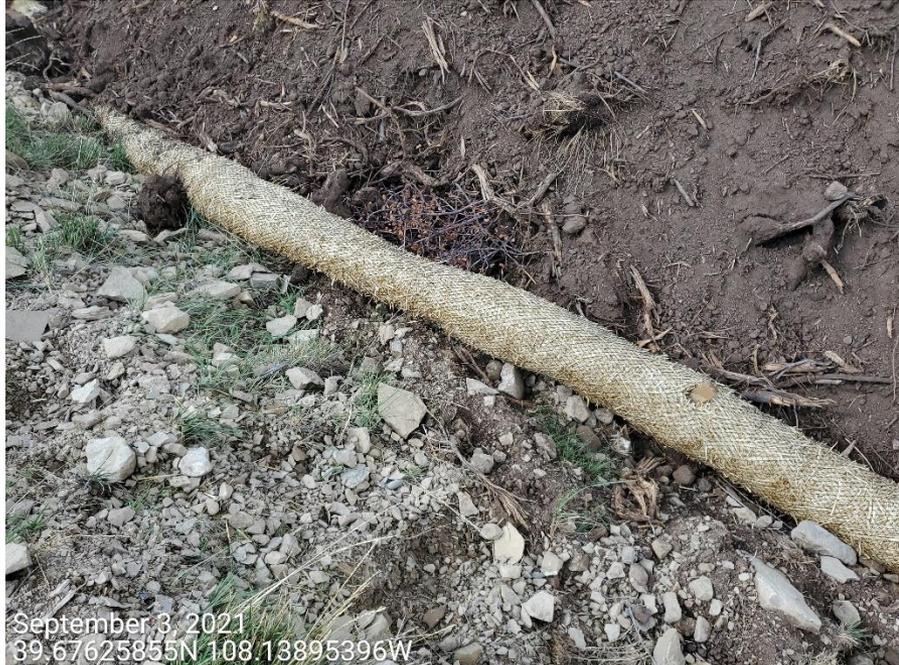
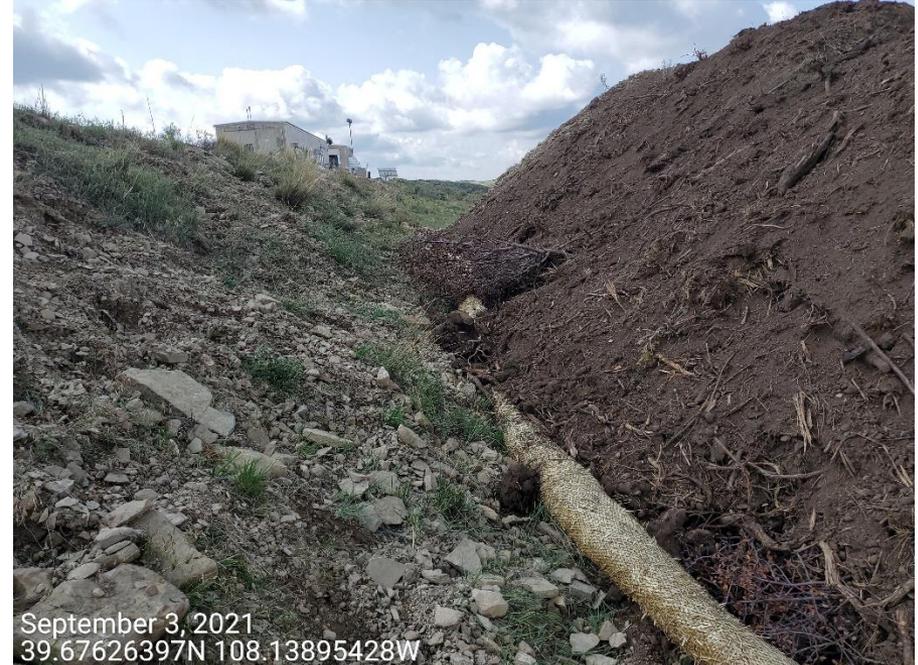
Photo 3: Photos taken from the stockpiled soils on the south end of the Location. Photo shows an example of where erosion logs (wattles) throughout the Location were observed to have not been installed in accordance with good engineering practices, or maintained in proper functioning condition. Photo also shows BMPs to protect and stabilize the stockpiled soils is missing or insufficient.

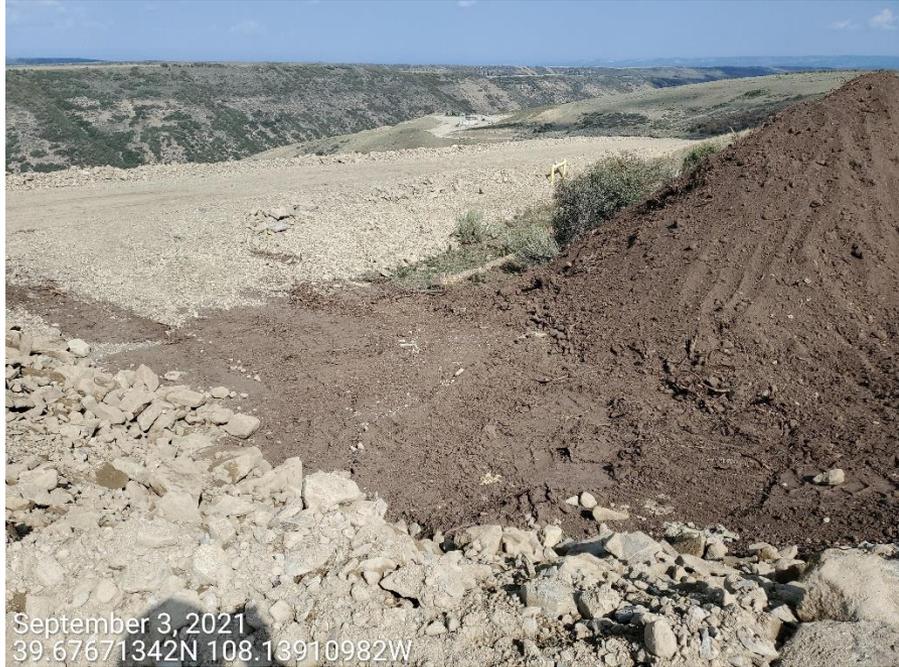
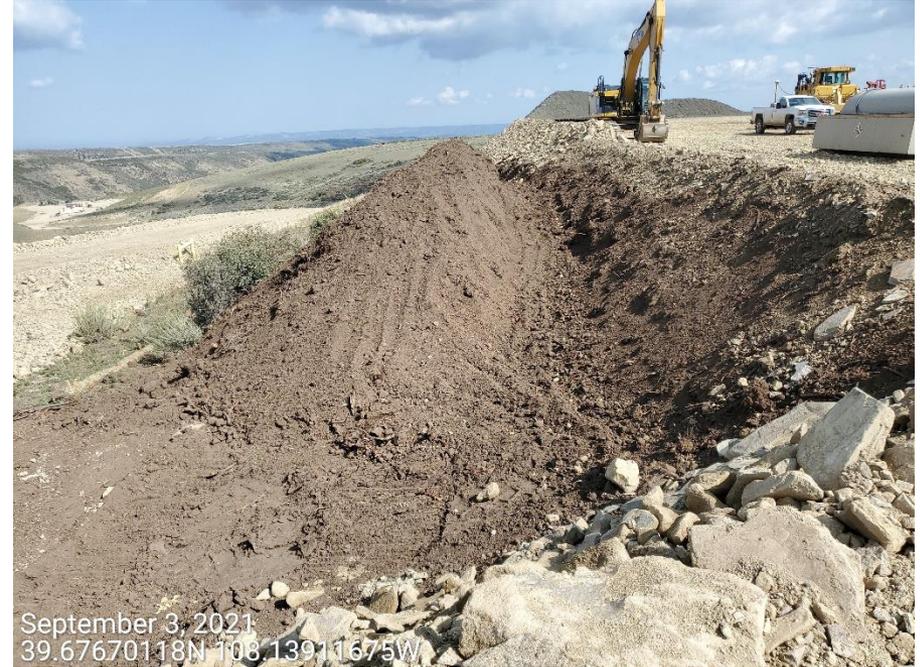
Photo 4: Photos provide an example where perimeter stormwater and erosion control measures are missing or insufficient. Photos also provide example showing BMPs to protect and stabilize the stockpiled soils, and to prevent mixing with other horizons (such as the fill slope material), are missing or insufficient.

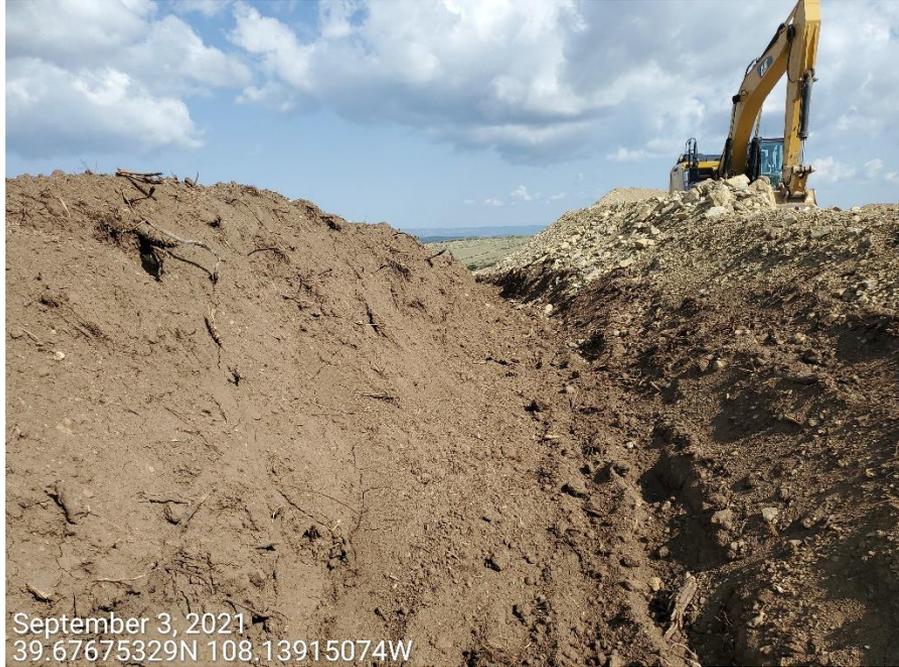
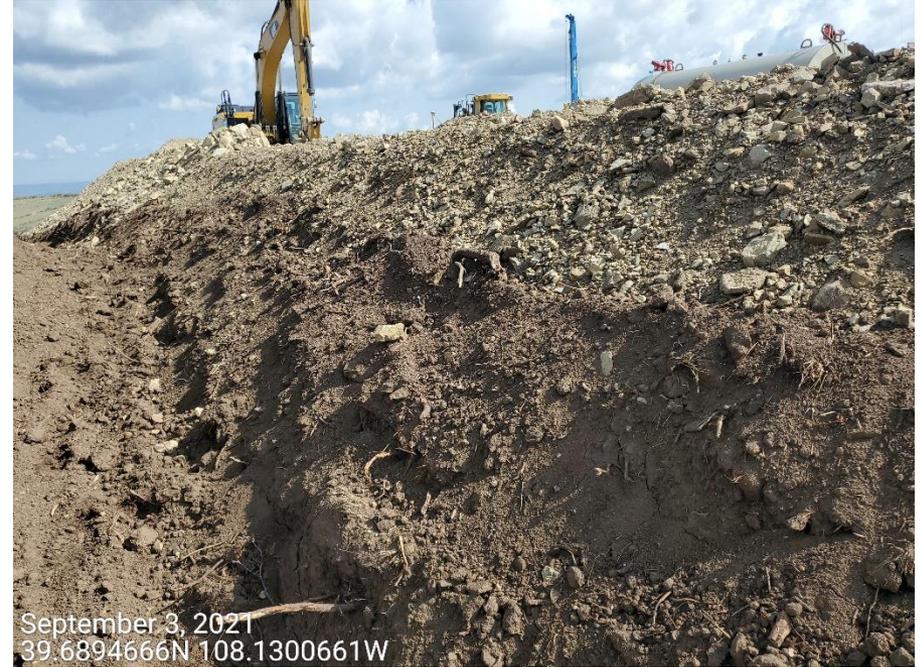
Photo 5: Photos provide an example showing BMPs to protect and stabilize the stockpiled soils and fill slopes, and to prevent mixing with other horizons (such as the fill slope material), are missing or insufficient. Operator appears to have excavated and placed topsoil material on top of the fill slopes.

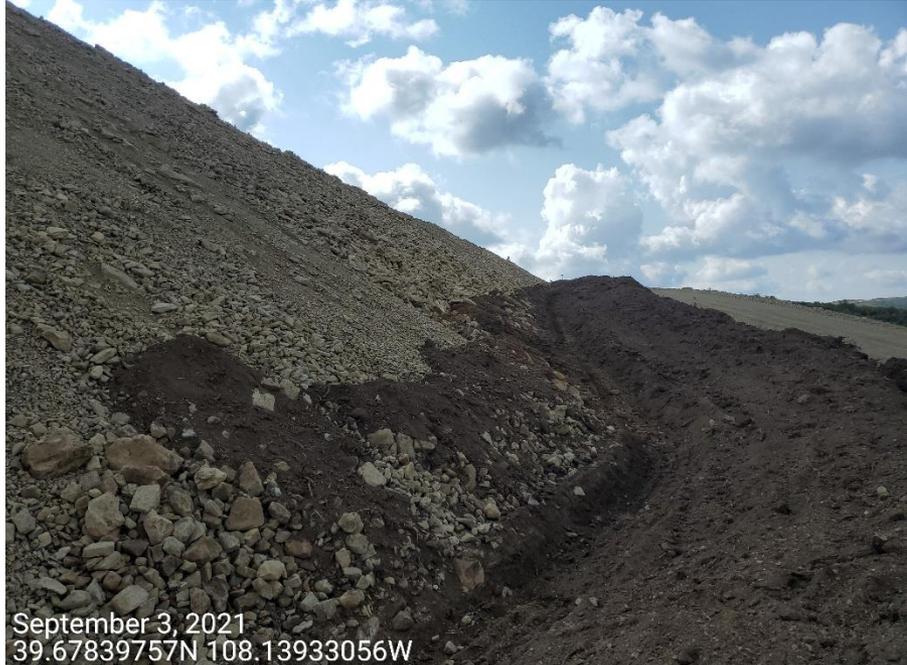
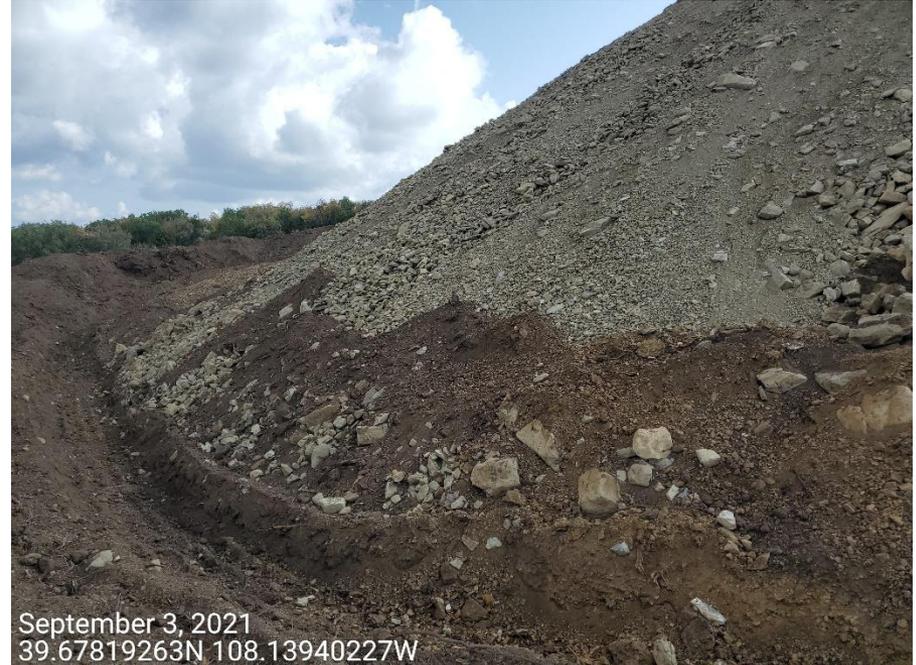
Photo 6: Photos taken from the northwestern areas of the Location. Photos provide an example where Operator appears to be in the process of implementing the topsoil stockpiles along the perimeter of the Location as a part of their perimeter stormwater BMPs; Operator has been previously notified verbally, and in other FIRs that the utilization of topsoil as stormwater control measures does not comport with Rule 1002.b and 1002.c, as the use of topsoil as a stormwater BMP puts the resource at risk of compaction, contamination due to mixing with sediment/subsoil, and places the resource at risk for loss due to stormwater discharge displacing the topsoil; perimeter stormwater and erosion control BMPs currently missing or insufficient to properly manage runoff from the large disturbance area. Photos also provide example showing BMPs to protect and stabilize the stockpiled soils, and to prevent mixing with other horizons (such as the fill slope material), are missing or insufficient.

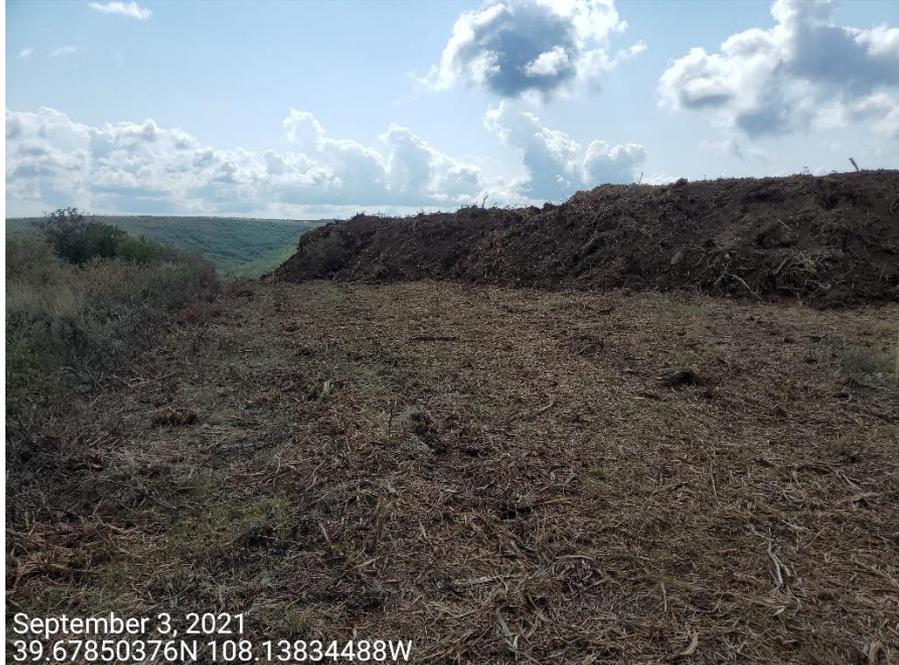
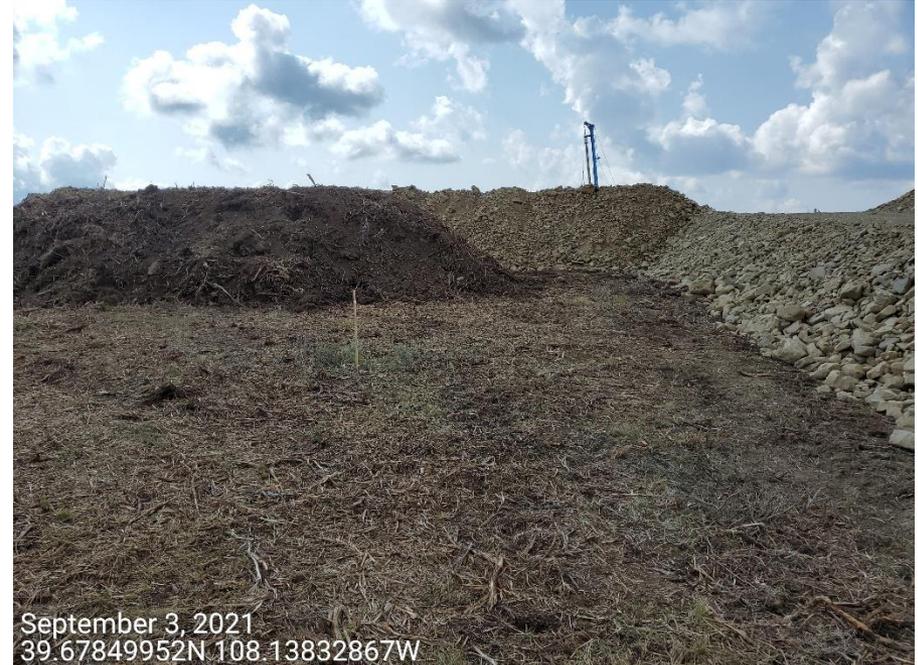
Photo 8: Photos taken from the north end of the Location, facing east/south. Photos provide example of areas where perimeter stormwater and erosion control BMPs are missing or insufficient. Photos also examples showing that BMPs to protect, stabilize and prevent sediment transport from the salvaged soils are missing or insufficient.

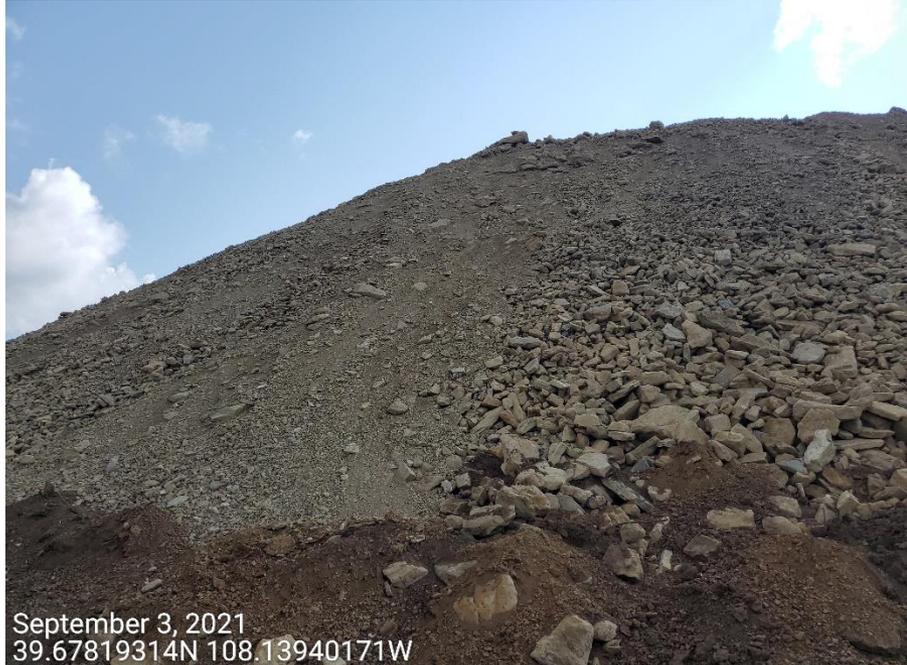
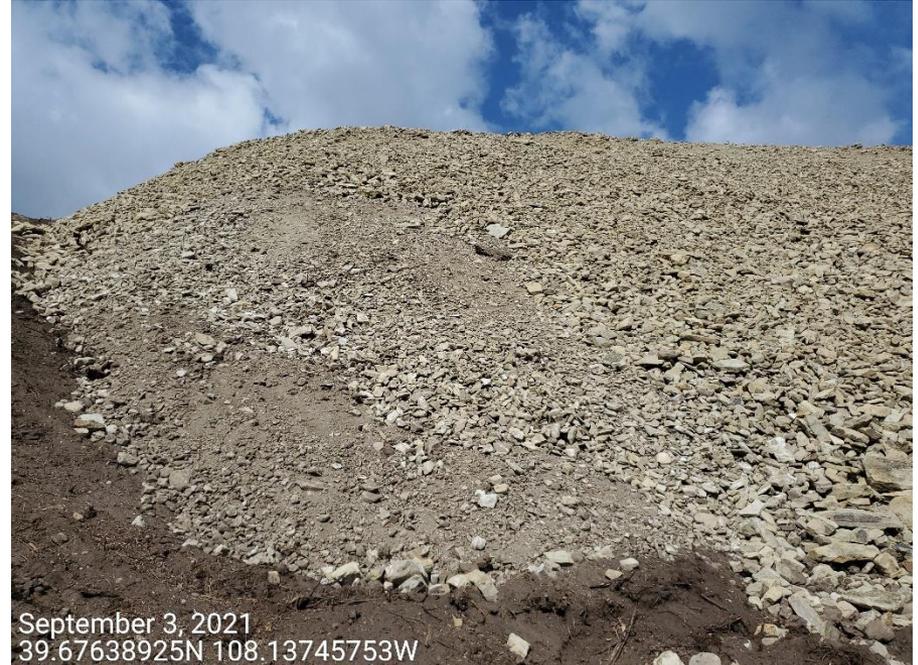
Photo 9: Photos show example of slopes on the Location; BMPs to protect and stabilize the (fill) slopes of the Location remain missing or insufficient/inadequate.

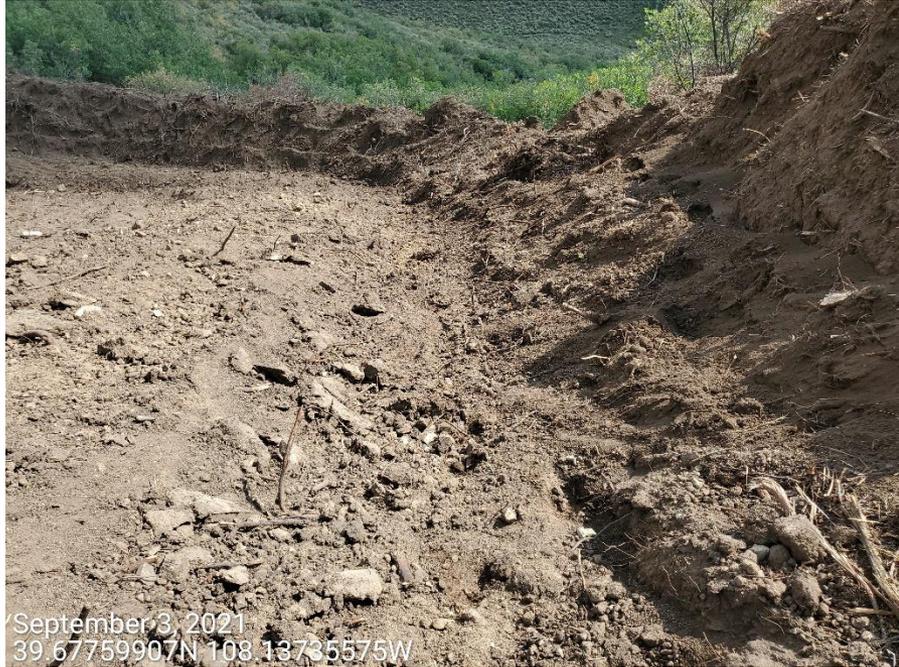
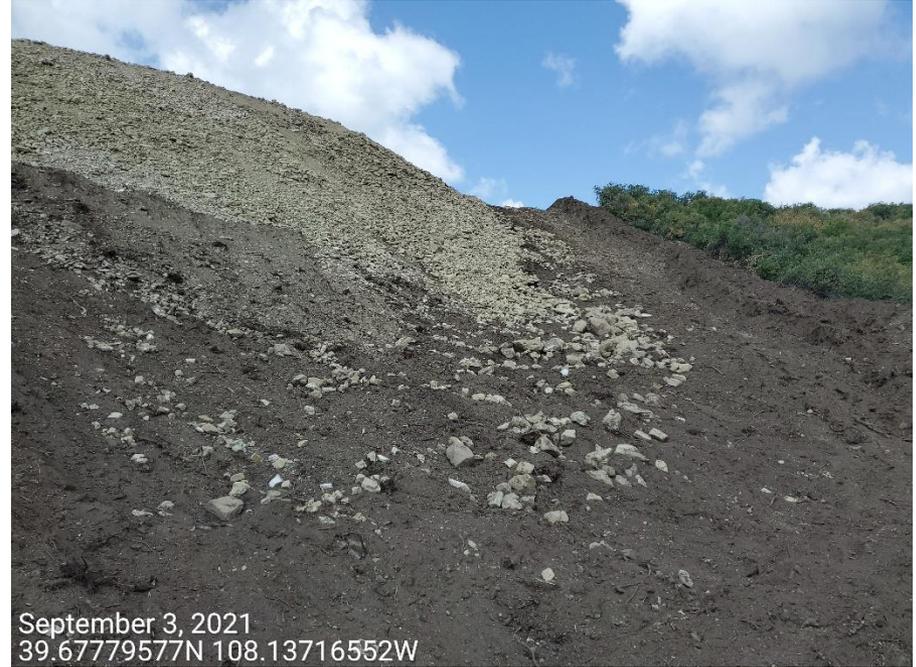
Photo 10: Photos taken from the eastern areas of the Location. Photos provide an example where Operator appears to be in the process of implementing the topsoil stockpiles along the perimeter of the Location, as a part of their perimeter stormwater BMPs; Operator has been previously notified verbally, and in other FIRs that the utilization of topsoil as stormwater control measures does not comport with Rule 1002.b and 1002.c, as the use of topsoil as a stormwater BMP puts the resource at risk of compaction, contamination due to mixing with sediment/subsoil, and places the resource at risk for loss due to stormwater discharge displacing the topsoil; perimeter stormwater and erosion control BMPs currently missing or insufficient to properly manage runoff from the large disturbance area. Photos also provide example showing BMPs to protect and stabilize the stockpiled soils, and to prevent mixing with other horizons (such as the fill slope material), are missing or insufficient.

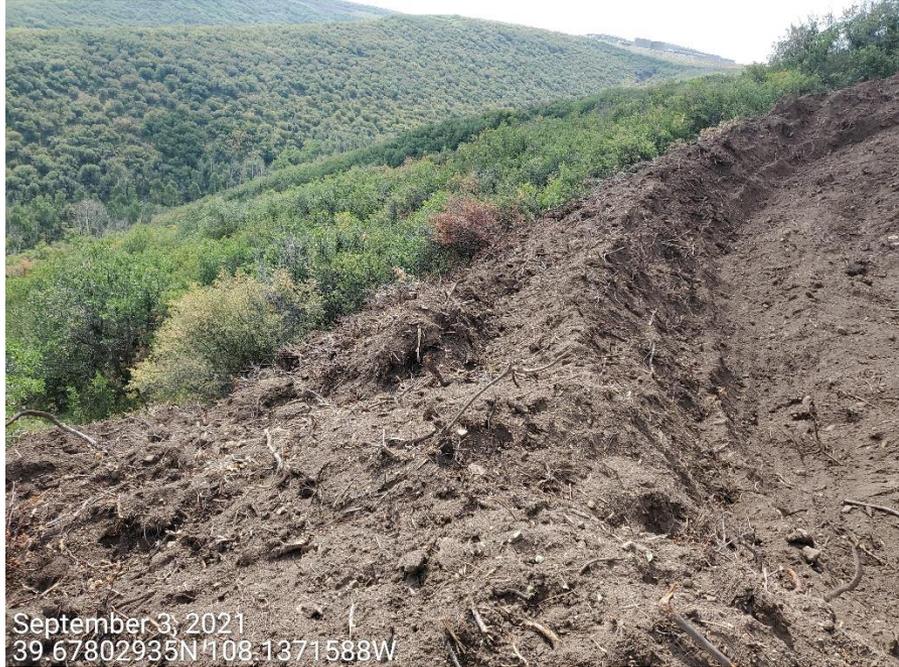
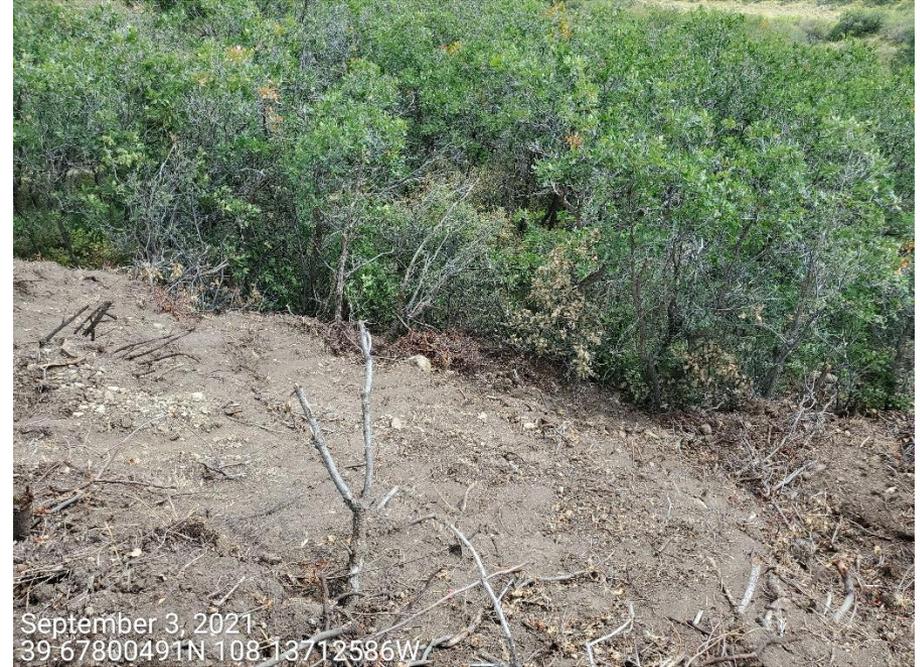
Photo 11: Photos taken from the west end of the Location. Photos provide an example showing that perimeter stormwater and erosion control BMPs that allow for sediment laden-free stormwater discharge is missing or insufficient measures are missing or insufficient. Photos also provide example showing BMPs to protect and stabilize the stockpiled soils are missing or insufficient.

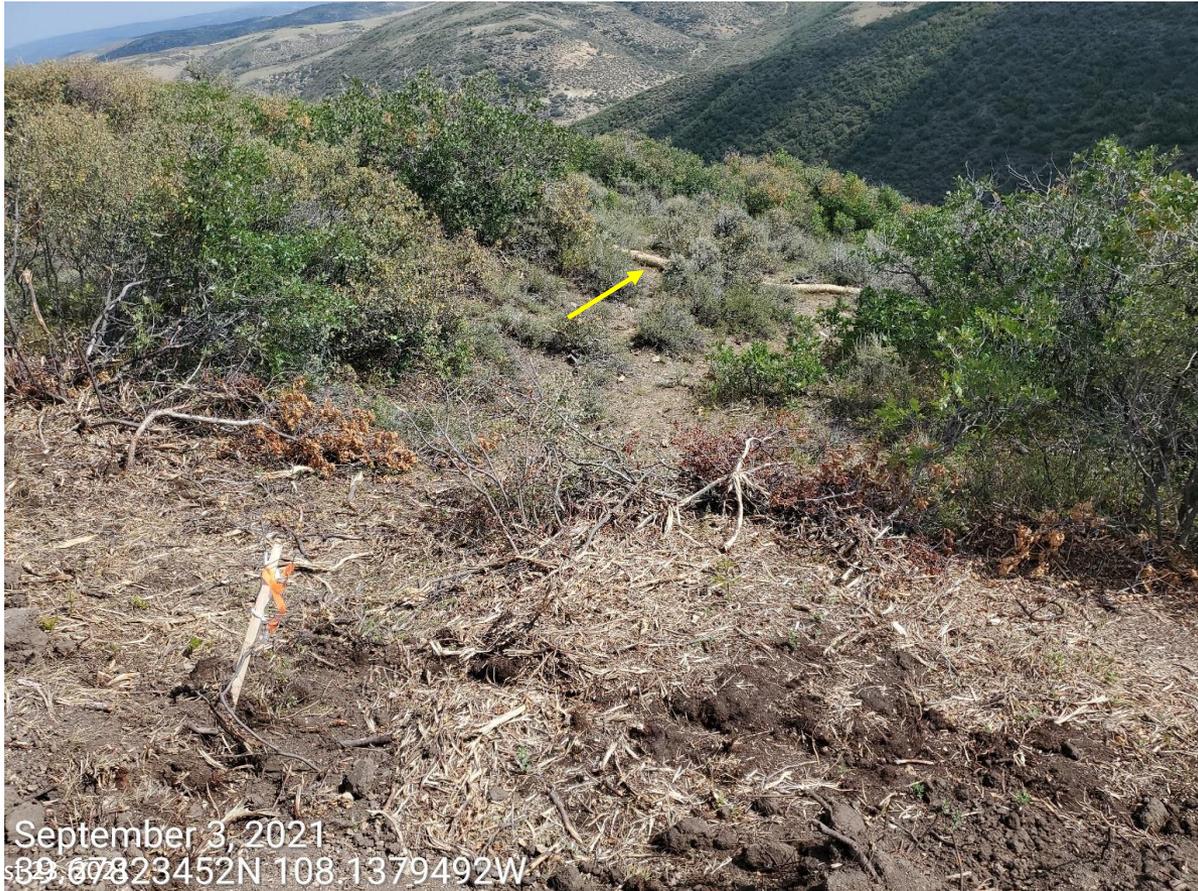
Photo 12: Photo taken from the topsoil stockpile on the north end of the Location. Photo shows example of areas where Operator has implemented a wattle ~100+ feet away from the disturbance area. Perimeter control measures inadequate.

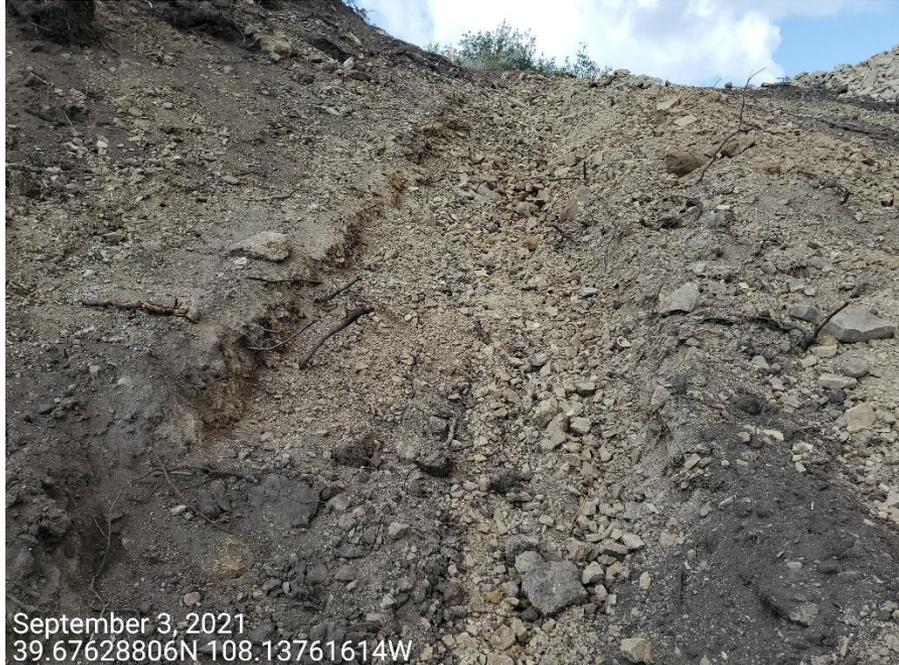
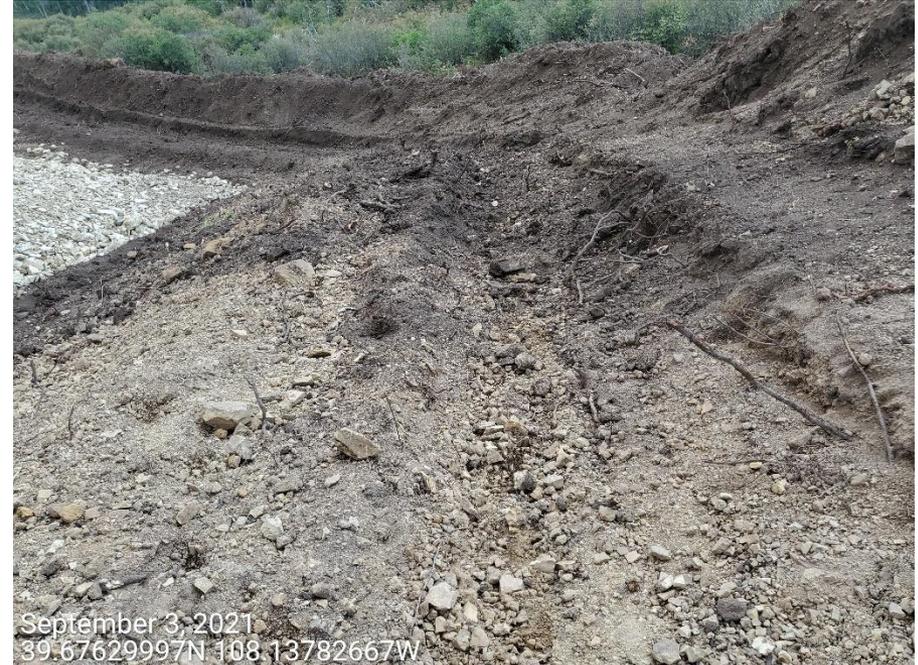
Photo 13: Photos taken from the east end of the Location. Photos provide example where proper soil segregation is inadequate. Photos also provide example showing BMPs to stabilize soils are missing or insufficient. See comments under photo 10 regarding use of topsoil as a stormwater and erosion control BMP.

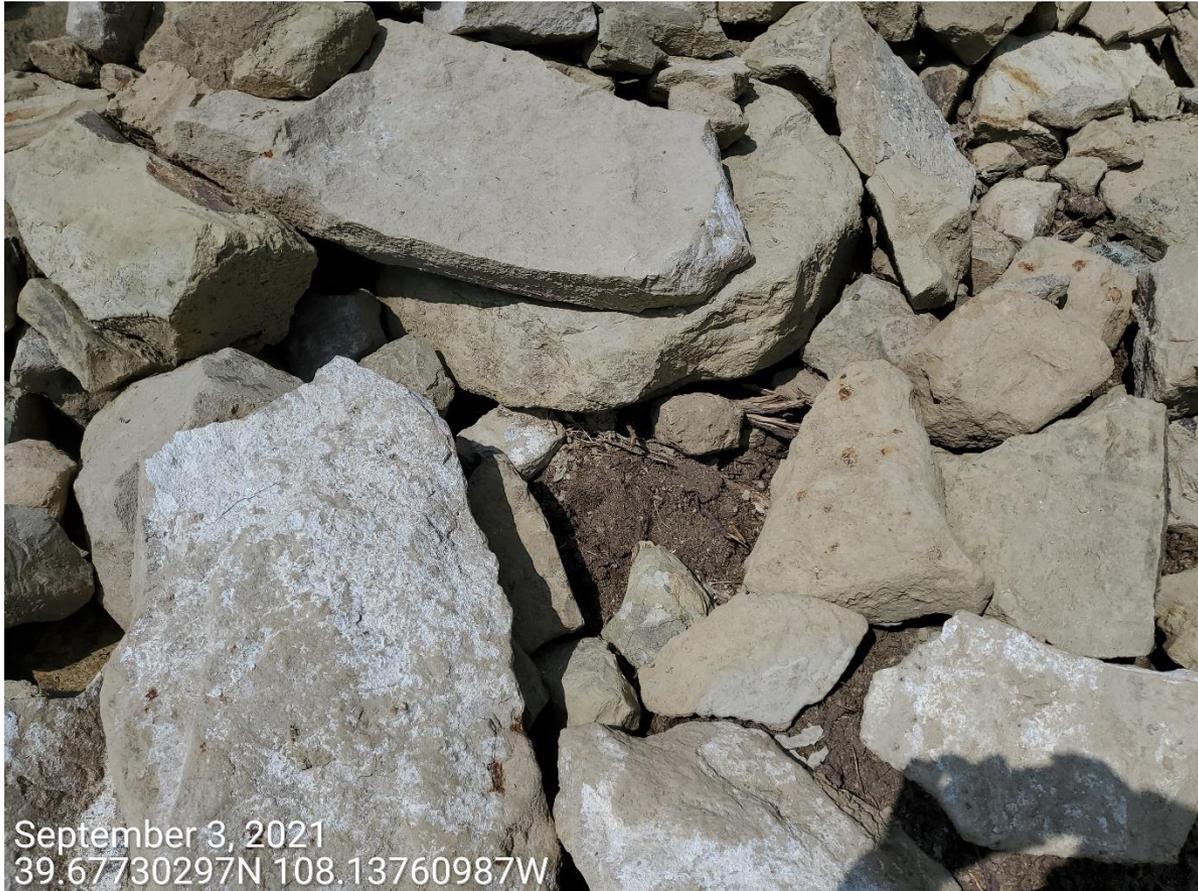
Photo 14: Photo taken from the fill slopes. Photo shows soils exposed by the Reclamation Specialist beneath the fill material; salvage of all the topsoil on the Location's disturbance appears inadequate; Reclamation Specialist observed soils beneath fill material containing organic matter typical of topsoil horizons; Operator does not appear to have salvaged and segregated all of the topsoil from the disturbed areas during construction activities.

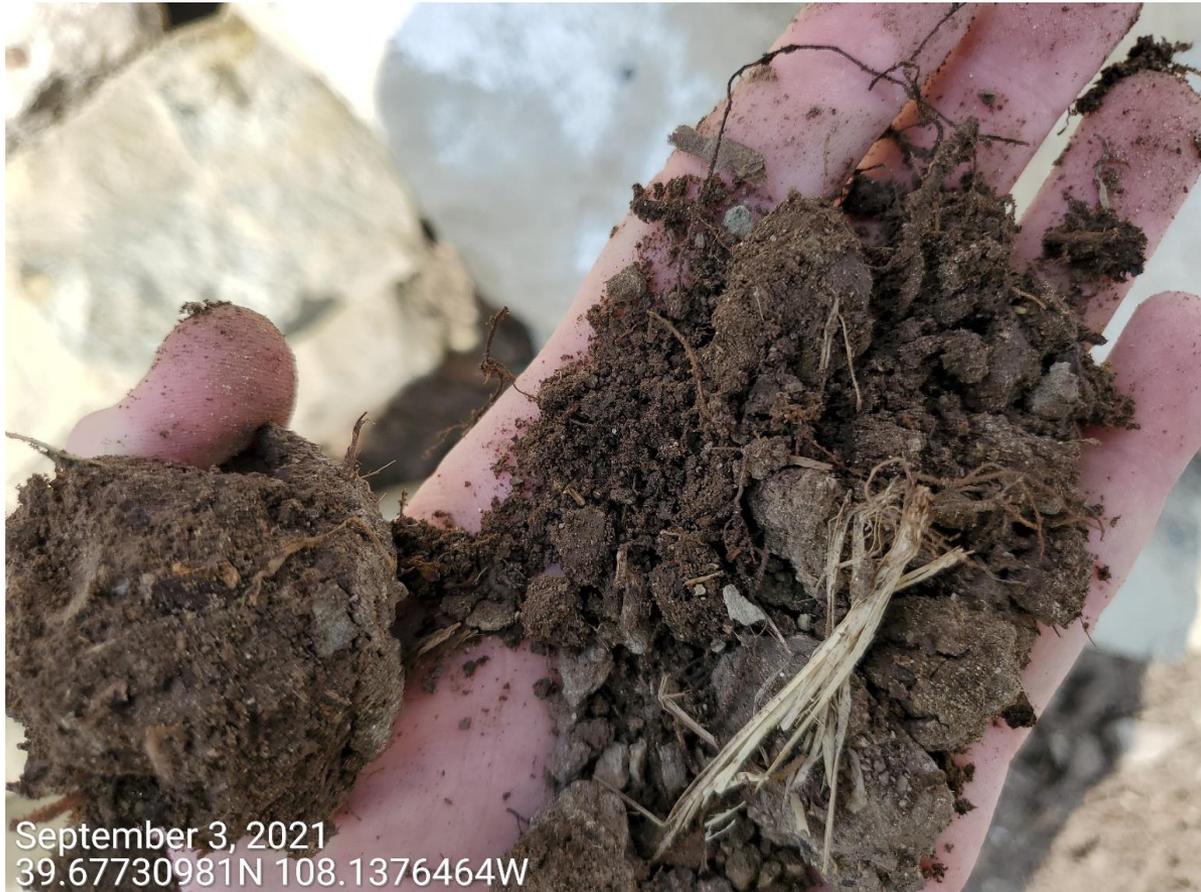
Photo 15: Continued from photo 14. Photo shows soils observed beneath the fill material; soils contain organic material typically observed within the topsoil horizons (including roots, and other vegetative/organic matter); woody/shrub and other plant matter can be observed sticking through the fill material throughout Location. Operator does not appear to have salvaged and segregated all of the topsoil from the disturbed areas during construction activities.
