# Inspection Photos

9/03/2021

Operator: CAERUS ENERGY SERVICES LLC -  
10668

Location ID: 479214  
Garfield County, CO

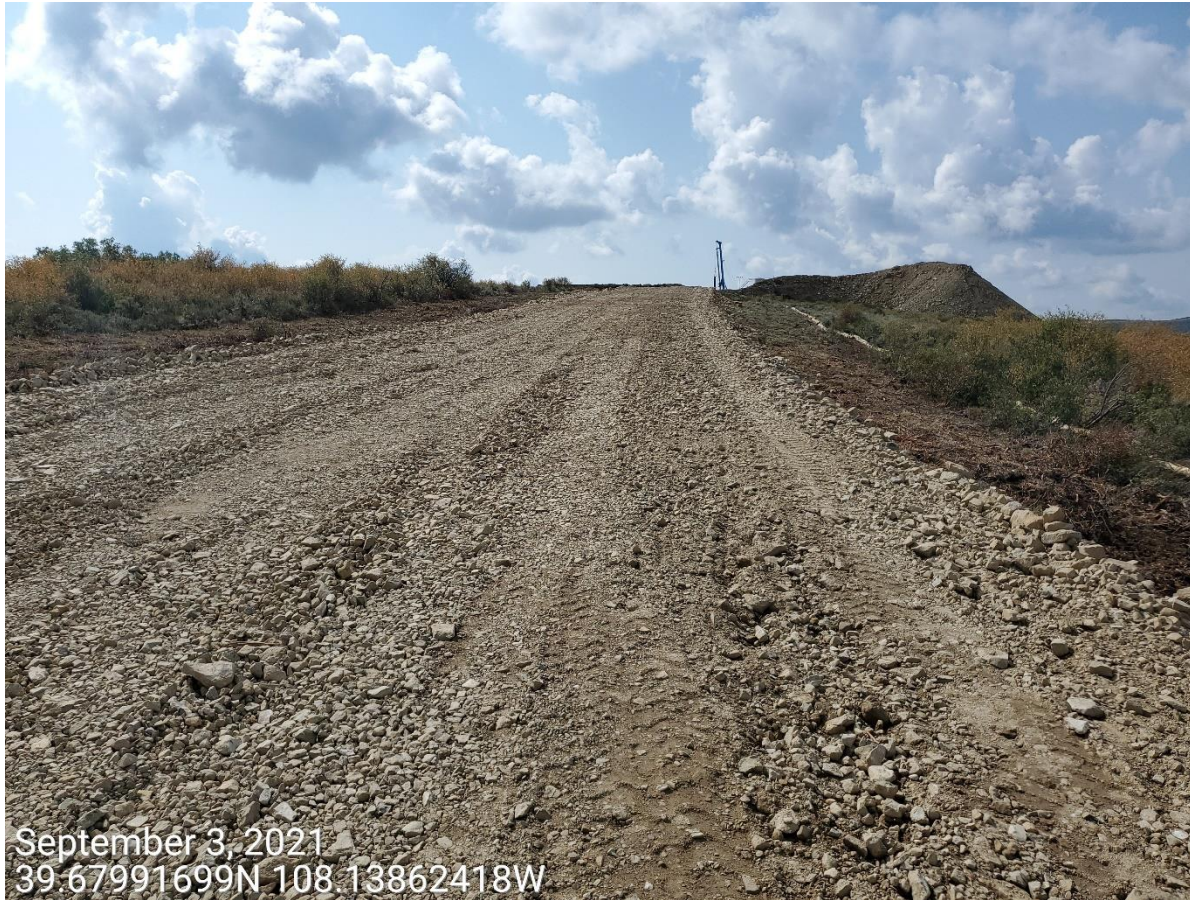
**Photo 1:** Photo taken from the south end of the Location, facing south. Photo shows Operator has constructed the “Proposed Secondary Access Road” between the BJU N23-496, to the BJU B26-496 Pad. Operator has also constructed another access road to the west, that leads to the Location's entrance. This does not comport with Rule 1002.e.(4). And Operator will be required to reclaim one of the access roads at time of interim reclamation, or site will remain out of compliance with Rule 1002.e.

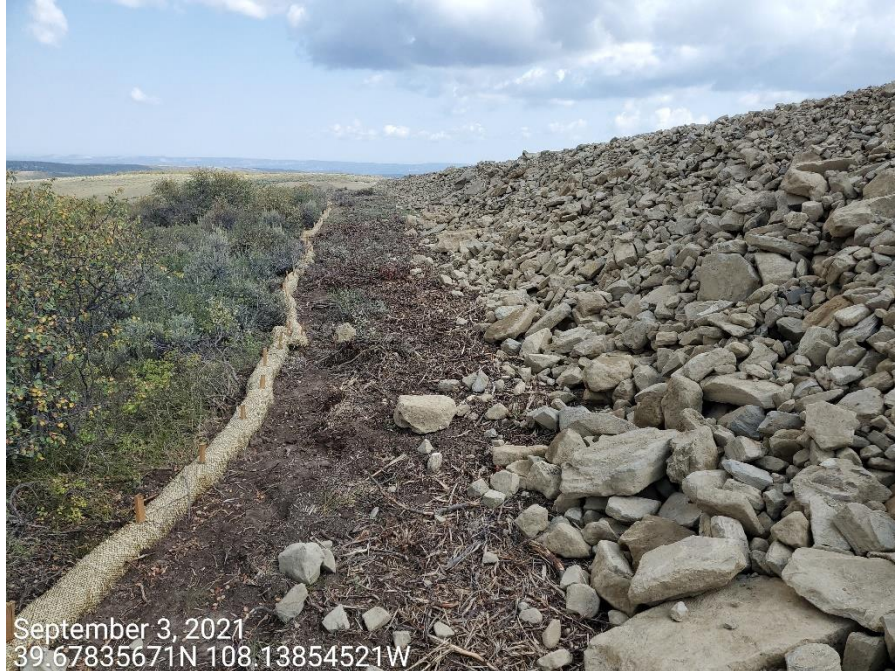
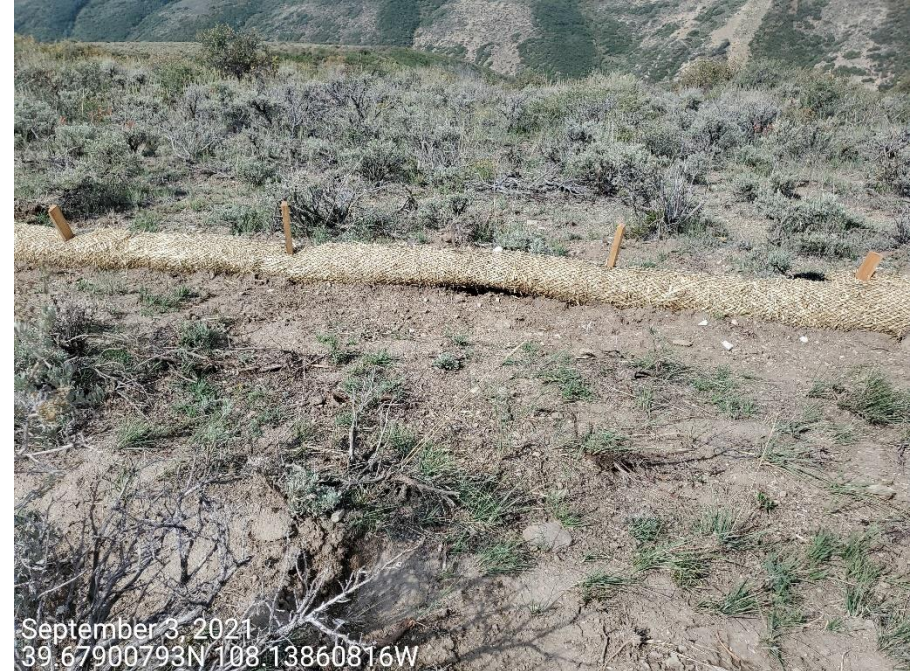
**Photo 2:** Photos provide example of wattle BMPs observed to not be installed in accordance with good engineering practices.

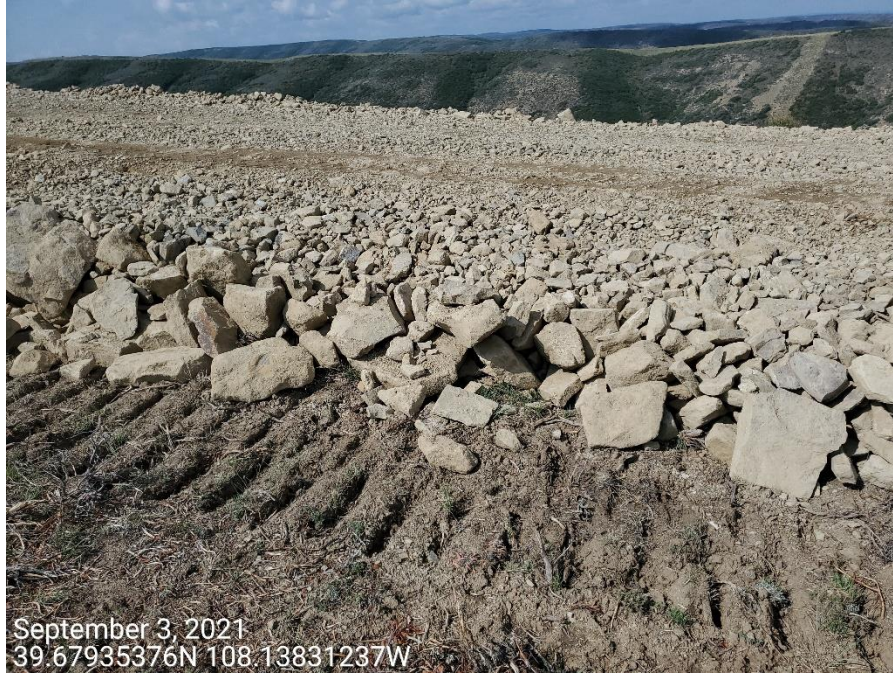
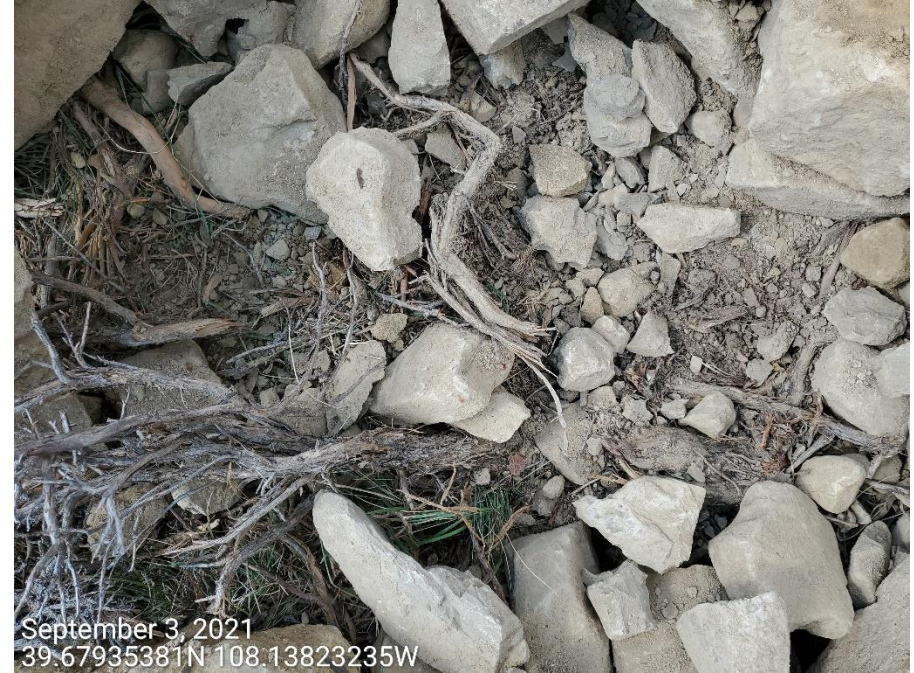
**Photo 3:** Photos taken at the “Proposed Secondary Access Road” constructed south of the Location. Upon removing fill material, Reclamation Specialist was able to observed intact vegetation and topsoil beneath the fill material. Unable to find evidence that Operator properly salvaged, segregated and stored all topsoil within the Location's disturbance area during construction.

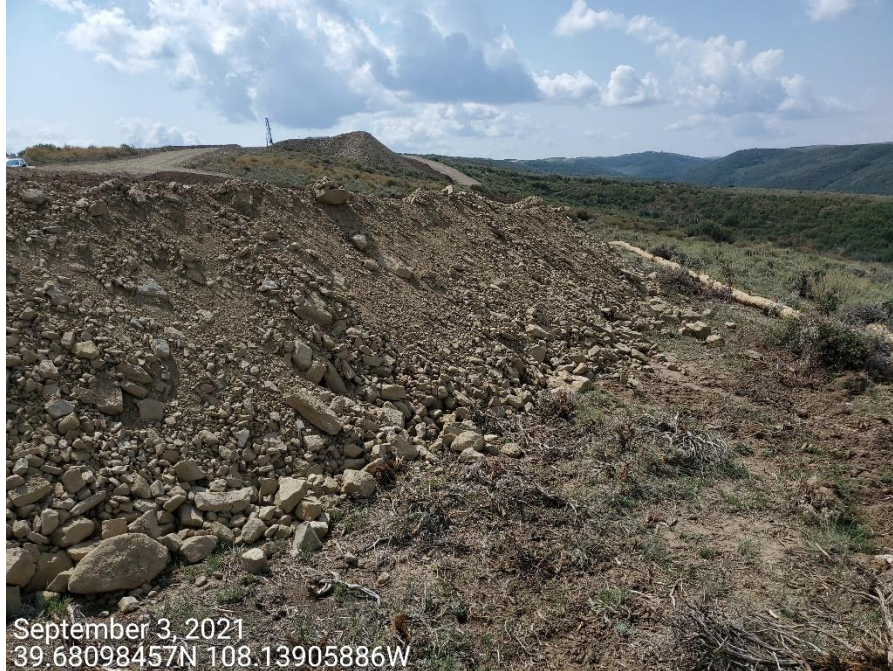
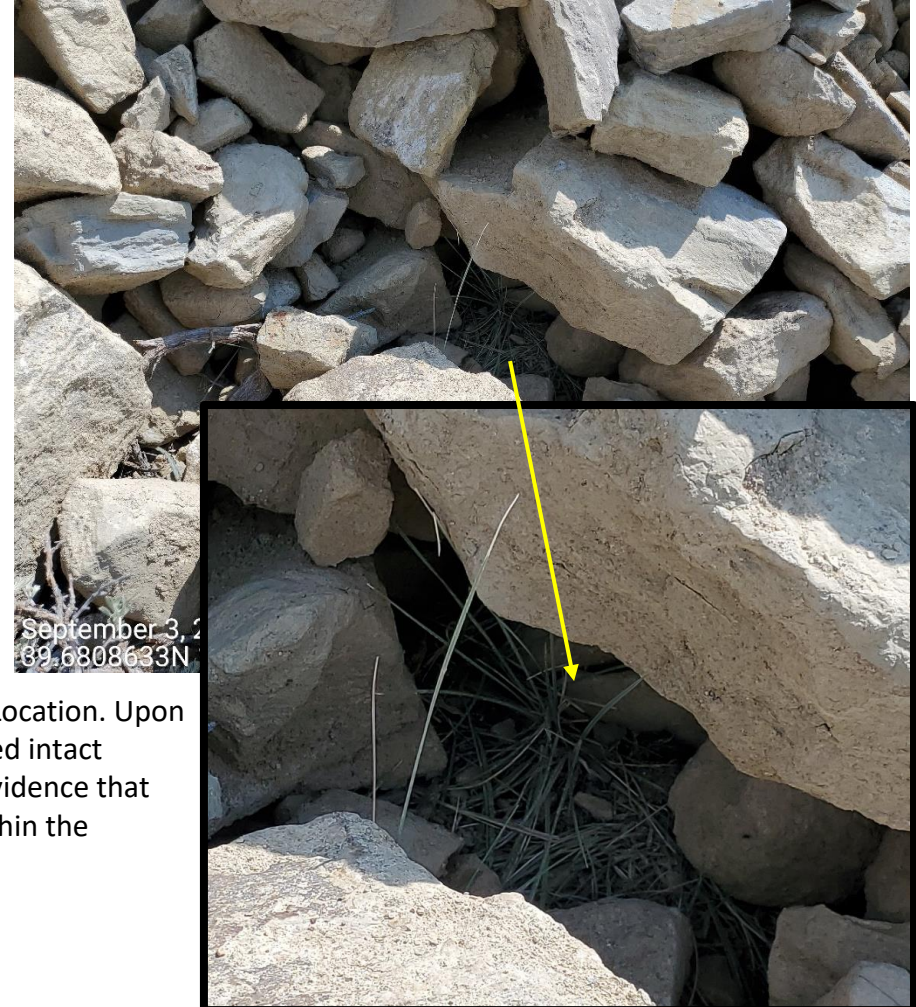
**Photo 4:** Photo taken from the fill slopes on the west end of the Location. Upon removing fill material, Reclamation Specialist was able to observe intact vegetation and topsoil beneath the fill material. Unable to find evidence that Operator properly salvaged, segregated and stored all topsoil within the disturbance area during construction.

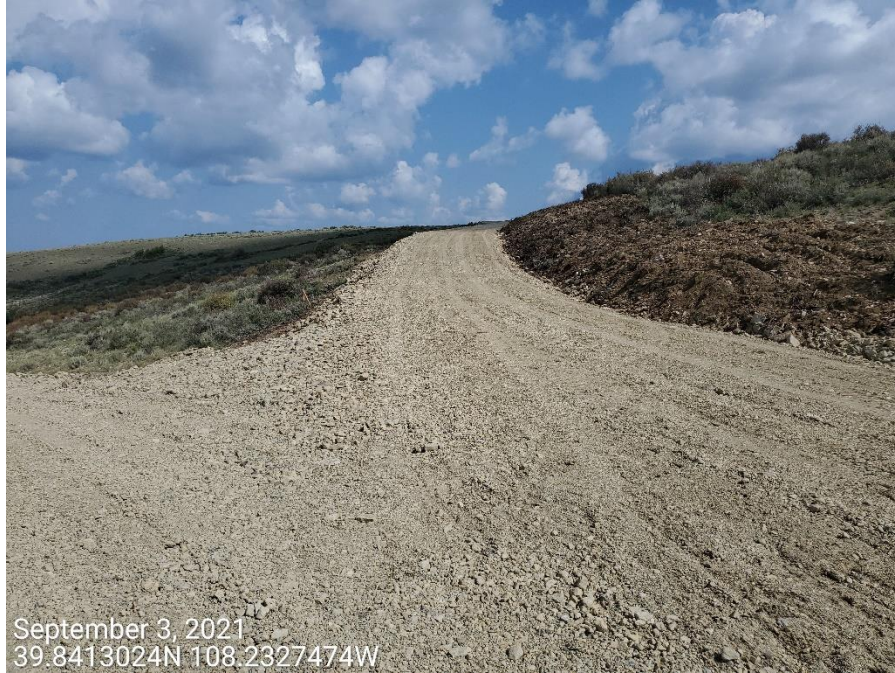
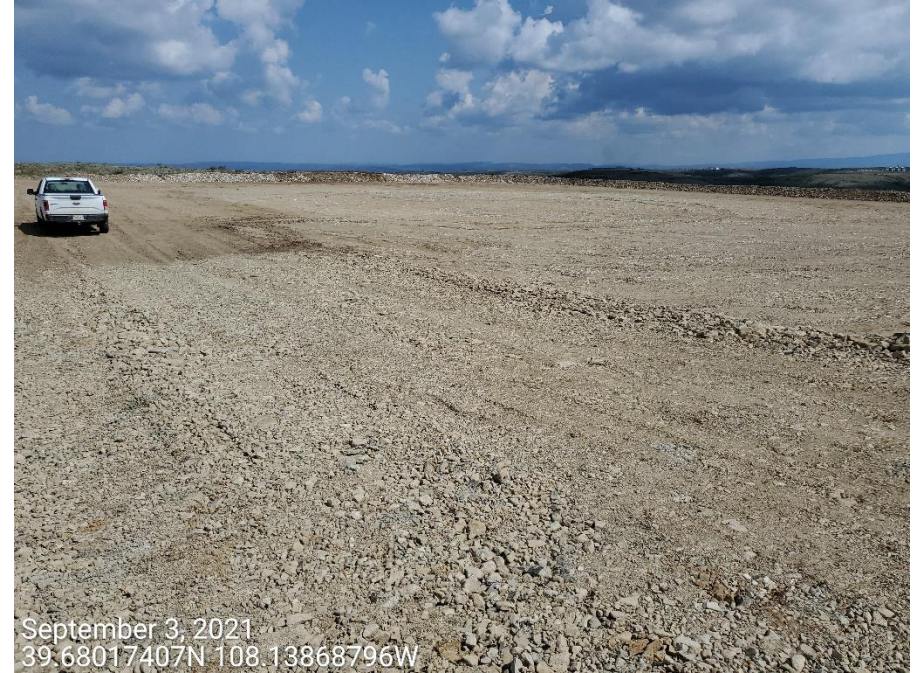
**Photo 5:** Photo on the left taken from the western access road. Photo right taken from southwestern location entrance. Required signage at Location entrance was not observed. Operator has also constructed two access roads to the Location; photo left shows one of the constructed roads.

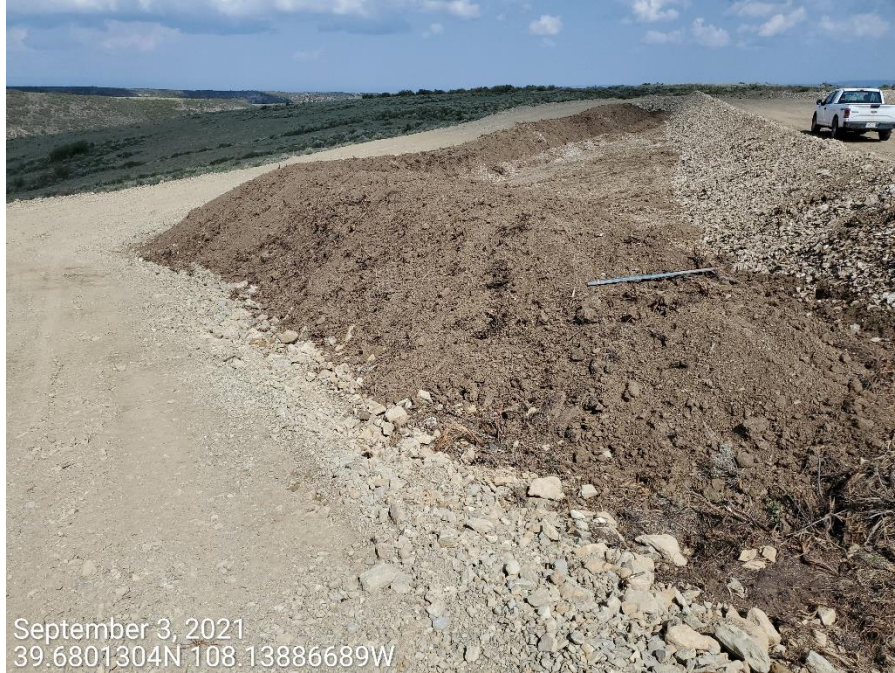
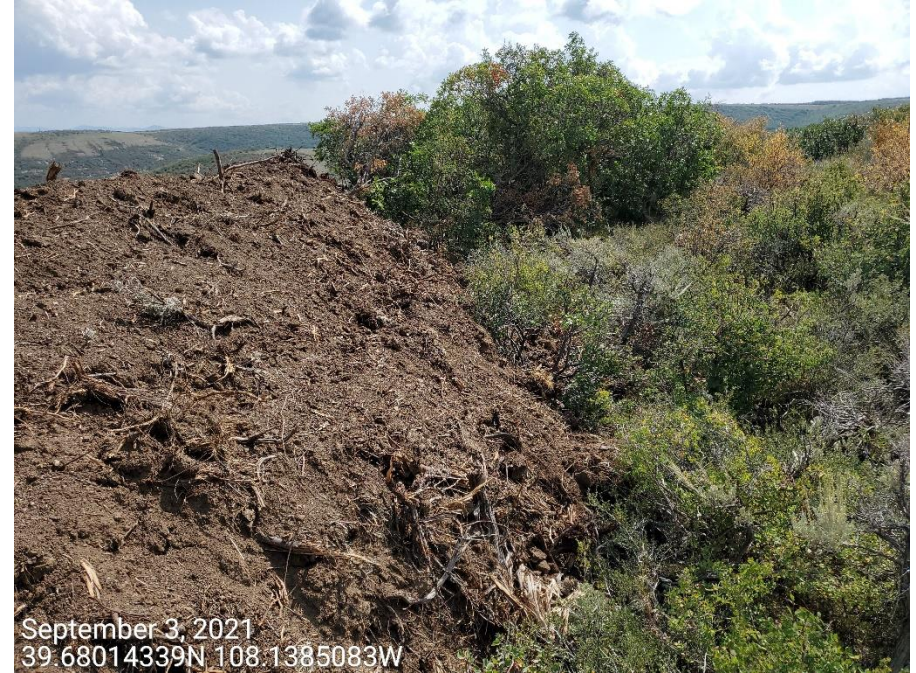
**Photo 6:** Photos provide an example showing BMPs manage runoff, and to protect and stabilize the stockpiled soils are missing of insufficient.

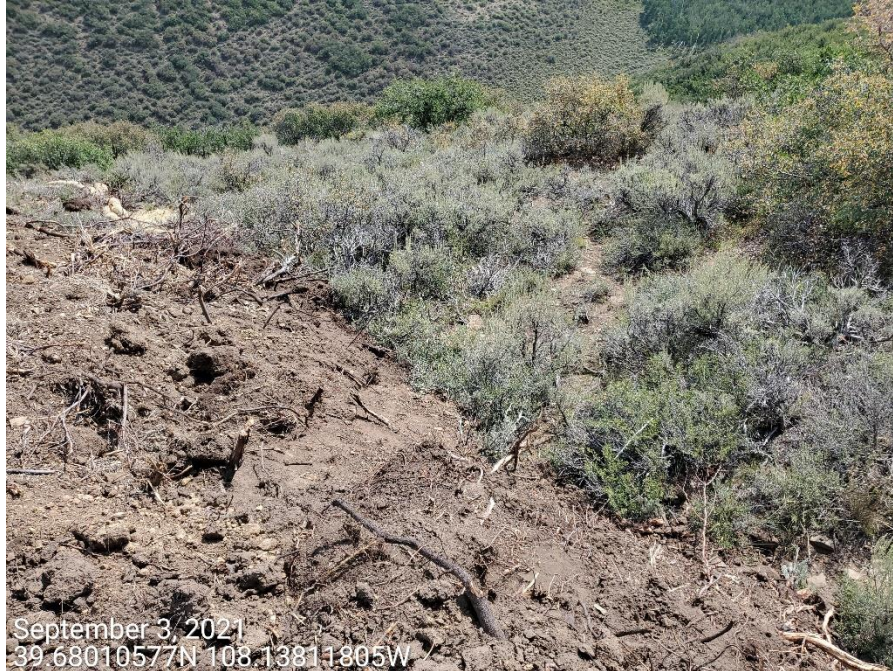
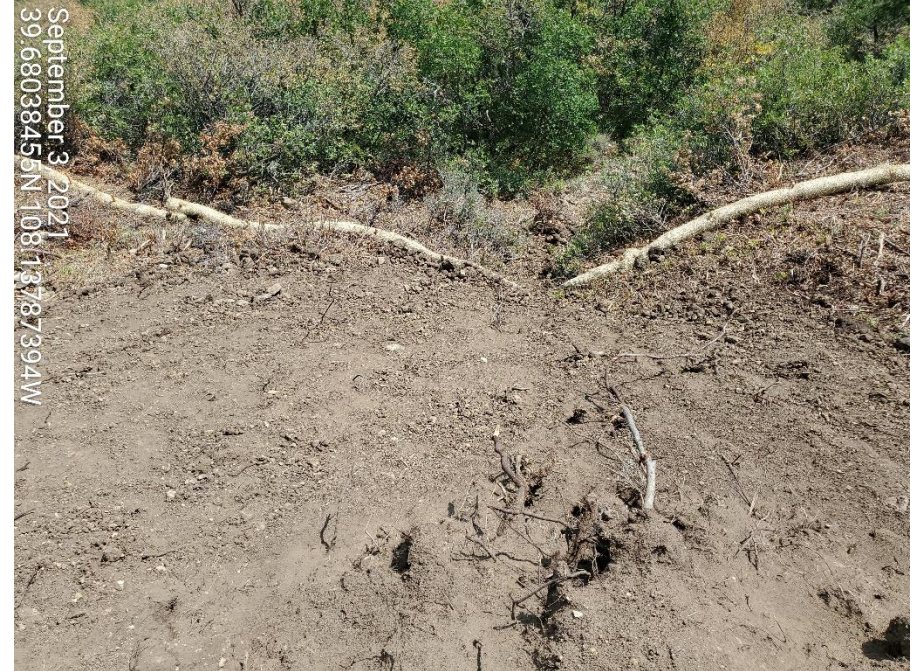
**Photo 7:** Photos show example where perimeter stormwater and erosion control BMPs to manage runoff, and stabilize slopes/soils are missing or insufficient. Photo on right shows soil has covered the erosion log and discharged off-site.

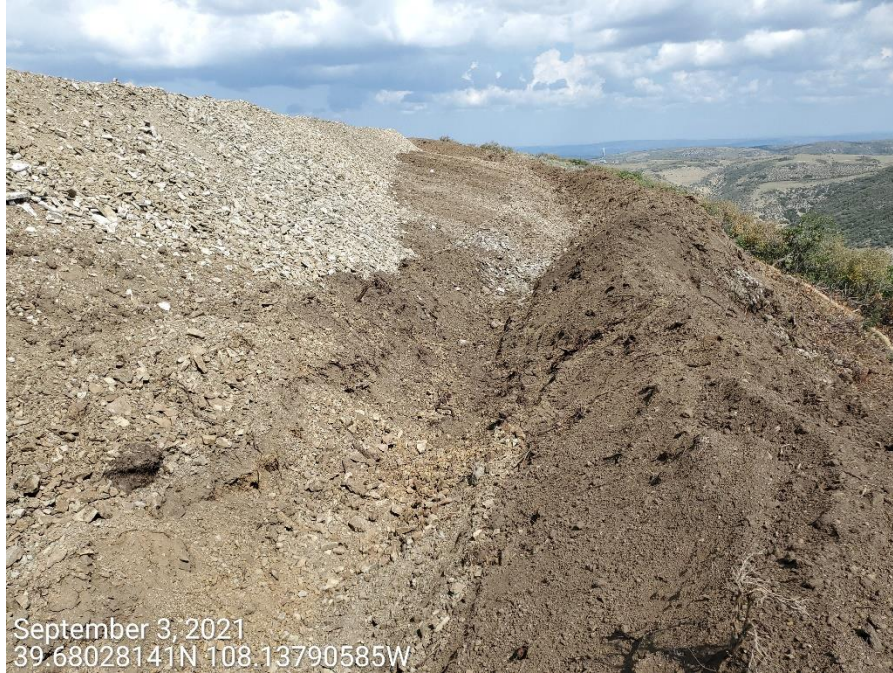
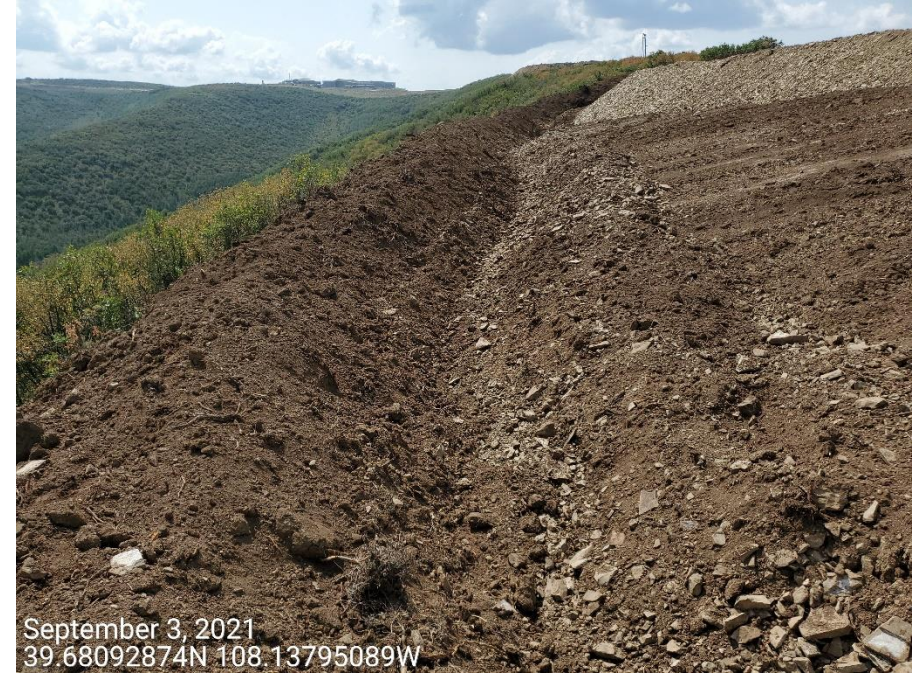
**Photo 8:** BMPs to stabilize slopes missing/insufficient. Photos taken from the eastern areas of the Location. Photos provide an example where Operator appears to be in the process of implementing the topsoil stockpiles along the perimeter of the Location, as a part of their perimeter stormwater BMPs; Operator has been previously notified verbally, and in other FIRs that the utilization of topsoil as stormwater control measures does not comport with Rule 1002.b and 1002.c, as the use of topsoil as a stormwater BMP puts the resource at risk of compaction, contamination due to mixing with sediment/subsoil, and places the resource at risk for loss due to stormwater discharge displacing the topsoil; perimeter stormwater and erosion control BMPs currently missing or insufficient to properly manage runoff from the large disturbance area. Photos also provide example showing BMPs to protect and stabilize the stockpiled soils and fill slopes are missing or insufficient.
