Inspection Photos
Location Name: Ehrlich 23-14
Location ID: 328417

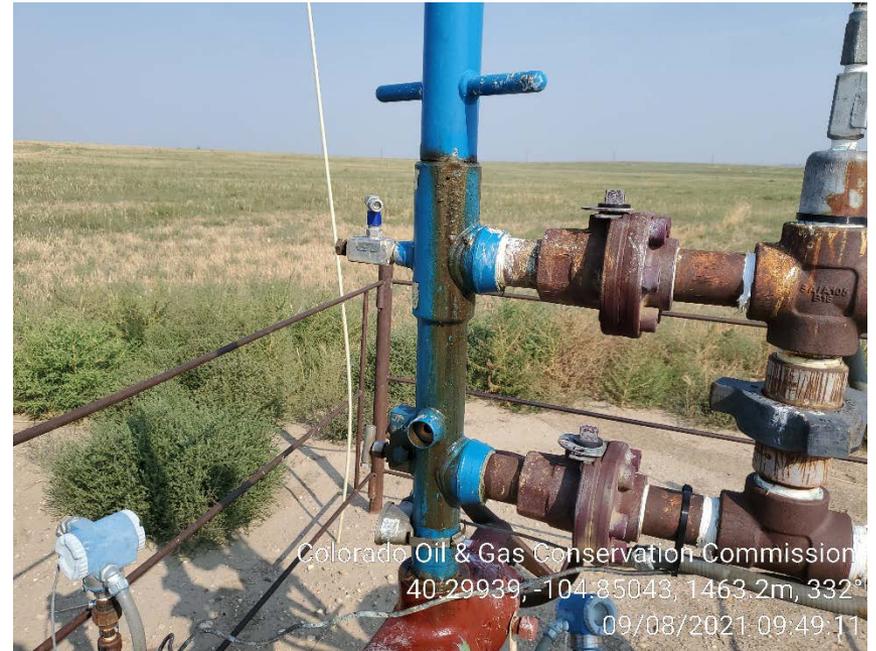
Lubricator leak
