Inspection Photos

9/09/2021

Operator: LARAMIE ENERGY LLC # 10433

Location ID: 335889

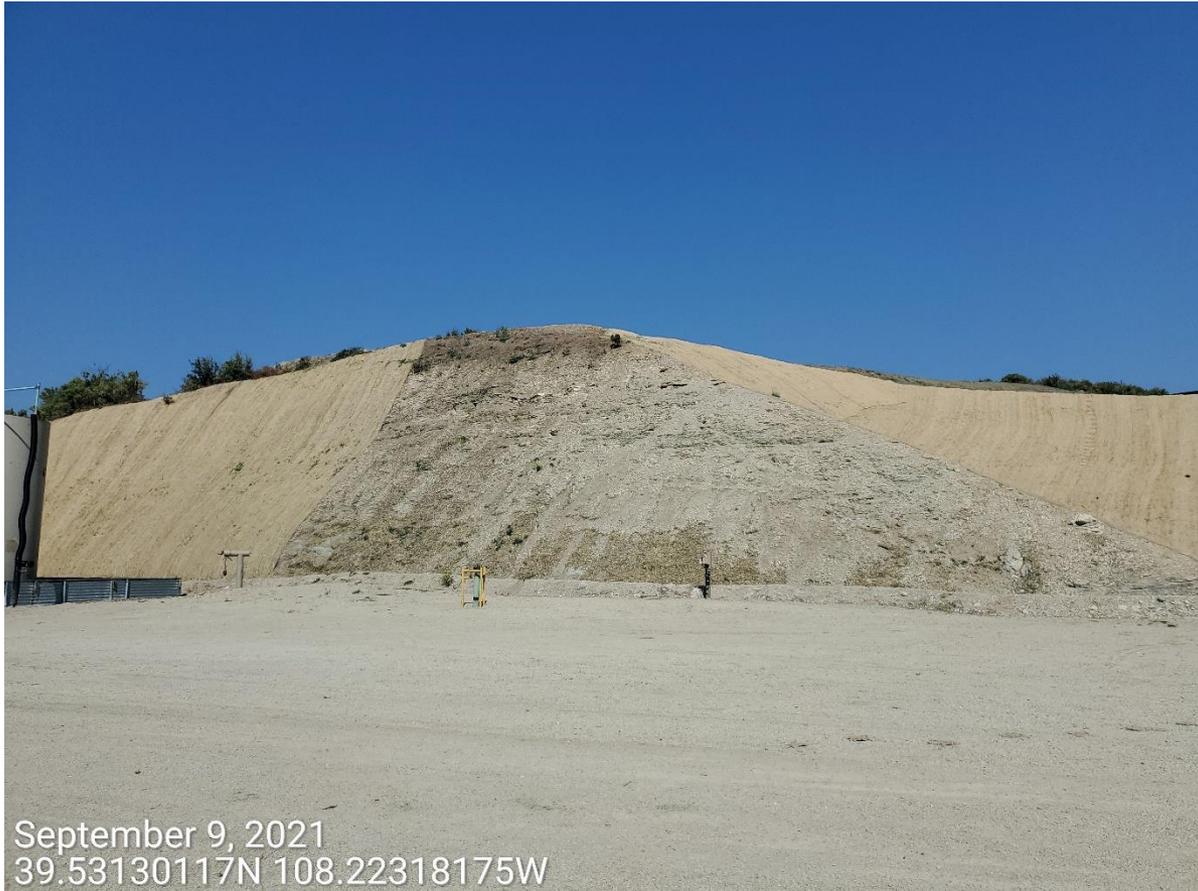
Photo 1: Photo taken from the Location, facing north. Photo shows large areas where BMPs to protect and stabilize the cut slope remains missing or insufficient.

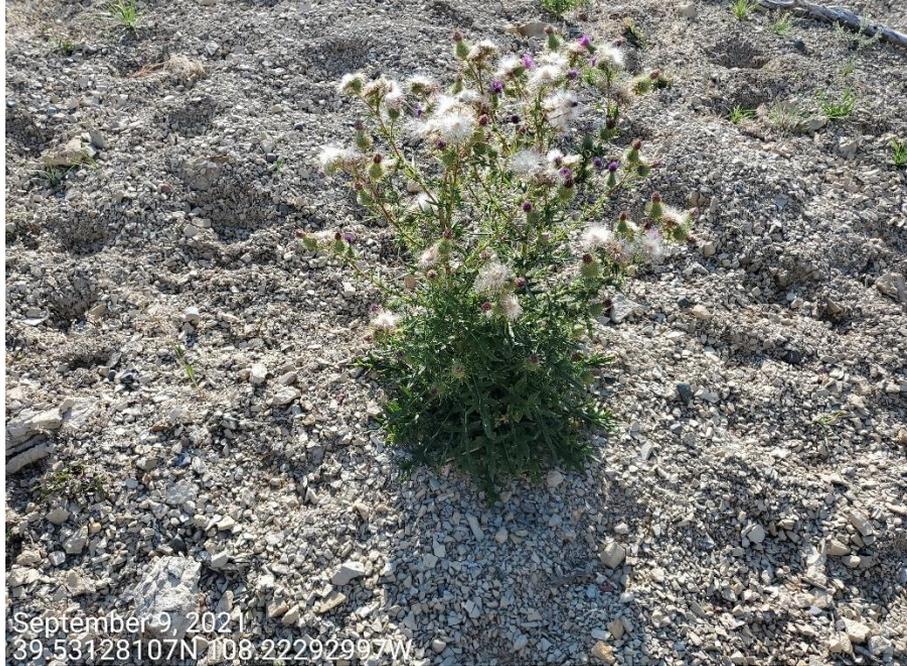
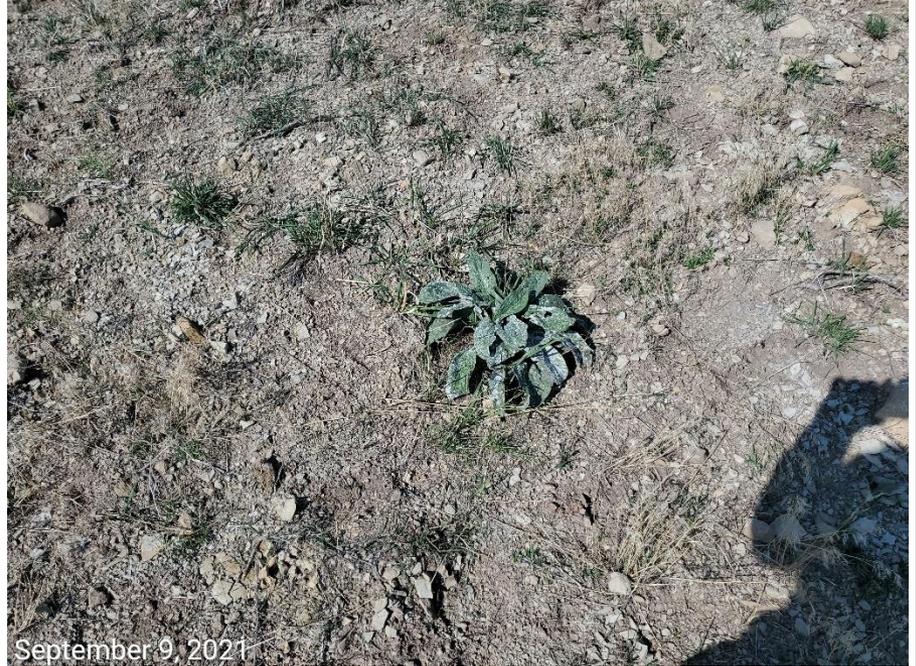
Photo 2: Photos provide example of noxious weeds (Bull thistle, Houndstongue) observed on the interim areas of the Location. It is noted that the Bull thistle (photo left) has reached maturity with seeds dispersing.

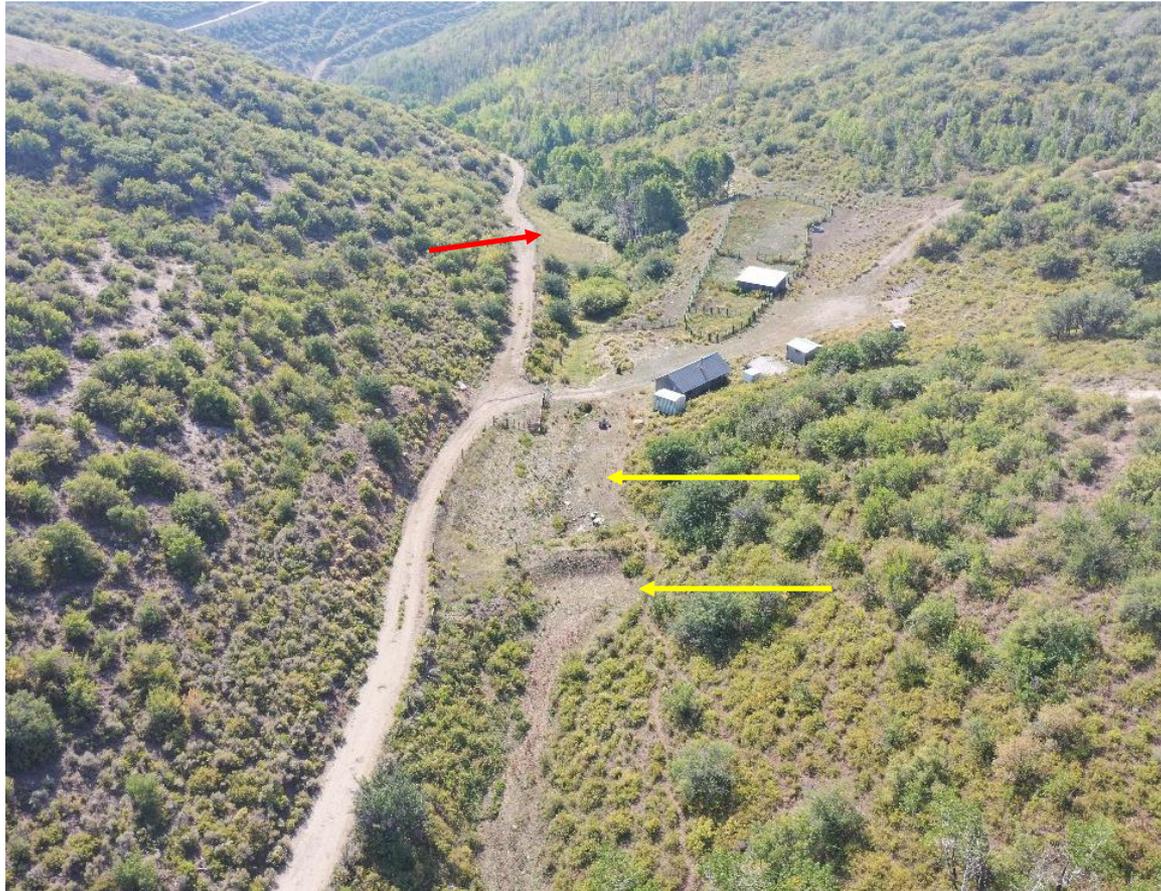
Photo 3: Aerial photo of the drainage, and Remediation Project area. Yellow arrows show disturbed areas around the “N. Trench” within Operator’s Remedial Action Workplan. Red arrow shows the area of the “S1/S2 Trench”. Upon closure of the Remediation Project, reclamation will need to be performed; Location will be required to meet 1004 reclamation standards.

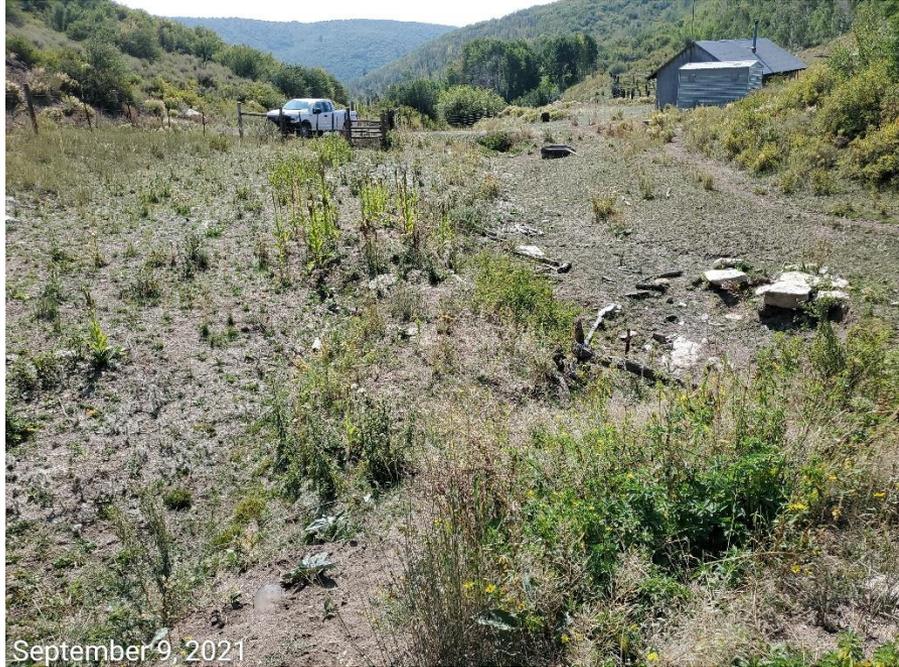
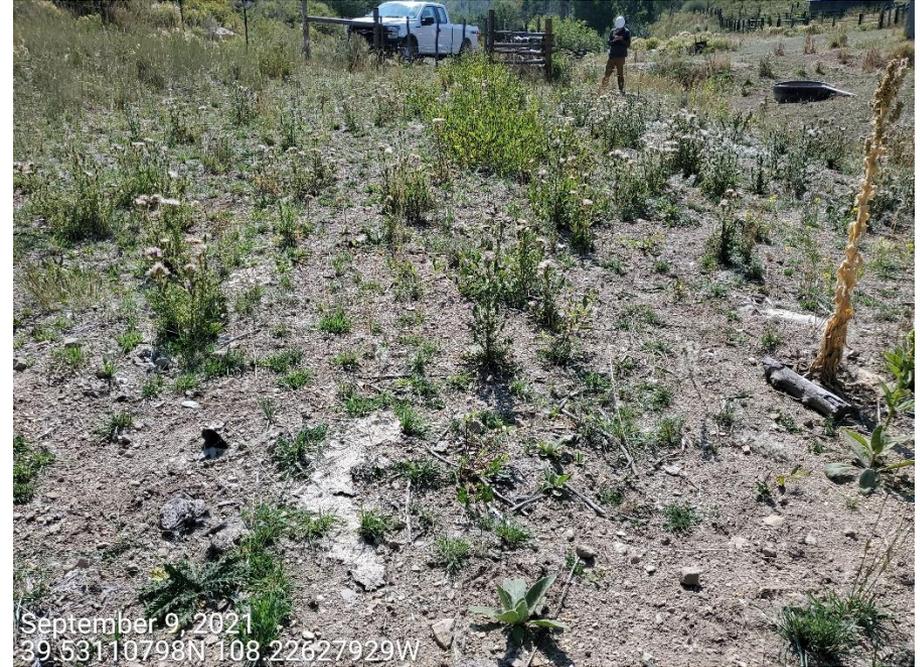
Photo 4: Photos taken from the areas identified as the “N Trench” within Operator’s Remedial Action Workplan. Photos provide examples of disturbed areas associated with the remediation project, where Noxious weed were observed in high densities. Noxious weeds observed include: Canada thistle, Musk thistle, Bull thistle, Common Mullein and Houndstongue. Weed management required throughout the entire Remediation Project’s disturbance area.

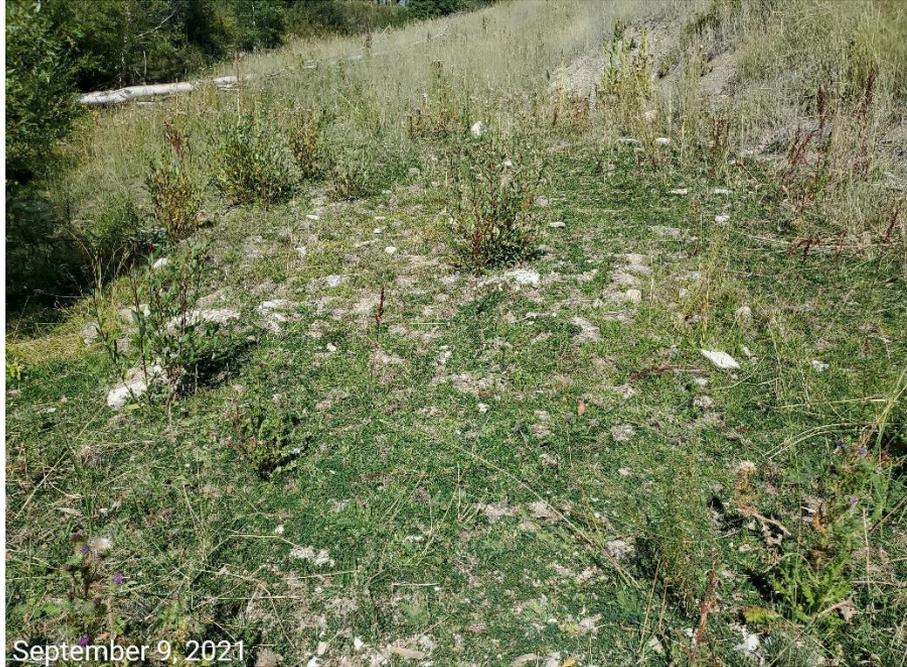
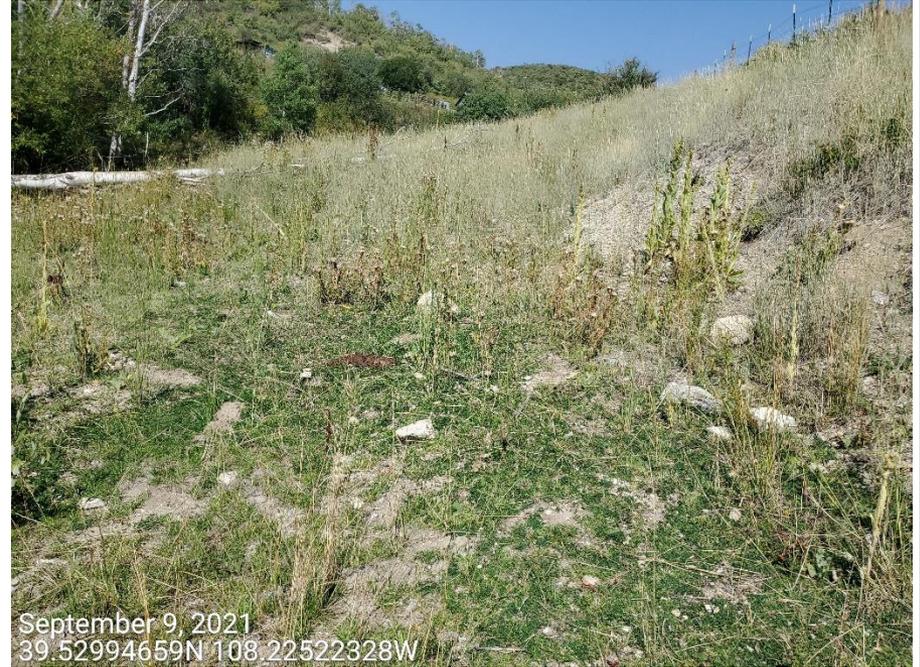
Photo 5: Photos taken from the areas identified as the “S1/S2 Trench” within Operator’s Remedial Action Workplan. Photos provide examples of disturbed areas associated with the remediation project, where Noxious weed were observed in high densities. Noxious weeds observed include: Canada thistle, Musk thistle, Bull thistle, Common Mullein and Houndstongue. Weed management required throughout the entire Remediation Project’s disturbance area.

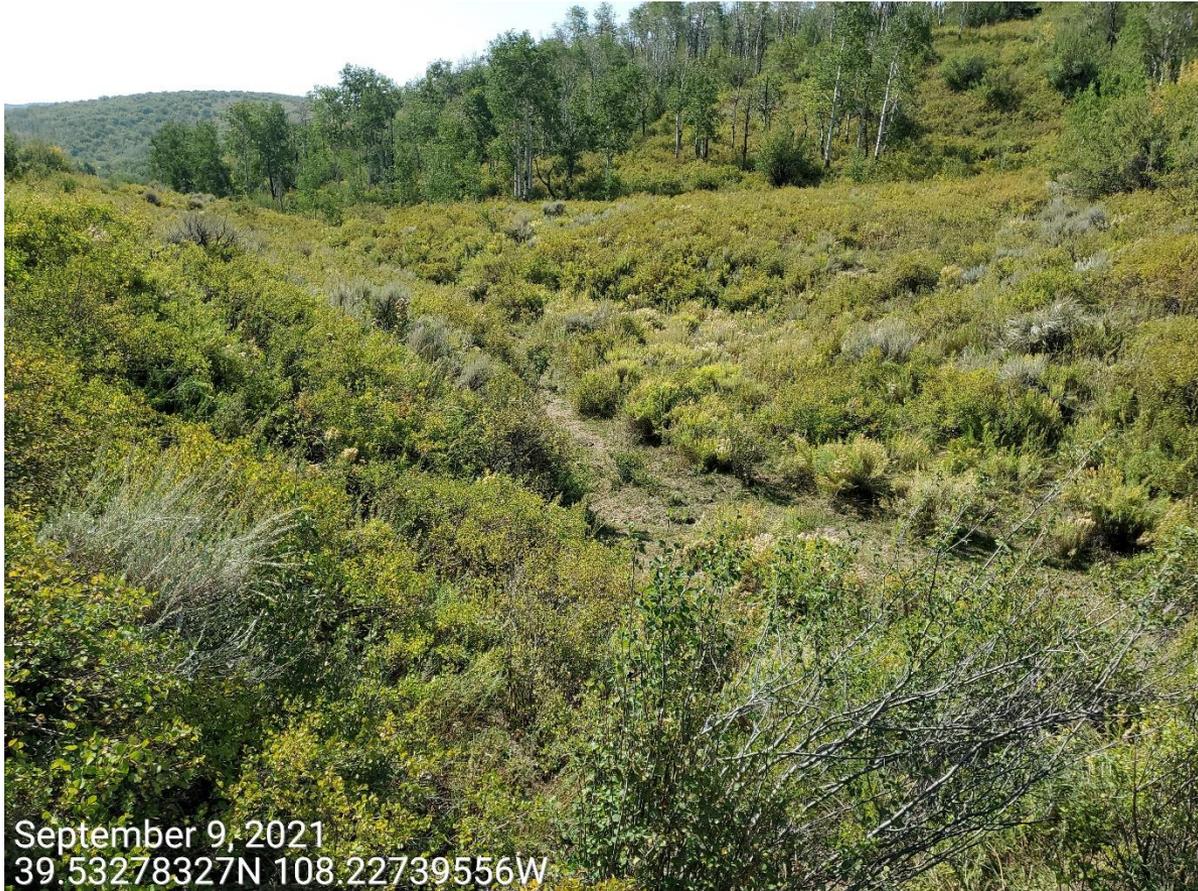
Photo 6: Photo taken from a reference point, upstream from the remediation project. Photo provides example of reference vegetation; upon closure of the Remediation Project, additional reclamation will need to be performed ; Location will be required to meet 1004 reclamation standards. It is also noted that noxious weed establishment and densities were low, or not observed upstream from the project's disturbance area.
