Inspection Photos
Operator: Petrox
API: 007-06213
Date: 9/13/2021

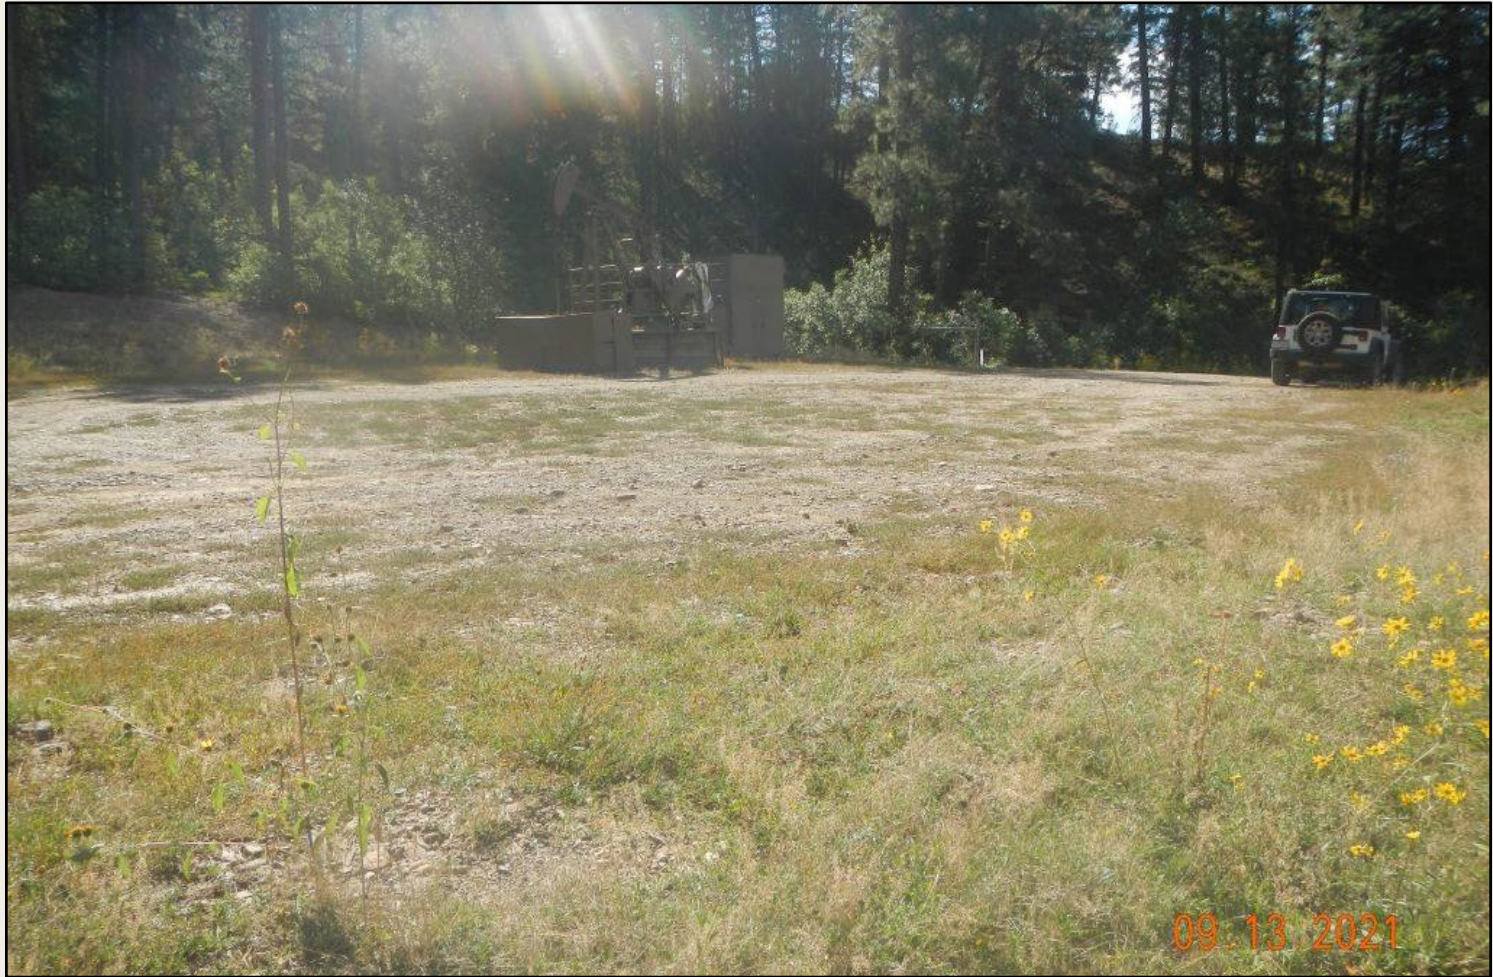
Photo 1. View of the project area from the northwestern corner facing center.

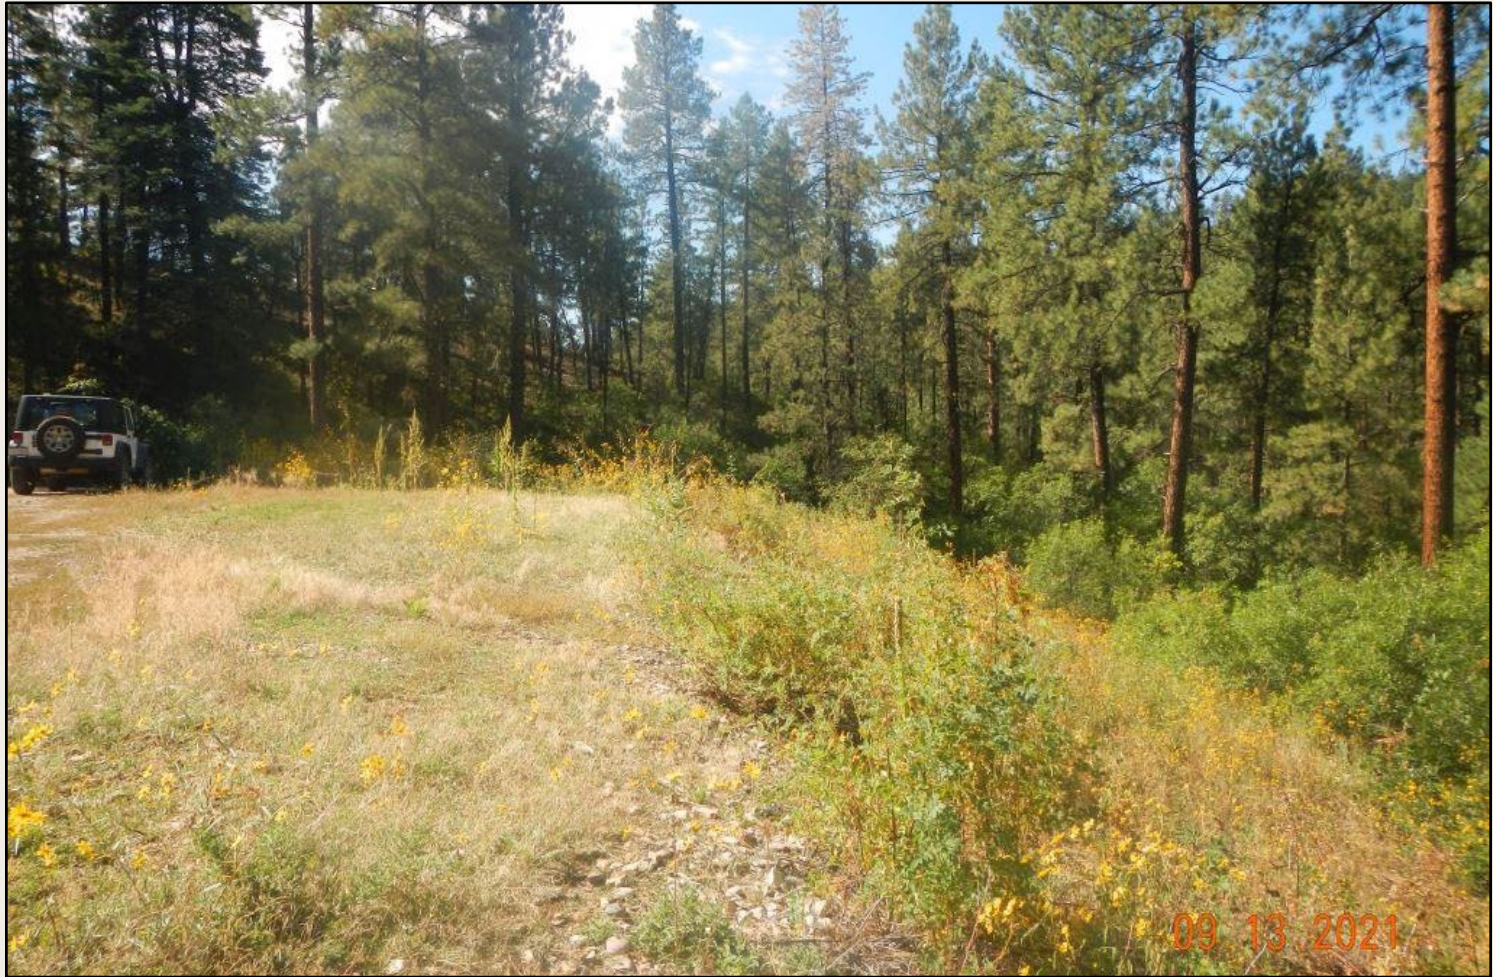
Photo 2. View of the western project area from the northwestern corner facing southward. Revegetation is progressing with western wheatgrass, gambel oak, Woods rose, and mugwort.

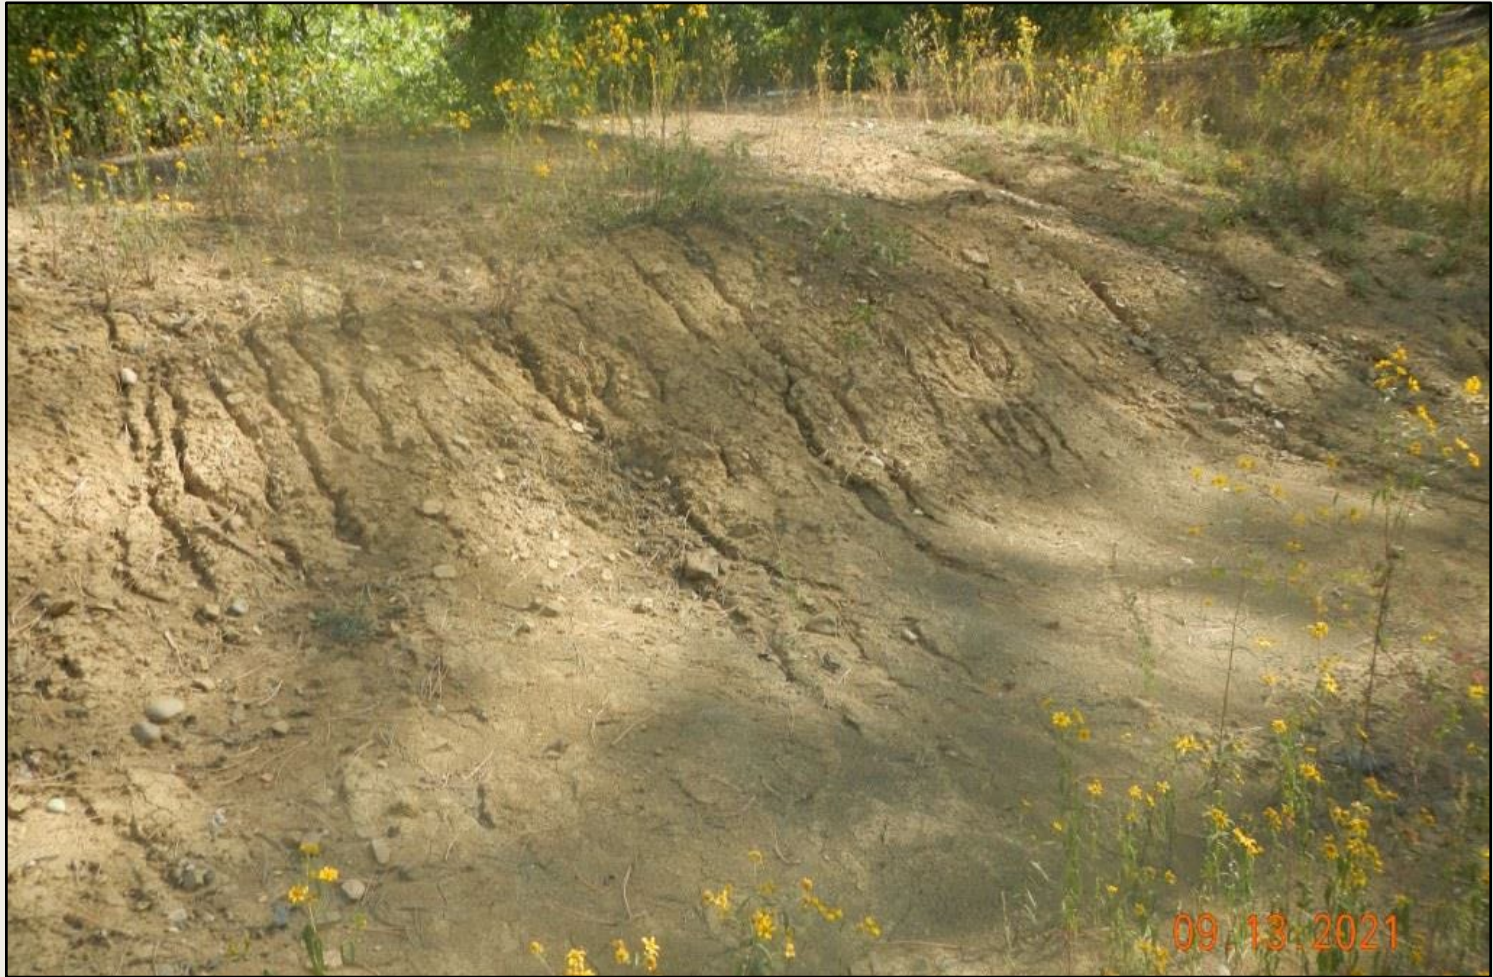
Photo 3. View of rilling erosion occurring within the northern cut-slope.

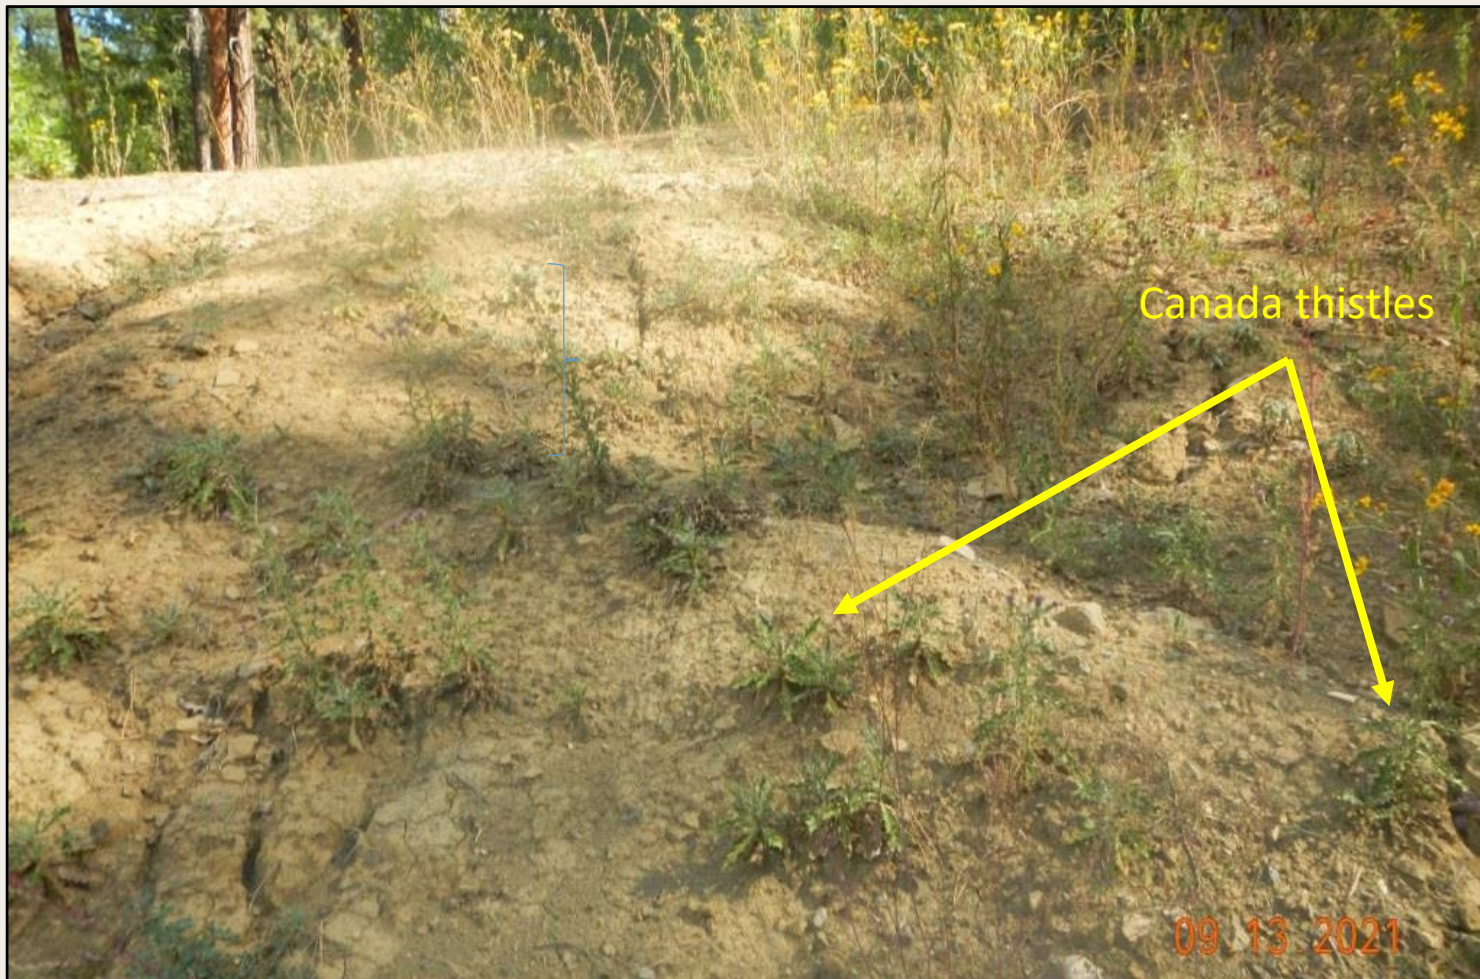
Photo 4. View of Canada thistles (approx. 75) on the northern cut-slope.
