Inspection Photos

Location Name: Cascade Creek 697-09-61 Pad & adjacent drainage

Location ID: #335889 & Remediation Project #4620

Inspection Date: September 9, 2021

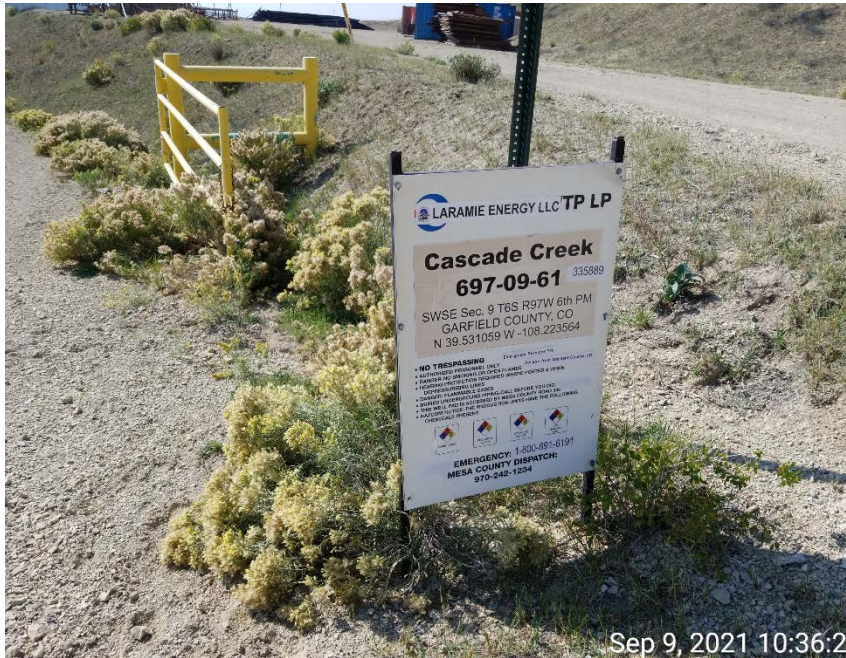
Photo #1 – Sign at pad entrance.

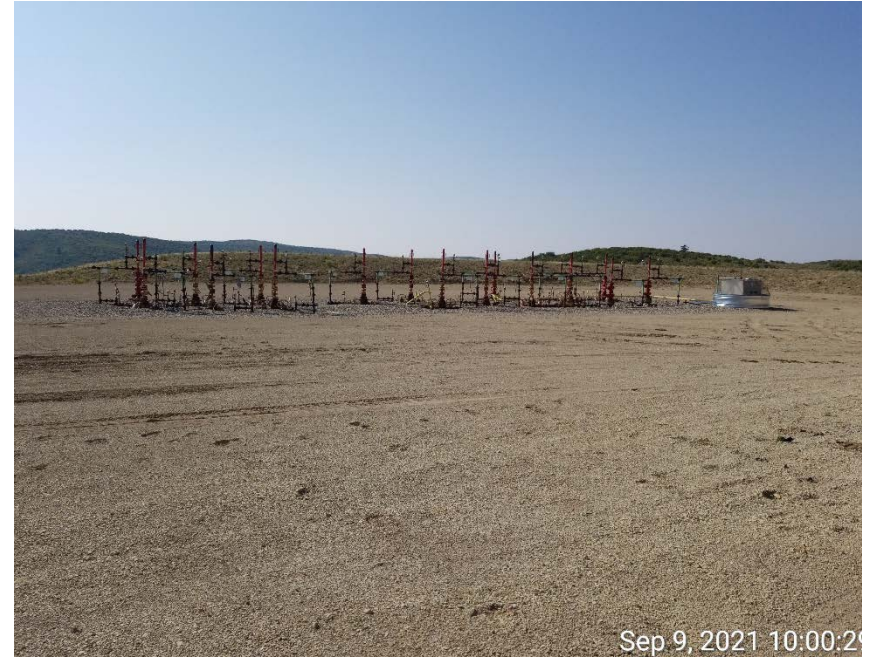
Photo #2 – View of wellheads from north.

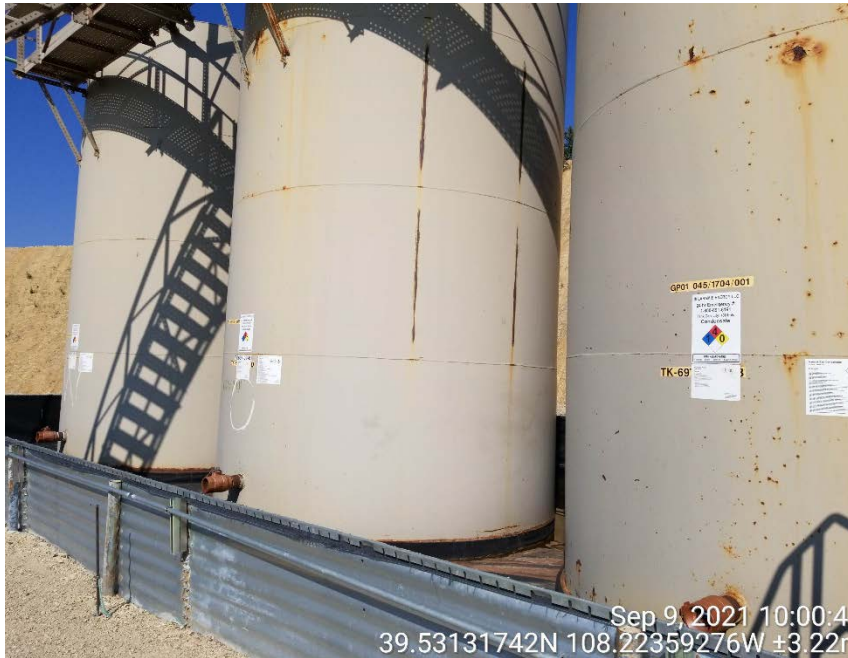
Photo #3 – Overview of tank battery from south.

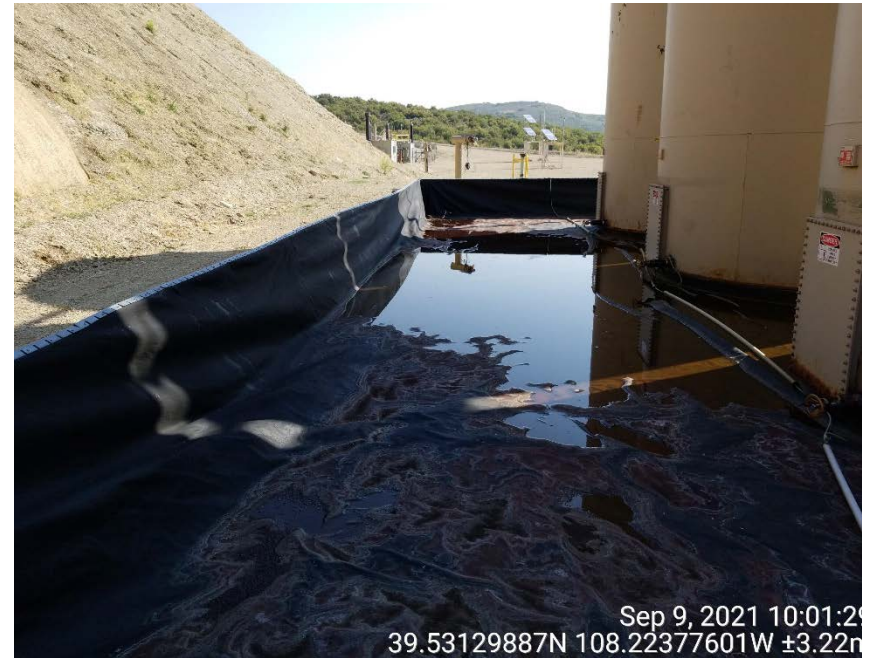
Photo #4 – North side of tank battery secondary containment contained water on inspection date.

No hydrocarbon sheens, stains, or odor were observed in this area on inspection date.

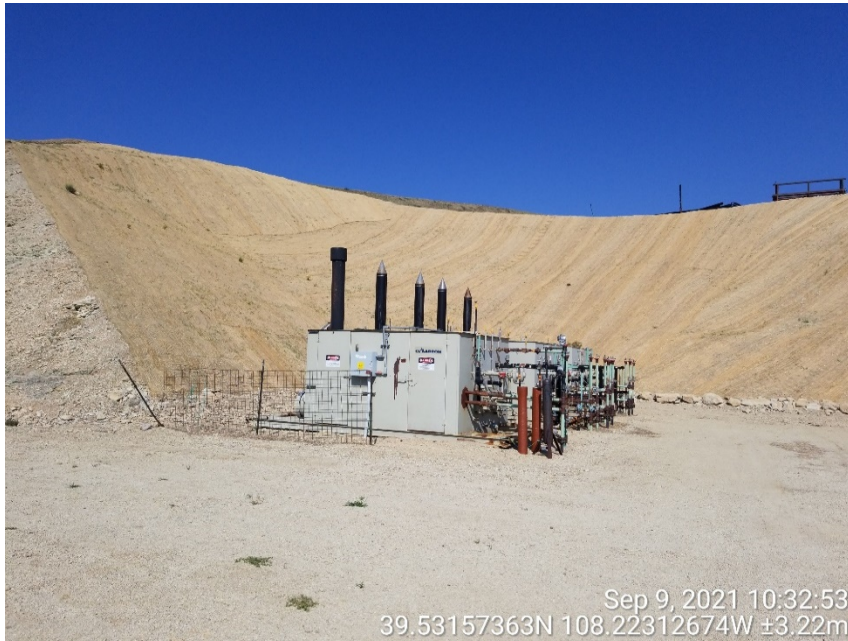
Photo #5 – West bank of separators.

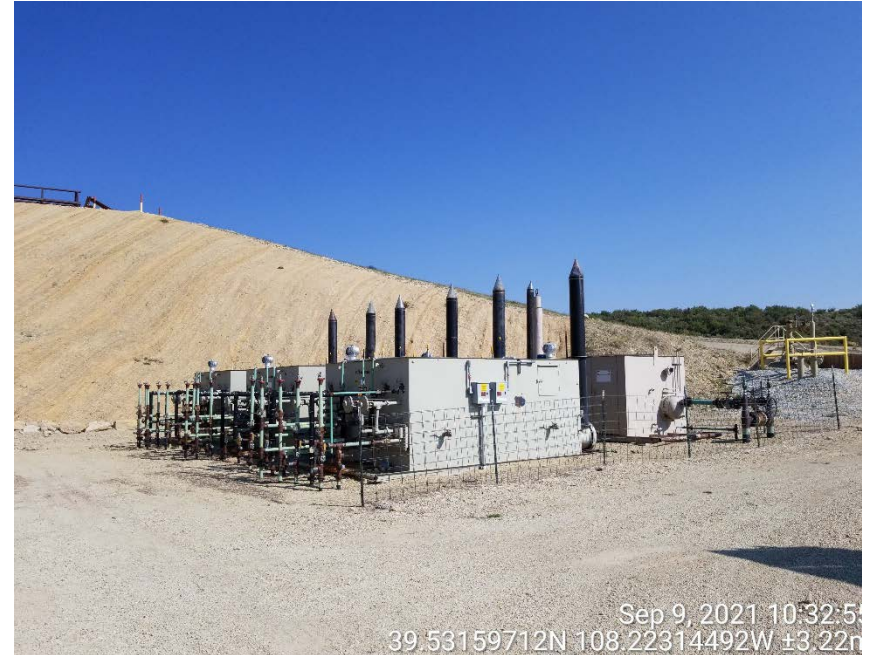
Photo #6 – East bank of separators.

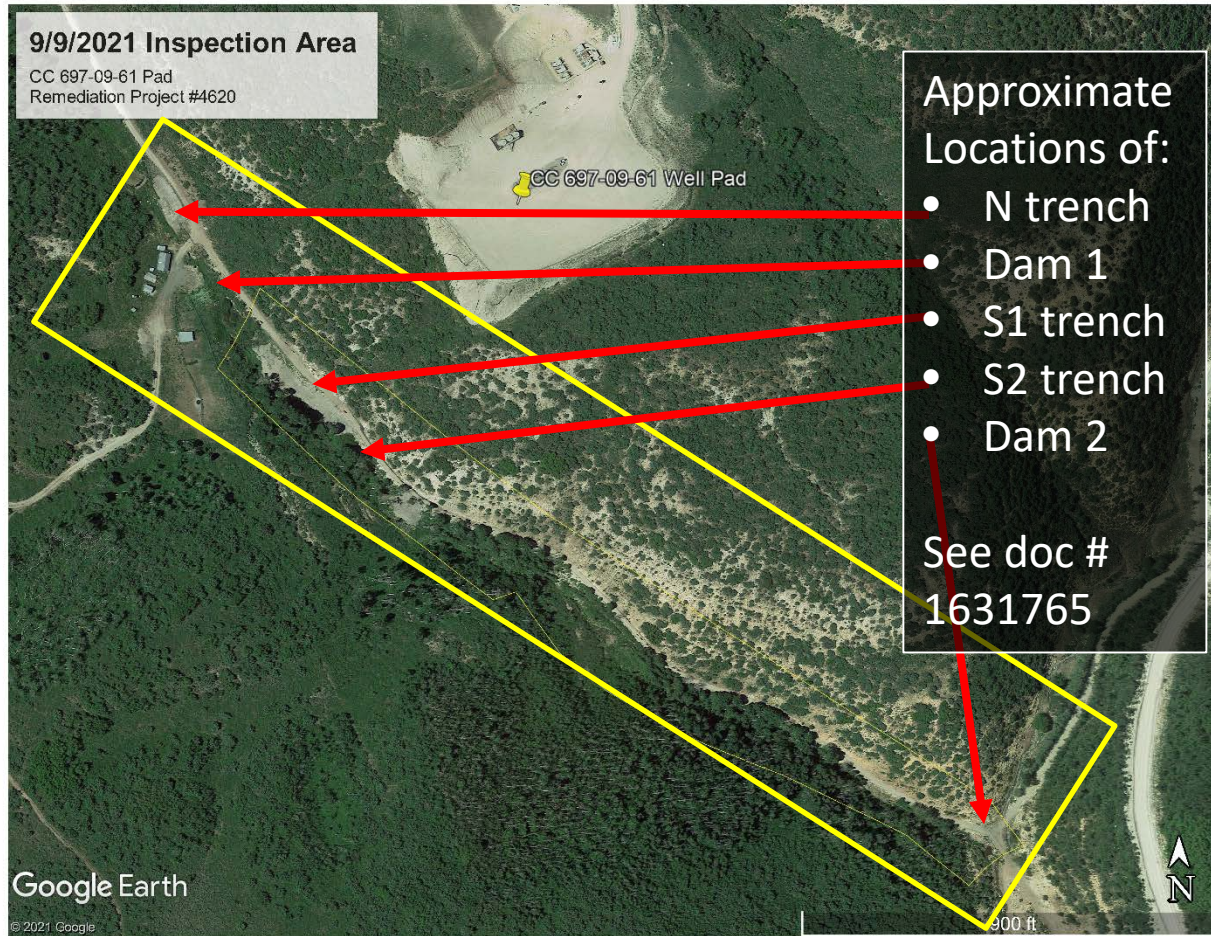
Photo #7 – Overview of adjacent drainage inspection/historical remediation area.

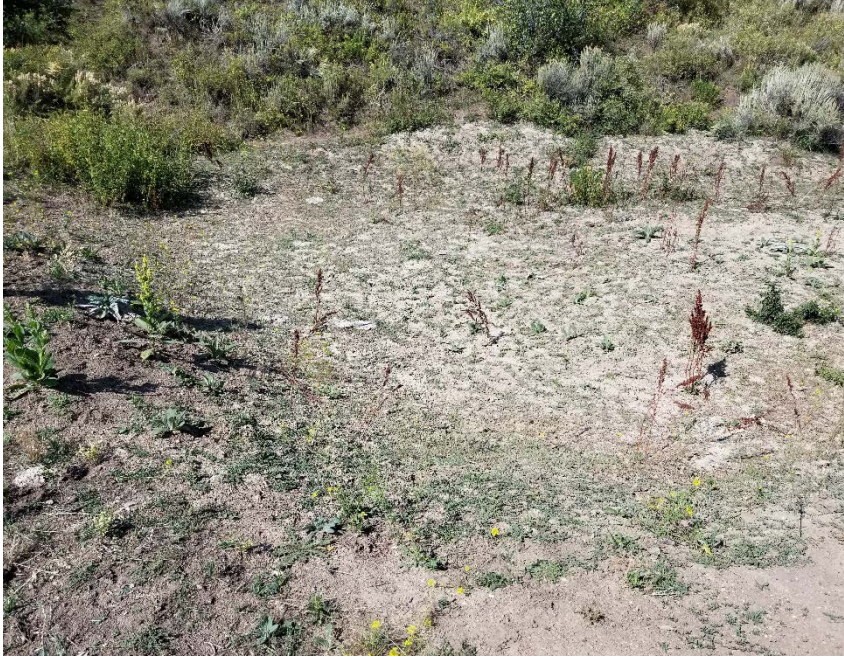
Photo #8 – Stock pond north of remediation area.

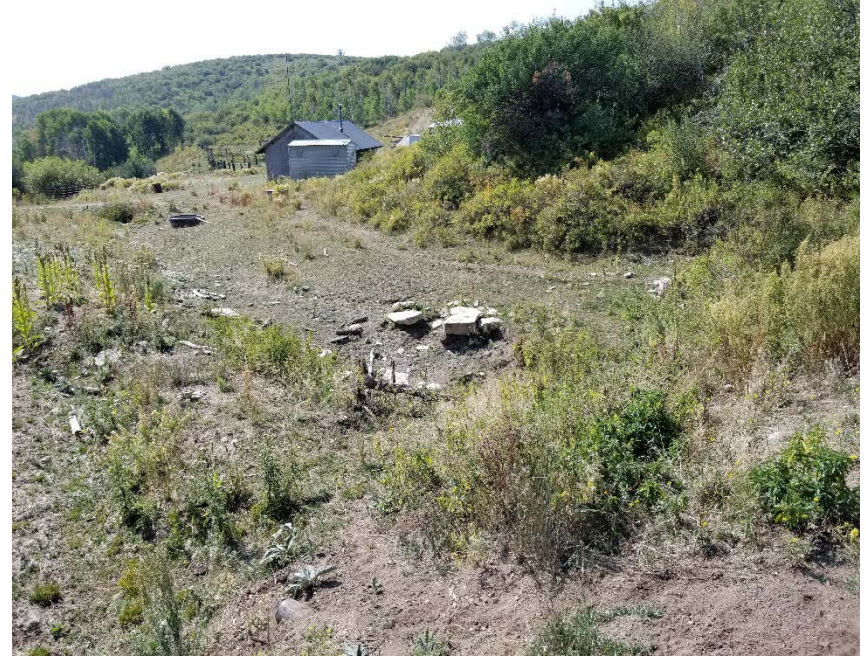
Photo #9 – View of north end of historical remediation area (N trench and Dam 1), looking south.

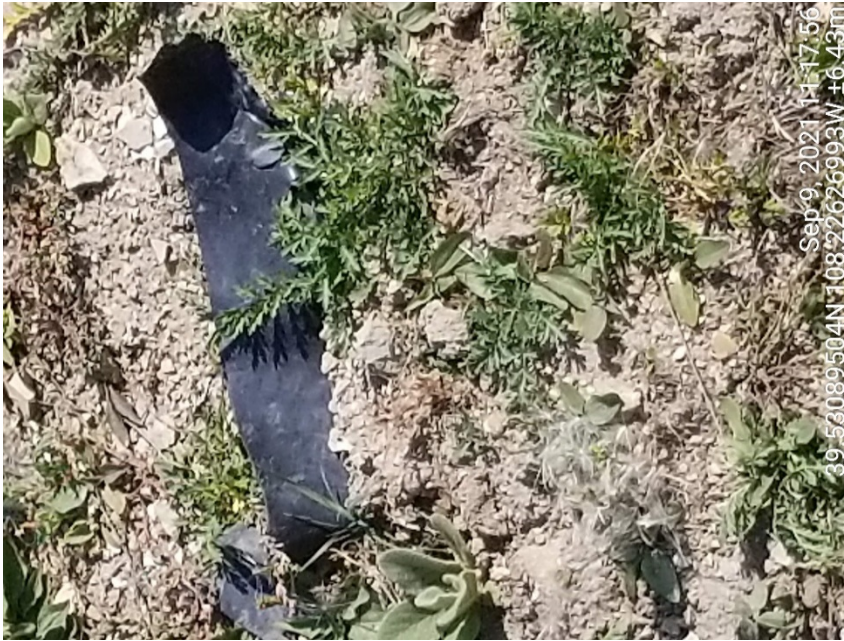
Photo #10 – Liner piece observed in remediation area (N trench).

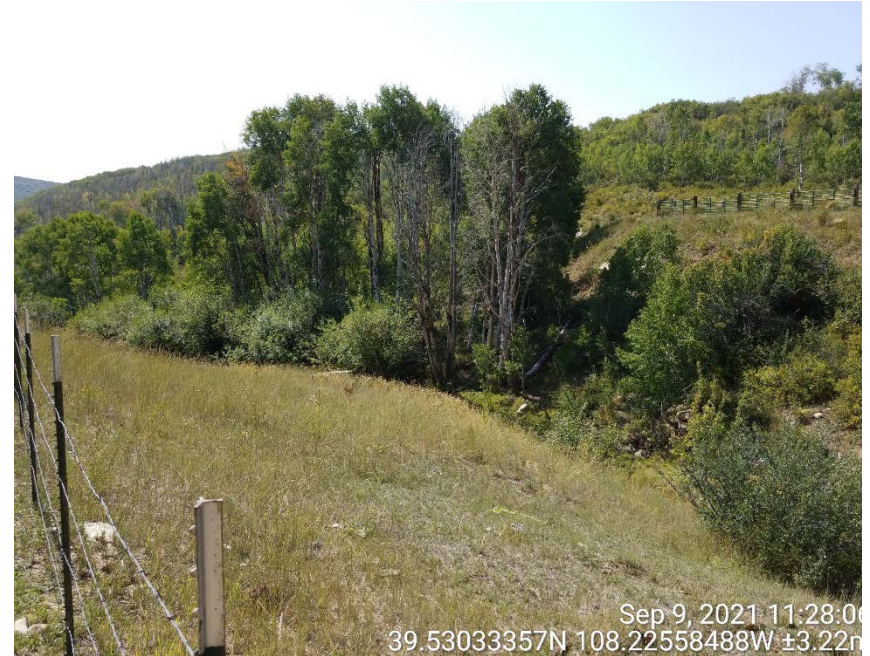
Photo #11 – Overview of remediation area (S1 and S2 trenches).

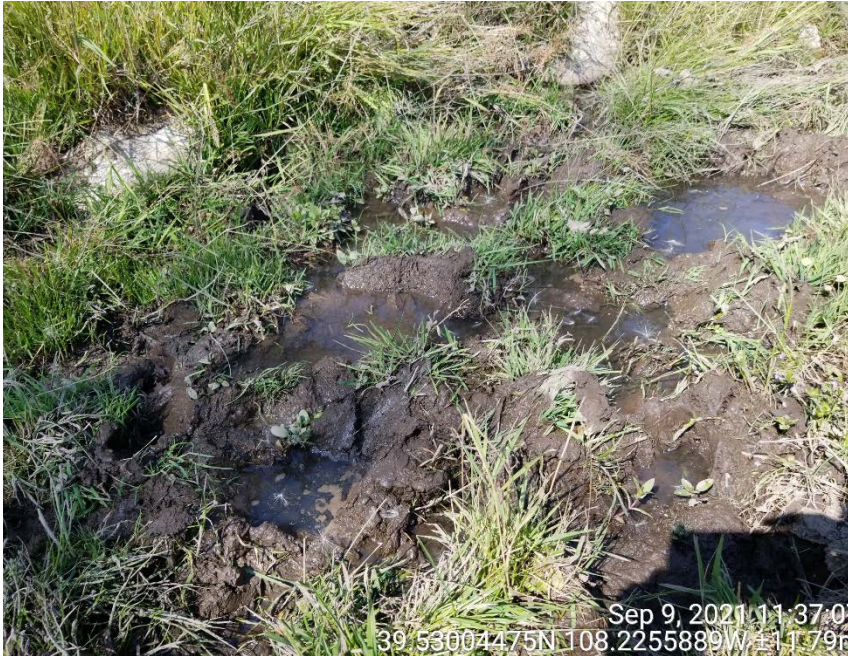
Photo #12 – Spring located in drainage.

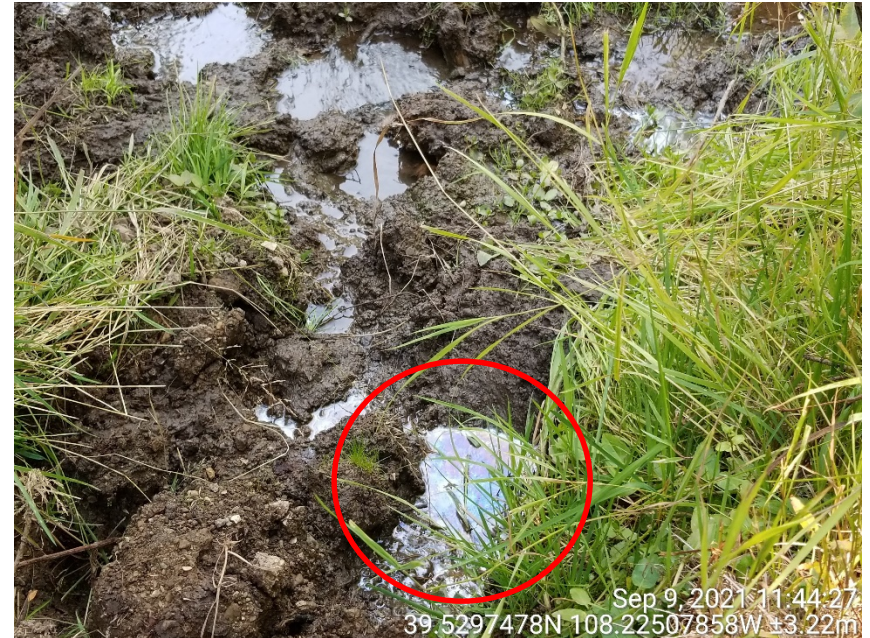
Photo #13 – Spring located west of former S2 trench. Red circle documents location where platy, rainbow sheen was observed on surface water. No hydrocarbon odors or staining were observed in this location on inspection date.

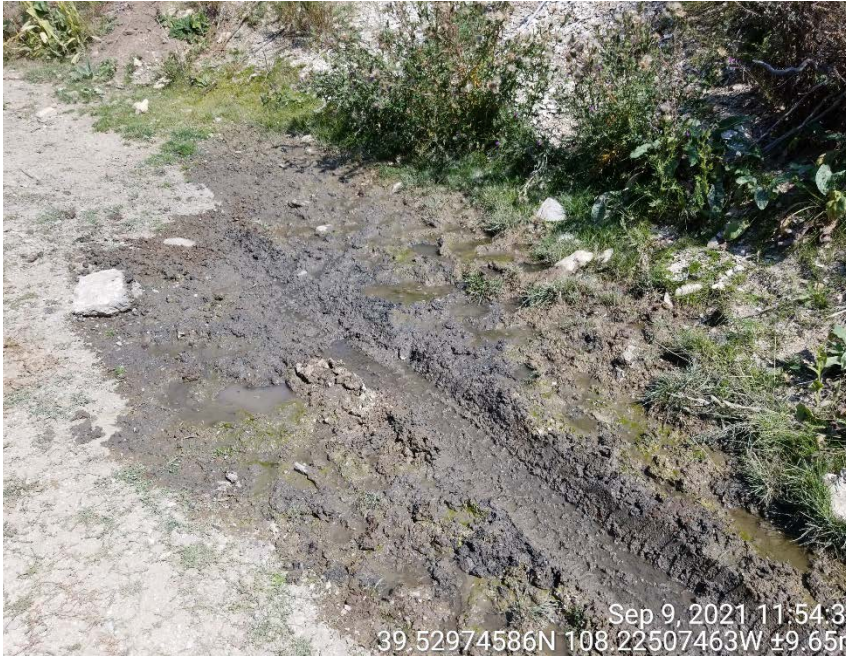
Photo #14 – Road seep.

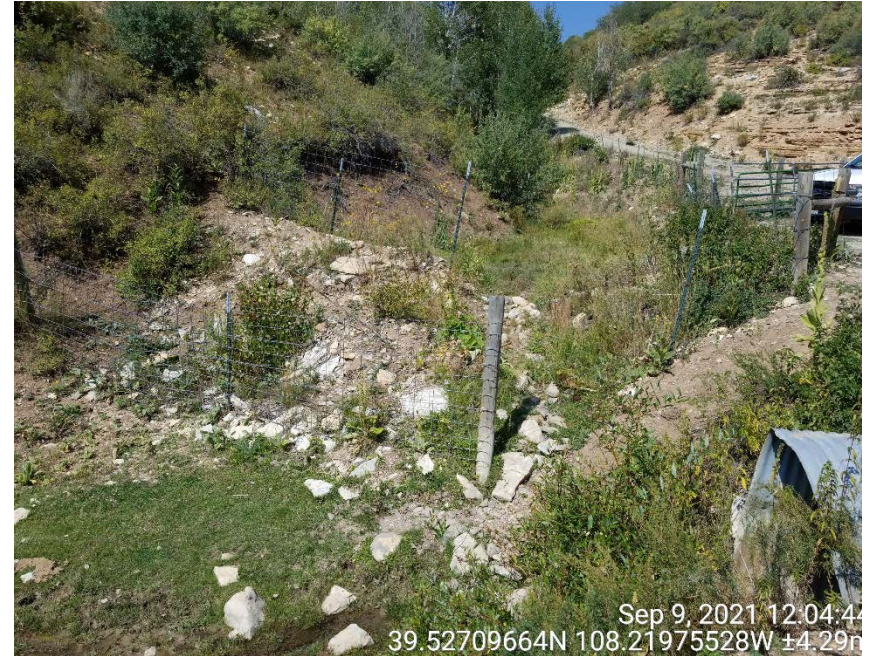
Photo #15 – Southern terminus of remediation area.
Remediation project file indicates that an earthen dam (Dam 2) had been constructed in this location to capture surface water for disposal.
