Inspection Photos  
Operator: Petrox  
Facility: 007-06235  
Date: 9/13/2021

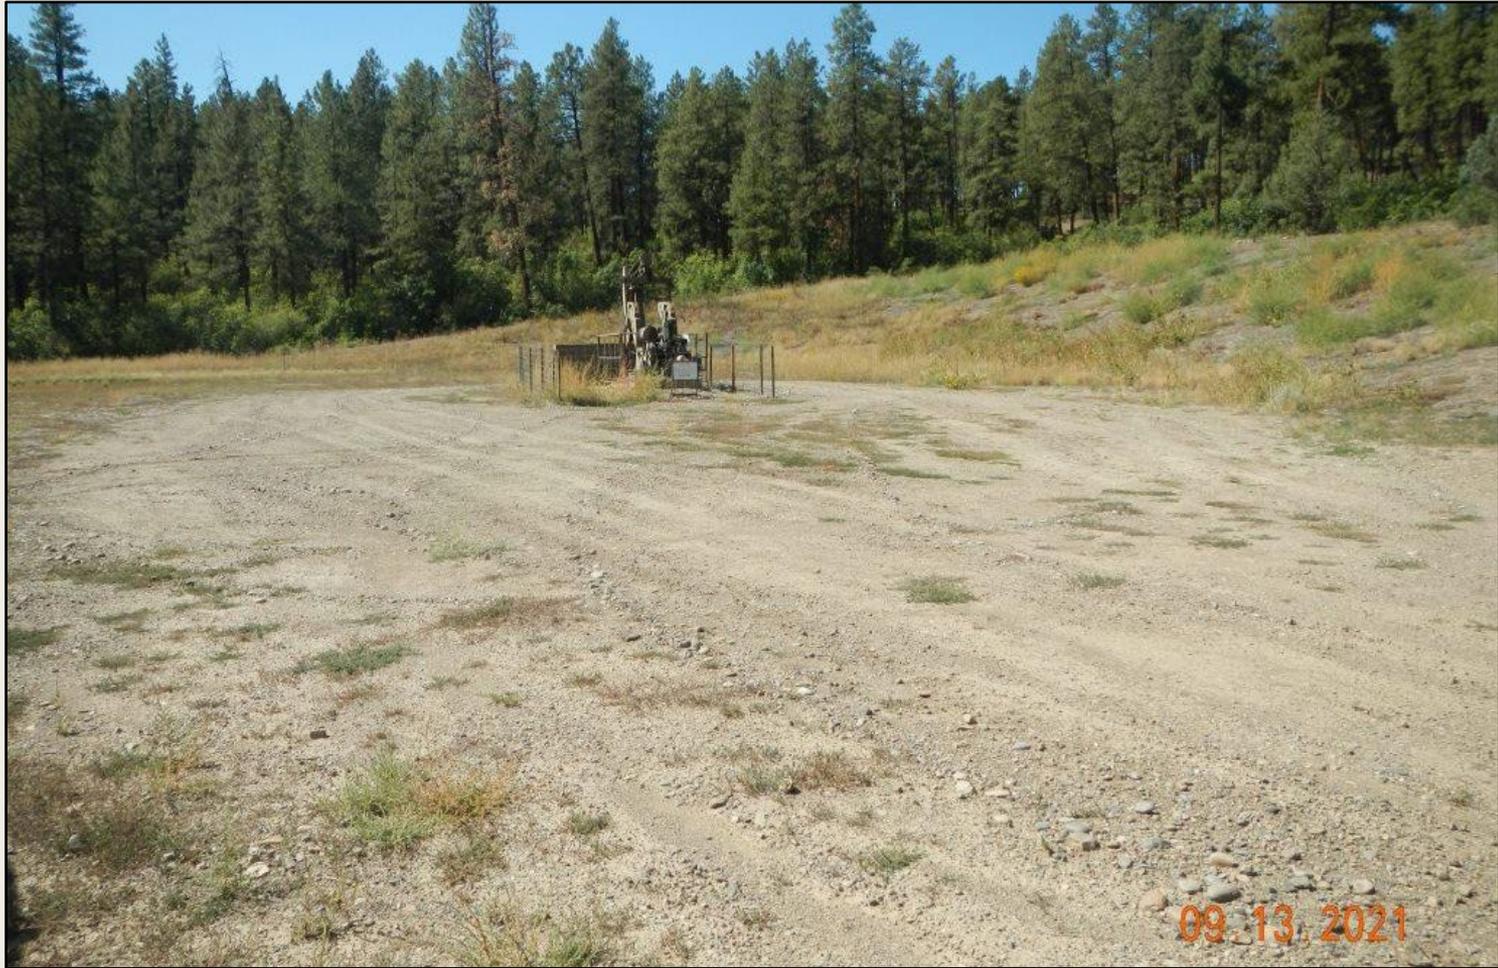
Photo 1. View of the project area from the well pad entrance facing center.

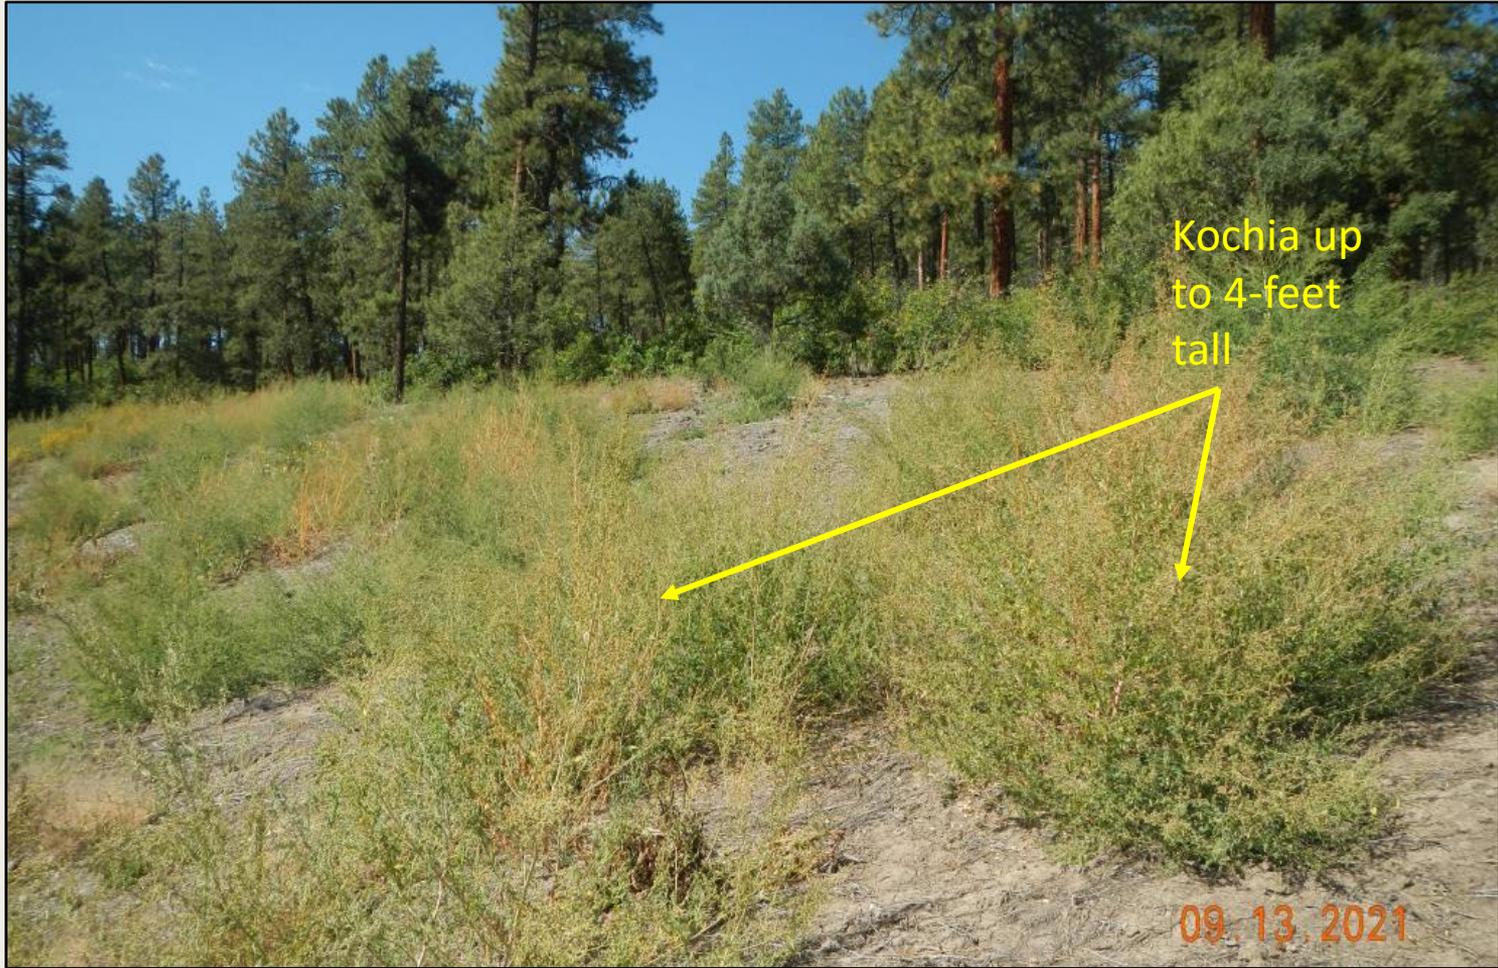
Photo 2. View of kochia growing up to 4-foot tall on the well pad cut-slope. Little desirable vegetation observed here.

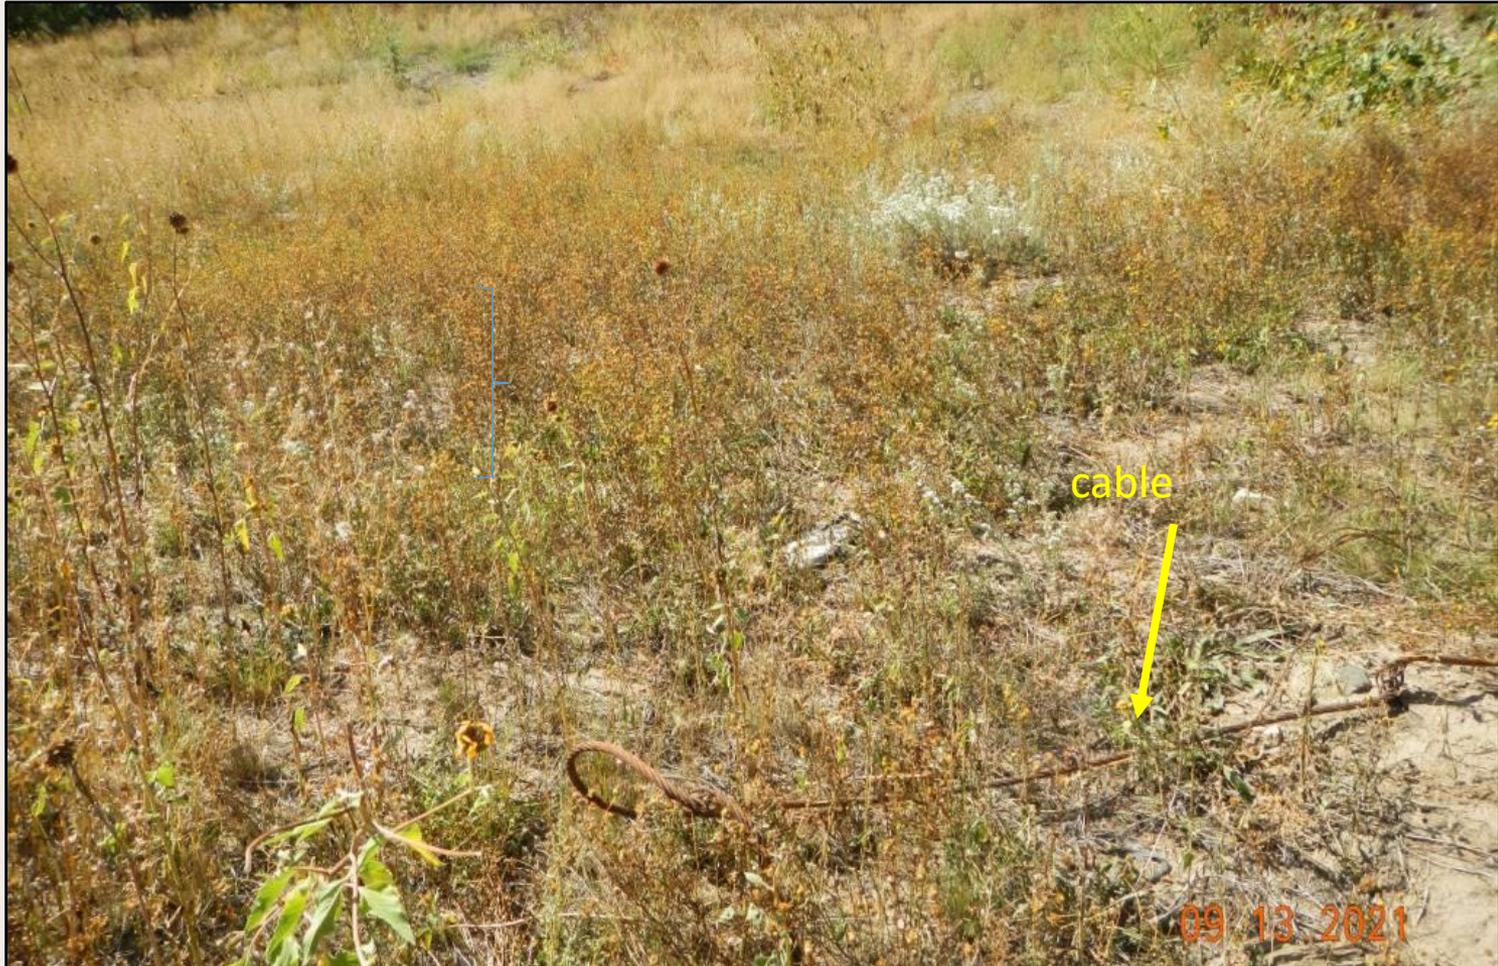
Photo 3. View of cable debris on the well pad.

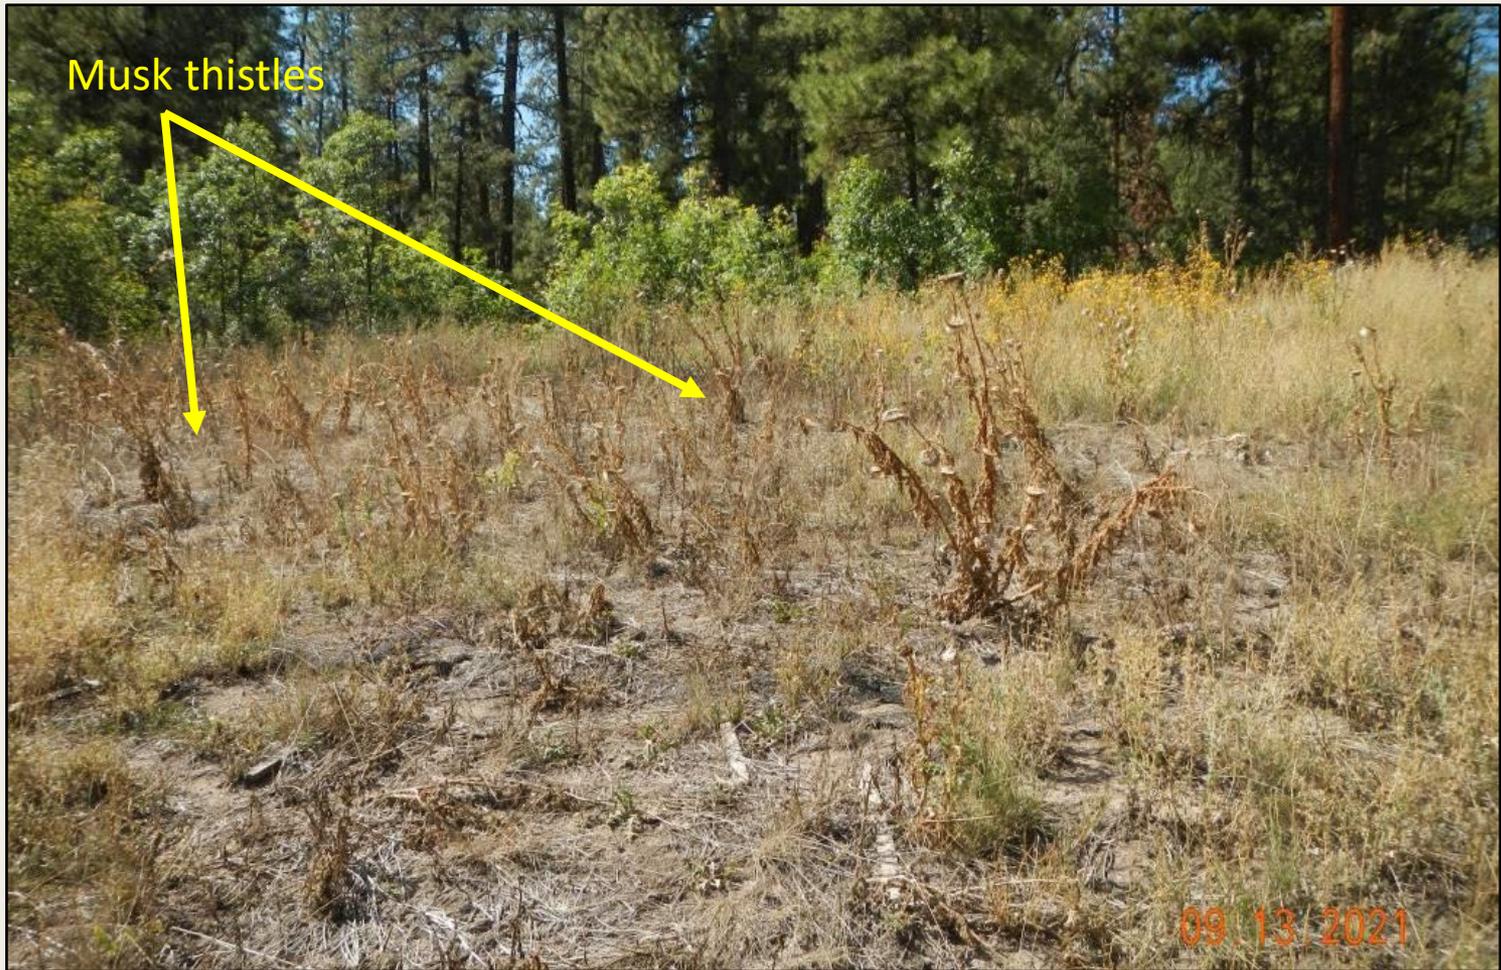
Photo 4. View of musk thistles (approx. 100) observed within the project area, largely in a post-flowering condition and dispersing seed.

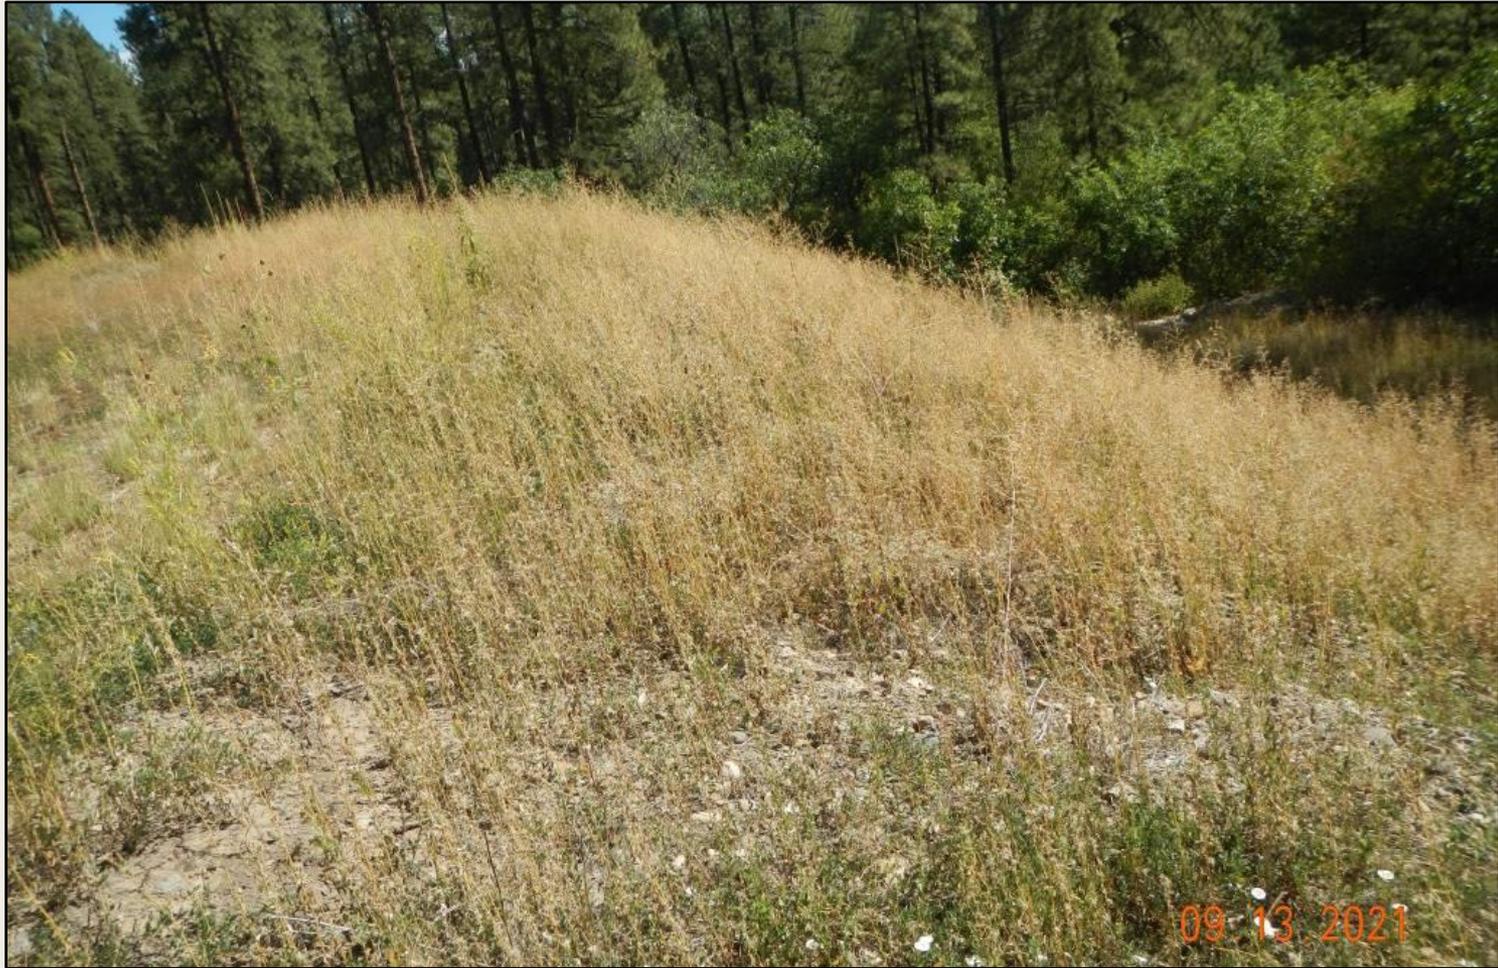
Photo 5. View of the southeastern fill slope from the southeastern corner facing northward. Desirable vegetation not observed. Dense prickly lettuce and field bindweed observable in photo.

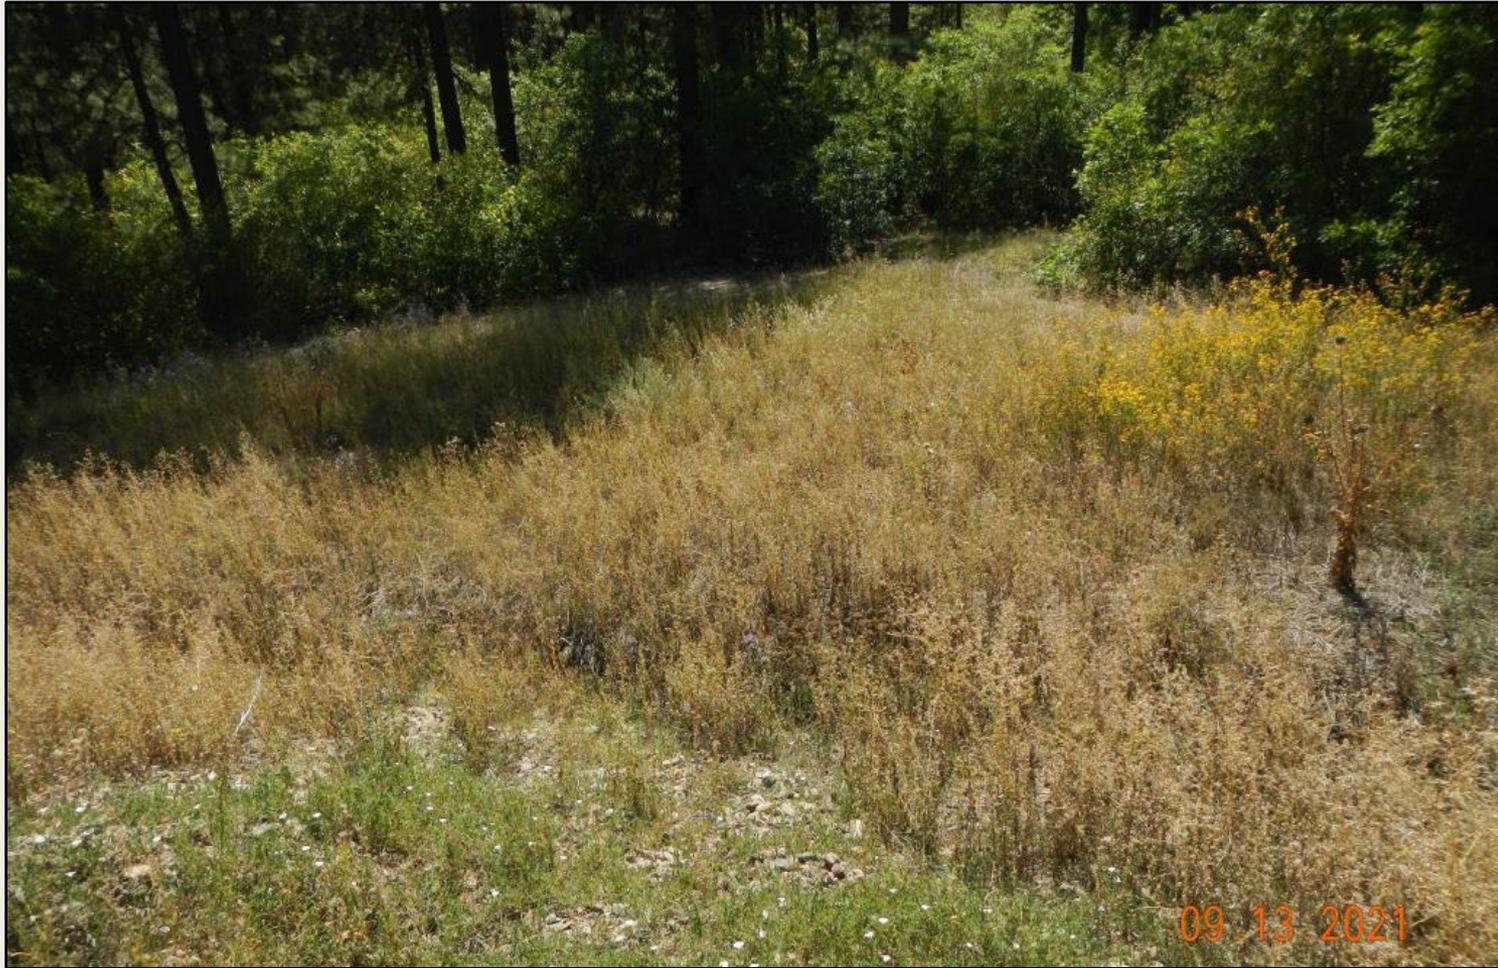
Photo 6. View of the southeastern project area facing southward from the well pad corner. Little to no desirable vegetation observed, as reclamation areas are infested with prickly lettuce and field bindweed.
