Inspection Photos
Location Name: Randall 41-10
Location ID: 319664

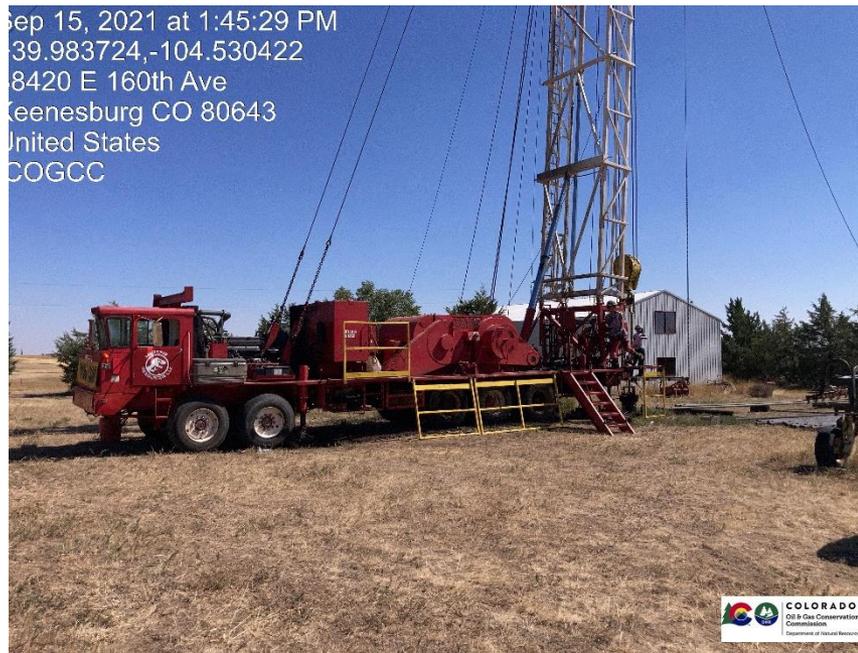
Pic 1 Rig on location

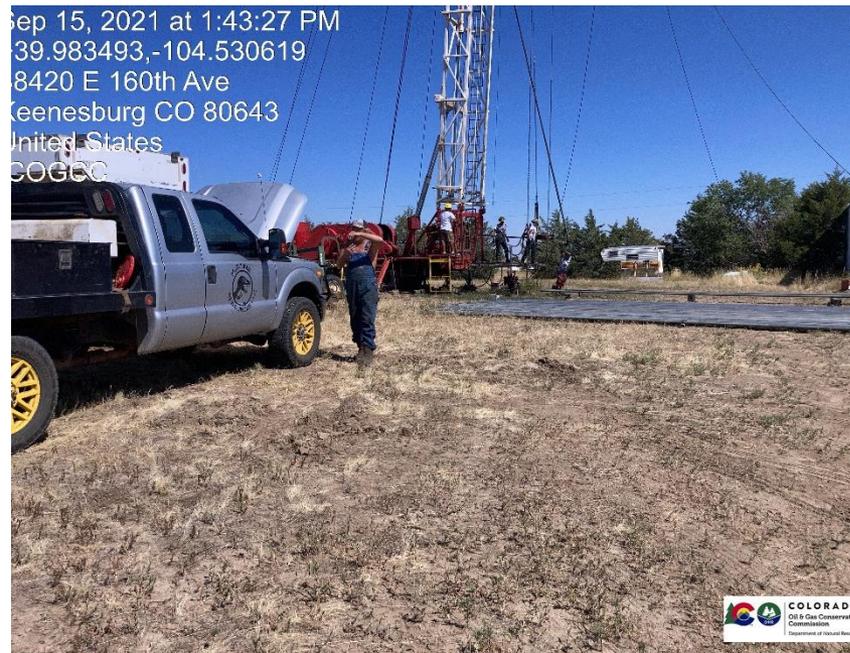
Pic 2 tubing laying on ground

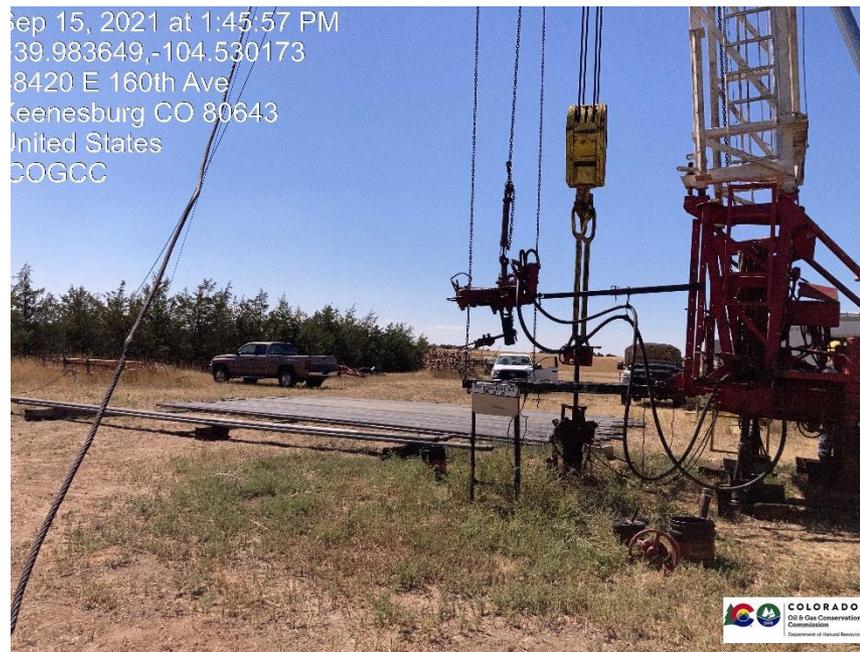
Pic 3 no Blow out preventer installed on wellhead.

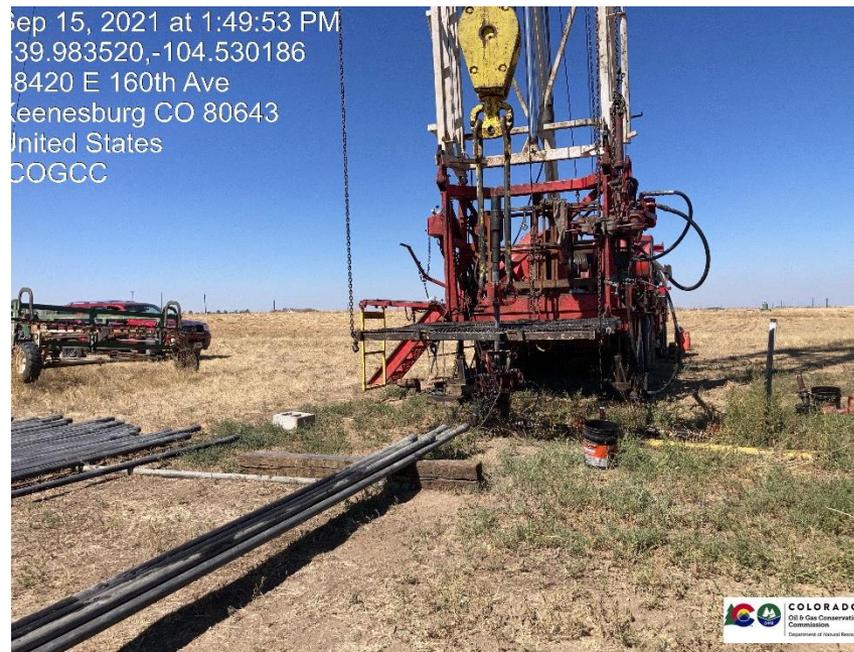
Pic 4 No blow out preventer installed on wellhead

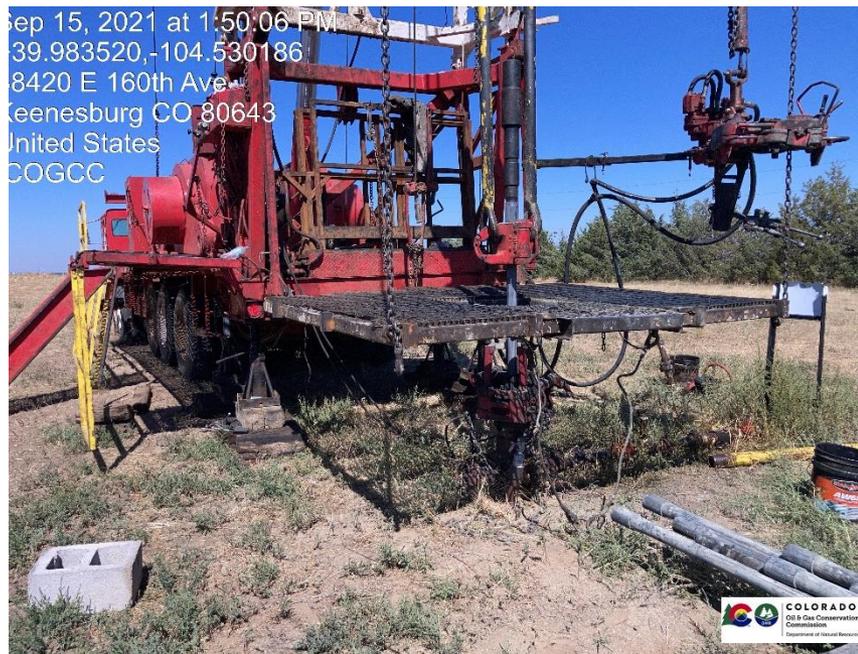
Pic 5 no blow out preventer installed on wellhead

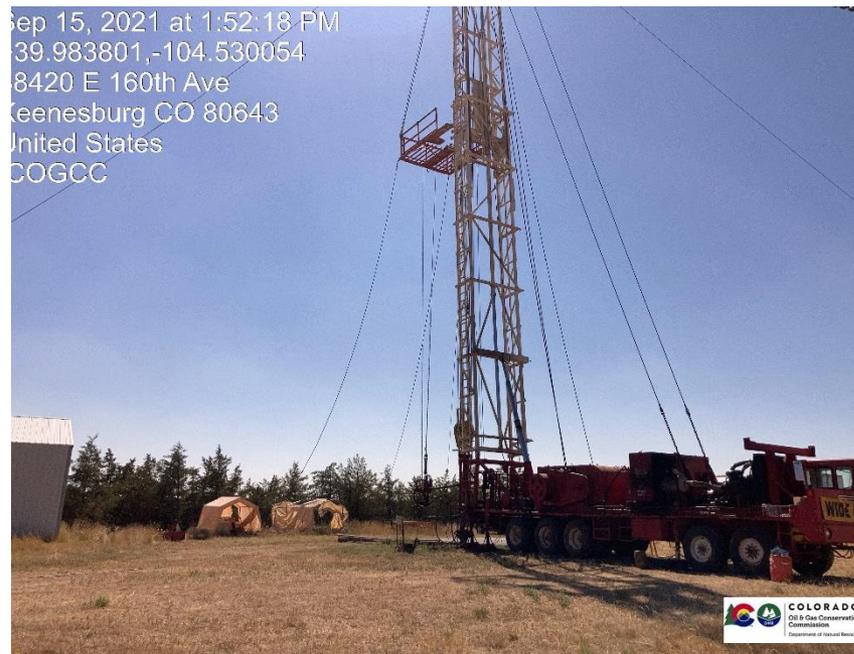
Pic 6 rig

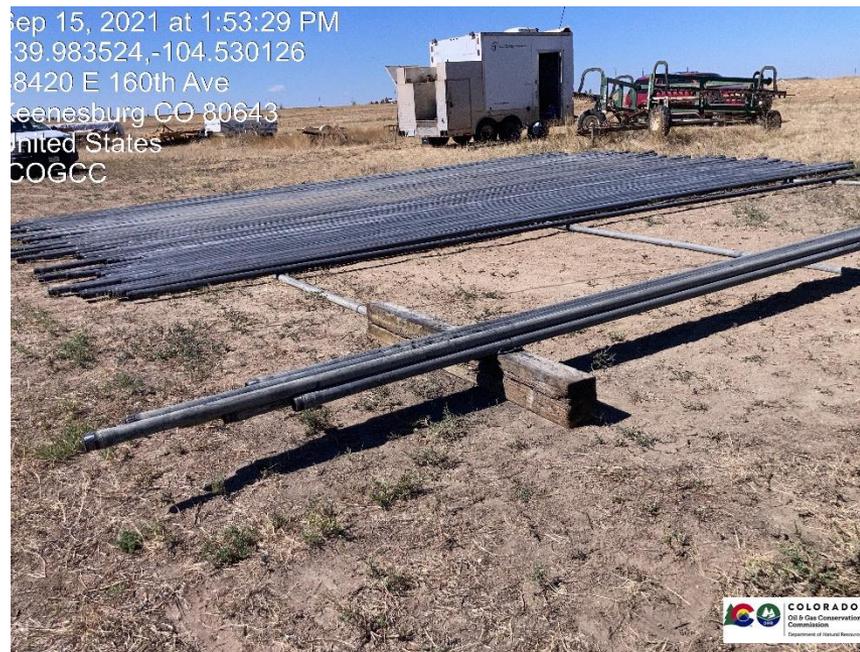
Pic 7 no containment under tubing

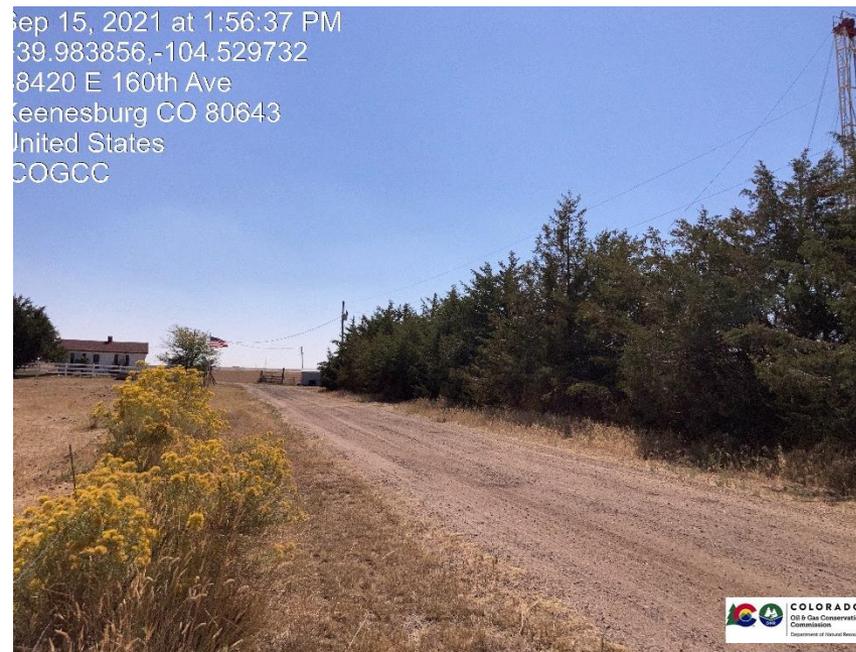
Pic 8 proximity of rig to residence was approx. 210' measured with wheel.

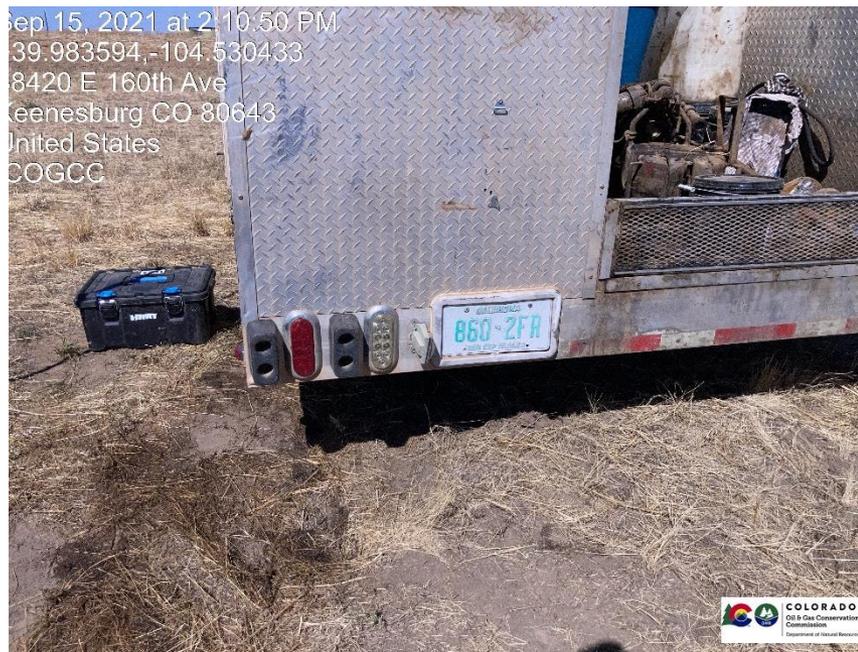
Pic 9 doghouse trailer on location

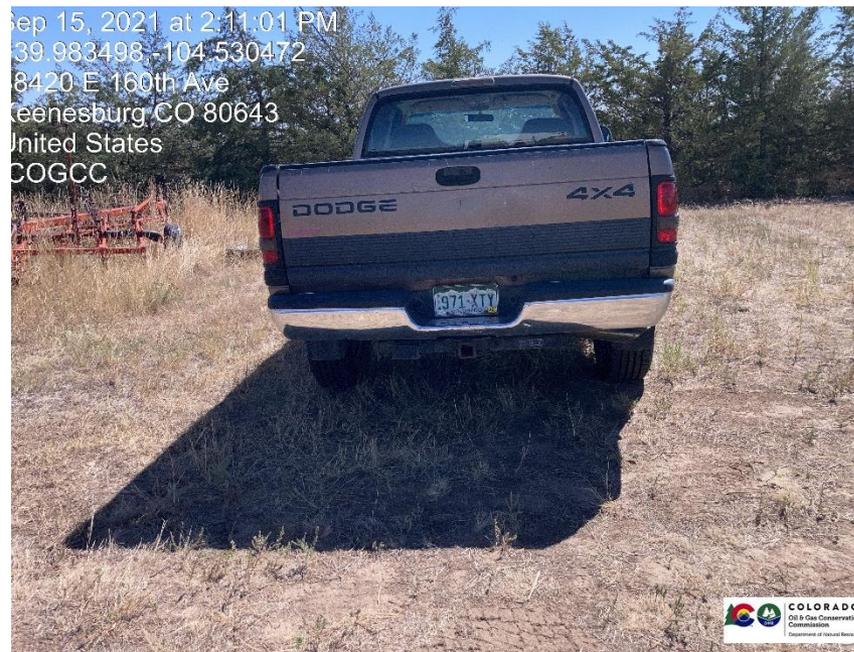
Pic 10 vehicle on location

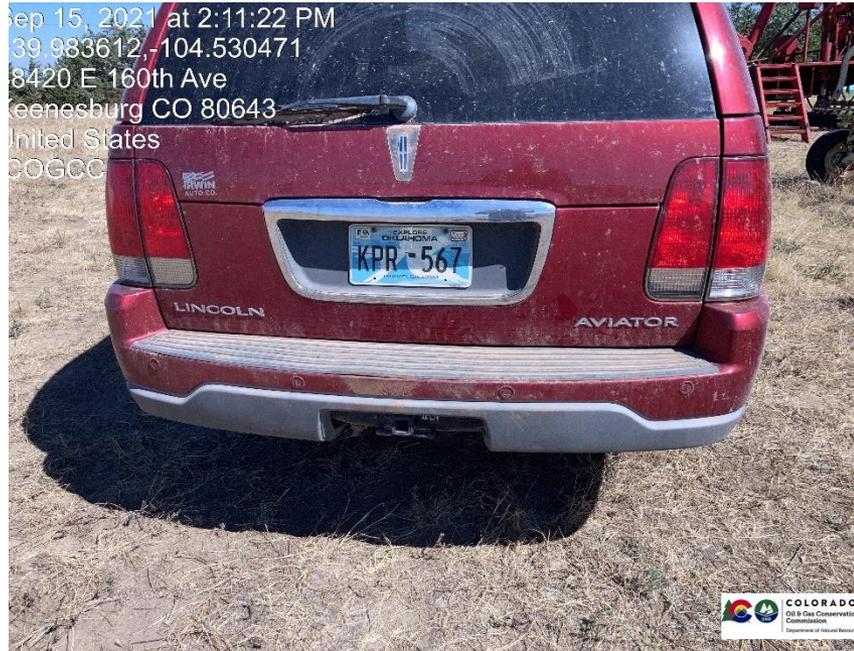
Pic 11 vehicle on location

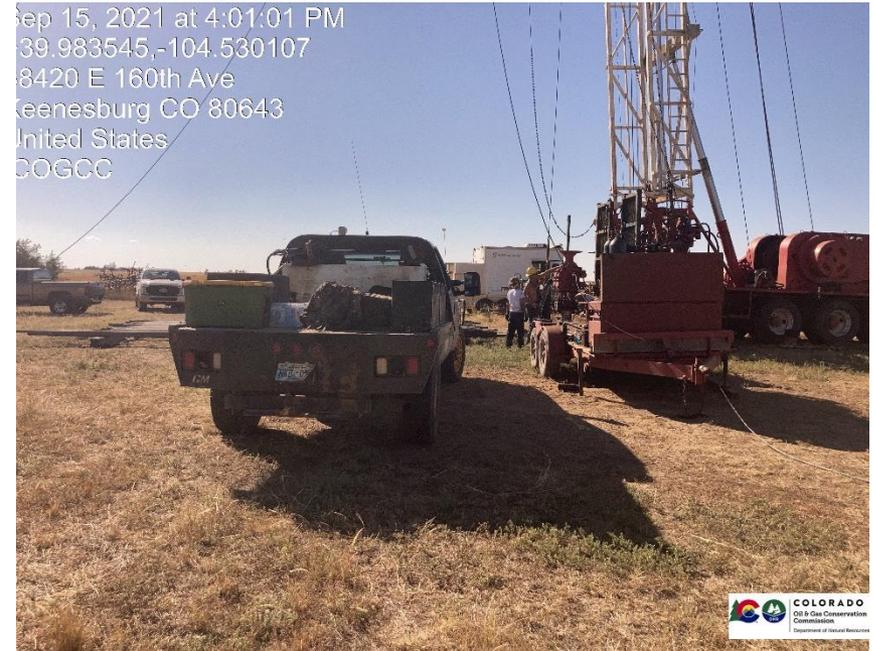
Pic 12 installation of BOP @ approx. 1630

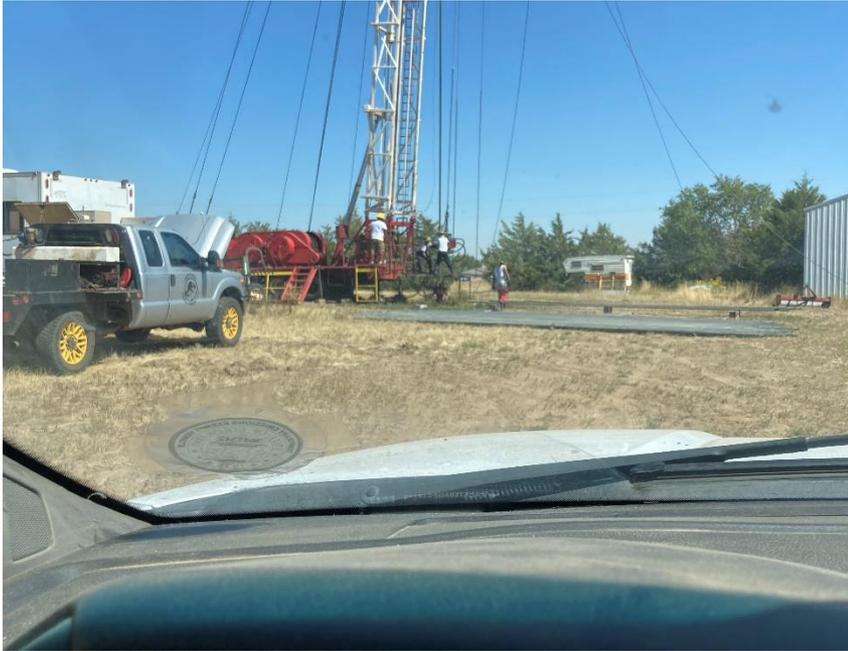
Pic 13 rig crew laying down tubing.
